**POTTERELLS FARM, STATION ROAD,
WELHAM GREEN, HERTFORDSHIRE**

HISTORIC BUILDING RECORDING

In September 2011 Archaeological Solutions conducted a photographic survey on workshops and stables at Potterells Farm, Station Road, Welham Green, Hertfordshire (NGR TL 23459 05177). The survey was undertaken as part of an application to convert the redundant workshop, stores and stables into three dwellings, with provision of new garaging, following demolition of existing silos/shed.

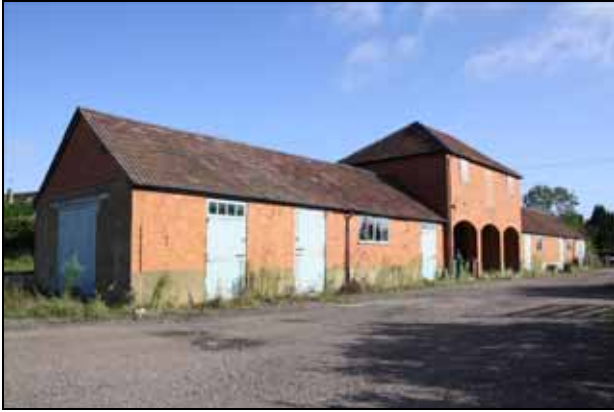
1

5.1 The building under investigation is a late 19th century brick-built agricultural building essentially aligned north-east to south-west with the principal façade facing south-east (DP 1), formerly fronting onto the farmyard and farmhouse.

Barns at Potterells Farm, south-east elevation, taken from the south

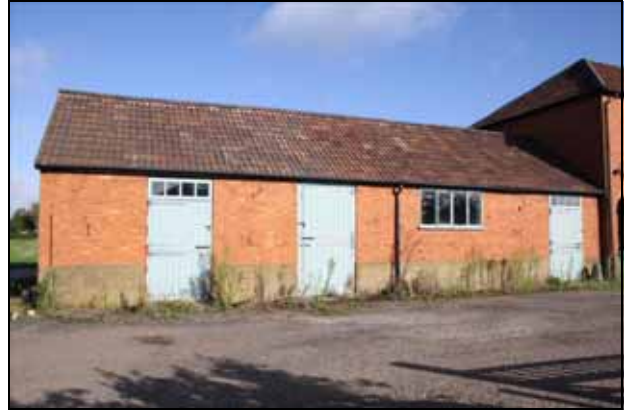
5.4 The flanking ranges are pierced by a number of doors and windows defining the individual units within, all formerly stables, workshops and similar. The doors are all of similar boarded form, all split stable doors apart from those to Unit 2 on the south-east (DP 2) and Unit 4 on the north-west (DP 11). Unit 4, in addition has double doors on the south-east, perhaps indicating this unit formed a cart shed. The south-west elevation of Unit 6 also houses double doors. The lower portion of the walls on the south-east have been

South-western range, south-east elevation, taken from the south-east

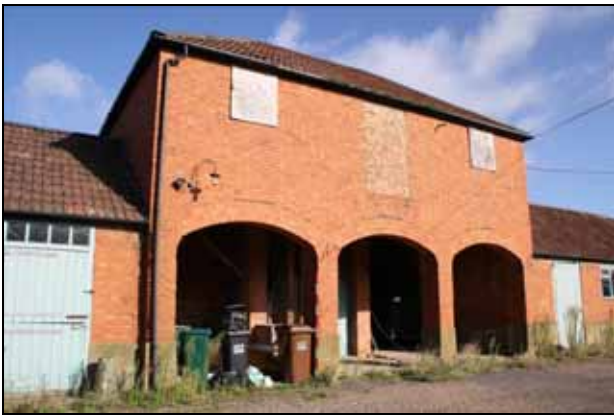
3

5.3 The south-east side of the central unit (Unit 1, DP 3) contains three wide apertures below cambered brick arches which lead to an open plan loading area at ground floor level. A loading door, blocked with Fletton brick, lies above the central arch and is flanked by small windows at eaves level, these boarded over.

Central two-storey block, south-east elevation, taken from the south-east

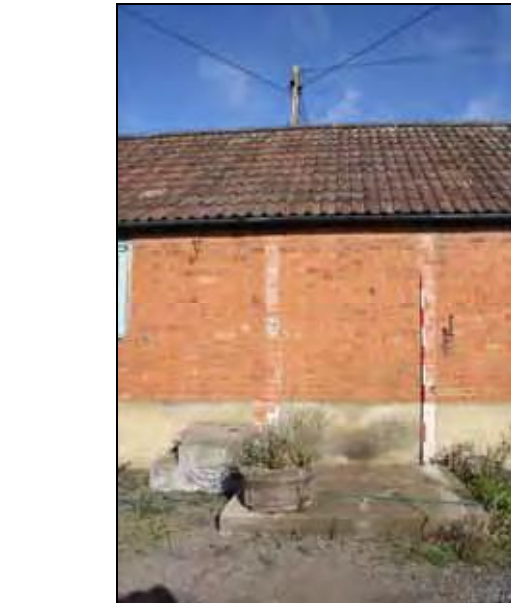
6

Evidence for a small external unit now removed, north-eastern range, south-east elevation, taken from the south-east

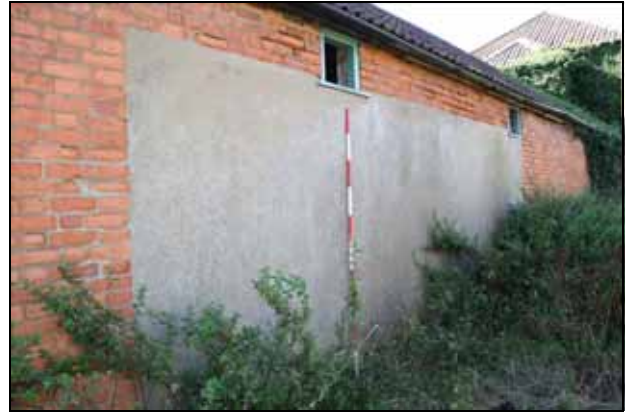
14

Rendered section and small ventilation apertures set at high level, north-eastern range, north-western elevation, taken from the north

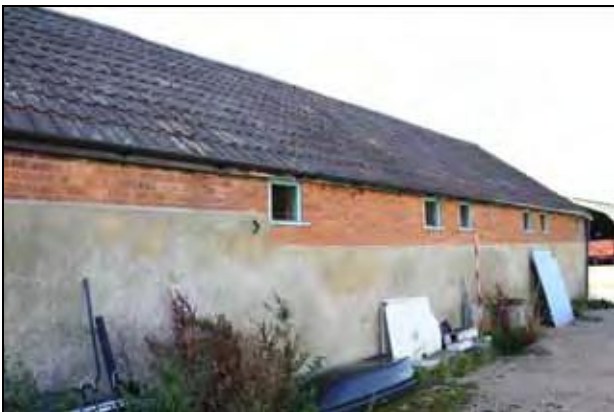
15

Rendered section and small ventilation apertures set at high level, south-western range, north-western elevation, taken from the north

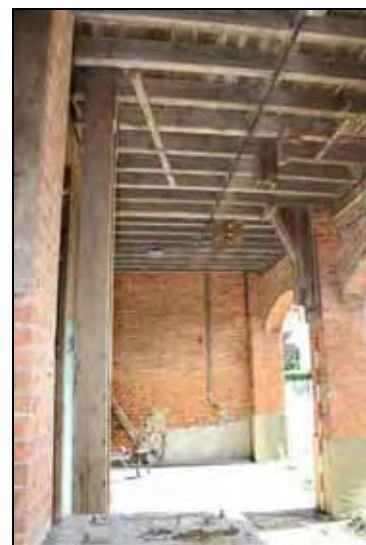
24

5.7 Unit 1, the central unit formerly comprised a loading and storing area, the three wide apertures to provide access for carts. The rear bays are largely partitioned from the rest with vertical boarding. A series of chutes pierce the ceiling above in a fairly regular manner across the front of the unit although one or two are set against the rear wall. Of most importance in this area is the survival of the Lainchbury belt and bucket elevator (DP 28 and 29) which rises from the central of this unit through the ceiling to the storage level above. This forms a system of small buckets mechanically lifted through an enclosed chute up to the floor over where the load was dispensed, presumably into bins or bags on that floor, before rotating down through the ceiling to begin another cycle. The upper floor retains additional timber elements presumably to support lost equipment, the chutes noted from below, as well as the head of the belt and bucket elevator (DP58).

Roof above the loading bay pierced by chutes, central two-storey block, taken from the south-west

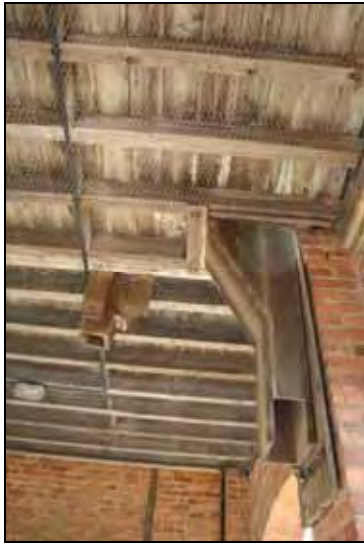
25
Chutes piercing the roof from the store above,
central two-storey block, taken from the south-west

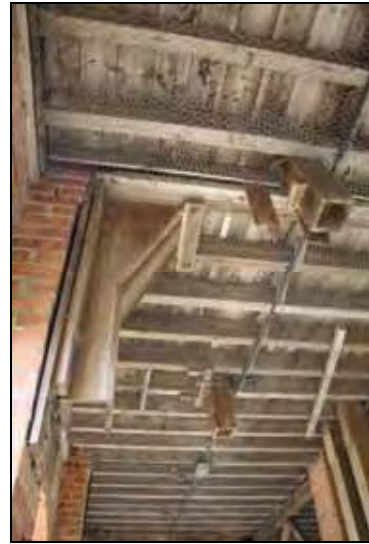
26
Chutes piercing the roof from the store above,
central two-storey block, taken from the north-east

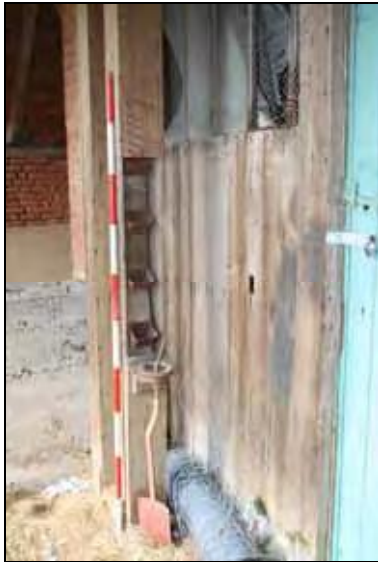
5.8 Lainchbury and Sons Ltd was a company operating from Kingham, Oxfordshire, which specialised in the manufacture of agricultural implements and machinery. The company was founded in 1862 but in 1927 took over another agricultural engineering company, Roberts of Deanshanger which had a productive range of equipment, particularly the 'Premier' and 'Litelift' elevators. Lainchbury and Sons Ltd prospered in the 1930s and 40s with their hay elevator the 'Superlite', but business subsequently fell with the introduction of combine harvesters and the decline in use of separate threshers and hay elevators. The company diversified with production of corn elevators and milking parlour equipment, but was liquidated in 1987 and taken over, the brand name disappearing.

27
Lainchbury belt and bucket elevator, loading bay,
taken from the north-east

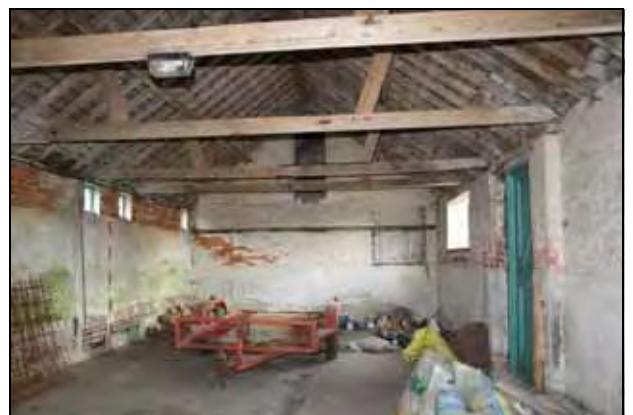
5.12 The south-west range includes Units 5 and 6 and the apparent rebuilding of the roof over this range is supported by the truncated chimney stack housed within Unit 5 (DP 38). This is a small unit with the stack on the north-west and likely formed a tack room. To the south-west, Unit 6 (DP 30) may have originally formed further stabling with split doors on the south-east as well as double doors on the south-west. This space is cement rendered at lower level conforming to 20th century hygiene regulations developed regarding housing for animals.

30
Workshop occupying south-west range, taken from
the south

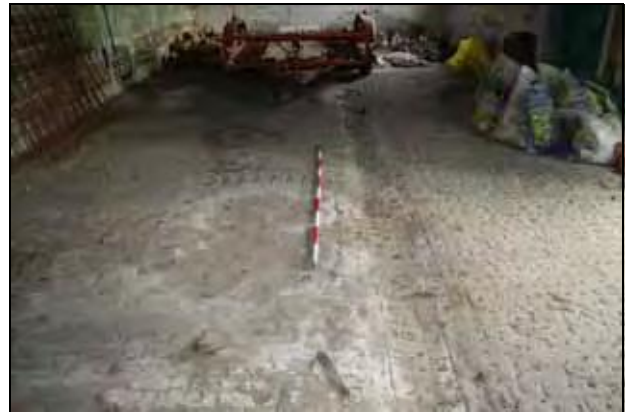
34

5.6 The units appear to have fulfilled a variety of functions. The floors in Units 3 and 6 retain a brick pavement floor (DP 34), with a central gully for drainage, while the remainder are of screed concrete and it is not known if these were originally paved. The walls throughout are of exposed painted brickwork and the roof form is of a typical 19th century construction. This consists of a double-framed truss with tie-beams and raking struts to principal rafters (DP 49). King posts are secured with coach bolts to the soffit of each tie beam and there is a single purlin per pitch over which common rafters rise to a ridgeboard at the apex. This can be seen over the central unit (Unit 1) and the north-east range, although it appears that the roof of the south-west range may have been rebuilt and simply comprises tie-beams with raking struts to a single purlin in each pitch with common rafters riding over to a ridgeboard in the apex (DP 31). Where there are ceilings, they are all of softwood with slender regularly-spaced common joists all with laced bracing typical of a late 19th century date.

Brick floor with central drain, workshop occupying south-west range, taken from the south-west

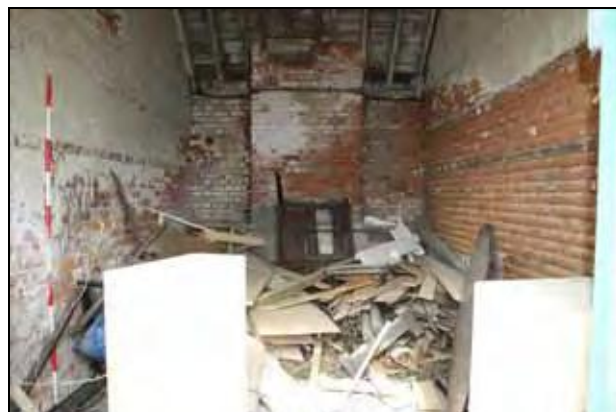
38
Stables occupying the south-west range, taken from the south-east

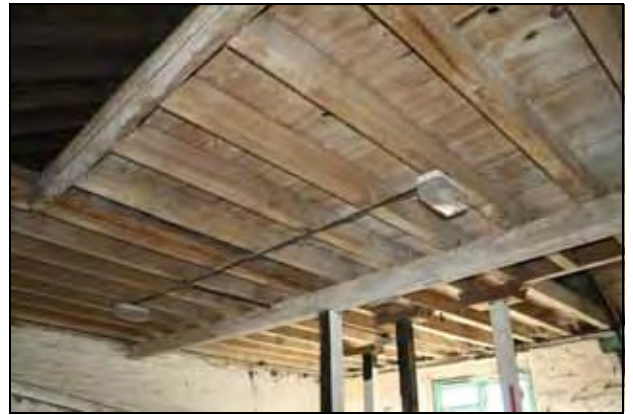
46

5.10 Unit 3 forms a stable block with a brick floor and painted brick walls. A series of timber partitions and gates survive, enclosing a number of stalls (DP 42-45). A ceiling in this area forms a hayloft in the roof space above which hatches towards the outer edges framed by trimmers for pitching hay down to the mangers below (DP 46).

Roof above the stables in the north-eastern range, taken from the west

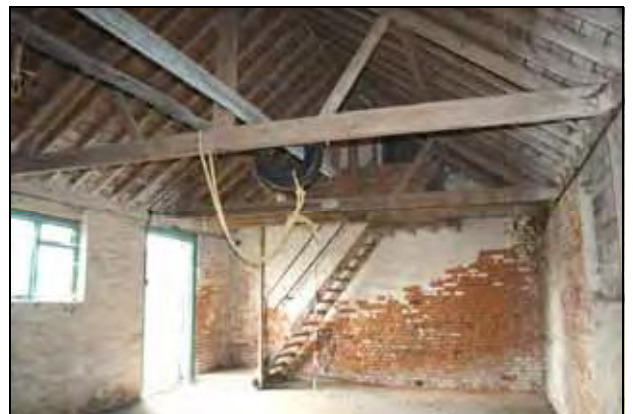
48

5.9 Unit 2 (DP 48), in the north-east range, may have originally comprised storage or a workshop and is given access through a standard boarded door. The first floor of Unit 1 is reached up a simple timber ladder stair which rises within a small timber-framed and weatherboarded stair turret at upper level.

Storage area within the north-eastern range, taken from the north

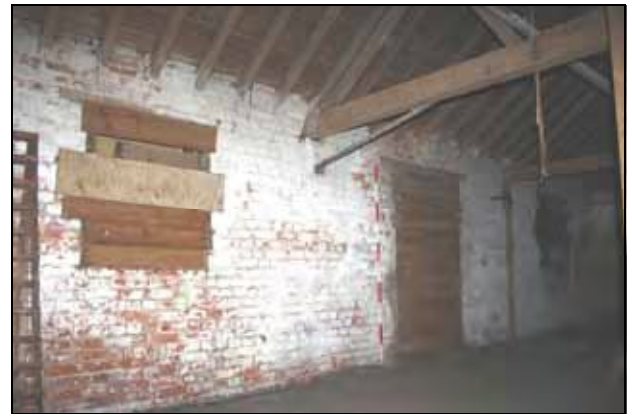
52

Blocked windows flanking central loading door also blocked, storage loft, south-east wall, taken from the north

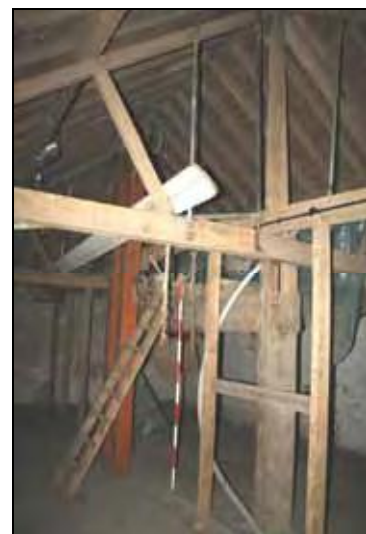
54

Wooden frame supporting machinery and modern water tank, storage loft, taken from the east

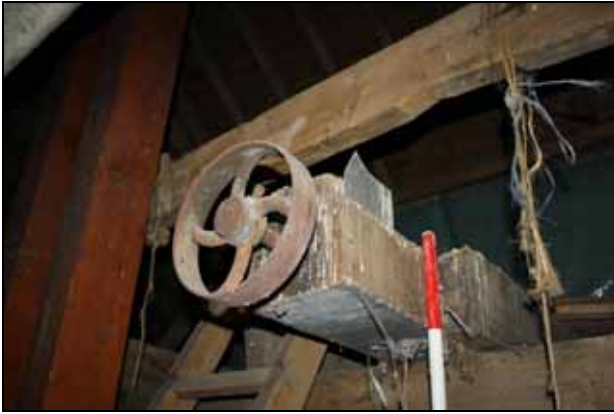
55

Pulley wheel supported by frame work, storage loft, taken from the east

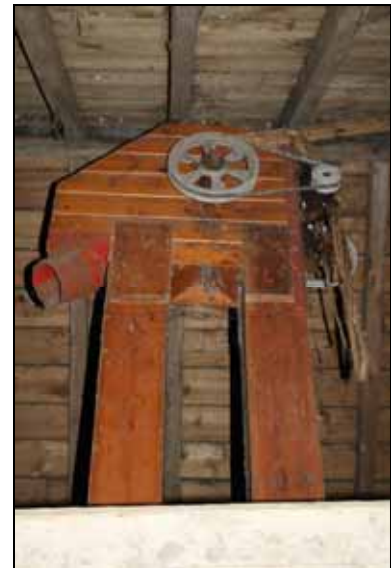
58

Lainchbury belt and bucket elevator, storage loft, taken from the south-east

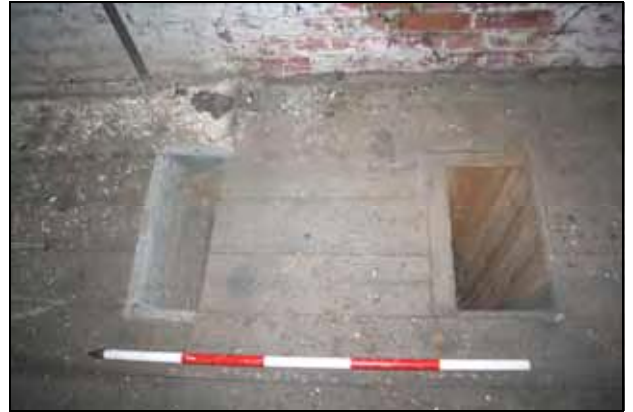
60

Chutes in the floor leading to the enclosed area within the loading bay, storage loft, taken from the south-east

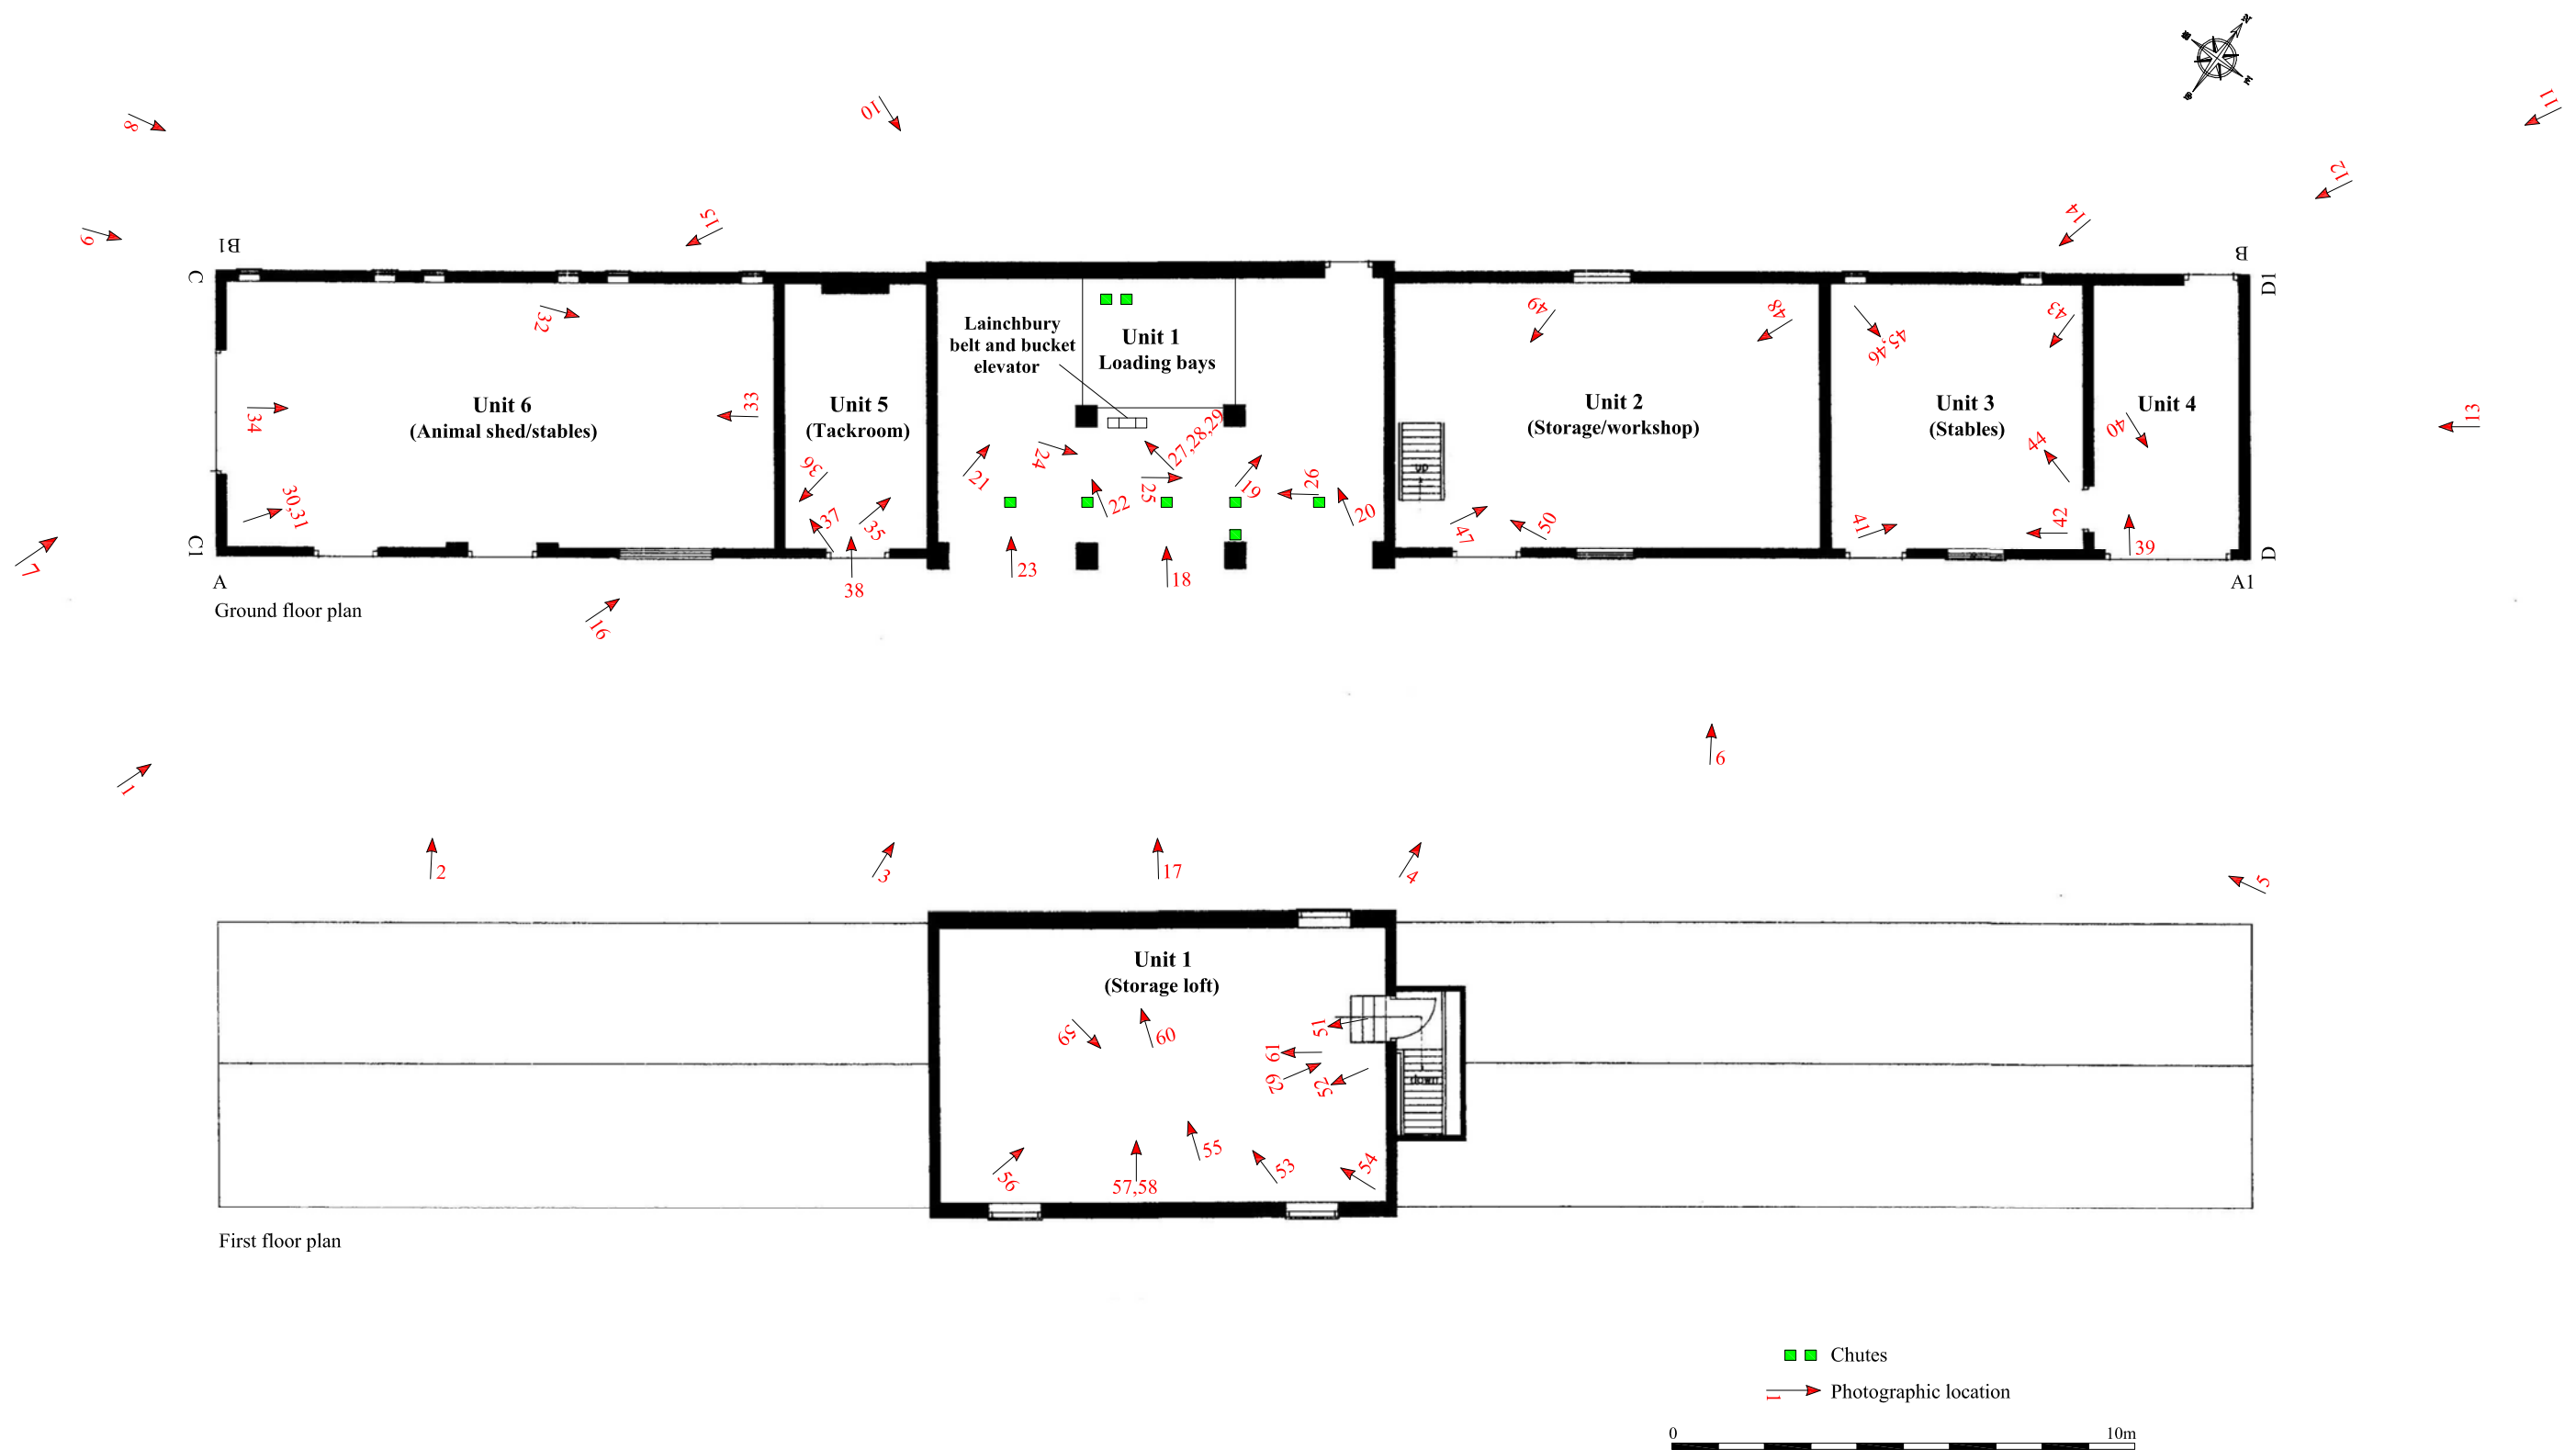
Fig. 2 Photographic location plan

5.5 Internally the building is divided into a number of discrete units, given numbers and marked on Fig. 2, their possible former functions also noted.
