**THE FORMER THAMES PAPER BOARD MILLS
PURFLEET, THURROCK
ESSEX**

**HISTORIC BUILDING RECORDING
Level 1-3**

HISTORIC BUILDING RECORDING

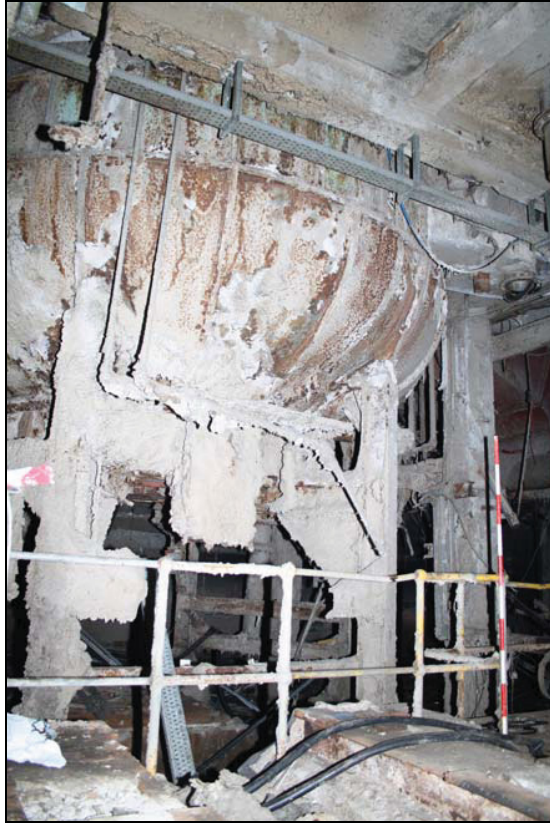
Plate 5 Base of hydro-pulper, ground floor, Building 4, taken from the north-west (DP 217)

5.17 The main machine spanned all levels of the building. At the western end, the remains of a cydro-pulper survives, which dealt with broken or spoilt paper products before being returned as raw material through a series of pipes back to the beginning of the process. On this level, the western projection was used as a warehouse for finished goods which were then distributed to the loading bay beyond. There are some offices on the southern elevation but these are of no interest.

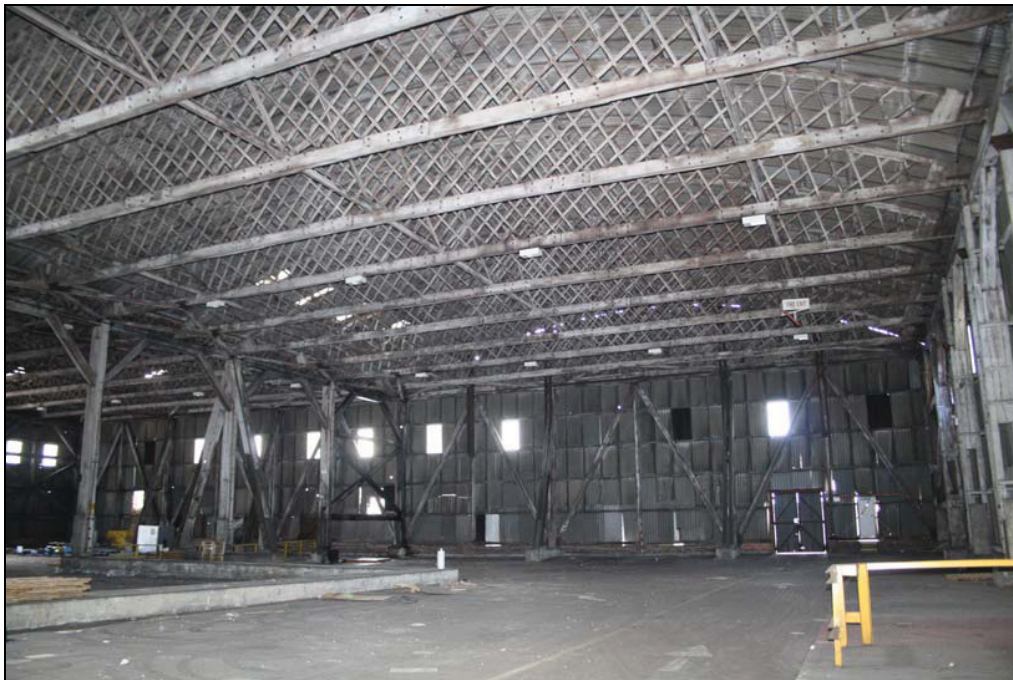
Plate 8 Interior, south-western unit, Building 6, taken from the north-west (DP 195)

5.26 Building 6 is an unusual survival in being, for its date, constructed almost entirely of timber, with Belfast trusses of impressive span in the manner of a First World War aircraft hangar (Plate 8). Originally the building comprised four identical units, but the north-eastern quadrant was demolished in the 1960s to make way for the north mill. From its original concept the building has been modified slightly on several occasions with low blockwork sub-divisions and some brick replacement of the plinth, but its simple structural form remains intact.

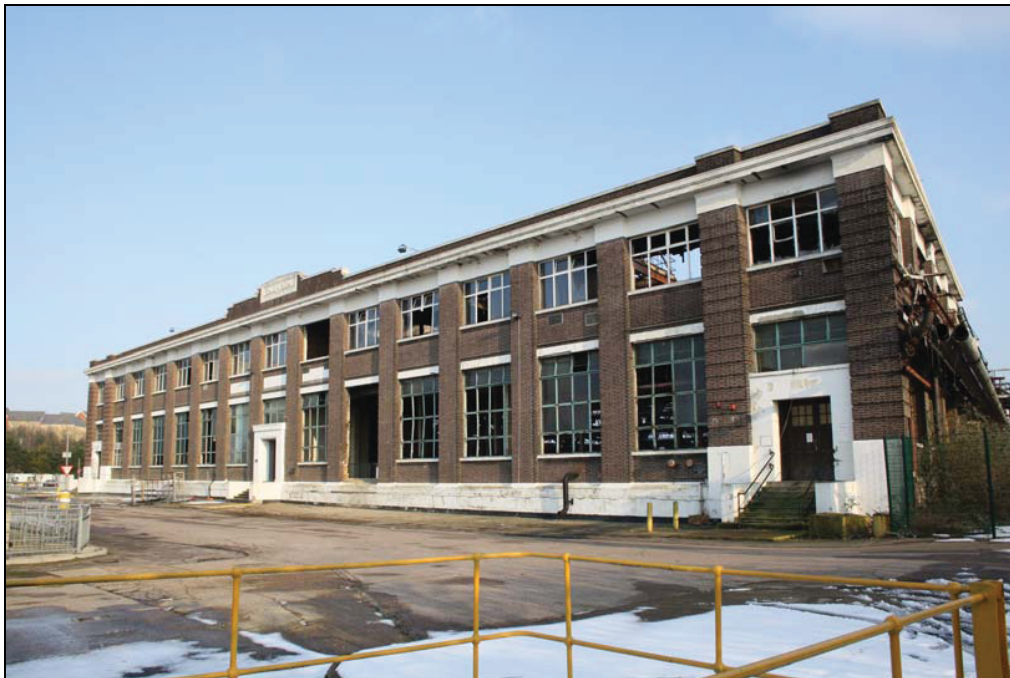
Plate 13 Main frontage, west elevation, Building 10, taken from the south-west (DP 84)

5.38 The main frontage, and much of the south elevation overlooking the railway and machine houses accommodated administration in the upper floors skirting the main factory floor, which lies concealed to the rear. To Mill Road, its fifteen bays are defined by large brick piers framing upper and lower steel casement windows, incorporating a three-bay shallow central frontispiece framing the main door. The outer bays are slightly narrower in proportion but embellished with rusticated quoins framing the doors. Despite the ransacking of the building, the north door preserves a little scrolled iron bracket supporting an overdoor lamp, while the original south doors of panelled oak survive. The main entrance formed an impressive introduction, with reconstituted stone laid as ashlar blocks to the door mouldings, reached by a flight of enclosed steps (Plate 14). Flush panels below the upper windows once proclaimed, in high letters: Thames Board Mills Ltd, but these have long been painted out and are only now re-emerging through the decay of the overlying paint. The centrepiece is topped by a slightly raised parapet in two stages with curved stone capping, with the raised dates of 1903 and 1924 in the flush panels, commemorating the major dates in the mill's history.

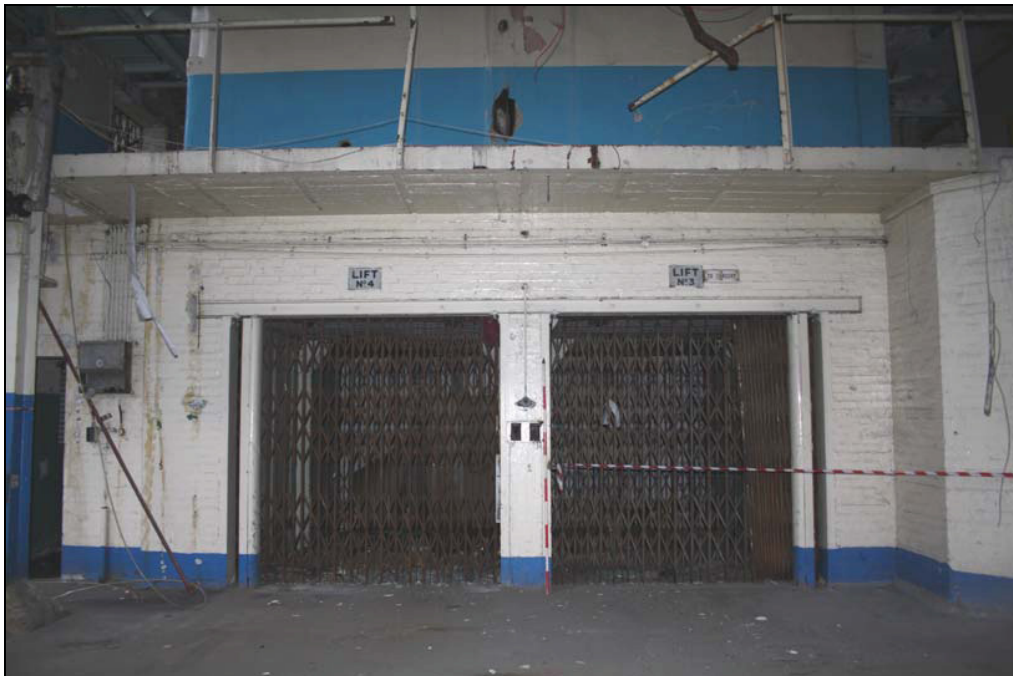
Plate 20 Freight lifts, Building 10, taken from the north (DP 104)

5.64 Rolador shutters, flanked by fixed windows provide access to the loading bays on the north as noted above, while further large apertures on the west serve the modern loading bays, some enclosed by roller shutters. Various freight lifts also remain in situ on the north and south with metal concertina doors and manufacturing plates with the date 1930.

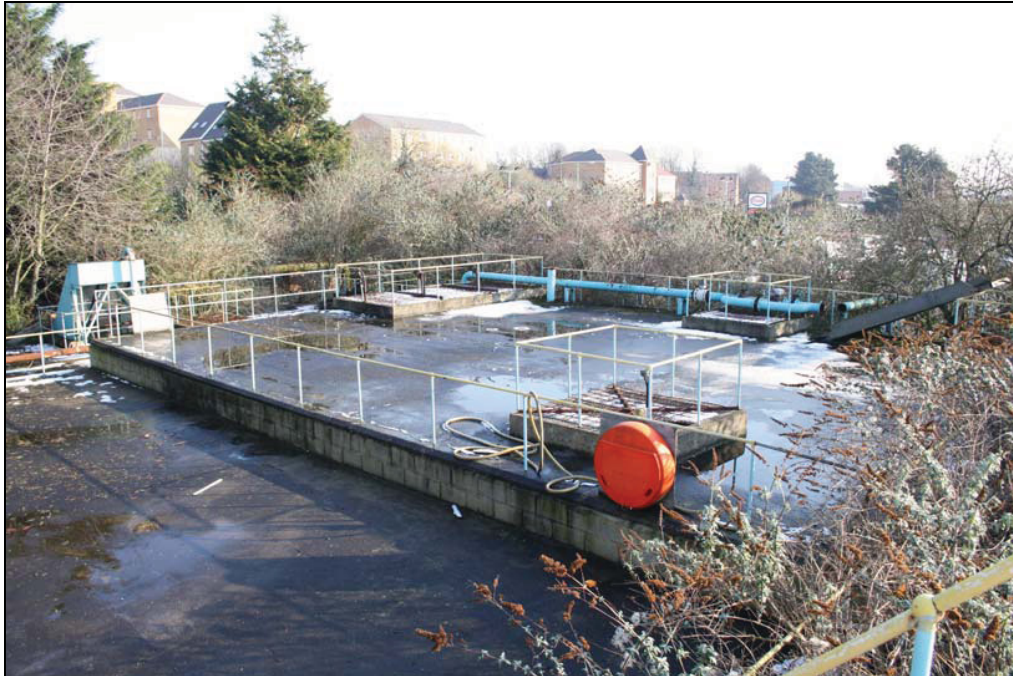
Plate 33 Reservoir, Building 18, taken from the south-east (DP 33)

5.88 Building 18 is a square unobtrusive block housing two covered reservoirs and associated with two smaller buildings to the south-west and immediately to the north. An inscription in the cement on the south side indicates a date of 1965. If so, it replaces a smaller late 19th century example visible on the 1897 map.

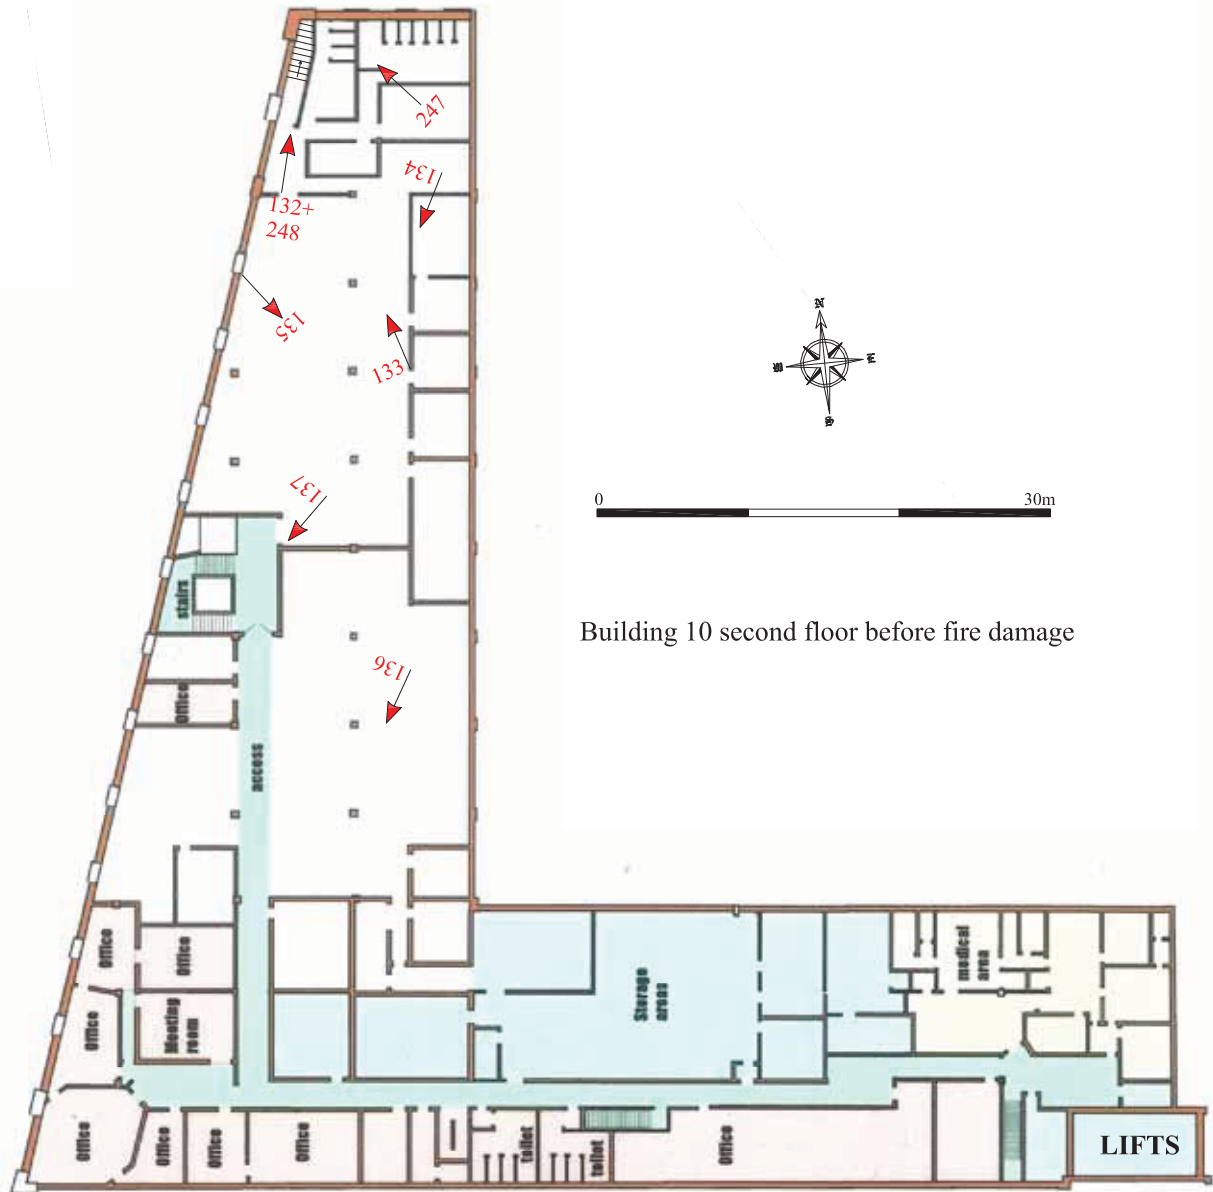
Archaeological Solutions Ltd
Fig. 19 Building 10, second floor & mezzanine
 Scale 1:500 at A4

Building 10 second floor before fire damage

Building 10 First floor mezzanine (south)

5.59 The southern part of the area could only be glimpsed from a distance, as the fire has deformed much of the steelwork and access was not possible. Latterly, the area appears to have been divided into small offices, many with plasterboard partitioning, but a few earlier, timber and glazed walls of 1920s date survive, albeit in a charred condition. The south-west corner room was clearly of some importance, as an enriched plaster ceiling can be glimpsed from the exterior. Latterly the area housed a dentist and medical rooms.
