**CHURCH VIEW, CHURCH LANE, WIDDINGTON,  
ESSEX**

**AN ARCHAEOLOGICAL EVALUATION**

Authors: Christopher Leonard (Fieldwork & report) Peter Thompson MA (Desk-based assessment) Antony Mustchin MSc (Editor)	
NGR: TL 5391 3168	Report No: 4032
District: Uttlesford	Site Code: WDCV12
Approved:	Project No: P4691
Signed:	Date: March 2012 Revised: May 2012

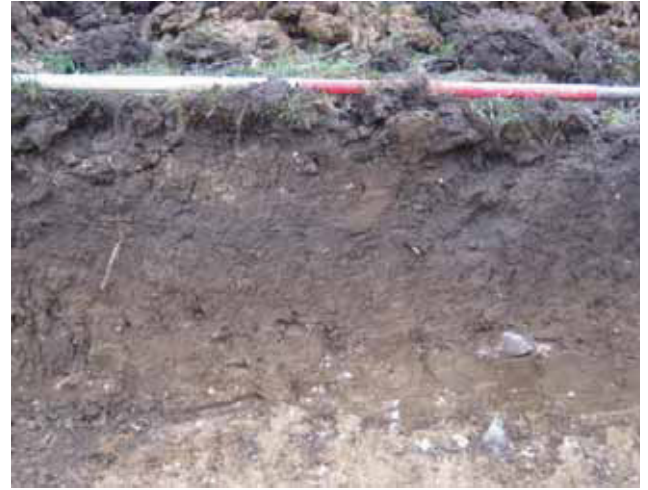
2  
*Sample section 1A. Looking south.*

Sample Section 1A (DP 2)		
West end, north facing.		
0.00= 103.20m		
0.00- 0.34m	L1002	Topsoil. Firm, dark greyish brown, silty clay.
0.34- 0.58m	L1003	Subsoil. Firm, mid yellowish brown, silty clay.
0.58m +	L1006	Natural. Compact, mid brownish yellow clay and chalk.
Sample Section 1B (DP 3)		
East end, north facing.		
0.00= 104.12m		
0.00- 0.24m	L1002	Topsoil. As above.
0.24- 0.48m	L1003	Subsoil. As above.
0.48m +	L1006	Natural. As above.

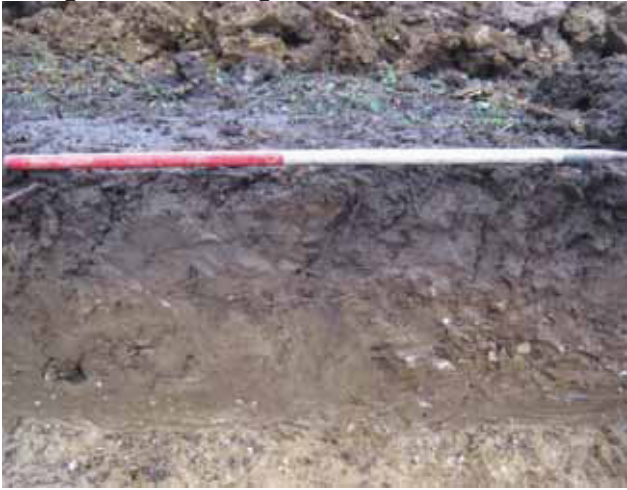
3  
*Sample section 1B. Looking south.*

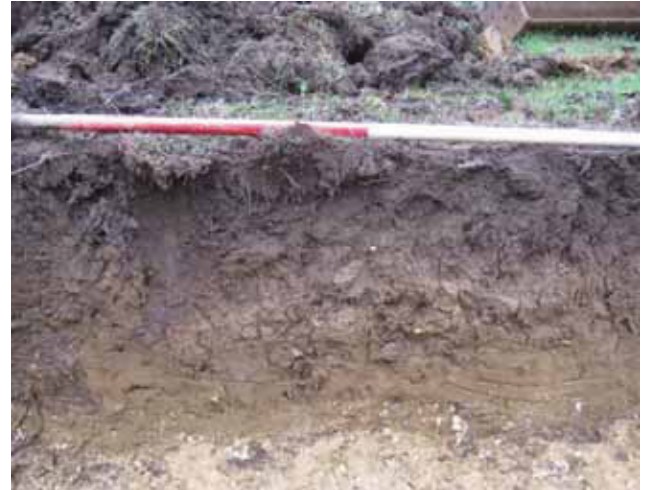
4  
*Sample section 2. Looking northwest.*

Sample Section 2 (DP 4) Southwest end, northwest facing. 0.00= 101.89m		
0.00- 0.20m	L1002	Topsoil. As above, Tr.1.
0.20- 0.47m	L1003	Subsoil. As above, Tr.1.
0.47m +	L1006	Natural. As above, Tr.1.

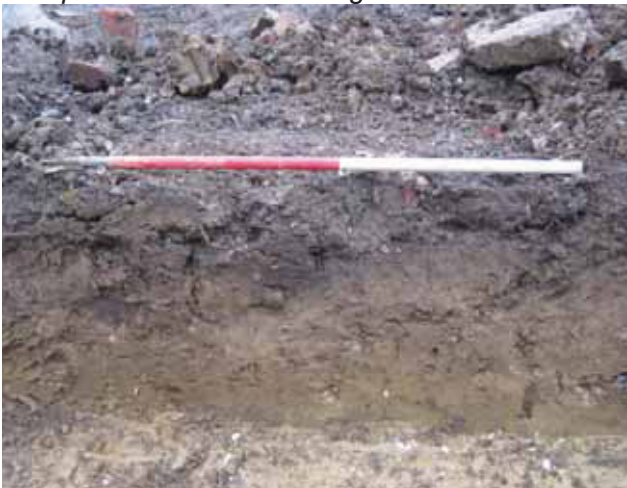
5  
*Sample section 3. Looking east.*

Sample Section 3 (DP 5) North end, west facing. 0.00= 101.58m		
0.00- 0.20m	L1000	Layer of demolition material.
0.20- 0.45m	L1002	Topsoil. As above, Tr.1.
0.45- 0.60m	L1003	Subsoil. As above, Tr.1.
0.60m+	L1006	Natural. As above, Tr.1.

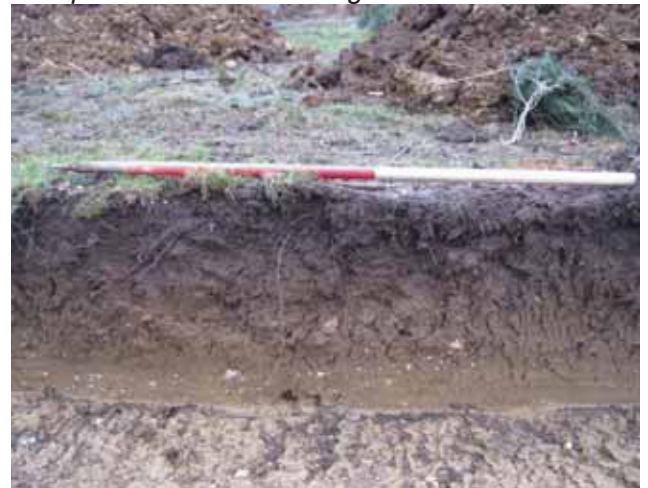
6  
*Sample section 4A. Looking east.*

Sample Section 4A (DP 6) South end, west facing. 0.00= 102.01m		
0.00- 0.21m	L1002	Topsoil. As above, Tr.1.
0.21- 0.44m	L1003	Subsoil. As above, Tr.1.
0.44m +	L1006	Natural. As above, Tr.1.

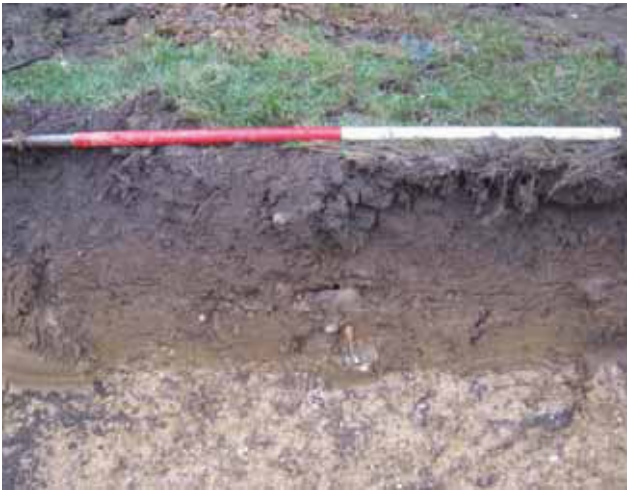
7  
Sample section 4B. Looking east.

Sample Section 4B (DP 7) South end, west facing. 0.00= 104.03m		
0.00- 0.27m	L1002	Topsoil. As above, Tr.1.
0.27- 0.49m	L1003	Subsoil. As above, Tr.1.
0.49m +	L1006	Natural. As above, Tr.1.

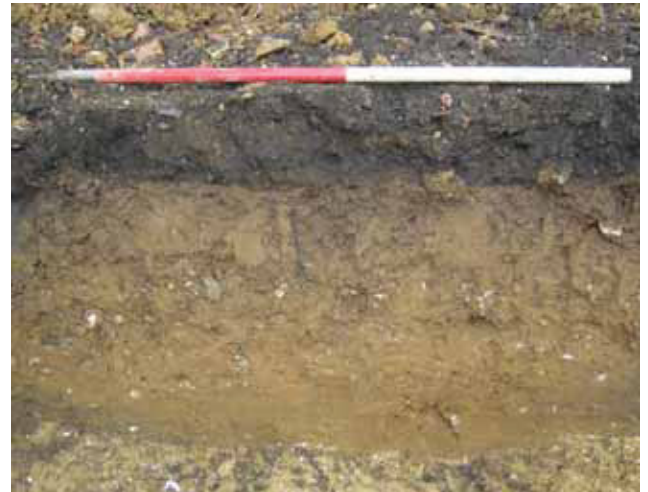
8  
Sample section 5A. Looking north.

Sample Section 5A (DP 8) West end, south facing. 0.00= 101.21m		
0.00- 0.16m	L1001	Gravel and tarmac drive way.
0.16- 0.34m	L1002	Topsoil. As above, Tr.1.
0.34- 0.76m	L1004	Made ground. Compact, mid orange-brown, silty clay.
0.76m +	L1006	Natural. As above, Tr.1.

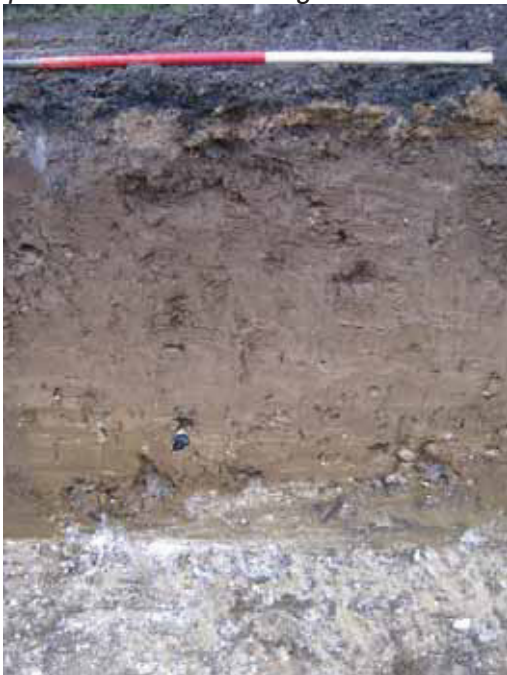
9  
Sample section 5B. Looking south.

Sample Section 5B (DP 9)		
West end, north facing.		
0.00= 101.98m		
0.00- 0.15m	L1001	Gravel and tarmac drive way.
0.15- 0.66m	L1004	Made ground. As above, Tr.5A.
0.66- 1.18m	L1005	Made ground. Compact, light brownish yellow, silty clay.
1.18m +	L1006	Natural. As above, Tr.1.

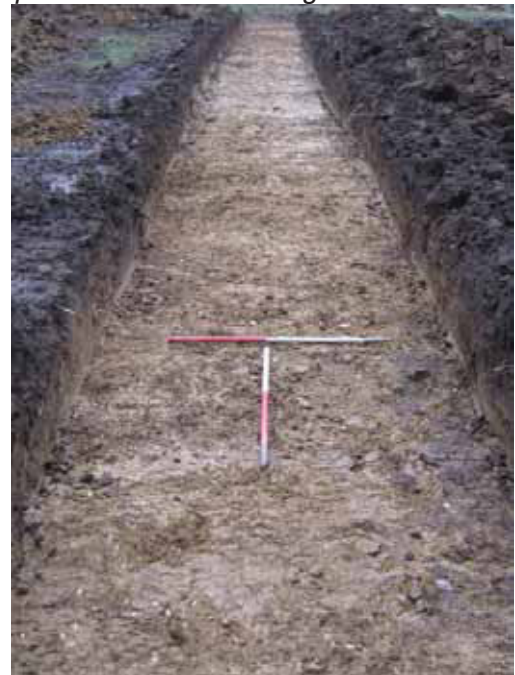
10  
Trial trench 1. Looking west.

*Description: Trench 1 contained undated Ditch F1007.*

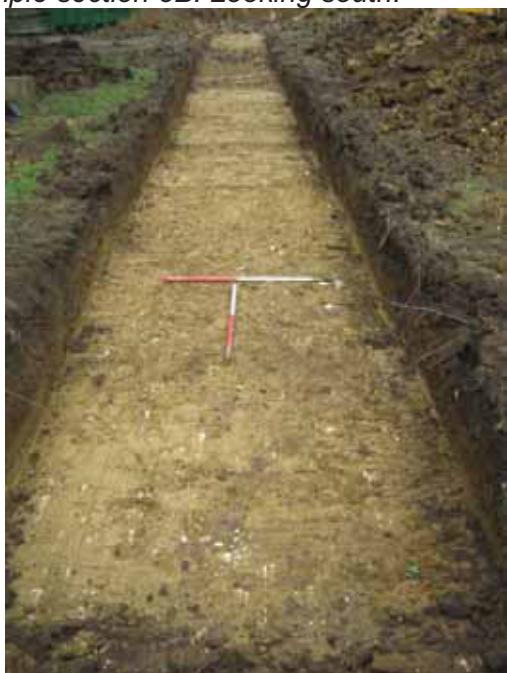
11  
Trial trench 2. Looking Northwest.

*Description: Trench 2 contained a modern drain and soakaway pit and two trenches relating to the demolition of Church View house.*

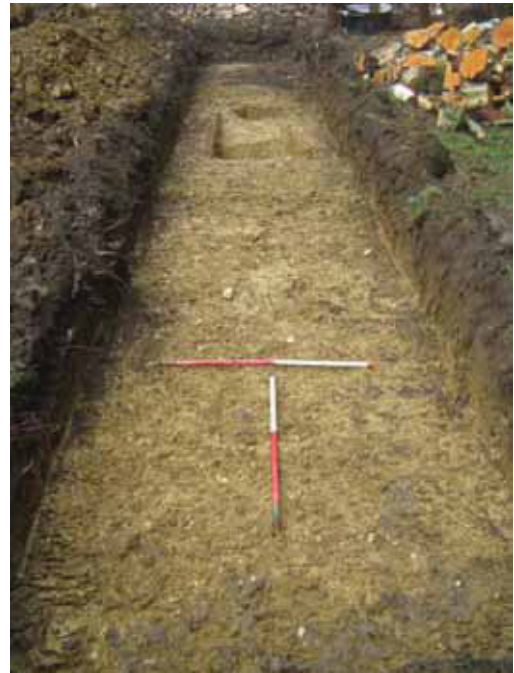
14  
*Trial trench 4B. Looking north.*

*Description: Trench 4B contained two undated ditches, F1015 and F1019, and a curvilinear gully, F1017, which cut both ditches. F1017 may have been modern.*

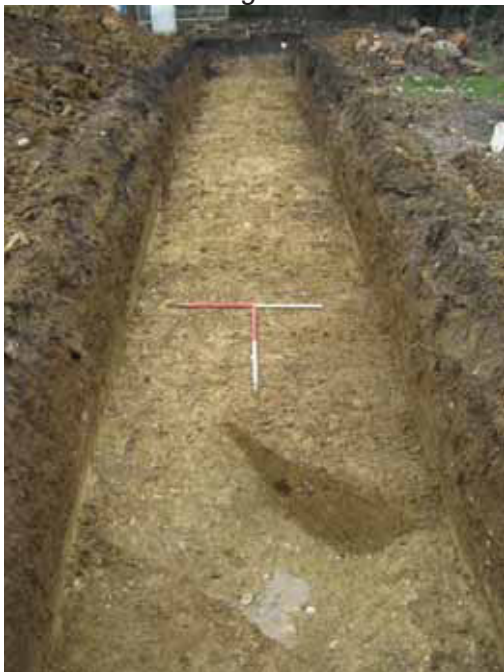
15  
*Trial trench 5A. Looking west.*

*Description: Trench 5A contained undated Ditch F1009.*

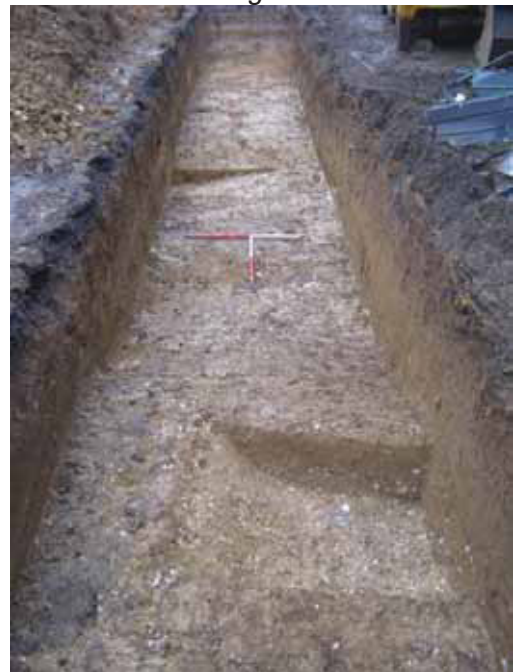
16  
*Trial trench 5B. Looking east.*

*Description: Trench 5B contained undated Ditch F1011, a continuation of F1009 (Trench 5A).*

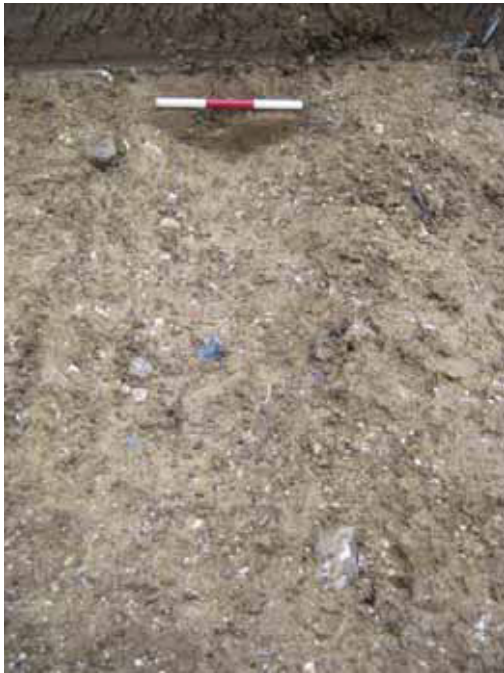
17  
F1007. Looking north.

Ditch F1007 was linear (1.3+ x 0.35 x 0.09m), orientated north/south. It had shallow, gently sloping sides and a concave base. F1007 had its northern terminus within the trench and extended beyond the trench to the south. Its fill, L1008, was a firm, mid brownish orange silty clay with occasional small, rounded flint and occasional chalk flecks. No finds were present within the fill.

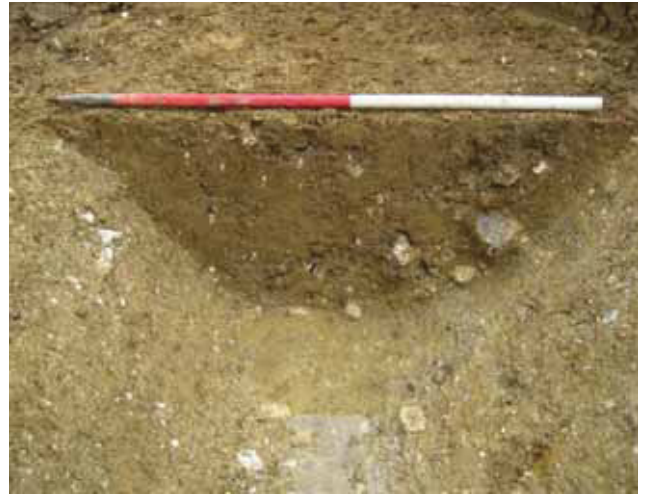
18  
F1009. Looking southeast.

Ditch F1009 was linear (4.22+ x 1.35 x 0.49m), orientated northwest / southeast. It had steep sides and a flattish base. Its fill, L1010, was a firm, mid orange-brown clay-silt with moderately frequent small, medium and large sub-rounded flint. Animal bone (98g) was recovered from the fill. Ditch F1009 was also excavated in Trench 5B (F1011).

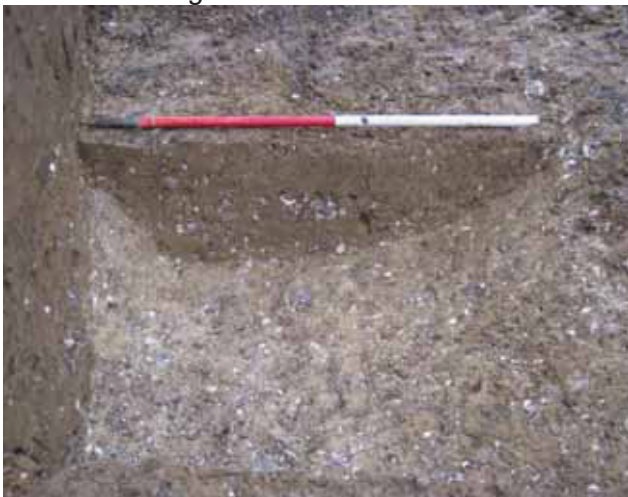
19  
F1011. Looking west.

Ditch F1011 was linear (4.64+ x 1.22+ x 0.35m), orientated northwest/southeast. It had steep sides and a flattish base. Its fill, L1012, was a compact, mid orange-brown silty clay with moderately frequent small, medium and large sub-rounded flint. No finds were present. F1011 was a continuation of F1009 (Tr. 5A)

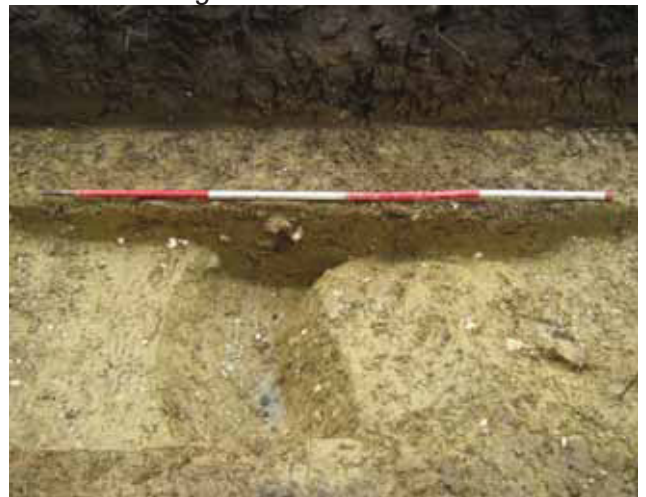
20  
F1015, F1017 & F1019. Looking west.

Ditch F1015 was linear (1.90+ x 1.80 x 0.20m), orientated east/west. It had shallow, gently sloping sides and a concave base. Its fill, L1016, was a moderately compact, mid brownish yellow silty clay with occasional small, sub-angular flint and occasional chalk flecks. No finds were present within the fill. F1015 cut Ditch F1019 and was cut by Gully F1017.

Gully F1017 was curvilinear (2.20+ x 0.68 x 0.45m). It had moderately steep sides and a flattish base. Its fill, L1018, was a moderately compact, mid orange-brown silty clay with moderately frequent chalk flecks and small, sub-rounded flint. L1018 also contained occasional large, rounded flint nodules. No finds were present within the fill. F1017 cut Ditches F1015 and F1019. Gully F1017 appeared to be modern based on its profile of very steep sides. Its backfill included a large number of large flint nodules, distinct from the smaller flint inclusions contained within the backfills of the other features. It was located near to a modern pond within the garden of Church View house and may have been a drainage feature associated with the pond.

Ditch F1019 was linear (2.65+ x 0.95 x 0.16m), orientated northeast/southwest. It had shallow, gently sloping sides and a gradual break of slope to a broad, flat base. Its fill, L1020, was a moderately compact, mid brownish grey silty clay with moderately frequent chalk flecks and occasional small, sub-rounded flint nodules. No finds were present within the fill. F1019 was cut by Ditch F1015 and Gully F1017.
