**DANSON CARE HOME, GLYNDE ROAD, BEXLEYHEATH,
LONDON BOROUGH OF BEXLEY**

ARCHAEOLOGICAL MONITORING AND RECORDING

Authors:	Adam Dyson BA Joseph Bampton MA	(Fieldwork and report) (Fieldwork and report)
NGR: TQ 48028 75654		Report No: 4044
Borough: Bexley		Site Code:
Approved: Claire Halpin		Project No: 4476
Signed:		Date: March 2012

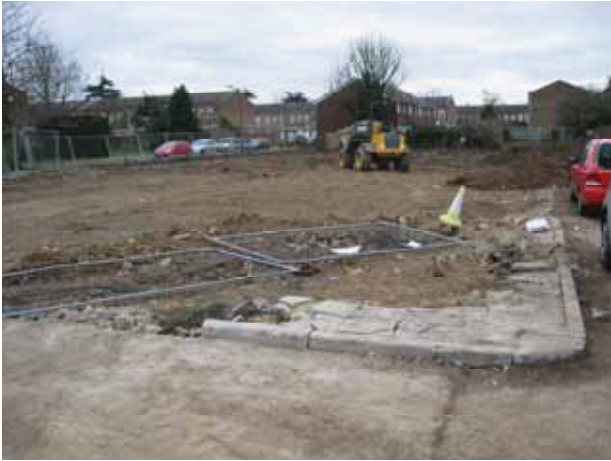
1
*General view of the eastern side of site.
Looking south.*

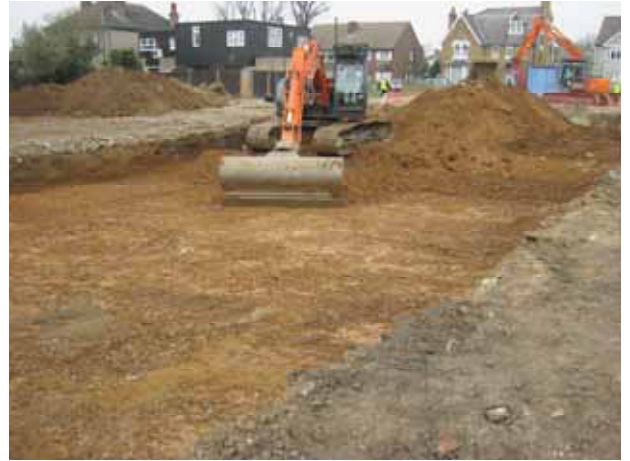
2
*General view of the basement excavations.
Looking north west.*

4.2 The basement excavations covered the entire area of the proposed eastern building (47 x 16m; Fig.3). The excavation was carried out using a tracked 360° excavator fitted with a smooth bladed ditching bucket. The later stages of the excavation were solely within natural geological deposits and therefore did not require archaeological monitoring.

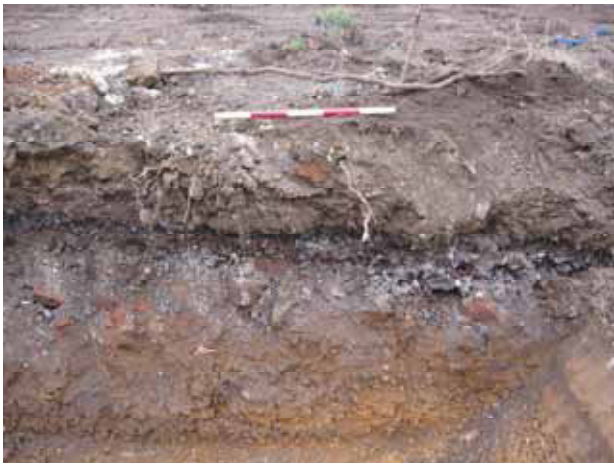
3
Sample section 1. Looking east.

<i>South end, west facing</i>		<i>DP 3</i>
<i>0.00m = 48.06m AOD</i>		
0.00 – 0.53m	L1001	Made Ground. Loose mixed modern rubble within a mid grey brown sandy silt.
0.53 – 0.72m	L1002	Subsoil. Mid - light orange brown, compact, silt.
0.72m+	L1003	Natural. Light orange and yellow, compact clay and gravel.

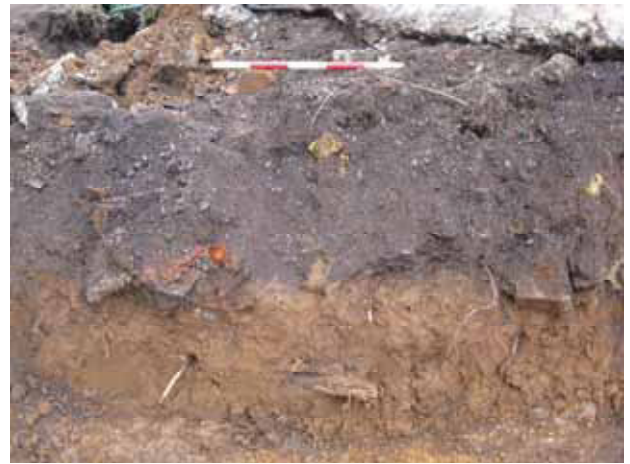
4
Sample section 2. Looking west.

<i>South end, east facing</i>		<i>DP 4</i>
<i>0.00m = 48.01m AOD</i>		
0.00 – 0.38m	L1001	Made Ground. As above.
0.38 – 0.80m	L1002	Subsoil. As above.
0.80m+	L1003	Natural. As above.

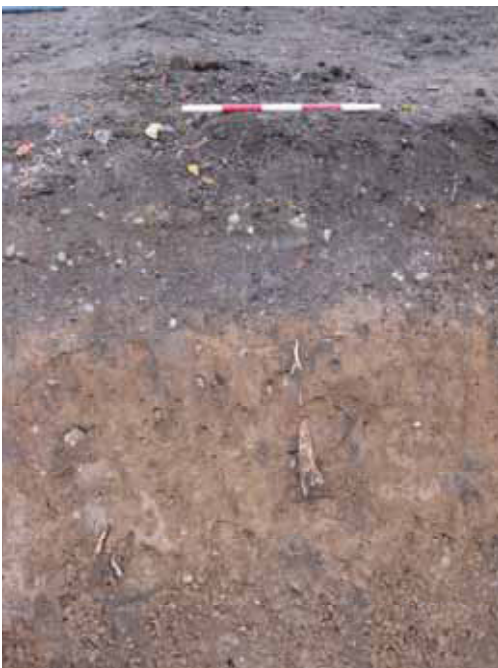
5
Sample section 3. Looking south.

<i>South end, north facing</i>		<i>DP 5</i>
<i>0.00m = 47.97m AOD</i>		
0.00 – 0.32m	L1001	Made Ground. As above.
0.32 – 0.65m	L1002	Subsoil. As above.
0.65m+	L1003	Natural. As above.

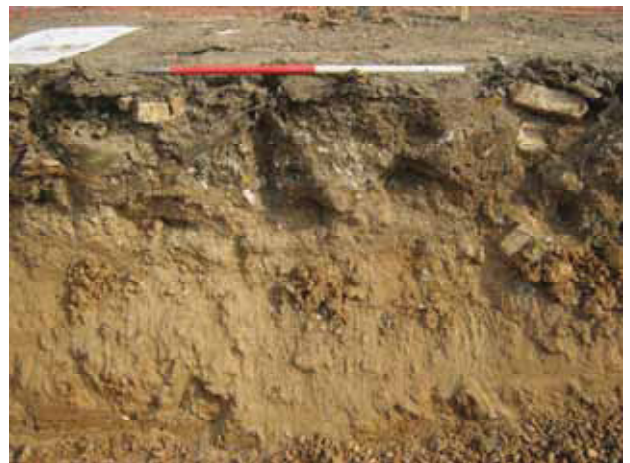
6
Sample section 5. Looking east.

<i>Centre, west facing</i>		<i>DP 6</i>
<i>0.00m = 48.21m AOD</i>		
0.00 – 0.82m	L1001	Made Ground. As above.
0.82 – 1.20m+	L1003	Natural. As above.

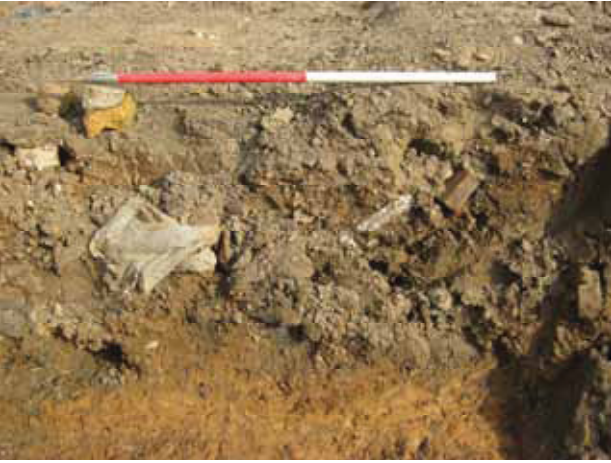
7
Sample section 6. Looking east.

<i>North end, west facing</i>		<i>DP 7</i>
<i>0.00m = 48.14m AOD</i>		
0.00 – 0.78m	L1001	Made Ground. As above.
0.78 – 0.92m+	L1003	Natural. As above.
