ST MARY'S ROMAN CATHOLIC PRIMARY SCHOOL, GLENURE ROAD, ELTHAM, LONDON

HISTORIC BUILDING RECORDING

Level 3

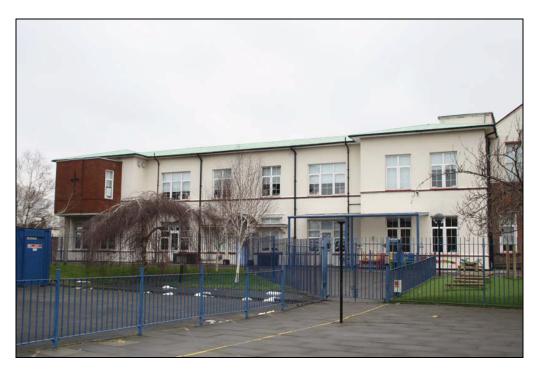
Plate 1 South elevation, taken from the south-east (DP 2)

- 6.2 In its present form the house comprises a central two-storey block with projecting wings to east and west and a shallow-pitched copper roof (Plate 1). The walls are all now covered with thick rough-cast render. A later extension to the east is partly of brick with some render. The central block can be traced on historic maps, suggesting that it retains a masonry carcass of something earlier, and these also show that it once possessed a central bow window with views over the lawns. This has been replaced by an early 20th century decorative doorway and flanking windows. The entrance has a heavy shell-hood supported by Tuscan columns and hood-moulds bisecting the adjacent windows (Plate 2).

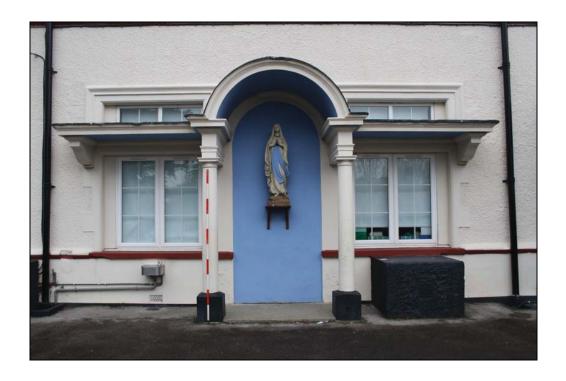
Plate 2 Early 20th century decorative door hood, south elevation, taken from the south (DP 3)

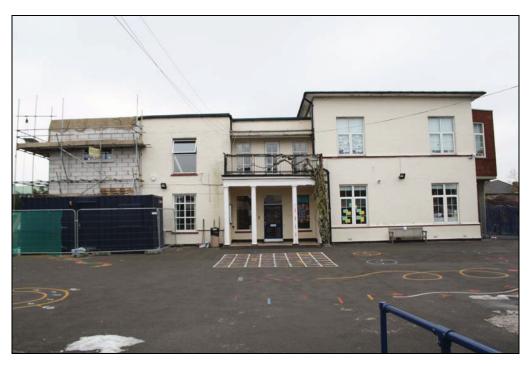
Plate 3 Original entrance and new extension, west elevation, taken from the west (DP 6)

- 6.4 The western elevation incorporates the original entrance to the house in the form of a modest portico, supported by cast-iron, painted Tuscan columns, with a slender timber entablature and an upper ironwork balustrade with a Greek key motif (Plate 3). Otherwise, the windows have been replaced, as elsewhere.

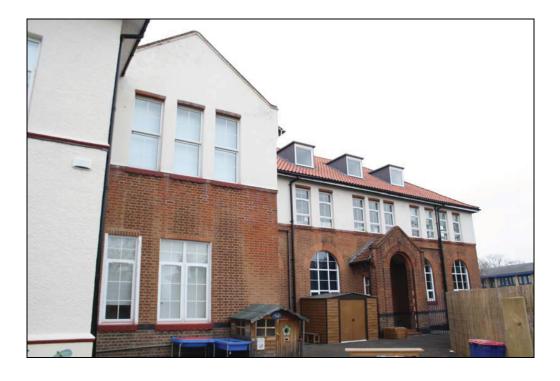
Plate 4 1940s eastern extension, south elevation, taken from the south-west (DP 4)

- 6.6 The building was extended to the east in the early 20th century in a typically Edwardian style, with fine orange brickwork laid in Flemish bond, rendered at upper level (Plate 4). It has as separate entrance into the school hall through a tall brick porch, flanked by fine arched windows with rusticated key-stones. At lower level, bands of ceramic tile or slate have been incorporated as a decorative flourish. The porch retains the only surviving original window joinery in the form of two, two-light windows of typical Edwardian style in the sides.

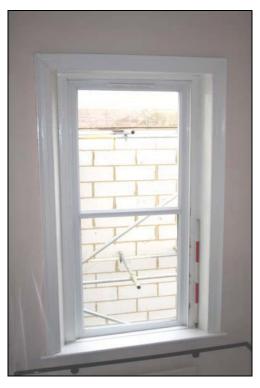
Plate 5 18th century moulded window surround, western stair hall, taken from the south-west (DP 34)

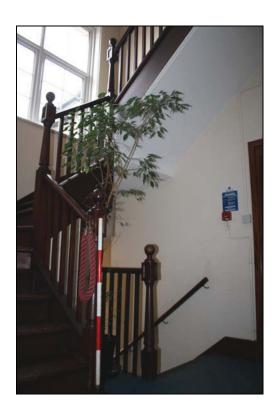
Plate 6 Central staircase, first floor, taken from the south-west (DP 30)

6.8 The interior is a typical reflection of a modern, working school, with large classrooms given access from an axial corridor which extends from the lobby at the west, through to the school hall housed in the eastern, Edwardian extension. Very little of historical interest remains; doors have been replaced with standard fireproof examples, and, as noted the windows are all of plastic. Suspended ceilings and hard-wearing surfaces extend throughout. One or two minor surviving features echo earlier phases. Immediately adjoining the vestibule, a solid staircase of 1930s date rises to the first floor, but this probably occupies the position of the Georgian stair, as a large landing light with 18th or early 19th century mouldings to the architrave has been retained (Plate 5) and a large decorative arch on the west wall may once have been open to the lobby. The central staircase, further east along the corridor is probably a little older, with a turned newel and shaped handrail with stick balusters on a closed string in the late 19th century style (Plate 6). Likewise.

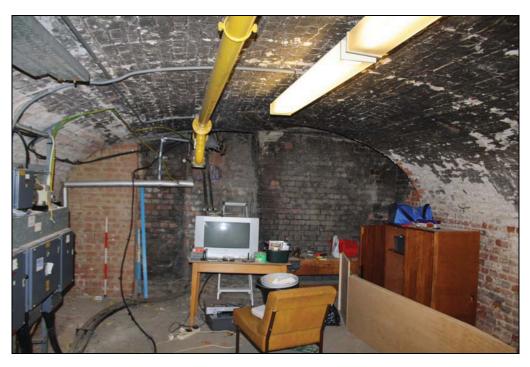
Plate 7 Vaulted unit within south-west quadrant of the basement, taken from the north-east (DP14)

- 6.11 An indication of the earlier form and layout of the building may now only be traced in the surviving basement, where little substantial alteration appears to have occurred. The area retains good, exposed 18th century brickwork throughout and some barrel-vaulted ceilings, which might suggest stone floors at ground floor level originally (Plate 7). Access is given from an external doorway to the rear. The area has several chambers of varying size, but seemingly comprising a main front and rear room, divided by a chimney stack, immediately to the west of the lobby (which is not underlain by a basement). The rear chamber has been most altered with concrete flooring and supports to accommodate a central heating system. Smaller western chambers, some with brick floors retain stone and brick wine bins and traces for timber shelving (Plate 8).

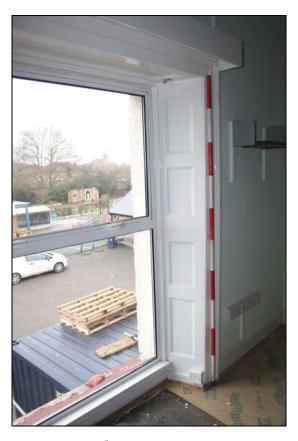
Plate 9 Splayed revels and 18th century type mouldings, west elevation, first floor, taken from the south-east (DP 23)

- 6.12 The area of the building specifically affected by the development lies to the rear of the building but is, like the rest fairly unremarkable in appearance, having been completely modernised. Soft stripping revealed only modern studwork and plasterboard. A single feature of note, though unaffected by the alterations is a window at first floor level set in splayed reveals with an 18th century moulded architrave (Plate 9). The window itself has been replaced.

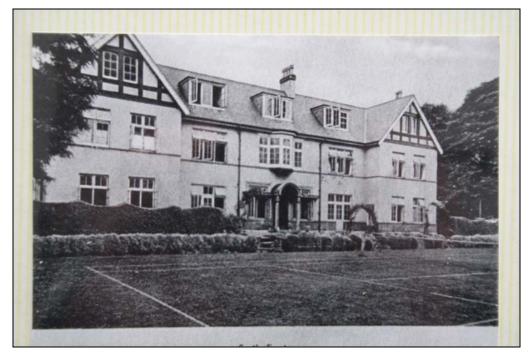
Plate 10 Main building with pitched roof and dormer windows prior to the eastern extension, taken from the south-west (DP 40)

- 7.1 The building is much altered, but it can be confirmed with some confidence that the core, or perhaps only the outline of the Georgian building remains within later, successive accretions.
- 7.2 There are no known early images of the house, but historic photographs show the nature of the early 20th century alterations, which created a fairly conventional appearance, embellished with the central

decorative door, but also fictive timber gables which were themselves removed and replaced in the 1950s with a copper roof, perhaps following fire damage during the Second World War (Plate 10).
