# TWO ACRES, BARKWAY ROAD, ANSTEY, HERTFORDSHIRE

ARCHAEOLOGICAL INVESTIGATION VIA 'STRIP, MAP & RECORD'

Authors: Tim Schofield (Fieldwork) Andy Peachey MA (Desk-based assessment) Antony Mustchin MSc (Editor)		
NGR: TL 40540 33220	Report No: 4101	
District: East Herts	Site Code: AS1277	
Approved: Claire Halpin MIfA	Project No: 3605	
Signed:	Date: July 2012 Revised: August 2012

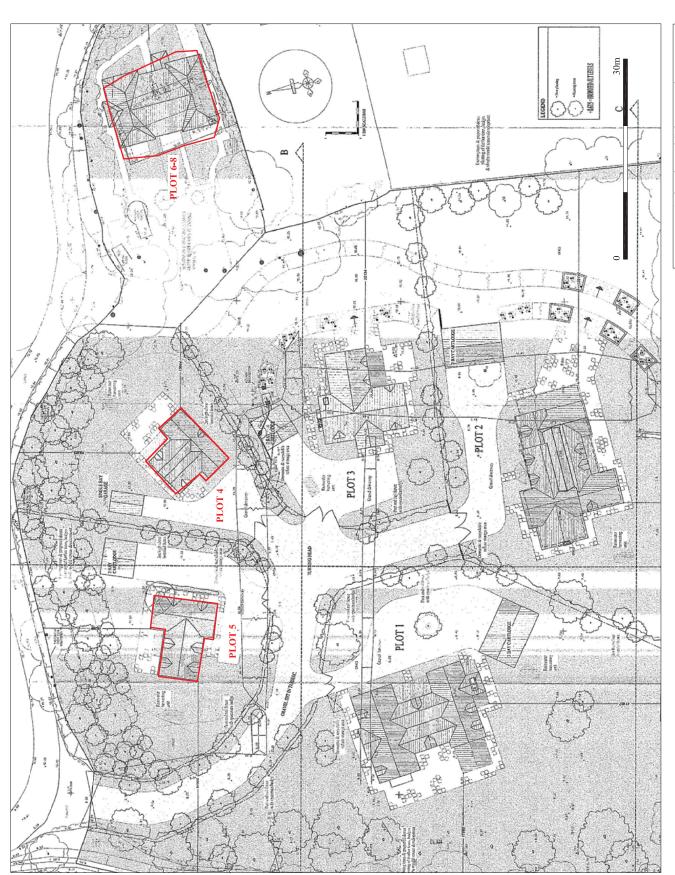
Archaeological Solutions Ltd
Fig. 8 Development plan
Scale 1:400 at A3

- 4.1 The stripped areas were located after consultation with HCC HEU and overlay the proposed building footprints (Nos.4 8) (Figs. 2, 7 8).
- 4.2 Undifferentiated overburden was mechanically excavated using a 3CX JCB. Thereafter all further investigation was undertaken by hand. Exposed surfaces were cleaned as appropriate and examined for archaeological features and finds. Deposits were recorded using *pro-forma* recording sheets, drawn to scale and photographed. Excavated spoil was checked for finds and the topsoil and trenches were scanned by metal detector. A Leica 805 Total Station was then used to accurately survey all features and building footprint locations.
