**FORMER ANGLIA RUSKIN UNIVERSITY SITE, VICTORIA
ROAD SOUTH, CHELMSFORD, ESSEX**

HISTORIC BUILDING RECORDING

Authors:	Tansy Collins BSc Lee Prosser PhD Megan Stoakley MA Kathren Henry	
NGR: TL 70561 07009		Report No: 4121
Borough: Chelmsford		Site Code: CF70
Approved: Claire Halpin MfA		Project No: 4783
Signed:		Date: August 2012

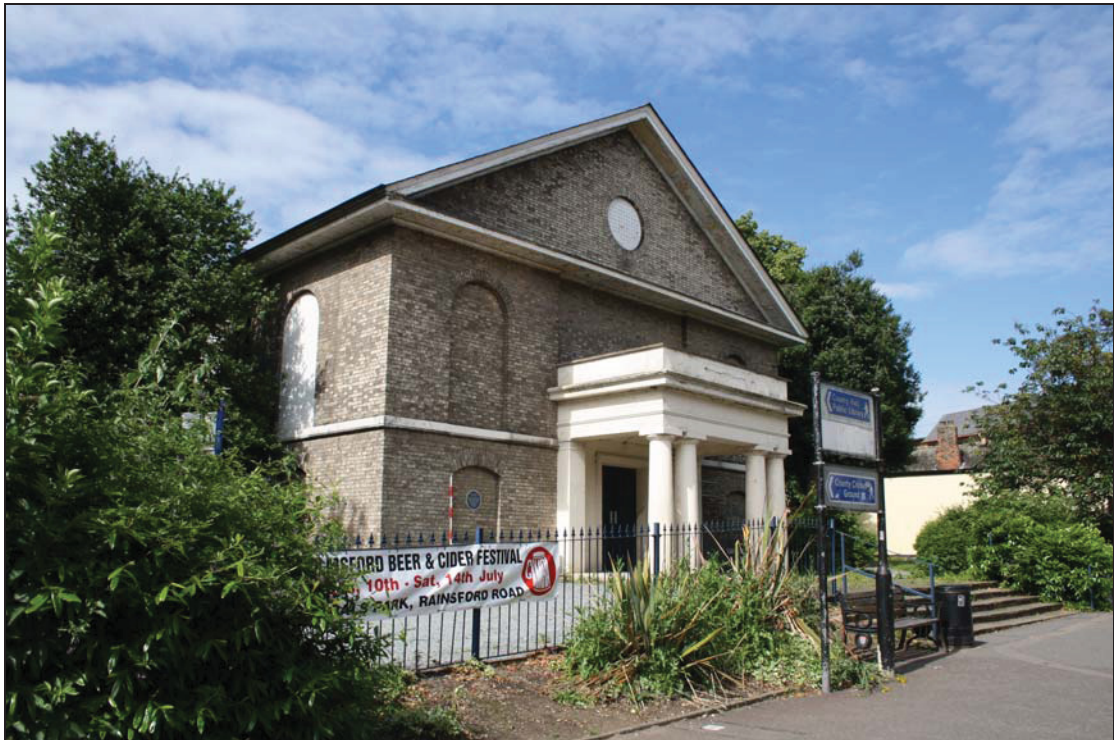
1 North elevation of the Anne Knight Building, taken from the north-east (128)

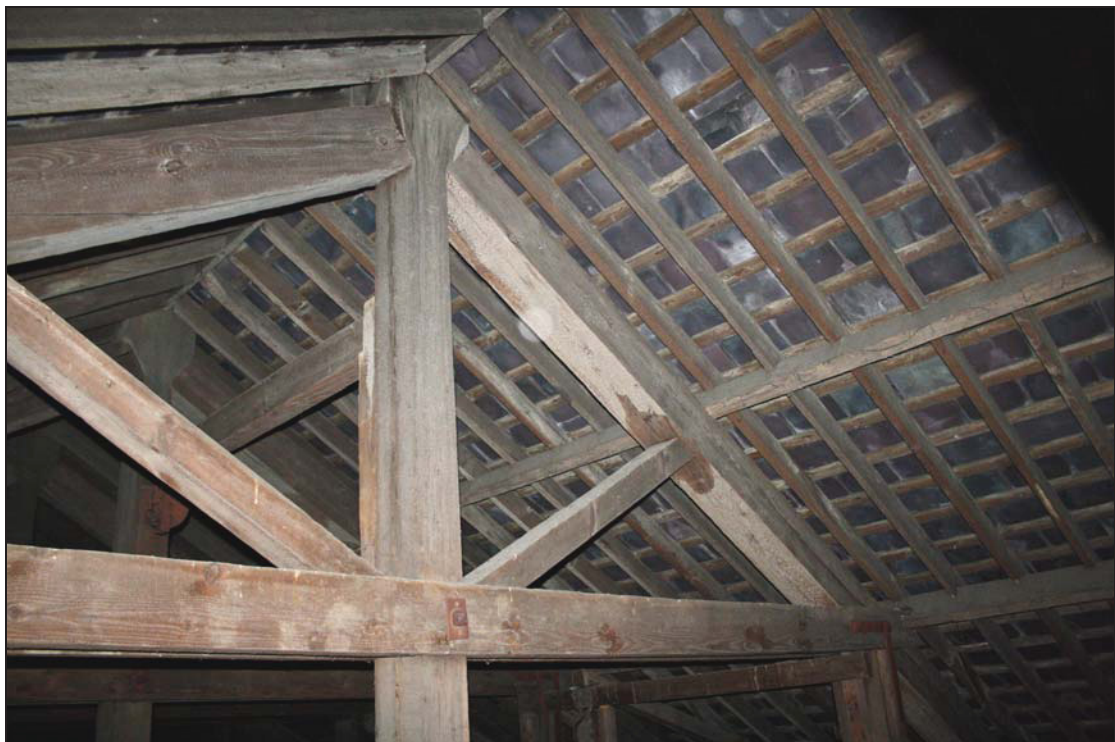
4 View of the roof structure over the Anne Knight Building, taken from the north-east (157)

5.3.6 Pevsner noted the unusually large span of the roof over the hall, and this was given access, with difficulty via a fixed timber ladder within a narrow void behind the bevel of the south-eastern corner of the hall. Apart from some loft insulation, the space appeared generally untouched, but given the constricted access, it is likely that a child would have been sent up to adjust the chandelier ventilation, and modifications could only ever have been effected by stripping the roof and gaining access from the exterior. Consequently the roof is extremely well preserved.

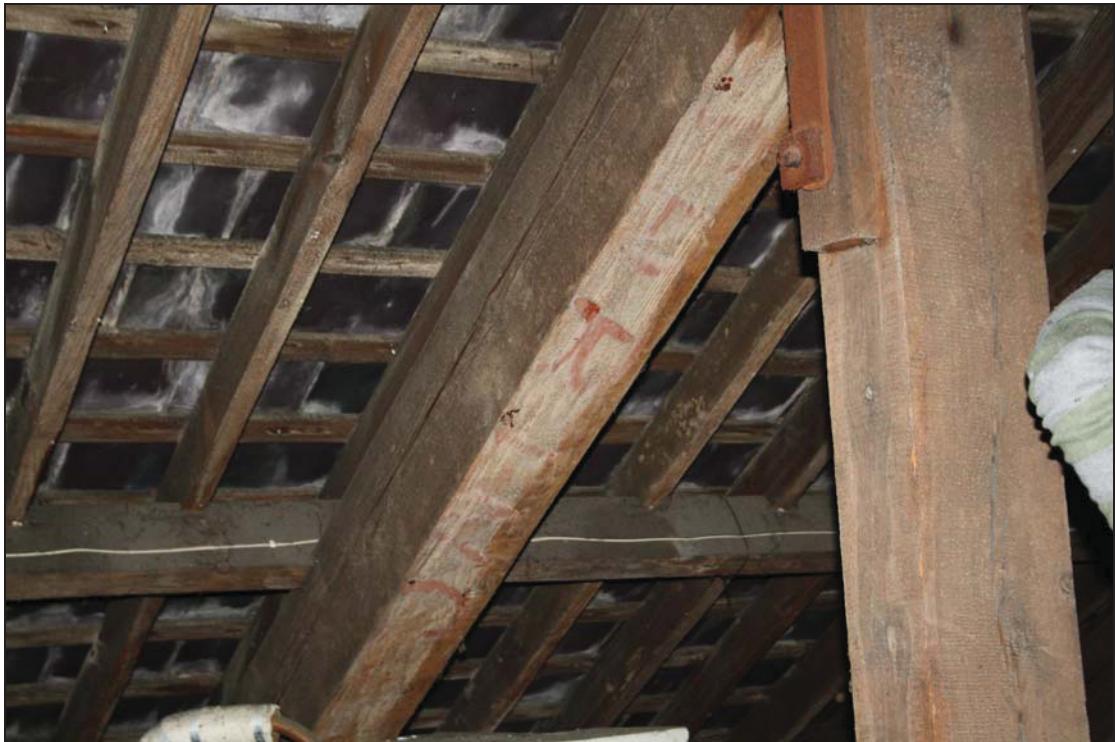
5 Painted batch mark on a principal rafter in the roof (Anne Knight Building), taken from the north-west (159)

5.3.9 Access through the roof is via a rudimentary wooden walk-way. The gable end-walls are of interest as they show a mixture of white with red or orange brick, suggesting that the white brick was deliberately selected as a fashionable facing for the building. The iron frames to the ventilation holes also survive as supports to the original chandeliers, together with an iron runner and pulleys for the sub-division noted above.

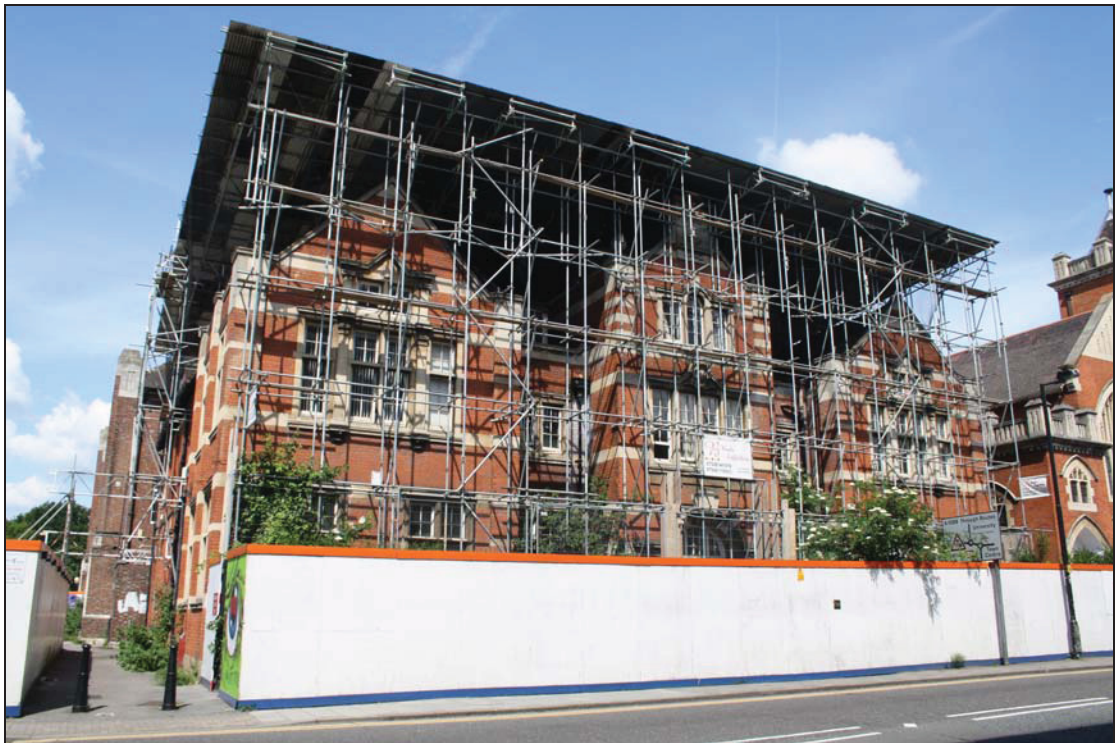
6 East façade of the Frederick Chancellor Building, taken from the east (20)

6.1.1 Building 2, now named after its architect, is absolutely typical of an Edwardian institutional structure; solidly built using modern ferro-concrete, with a veneer of stone and brick, reflecting the typical early 20th century eclectic architectural style with heavy, almost ponderous neo-classical details. Even without prior knowledge, its use as a school is apparent in its layout and the proportions of its rooms. At the time of the survey, it had suffered considerable localised damage from water ingress following the theft of lead roofing material, and was scaffolded all round.

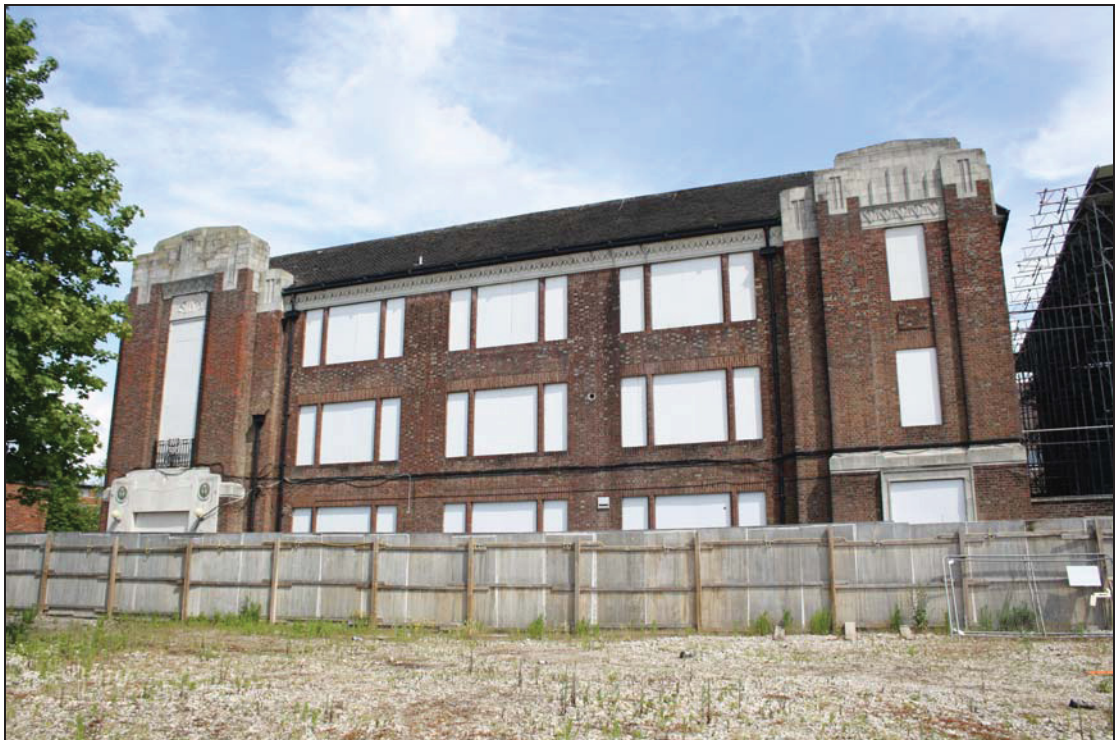
16 South elevation of the Law Building, taken from the south (11)

7.1.1 The Law Building, constructed in 1931 has a typical Art Deco facade of that date, with vertical lines and embellishments entirely in keeping with the ‘jazz-age’ spirit of the times, though in other respects it is fairly conventional in form, with tiled, pitched roofs and fairly restrained decorative details. It was constructed as a new addition to the educational complex, and is described in earlier records as having rooms with facilities for music, domestic science and a chemistry laboratory. At the time of the survey, it had suffered considerable damage from water penetration and damp, and its principal feature, a long stair window with coloured glass and typical Art Deco tracery had been badly damaged by vandalism.

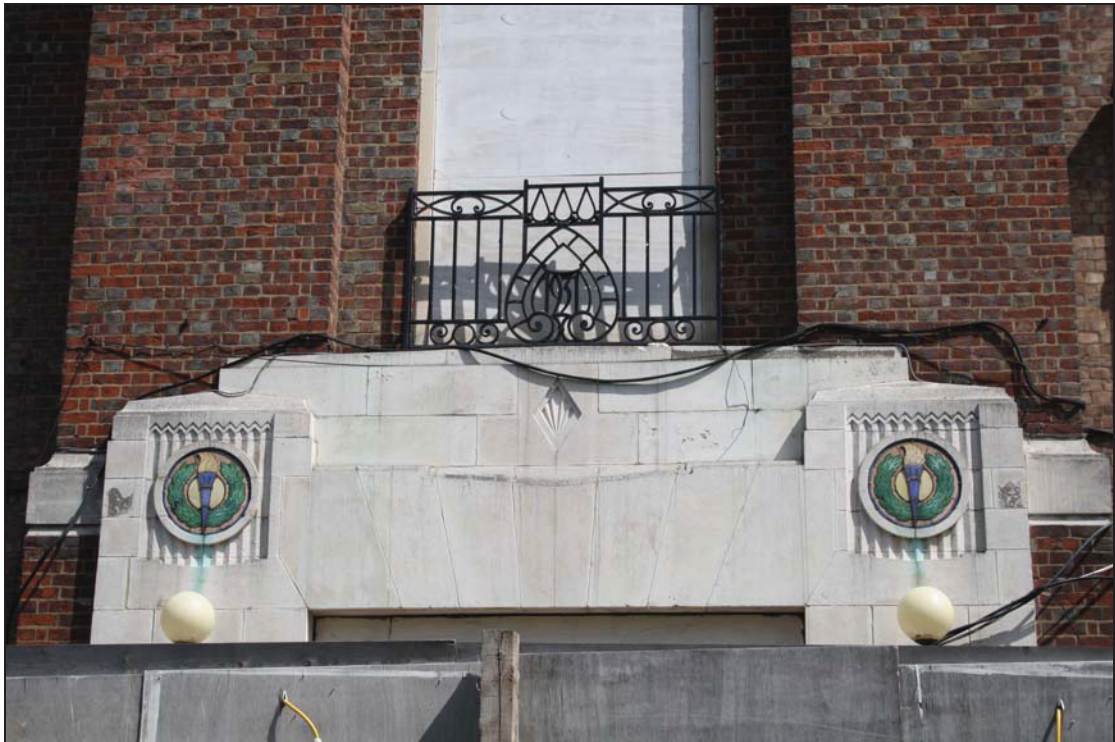
17 Detail of the principal entrance on the south side of the Law Building, taken from the south (15)

7.3.1 The principal doorway is, as noted above, set in an elaborate recessed and chamfered embrasure with decorative twisted rope-work moulding framing the aperture. This is all of composite stone laid as ashlar blockwork. The doorway has a robust moulded oak frame with an overlight which was once glazed with a stained-glass central shield bearing the arms of Essex and quarries of green glass, but these have been smashed. The oak doors are panelled with upper diamond panels and bronze Art Deco knobs.

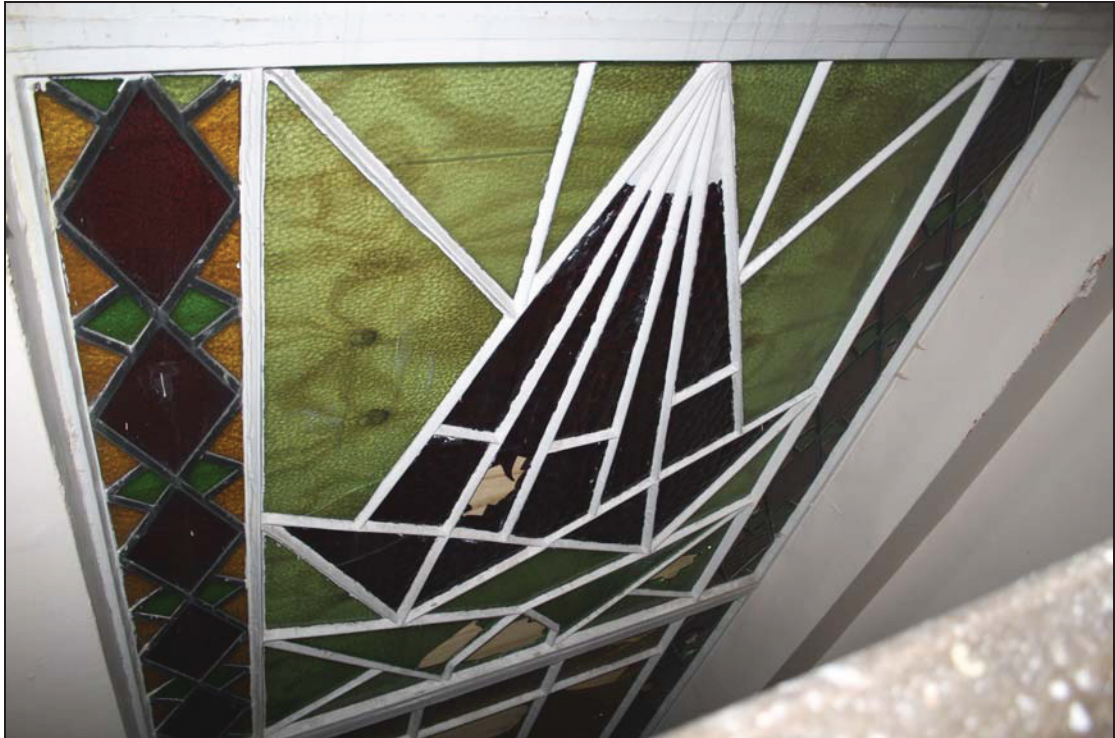
23 Stairlight on the second floor landing SF01 (Law Building), taken from the north (69)

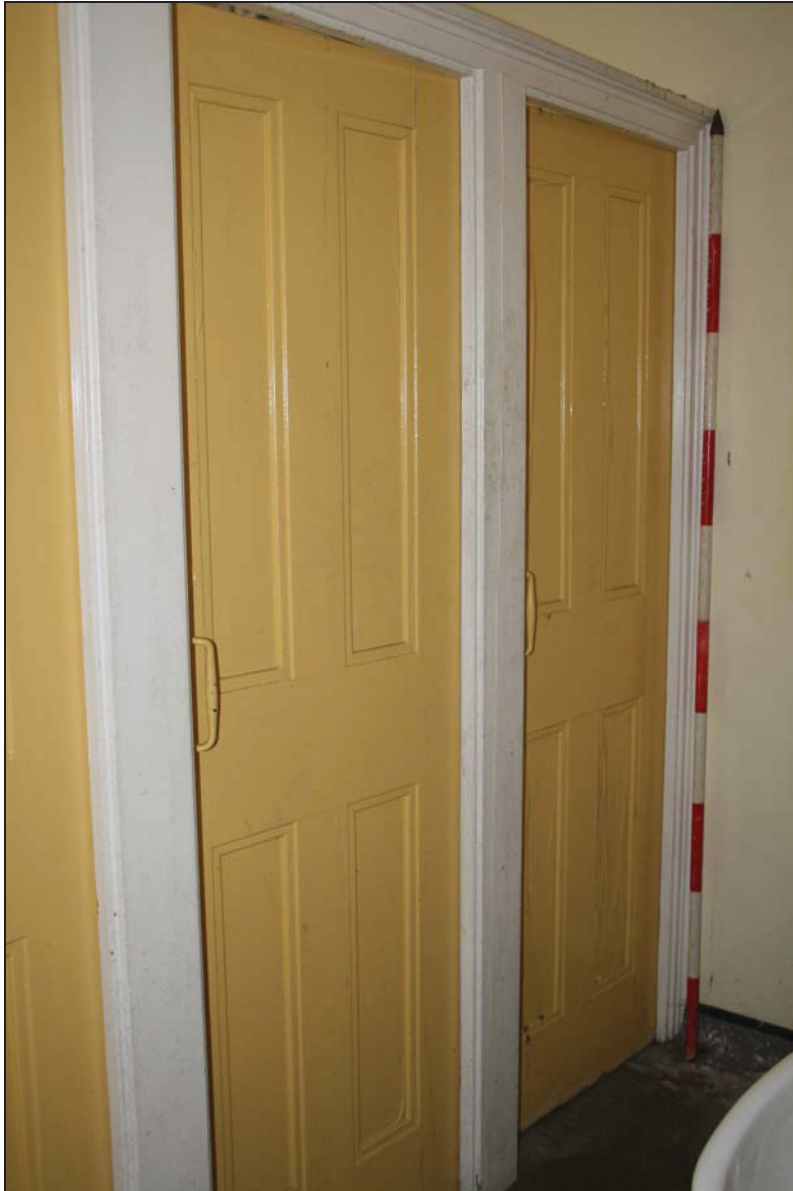
25 Original doors in Room SF03 (Law Building), taken from the south-east (72)
