**RUDOLF STEINER SCHOOL, KINGS LANGLEY,  
HERTFORDSHIRE**

**AN ARCHAEOLOGICAL DESK-BASED ASSESSMENT**

Authors: Peter Thompson MA (Desk-based assessment) Tansy Collins (Site Visit) Kath Henry (Graphics)	
NGR: TL 06572 02586	Report No: 4115
District: Dacorum	Site Code: N/A
Approved: Claire Halpin	Project No: 4896
Signed:	Date: July 2012

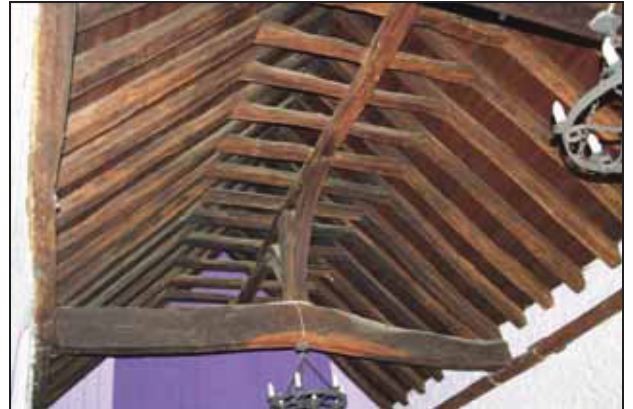
57  
*View of the crown-post roof within Building M (west  
range, centre)*

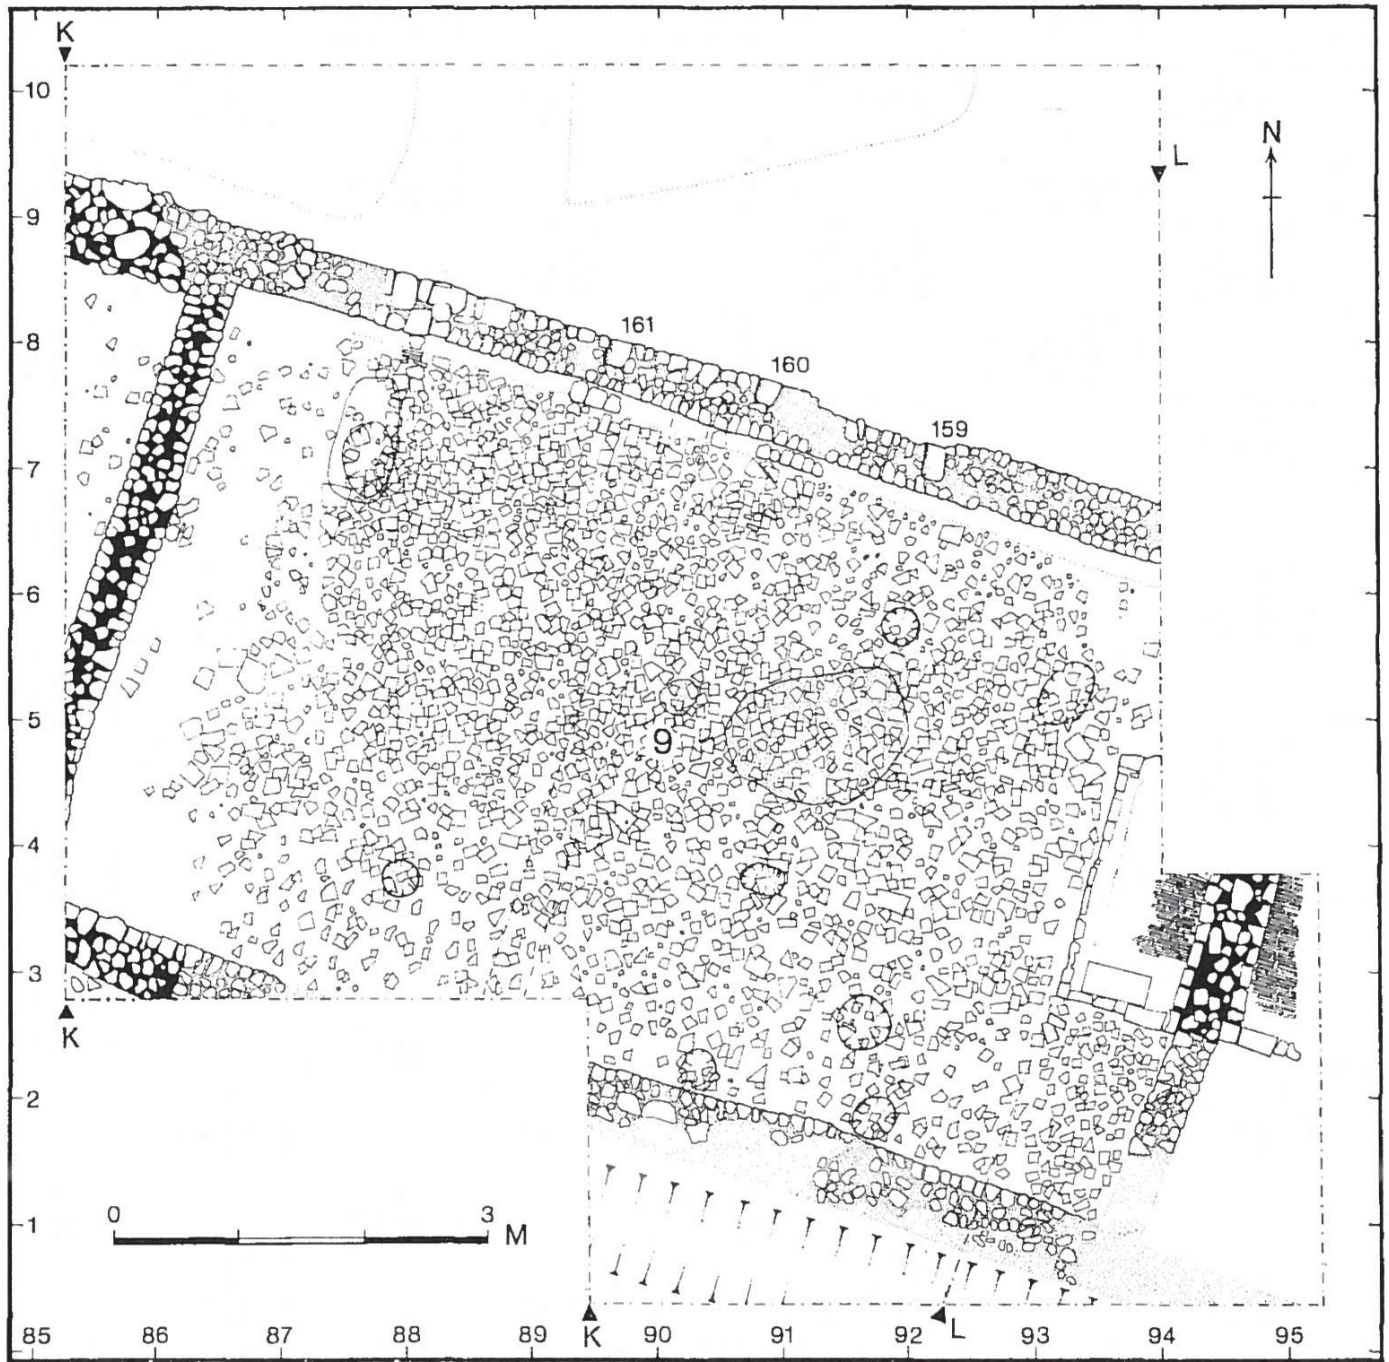
Fig. 11 Building C, 'Le Longrewe', Site 1, excavated by Neal 1974-6

FIG. 46  
KINGS LANGLEY PALACE, LE LONGREWE  
Building C, Site 1
