**GODWICK GREAT BARN, GODWICK HALL,
TITTLISHALL, NORFOLK, PE32 2RJ**

ARCHAEOLOGICAL MONITORING AND RECORDING

Authors: Joseph Bampton MA	(Fieldwork and report)
NGR: TF 9041 2209	Report No: 4216
District: Breckland	Site Code:
Approved: Claire Halpin MlfA	Project No: 4610
Signed:	Date: December 2012

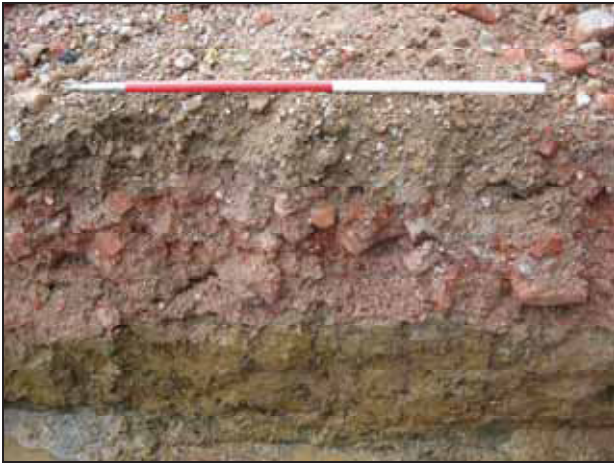
<i>Central south side, north facing</i>		<i>DP 1</i>
<i>0.00 = 66.57m AOD</i>		
0.00 – 0.20m	L1002	Made ground. Grey, loose, sandy gravel with modern rubble.
0.20 – 0.60m	L1003	Made ground. Mid-light pink red, loose, sandy demolition rubble.
0.60 – 1.05m+	L1005	Natural. Mid orange, friable, sand - mid blue grey, compact, clay.

1
Sample section 1. Looking south.

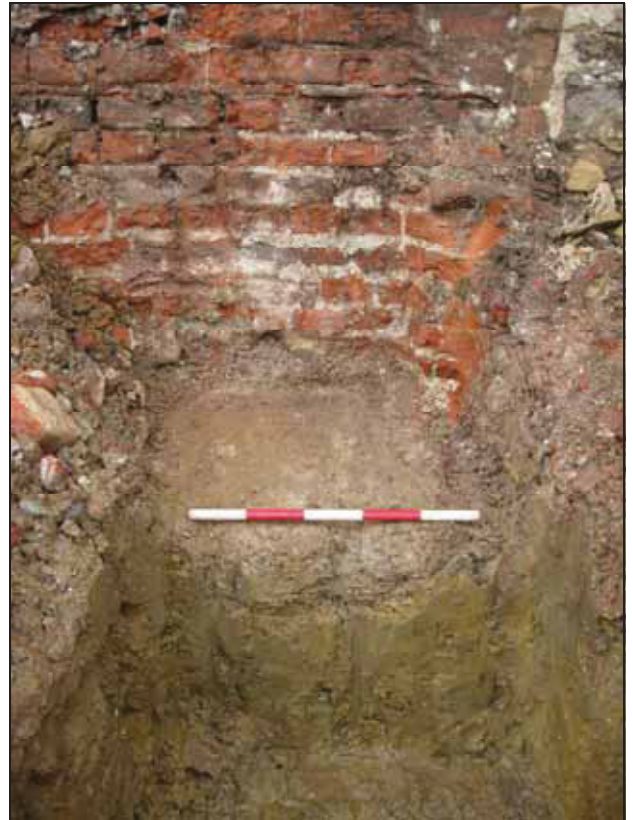
<i>South west corner, east facing</i>		<i>DP 2</i>
<i>0.00 = 66.53m AOD</i>		
0.93 – 1.27m+	L1005	Natural. As above.

Description: Sample section 2 revealed the lower courses of the barn (M1010) and the construction cut for the demolished cattle shed (F1007).

The lower brick courses of the barn's eastern wall were revealed, M1010, and comprised unweathered, regularly-coursed brickwork (0.24x0.07x0.11m) constructed with lime mortar. Above ground the brick was laid in English bond, while King closer bricks (chamfered) were seen on the northern side of the section and may have formed part of a buttress for an earlier extension or support for a stone step at the threshold of a doorway above and slightly north of the section.

F1007 was the construction cut for a support, perhaps to the demolished cattle shed and contained L1009 and L1008. L1009 was a light grey cementitious mortar pad. L1008 was a mid blue grey, firm, clay, construction backfill (re-deposited natural clay). F1007 abutted the barn wall (M1010) and may have followed the course of the demolished 18th/19th century extension.

2
Sample section 2. Looking west.

8.4 At the west end of the southern footing trench the lower brickwork of the barn was recorded (M1010) as well as a small area of possible earlier floor (L1009), almost completely truncated, or a construction pad relating to the 18th / 19th century or later ranges. This abutted, and so is later than the original barn but otherwise it is impossible to ascertain which phase of work this belongs to.

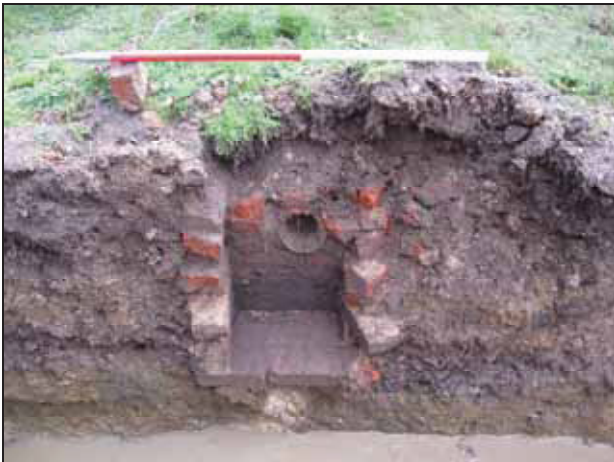
<i>North east corner, west facing</i>		<i>DP 3</i>
<i>0.00 = 66.59m AOD</i>		
0.00 – 0.20m	L1000	Topsoil. Dark grey brown, friable, sandy silt.
0.20 – 0.87m	L1004	Made ground. Mottled mid orange- and blue grey, friable, silty sand with frequent clay, CBM rubble and stones.
0.87 – 1.22m+	L1005	Natural. As above.

L1004 was made ground derived from the demolition of the 18th/19th century extension at the north end of the east side of the barn. The northern wall of this extension still survives but with alterations. Brick and worked flint, similar to that seen in the northern wall was present throughout the layer.

A drainage pipe recorded which ran from the eastern side of the footing trench to a pond on the edge of the 1960's farm complex to the east. It had a brick chamber (M1006; 0.23x0.07x0.11m) which was truncated by the footing trench. The brick was unweathered, had regular and ashlar coursing with occasional sandy cementitious bonding of poor quality.

3
Sample section 3. Looking east.

8.6 The final phase of work reflected in the archaeological evidence comprised the remains of a drain pipe and surrounding brickwork (M1006) which is apparently linked to the 20th century phase of work but may represent an earlier drain associated with the 18th / 19th century phases of work.

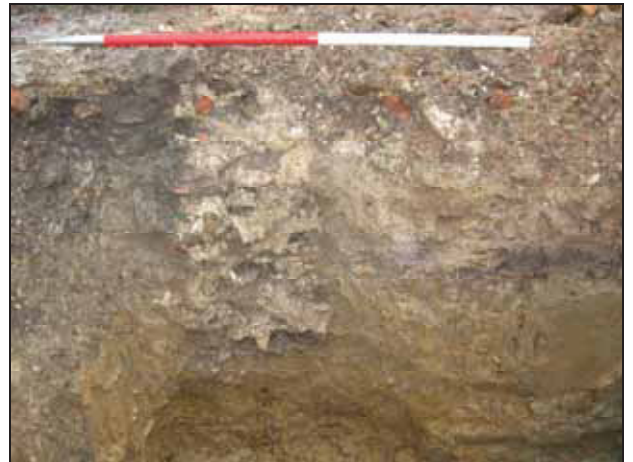
<i>South east corner, north facing</i>		<i>DP 4</i>
<i>0.00 = 66.61m AOD</i>		
0.00 – 0.24m	L1000	Topsoil. As above.
0.24 – 0.42m	L1004	Made ground. As above.
0.42 – 1.15m+	L1005	Natural. As above.

<i>South east corner, north facing</i>		<i>DP 4</i>
<i>0.00 = 66.63m AOD</i>		
0.00 – 0.27m	L1002	Made ground. As above.
0.27 – 0.60m	L1003	Made ground. As above.
0.60 – 1.15m+	L1005	Natural. As above.

Description of features: F1011 and M1012 were recorded in sample section 4.

F1011 was the linear construction cut of a wall aligned north/south, perhaps of the demolished 18th/19th century extension. It had vertical sides and a flat base and was filled with masonry building material representing M1012. It appeared to have been truncated by the demolition, levelling and instatement of made ground on the east and west sides of the cut. These layers abut the surviving rubble and structure of M1012, which was levelled off and sealed by L1001.

M1012 was a damaged wall and its foundation. It was an uncoursed CBM rubble and mortar construction abutted by L1000, L1003 and L1004 and sealed by L1002. M1012 represents only a fragment of surviving wall, the majority of the wall having been demolished during earlier developments. This wall would originally have been the same style as, and been tied into the northern wall of the extension.

4
Sample section 4. Looking south.

8.5 A foundation cut as well as a section of truncated wall (F1011 and M1012) were recorded in the eastern arm of the footing trench, these forming the remnants of the east wall of the lost 18th or 19th century range. This survived only in part and has been mostly lost with later alterations particularly the application of 20th century concrete yard surfaces.

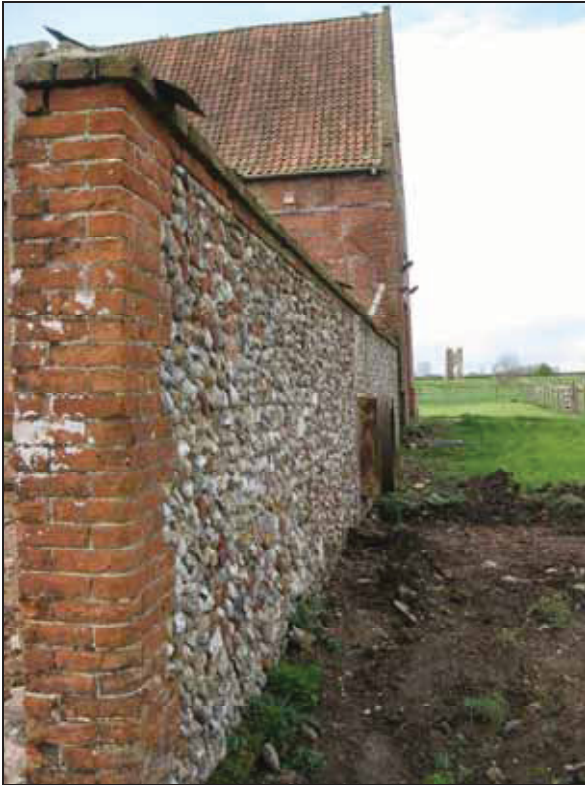
7
Surviving north wall of 18th/19th century extension.
Looking west.

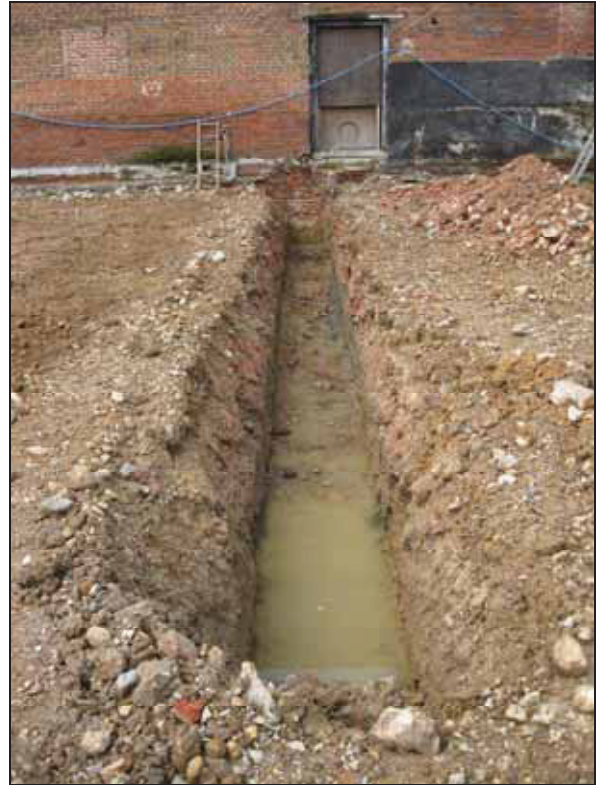
8
Footing trench to the south wall of the northern extension.
Looking west.

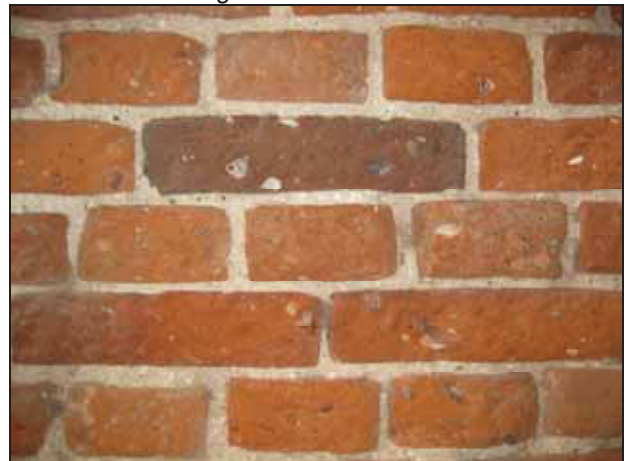
10
Late 16th century brickwork within the barn.
