CAPPS COTTAGE, HOUSE LANE, SANDRIDGE,
ST ALBANS, HERTFORDSHIRE

HISTORIC BUILDING RECORDING

Authors:	Lee Prosser PhD Tansy Collins BSc Megan Stoakley MA Kathren Henry	
NGR: TL 18385 09931		Report No: 4089
District: St Albans		Site Code: AS1501
Approved: Claire Halpin		Project No: P4825
Signed:		Date: June 2012

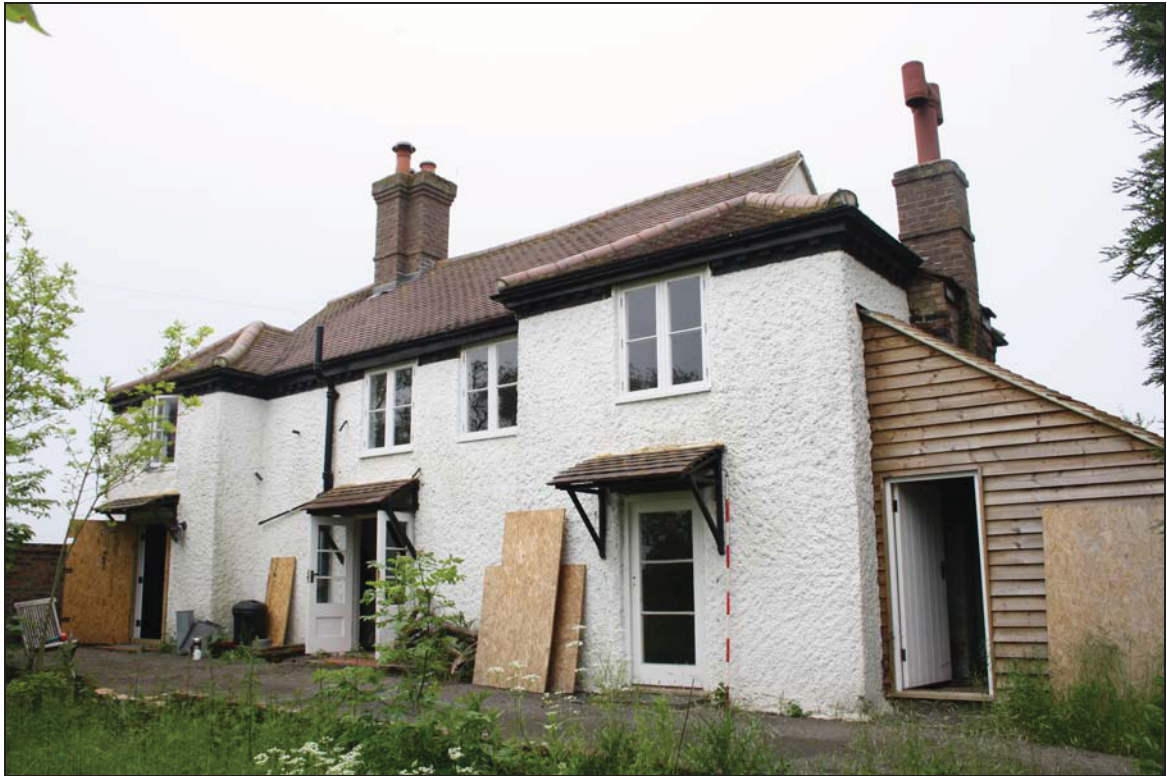
5.1 The house is of two storeys, comprising a central range with lower, hipped-roofed cross-wings at the north and south (Plate 1); these project slightly on the

Plate 1 East elevation, taken from the north-east (DP 1)

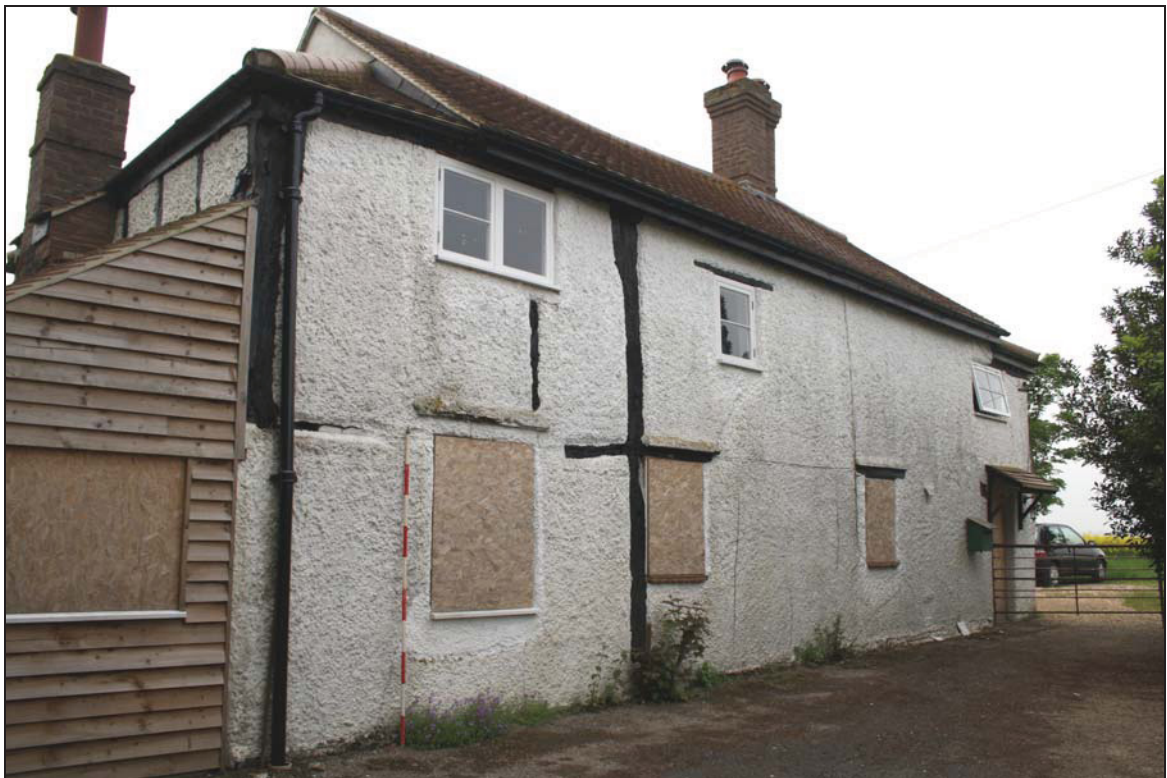
5.5 The rear, west elevation is similarly clad with rough-cast render, although small sections of the original timber frame have been left exposed to the north (Plate 2). The eaves are plain and undentilated, apart from the return of the south cross-wing. Three lower windows are symmetrically placed, with three at upper level. These all vary in form, but are now of no interest, apart from the central window which has an exposed timber lintel.

Plate 2 West elevation, taken from the north-west (DP 6)

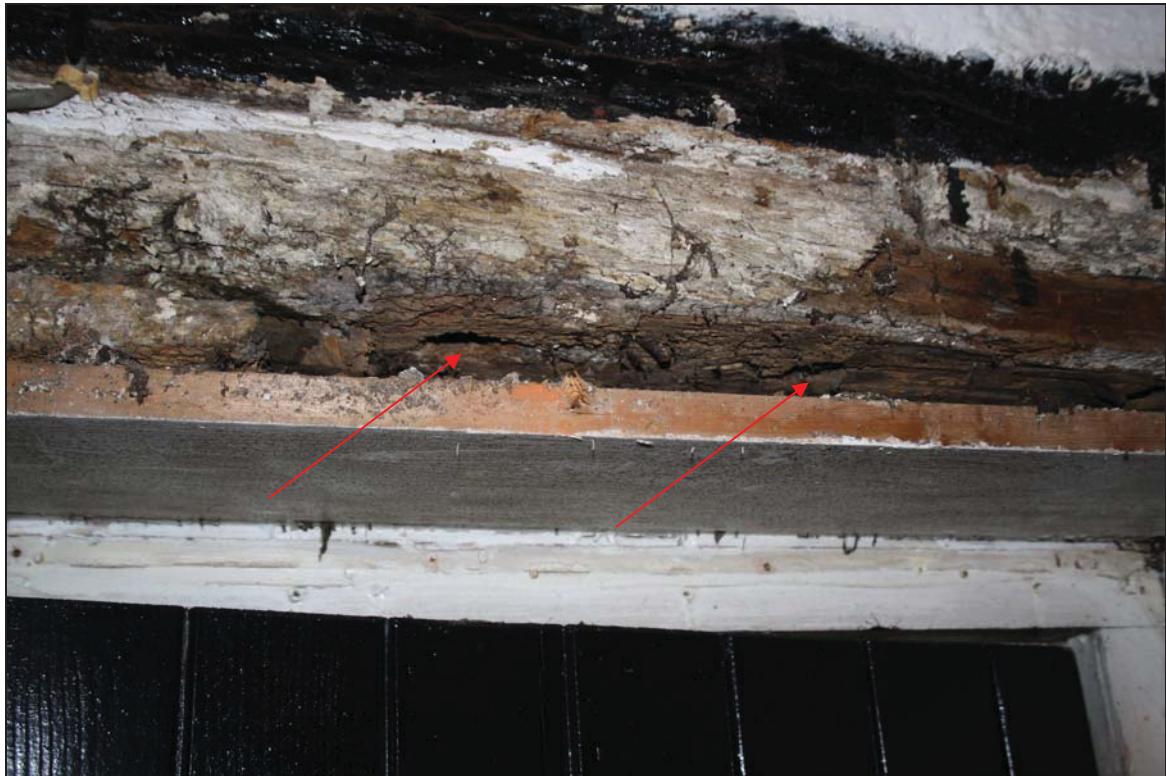
Plate 3 Detail of the formerly external north wall of the house from within Room GF04 showing wattle holes in the mid-rail (indicated), taken from the north-east (DP 21)

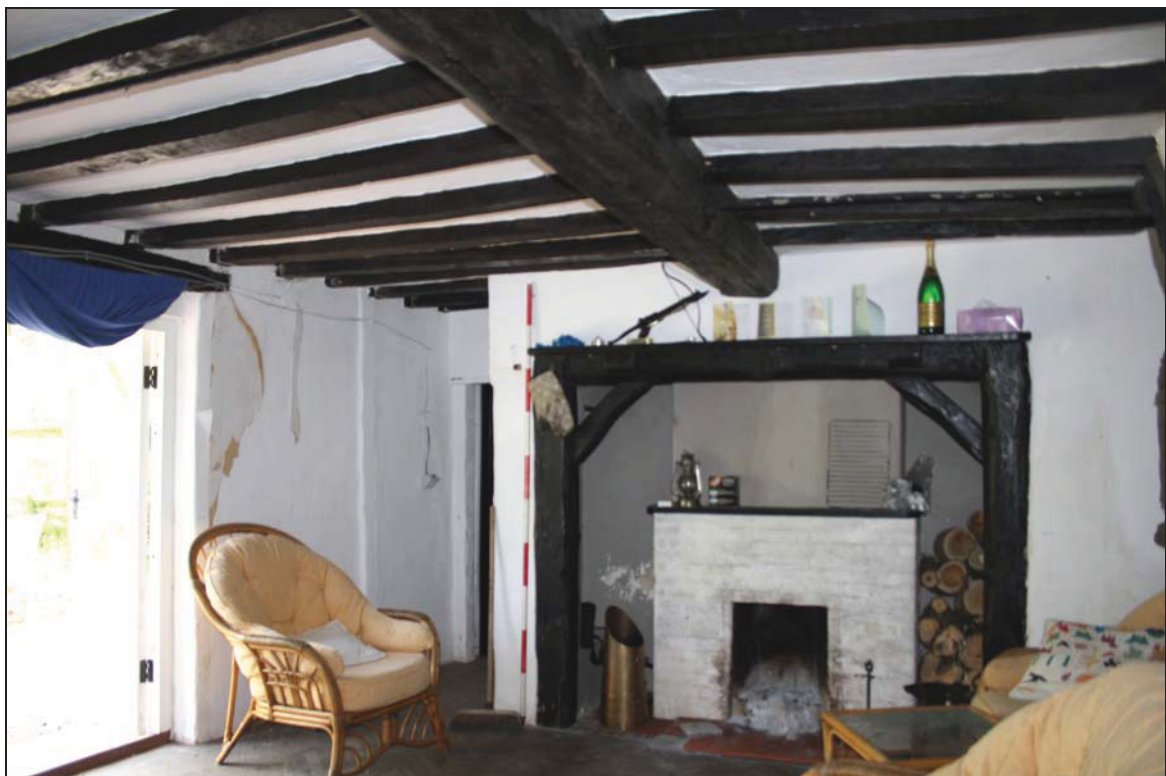
5.10 Room GF01 occupies the central, hall range and retains exposed ceiling joisting (Plate 4). The room is floored with herringbone oak parquet, probably of 1950s date, though this is lifting in places where moisture has penetrated the sub-surface. The south wall is dominated by a large inglenook fireplace framed with rough timber jambs and short braces nailed to a solid bressumer, and having projecting brackets supporting a shelf. All of this, with the exception of the lintel or bressumer is cosmetic and modern. A secondary, inner fireplace is perhaps of the 1950s and of no historic interest, though within the inglenook, small recessed seats remain from an earlier phase. A doorway to the south comprises very rudimentary bead-moulded timber, which is probably 19th century in date. The door, like every other example in the building, is of simple, boarded and ledged form, any earlier historic examples having been removed during a period of poor conversion in recent years.

Plate 4 South side of Room GF01 showing inglenook fireplace, taken from the north (DP 15)

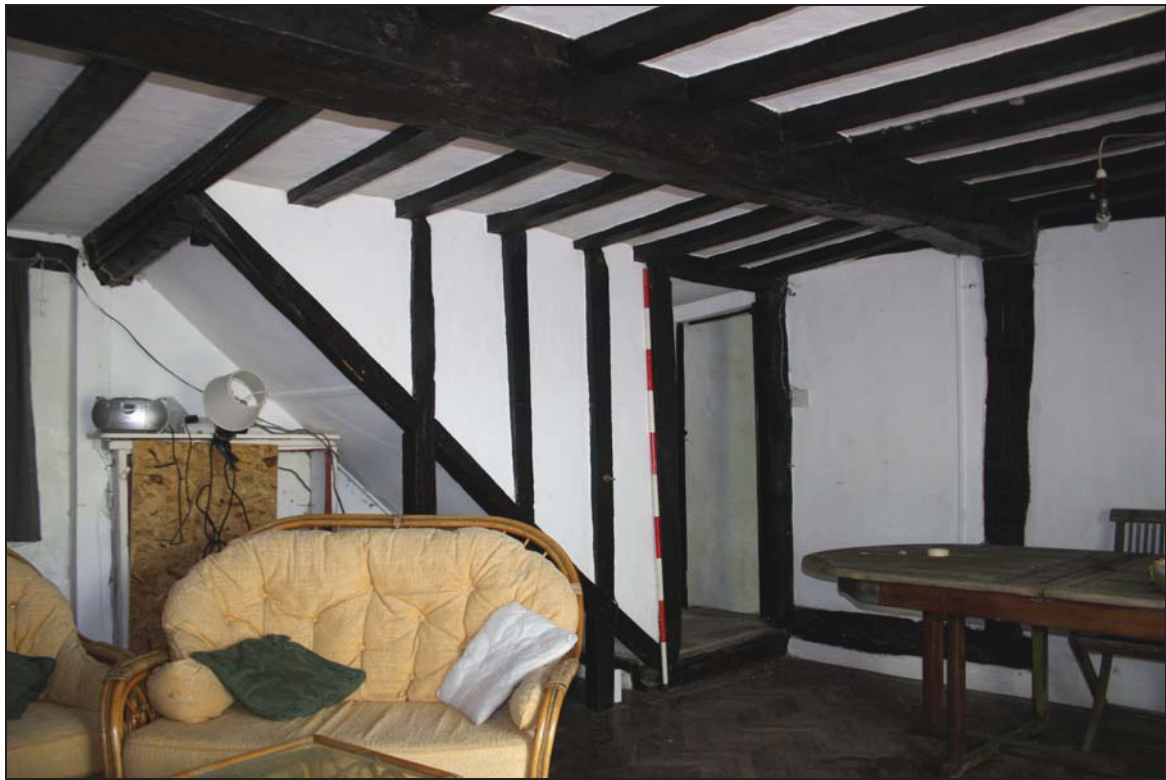
Plate 5 North-west area of Room GF01 showing enclosed staircase, taken from the south-east (DP 14)

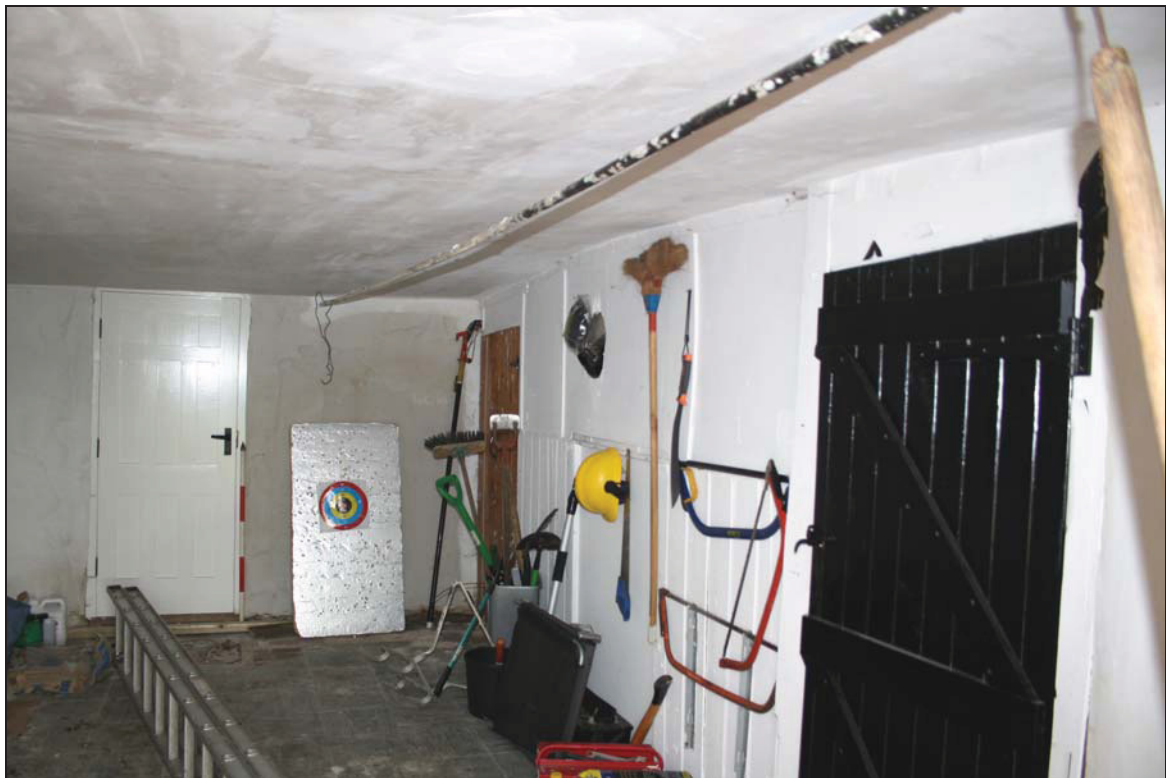
Plate 6 Room GF02, taken from the south-east (DP 12)

5.14 The southern cross-wing (Room GF02) is fairly undistinguished, with a modern floor and recently re-plastered walls. The line of an earlier partition can be seen defining the location of a small entrance lobby. The north wall preserves the only features of note in the form of a blocked fireplace, now flanked by a bead-moulded dado of early 19th century date (Plate 6). Further historic features may lie beneath modern boarding above. To the west, a modern door encloses a cupboard which retains timber brackets for shelves and evidence for a possible former doorway through to the hall. The ceiling appears to be of modern fabric; an iron tension rod extends east–west across the room at this level.

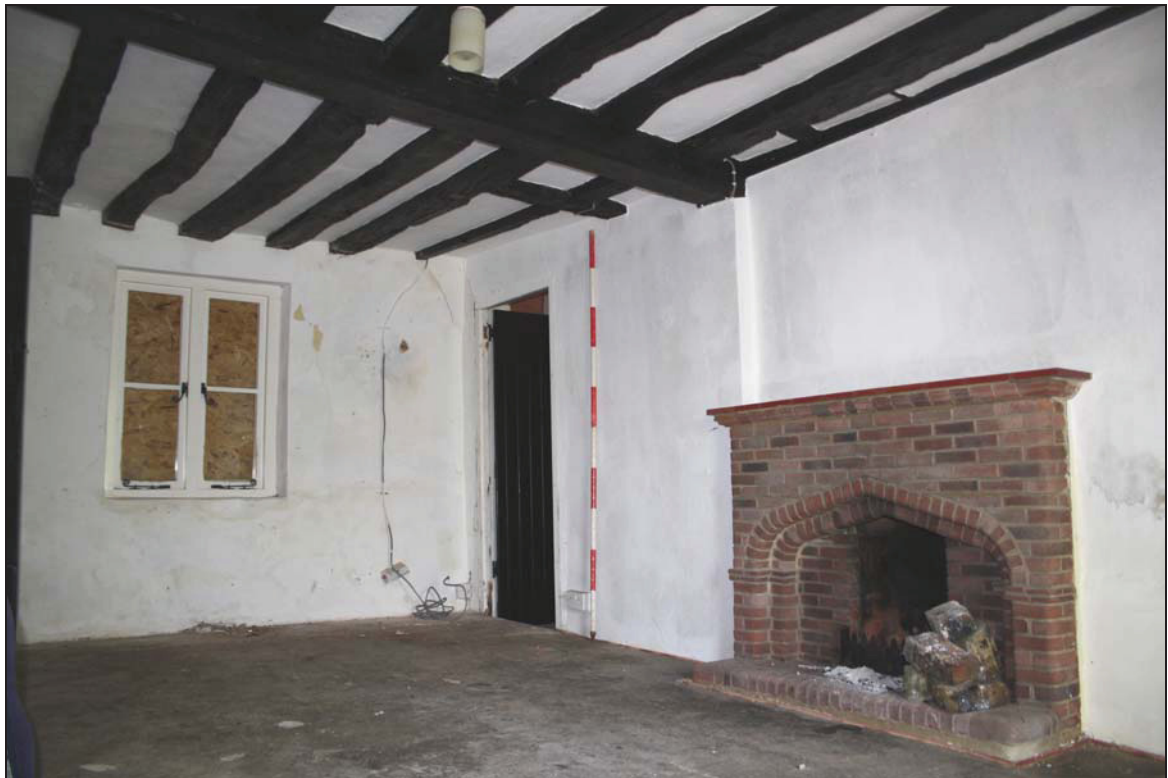
Plate 7 North-west area of Room GF03, taken from the south-east (DP 18)

5.15 The northern cross-wing (GF03) is fairly plain, with a cement floor and plain rendered walls, excepting only the central principal joist on the south. This thickens at the head to support a ceiling joist, chamfered on both sides with simple stops at either end. In-line common joists extend east-west and are of fairly large scantling, side-set and closely-spaced in the medieval manner (Plate 7). These are jointed to the binder with pendant soffits. In the north-west corner a trimmer marks the position of staircase, together with notches for lost fabric which once enclosed it. A fireplace on the north has been reconstructed in modern brick, but with a Gothic arch, and as with the example in Room GF01 is of no historic interest.

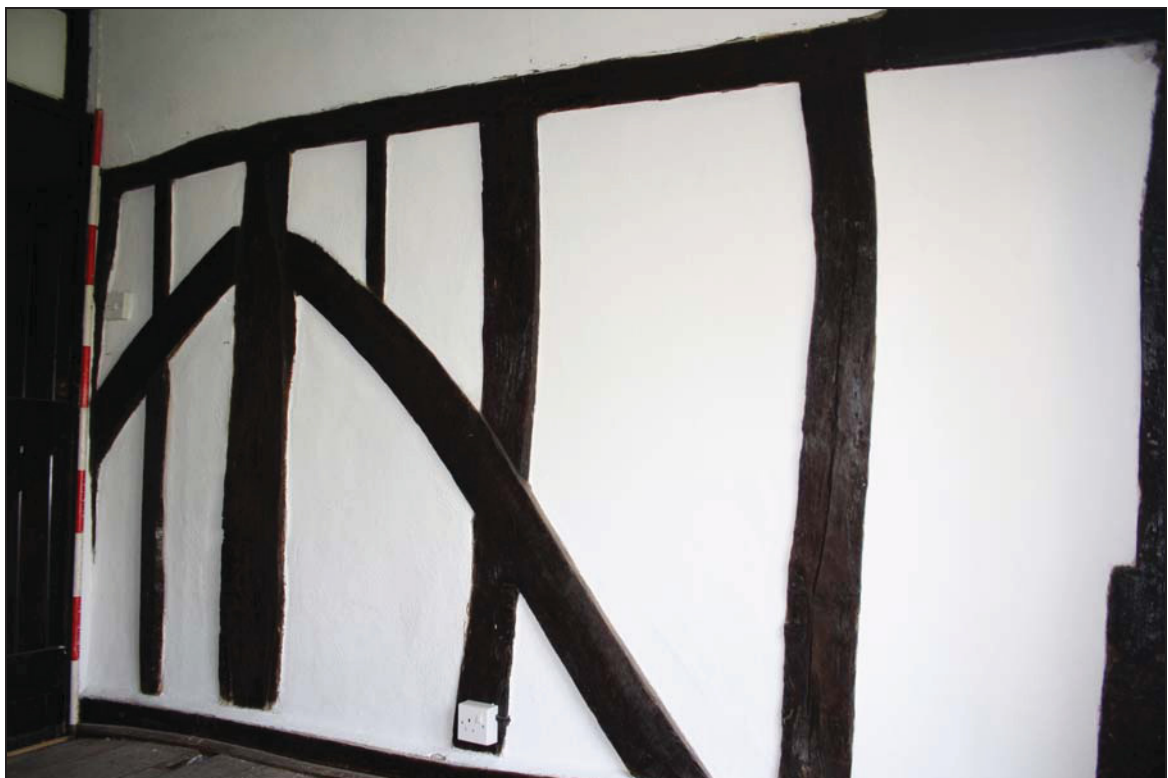
Plate 8 North wall of Room FF03, taken from the south-east (DP 26)

5.18 Within Room FF03 the early floorboards continue from beneath the later partition on the south, though some boards are cut through in places. The north wall preserves the early structural timber-framing of the north cross-wing, and includes a central post with curved downward braces on either side (that to the west cut to accommodate a doorway), but both trenched over pegged studs (Plate 8). Other independent studs are also pegged, but several slender members are modern inserts. The early timber displays signs of pit-sawing, but is also unweathered and so has always been protected by an adjoining structure in this position. The ceiling is underdrawn at collar level.

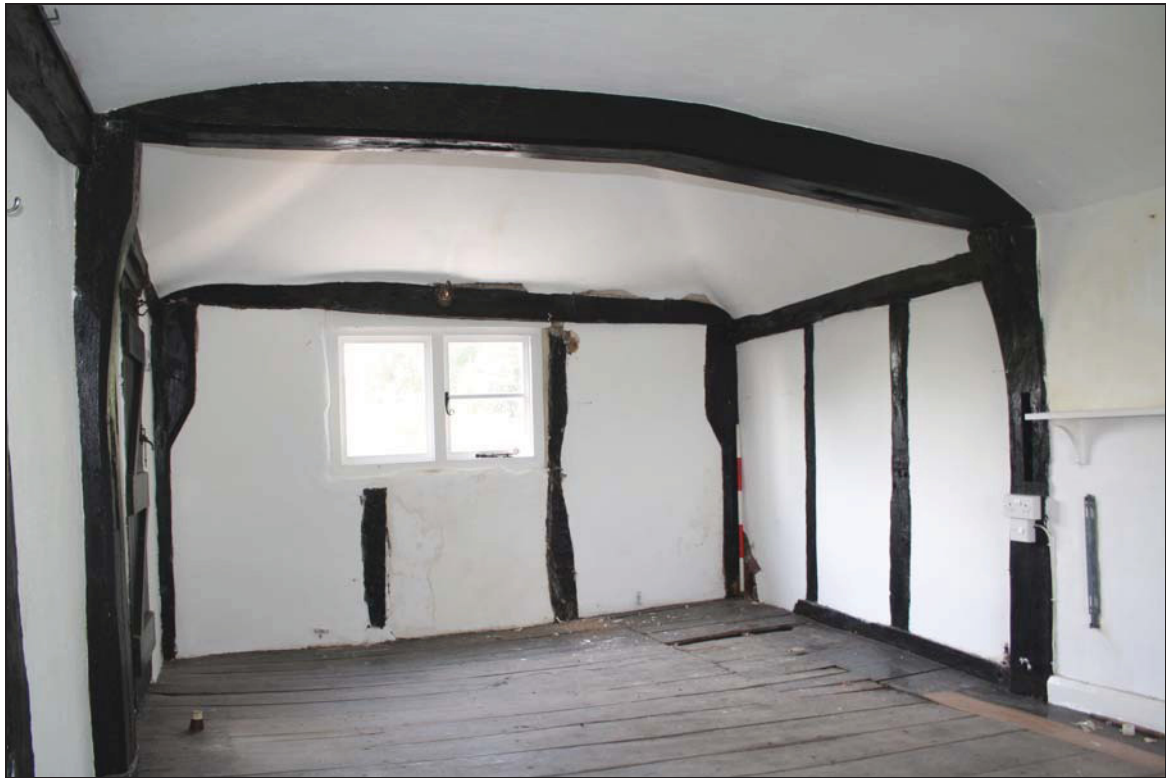
Plate 9 West side of Room FF05, taken from the east (DP 28)

5.21 The northern cross-wing (FF05) retains features of most interest, both in terms of dating and surviving fabric. It is floored with wide, close-fitted oak or elm boards, of a similar size to the adjoining area, and retaining the distinct cut in the north-west corner through which the earlier staircase rose. The range is divided into two bays by a substantial and slightly cambered tie-beam which is chamfered on both sides and stopped in the same manner as the principal joist below (Plate 9). This is supported on either side by robust principal posts which have gently swelling jowls, also chamfered, though the south post has been hacked back. Large double-pegged mortices in the posts and in the soffit of the tie-beam indicate the presence of robust braces, now lost. No traces such as peg-holes in the upper part of the tie-beam indicate whether queen, king- or crown-posts were ever present.

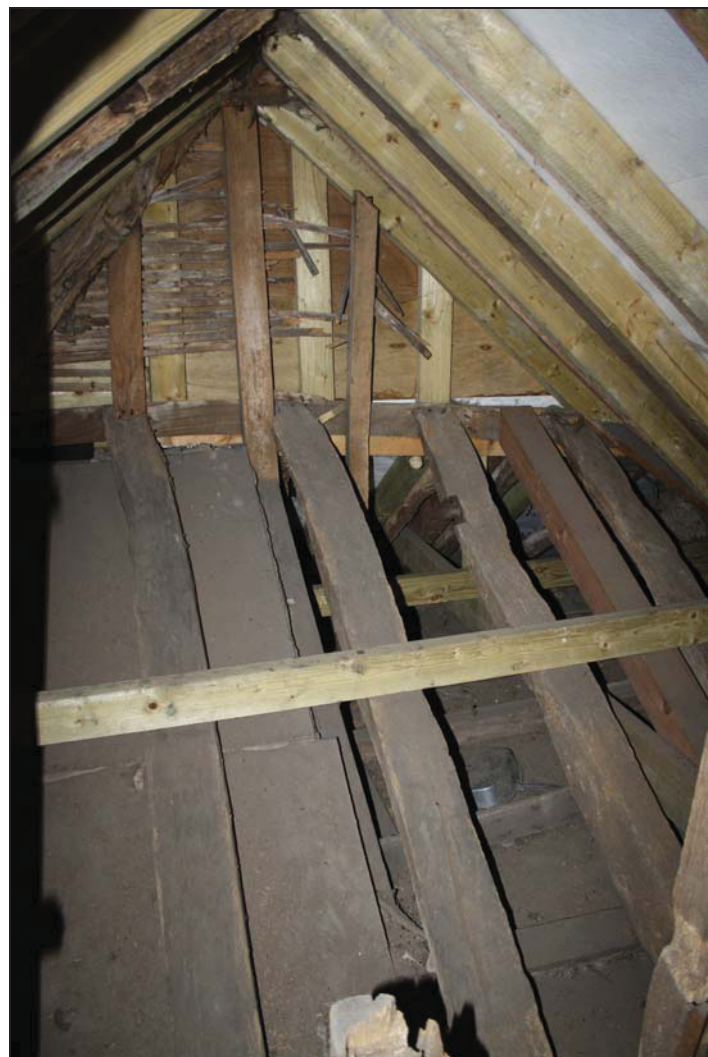
Plate 10 View of the roof over the northern cross-wing showing early repositioned rafters, taken from the south (DP 32)

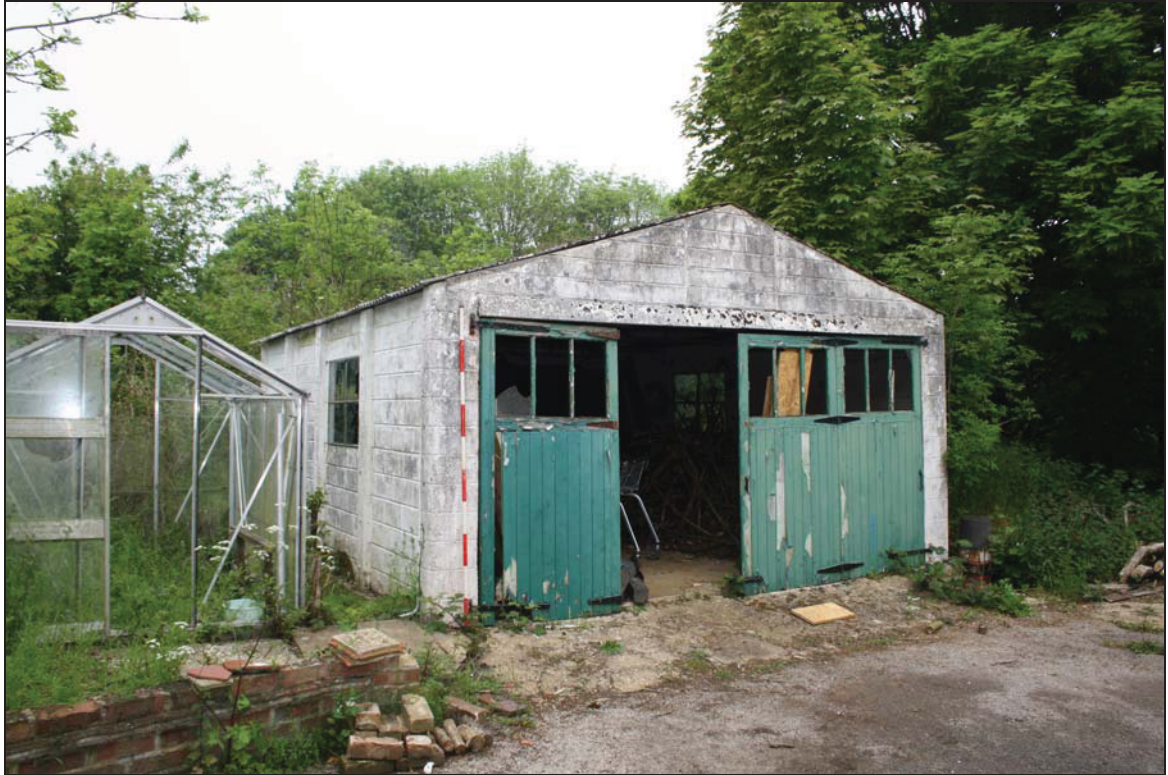
6.9 The adjoining garage is a typical 1950s 'kit-form' construction, though no manufacturer's plate was noted. Such garages were often ordered from catalogues to be self-built, and reflect the increased ownership of cars from that period onwards.

Plate 11 View of the garage to the west of the house, taken from the south-east (DP 7)

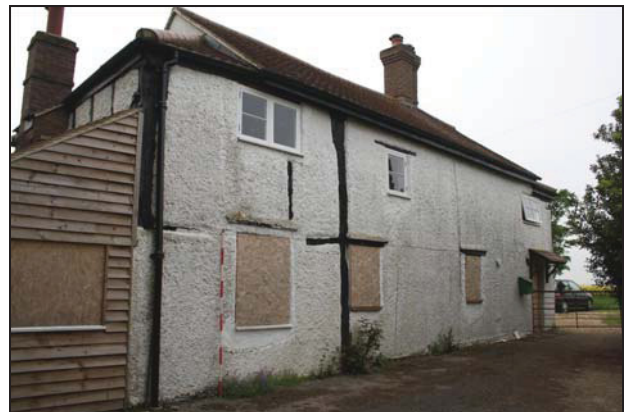
DP 6

West elevation, taken from the north-west

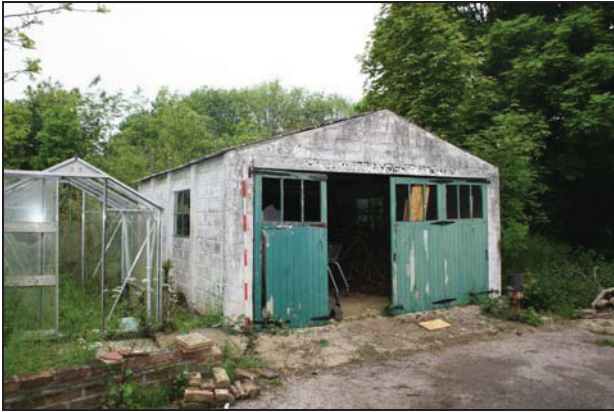
DP 7

5.28 A free-standing garage lies to the rear west side of the property (Plate 11). It is constructed of pre-fabricated concrete slabs held together with bolts and washers, the exterior being slightly decorative with inscribed lines giving the impression of ashlar-lining. The roof is of light-weight composite iron trusses, covered with corrugated chrysotile asbestos sheeting.

View of the garage to the west of the house, taken from the south-east

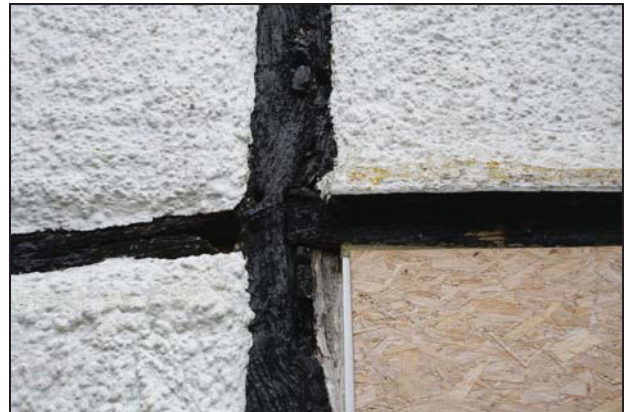
DP 10

Detail of the west elevation showing exposed timber frame, taken from the west

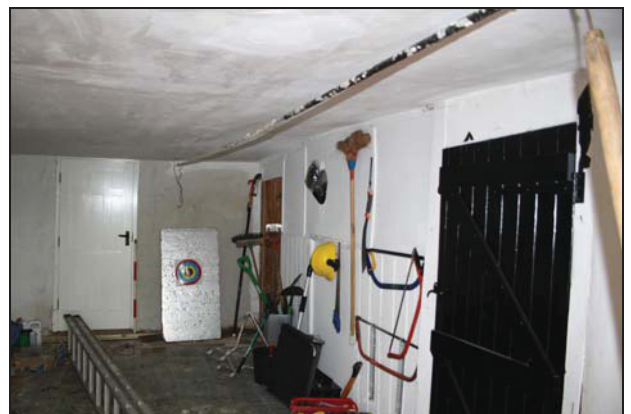
DP 12

Room GF02, taken from the south-east

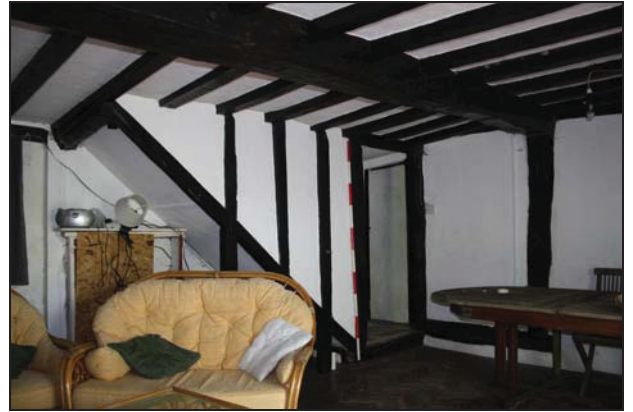
DP 14

5.12 An enclosed timber staircase in the north-west corner sits on a single bearer and a corner brace, notch-lapped over vertical staves which are jointed with small pegs to the existing ceiling joisting (Plate 5). Two staves retain scribed assembly marks including XXVIII and XXV. A small window below the staircase appears to be framed with similarly fictive timber as on the east.

North-west area of Room GF01 showing enclosed staircase, taken from the south-east

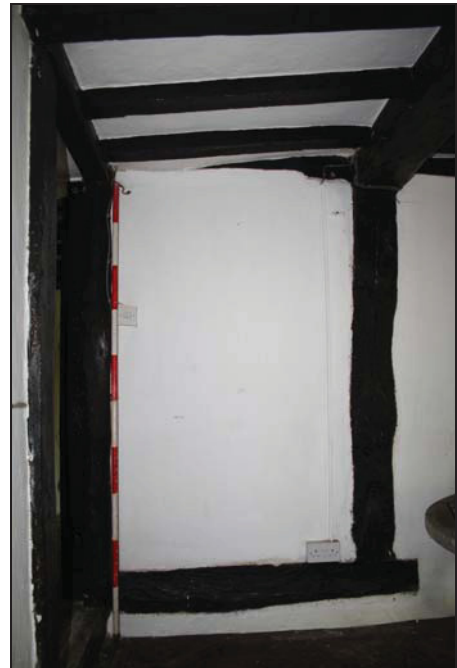
DP 16

North wall of Room GF01 showing timber framing and surviving section of sole-plate, taken from the south

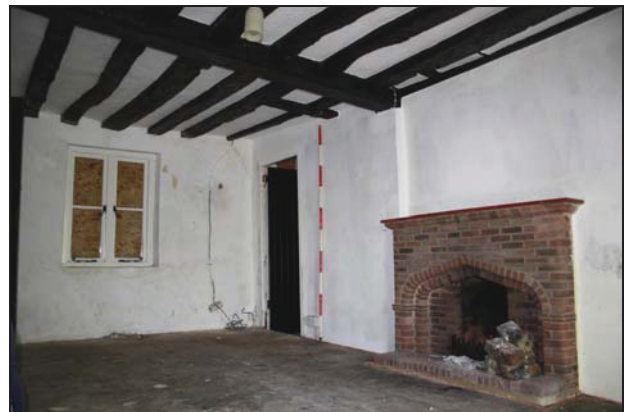
DP 18

North-west area of Room GF03, taken from the south-east

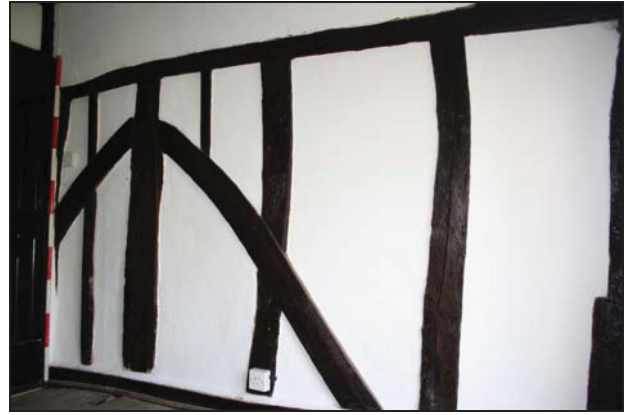
DP 26

North wall of Room FF03, taken from the south-east

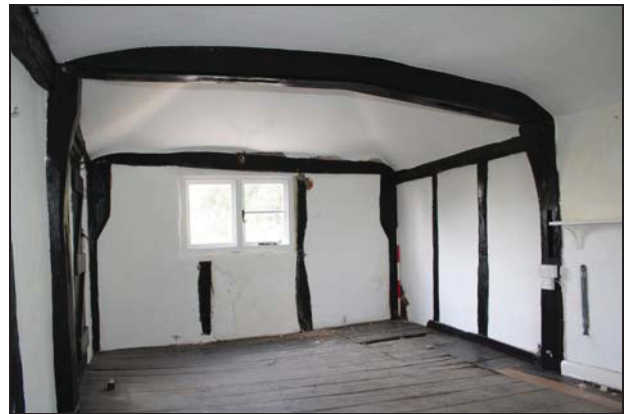
DP 28

West side of Room FF05, taken from the east

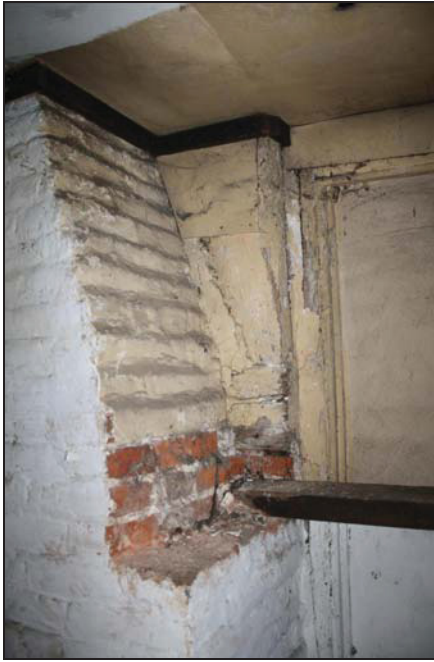
DP 31

Cupboard on the east side of the principal chimney stack showing shouldered stack and timber elements, taken from the south-east

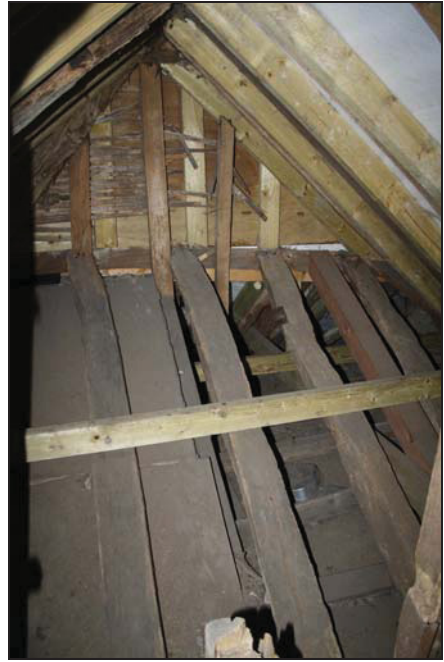
DP 32

View of the roof over the northern cross-wing showing early repositioned rafters, taken from the south

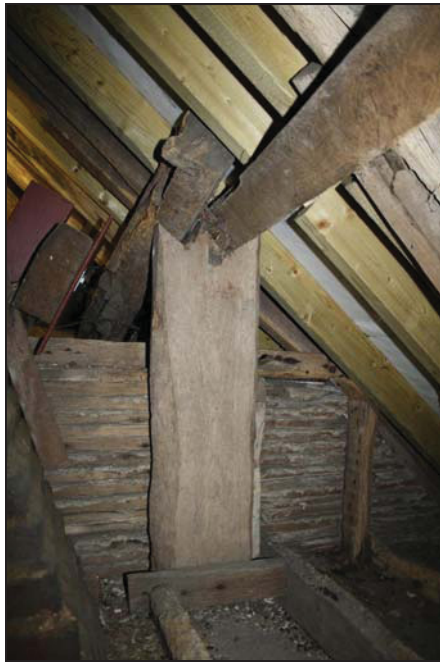
DP 35

Detail of the double bird-mouthed strut to the purlins of the central and the southern cross-wing, taken from the south

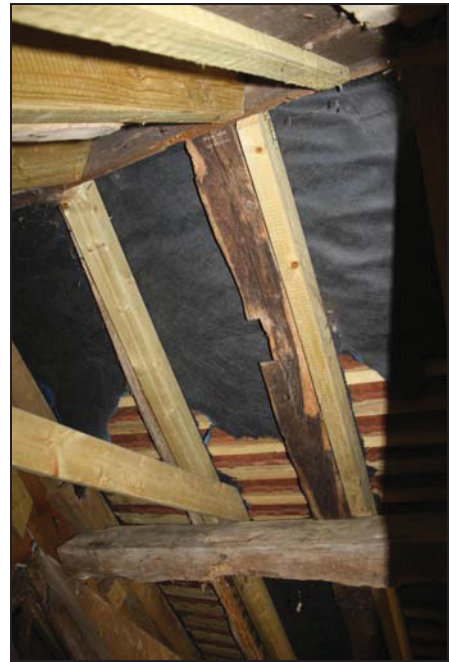
DP 36

Example of a reused smoke-blackened timber in the roof over the southern cross-wing, taken from the east

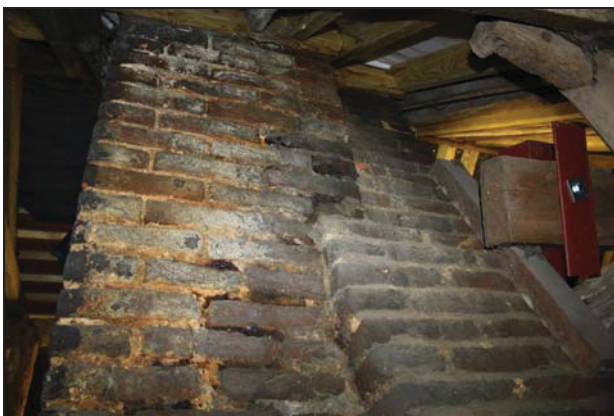
DP 37

Detail of the brickwork of the principal chimney stack at roof level, taken from the east

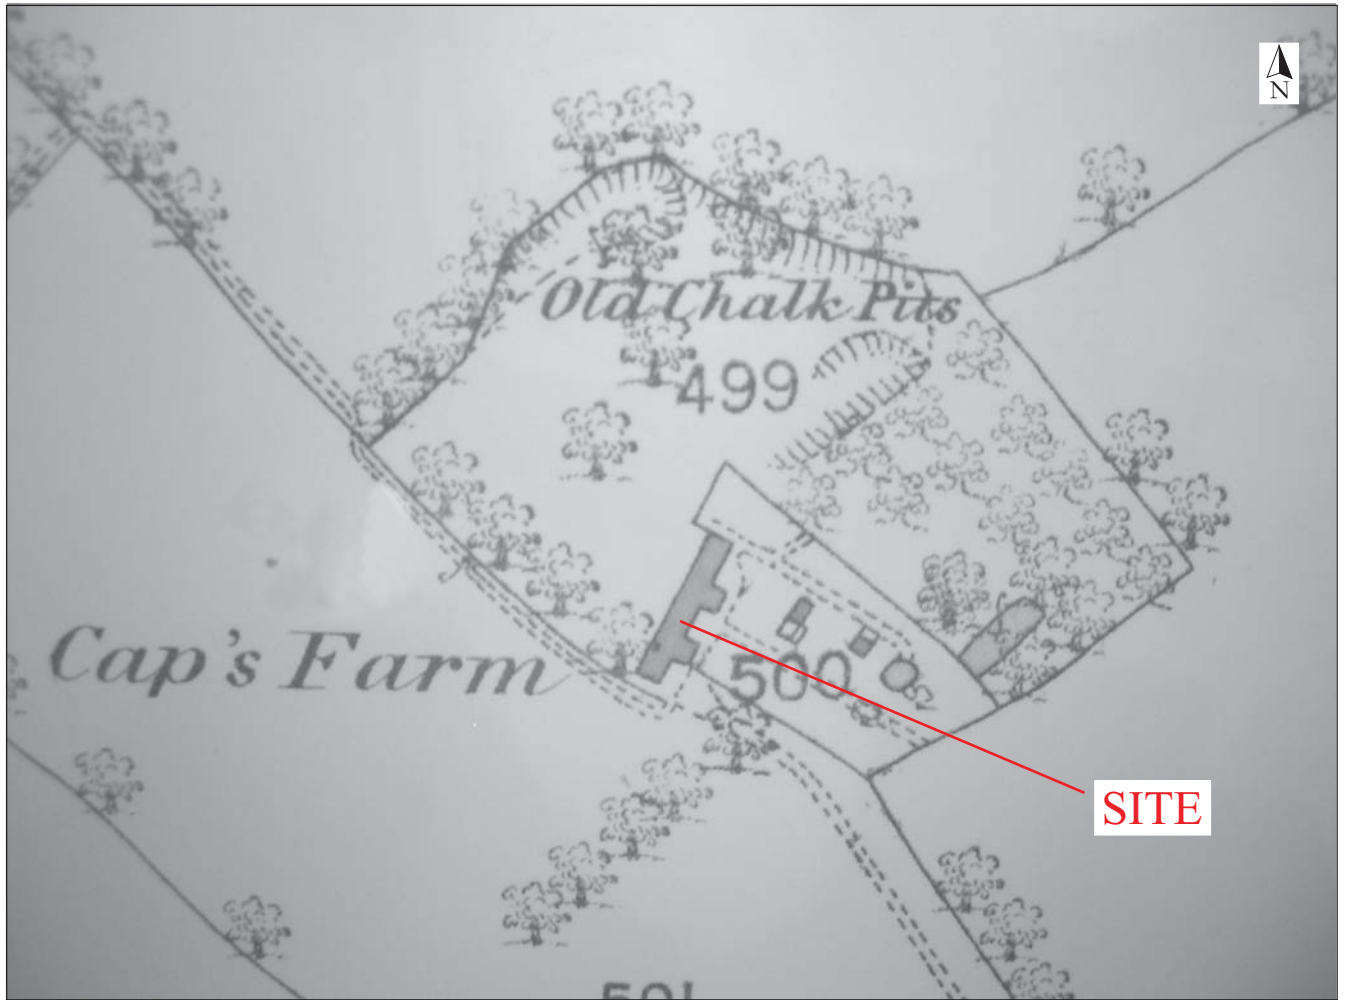
Archaeological Solutions Ltd
Fig. 7 1st edition OS map, 1879
Not to scale: reproduced from the 1:1250 map
