**3 ANVIL AVENUE, LITLINGTON,  
CAMBRIDGESHIRE**

**ARCHAEOLOGICAL MONITORING & RECORDING**

CHER ECB3696

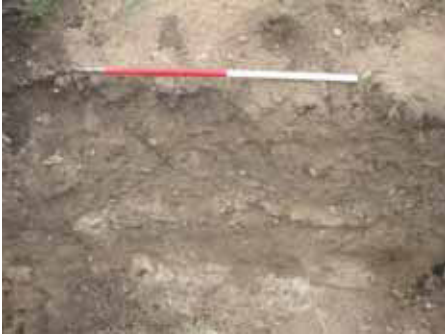
DP1

| <i>Sample Section 1; north-east facing. DP1</i> | | |
| <i>Centre of foundation trench</i> | | |
| <i>0.00 = 37.63m</i> | | |
| 0.00 – 0.20m | L1000 | Topsoil. Mid grey brown, loose silty clay with occasional small angular flint and chalk. |
| 0.20 – 1.00m | L1001 | Made Ground Levelling Layer. Mixed yellow and grey, friable silty sand and chalk demolition rubble. |
| 1.00m+ | L1002 | Made Ground Levelling Layer. Mixed whitish grey, friable sandy mortar and demolition rubble. |

Post-excitation photograph of footings, Sample Section 1, looking south-west.

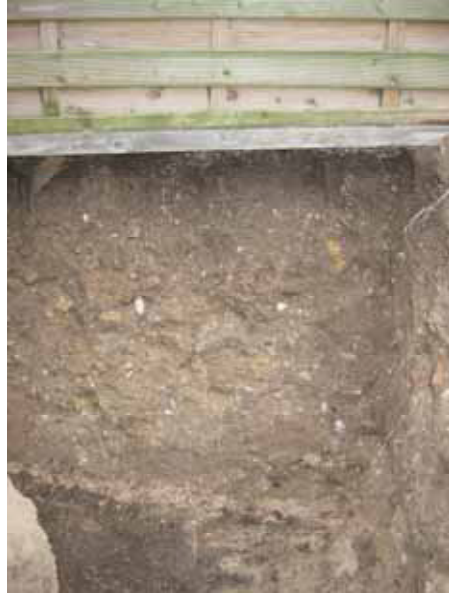
DP2

| <i>Sample Section 2; south-east side, north-west facing. DP2</i> | | |
| <i>SE side of foundation trench</i> | | |
| <i>0.00 = 37.60m</i> | | |

| 0.00 – 0.30m | L1000 | Topsoil. As above. |
| 0.30 – 1.00m | L1001 | Made Ground Levelling Layer. As above. |
| 1.00 – 1.10m | L1002 | Made Ground Levelling Layer. As above. |
| 1.10m+ | L1003 | Natural drift geology. Light grey white chalk. |

Post-excitation photograph of footings, Sample Section 2, looking south-east.

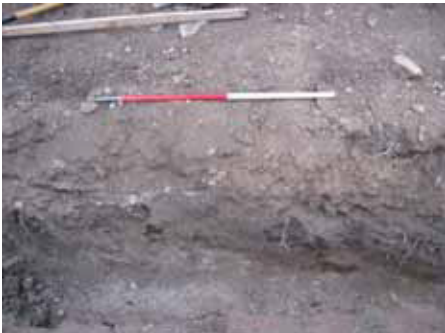
DP3

| <i>Sample Section 3; north-west end, north-east facing. DP3<br/>NW end of foundation trench<br/>0.00 = 37.52m</i> | | |
| 0.00 – 0.20m | L1000 | Garden Topsoil. As above. |
| 0.20 – 1.05m | L1001 | Made Ground Levelling Layer. As above. |
| 1.05m+ | L1003 | Natural drift geology. As above. |

Post-excitation photograph of footings, Sample Section 3, looking south-west.

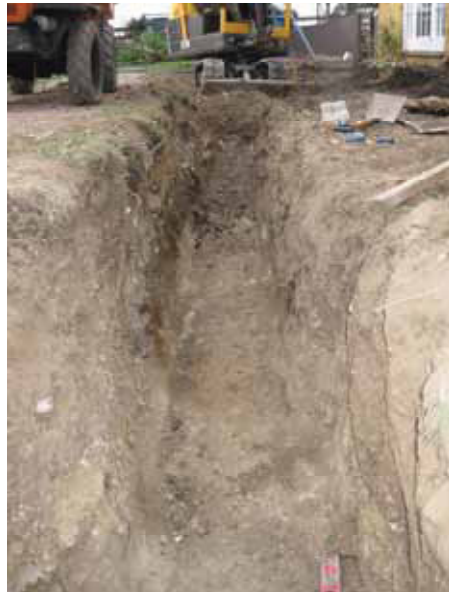
DP4

Excavated conservatory footings, looking north-west.

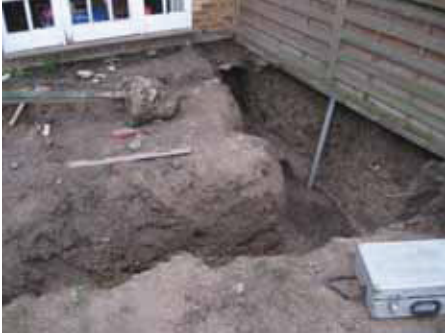
DP5

General site photograph, conservatory footings, looking north-east.

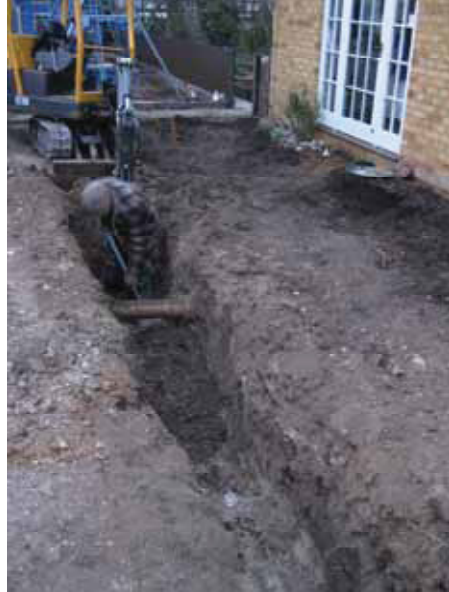
DP6

*Description:* Two modern drains were present between Sample Sections 1 and 3, both were aligned broadly north-east/south-west. No other features or finds were present.

General site photograph, conservatory footings with modern drains and house in background, looking north.
