**THE BULL P.H., 1 CHIPPERFIELD ROAD,
BOVINGDON, HERTFORDSHIRE**

**HISTORIC BUILDING ASSESSMENT
& ARCHAEOLOGICAL EVALUATION**

Authors:	Tansy Collins BSc Lee Prosser PhD Tim Schofield HND BSc Kate Higgs MA	
NGR: TL 01670 03567		Report No. 3967
District: Dacorum		Site Code: AS 1448
Approved: Claire Halpin MIFA		Project No. 4359
Signed:		Date: Nov. 2011

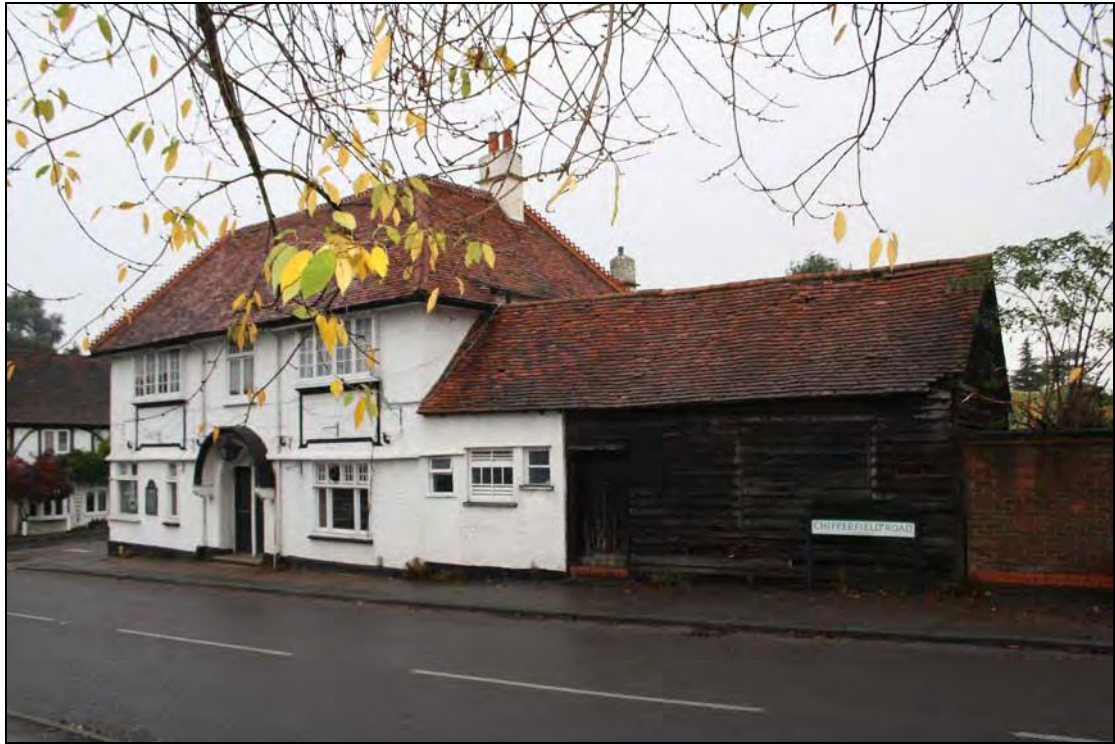
Plate 1 South elevation, taken from the south (1)

5.1 The building rises in two storeys with a steeply pitched, old peg-tile roof, and a lower single-storey, timber-framed range extending to the east (Plate 1). It fronts, as noted, onto Chipperfield Road to the south which forms

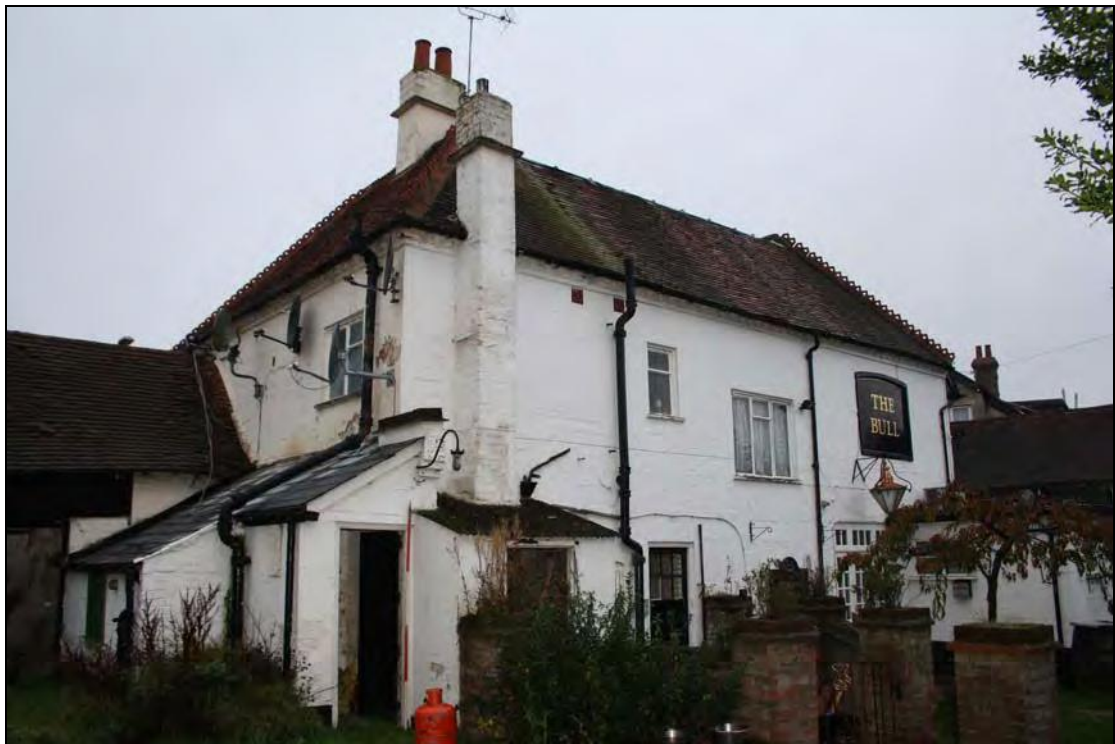
Plate 2 East and north elevation, taken from the north-east (5)

5.7 The rear, north elevation is of unrendered brick, but has been painted several times with thick masonry paint, obscuring much of the detail (Plate 2). However, various relic features such as repair and blocked window apertures remain visible. The brickwork is laid in an indeterminate bond, though largely

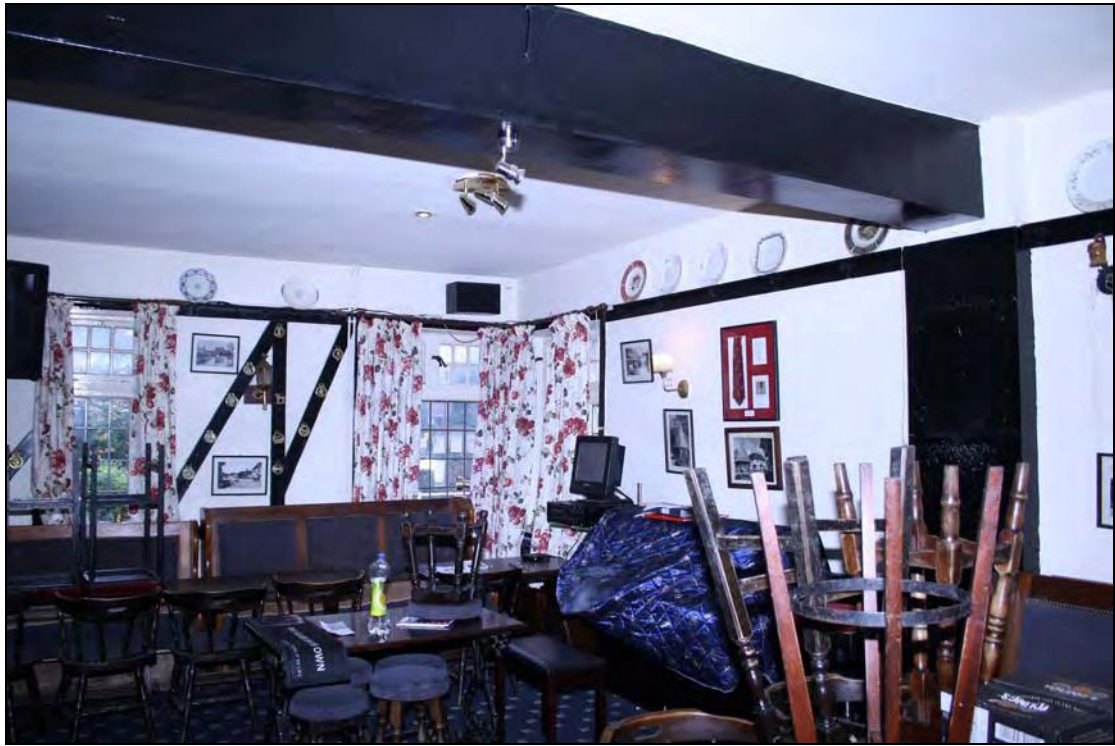
Plate 3 South side of Room GF01, taken from the north (9)

5.13 The west room (Room GF01) consolidates two earlier rooms, which were formerly divided (according to oral testimony) by a large inglenook fireplace. It is now dressed in 'tea-shop fakery' style with applied cosmetic timberwork (Plate 3). The bar is a good 1950s example with a tapering profile, fluted decorations and veneers. The eastern part of the bar (Room GF02) is similarly plain, but does retain the chimney stack on the north (Plate 4). The fireplace, however, is a 1950s replacement. More fictive timberwork adorns the ceiling, a number of the 'joists' having early 1970s graffiti. The windows throughout are all consistent with a date around 1910 with fairly plain mouldings. The ceilings may be of some age, though that in the central area is set slightly higher perhaps indicating that the western area is suspended.

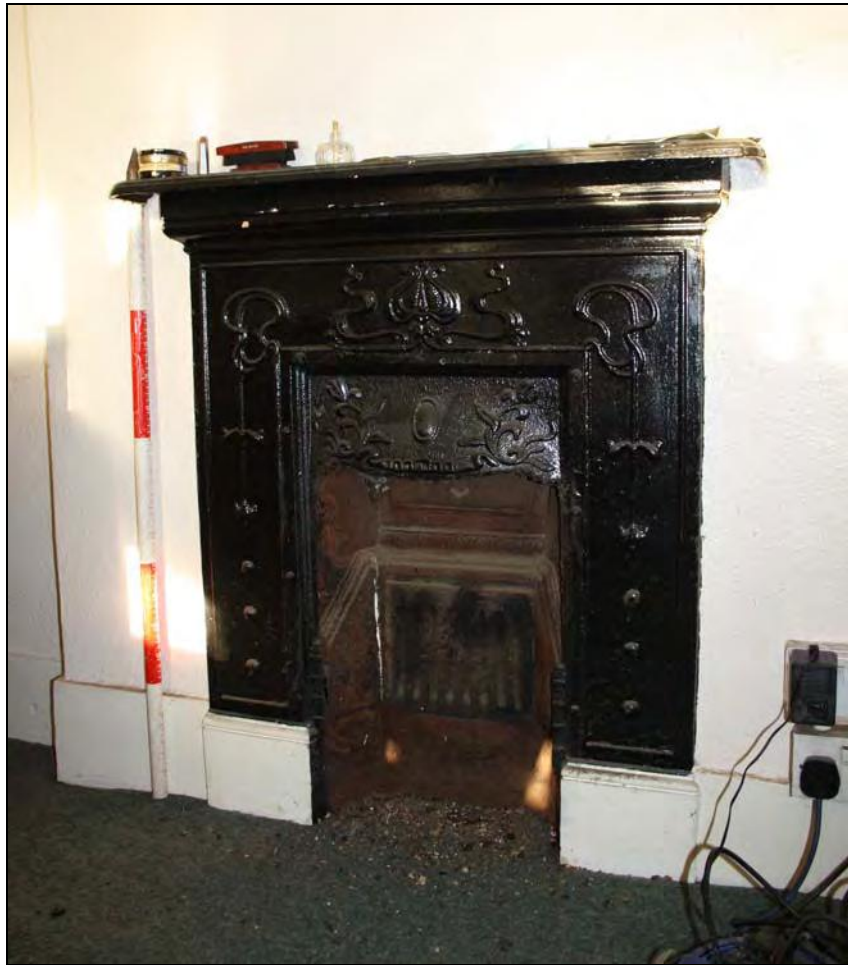
Plate 7 Fireplace on the north side of Room FF05, taken from the south (38)

5.20 Room FF05 has a wide probable 1930s replacement window, but as with Room FF02 the doorway retains a probable mid-19th century surround. In addition, the fireplace on the north retains a good cast-iron decorative surround with embossed Art Nouveau relief of c.1910 (Plate 7). In the lobby FF06 and the bathroom Room FF07 nothing of note survives except for 1950s fitted cupboards.

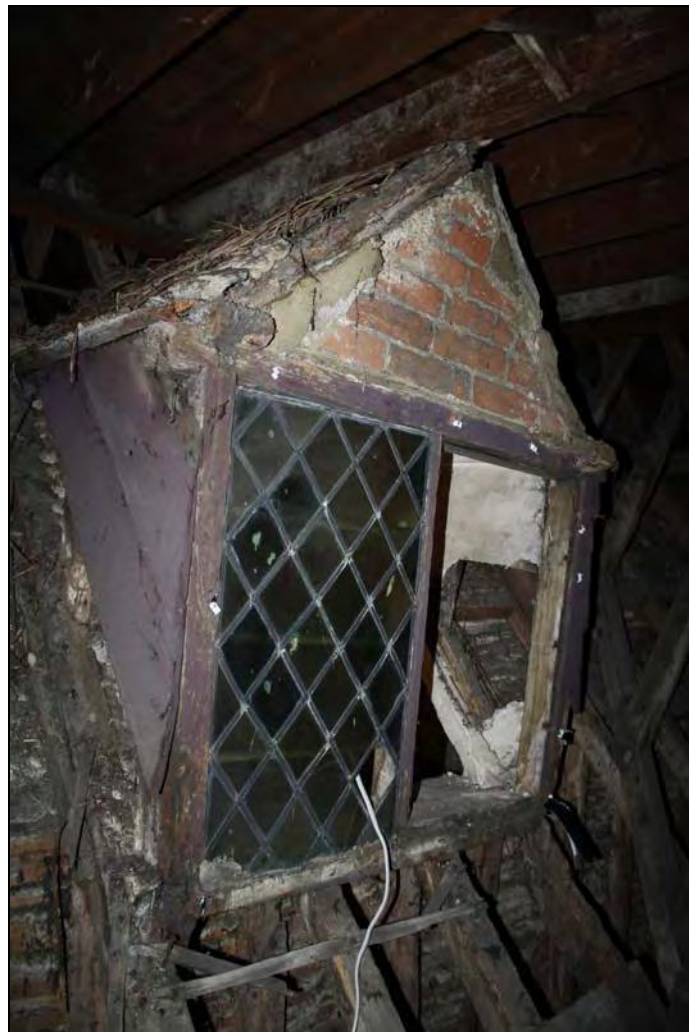
Plate 10 Original west dormer window, now entombed, taken from the north-east (51)

5.25 The dormer windows are exceptional survivals, though have been damaged in recent times. The flat-roof which has served to preserve them so well was probably added with the removal of the west chimney stack. Both dormers retain their original surrounds with little brick-nogged gables, while both retain one of a pair of fixed lights with iron bars and original diamond paned glazing. One light of on the east dormer has been replaced with a Victorian casement, while its counterpart to the west has been kicked out and now lies, badly crushed in the gutter. Externally, both dormers rest on the rafters of the roof structure and preserve original joinery features. They have, for example, little shaped ends to the wall-plates, with some weatherboarding to the side. How they could be given access for repair and maintenance is unknown, suggesting that they are little altered from their original construction (Plate 10).

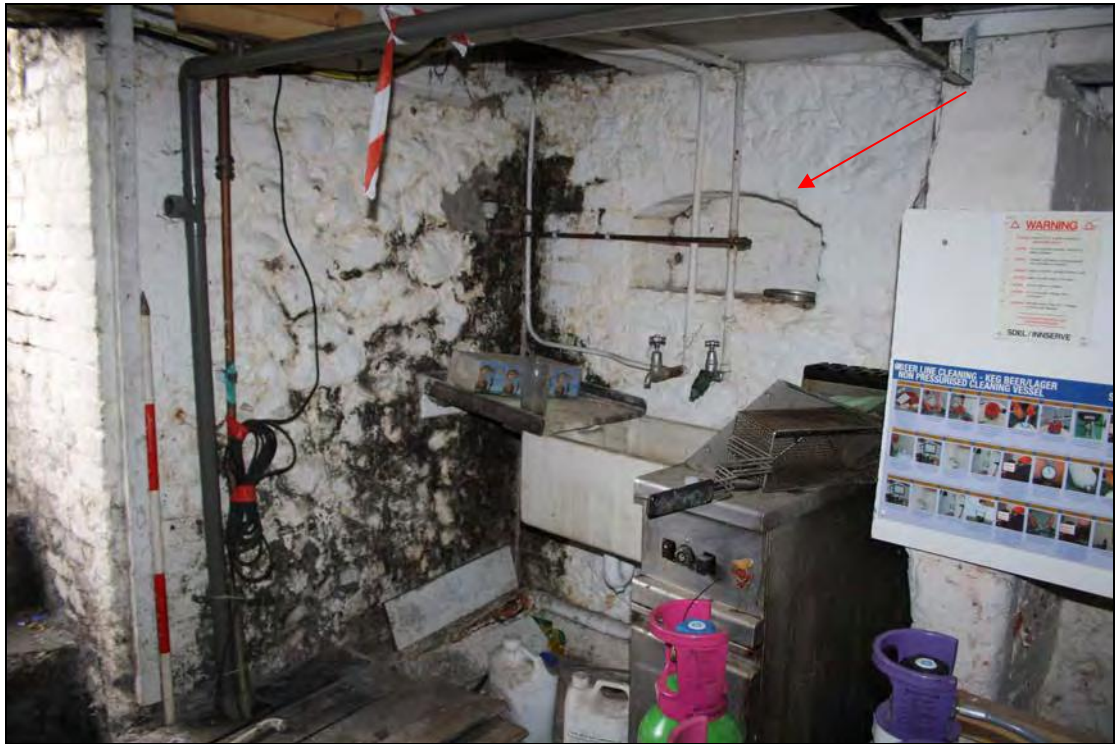
Plate 11 North-west corner of Room BF showing flint construction and original niche (indicated), taken from the south-east (17)

5.28 There is little to see. The walls are constructed of brick on the south and east, with a short return to the west. The north, by contrast is made of flint cobbles, all smothered in paint, and broken only by the base of the lost chimney stack. The ceiling is boarded out in modern materials. The only feature of any interest is a small brick-arched niche to the west of the chimney stack set into the original walling (Plate 11). This is original to the building.

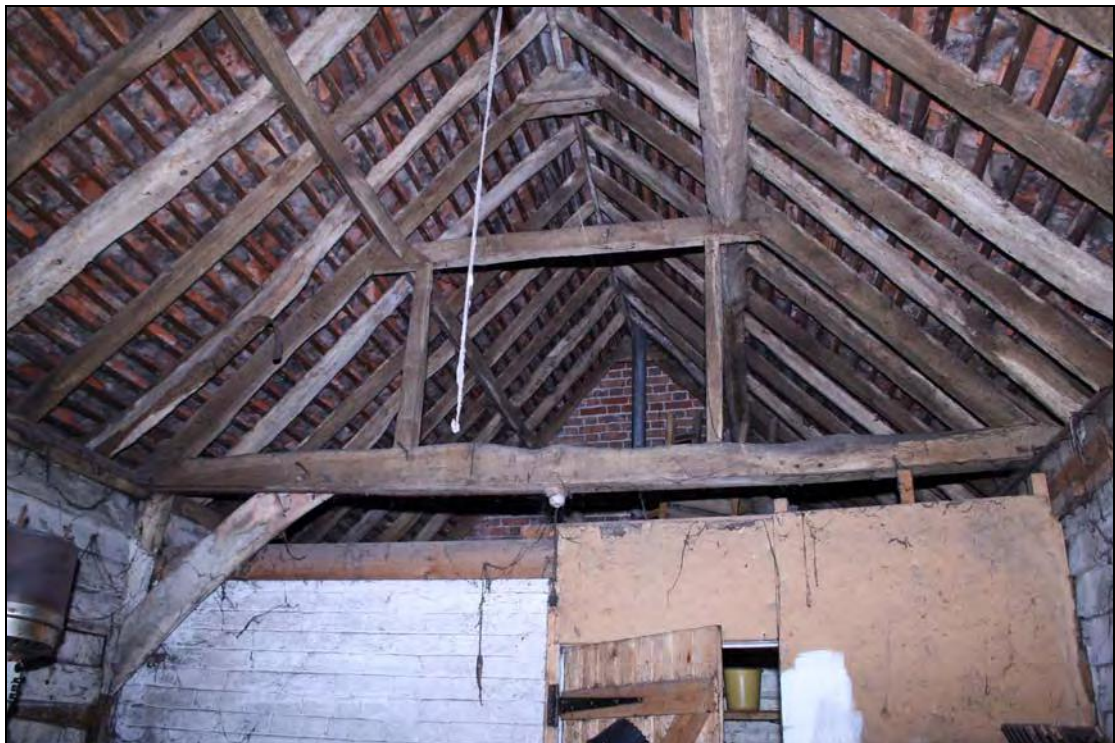
Plate 12 West truss of Room GF07 (east range), taken from the east (26)

6.8 It is proposed to convert the east range into garage space or bicycle sheds. Most of the framing in this area is original, including the mezzanine, and although in places in need to repair, conversion to garages will have a considerable impact into the original timber-framing. However, alternative proposals for use as bicycle accommodation will impact to a lesser degree and can be carried out to retain much of the original framing.

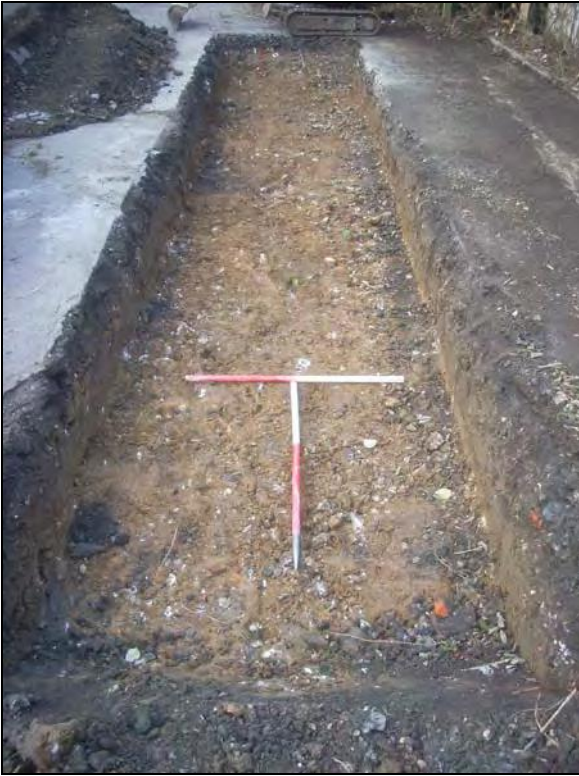
DP 1

Post-excavation shot, Trench 1, looking west.

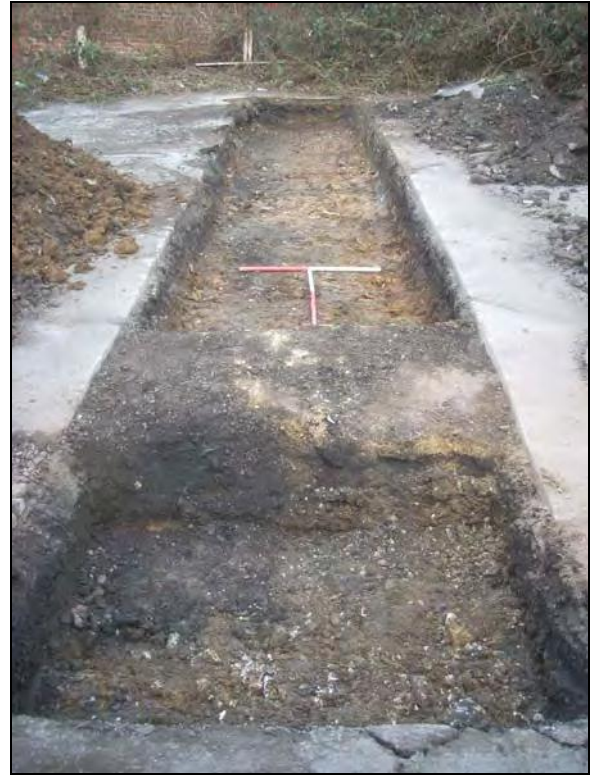
DP 2

Post-excavation shot, Trench 2, looking north.

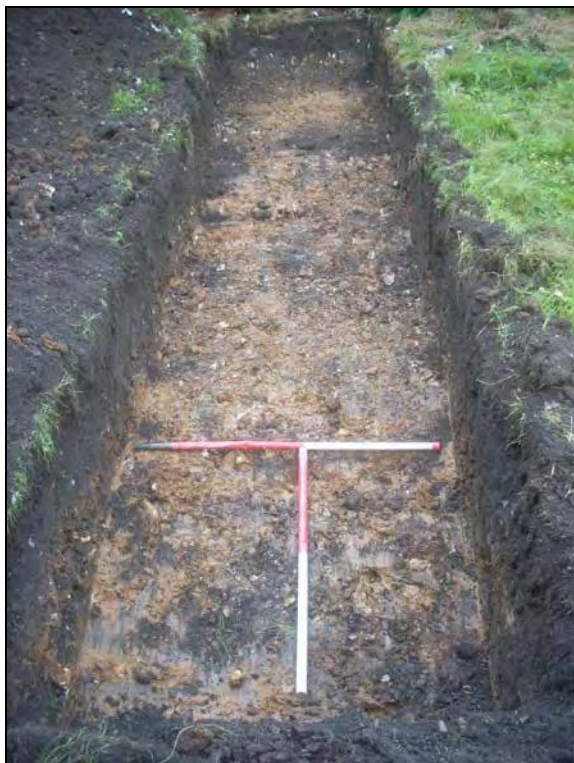
DP 3

Post-excavation shot, Trench 3, looking west.

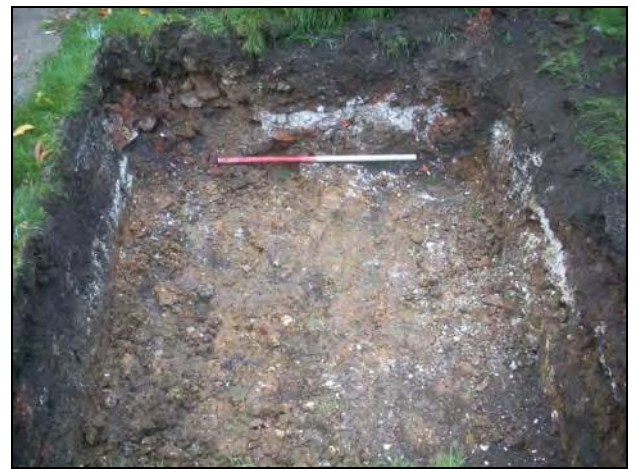
DP 4

Post-excavation shot Trench 4, Test Pit 4B in foreground. Looking north-west.
