**OVERSTONE HOUSE, 112 KETTERING ROAD
MARKET HARBOROUGH, LEICESTERSHIRE**

AN ARCHAEOLOGICAL EVALUATION

Authors:	Samuel Egan (Fieldwork and report) Antony Mustchin MSc (Editor)	
Illustrations:	Kathren Henry	
NGR: SP 7485 8660		Report No: 4274
District: Harborough		Site Code: AS1570
Approved: C Halpin MIfA		Project No: 4480
Signed:		Date: March 2013 Revised: 03/06/2013

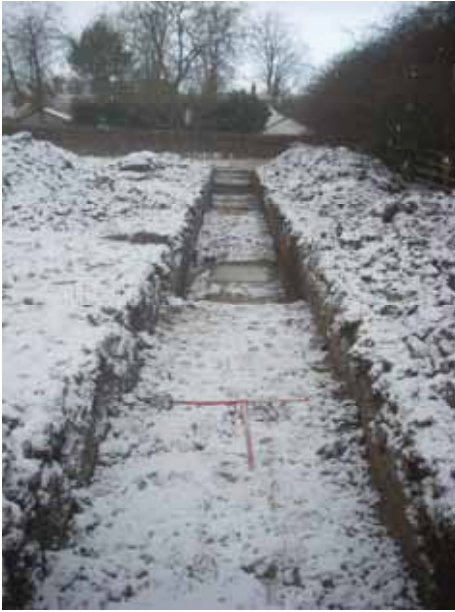
DP 1: Trench 1, looking ESE

Description: Trench 1 contained no archaeological features or finds.

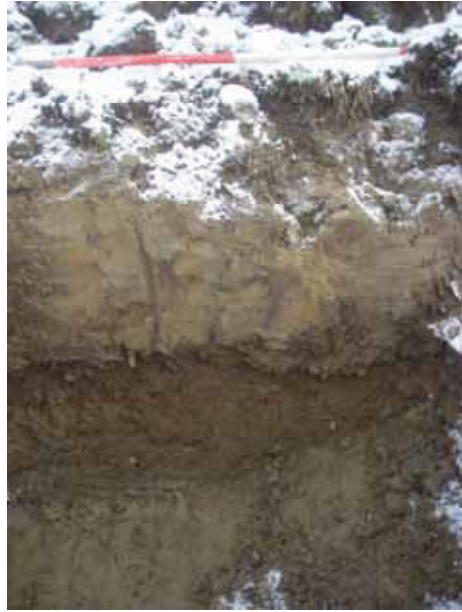
DP 2: Sample Section 1A, looking NNE

<i>Sample section 1A: south-east end</i> <i>0.00 = 107.60m AOD</i>		
0.00 – 0.44m	L1000	Topsoil. Mid greyish brown, silty clay
0.44 – 0.85m	L1001	Modern Made Ground. Mid greyish blue silty clay with modern debris.
0.85 – 1.06m	L1002	Buried Topsoil. Dark greyish brown, silty clay.
1.06 – 1.25m	L1003	Subsoil. Mid orange brown, silty clay.
1.25m+	L1004	Natural. Pale orange / yellow, blue, compact, silty clay.

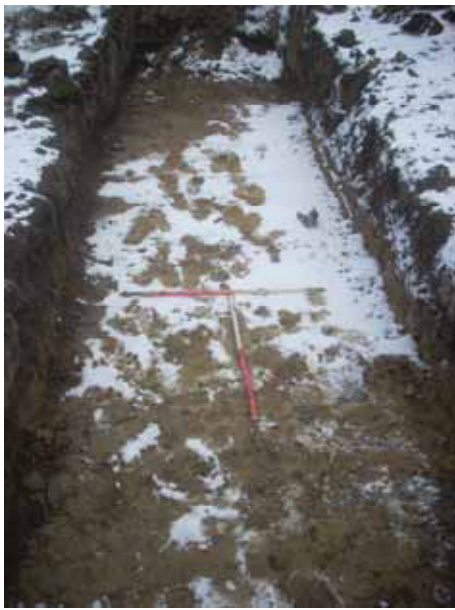
DP 3: Trench 2, looking NNE

<i>Sample section 2A: centre</i> <i>0.00 = 110.83m AOD</i>		
0.00 – 0.31m	L1000	Topsoil. As above Tr.1.
0.31 – 0.92m	L1001	Modern Made Ground. As above Tr.1.
0.92 – 1.02m	L1002	Buried Topsoil. As above Tr.1.
1.02 – 1.08m	L1003	Subsoil. As above Tr.1.
1.08m+	L1004	Natural. As above Tr.1.

Description: Trench 2 contained no archaeological features or finds.

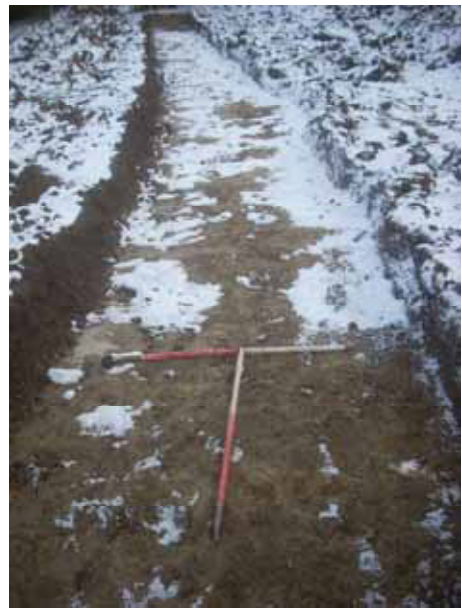
DP 4: Trench 3, looking ESE

Description: Trench 3 contained no archaeological features or finds.

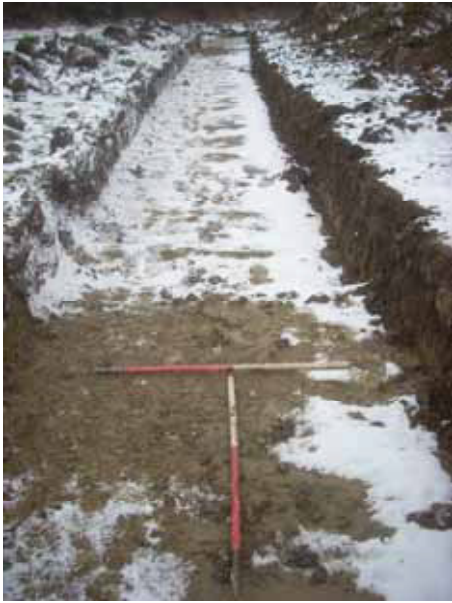
DP 5: Trench 4, looking ENE

Description: Trench 4 contained no archaeological features or finds.

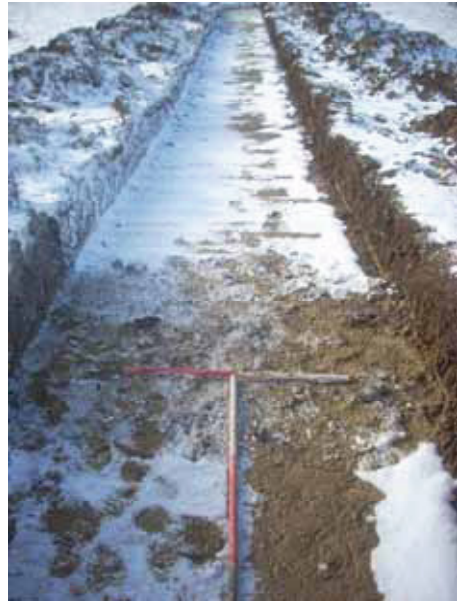
DP 6: Trench 5, looking ENE

Description: Trench 5 contained no archaeological features or finds.

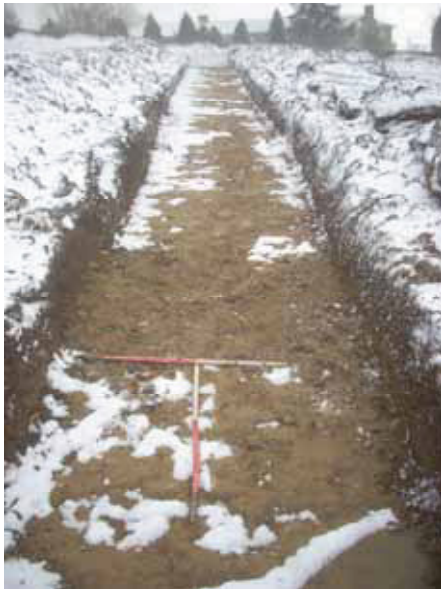
DP 7: Trench 6, looking NNE

Description: Trench 6 contained no archaeological features or finds.

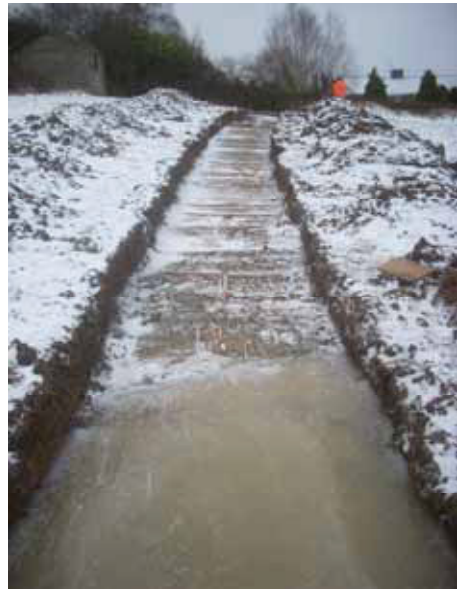
DP 8: Trench 7, looking SSW

Description: Trench 7 contained no archaeological features or finds.

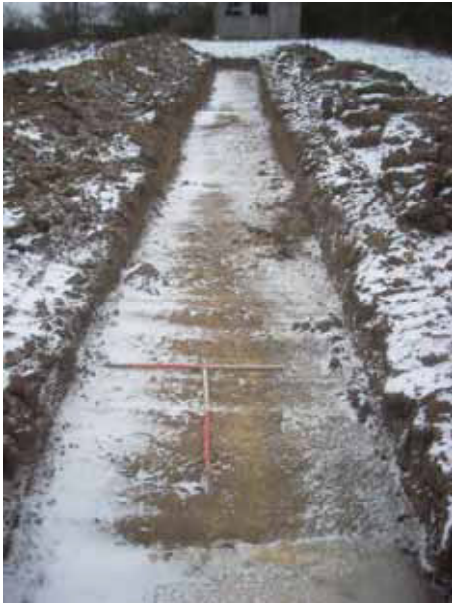
DP 9: Trench 8, looking ESE

Description: Trench 8 contained no archaeological features or finds.

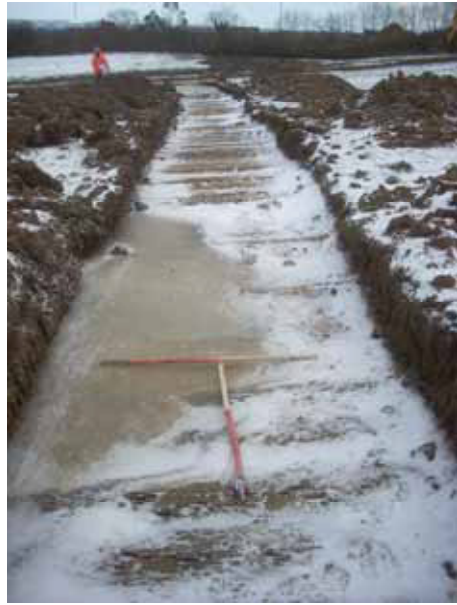
DP 10: Trench 9, looking NNE

Description: Trench 9 contained no archaeological features or finds.

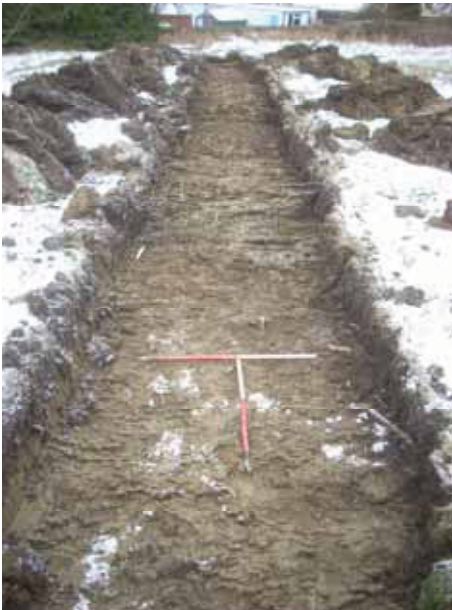
DP 11: Trench 10, looking NE

Description: Bar traces of ridge and furrow, Trench 10 contained no archaeological features or finds.

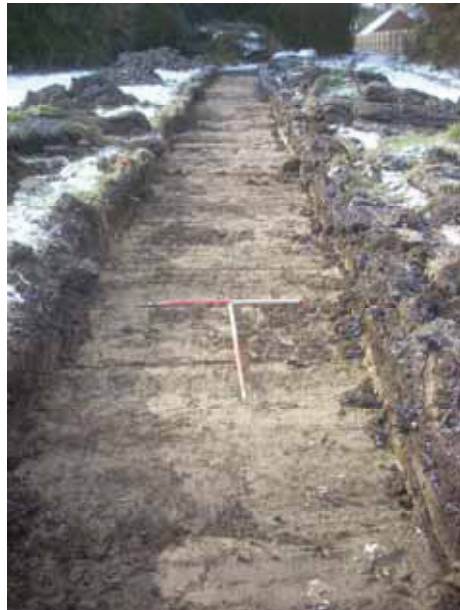
DP 12: Trench 11, looking SSW

Description: Bar traces of ridge and furrow, Trench 11 contained no archaeological features or finds.

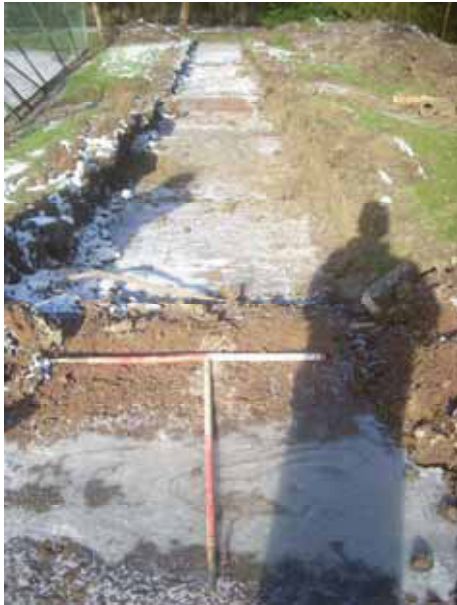
DP 13: Trench 12, looking NW

Description: Trench 12 contained no archaeological features or finds.

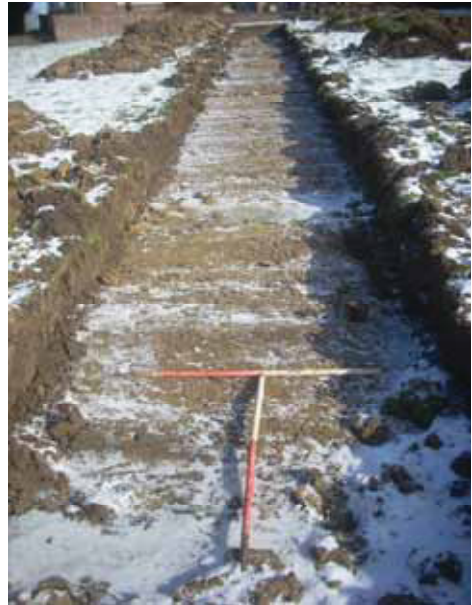
DP 14: Trench 13, looking NNE

Description: Bar traces of ridge and furrow, Trench 13 contained no archaeological features or finds.

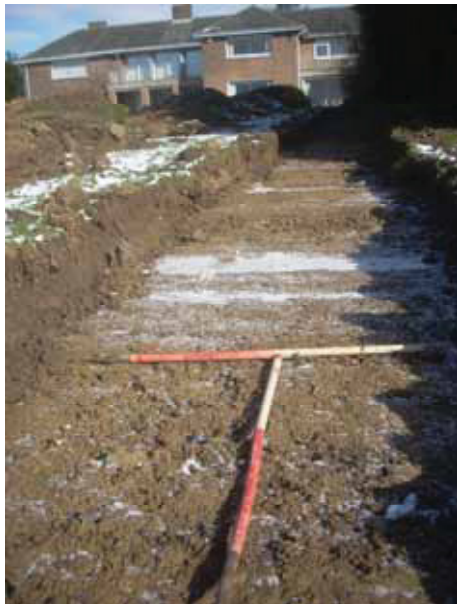
DP 15: Trench 14, looking N

Description: Bar traces of ridge and furrow, Trench 14 contained no archaeological features or finds.

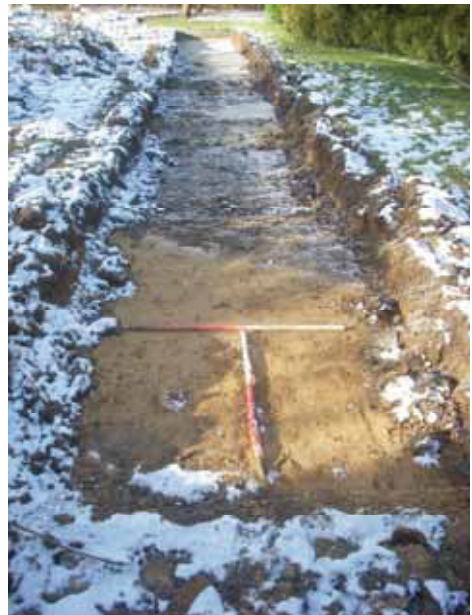
DP 16: Trench 15, looking SW

Description: Trench 15 contained no archaeological features or finds.

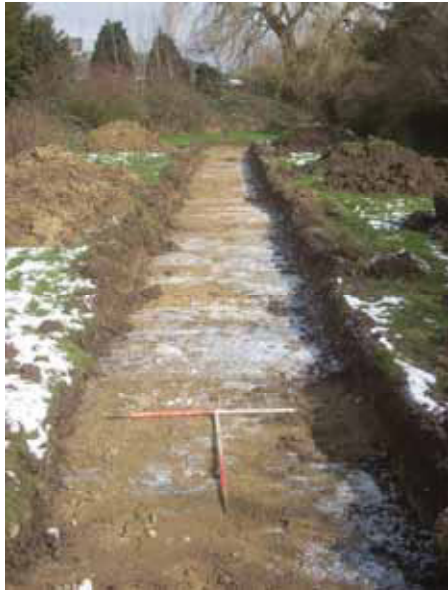
DP 17: Trench 16, looking NNE

Description: Bar traces of ridge and furrow, Trench 16 contained no archaeological features or finds.

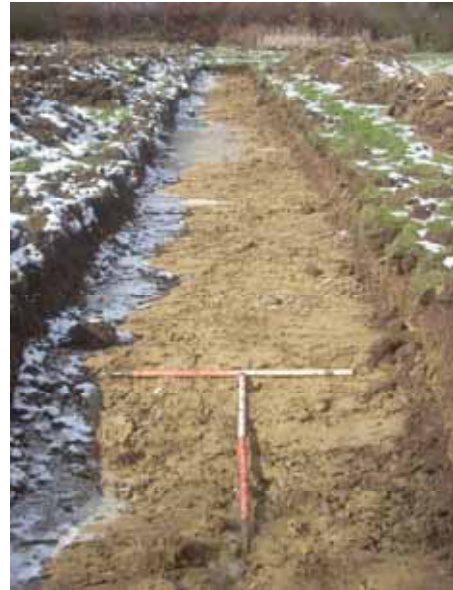
DP 18: Trench 17, looking WNW

Description: Bar traces of ridge and furrow, Trench 17 contained no archaeological features or finds.

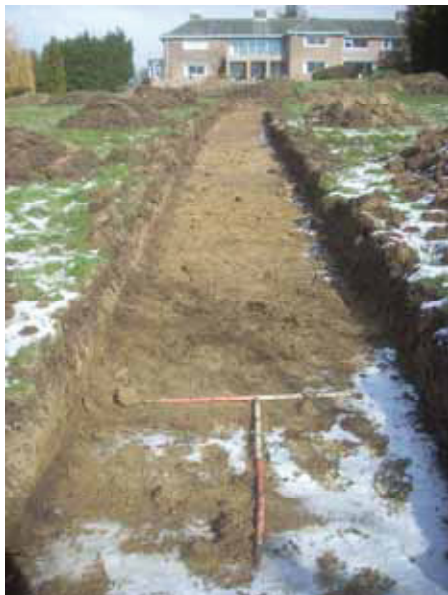
DP 19: Trench 18, looking NNE

Description: Bar traces of ridge and furrow, Trench 18 contained no archaeological features or finds.

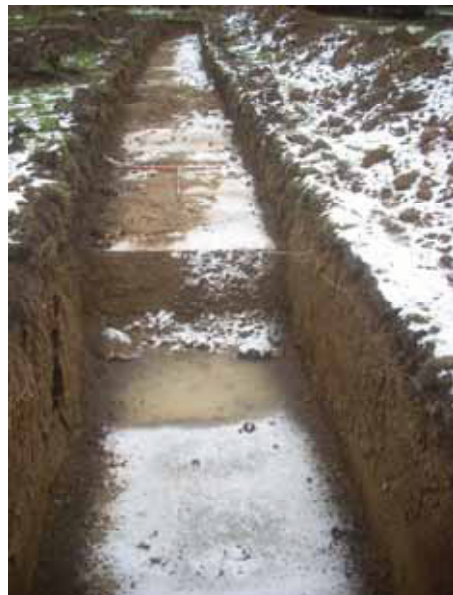
DP 20: Trench 19, looking NE

Description: Modern services were encountered running approximately north-west to south-east across the west-south-western half of trench 19. No archaeological features or finds were present.

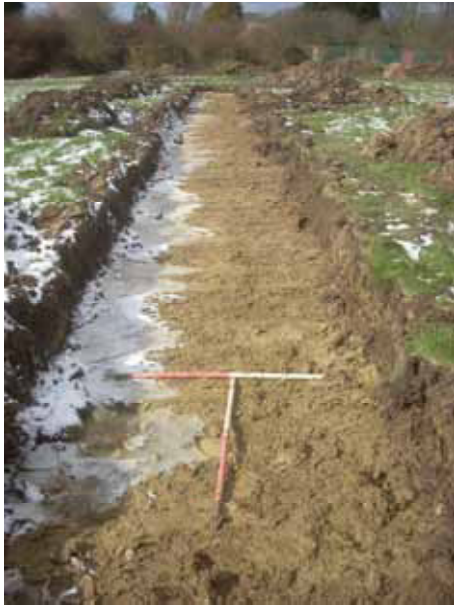
DP 21: Trench 20, looking WNW

Description: Bar traces of ridge and furrow, Trench 20 contained no archaeological features or finds.

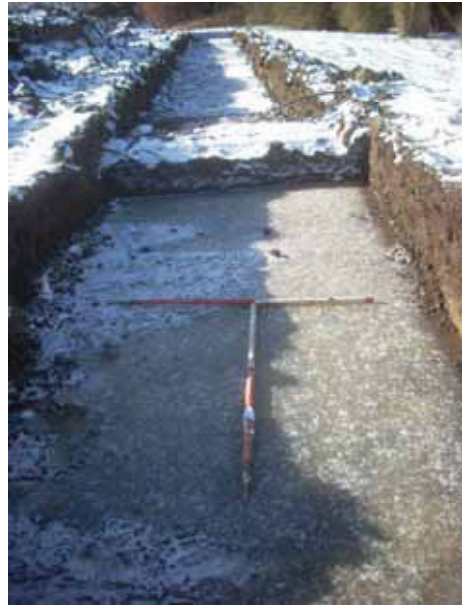
DP 22: Trench 21, looking SSW

Description: Bar traces of ridge and furrow, Trench 21 contained no archaeological features or finds.

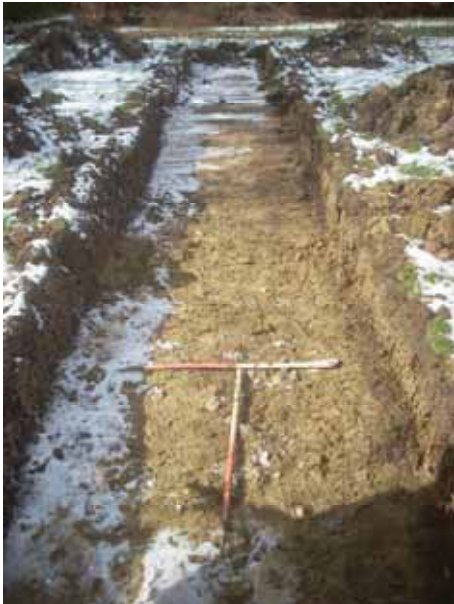
DP 23: Trench 22, looking WNW

Description: Modern services were encountered running approximately north-west to south-east across the centre of trench 22. Traces of ridge and furrow were present in the west-north-western end of this trench.

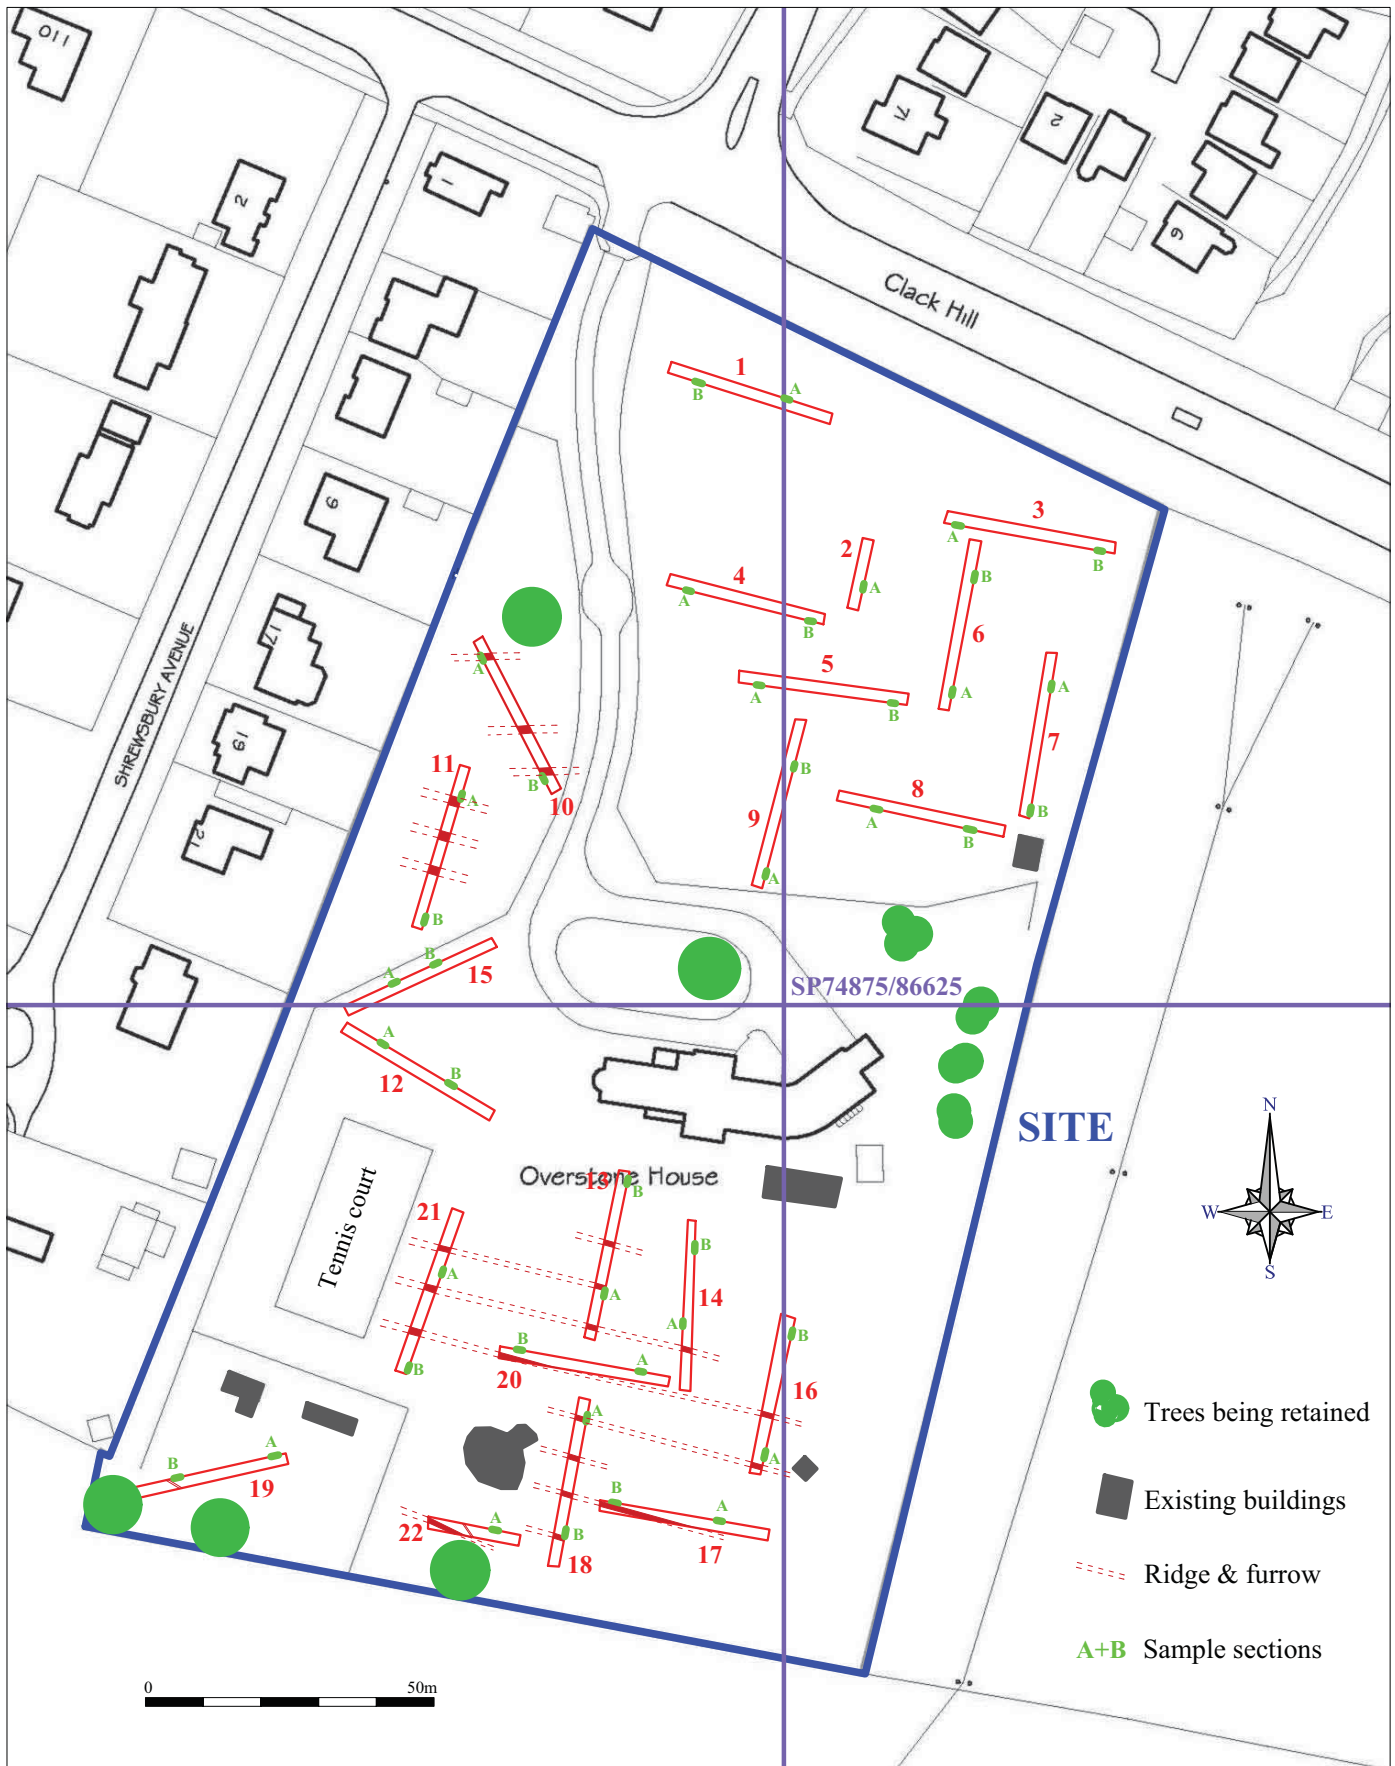
Archaeological Solutions Ltd
Fig. 2 Trench location plan
 Scale 1:1250 at A4

3.1 Twenty two trenches were excavated using a mechanical excavator fitted with a toothless ditching bucket (Fig. 2). The trench locations were approved by CCC HET and targeted those areas impacted by the proposed residential development (Fig. 3). All trenches were 1.8m wide and the majority were 30m in length. Proposed Trench 2 could not be fully excavated due to the occurrence of modern disturbance; on completion trench 2 measured 12m in length. In agreement with the planning archaeologist an additional trench (Tr. 22) was excavated. Trench 22 was 15m long.
