**READES BRICKWORKS, ALDEBURGH,
SUFFOLK**

HERITAGE ASSET STATEMENT

Level 2

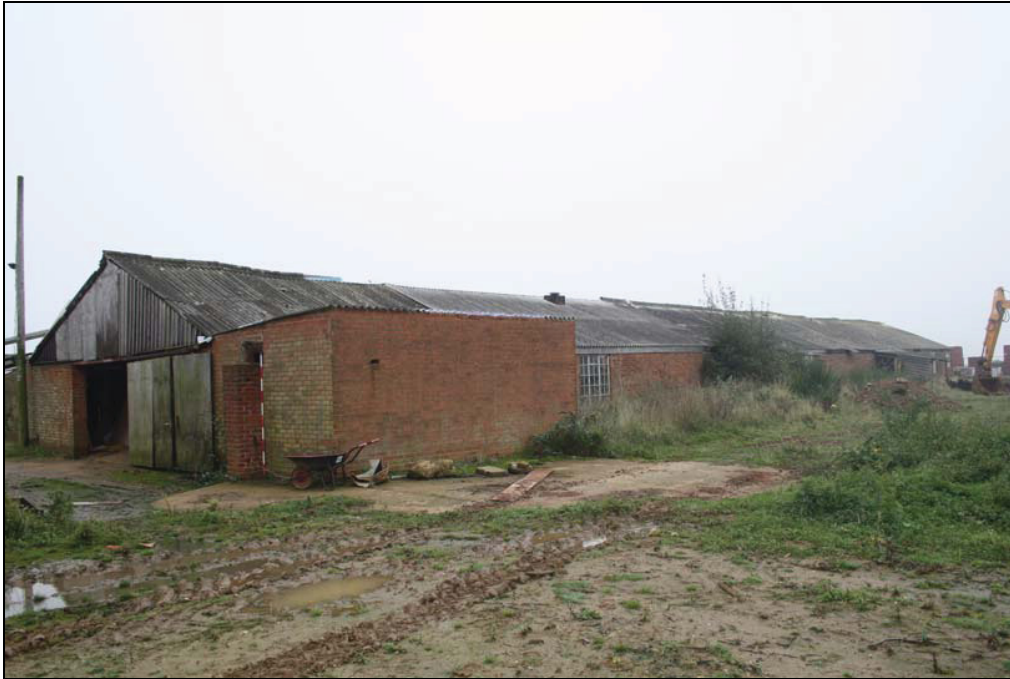
5.2 The factory is the largest building on the site, extending as a narrow, unadorned range, part-brick and timber, and roofed in corrugated sheeting (Plate 1). The northern elevation is constructed of bright orange brickwork laid in Flemish-bond, pierced by a large sliding door of modern plywood. Short outshuts extend to the east and west to protect the machinery and provide a store for sand. The western elevation is similarly bricked and pierced by sliding doors and Crittall-type steel casement windows.

Plate 1 Main brick making building, Building 1, taken from the north-west (DP 5)

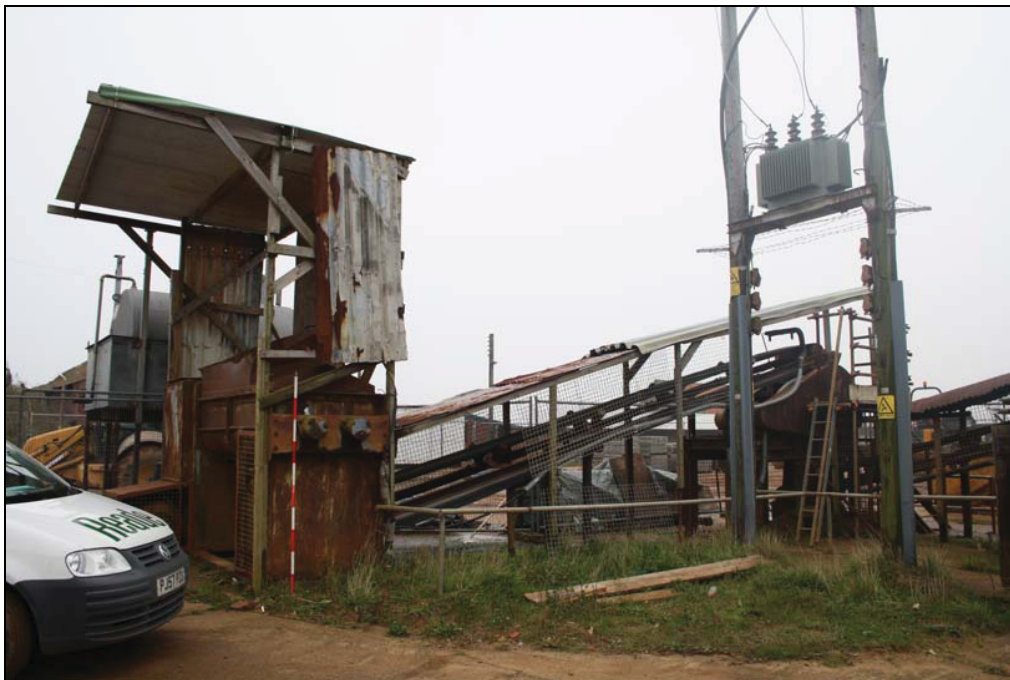
5.4 The northern end marks the beginning of the brick-making process, where the basic machinery survives in outline. A raised hopper and conveyor belts transported the clay to a grinding mill (Plate 2). These lie outside the building, but are protected by flimsy timber and sheet-tin canopies. Within the building, the clay fell into the pug mill, which was driven by a series of drive

Plate 2 External machinery and conveyor belts, taken from the north-west (DP 9)

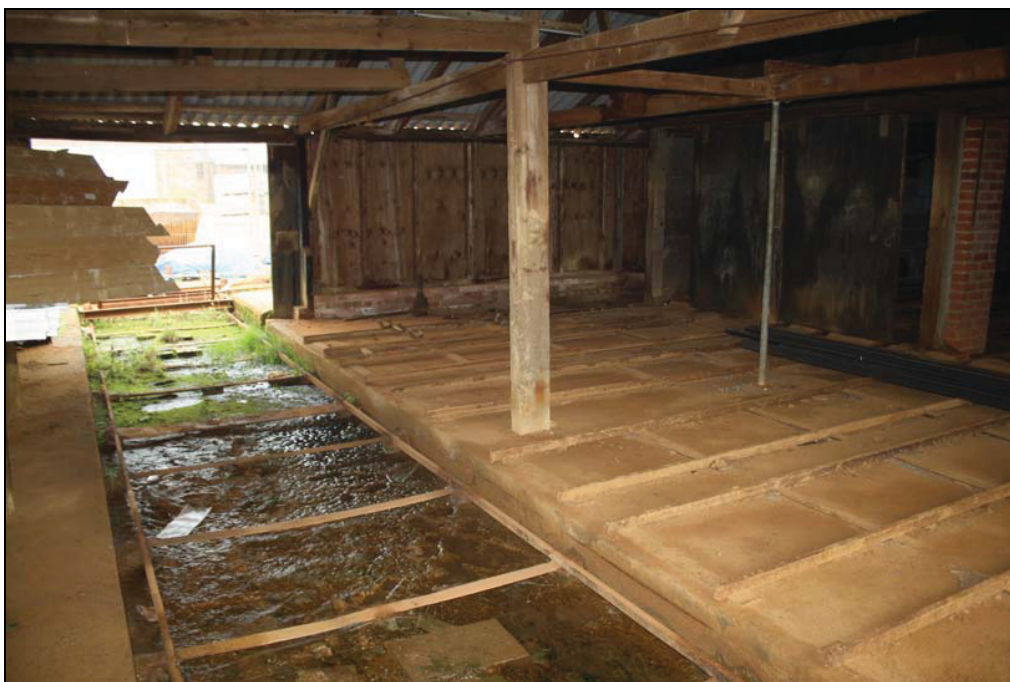
5.5 A wide lateral transfer rail with moveable bogie or simple wheeled chassis divides the area from the adjoining brick store, and allowed the stacked green bricks to be transported elsewhere, via a second narrow rail or into the storage area beyond, via six parallel secondary rails (Plate 3). Three of the tracks on the east side are properly gauged and welded to cross-bars while those of the west are of much simpler form.

Plate 3 Series of trackways with a lateral track and surviving moveable trolley, north end of Building 1, taken from the north-west (DP 54)

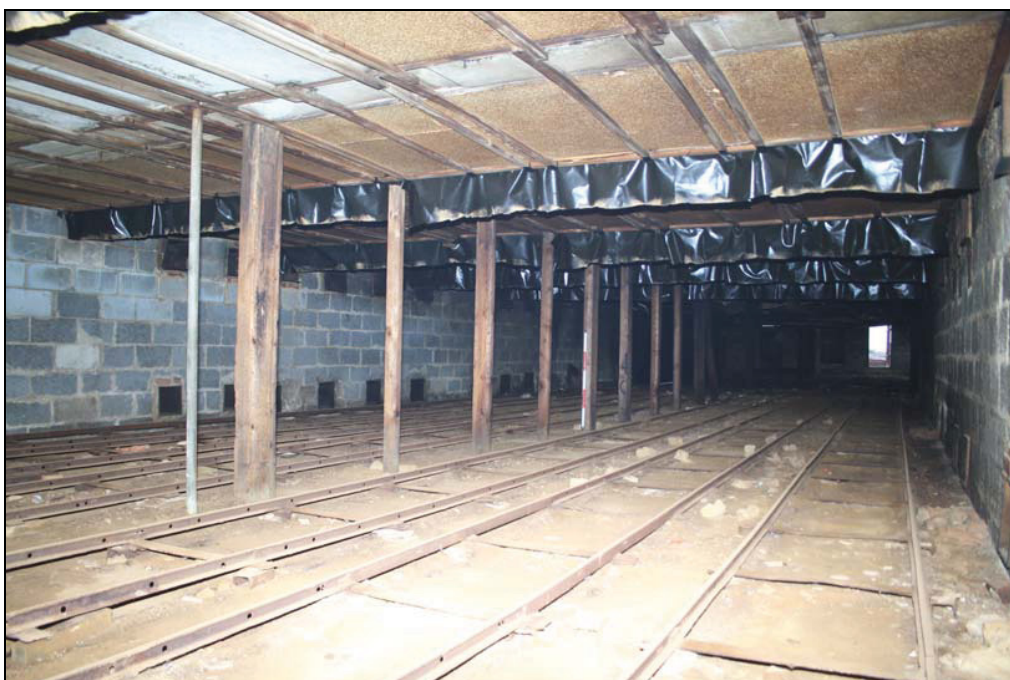
5.6 The central section of the building was used chiefly as a hack-shed to dry the bricks prior to firing. The area is partly enclosed with a secondary internal blockwork wall set in from the outer walls, and divided from the ends of the building by sliding wooden doors (Plate 4). The area is also enclosed with a flimsy ceiling of insulation tiles and slats.

Plate 4 Central section of Building 1 lined with trackways, taken from the north-west (DP 58)

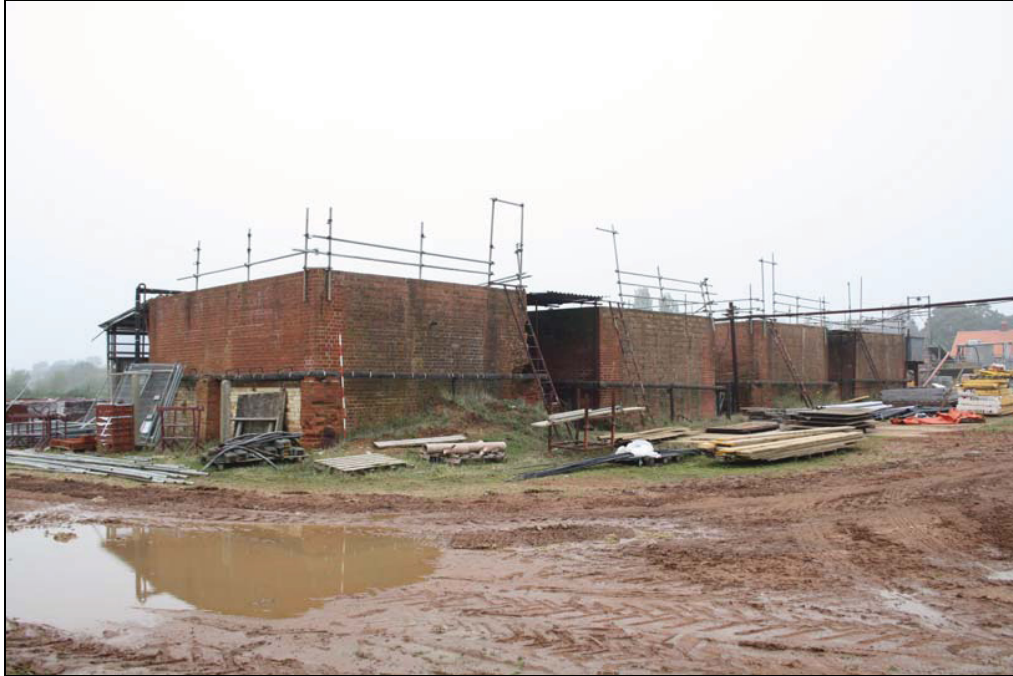
5.10 Four rectangular updraught kilns stand in a line to the east of the factory (Building 1) (Plate 5). When not charged, they stand as 4.0m high open enclosures, entered through a wide aperture on the west side. These were sealed over during firing, and a roof formed above the stacks of bricks. The kilns are faced on the exterior by locally made bricks with some secondary supporting buttresses, but internally, more durable shale bricks are laid in English-bond with thin mortar joints; some retain scorch marks from the firings. Each side of the kiln is pierced by six regularly-spaced apertures at low level, through which oil burners heated the kilns (Plate 6). All the kilns show signs of failure and buckling from the intense firing process, with frequent signs of patching and repair. Between each structure, various pipe-runs survive, though the actual burner heads have been removed. These introduced flame into the kilns via specially-made square bricks with circular apertures.

Plate 5 The kilns, Building 2, taken from the south-east (DP 19)

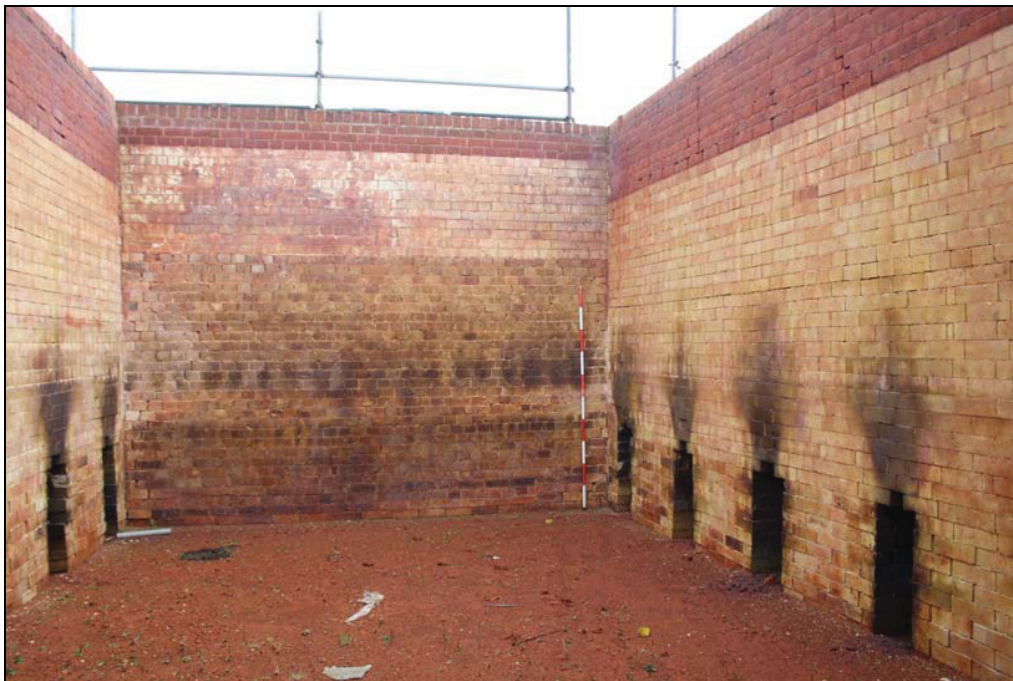
Plate 6 Kiln (Building 2), interior, taken from the north-west (DP 70)

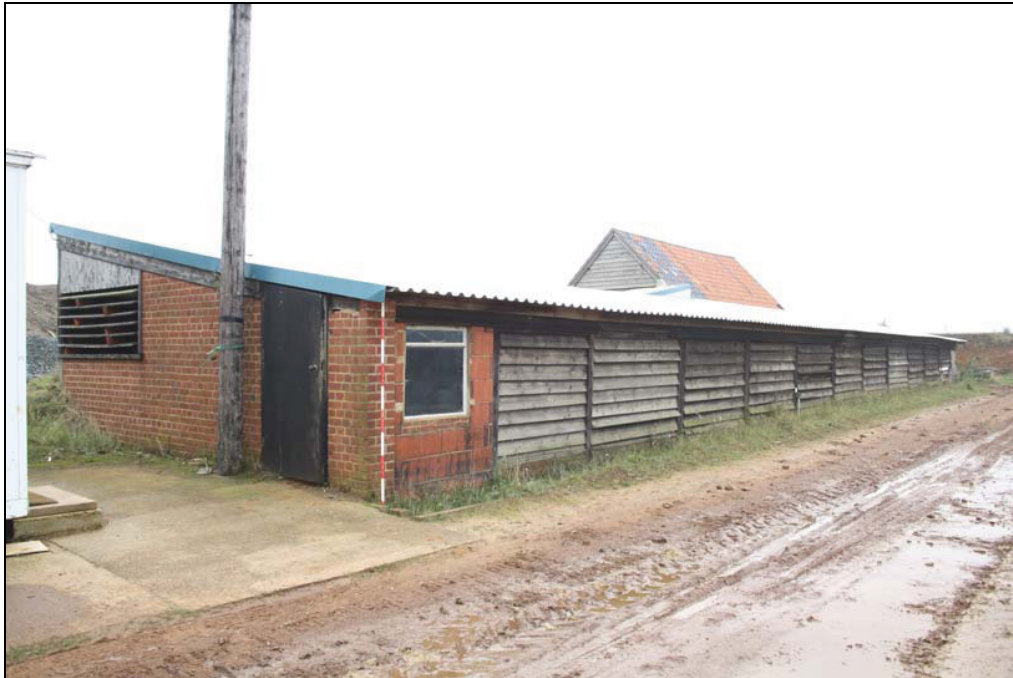
5.12 The principal element is low, providing barely enough internal head-room, and rises in a shallow, single pitch to the east (Plate 7). The northern gable end and low section of the eastern elevation are constructed in brick laid in English-bond, with a small doorway giving access from the north. Upper sections of the western wall and the eastern wall are occupied by wide wooden louvred slats for ventilation, adjusted by internal swivelling posts with horizontal pegs. The southern gable is a ramshackle arrangement of plywood and corrugated sheeting pierced by two domestic doors flanking a central window.

Plate 7 Drying and storage shed, Building 3, taken from the north-east (DP 11)

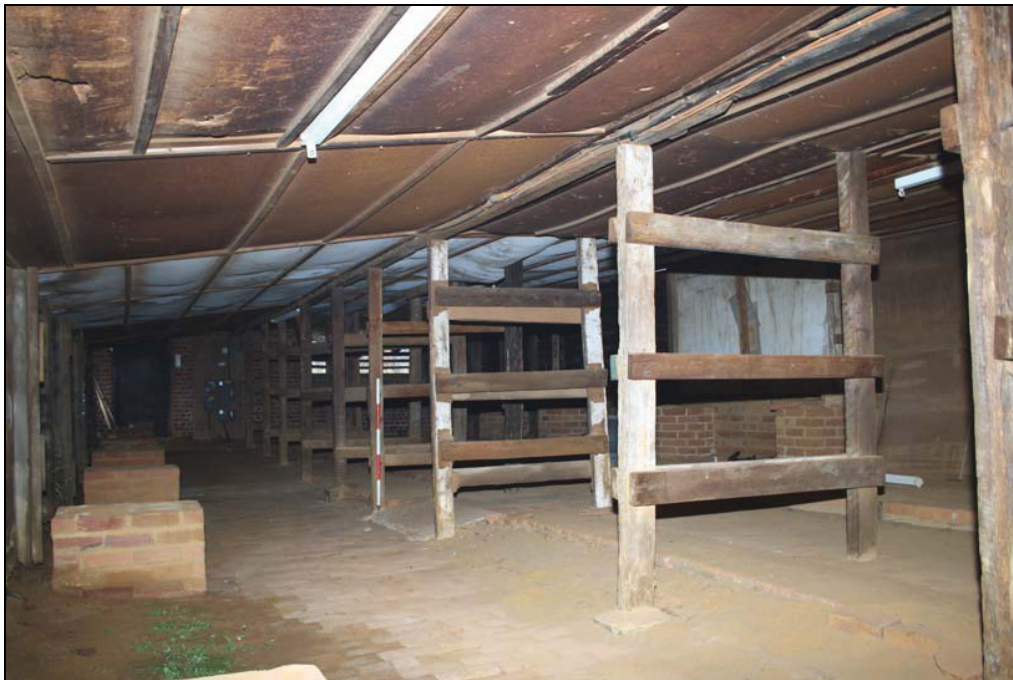
5.14 Internally the floor of the older element is brick throughout, rising in three shallow steps from east to west. Large bases or plinths stand on either side for structures or shelving now removed, while the central section of the building retains a rough framework for shelving (Plate 8). At the southern end, three parallel rails and a lateral rail with surviving bogie link the shed with the eastern extensions. To the east the stores are constructed as noted above in modern brickwork and steel (Plate 9). At the time of the survey these buildings were being used to store moulds.

Plate 8 Partitions for shelving, interior, Building 3, taken from the south-west (DP 76)

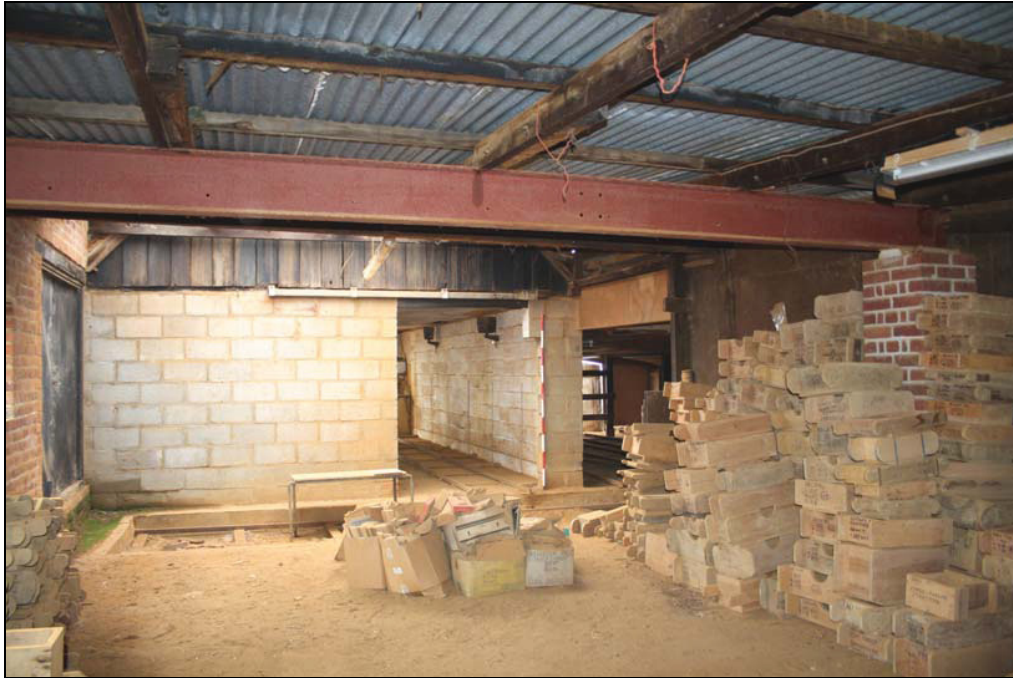
Plate 9 Stacked brick moulds, north-east extension to Building 3, taken from the north-east (DP 79)

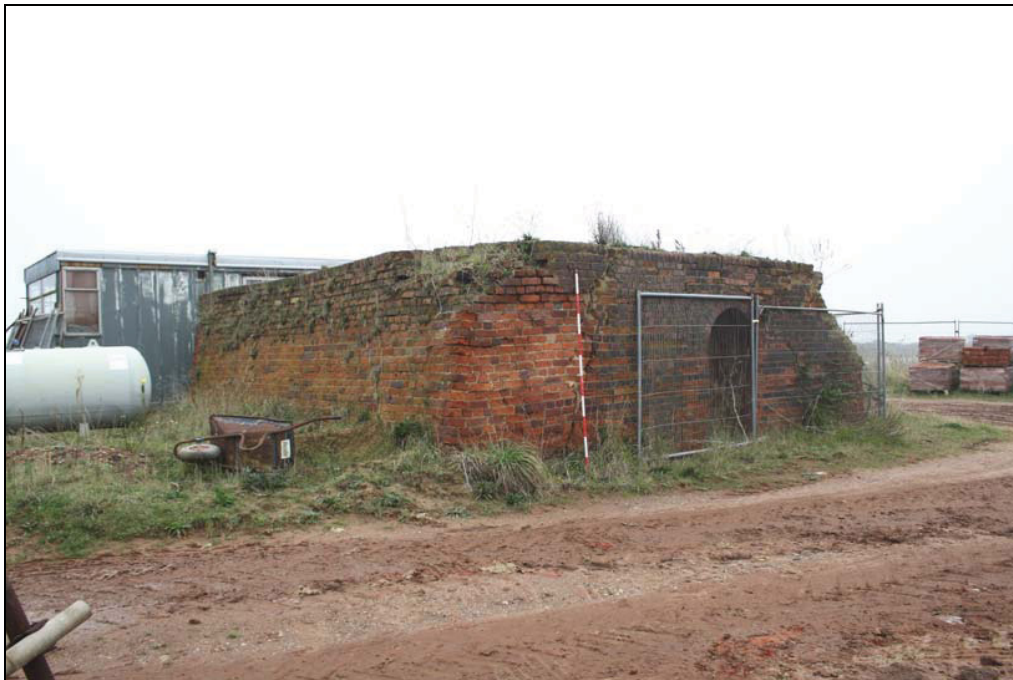
5.15 The disused remains of a 19th century ‘Suffolk’ kiln stands to the east of its modern counterparts (Plate 10). This is similar in form to the later types, but differing in having a recessed floor below ground level. It is constructed in English-bond with walls of immense, 1.3m thickness, though now in poor condition and partly collapsed in the south-western corner, where attempts at repair in modern cement are visible. Access is given from the west through a semi-circular aperture. The eastern wall appears slightly concave, though this may be an effect of structural movement.

Plate 10 Early kiln, Building 4, taken from the north-west (DP 41)

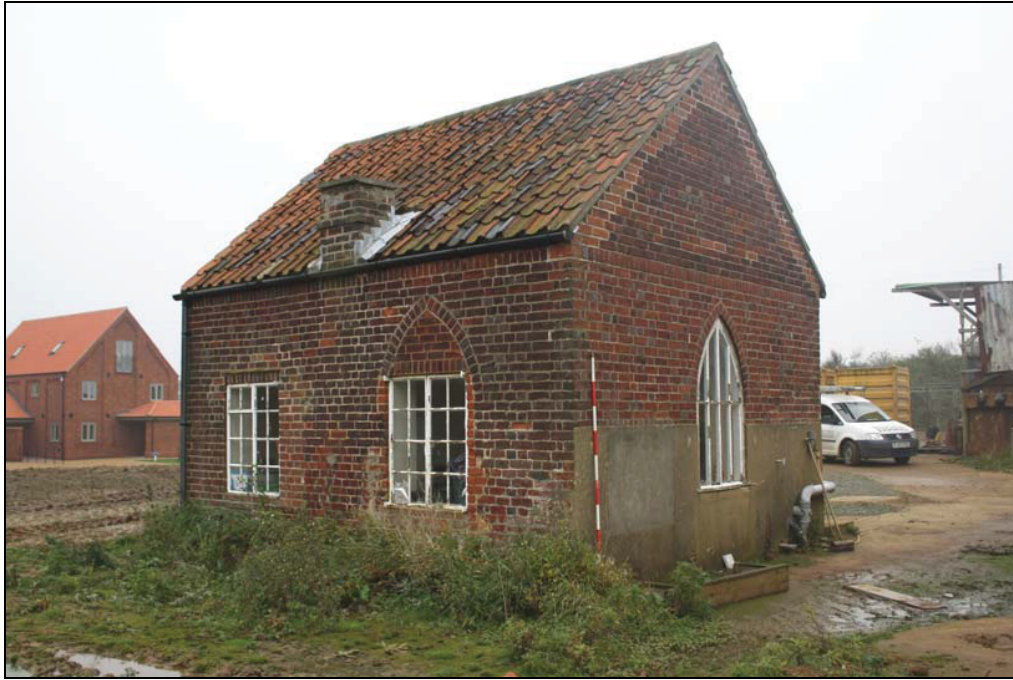
Plate 11 Building 5, south and west elevation, taken from the south-west (DP 4)

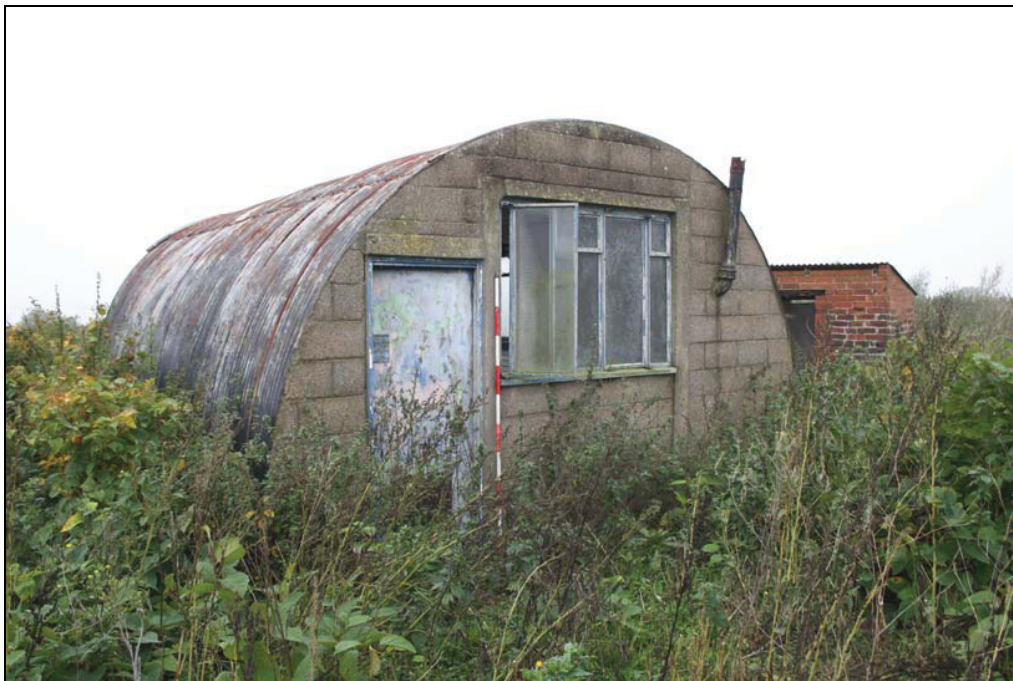
Plate 12 Nissen Hut, Building 6, taken from the north-east (DP 28)

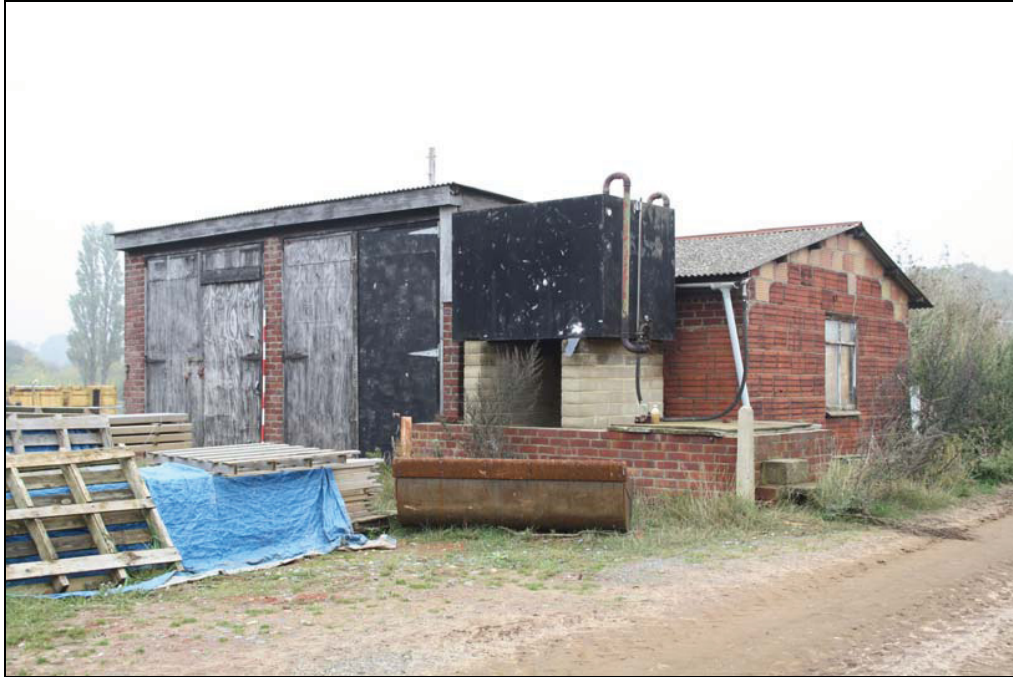
Plate 13 Storage building, Building 7, taken from the south-east (DP 35)

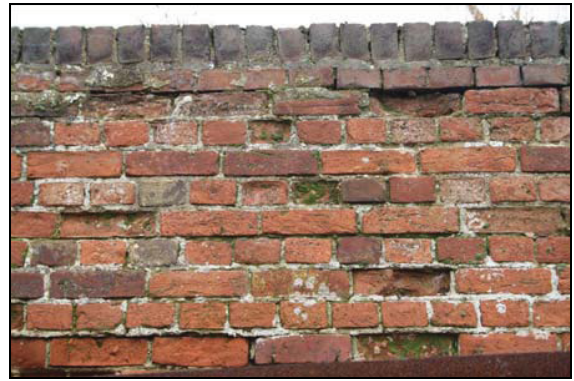
44

Brickwork, early kiln, Building 4, taken from the south

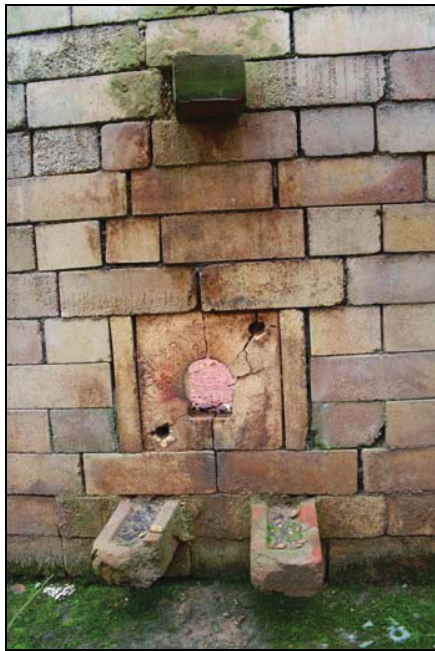
45

Pipe inlet into kiln, Building 2, taken from the north

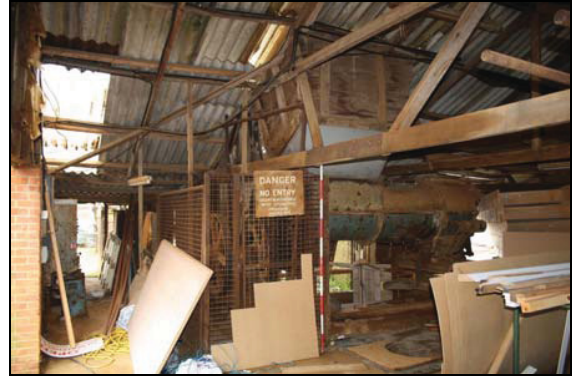
50

wheels and belts, which remain in situ. The brick-making machine is marked 'Perry's Patent Brick Machine, Westcliff-on-Sea, No. 3 No. 259656'. In the adjoining workshop area, the bricks were moulded and produced by hand for the next stage of the process.

Brick making machinery, Building 1, taken from the north-west

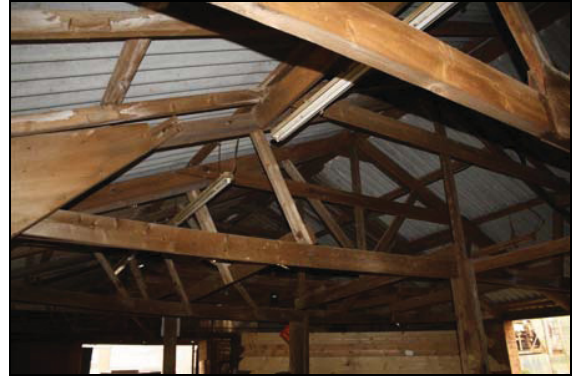
56

5.8 The roof of the factory is surprisingly flimsy, being constructed of nailed or bolted members throughout as a series of close-set trusses. Tie-beams with raking-struts rise to principal-rafters and are connected by plywood fishplates in the manner of a steel roof, but here in slender softwood. All appears to be of fairly modern date.

Roof structure above the northern end of Building 1, taken from the south-west

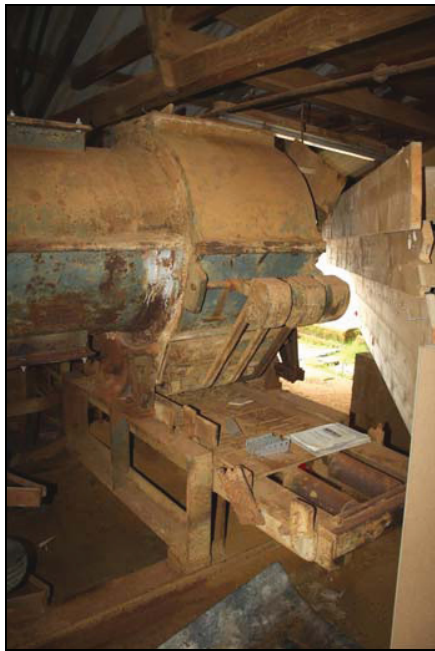
81

Brick making machine, Building 1, taken from the north-west
