BARN ON LAND BETWEEN 64 & 76 LOW ROAD
BURWELL, CAMBRIDGESHIRE

HISTORIC BUILDING RECORDING

CHER Event Number:
CHER ECB 3934

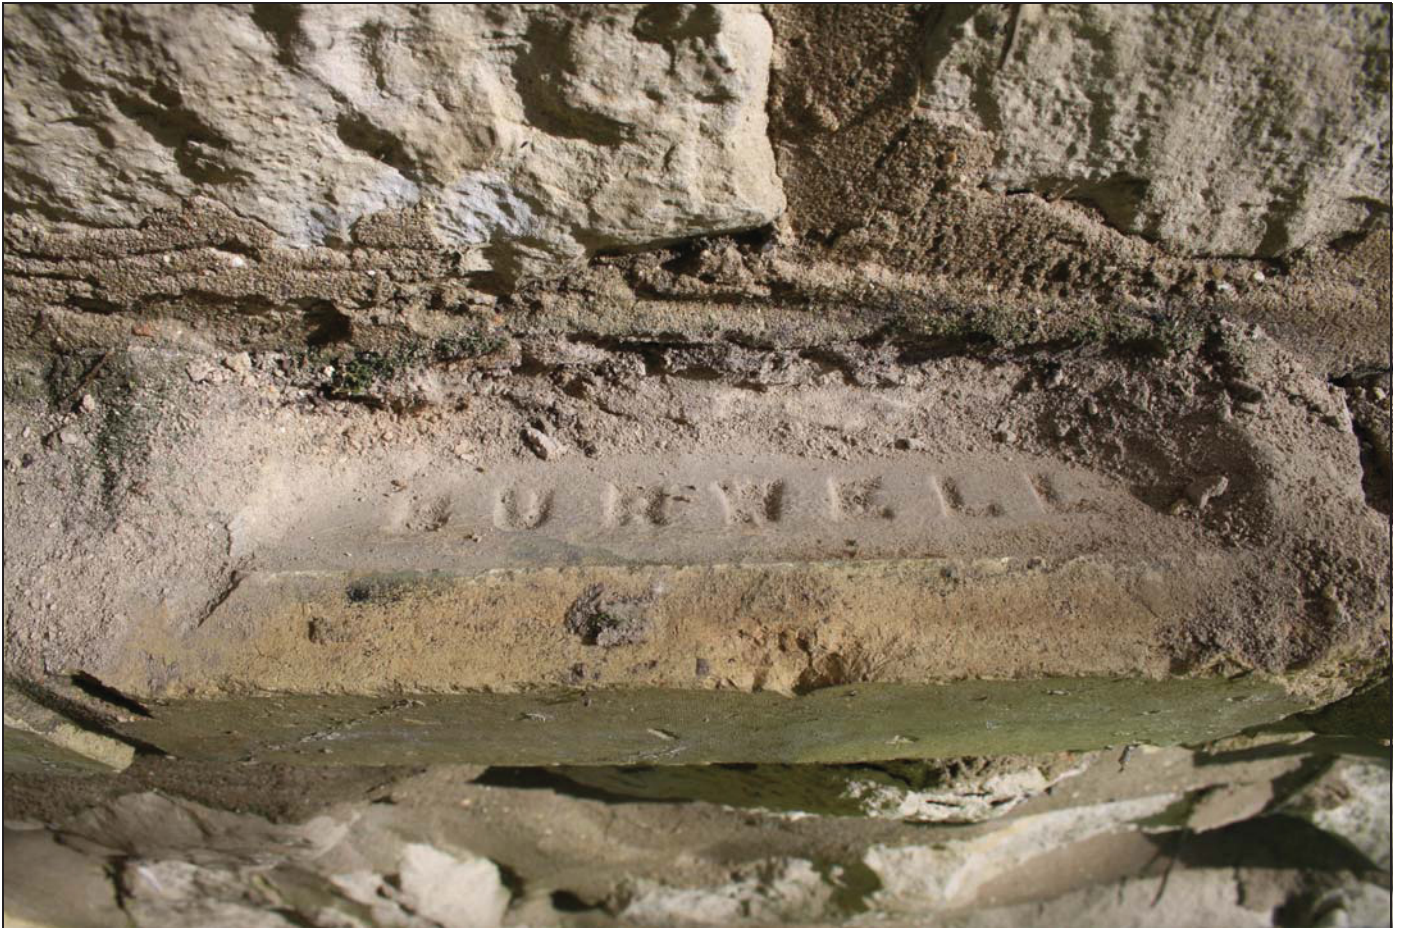
Plate 1 Burwell brick from the brick course along the top of the plinth extending around the barn, taken from the west

5.2 The brickwork is of a variable pinkish-yellow gault or shale brick, typical of the late 19th century and in one or two places where the brick is laid with the frog uppermost, they can be identified as being locally manufactured Burwell bricks (Plate 1). The clunch is for the most part weathered back on the exterior face except where protection has been afforded by a pre-existing structures, and here rough, parallel tooling survives (Plate 2). The stonework has been mostly repointed with a cementitious mortar.

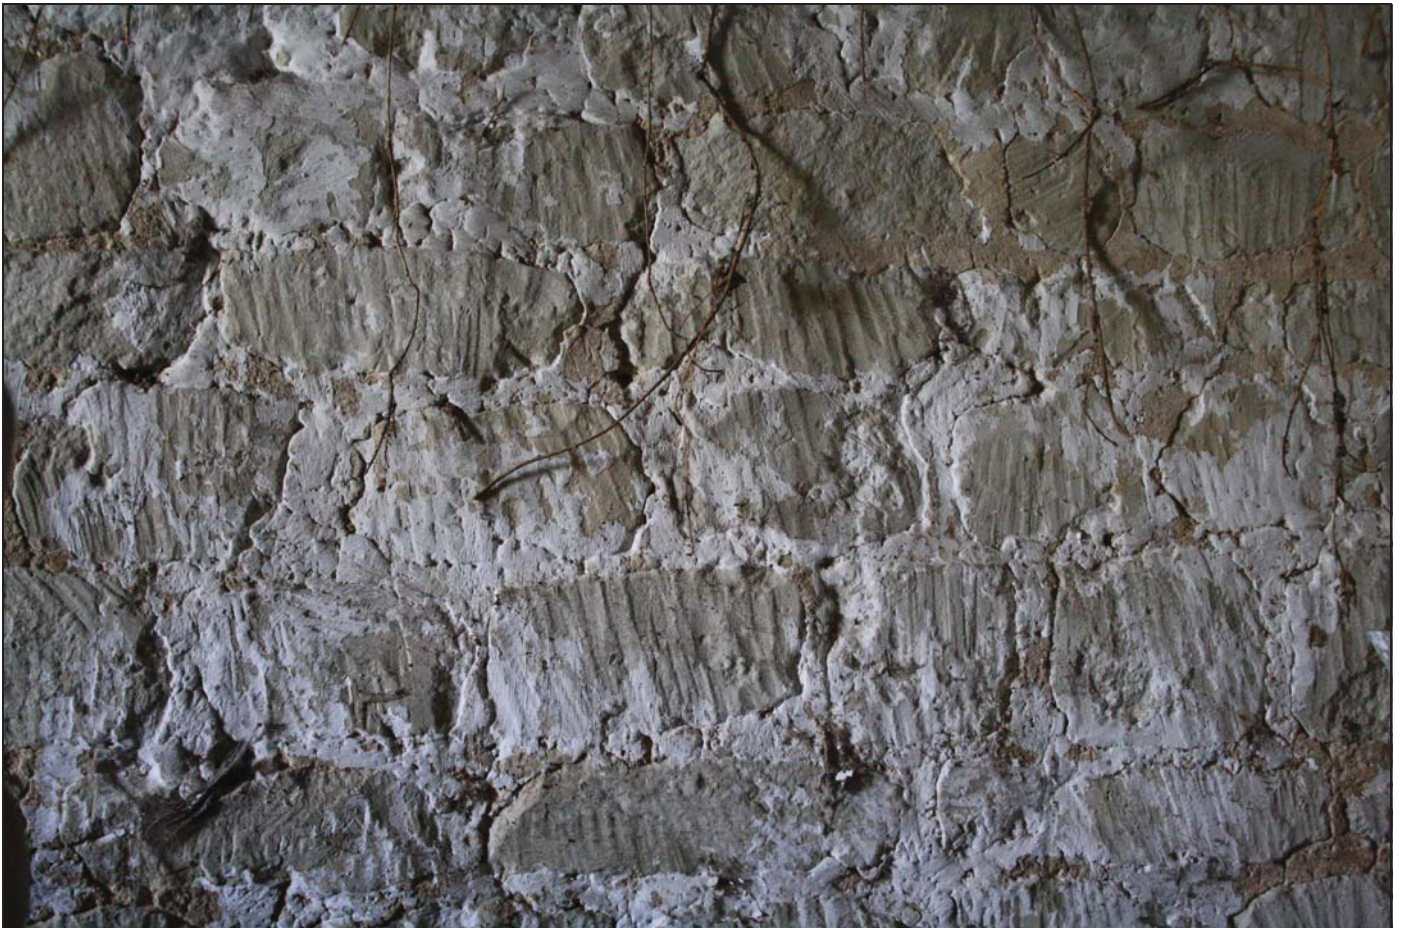
Plate 2 Example of the tooling marks on the clunch blocks on the south side of the porch, taken from the north

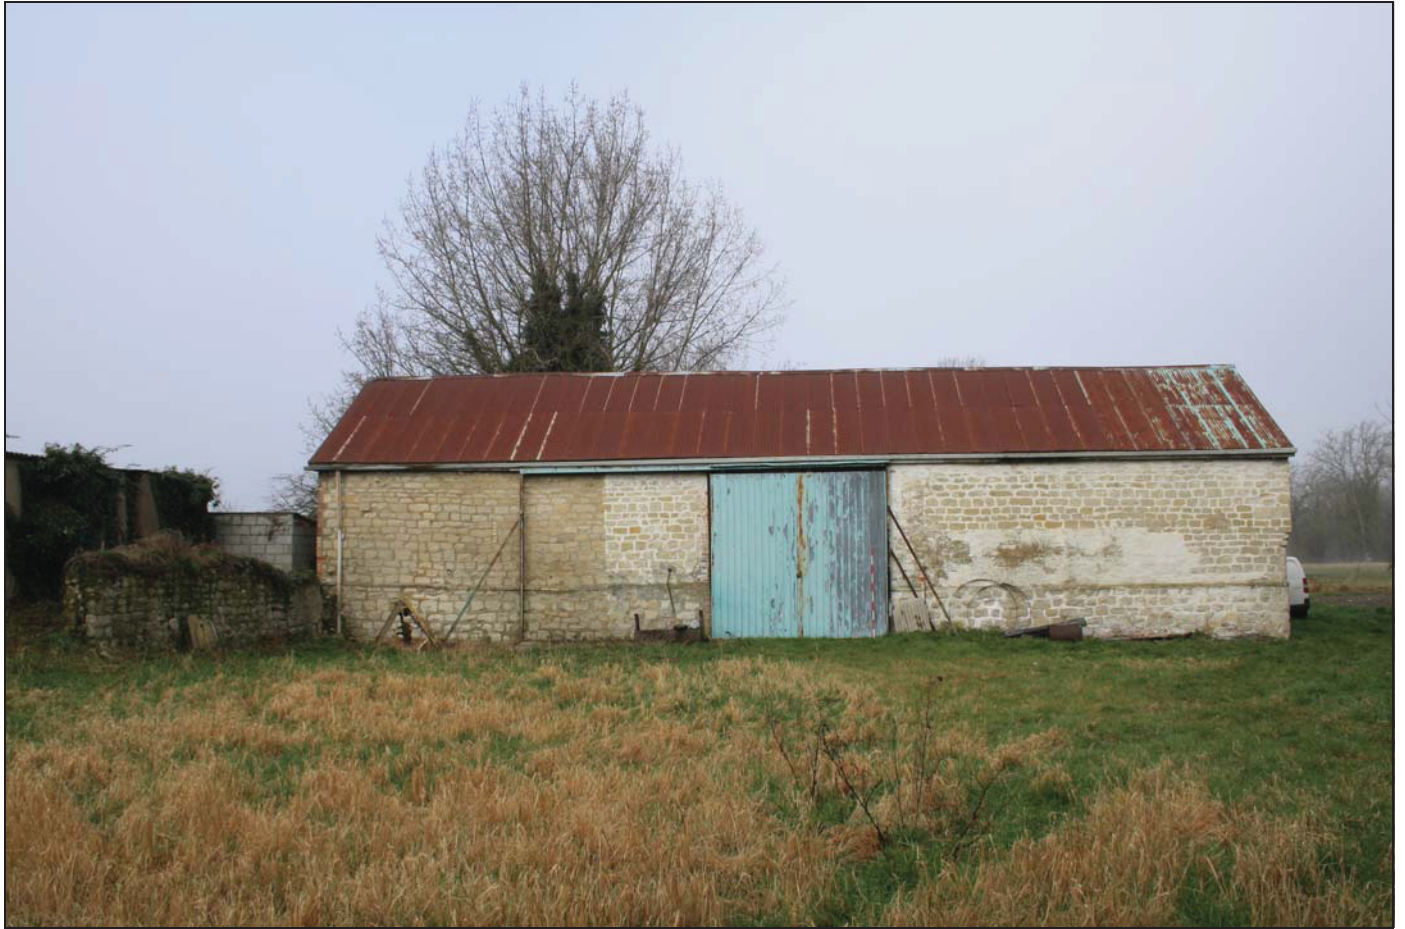
Plate 3 East elevation, taken from the east

5.4 The east elevation faces the road, and displays a clear gradation in the coursing from large, almost square blocks at the base to more refined coursing and smaller blocks near the eaves (Plate 3). A full-height doorway marks the central bay, now enclosed with modern metal sliding doors, although restraining hooks fixed to the walls on either side indicate the existence of earlier double doors. The jambs have been made good with late 19th century brick but with the evidence for earlier doors, it is probable the doorway was remodelled at this time rather than being a new insertion. A blocked ventilation slit lies to the south, though an area of render to the north conceals a second example.

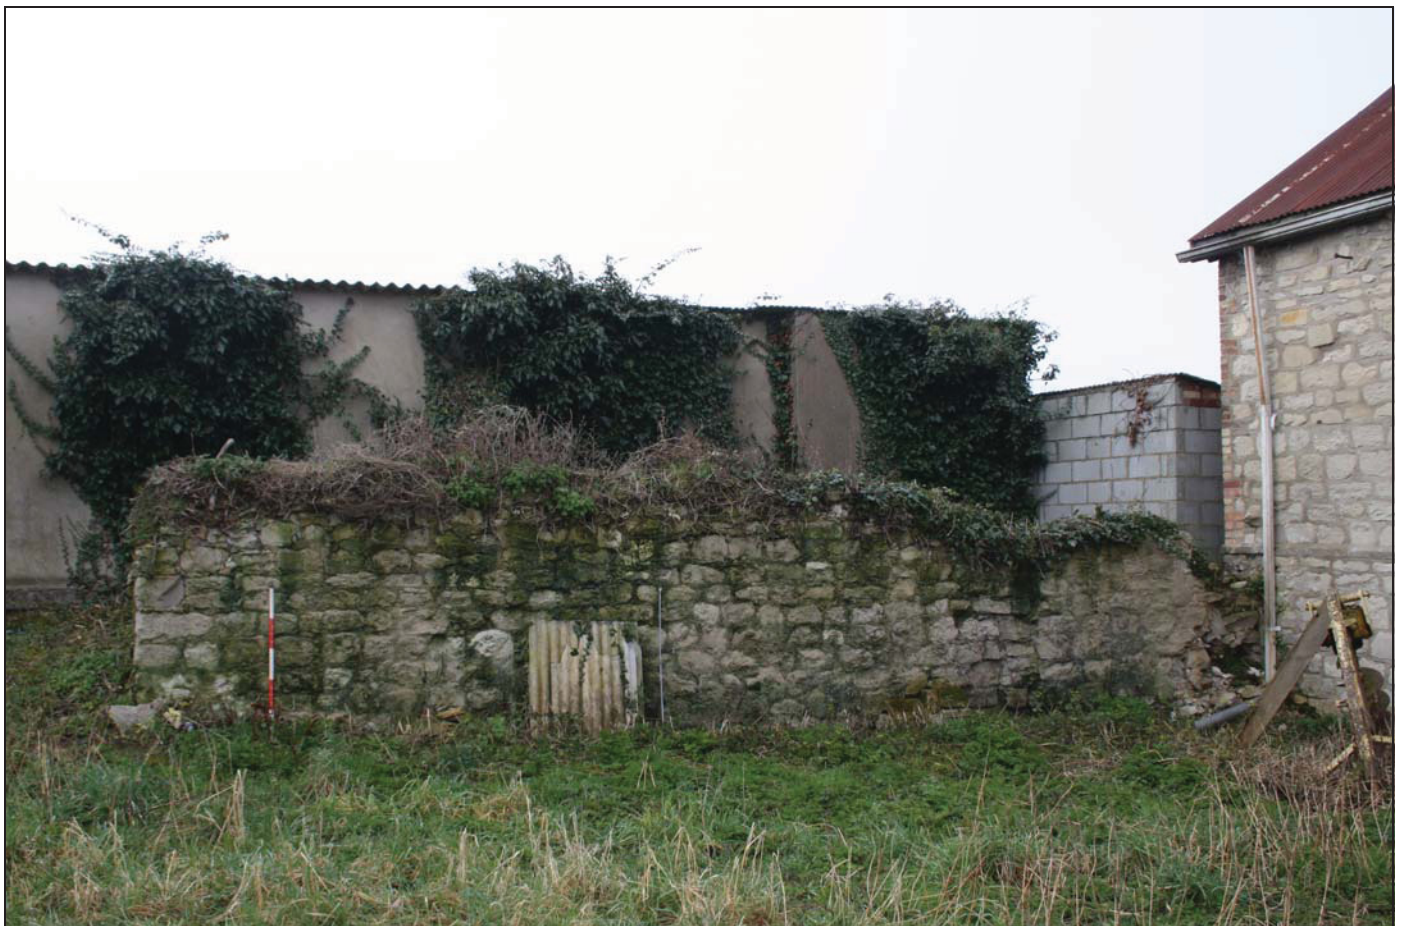
Plate 4 Surviving wall from an earlier range adjoining to the south-east of the barn, taken from the north

5.5 At the south-east corner a low wall extends laterally from this east elevation and forms a surviving fragment of an adjoining range visible on the tithe map (Plates 4 and 5). The stonework is coursed in the same manner and appears to be tied into the barn, although some making good at the corner post-dates the demolition of the building. The wall survives to a height of approximately 2m and has not been repointed as the barn, so that the original hard, pinkish mortar survives. The structure now forms a retaining wall for a high bank to the rear, though on that side the continuous brick string course indicates this was originally the south external wall of the range. There are no surviving marks for the original roof line where it abutted the main structure, though one or tether rings survive, presumably once internal within the range.

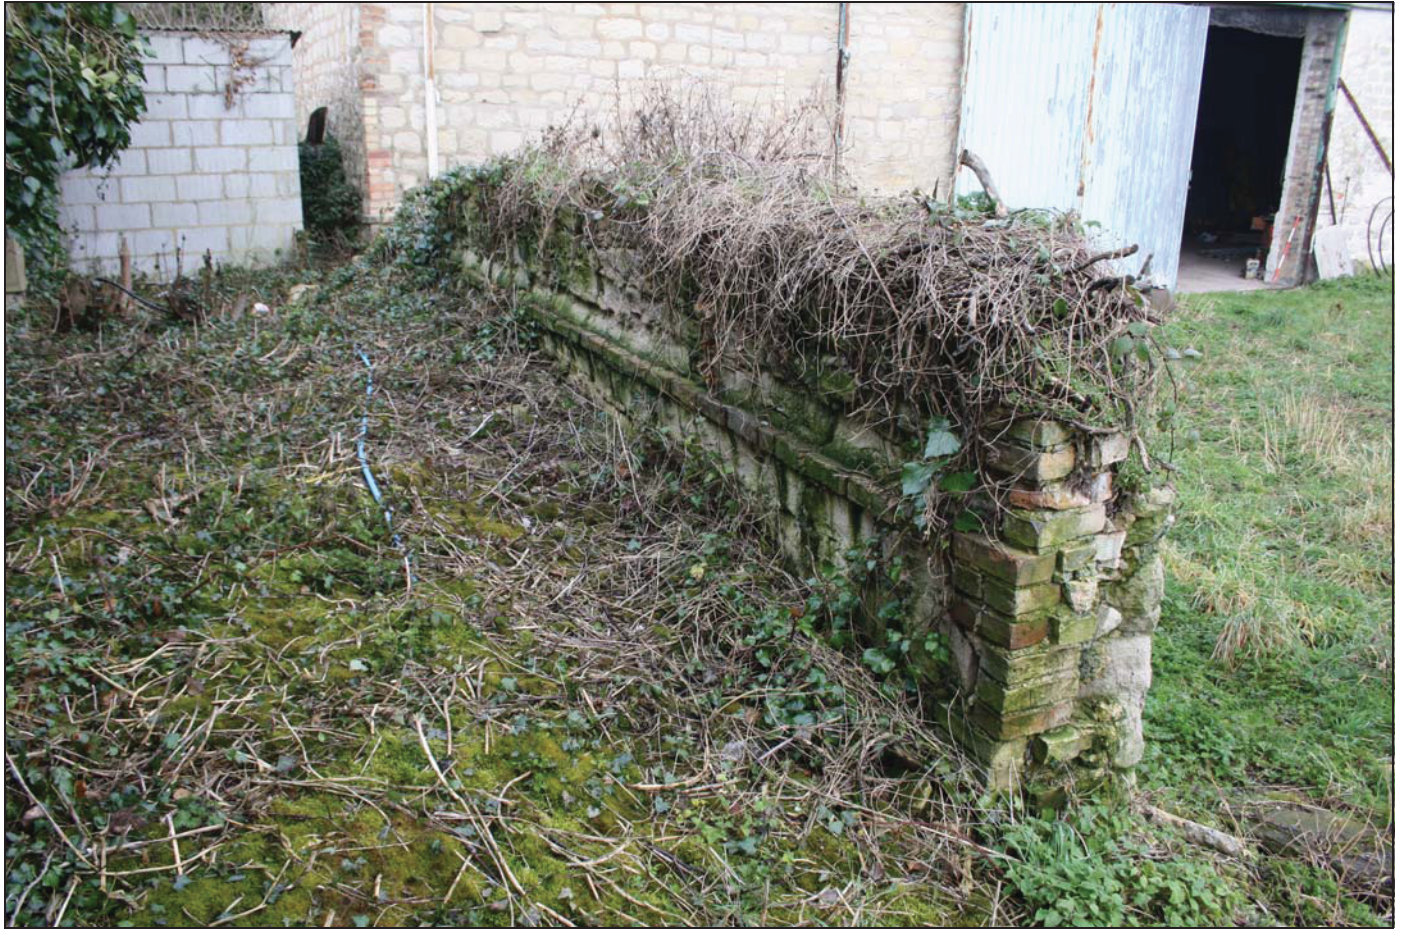
Plate 5 Outer face of the surviving wall from an earlier range adjoining to the south-east of the barn, taken from the south-east

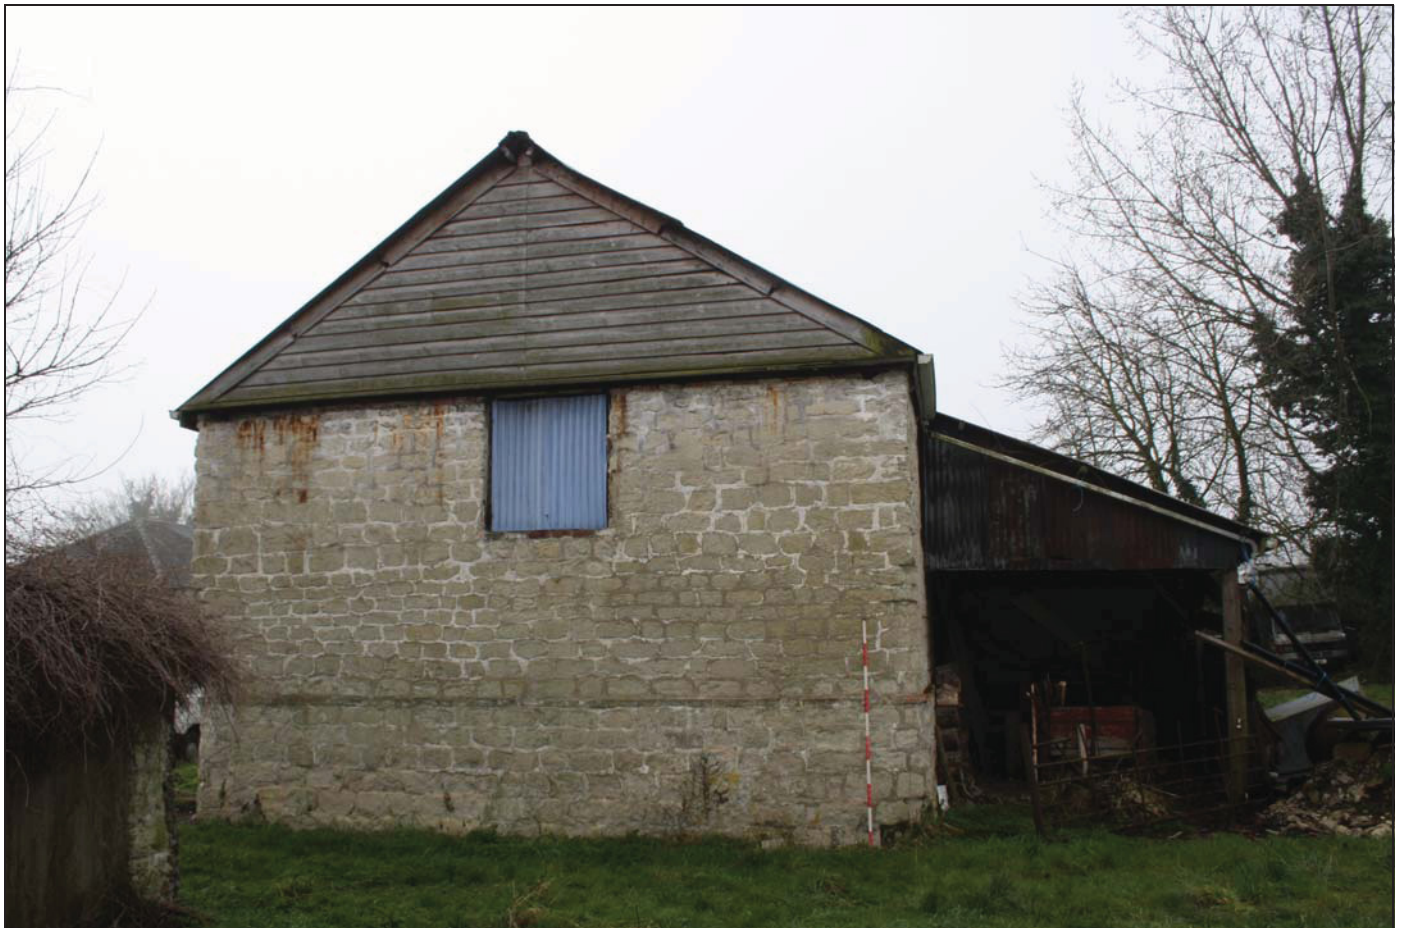
Plate 6 North elevation, taken from the north

5.6 The north gable end of the barn is entirely regular in form as on the east, with stonework rising to eaves level (Plate 6). Above eaves level, the gable is clad in modern weatherboarding, although the wall-plate is supported by late 19th century gault bricks. Both corners are bevelled at lower level and corbelled out above to a

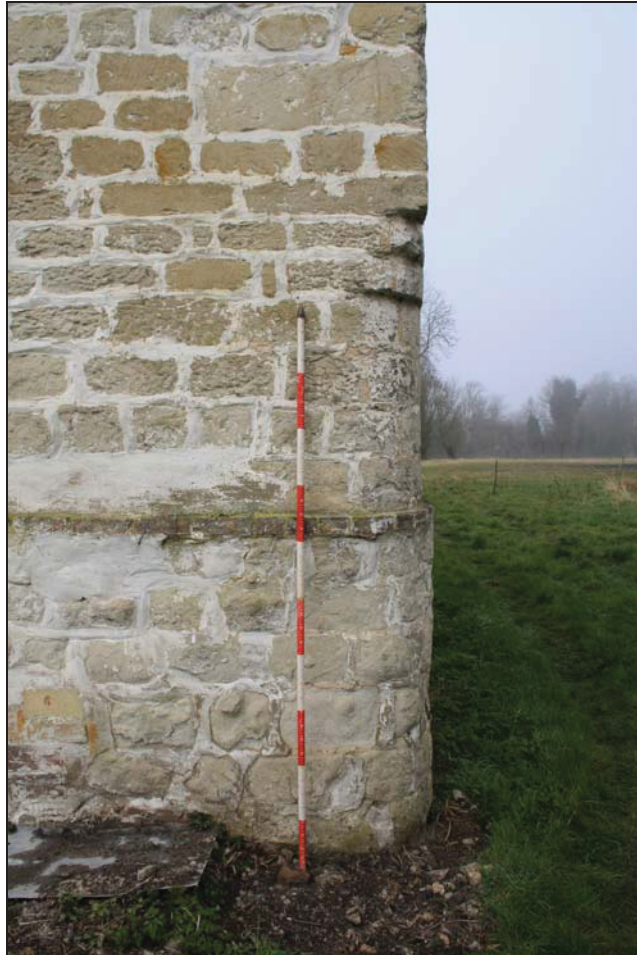
Plate 7 East elevation (north end) showing bevelled corner, taken from the east

standard corner (Plate 7). A central pitching door is set at high level, framed by oak. This is a later insertion, as the remains of an earlier ventilation aperture remains visible inside, and has been disturbed by its insertion.

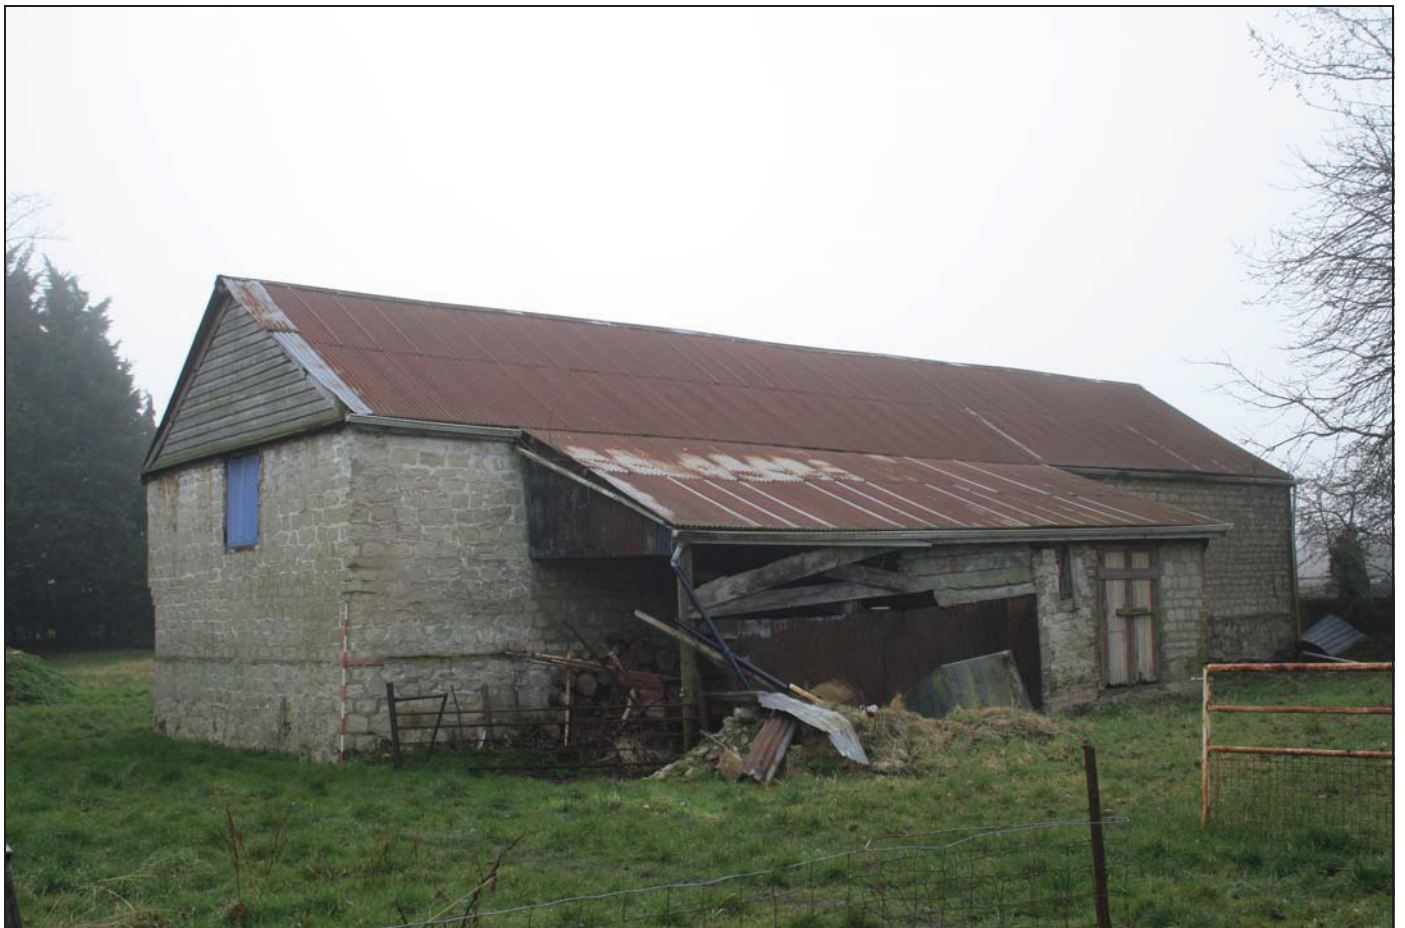
Plate 8 North and west elevation of the barn, taken from the north-west

5.7 The west façade incorporates a porch and modern lean-to to the north (Plates 8 and 9). The southern bays are coursed as on the east and pierced by two ventilation slits, the northern example having been widened and then latterly blocked with 19th century brick (Plate 10). The porch appears contemporary and tied into the main body of the barn but rises only to 2.4m height, possibly to upper timber-framing and a pitched roof, though now covered by an in-line pent-roofed structure (Plate 11). The porch has been extensively repaired by the insertion of brick at the corners, the lower parts of the wall on the west, and the door jambs are all of 19th century brick. The west side is pierced by a wide doorway containing double boarded doors of 20th century date, while to the immediate north is a probable contemporary window, although much of this side has failed structurally, and is in a precarious condition.

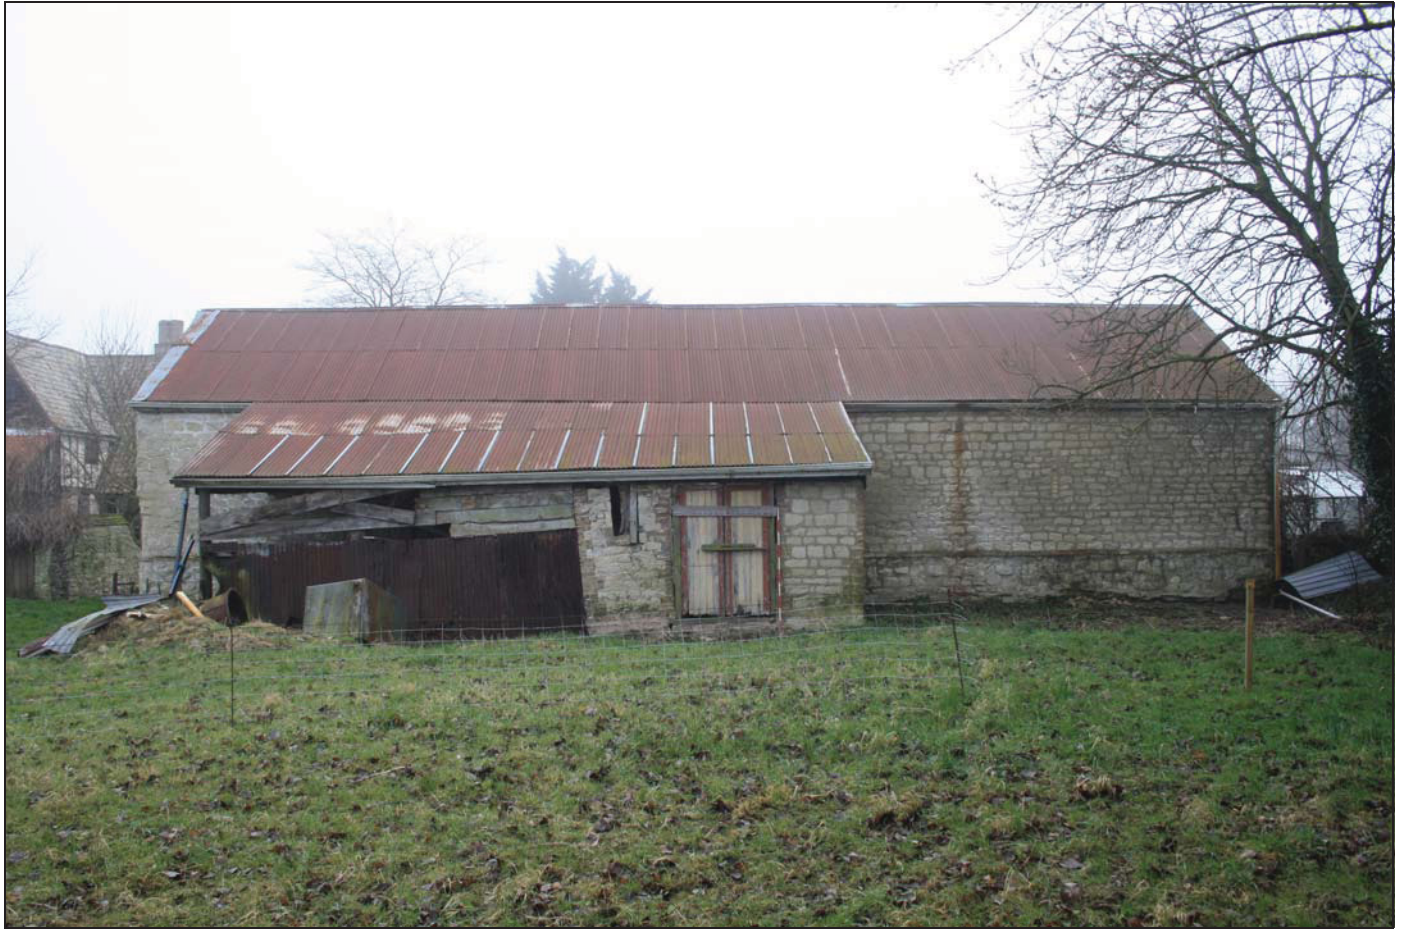
Plate 9 West elevation, taken from the west

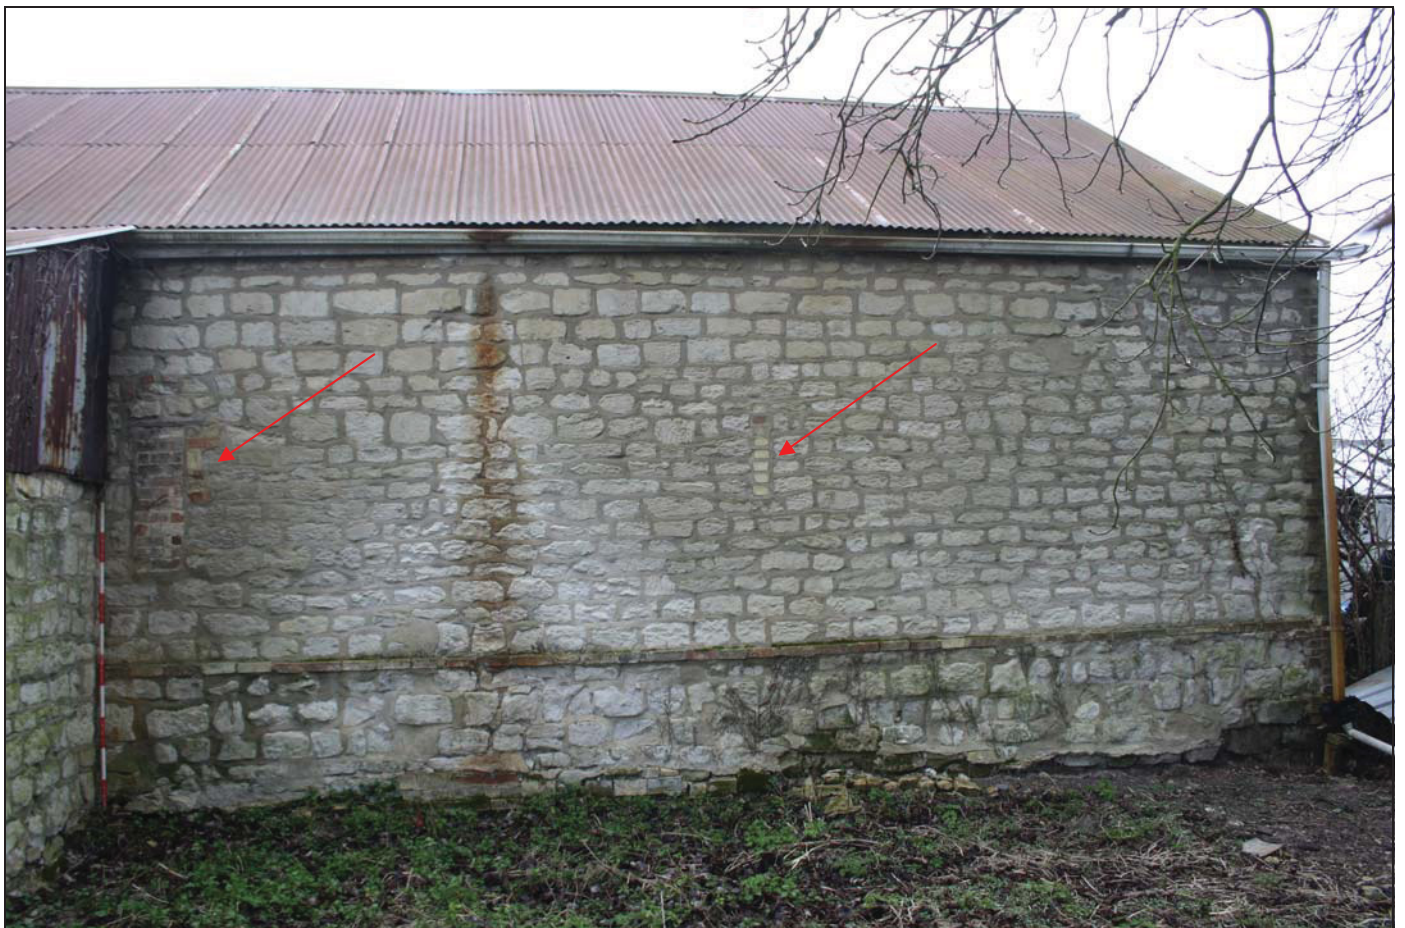
Plate 10 West elevation (south end) showing blocked ventilation slits (indicated), taken from the west

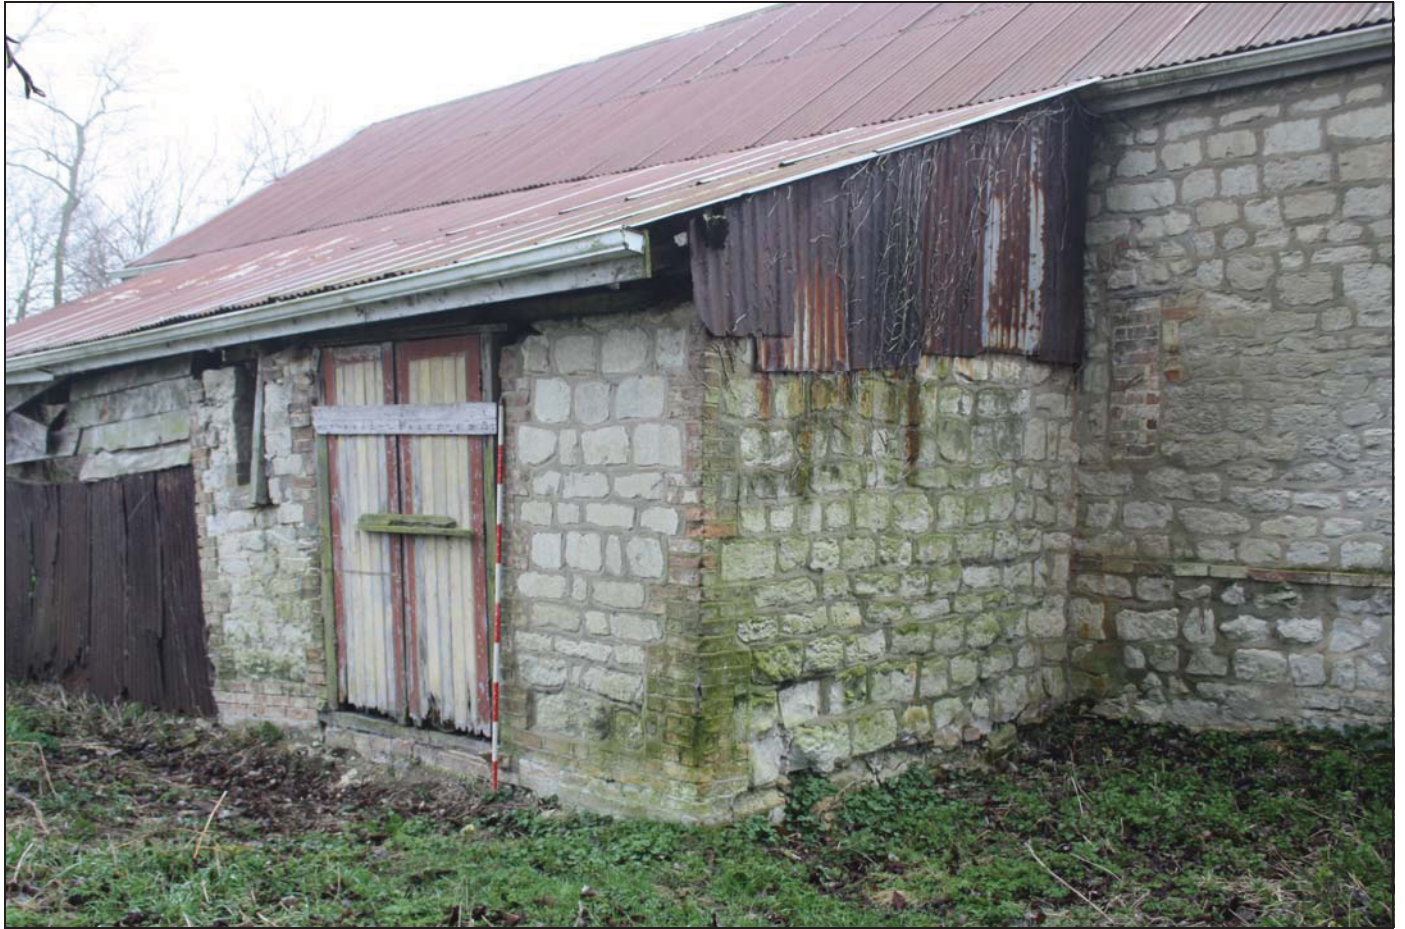
Plate 11 West and south side of the porch, taken from the south-west

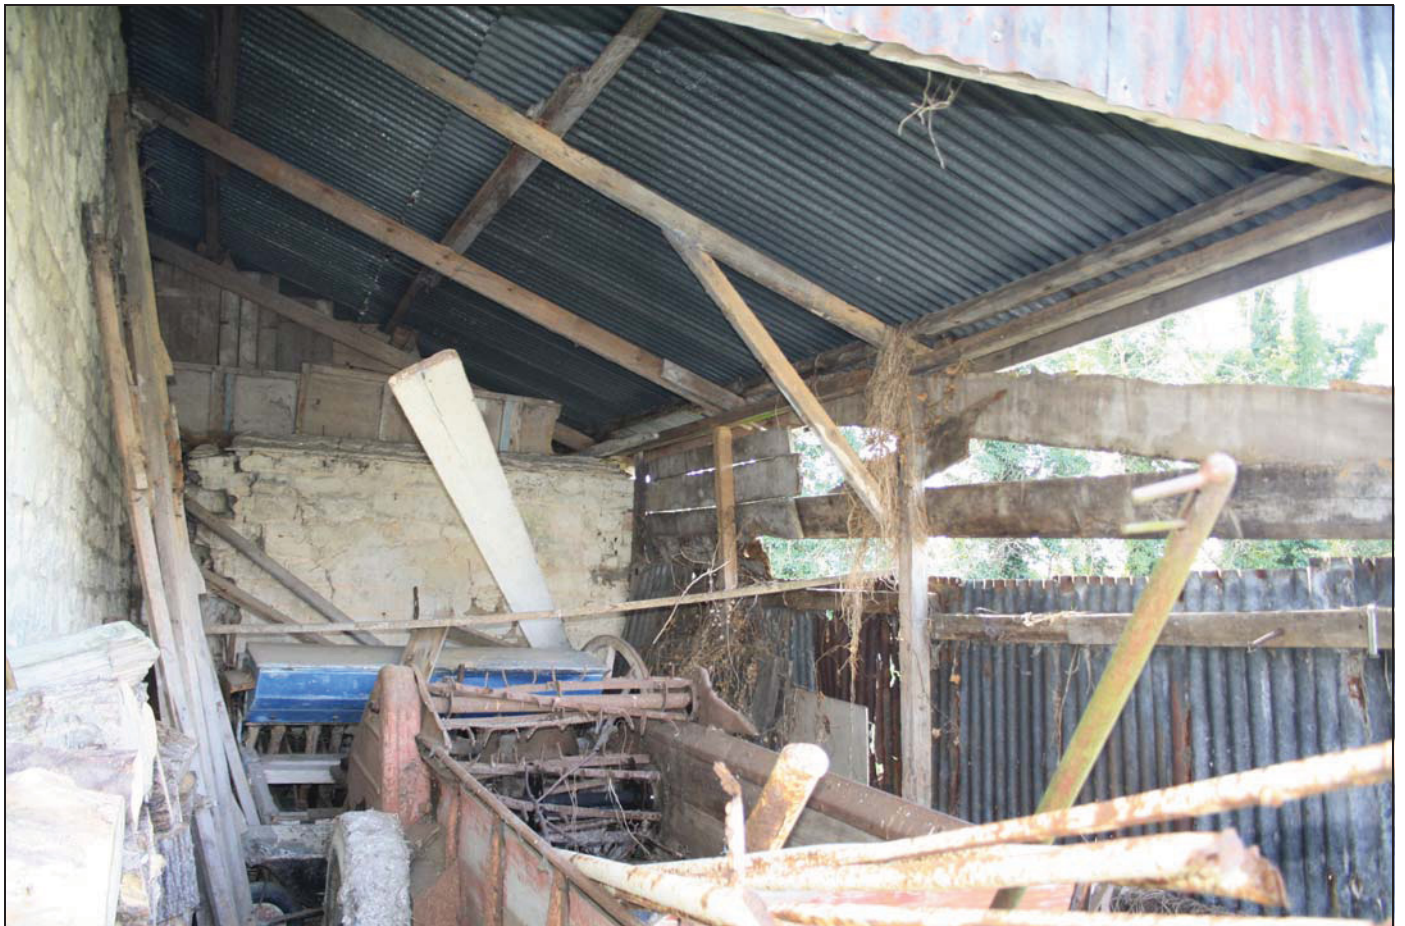
Plate 12 Interior of the modern lean-to on the west side of the barn, taken from the north

5.8 The pent-roofed lean-to along the northern bays is of fairly ephemeral and modern construction, but has served to protect the original walls from weathering (Plate 12 and 13). Surviving features include tile flaunching of the north wall of the porch as well as a third ventilation slit in the main body of the barn. Distinct modern tooling is also present on the lower edge of the blocks, presumably made where the original lime mortar was chipped out and replaced in cement.

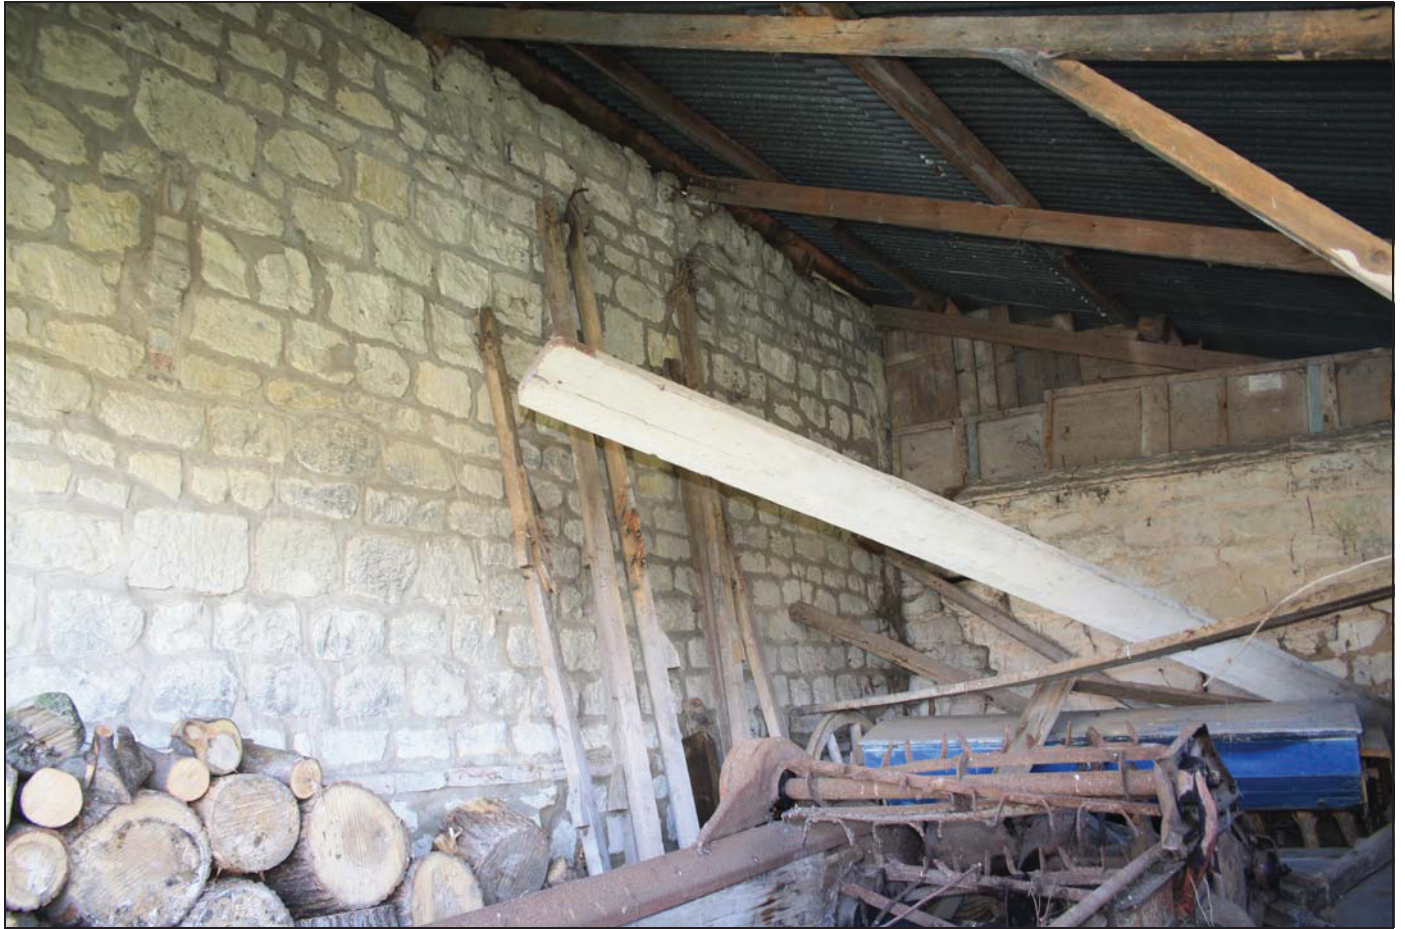
Plate 13 Formerly external west wall of the barn from within the lean-to, taken from the north

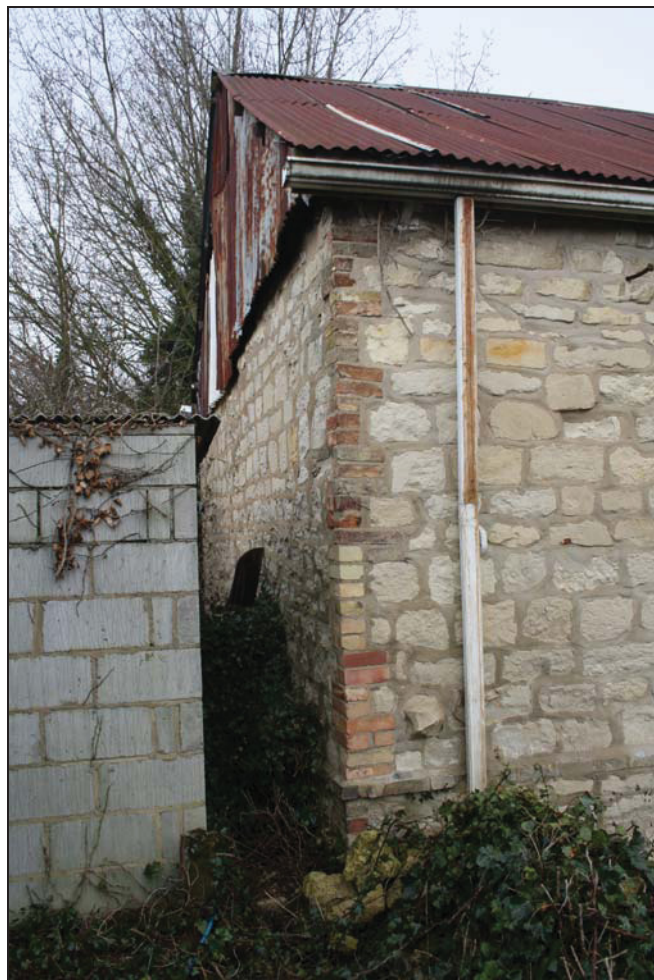
Plate 14 View of the south elevation, taken from the east

5.9 The south gable end abuts the adjoining property but appears to be fairly plain, again with some repair on the corners in late 19th century and later Fletton brick (Plate 14). A central ventilation slit is visible, blocked as elsewhere.

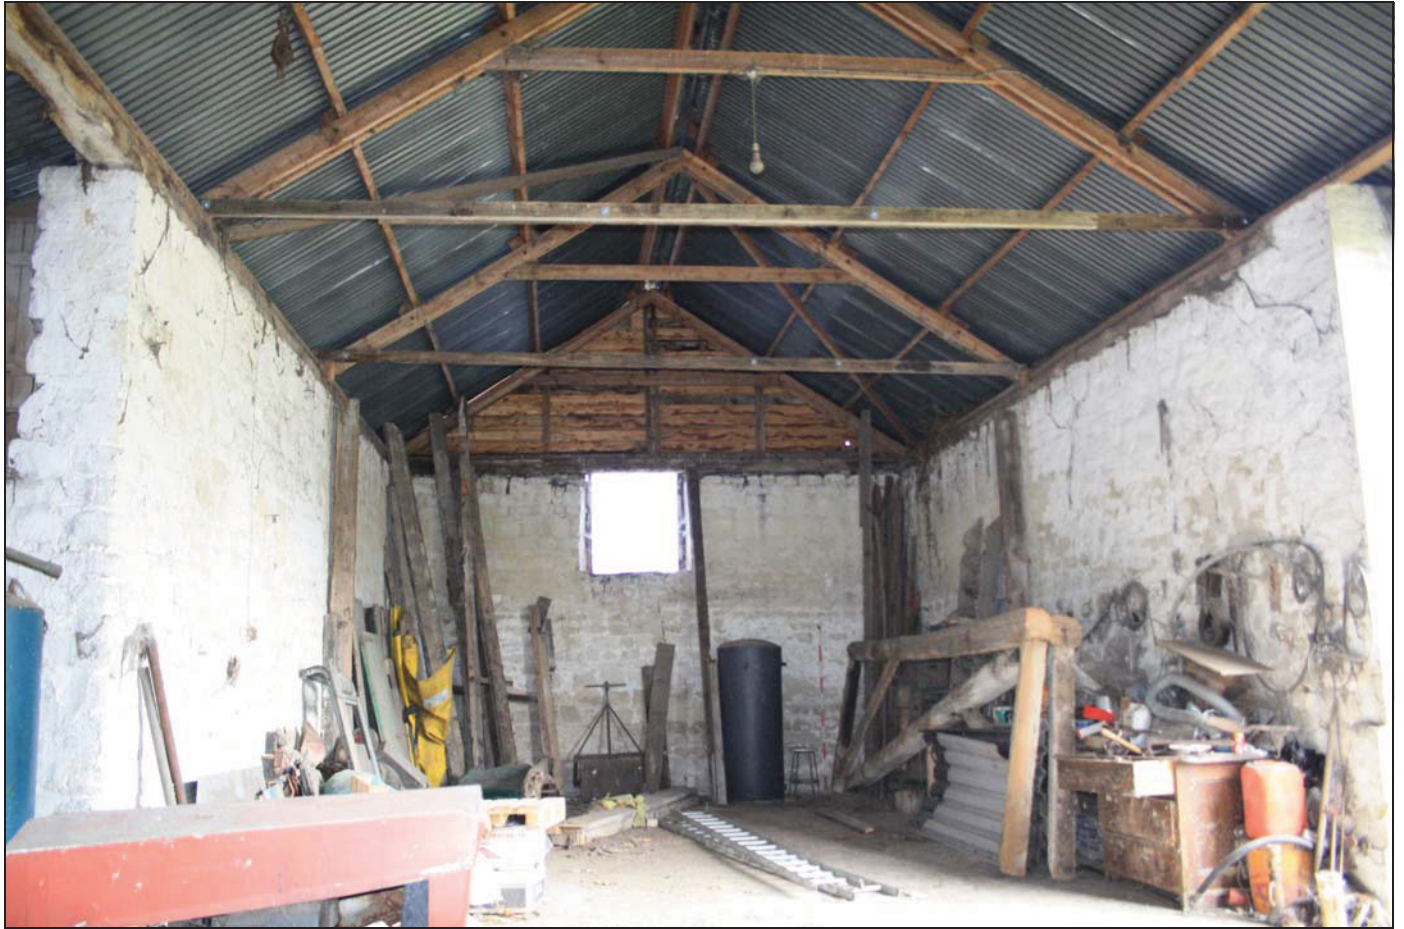
Plate 15 Interior of the barn (north end) showing modern roof structure, taken from the south

5.10 The interior of the barn is floored in cement throughout, while the original external walls have been left exposed and only white-washed. Internally, the stone coursing is as well-handled as the exterior (Plates 15 and 16). The original aperture on the west is dressed with good stonework which continues into the porch structure, confirming the porch as contemporary (Plates 17 and 18) but with replacement boarded doors on the west (Plate 19). Much of the original pinkish lime mortar survives.

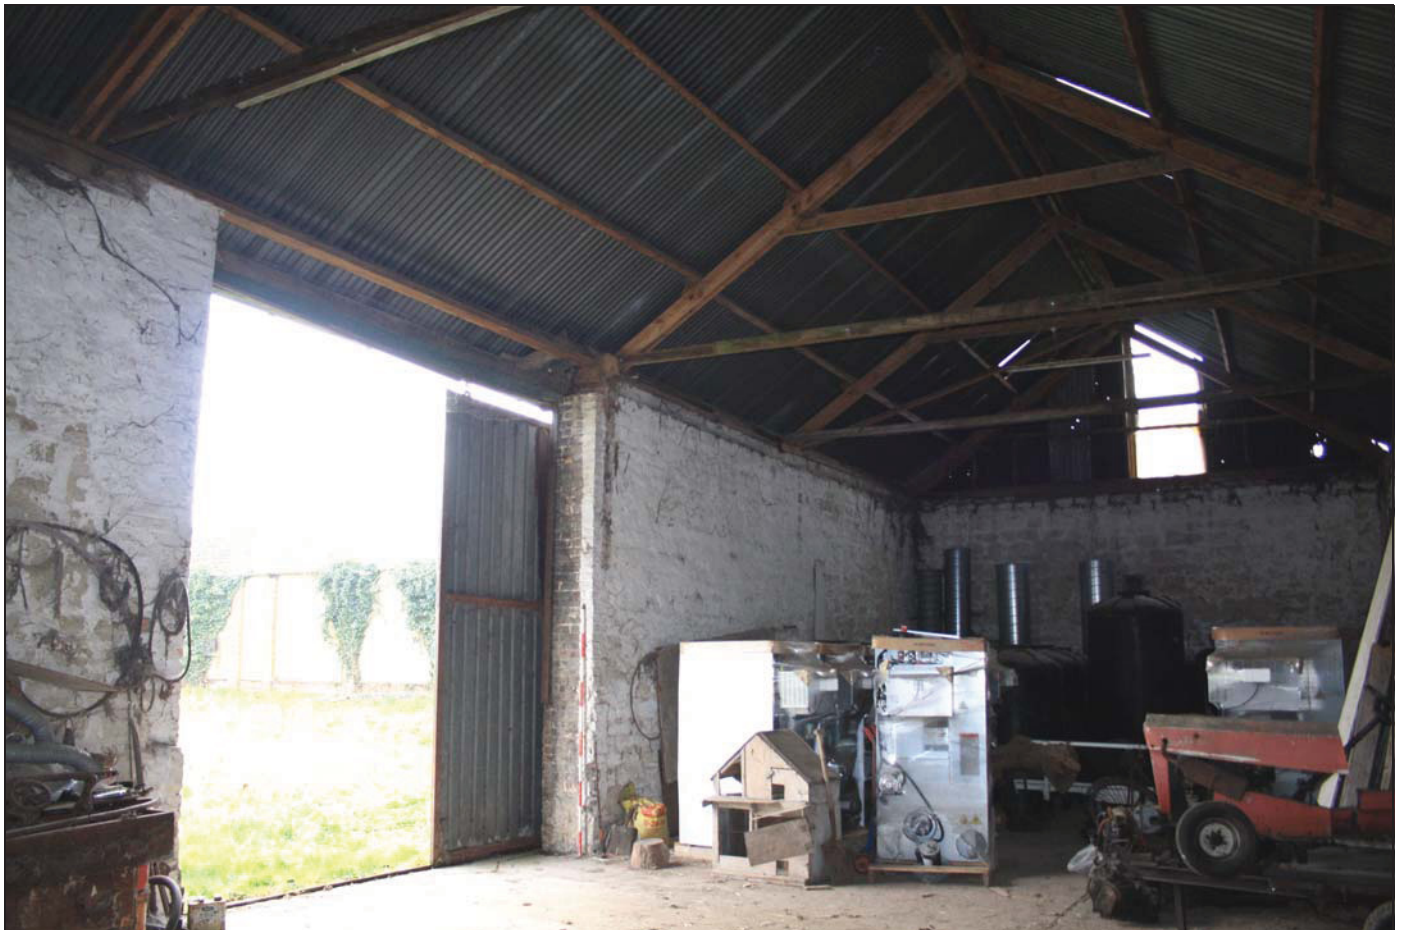
Plate 16 Interior of the barn (south end) showing the entrance, taken from the north

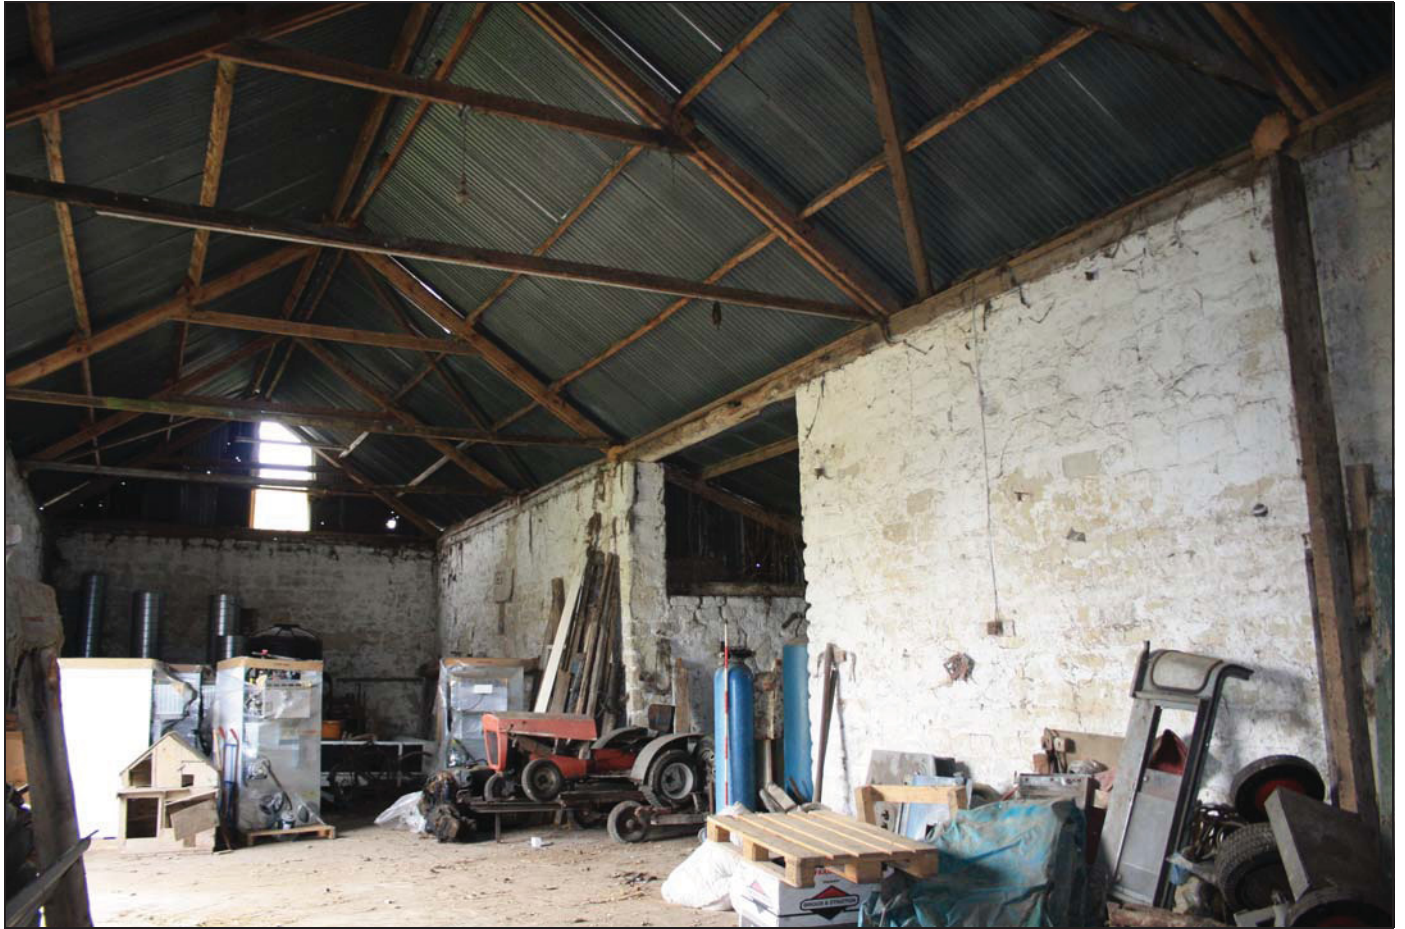
Plate 17 Interior of the barn (west side) showing position of porch, taken from the north-east

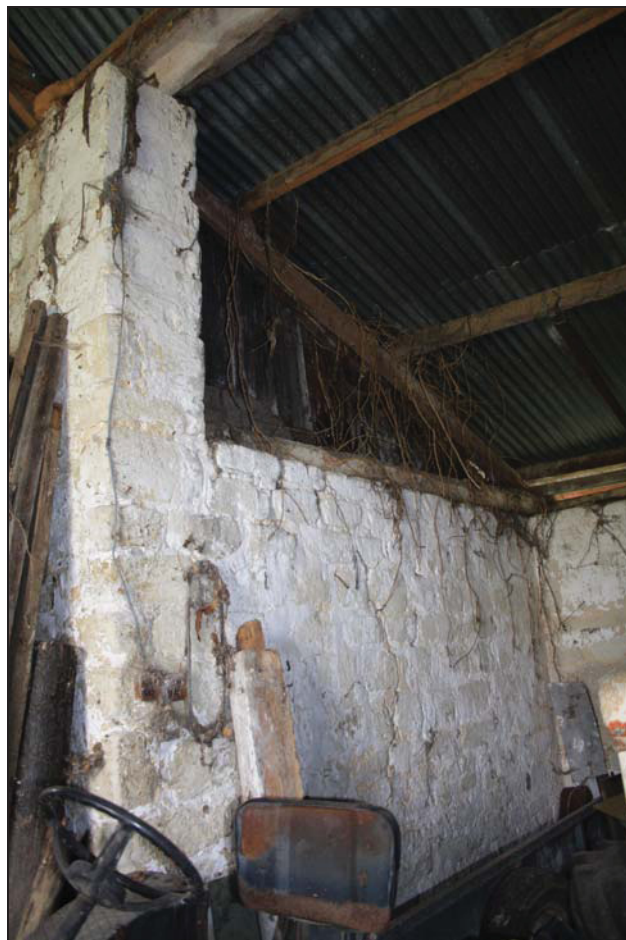
Plate 18 South wall of the porch, taken from the north-east
