BARN ON LAND BETWEEN 64 & 76 LOW ROAD
BURWELL, CAMBRIDGESHIRE

HISTORIC BUILDING RECORDING

CHER Event Number:
CHER ECB 3934

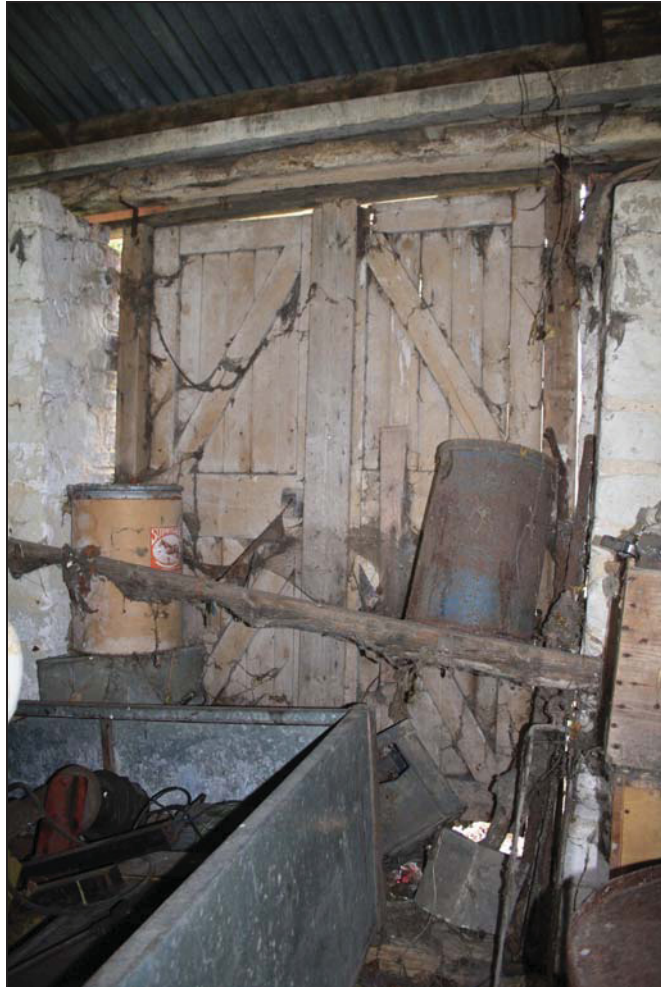
Plate 19 West wall of the porch showing the 20th century boarded doors, taken from the east

5.10 The interior of the barn is floored in cement throughout, while the original external walls have been left exposed and only white-washed. Internally, the stone coursing is as well-handled as the exterior (Plates 15 and 16). The original aperture on the west is dressed with good stonework which continues into the porch structure, confirming the porch as contemporary (Plates 17 and 18) but with replacement boarded doors on the west (Plate 19). Much of the original pinkish lime mortar survives.

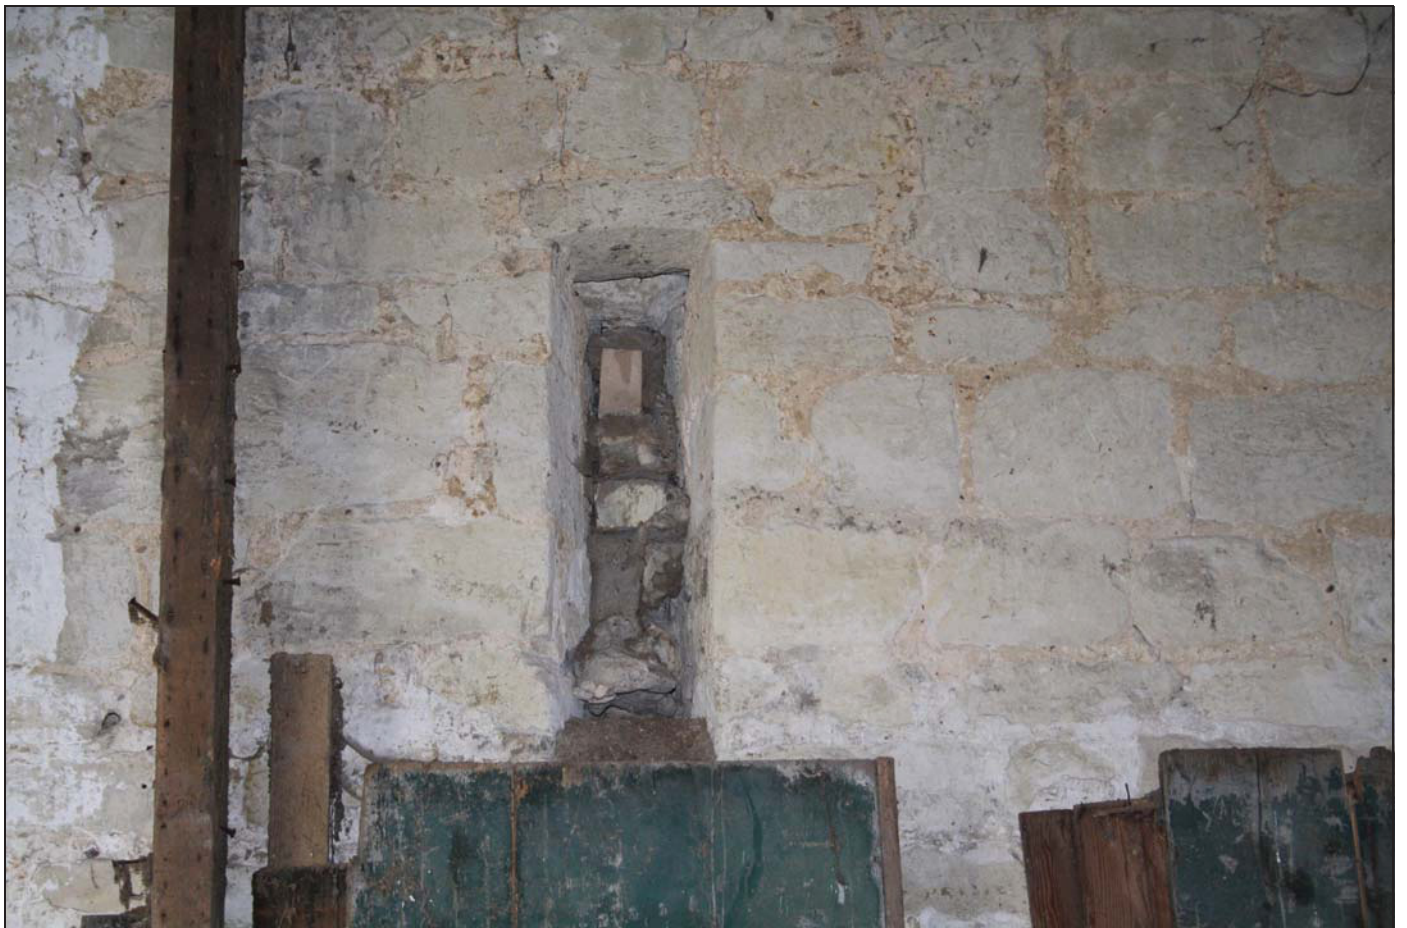
Plate 20 Blocked ventilation slit on the west side of the barn (Bay 1), taken from the east

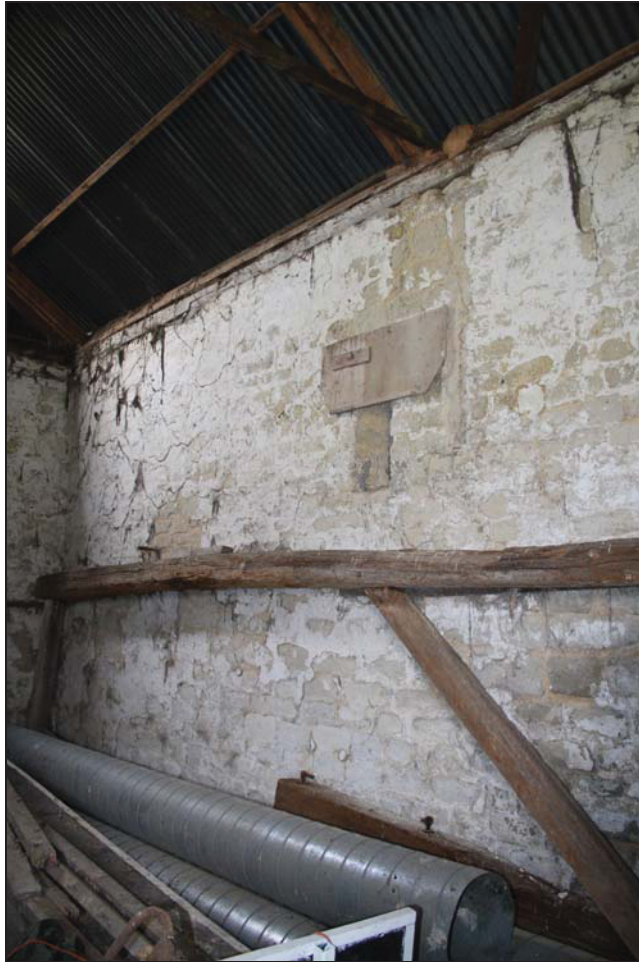
Plate 21 West wall of the barn (south end), taken from the north-east

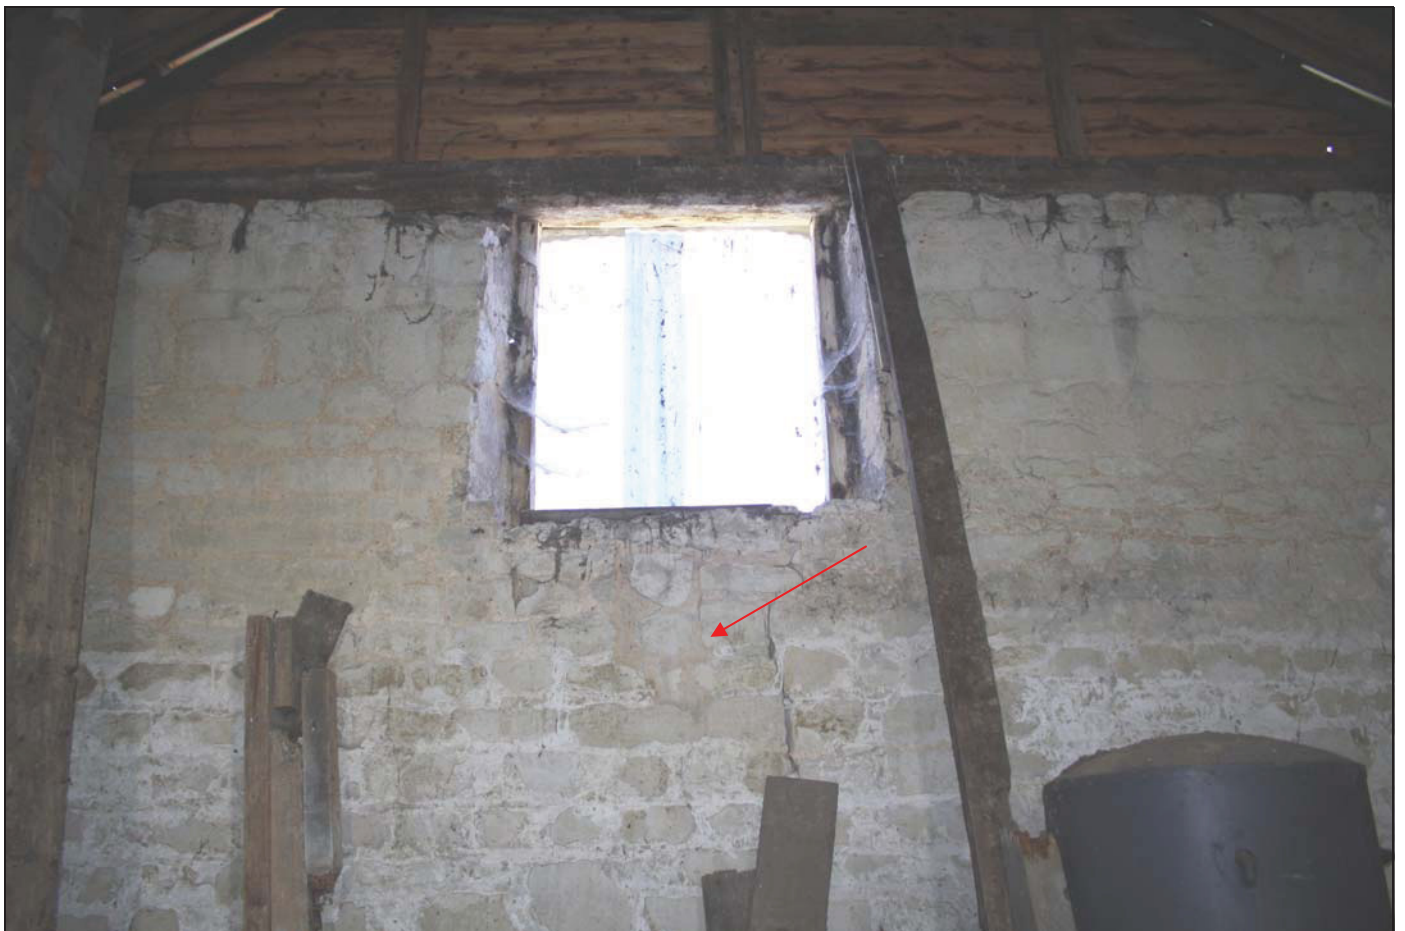
Plate 22 Inserted window at the north end of the barn with original blocked ventilation slit below (indicted), taken from the south

5.11 The ventilation slits all round are blocked from the exterior and so remain well expressed on the internal face. Two of the three on the west are well-preserved, as well as one on the south (Plates 20 and 21), while a further possible example is visible at the north end below the inserted window (Plate 22).

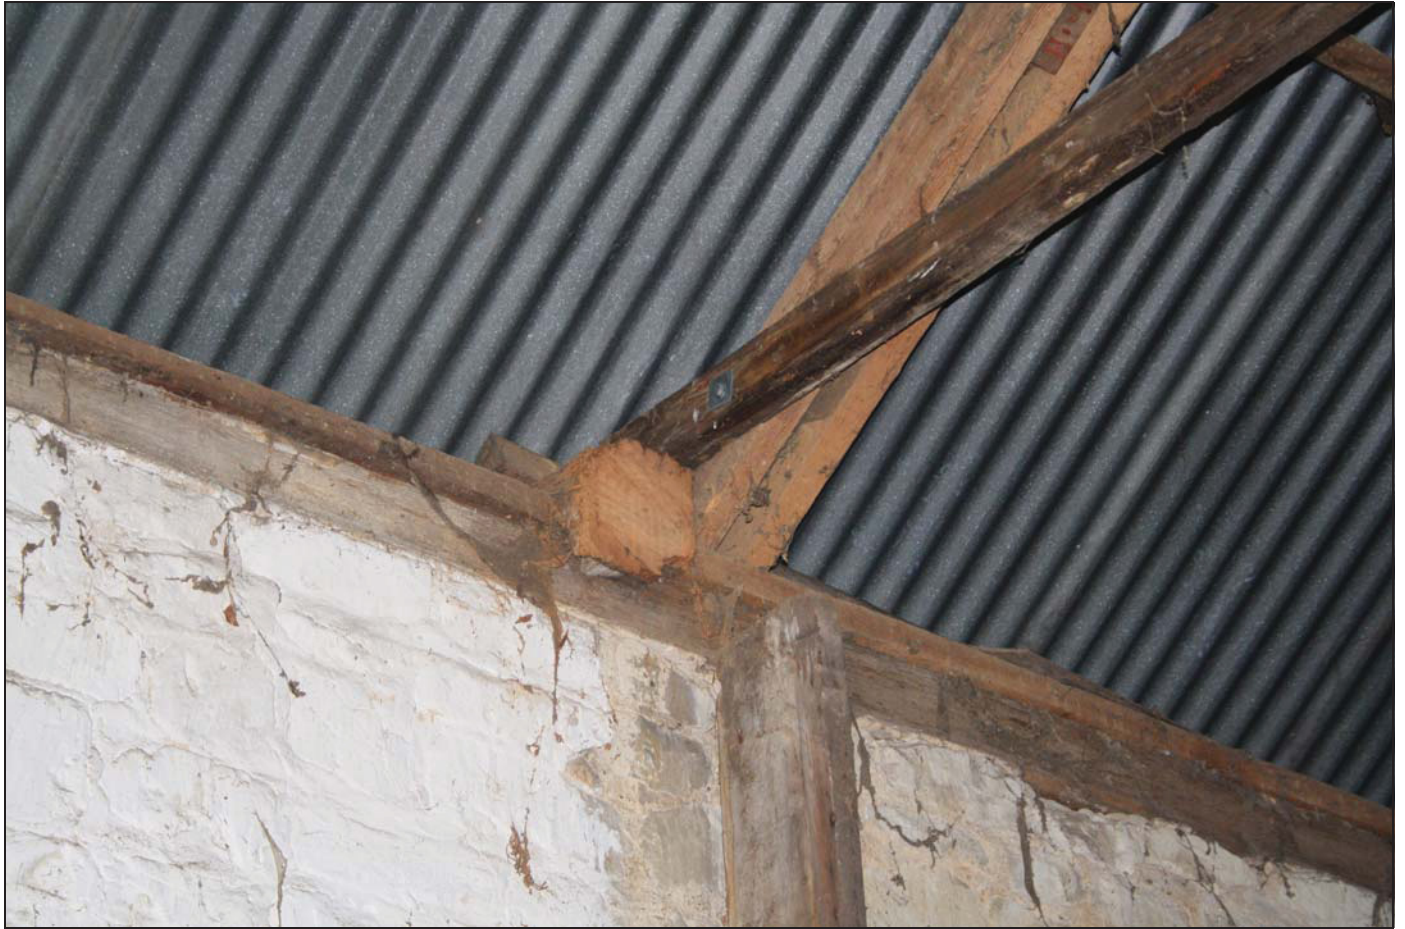
Plate 23 West side of the barn at roof level showing surviving wall plate and truncated tie-beam stump, taken from the south-east

5.12 As the building is stone-built, little structural carpentry survives, apart from the wall-plates and truncated stumps of the tie-beams (Plate 23). A number of edge-halved scarf joints are visible in the wall-plate (Plate 24) but further characteristics are not visible.

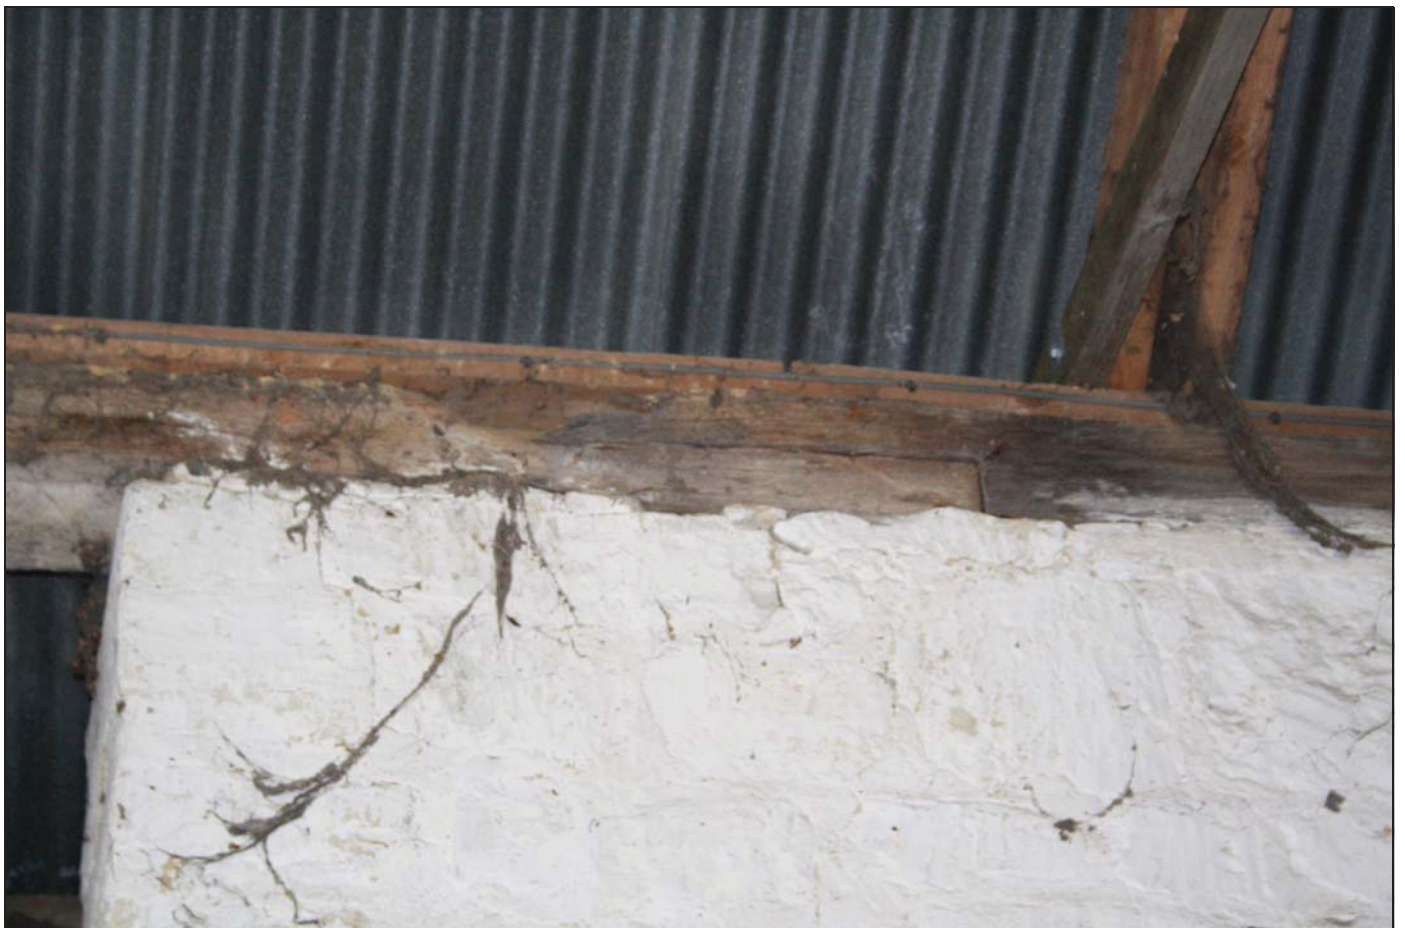
Plate 24 Edge-halved scarf joint in the west wall-plate, taken from the east

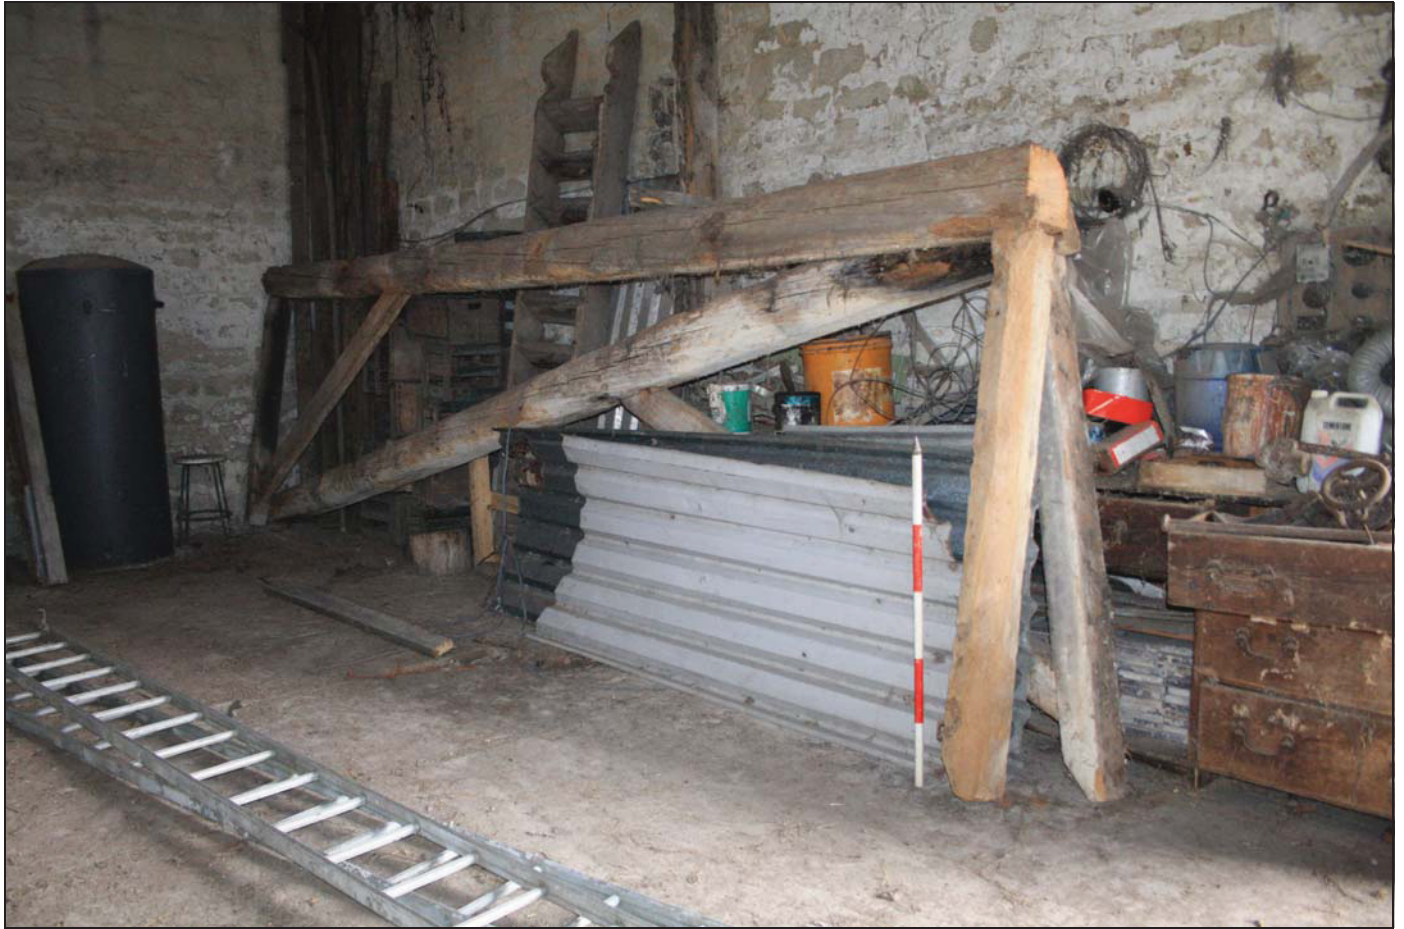
Plate 25 Two ex-situ roof trusses, taken from the south

5.13 Lying *ex-situ* within the barn, several of the original tie-beams and their associated braces survive (Plates 25 and 26). Other elements like rafters may also be present amid various piles of lumber stored in the building but could not be identified with the same certainty. The timber appears to be entirely of oak and where seen in cross-section, is fairly slow-grown. The original truss arrangement is clear, and

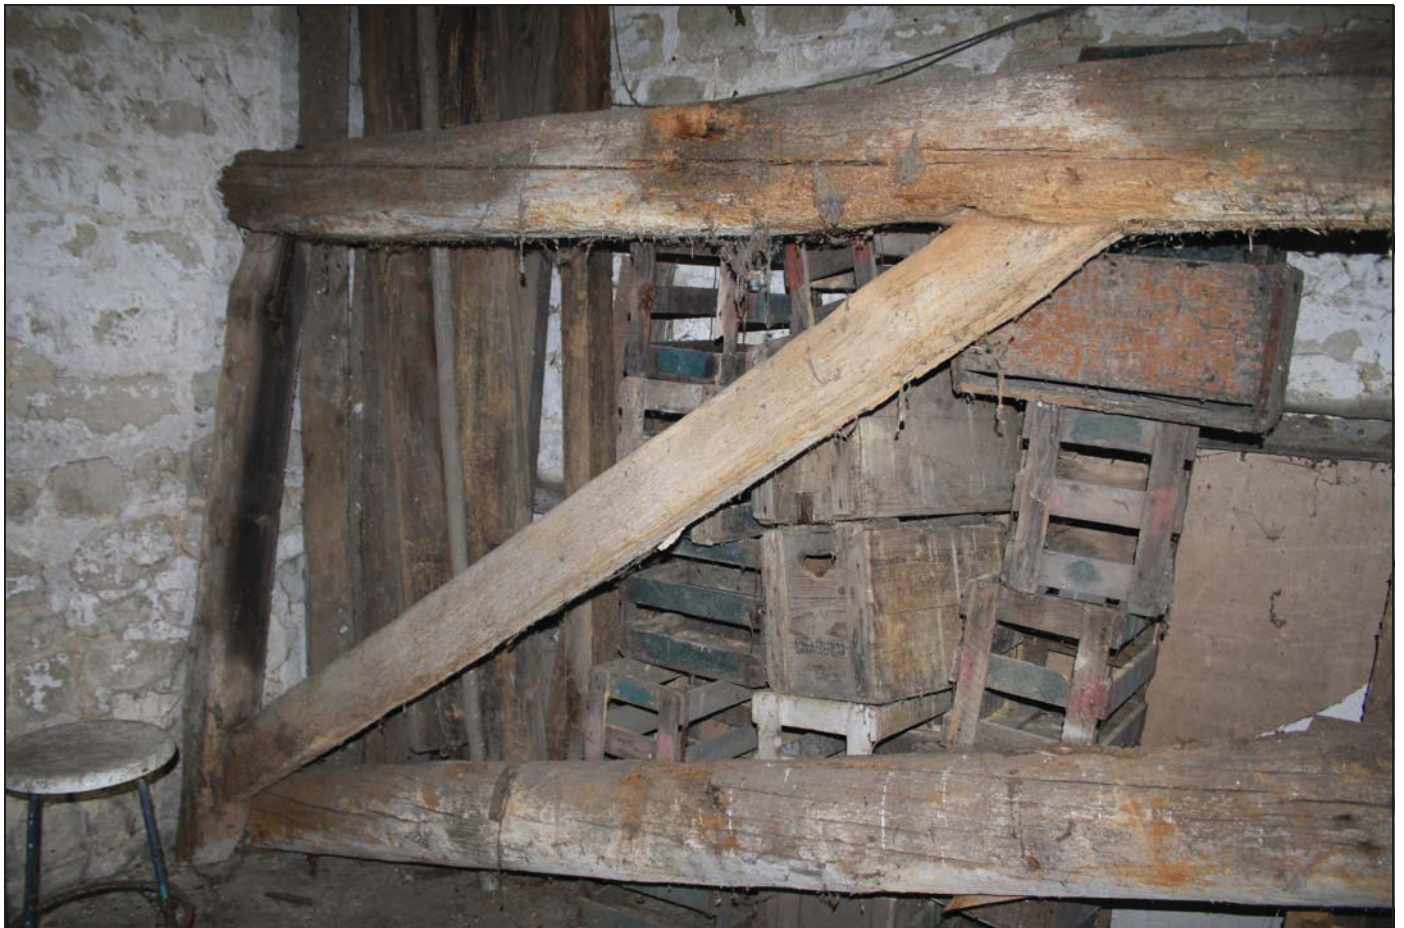
Plate 26 End of an ex-situ truss showing the earlier roof construction including tie-beam, post and brace, taken from the west

included tie-beams with short pendant outer posts, from which slender, curved braces sprang. Normally, such posts would stand on corbels, but there is no evidence for this, and instead it is likely that they were held in compression by simple triangulation of the timber and so needed no additional support. The timbers were all pegged, and additionally supported by a strap and staple threaded through the tie-beam. There is no evidence in the upper face of the tie-beams to indicate the presence of any king- or queen-posts.

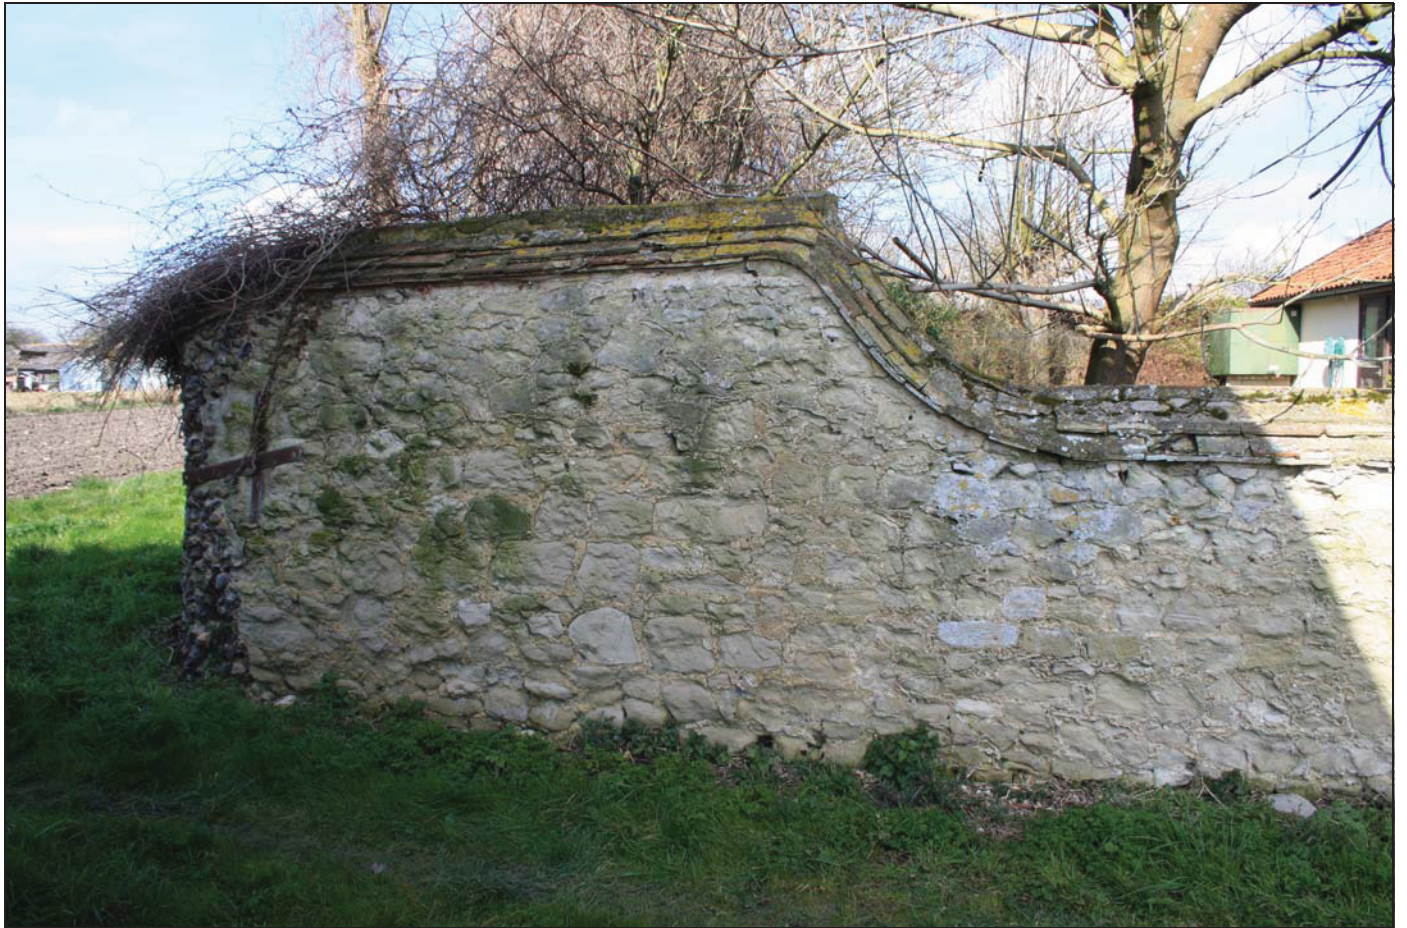
Plate 27 Retaining boundary wall of slightly varying construction to the barn enclosing The Poplars, taken from the south
