ARCHAEOLOGICAL SOLUTIONS LTD

BARN ON LAND BETWEEN 64 & 76 LOW ROAD  
BURWELL, CAMBRIDGESHIRE

HISTORIC BUILDING RECORDING

Authors:	Tansy Collins BSc (historic building appraisal) Lee Prosser PhD (historic building appraisal) Peter Thompson MA (research) Kathren Henry (graphics)	
NGR: TL 5850 6699		Report No: 4291
District: East Cambridgeshire		Site Code: AS 1579
Approved: Claire Halpin MIFA		Project No: 4496
Signed:		Date: March 2013

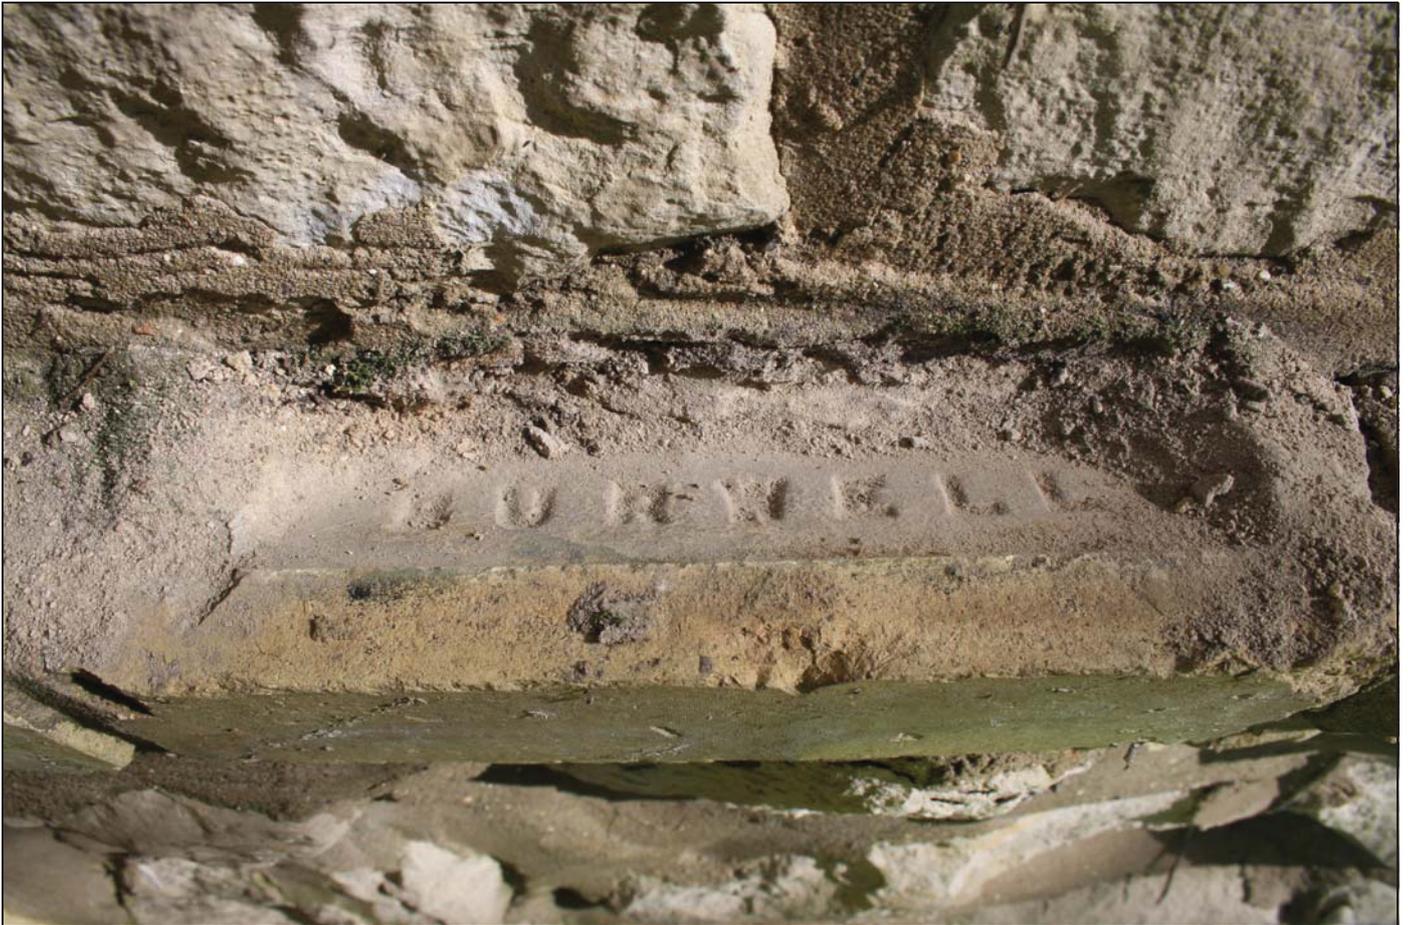
Plate 1 Burwell brick from the brick course along the top of the plinth extending around the barn, taken from the west

5.2 The brickwork is of a variable pinkish-yellow gault or shale brick, typical of the late 19<sup>th</sup> century and in one or two places where the brick is laid with the frog uppermost, they can be identified as being locally manufactured Burwell bricks (Plate 1). The clunch is for the most part weathered back on the exterior face except where protection has been afforded by a pre-existing structures, and here rough, parallel tooling survives (Plate 2). The stonework has been mostly repointed with a cementitious mortar.

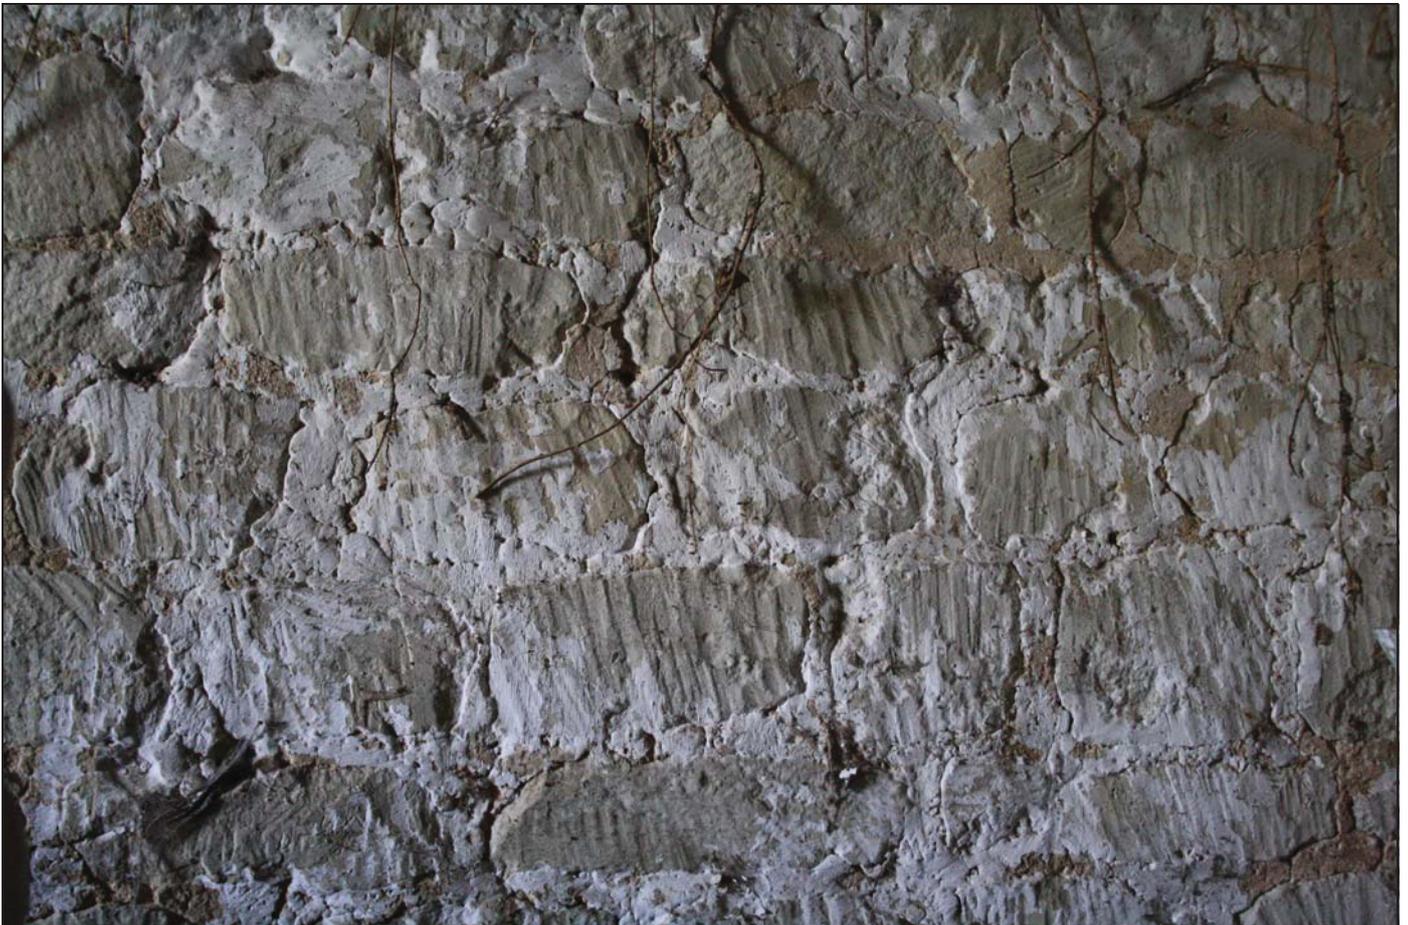
Plate 2 Example of the tooling marks on the clunch blocks on the south side of the porch, taken from the north

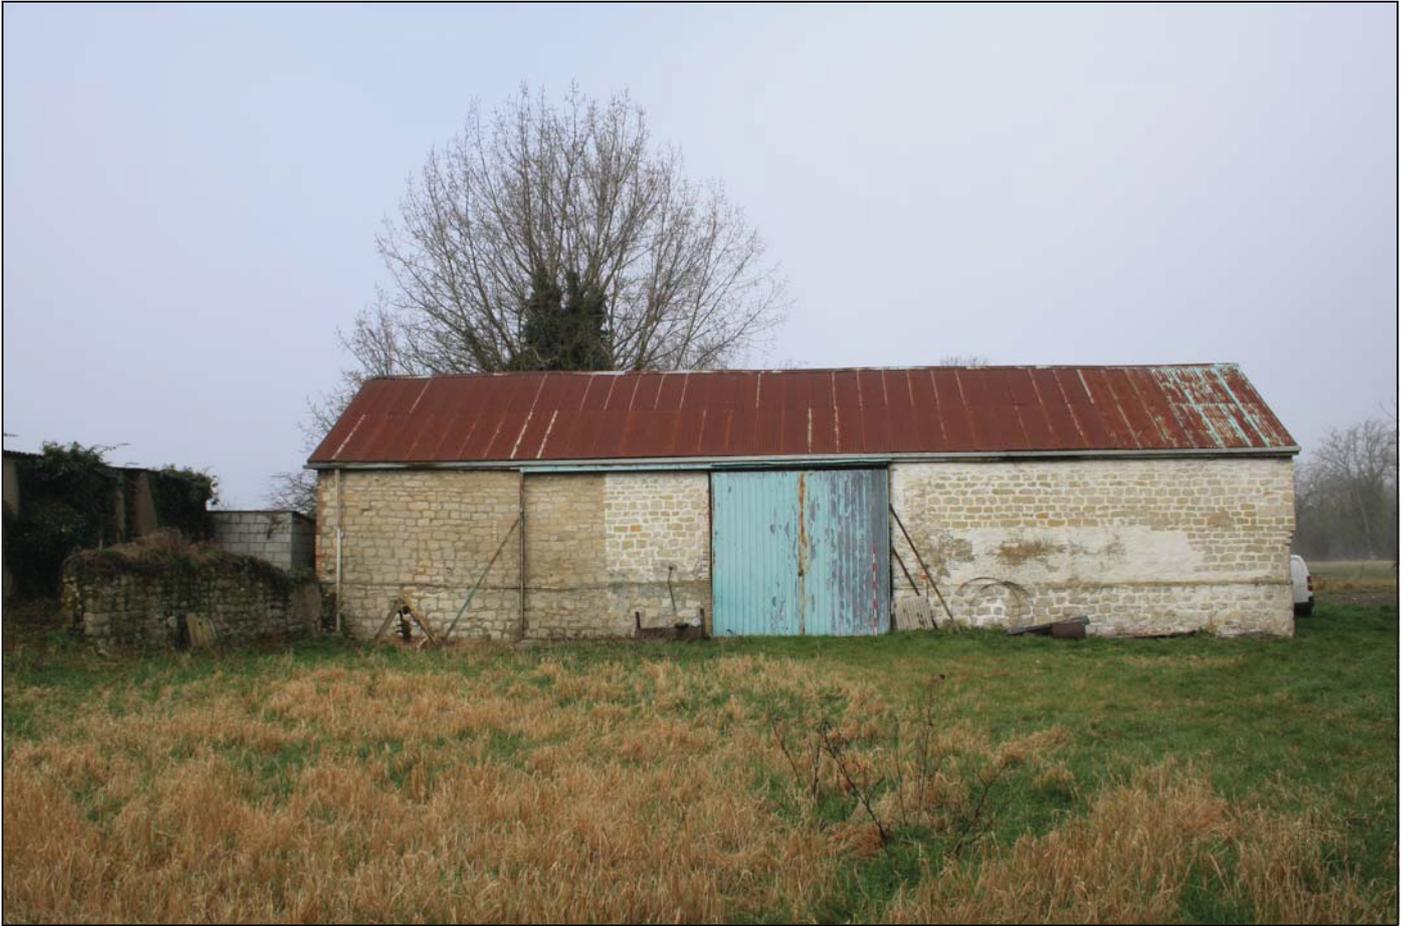
Plate 3 East elevation, taken from the east

5.4 The east elevation faces the road, and displays a clear gradation in the coursing from large, almost square blocks at the base to more refined coursing and smaller blocks near the eaves (Plate 3). A full-height doorway marks the central bay, now enclosed with modern metal sliding doors, although restraining hooks fixed to the walls on either side indicate the existence of earlier double doors. The jambs have been made good with late 19<sup>th</sup> century brick but with the evidence for earlier doors, it is probable the doorway was remodelled at this time rather than being a new insertion. A blocked ventilation slit lies to the south, though an area of render to the north conceals a second example.

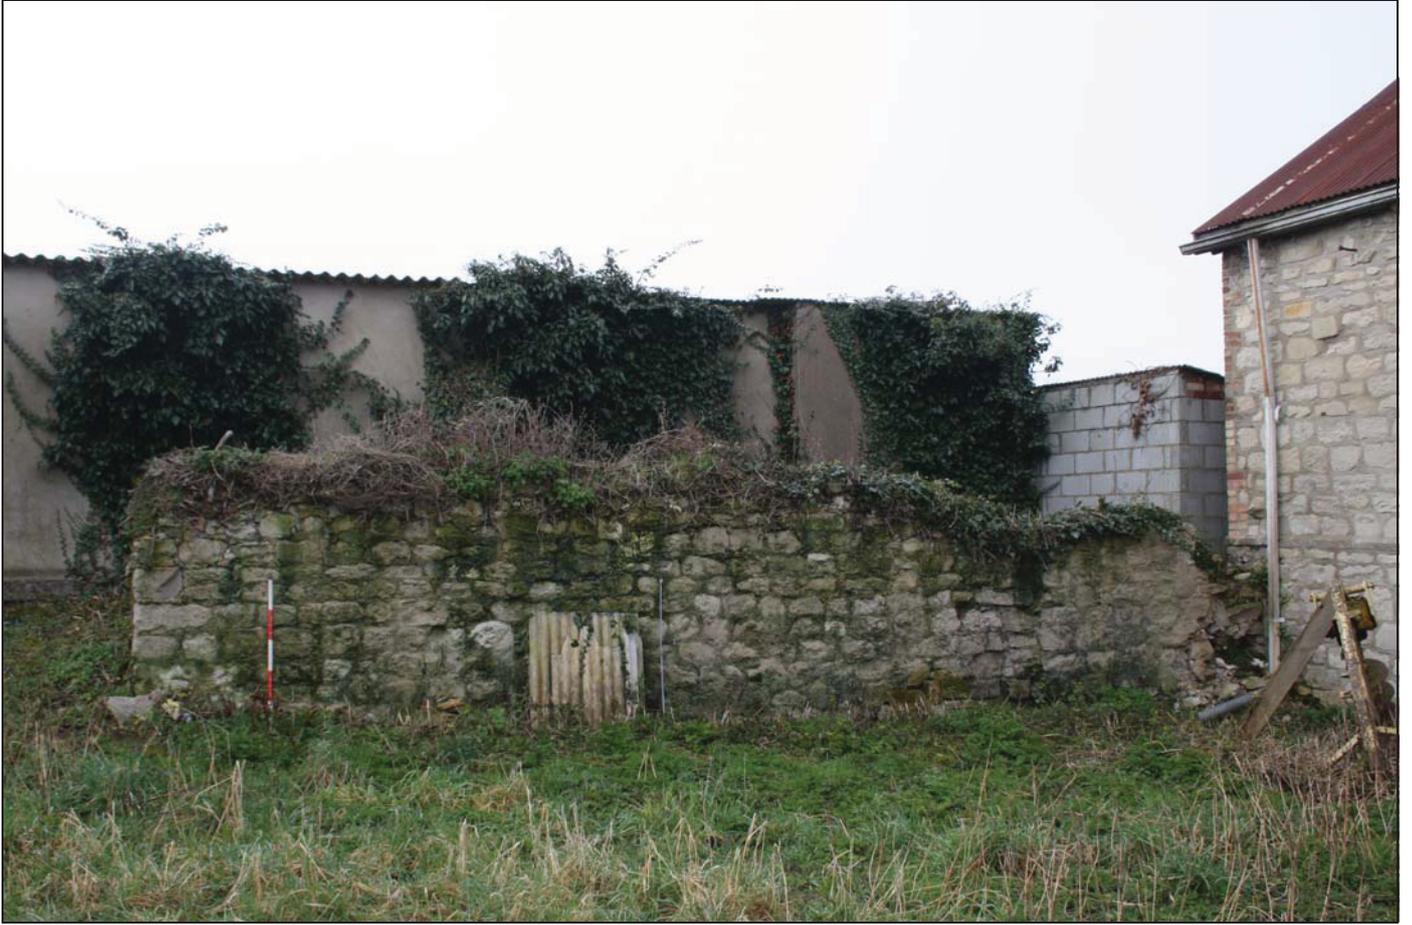
Plate 4 Surviving wall from an earlier range adjoining to the south-east of the barn, taken from the north

5.5 At the south-east corner a low wall extends laterally from this east elevation and forms a surviving fragment of an adjoining range visible on the tithe map (Plates 4 and 5). The stonework is coursed in the same manner and appears to be tied into the barn, although some making good at the corner post-dates the demolition of the building. The wall survives to a height of approximately 2m and has not been repointed as the barn, so that the original hard, pinkish mortar survives. The structure now forms a retaining wall for a high bank to the rear, though on that side the continuous brick string course indicates this was originally the south external wall of the range. There are no surviving marks for the original roof line where it abutted the main structure, though one or tether rings survive, presumably once internal within the range.

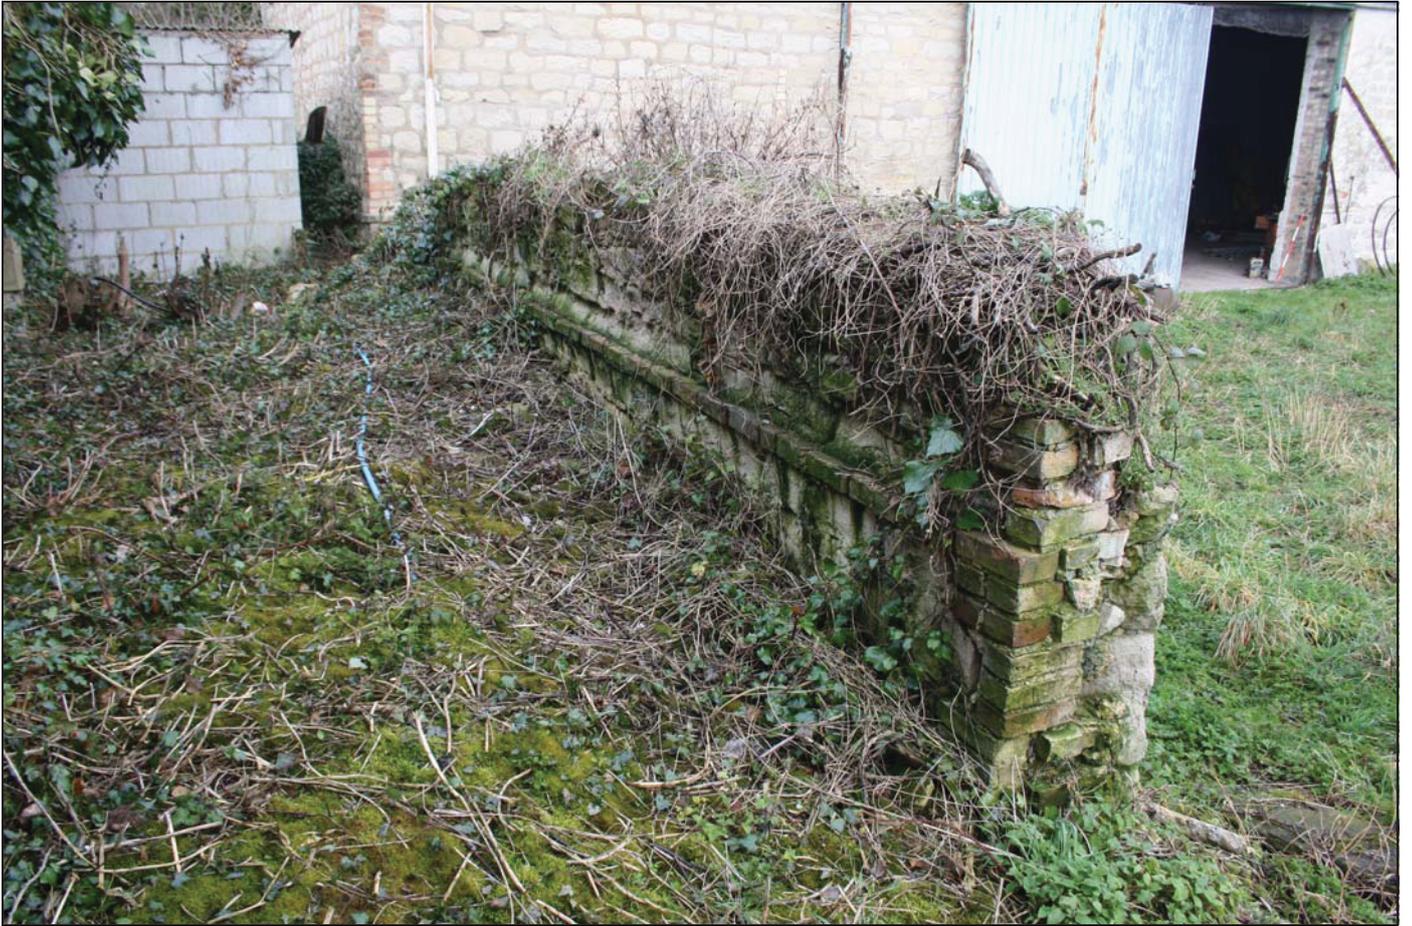
Plate 5 Outer face of the surviving wall from an earlier range adjoining to the south-east of the barn, taken from the south-east

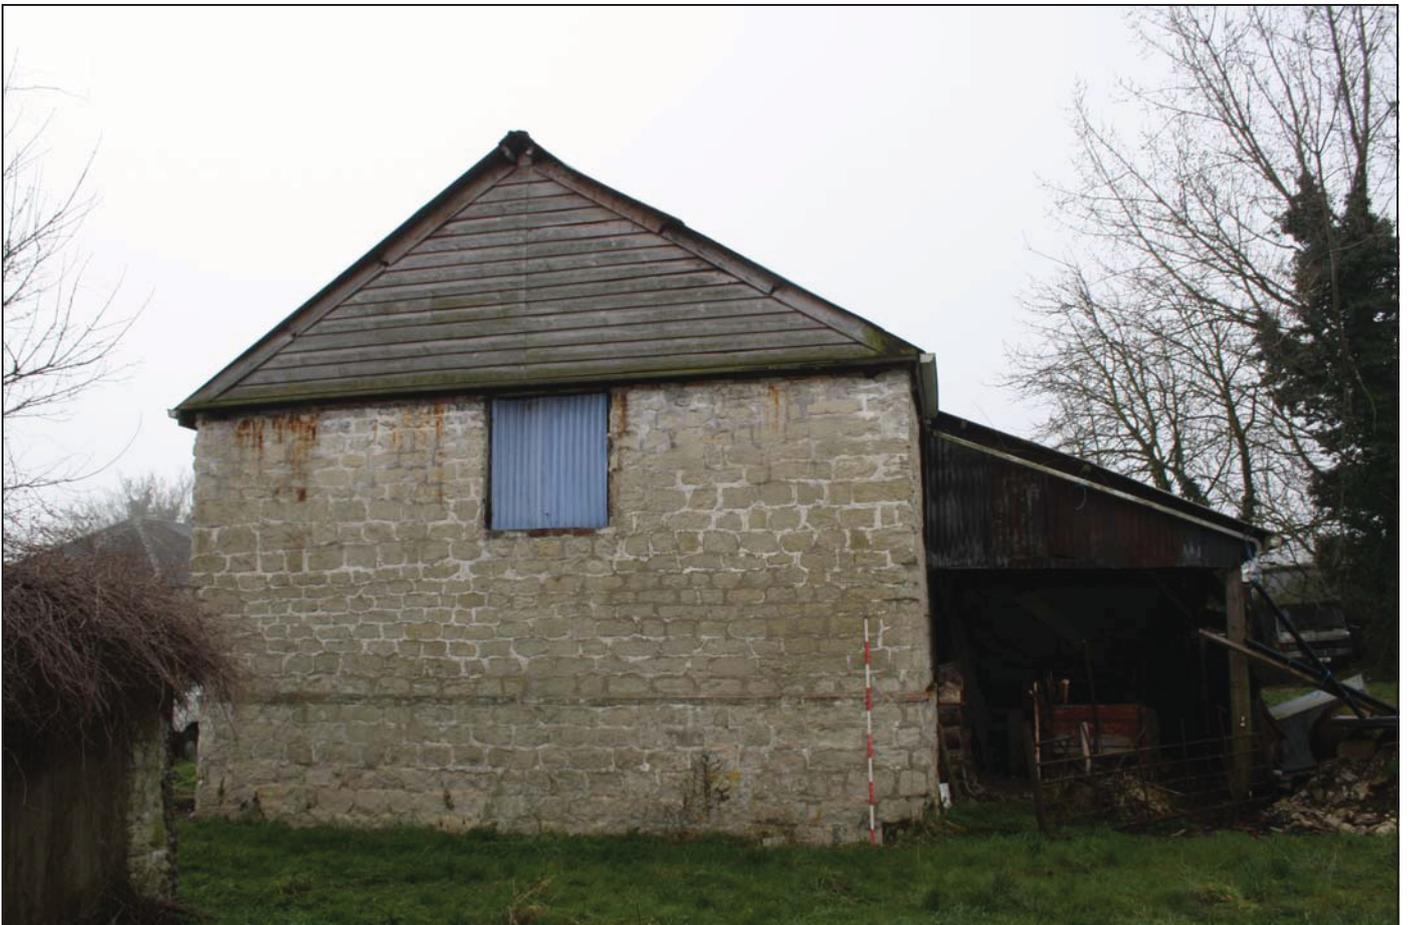
Plate 6 North elevation, taken from the north

5.6 The north gable end of the barn is entirely regular in form as on the east, with stonework rising to eaves level (Plate 6). Above eaves level, the gable is clad in modern weatherboarding, although the wall-plate is supported by late 19<sup>th</sup> century gault bricks. Both corners are bevelled at lower level and corbelled out above to a

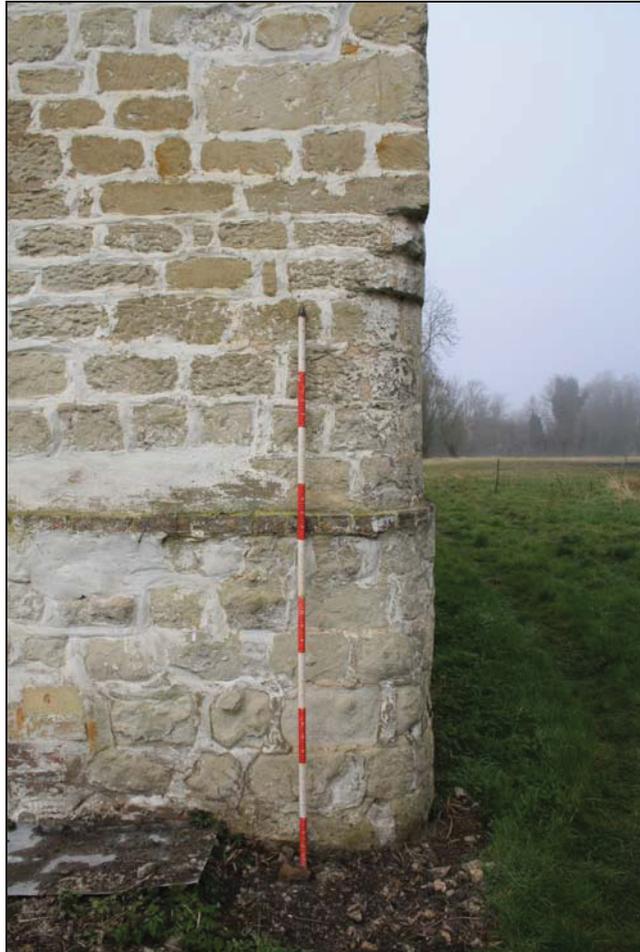
Plate 7 East elevation (north end) showing bevelled corner, taken from the east

standard corner (Plate 7). A central pitching door is set at high level, framed by oak. This is a later insertion, as the remains of an earlier ventilation aperture remains visible inside, and has been disturbed by its insertion.

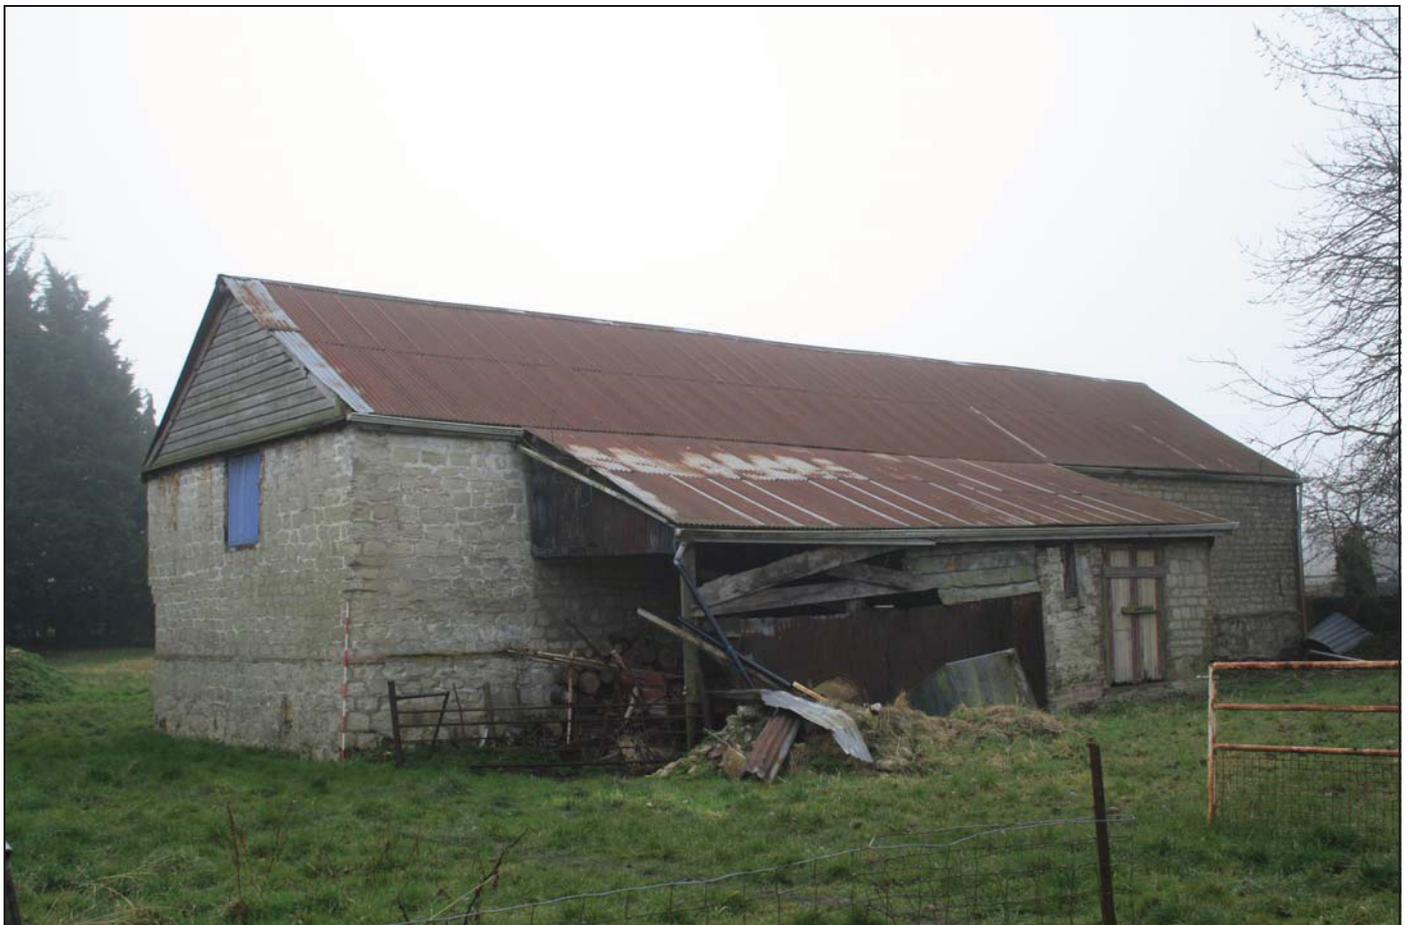
Plate 8 North and west elevation of the barn, taken from the north-west

5.7 The west façade incorporates a porch and modern lean-to to the north (Plates 8 and 9). The southern bays are coursed as on the east and pierced by two ventilation slits, the northern example having been widened and then latterly blocked with 19<sup>th</sup> century brick (Plate 10). The porch appears contemporary and tied into the main body of the barn but rises only to 2.4m height, possibly to upper timber-framing and a pitched roof, though now covered by an in-line pent-roofed structure (Plate 11). The porch has been extensively repaired by the insertion of brick at the corners, the lower parts of the wall on the west, and the door jambs are all of 19<sup>th</sup> century brick. The west side is pierced by a wide doorway containing double boarded doors of 20<sup>th</sup> century date, while to the immediate north is a probable contemporary window, although much of this side has failed structurally, and is in a precarious condition.

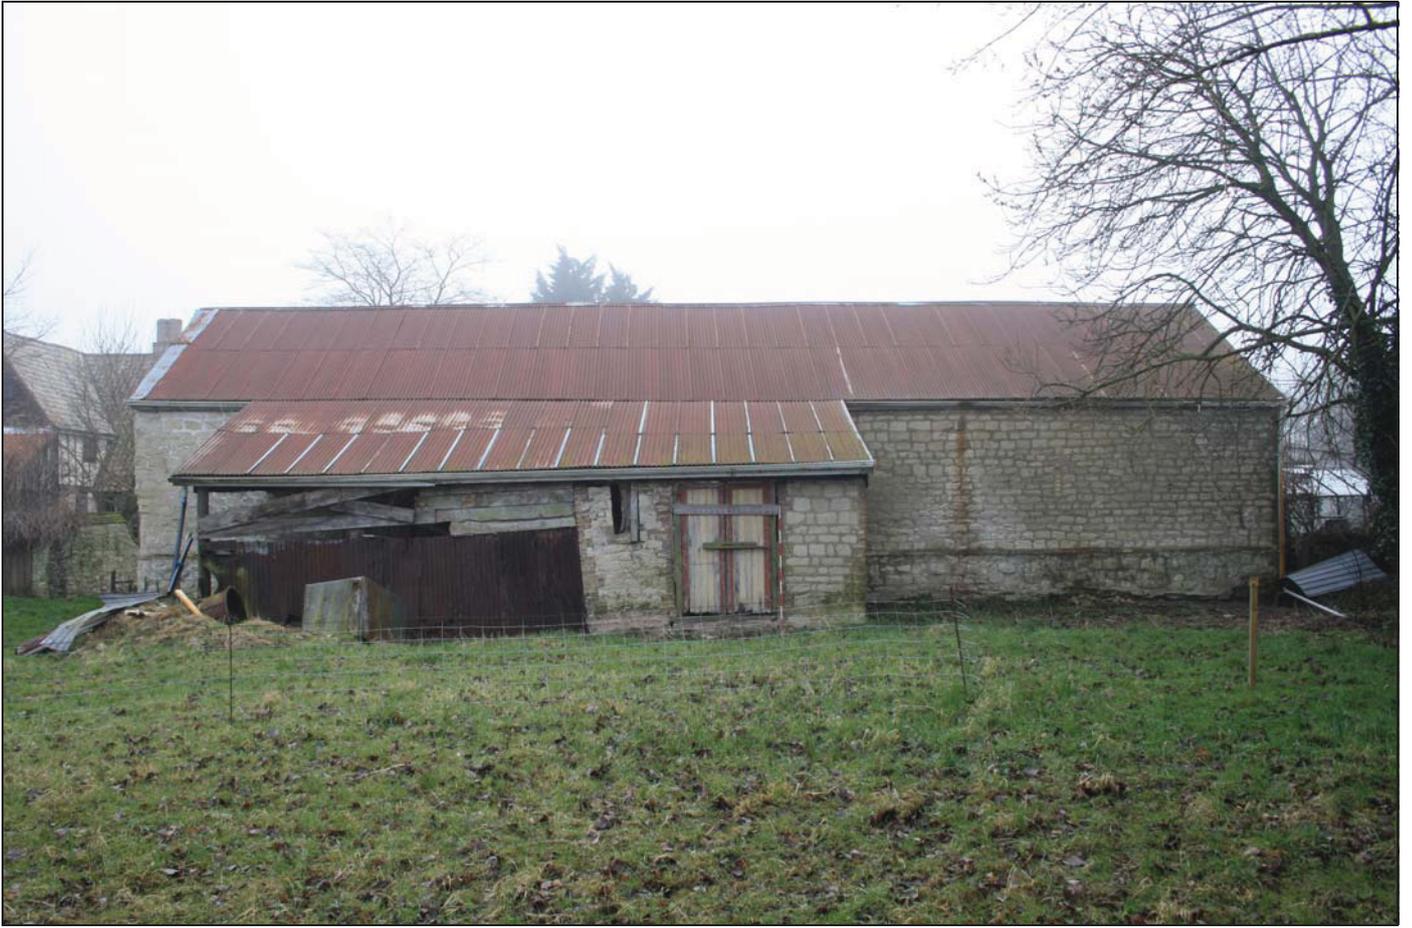
Plate 9 West elevation, taken from the west

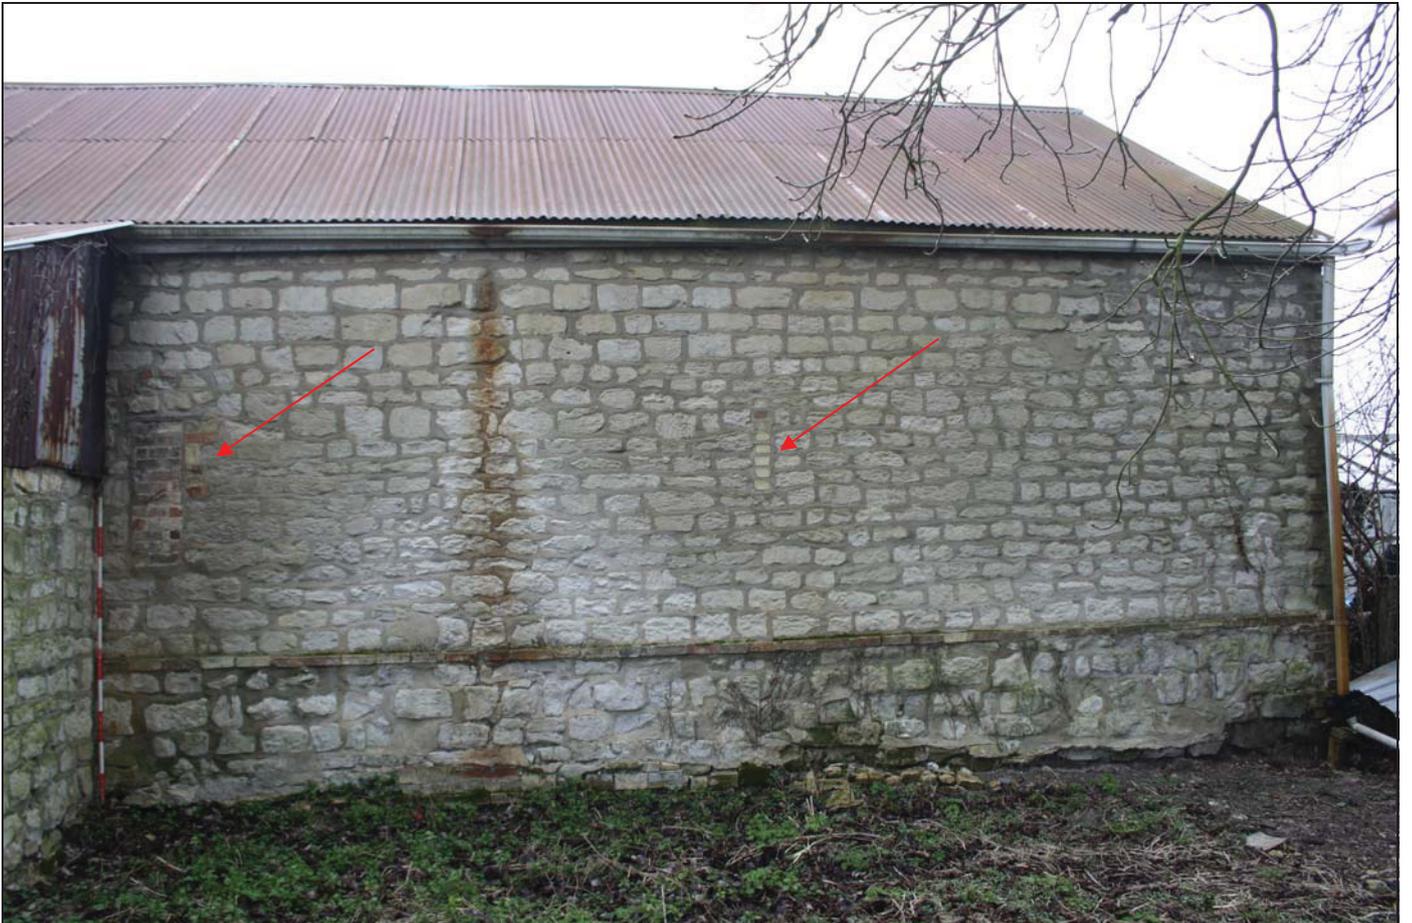
Plate 10 West elevation (south end) showing blocked ventilation slits (indicated), taken from the west

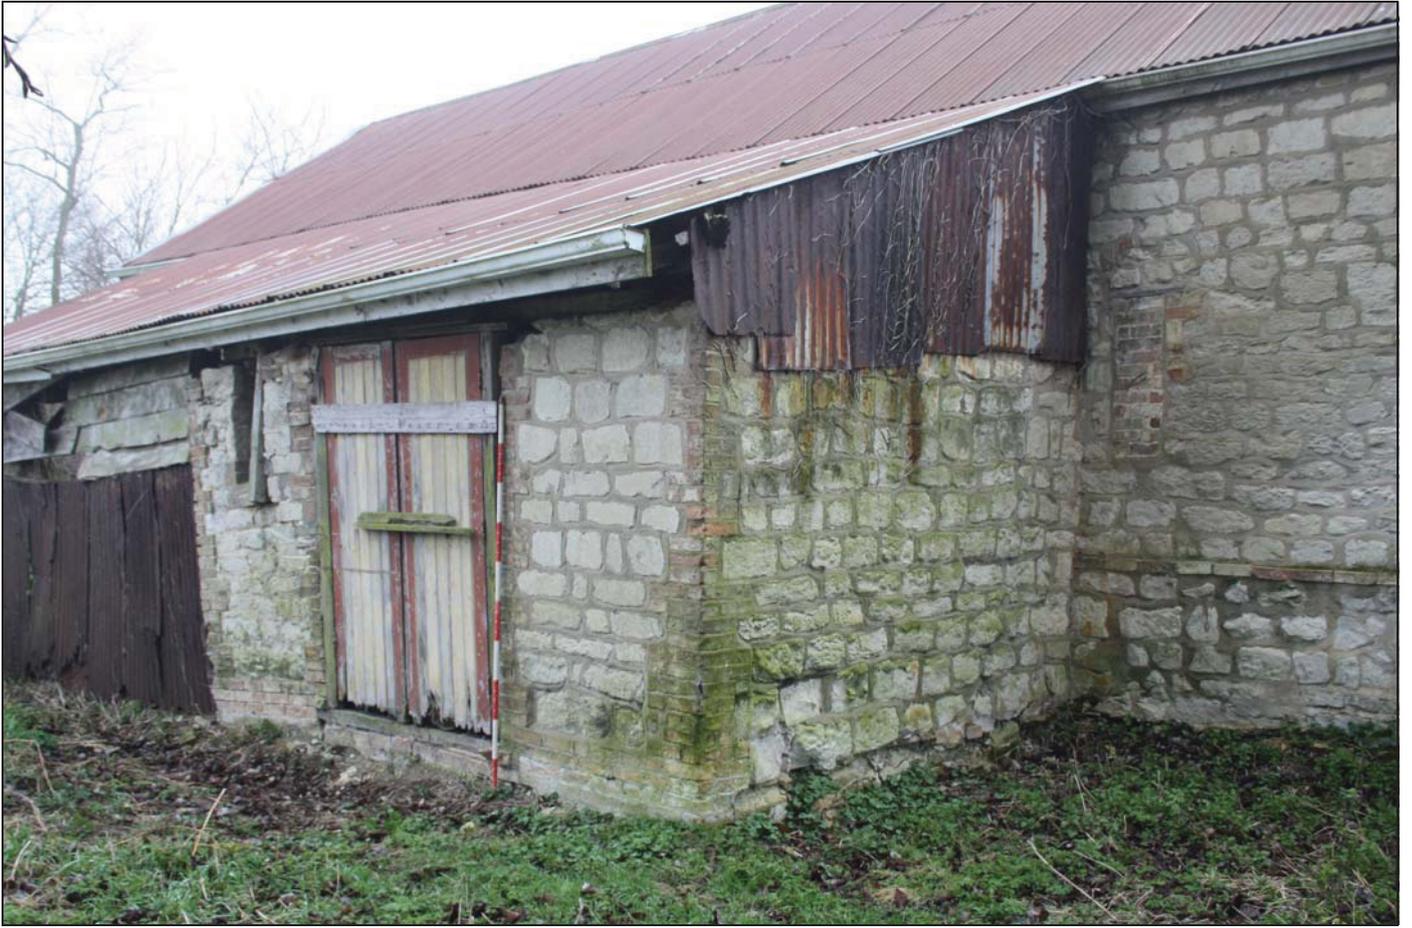
Plate 11 West and south side of the porch, taken from the south-west

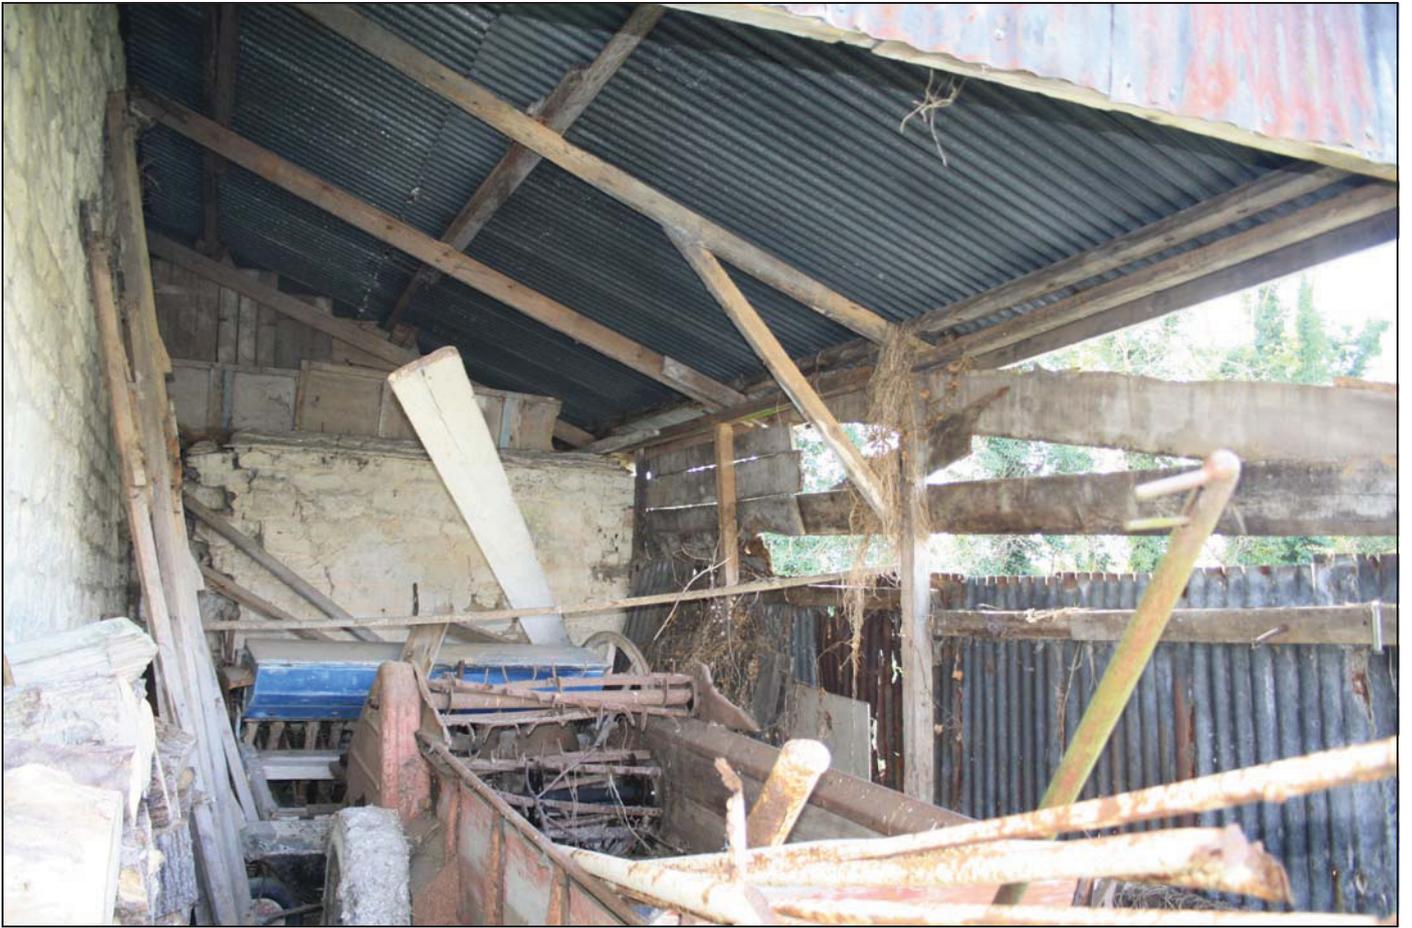
Plate 12 Interior of the modern lean-to on the west side of the barn, taken from the north

5.8 The pent-roofed lean-to along the northern bays is of fairly ephemeral and modern construction, but has served to protect the original walls from weathering (Plate 12 and 13). Surviving features include tile flaunching of the north wall of the porch as well as a third ventilation slit in the main body of the barn. Distinct modern tooling is also present on the lower edge of the blocks, presumably made where the original lime mortar was chipped out and replaced in cement.

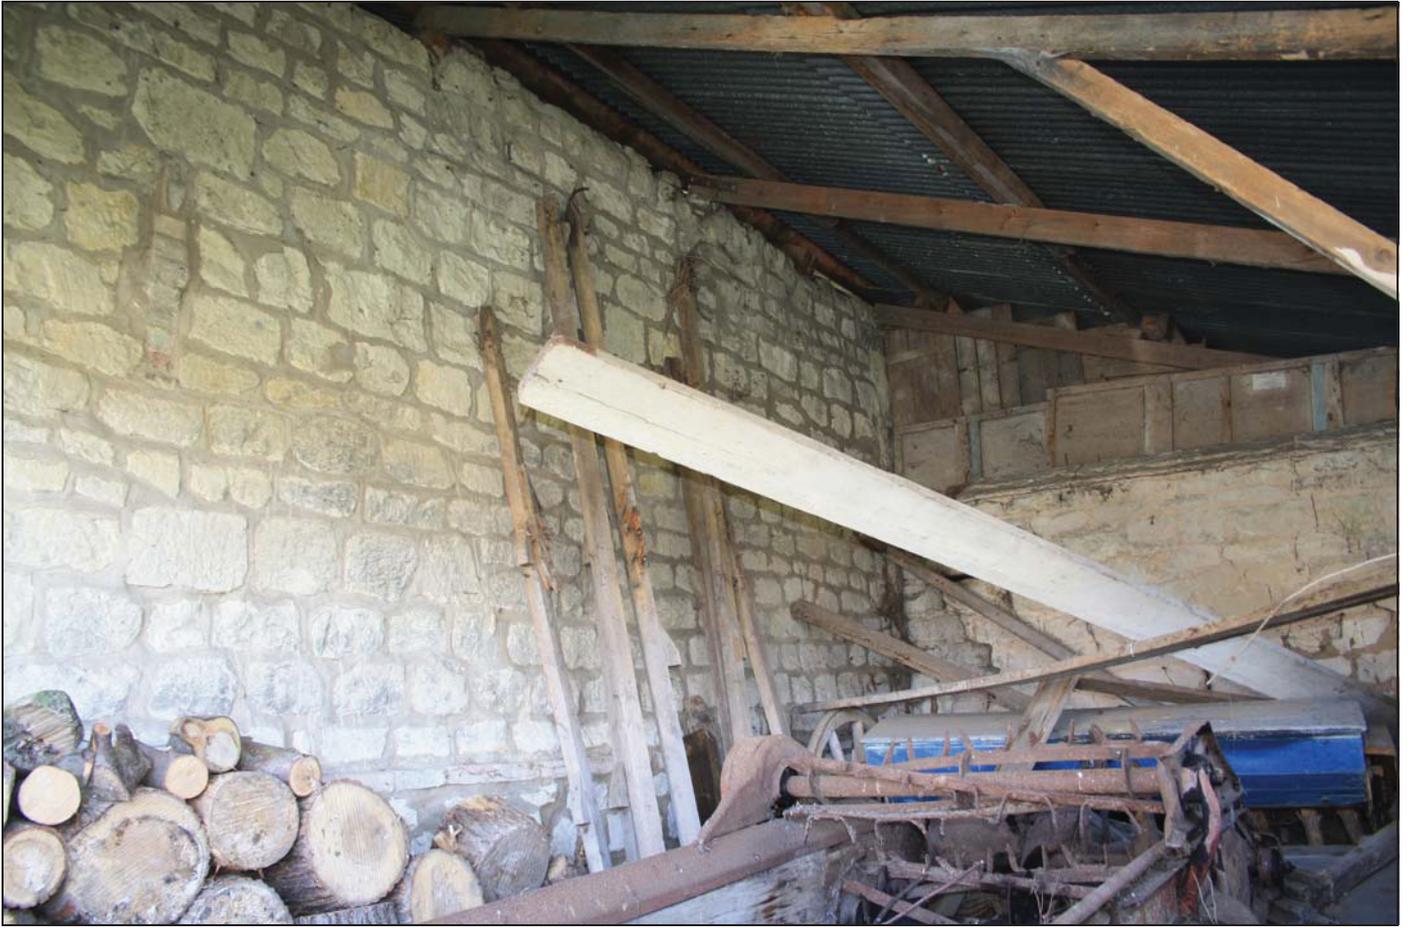
Plate 13 Formerly external west wall of the barn from within the lean-to, taken from the north

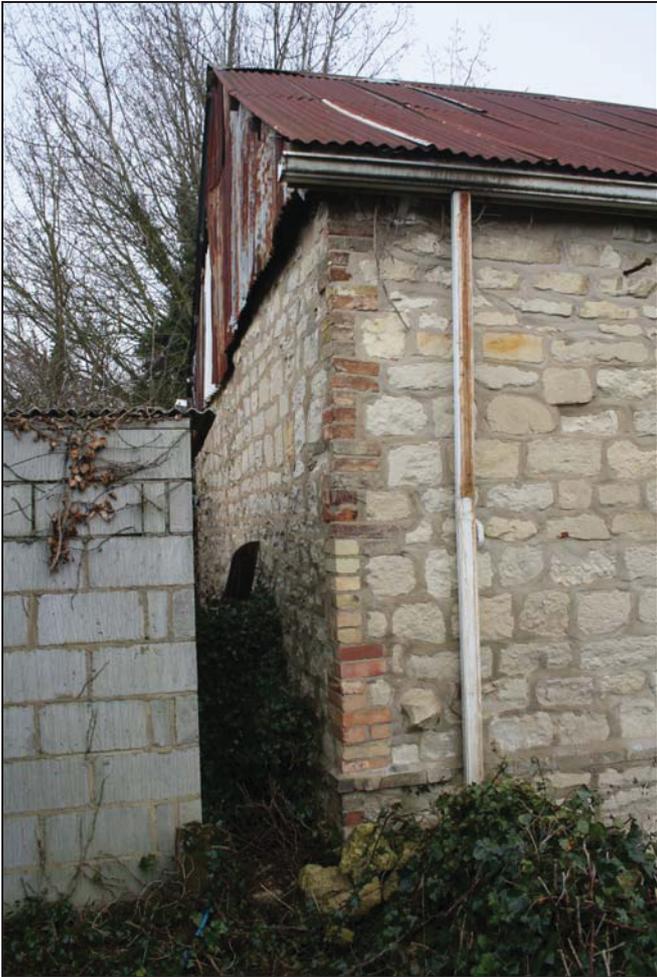
Plate 14 View of the south elevation, taken from the east

5.9 The south gable end abuts the adjoining property but appears to be fairly plain, again with some repair on the corners in late 19<sup>th</sup> century and later Fletton brick (Plate 14). A central ventilation slit is visible, blocked as elsewhere.

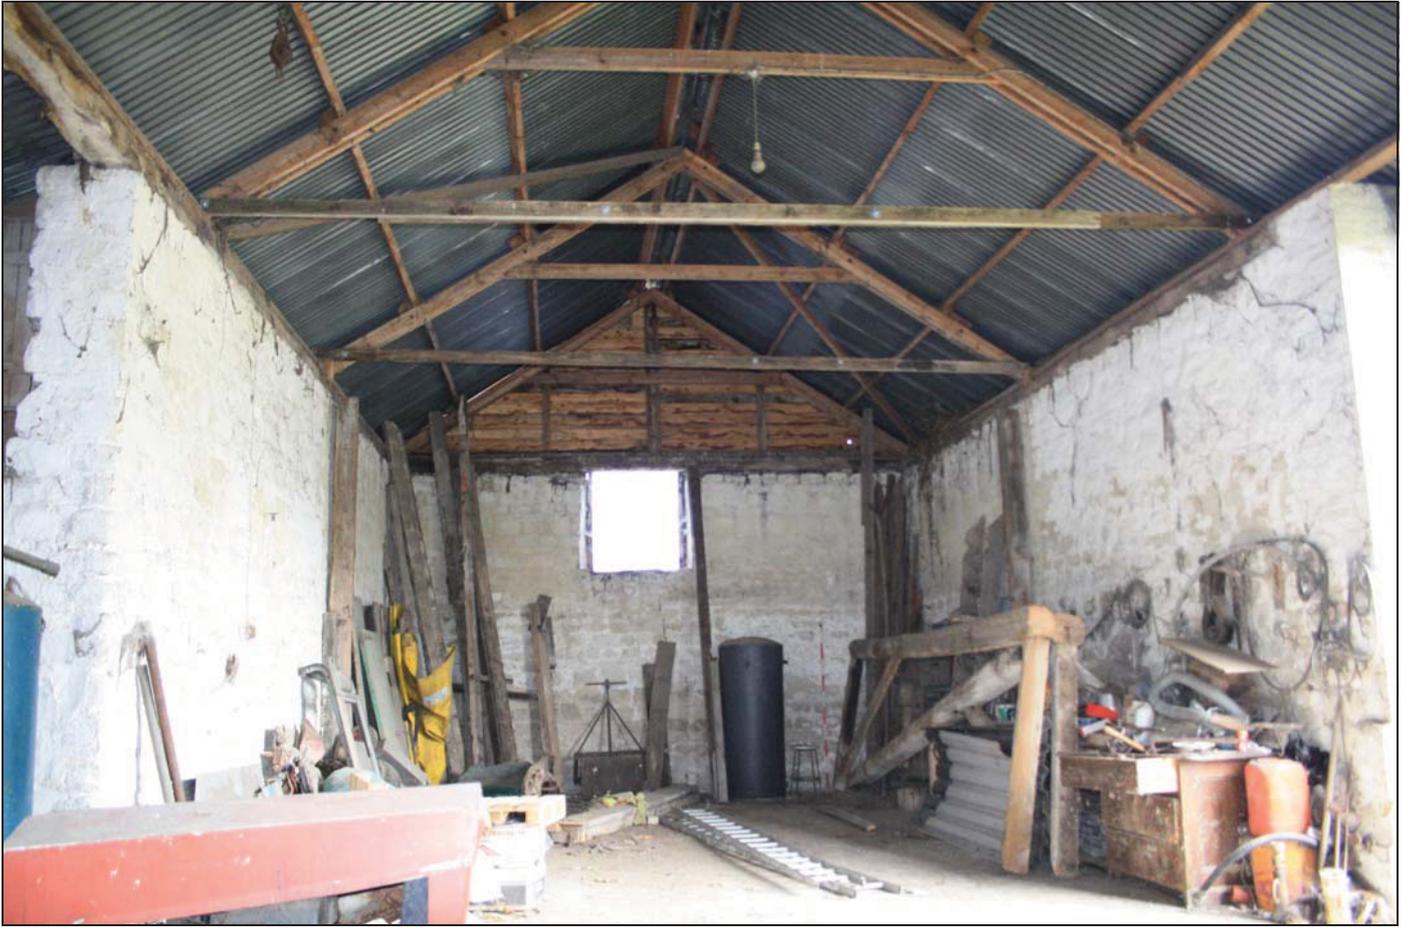
Plate 15 Interior of the barn (north end) showing modern roof structure, taken from the south

5.10 The interior of the barn is floored in cement throughout, while the original external walls have been left exposed and only white-washed. Internally, the stone coursing is as well-handled as the exterior (Plates 15 and 16). The original aperture on the west is dressed with good stonework which continues into the porch structure, confirming the porch as contemporary (Plates 17 and 18) but with replacement boarded doors on the west (Plate 19). Much of the original pinkish lime mortar survives.

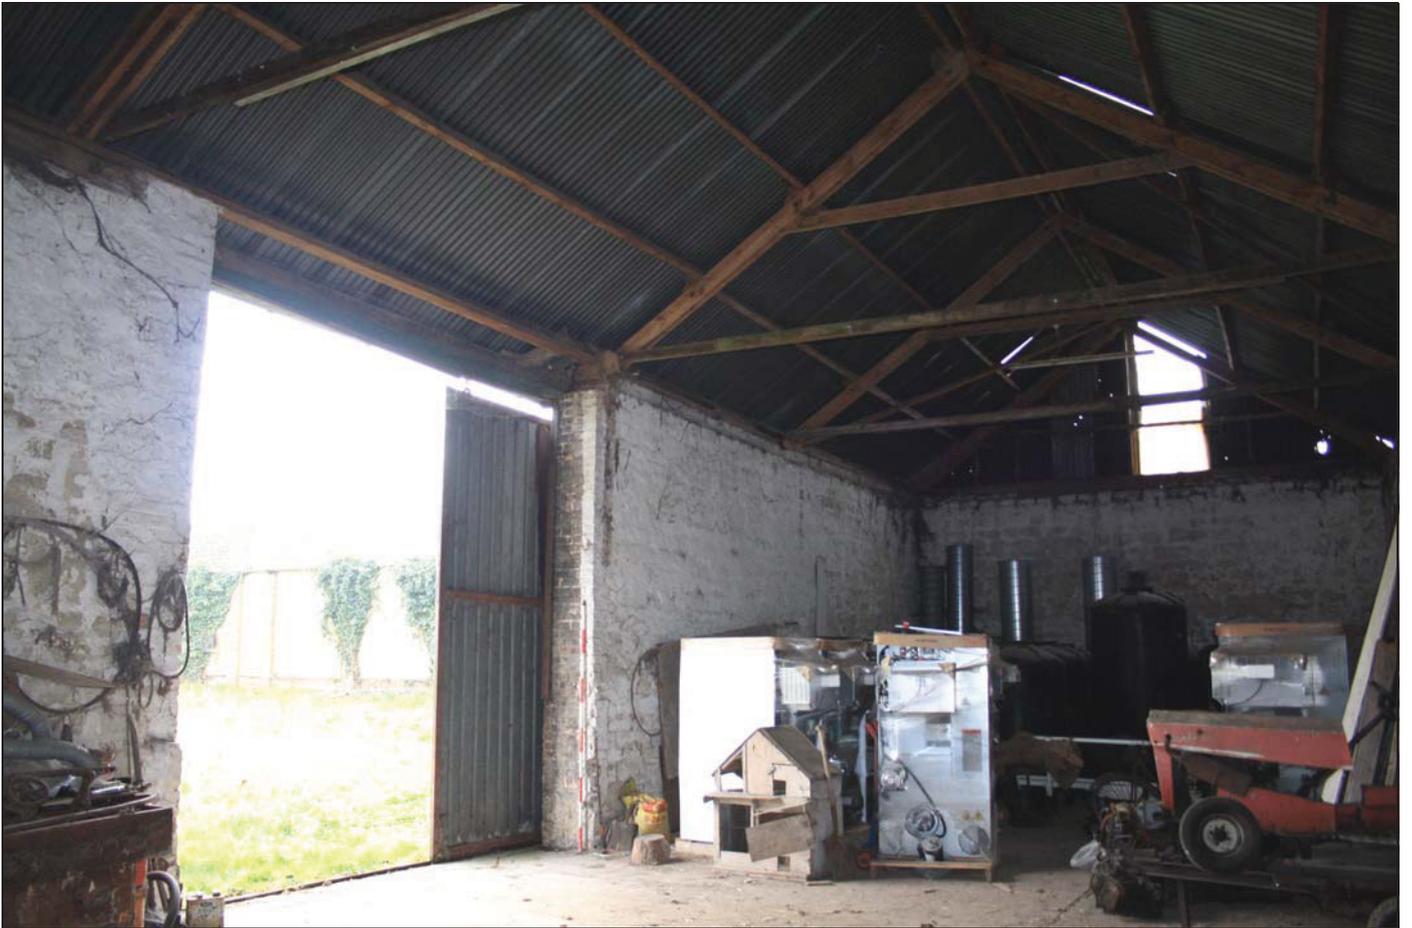
Plate 16 Interior of the barn (south end) showing the entrance, taken from the north

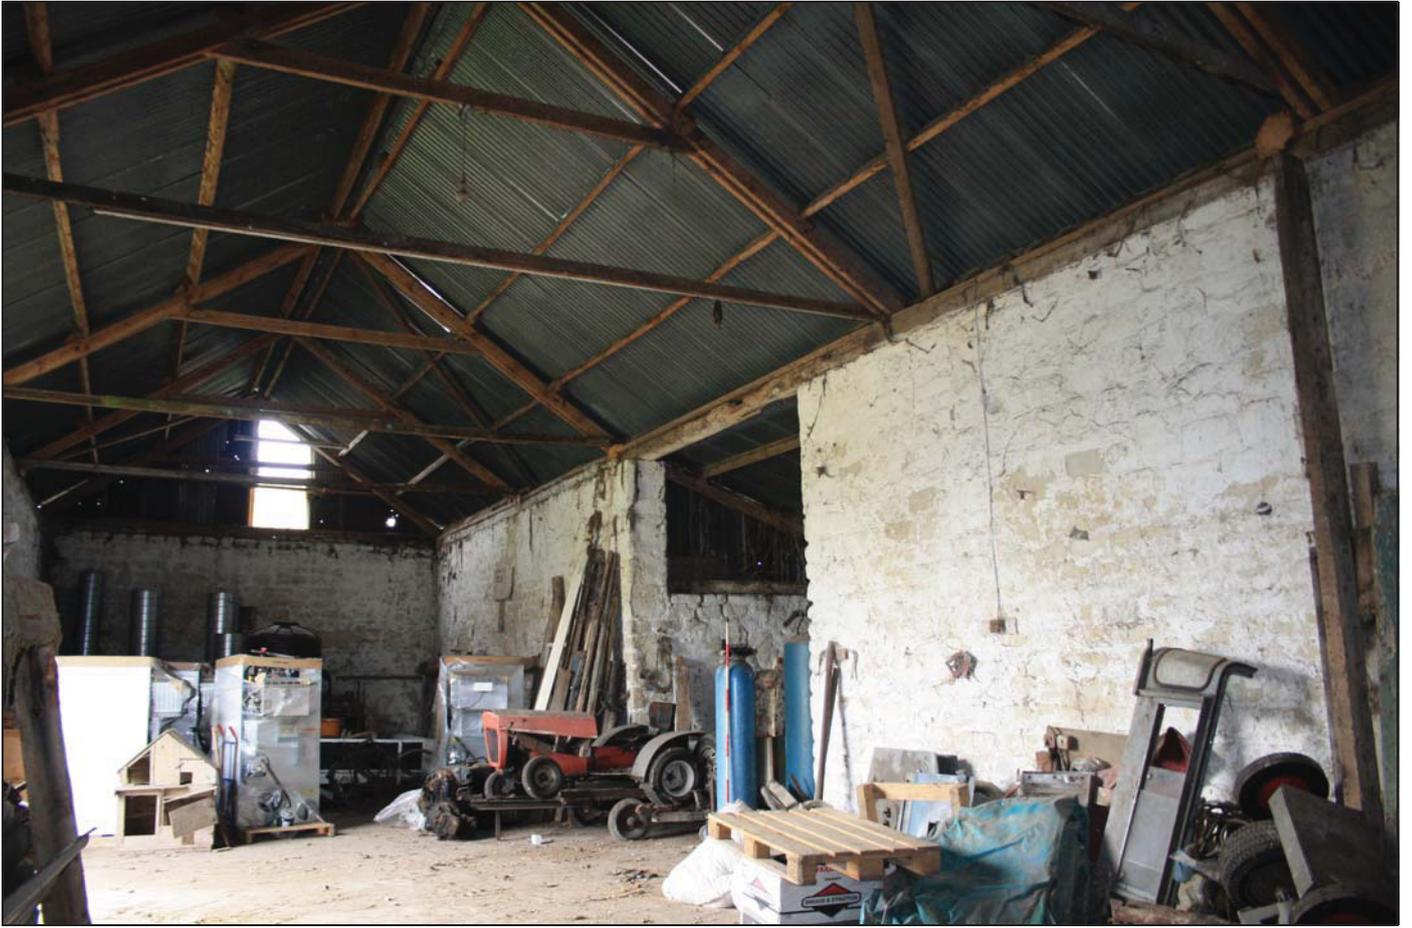
Plate 17 Interior of the barn (west side) showing position of porch, taken from the north-east
