ARCHAEOLOGICAL SOLUTIONS LTD

BARN ON LAND BETWEEN 64 & 76 LOW ROAD  
BURWELL, CAMBRIDGESHIRE

HISTORIC BUILDING RECORDING

Authors:	Tansy Collins BSc (historic building appraisal) Lee Prosser PhD (historic building appraisal) Peter Thompson MA (research) Kathren Henry (graphics)	
NGR: TL 5850 6699		Report No: 4291
District: East Cambridgeshire		Site Code: AS 1579
Approved: Claire Halpin MIFA		Project No: 4496
Signed:		Date: March 2013

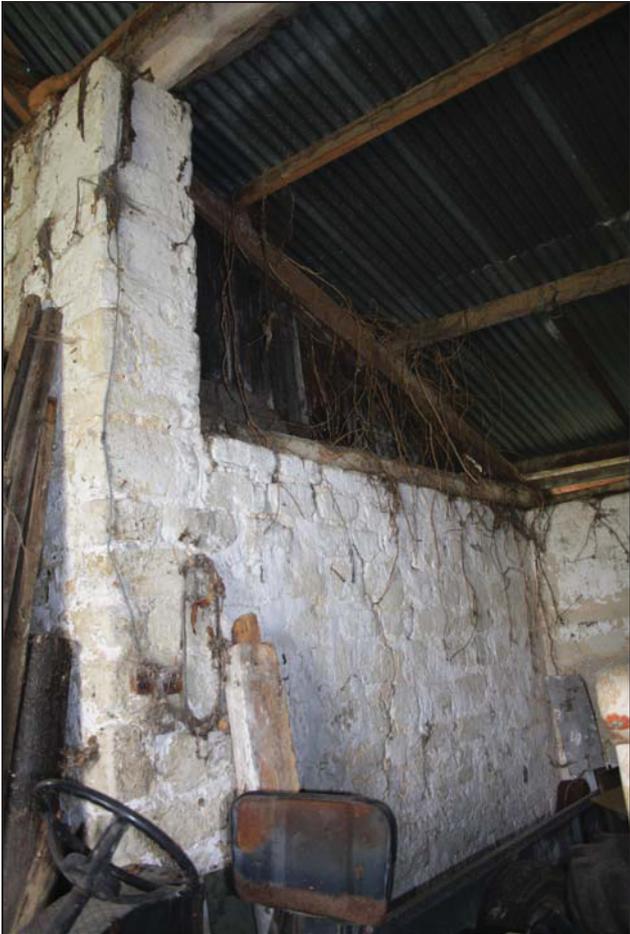
Plate 18 South wall of the porch, taken from the north-east

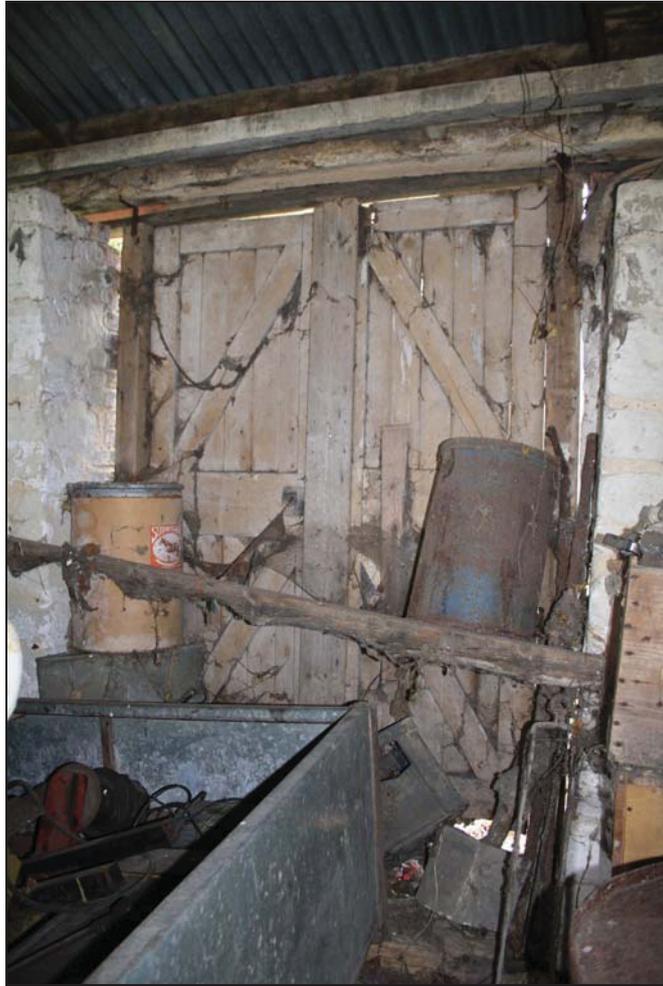
Plate 19 West wall of the porch showing the 20th century boarded doors, taken from the east

5.10 The interior of the barn is floored in cement throughout, while the original external walls have been left exposed and only white-washed. Internally, the stone coursing is as well-handled as the exterior (Plates 15 and 16). The original aperture on the west is dressed with good stonework which continues into the porch structure, confirming the porch as contemporary (Plates 17 and 18) but with replacement boarded doors on the west (Plate 19). Much of the original pinkish lime mortar survives.

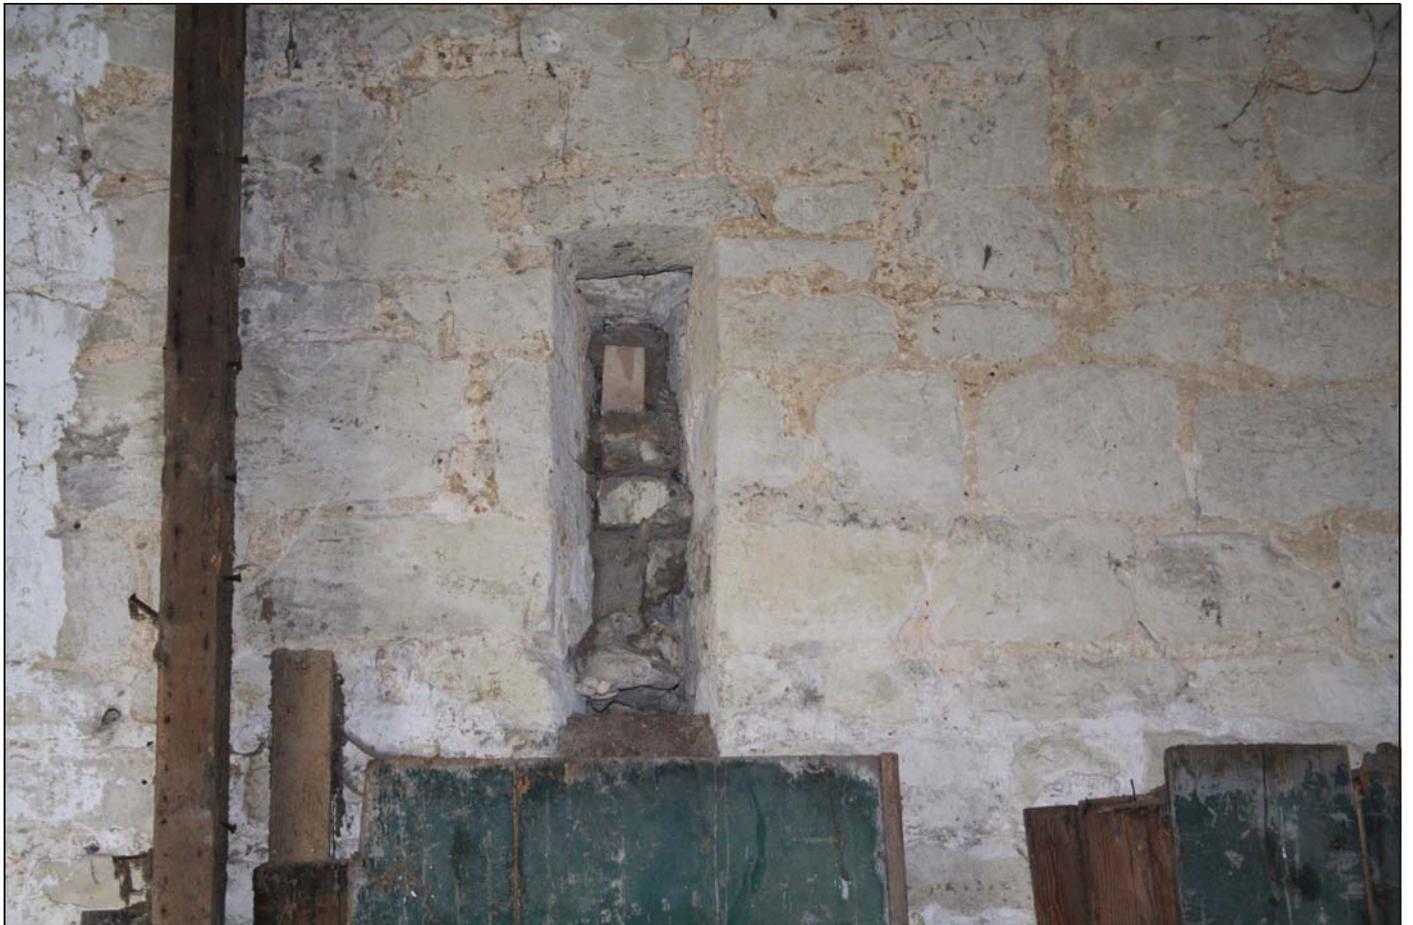
Plate 20 Blocked ventilation slit on the west side of the barn (Bay 1), taken from the east

5.11 The ventilation slits all round are blocked from the exterior and so remain well expressed on the internal face. Two of the three on the west are well-preserved, as well as one on the south (Plates 20 and 21), while a further possible example is visible at the north end below the inserted window (Plate 22).

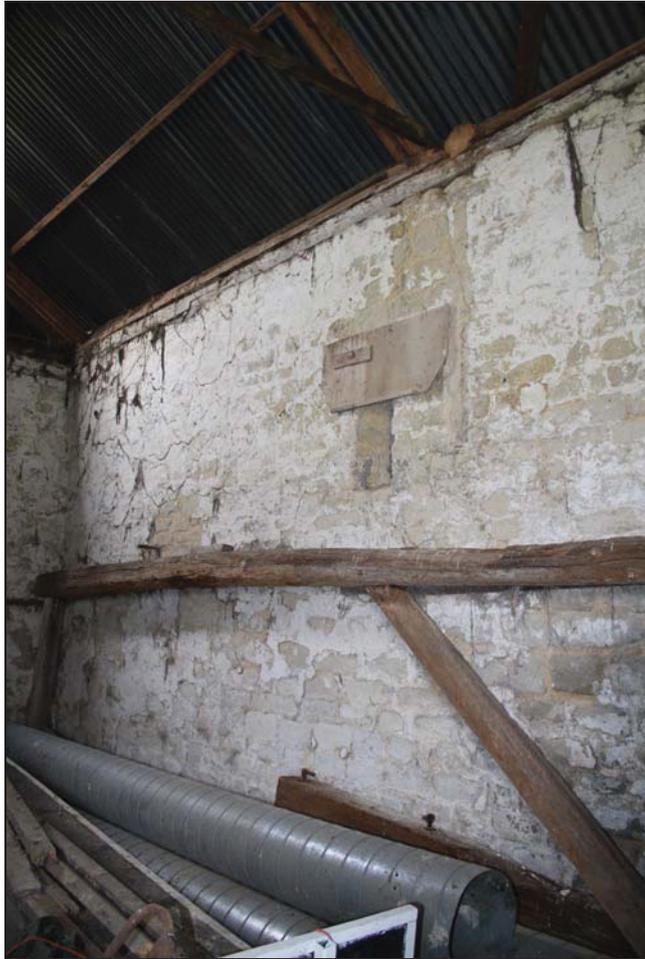
Plate 21 West wall of the barn (south end), taken from the north-east

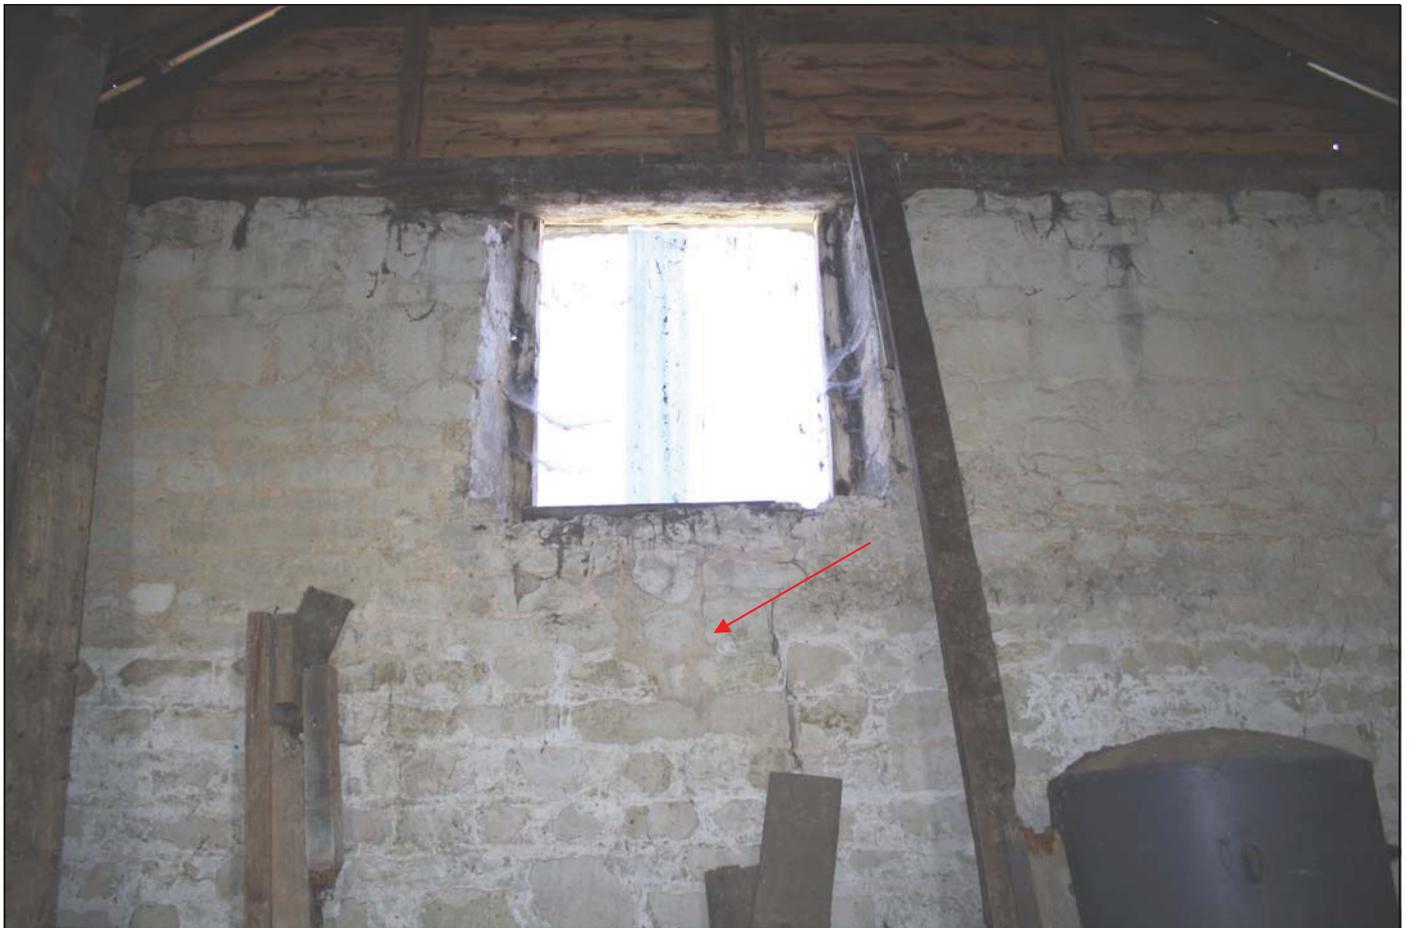
Plate 22 Inserted window at the north end of the barn with original blocked ventilation slit below (indicted), taken from the south

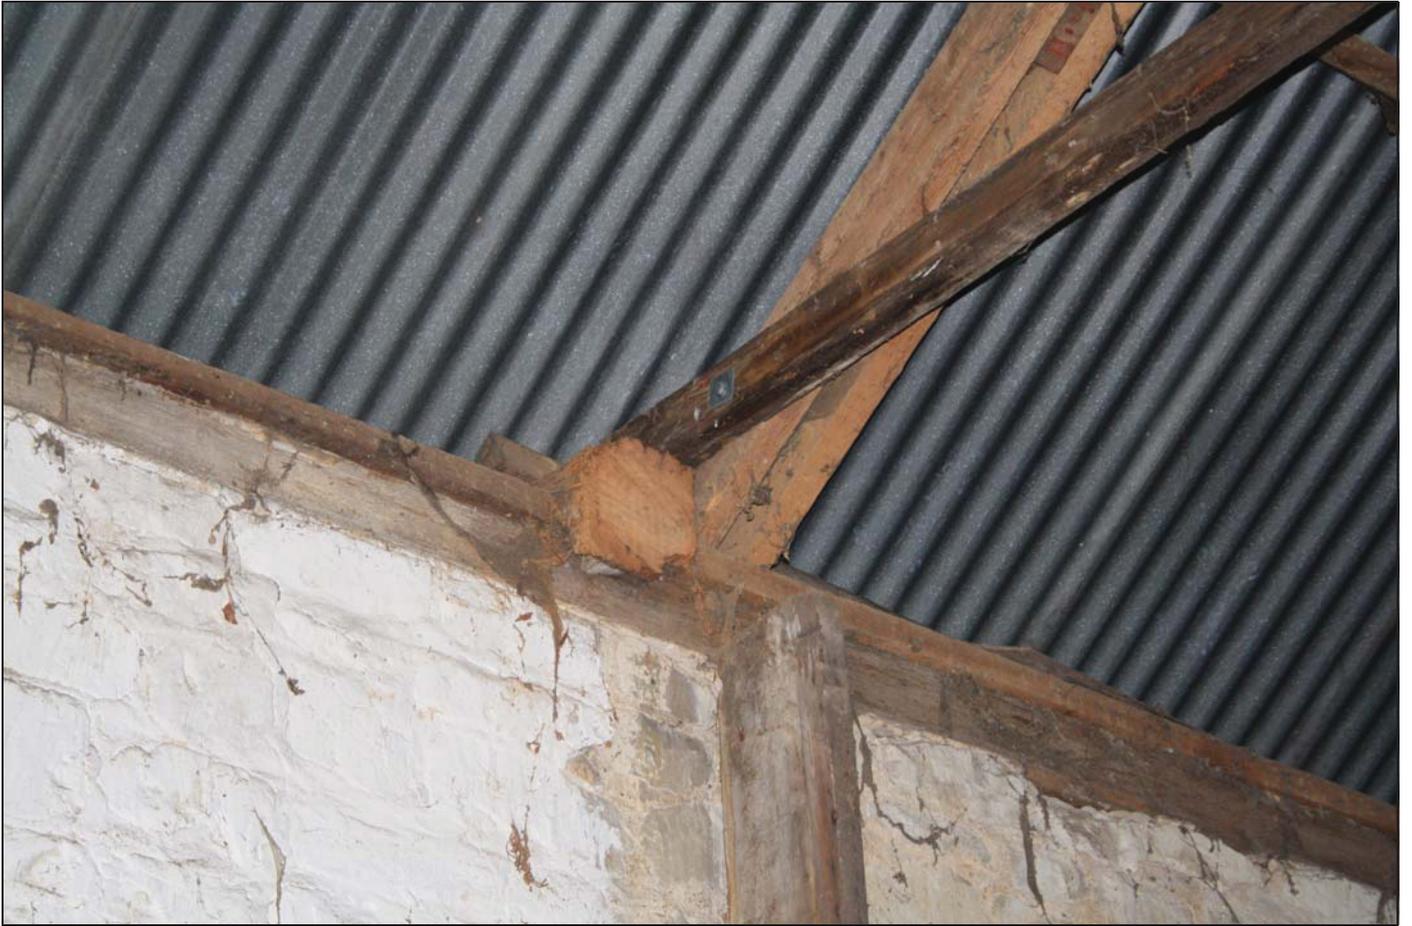
Plate 23 West side of the barn at roof level showing surviving wall plate and truncated tie-beam stump, taken from the south-east

5.12 As the building is stone-built, little structural carpentry survives, apart from the wall-plates and truncated stumps of the tie-beams (Plate 23). A number of edge-halved scarf joints are visible in the wall-plate (Plate 24) but further characteristics are not visible.

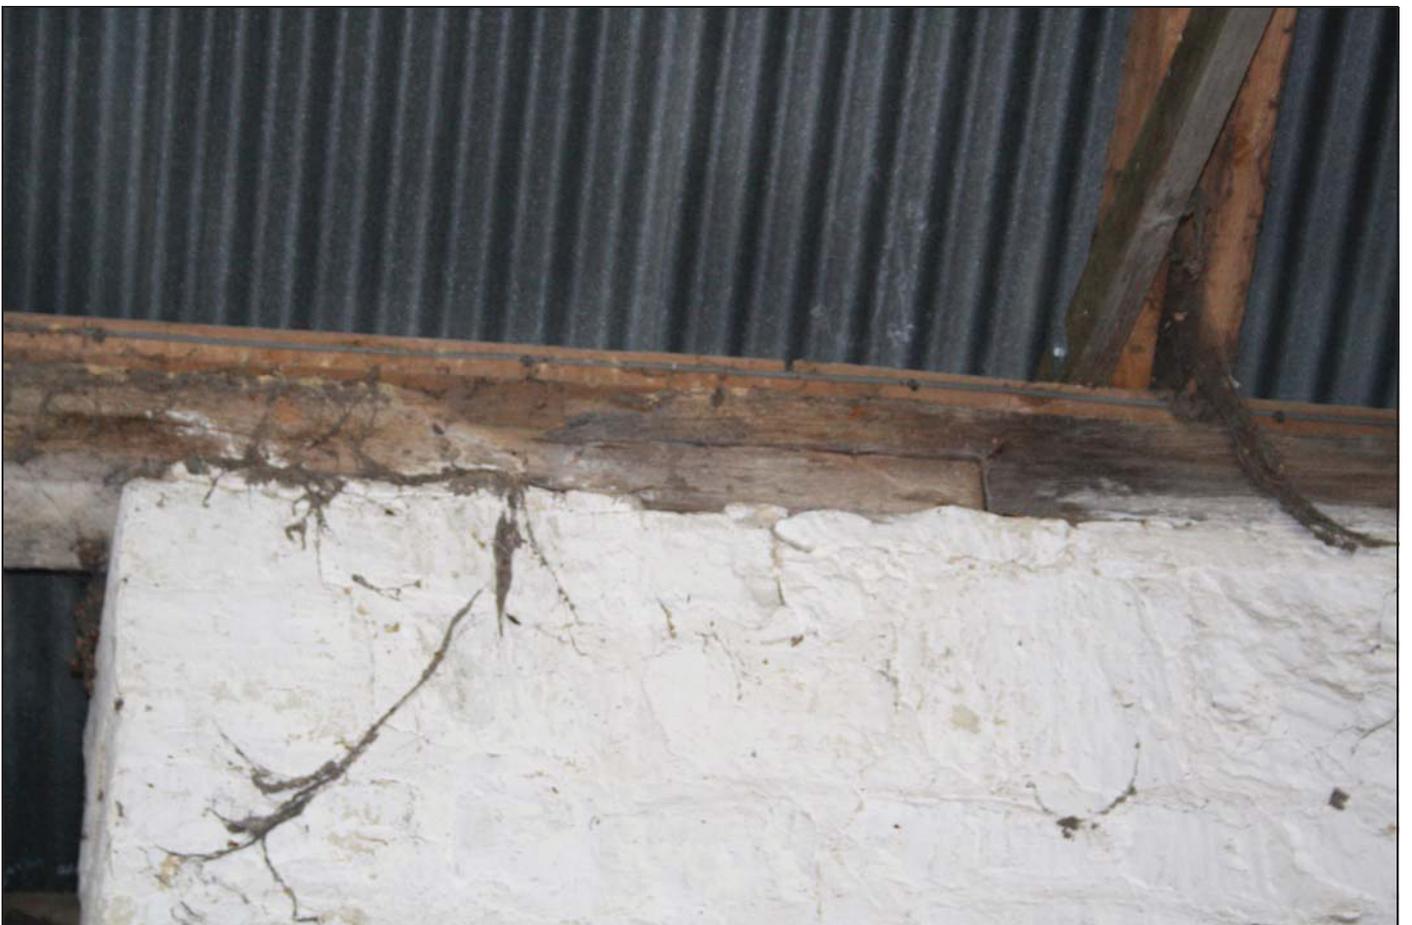
Plate 24 Edge-halved scarf joint in the west wall-plate, taken from the east

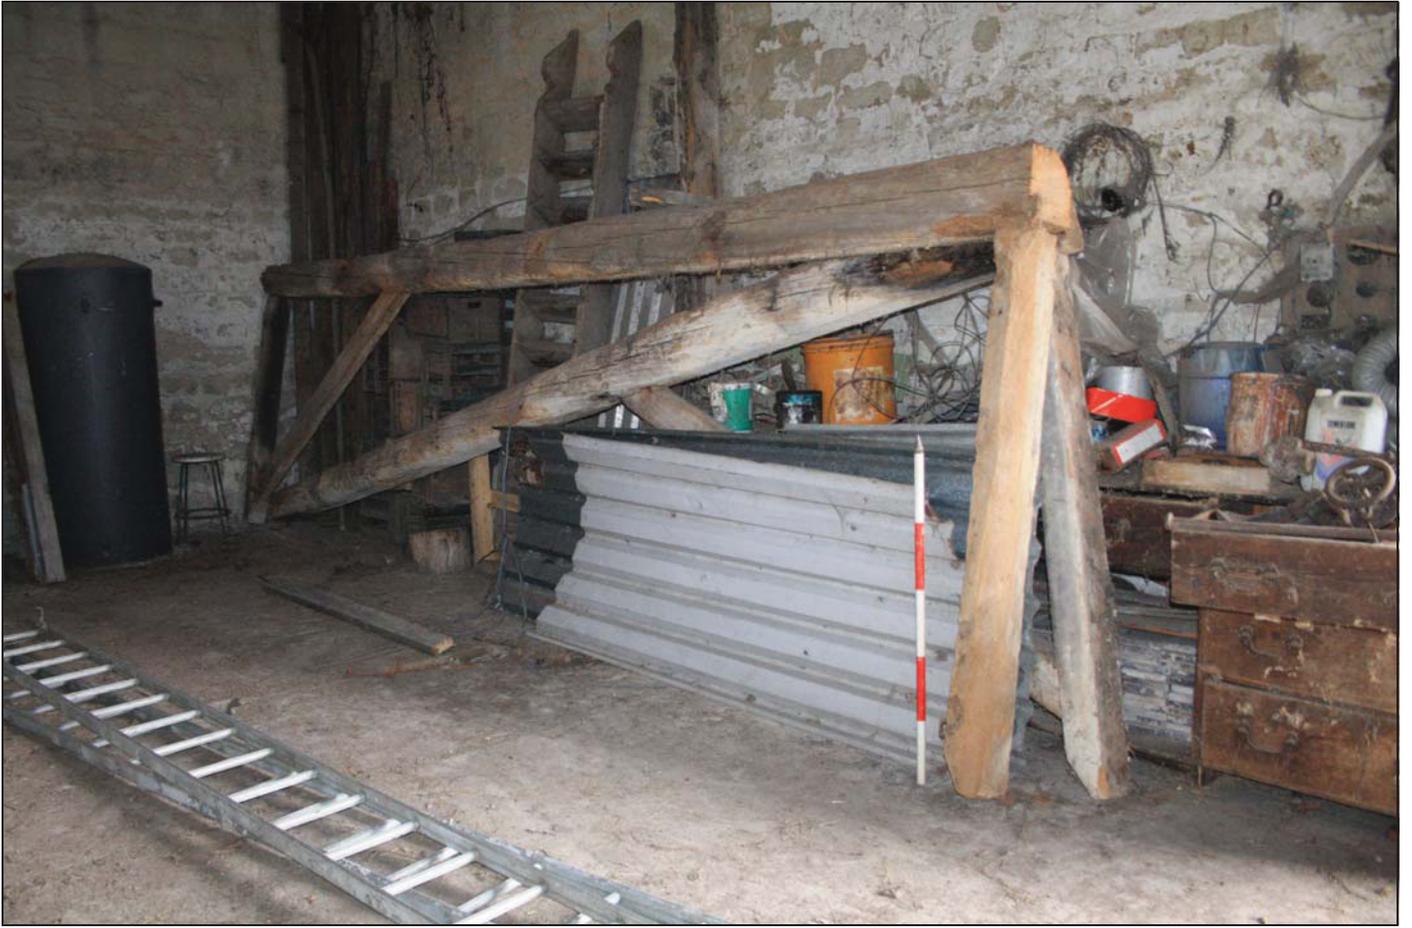
Plate 25 Two ex-situ roof trusses, taken from the south

5.13 Lying *ex-situ* within the barn, several of the original tie-beams and their associated braces survive (Plates 25 and 26). Other elements like rafters may also be present amid various piles of lumber stored in the building but could not be identified with the same certainty. The timber appears to be entirely of oak and where seen in cross-section, is fairly slow-grown. The original truss arrangement is clear, and

included tie-beams with short pendant outer posts, from which slender, curved braces sprang. Normally, such posts would stand on corbels, but there is no evidence for this, and instead it is likely that they were held in compression by simple triangulation of the timber and so needed no additional support. The timbers were all pegged, and additionally supported by a strap and staple threaded through the tie-beam. There is no evidence in the upper face of the tie-beams to indicate the presence of any king- or queen-posts.

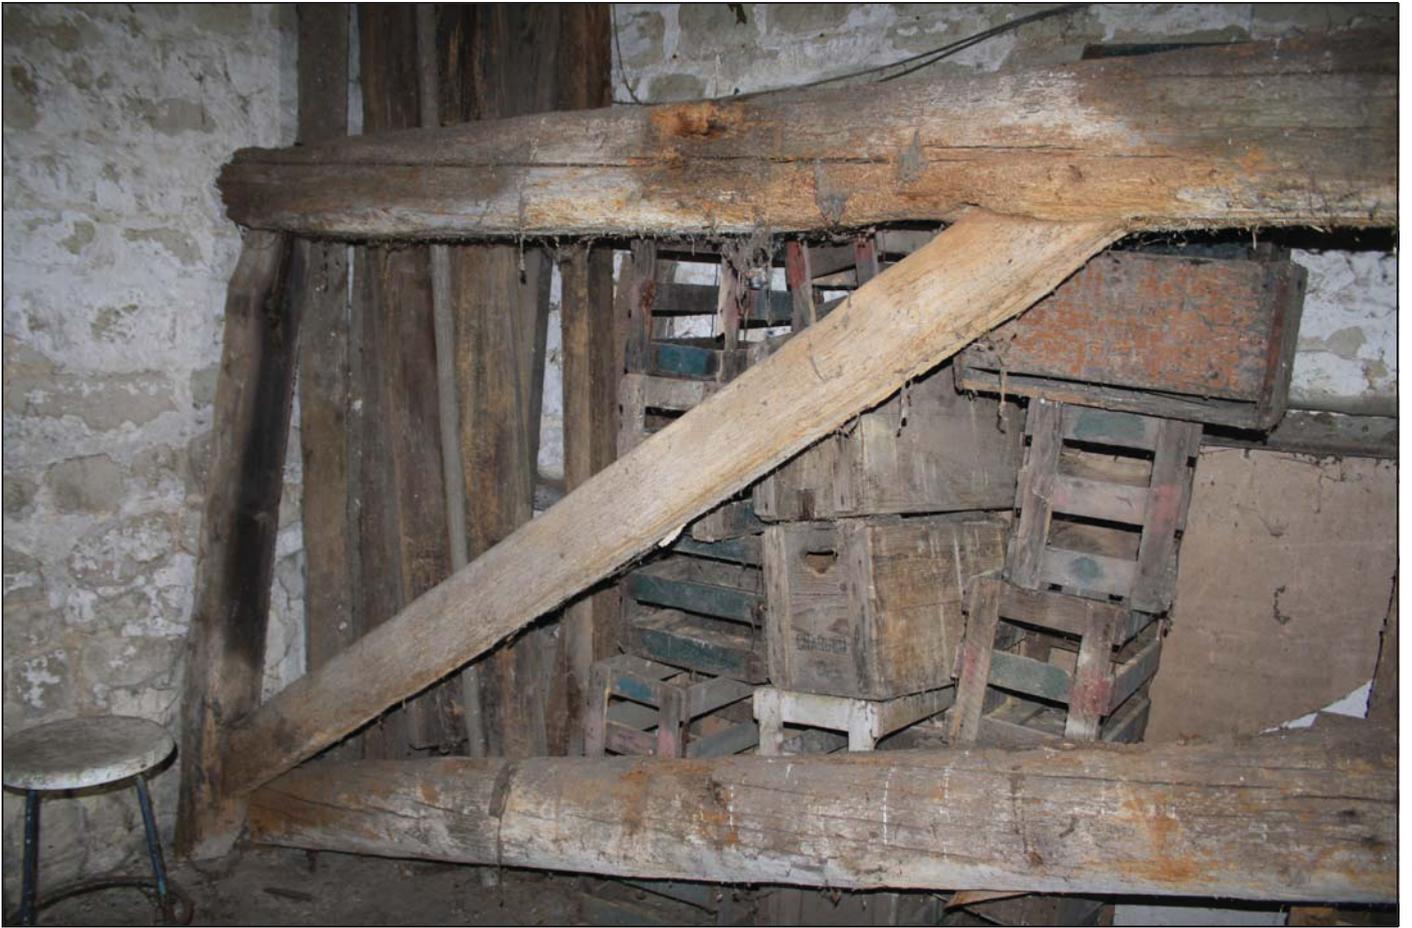
Plate 26 End of an ex-situ truss showing the earlier roof construction including tie-beam, post and brace, taken from the west

Tie-beam	8" x 8" (203mm x 203mm)
Wall-post	5" x 6" (127mm x 152mm)
Brace	6" x 3" (152mm x 76mm)

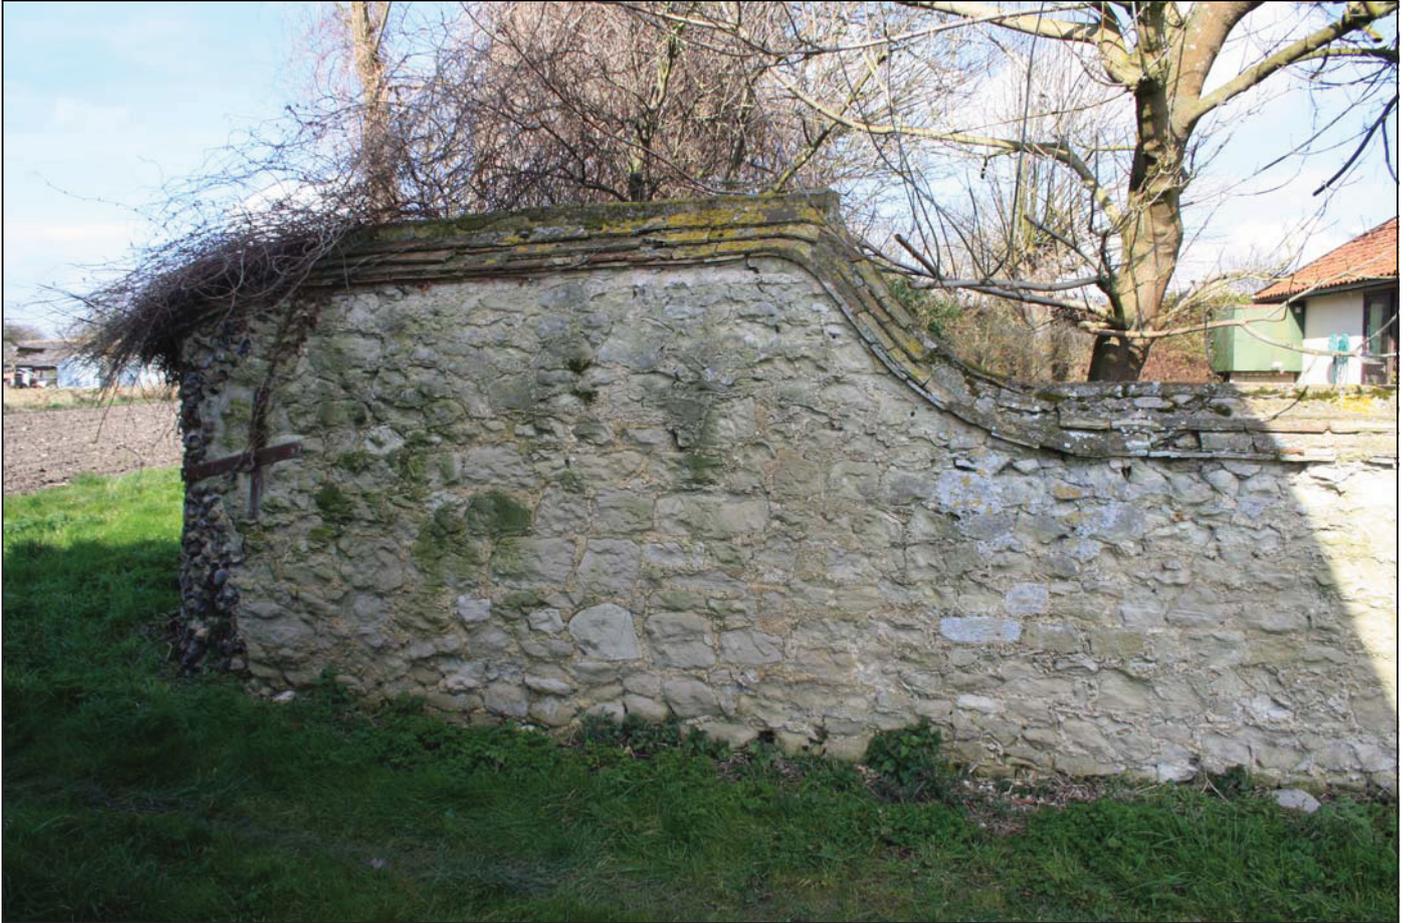
Plate 27

Retaining boundary wall of slightly varying construction to the barn enclosing The Poplars, taken from the south
