# ARCHAEOLOGICAL SOLUTIONS LTD

# ELIZABETH HOUSE, 28-30 BADDOW ROAD, CHELMSFORD, ESSEX

# **ARCHAEOLOGICAL MONITORING & RECORDING**

Authors:	Sam Egan (fieldwork & report) Peter Thompson (preparative research) Antony RR Mustchin (Editor)		
Illustrations:	Charlotte Davies		
NGR: TL 7104 0639		Report No: 4342	
District: Chelmsford		Site Code: CF73	
Approved: C	laire Halpin MIfA	Project No: 5304	
Signed:		Date: 28/06/2013 Revised: 15/07/2013

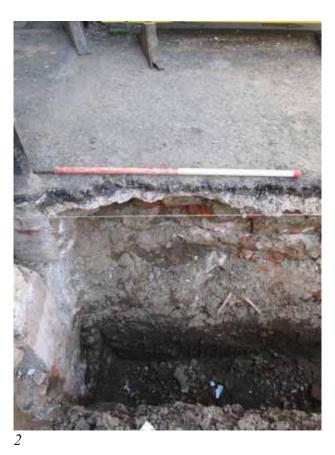
Sample Section 1

Sample section 1	1	
West foundation trench, facing east-south-east		
0.00 = 33.12m  AOD		
0.00 – 0.07m	L1000	Tarmac. Surface of pavement.
0.07 – 0.12m	L1001	Concrete. Basal layer for L1000.
0.12 – 0.33m	L1002	Made ground. Light brownish grey, loose, silty sand and
		CBM rubble.
0.33 – 0.68m	L1003	Made ground. Light brownish grey, loose, silty sand.
0.68 – 0.78m	L1004	Made ground. Light grey, loose, sand with frequent
		CBM (roof tiles) fragments.
0.78m+	L1005	Made ground. Dark grey, compact, clayey silt.

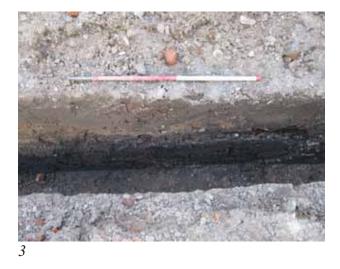
Sample Section 2

Sample section 2 0.00 = 33.56m A0		
0.00 – 0.m	L1000	Tarmac. Car park.
0. – 0.m	L1002	Modern Made Ground. Building demolition debris with
		frequent brick, tile and rubble.
0.m+	L1006	Natural Clay. Dark bluish grey, compact, clay with
		occasional chalk flecks
