'BREWHOUSE' AT
ST OSYTH'S PRIORY, ST OSYTH, ESSEX

HISTORIC BUILDING RECORDING AND
ARCHAEOLOGICAL MONITORING AND RECORDING

Authors:	Tansy Collins BSc Kathren Henry Amy Goldsmith Melissa Wotherspoon	
NGR: TM 1210 1570		Report No. 4401
District: Tendring		Site Code:
Approved: C. Halpin MIfA		Project No. 5356
Signed:		Date: 30 August 2013

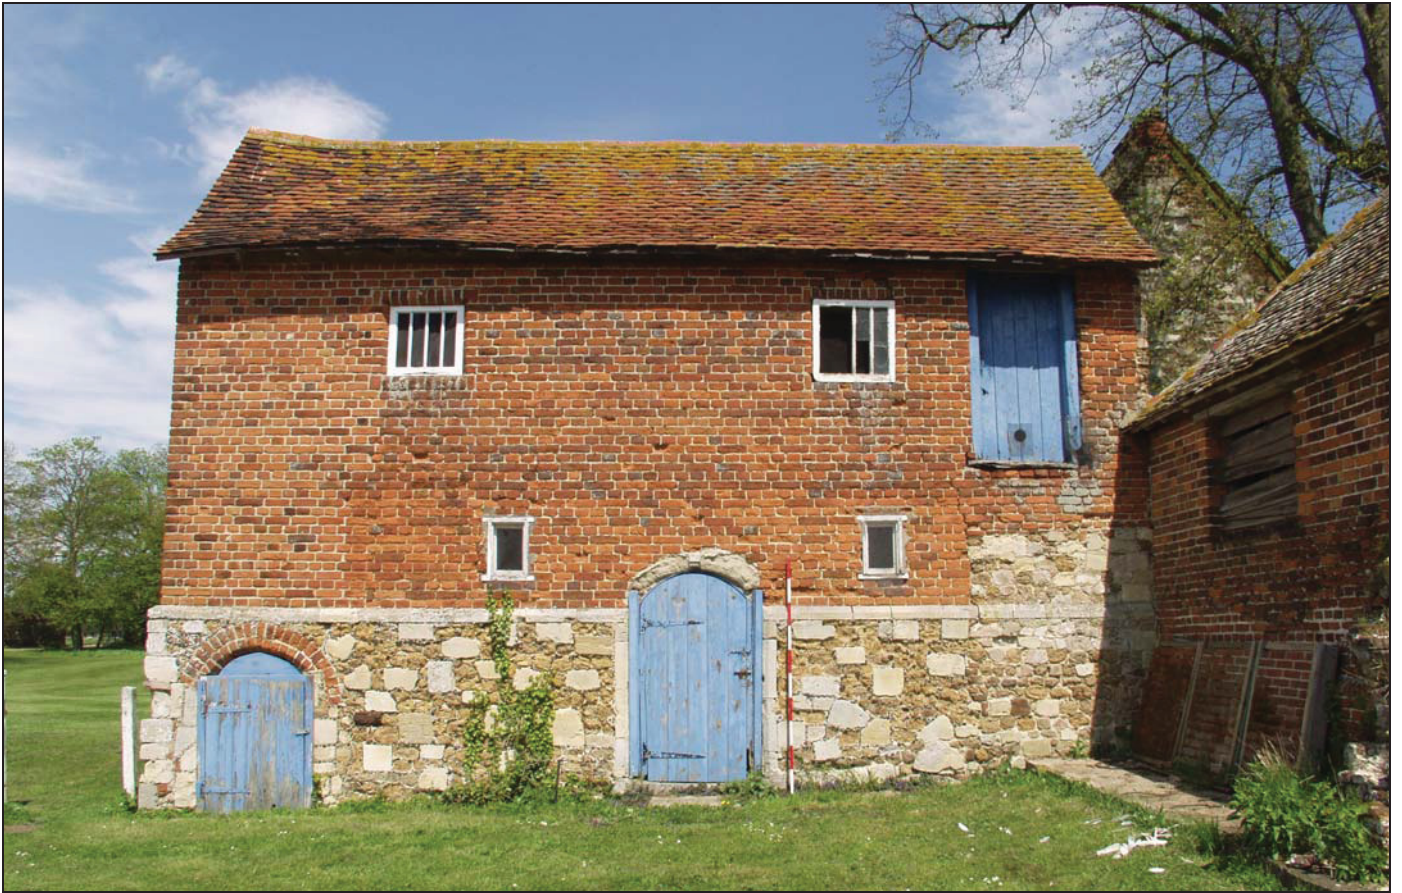
Plate 1 South elevation of the assessment structure, taken from the south (DP06)

5.3 The south façade (Plate 1) has a central doorway with a round-arched stone head with keystone, now supported by an iron band. The limestone jambs are chamfered with simple stops at their bases. The door which is boarded and ledged is a later replacement and pintles remain within the opening for an earlier door. On either side of the doorway is a small inserted window, each comprising a single side-hung light. To the east is an area of differing stonework comprising coursed limestone and septaria rubble with occasional flint, brick and tile. This may comprise an area of rebuilding or infilling of an earlier aperture.

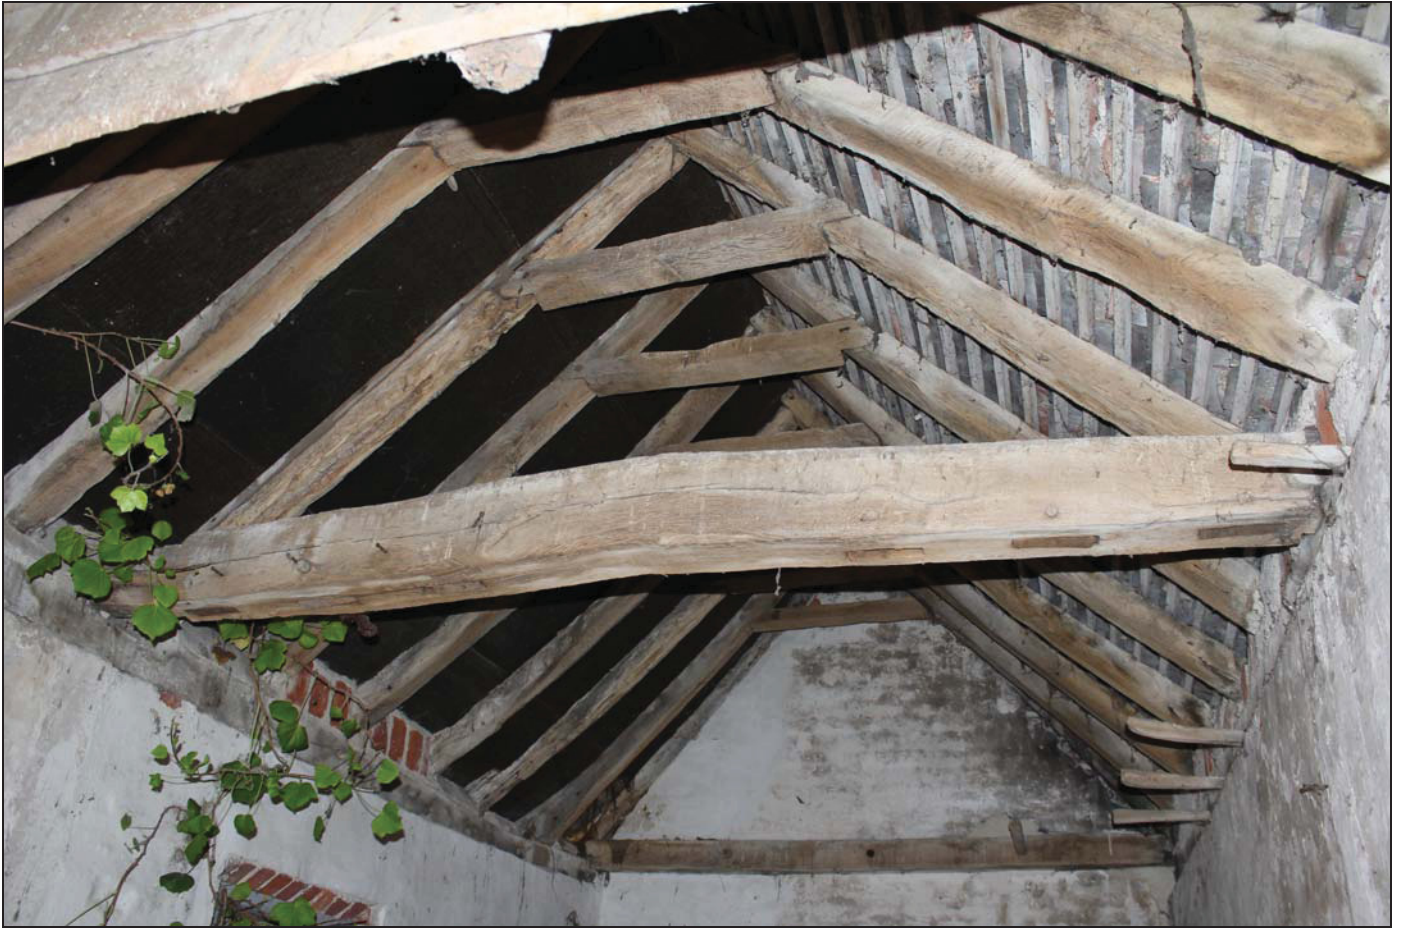
Plate 8 Roof structure over Room FF01, taken from the east (DP39)

5.21 Later alterations are represented by those noted above such as the reconstruction of the east end wall and the inserted window, as well as the addition of a secondary pole tie at the east end. There is also a later rudimentary boarded partition in the centre above tie-beam level.

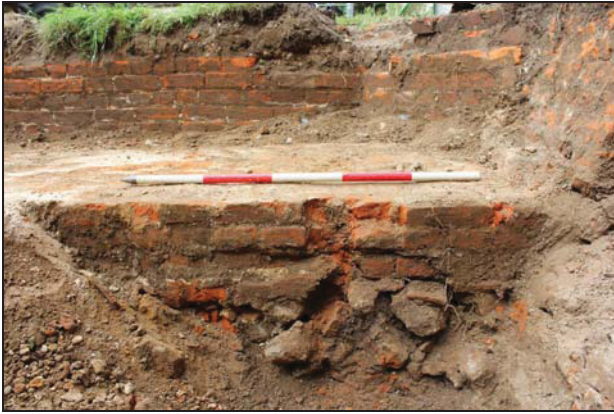
DP 61

6.1.2 Description: Walls M1004 and M1005 were recorded within the area of ground reduction. A possible ephemeral foundation cut was encountered at the lowest level of ground reduction at the base of Wall M1005.

North-east area of ground reduction exposing M1004 and M1005 with foundation layer L1006 at the base, taken from the south
