**ALL SAINTS CHURCH, NEWMARKET ROAD,
KIRTLING, CAMBRIDGESHIRE**

ARCHAEOLOGICAL MONITORING AND RECORDING

CHER ECB3702

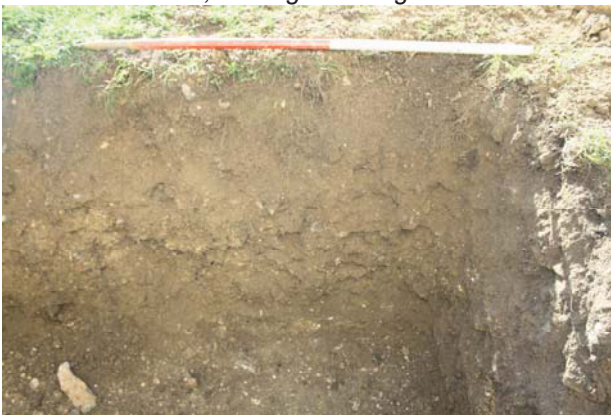
| <i>Sample Section 1 (DP 3)</i> <i>North facing.</i> <i>0.00m = 100.43m AOD</i> | | |
| L1000 | 0.00- 0.44m | Topsoil. Friable mid greyish brown sandy silt. |
| L1001 | 0.44- 0.97m+ | Subsoil. Friable mid yellowish brown sandy silt. |

3
Sample section 1. Looking south.

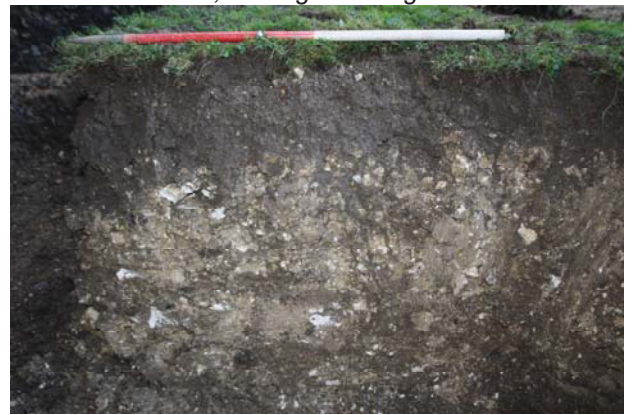
| <i>Sample Section 2 (DP 4)</i> <i>East facing.</i> <i>0.00 = 100.53m AOD</i> | | |
| L1000 | 0.00-0.36m | Topsoil. As above. |
| L1002 | 0.36- 1.06m+ | Graveyard soil. Firm mid yellowish brown silty clay. |

4
Sample section 2. Looking west.

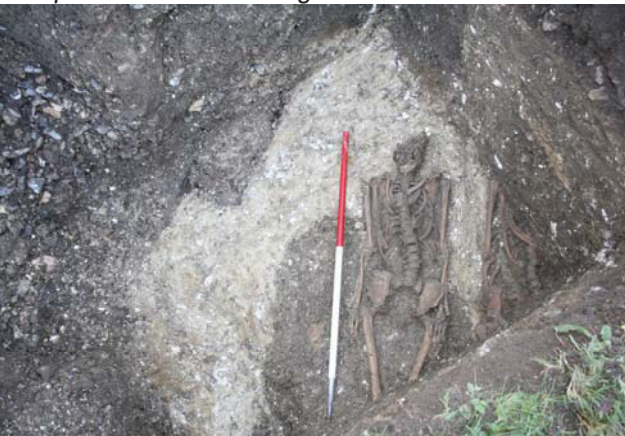
Grave F1004 (Fig. 3, DP 5) was rectangular in plan, orientated east/west. Only a small portion of the grave was located within the excavated area, making it impossible to record the feature's dimensions. It contained an articulated skeleton, Skeleton 2, and backfill layer L1005. The latter was a firm, dark yellowish brown, silty clay with frequent chalk and small rounded flint pebble inclusions. Skeleton 2 was not fully exposed within the excavation area and the majority of the skeleton remained *in situ*, undisturbed by the groundworks. The right half of the pelvis, the lumbar and some thoracic vertebrae, part of the right side of the rib cage and the right arm and hand were recorded and lifted. It was fully articulated and aligned east/west with its head to the west. The individual was buried in an extended supine position. Arms and hands were extended beside the body. Bone preservation was generally good, although the ribs were very fragile. The grave contained no grave goods and there was no indication of a coffin or grave furniture. The backfill contained no datable finds.

Grave F1006 (Fig. 3, DP 5) was rectangular in plan, 0.47m in width and orientated east/west. The western part (1.09m) lay within the excavation area. It had vertical sides and a flat base. F1006 contained an articulated skeleton, Skeleton 3, and backfill layer L1007. The latter was a firm, dark yellowish brown, clay silt with frequent chalk and small rounded flint pebbles. Skeleton 2 was not fully exposed within the excavation area and the lower legs and feet remained *in situ*, undisturbed by the groundworks. The upper body, pelvis and femurs were recorded and lifted. It was fully articulated and aligned east/west, with its head to the west. The individual was buried in an extended supine position. The arms and hands were extended beside the body and the legs were also extended. Bone preservation was generally good, although the ribs were very fragile. The grave contained no grave goods and there was no indication of a coffin or grave furniture. The backfill contained no dateable finds.

5
SK2 (F1004) and SK3 (F1006). Looking west.

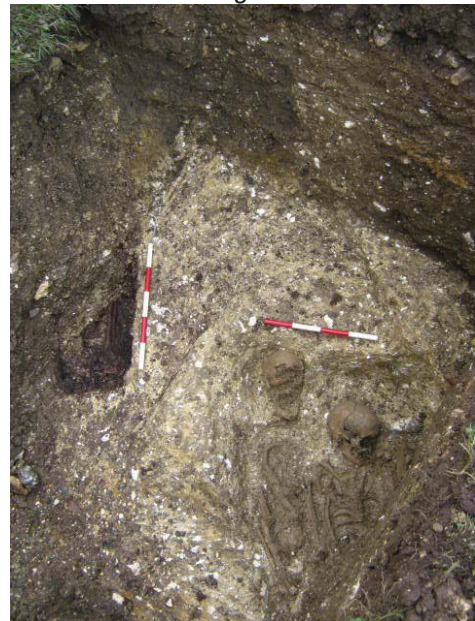
Grave F1008 (Fig. 3, DP 6) was rectangular in plan, 0.43m in width, and orientated east/west. The western part (0.73m) lay within the excavation area. It had vertical sides and a flat base. F1008 contained an articulated skeleton, Skeleton 4, and backfill layer L1009. The latter was a firm dark yellowish brown clay silt with lenses of re-deposited clay natural throughout and frequent chalk and small flint pebbles. Skeleton 4 was not fully exposed within the excavation area; the skull, upper torso and both humeri were recorded and lifted, the remainder of the skeleton remained *in situ*, undisturbed by the groundworks. Skeleton 4 was fully articulated and aligned east/west with the head at the west. The individual was buried in an extended supine position. The arms were extended beside the body. Bone preservation was poor. The cranium remained mostly intact, although the mandible was damaged and there were no teeth present. The grave contained no grave goods and there was no indication of a coffin or of grave furniture. The backfill contained no dateable finds. Grave F1008

cut and truncated Grave 1010.

Grave F1010 (Fig. 3, DP 6) was rectangular in plan with a projection at the western end surrounding the head of the skeleton. It was orientated east/west. Grave F1010 was truncated on its north side by Grave F1008 and only the western segment (0.85m) lay within the excavation area. It had vertical sides and a flat base, except at the western end, where an area of the grave had been left slightly high, providing a "pillow" for the deceased. F1010 contained an articulated skeleton, Skeleton 5, and backfill layer L1011. The latter was a firm dark yellowish brown clay silt with lenses of re-deposited natural clay throughout and frequent chalk and small flint pebbles. Skeleton 5 was not fully exposed within the excavation area and was heavily truncated by Grave F1008. Only the skull and the right half of the upper torso could be recorded and lifted. What remained of Skeleton 5 was fully articulated and aligned east/west with the head at the west. The individual was buried in an extended supine position. The arms were extended beside the body. Bone preservation was very poor, especially the ribs and vertebrae which were spongy and friable. The cranium was largely well preserved. The cranial sutures had not fused indicating that the individual was a young adult. The grave contained no grave goods and there was no indication of a coffin or of grave furniture. The backfill contained no dateable finds.

Grave F1012 (Fig. 3, DP 6) was rectangular in plan, 0.33m in width and orientated east-west. The eastern segment (0.68m) of the cut lay within the excavation area. It had vertical sides and a flat base. F1012 contained an articulated skeleton, Skeleton 6, a dark soil stain, L1013, and a backfill layer L1014. The latter was a loose, dark yellowish brown, clay silt with lenses of re-deposited natural clay throughout and frequent chalk and small flint pebbles. Skeleton 6 was not fully exposed within the excavation area and the majority of the skeleton remained *in situ*, unaffected by the groundworks. The left tibia and fibula and both feet were recorded and lifted. Both legs were extended and in positions consistent with an extended supine burial. Soil stain L1013 was a friable dark reddish brown silty organic deposit formed by the decomposition of the coffin for Skeleton 6. The coffin was lined on the interior sides and base by a thin layer of bitumen, which remained in place after the coffin had degraded. The backfill contained no dateable finds.

6
SK4 (F1008), SK5 (F1010) & SK6 (F1012). Looking west.
