**ROBIN HOOD PUBLIC HOUSE, 63 HIGH STREET,
WALKERN, HERTFORDSHIRE SG2 7NT**

HISTORIC BUILDING MONITORING AND RECORDING

HER Enquiry No: 91/12

MONITORING OF HISTORIC BUILDING ALTERATIONS

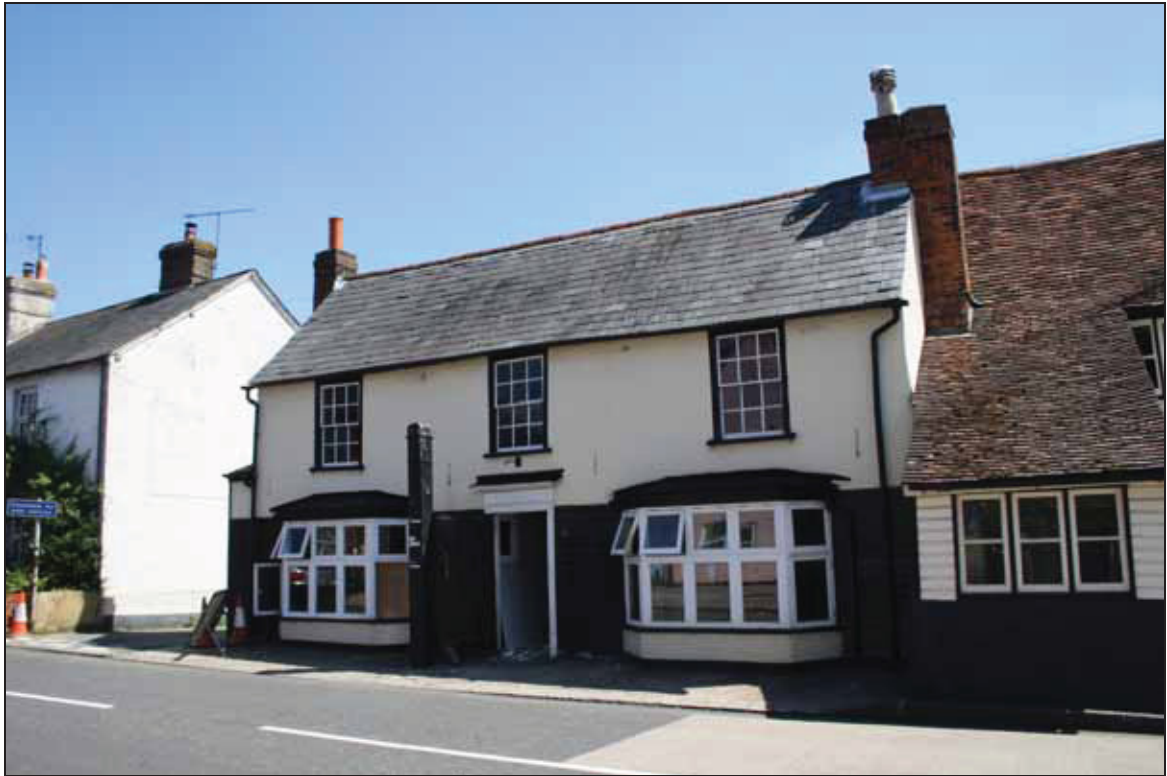
Plate 1 West elevation fronting the High Street, taken from the west (DP 7)

5.1 The assessment structure comprises a three-bay range aligned north to south, with the principal west façade fronting directly onto the High Street (Plate 1). It has mixed weatherboarding and render over a timber frame, rising to a pitched roof covered with slate on the west but simple peg-tiles on the east, rear elevation. Brick chimney stacks lie at the north and south ends, to the south this is integral to the building, but the north stack projects in the conventional manner.

5.3 The principal street frontage is of three equal bays with modern weatherboarding at ground floor level and painted render at first floor level. A central entrance is flanked by two bay windows, the latter with modern casements and low hipped roofs covered in asphalt. The doorway is set in a moulded surround with a hood, though the door itself is modern. Three double-hung six-over-six sash windows light the upper floor, all without horns and set in moulded surrounds with little timber sills. These abut the eaves, which overhang slightly but are otherwise unadorned.

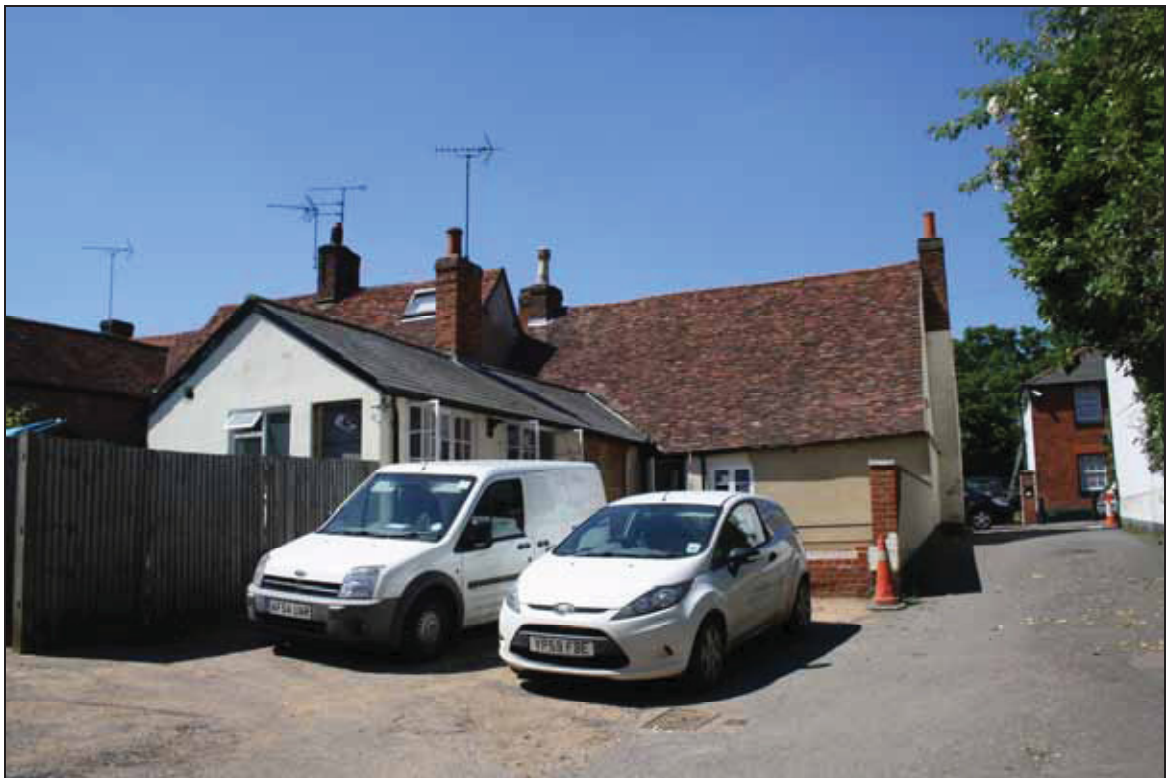
Plate 2 View of the assessment structure after the removal of the north-east range, taken from the east (DP 13)

5.2 The rear side has a continuous outshut with a single-storey range extending to the east at the south end, while a second rear range formerly lay to the north but has recently been demolished and the area made good in modern materials at the junction with the outshut (Plate 2). The lost unit comprised a service range with WCs and stores.

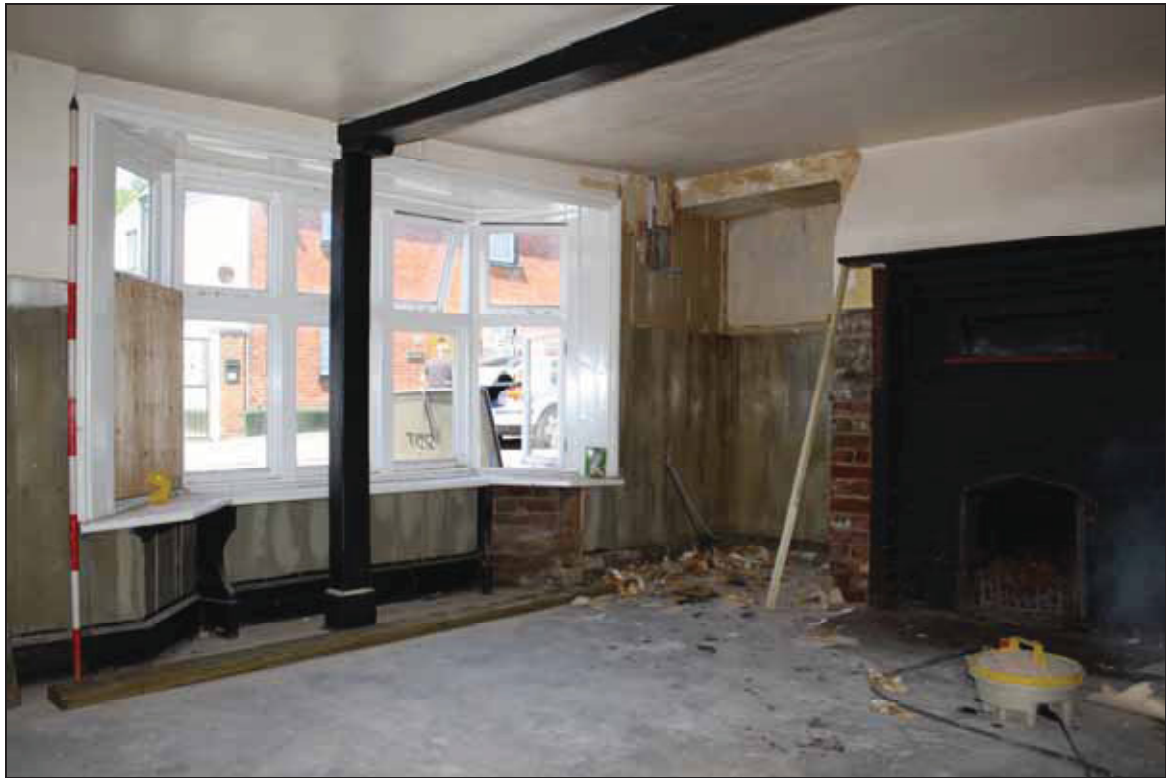
Plate 3 North end of Room GF01, taken from the south-east (DP 19)

5.10 The floor throughout is covered with a mix of modern screed cement with an area of thin tiling to the south. In the northern space where these have been removed some parquet floor is exposed, perhaps from the earlier part of the 20th century. The east and south walls in this area have been recently covered with the modern dado boarding, but otherwise an earlier dado is visible. This comprises match-lined vertical boarding with upper painted plasterwork over lath and plaster which is attached to the timber-frame. The dado extends within the apron of the bay window which, with presence of a moulded surround confirms that the bay windows are at least early 20th century, despite the presence of the modern casements (Plate 3). The chimney breast on the north is constructed of brick, which is partially exposed but mostly painted and in fairly poor condition. A brick and tile 1950s or later surround and hearth are defined by an area of slender bricks or pampments set in a herringbone pattern. In this area the cosmetic timber-work includes a post, set within the area of the bay window with a binding joist above. The east wall was

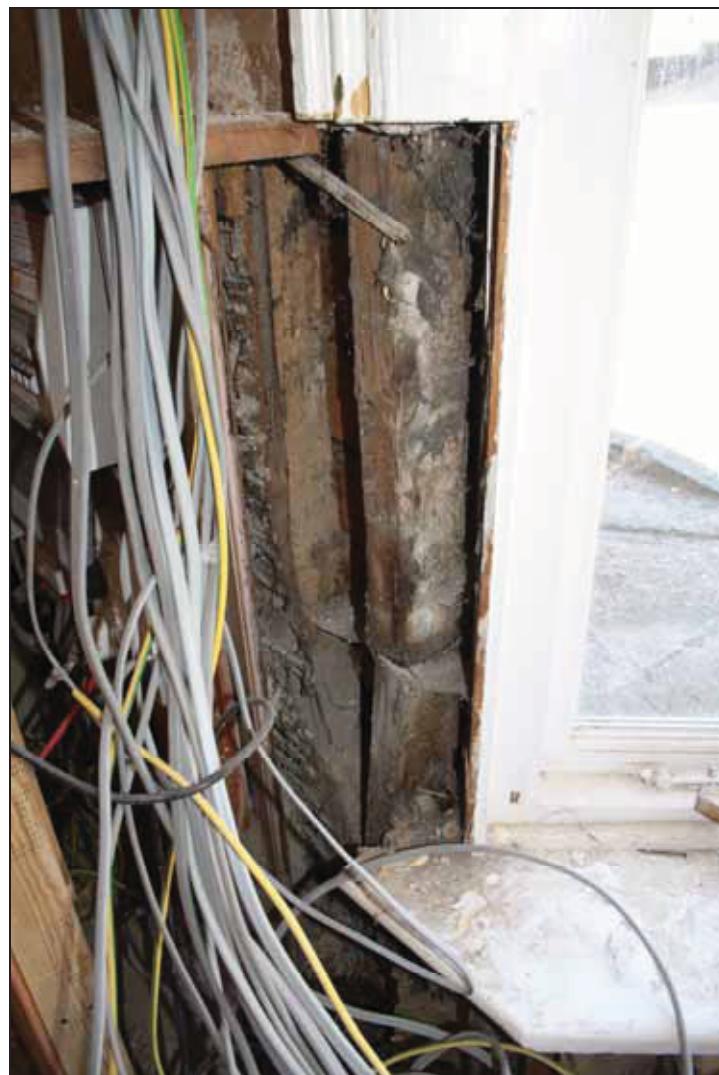
Plate 4 Detail of the primary-braced timber-framing on the west wall of Room GF01 adjoining the south window, taken from the east (DP 18)

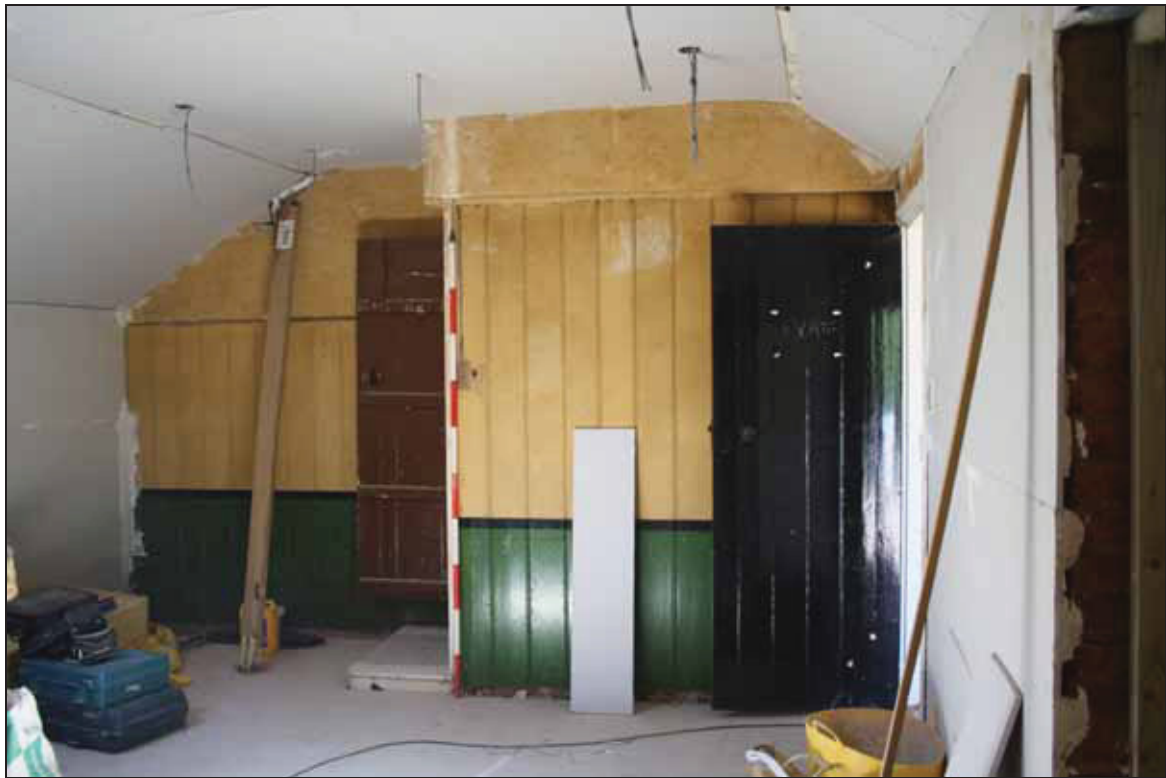
Plate 5 West end of the south-east range (Room GF02) showing staircase and match-lined boarding to the main range, taken from the east (DP 26)

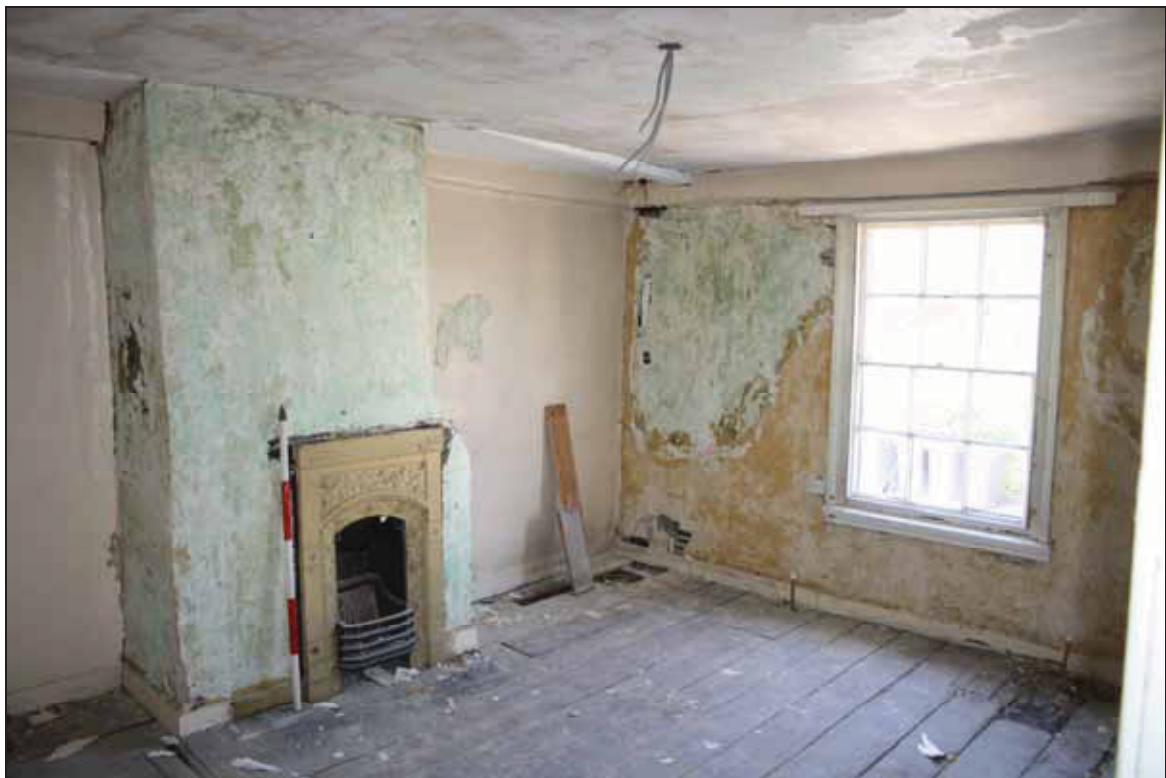
Plate 6 Room FF03, taken from the north-east (DP 35)

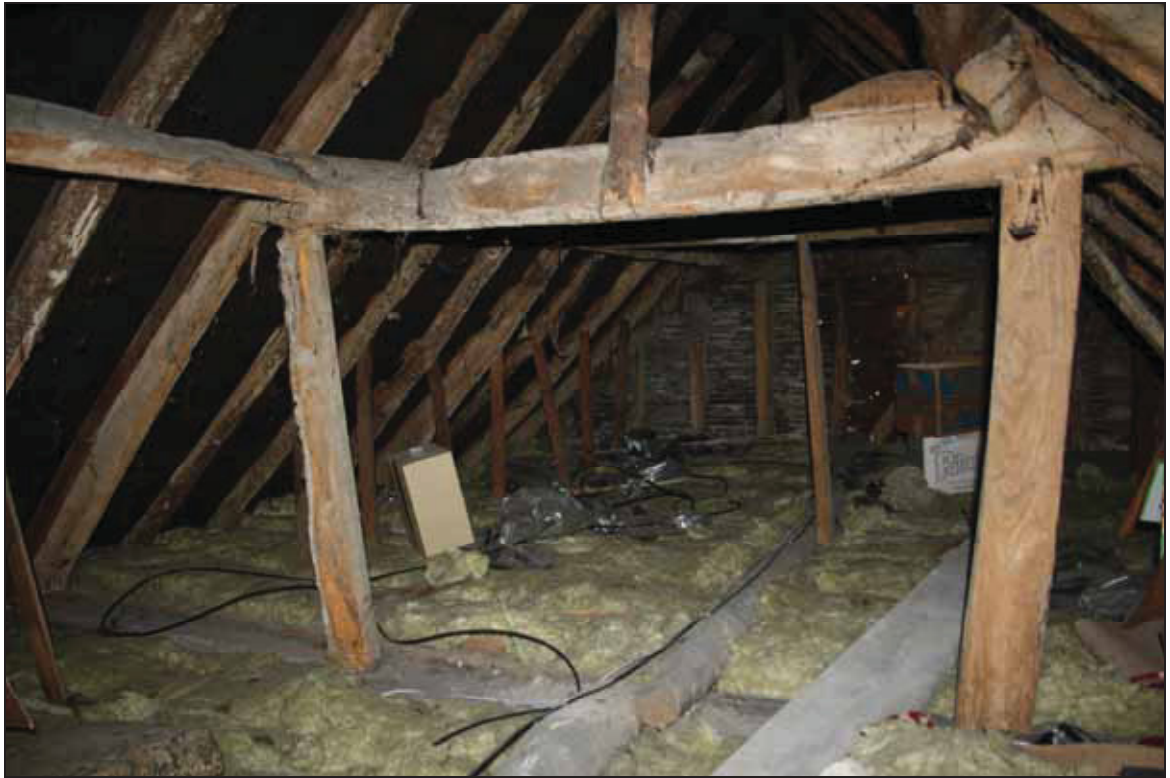
Plate 7 View of the roof structure over the main range, taken from the south (DP 01)

5.25 The roof was viewed though a small hatch on the landing, though detailed examination was not possible. It is constructed mostly of oak with some replacement in softwood. As with the external framing, the timber used is waney, with many members retaining bark, though the best quality pieces were clearly reserved for the principal structural elements which are generally squared and pegged (Plate 7). The truss form includes tie-beams with queen posts and collar clamping a single side purlin in each pitch, these crudely scarfed at each bay.

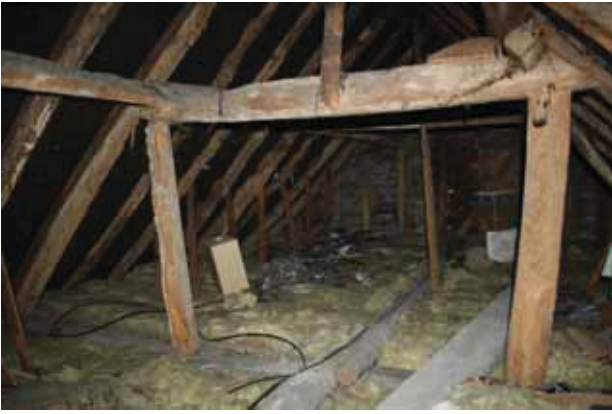
DP 1
View of the roof structure over the main range,
taken from the south

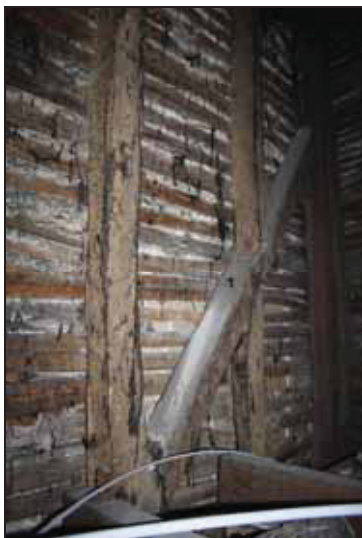
DP 5
East side of the main range showing primary-
braced timber-framing, taken from the south-east

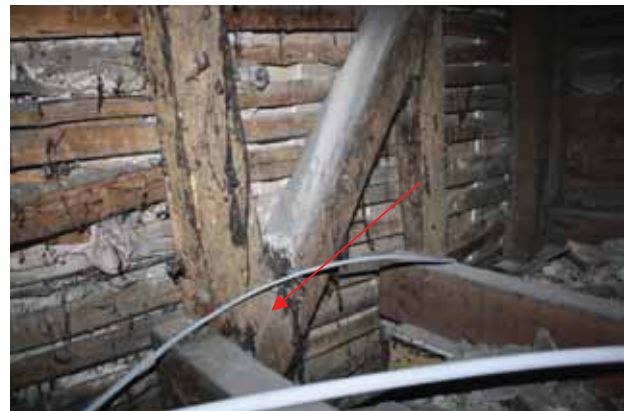
DP 6
Detail of the primary-braced studwork showing
assembly mark (indicated), taken from the east

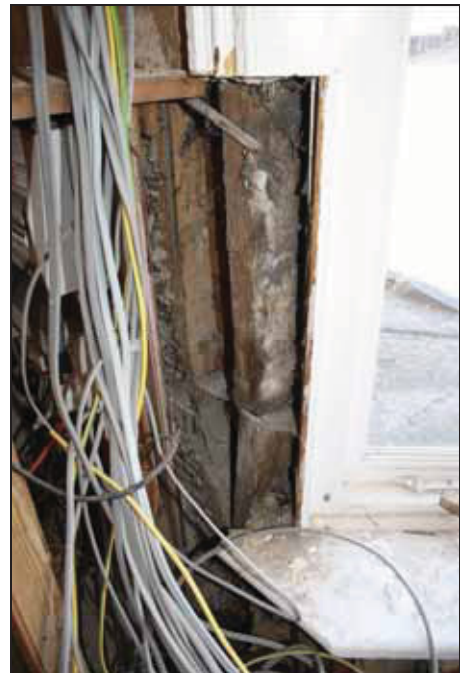
DP 18

Detail of the primary-braced timber-framing on the west wall of Room GF01 adjoining the south window, taken from the east

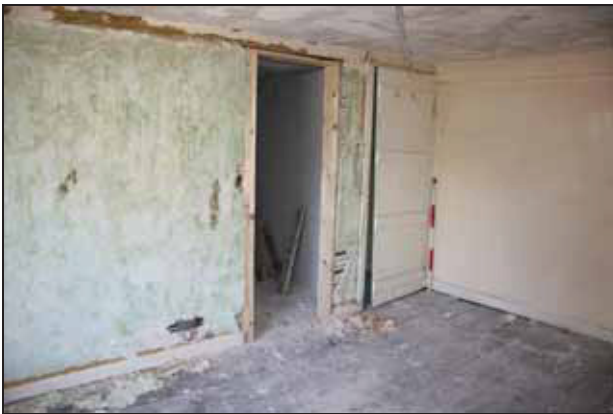
DP 39

North side of Room FF03 with second doorway recently punched through for an en-suite, taken from the south-west

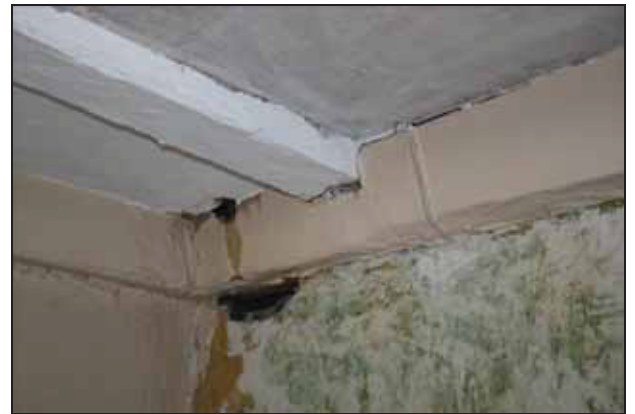
DP 40

Detail of the ceiling joisting in Room FF03, taken from the north-east
