ARCHAEOLOGICAL SOLUTIONS LTD

22-26 CHEQUER STREET, ST ALBANS, HERTFORDSHIRE

HISTORIC BUILDING MONITORING AND RECORDING

HISTORIC BUILDING MONITORING & RECORDING

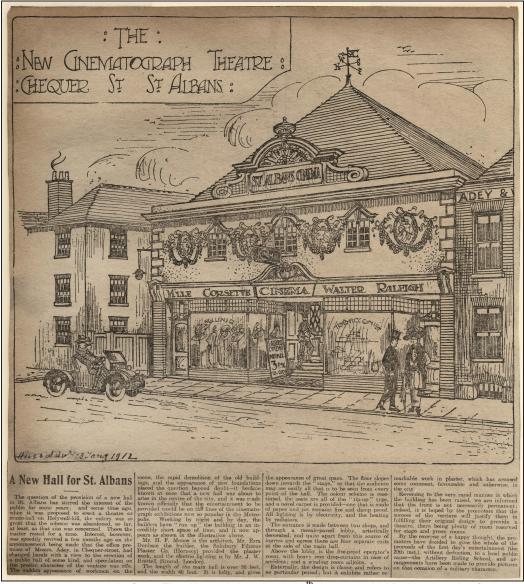
3.1 Newspaper article from The Herts Advertiser, 13th January 1912 showing the frontage of Nos. 24-28 (St Albans Museum Image no PX7464)

- 4.11 The larger building occupying Nos. 24-26 (including No. 28) was removed from the ownership of the brewery and in 1912 'The New Cinematograph Theatre' was opened. A newspaper article from The Herts Advertiser dated the 13th January 1912 provides much information regarding this building (Appendix 3.1) and suggests the building formerly included the offices of the brewery and had changed hands only a few months before. There are clearly differences in appearance between the existing building and that depicted in this article but there are also distinct similarities, and furthermore additional detail can be gleaned which shows that the two outer shop premises were occupied by a milliners and a tobacconists, and also that a mix of architectural styles is visible with some classical motifs at upper level with some rustication, while the shop fronts at lower level look typically Edwardian with large glass panes topped by a frieze of small panes.

- 4.12 The text of the article suggests the previous building was demolished in order to construct the cinema although the size and alignment visible on earlier maps correspond well to that which exists today and it is possible that the earlier range was largely rebuilt but retaining some elements of the former building. The architect for the new cinema was Mr. H.F. Mence, with Mr Ezra Dunham the builder and the Salisbury Fibrous Plaster Co. (Hornsey) providing the plasterwork. The cinema was given electrical lighting installed by Mr. J. W. Brettell (Strand, London). The construction clearly utilised modern fabric and methods and an awareness of the risk of fire in cinemas is evidenced by the comments regarding the fire-proof operator's room with iron drop-curtains and the floor covering, which was described as 'novel', being of paper but remaining fire and damp proof.

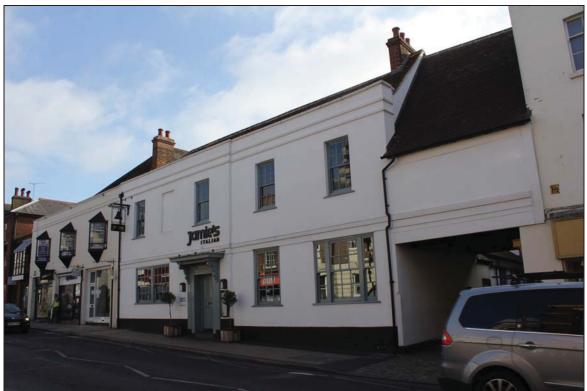
Plate 1 West street front elevation of Nos. 22 (right) and Nos. 24-26 (left), taken from the south-west (DP 12)

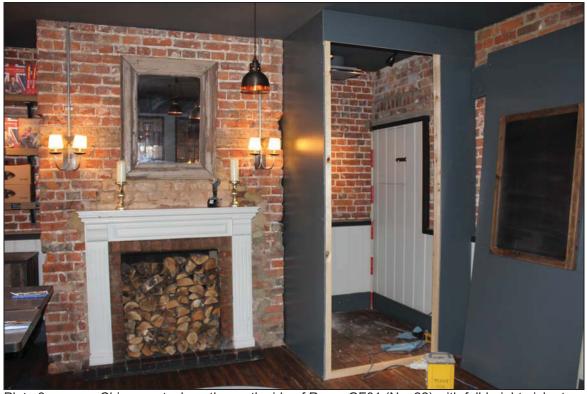
Plate 3 Chimney stack on the north side of Room GF01 (No. 22) with full-height niche to the east where the new doorway is to be located, taken from the south-west (DP 1)

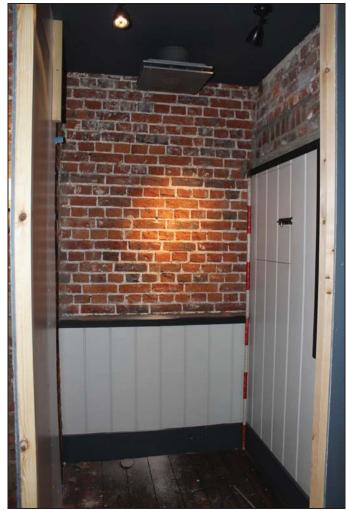
Plate 4 Full-height niche to the east of the chimney stack (GF01, No. 22) showing location of new doorway, taken from the south (DP 2)

- 6.2 Within the recess, the section to be removed comprises modern vertical dado boarding above which is exposed brickwork, although the brickwork was clearly formerly rendered and traces remain (Plate 4). This is of a similar fabric to that seen elsewhere at the north end of the restaurant and comprises a fairly large variable orange brick with occasional kiss marks and wide lime mortar joints. The brickwork is laid in English bond and the bricks measure an average of $8\frac{1}{2}$ " x 4" x $2\frac{1}{4}$ " (216mm x 102mm x 57mm) with a $\frac{1}{2}$ " (13mm) mortar joint.

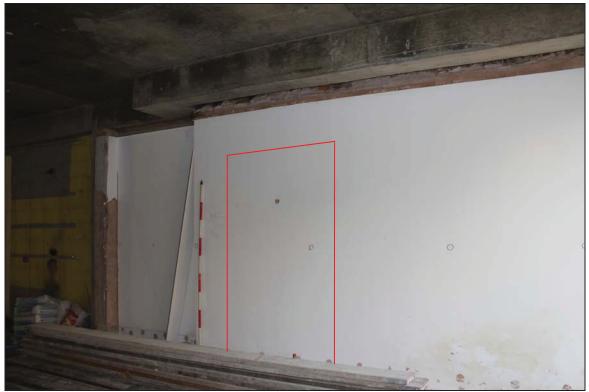
Plate 5 South wall of Room GF02 (No. 24) with position of new doorway outlined, taken from the south-west (DP 6)

- 6.3 From within No. 24, this stretch of wall is covered in a cementitious render (Plate 5) but above, at ceiling level a brick offset is visible, above which the brickwork appears fairly disturbed. Otherwise, Nos. 24 and 26 are now contiguous and largely open plan with blockwork partitions dividing the two spaces, these having been pierced to create wide apertures. From within, this building appears constructed of modern blockwork with reinforced concrete ceilings and modern shop fronts.

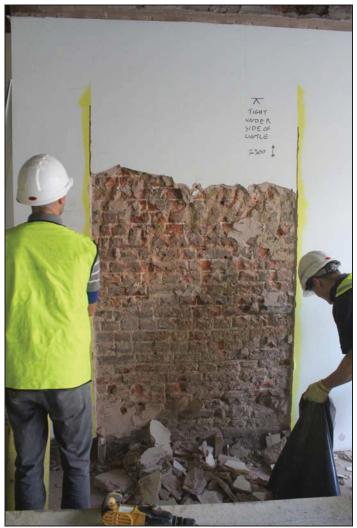
Brick work exposed during insertion of the new doorway, taken from the north (DP 10)

- 6.4 The aperture was pierced from the north side within No. 24. The modern hard render was removed exposing this face of the brickwork, where the bricks measure the same as noted above from within No. 22 (Plate 6). The brickwork was removed course by course so that three concrete lintels could be inserted to support the upper fabric. Removal of the brickwork revealed that instead of parallel walls divided by a cavity as was suggested, the wall spans 0.45m depth or two stretcher lengths. The brickwork of the wall is all of one phase, though it is unclear as to why the substantial depth was necessary, particularly with the clear offset at upper level, perhaps this relates to reinforcement after removal of earlier timber-framing. Further evidence for the phasing of the range was discovered where brick was removed to a slightly wider extent at the head of the doorway in order to accommodate the lintels. Removal extended to the rear of the chimney stack in No. 22 and the fabric exposed in this small area suggests that the chimney stack is of a different phase. There is a straight joint in the brickwork at this point and although the view was limited it may show the chimney stack constructed against the pre-existing brickwork of the wall. The brick of the chimney stack is similar in appearance and form and is also laid in English bond, although displays fewer overburnt headers and is fractionally larger on average, being 8½" x 4" x 2½" (216mm x 102mm x 64mm), suggesting the chimney stack

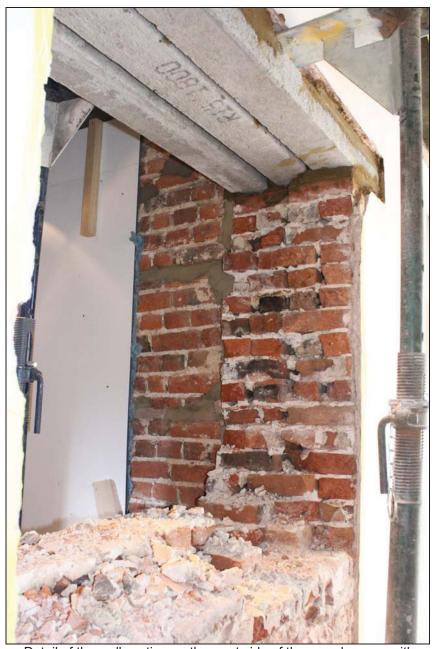
Plate 7 Detail of the wall section on the west side of the new doorway with new concrete lintels inserted above, taken from the east (DP 19)

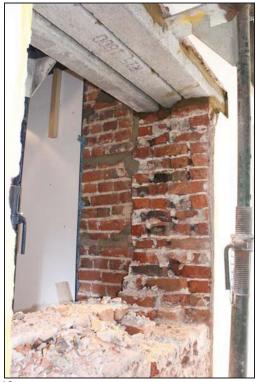
DP 19

Detail of the wall section on the west side of the new doorway with new concrete lintels inserted above, taken from the east

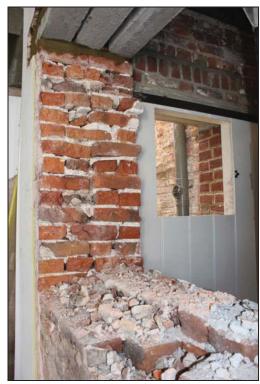
DP 20

Detail of the wall section on the east side of the new doorway with new concrete lintels inserted above, taken from the west
