**ACTON MAGISTRATES COURT,  
WINCHESTER STREET, ACTON, LONDON**

**ARCHAEOLOGICAL MONITORING & RECORDING**

Authors: Zbigniew Pozorski (Fieldwork & report) Megan Stoakley (Research)	
NGR: TQ 20335 79952	Report No: 4348
District: London Borough of Ealing	Site Code: AMU 12
Approved: Claire Halpin MfA	Project No: 4976
Signed:	Date: 2 July 2013

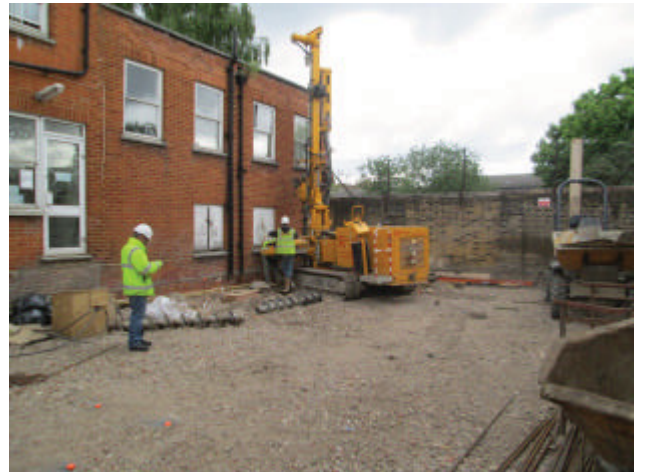
DP 2. Piling in progress. Looking north-east.

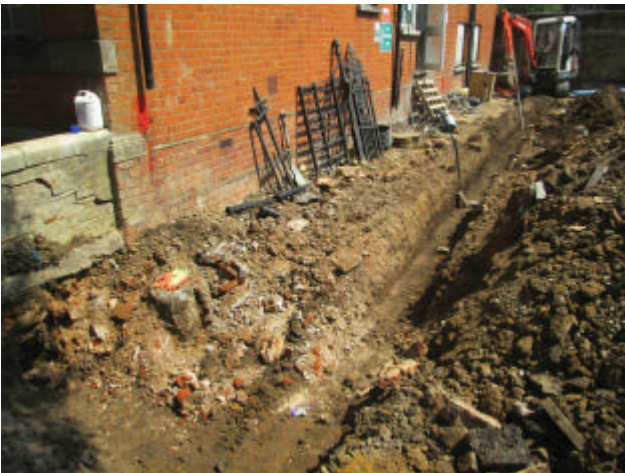
DP 3. Service trench along northern side of the site. Looking east-north-east.

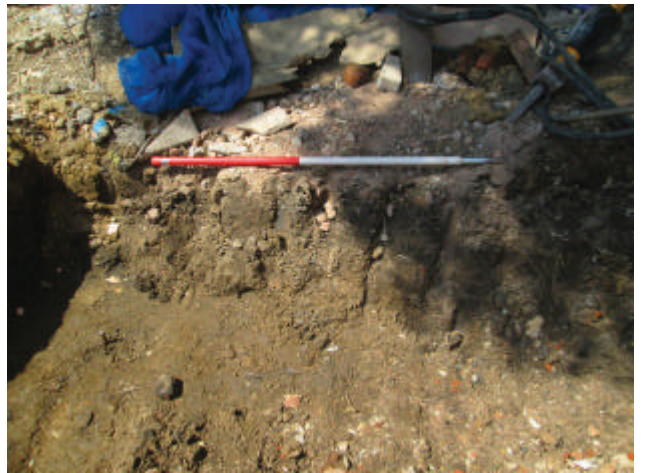
<i>Sample section 1 (DP 4)</i> <i>North-western corner of the site, facing east-north-east</i> <i>0.00 = 12.47m AOD</i>		
0.00 – 0.04m	L1000	Modern layer of crushed CBM.
0.04 – 0.50m+	L1001	Made ground. Dark greyish brown, compact, sandy silt with occasional CBM fragments and small stones.

DP 4. North-western corner of the site. Sample section 1. Looking west-south-west.

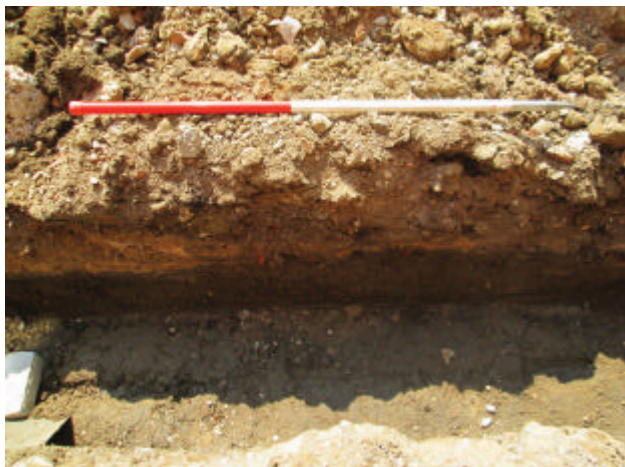
<i>Sample section 2 (DP 5)</i> <i>Service trench along northern limit of the site, facing south-south-east</i> <i>0.00 = 12.63m AOD</i>		
0.00 – 0.10m	L1000	Modern layer of crushed CBM. As above.
0.10 – 0.24m	L1002	Made ground. Light grey, friable, silty sand with frequent CBM fragments.
0.24 – 0.28m	L1003	Mid yellow, loose, sand with moderate CBM fragments.
0.28 – 0.55m+	L1001	Made ground. As above.

DP 5. Service trench. Sample section 2. Looking north-north-west.

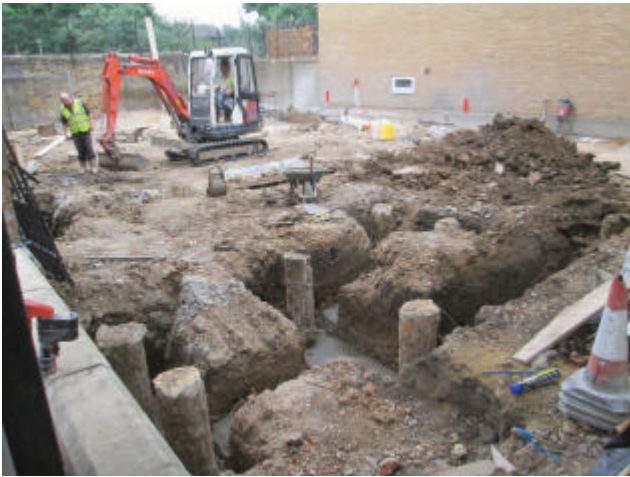
DP 7. Foundation trenches in western part of the site. Looking east.

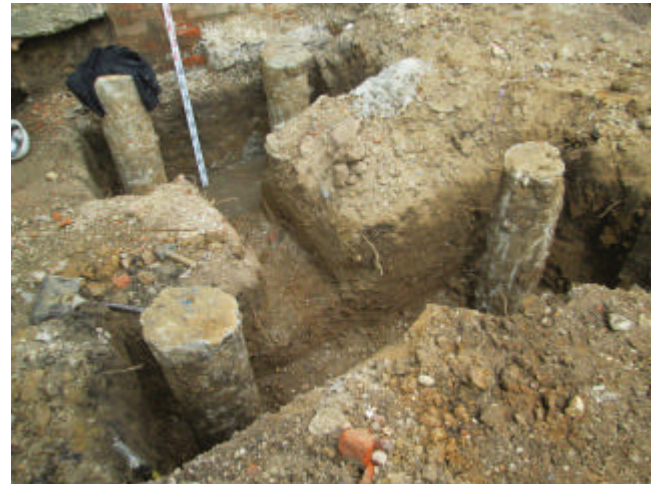
DP 8. . Foundation trenches in north-western corner. Looking north-north-west.

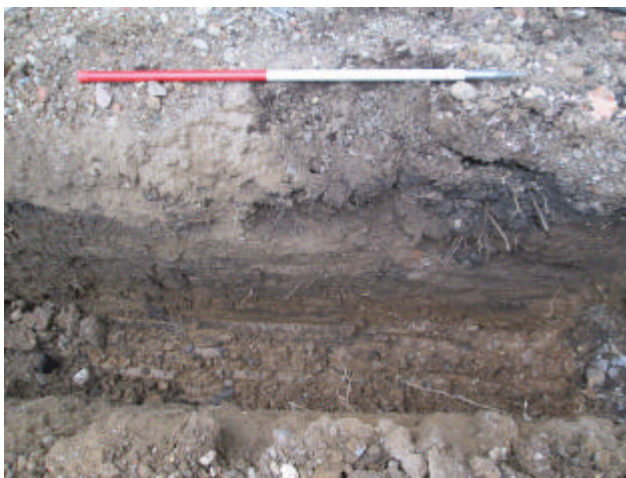
<i>Sample section 4 (DP 9)</i> <i>Western foundation trench, facing east-north-east</i> <i>0.00 = 12.54m AOD</i>		
0.00 – 0.08m	L1000	Modern layer of crushed CBM. As above.
0.08 – 0.28m	L1004	Dark grey, friable, sandy silt with frequent roots.
0.28 – 0.71m	L1001	Made ground. As above.
0.71m+	L1005	Natural mid to dark yellow, compact, clay.

DP 9. Western foundation trench. Sample section 4. Looking west-south-west.

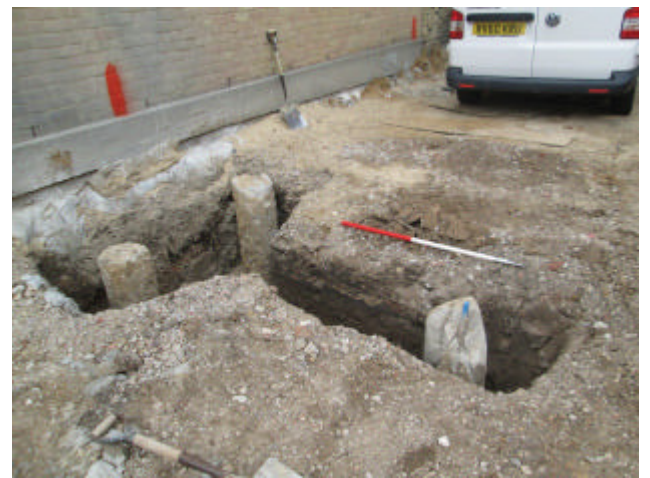
DP 10. Foundation trench in south/central part of the site. Looking south-west.

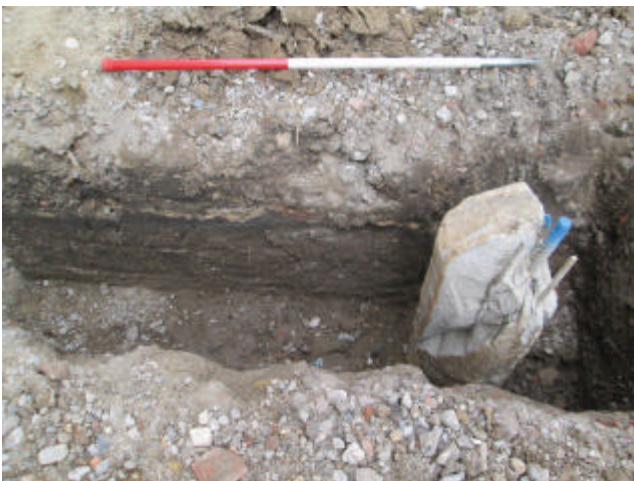
<i>Sample section 5 (DP 11)</i> <i>South/central foundation trench, facing east-north-east</i> <i>0.00 = 12.62m AOD</i>		
0.00 – 0.10m	L1000	Modern layer of crushed CBM. As above.
0.10 – 0.83m+	L1001	Made ground. As above.

DP 11. Foundation trench in south/central part of the site. Sample section 5. Looking west-south-west.

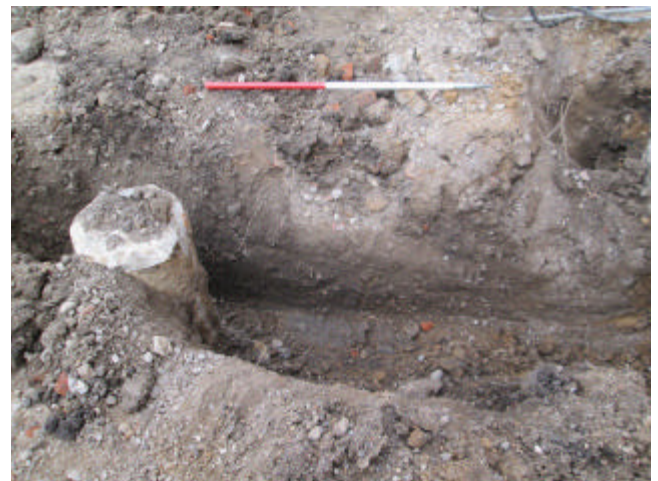
<i>Sample section 6 (DP 12)</i> <i>South/eastern foundation trench, facing west-south-west</i> <i>0.00 = 12.68m AOD</i>		
0.00 – 0.15m	L1000	Modern layer of crushed CBM. As above.
0.15 – 1.00m+	L1001	Made ground. As above.

DP 12. South-eastern foundation trench. Sample section 6. Looking east-north-east.

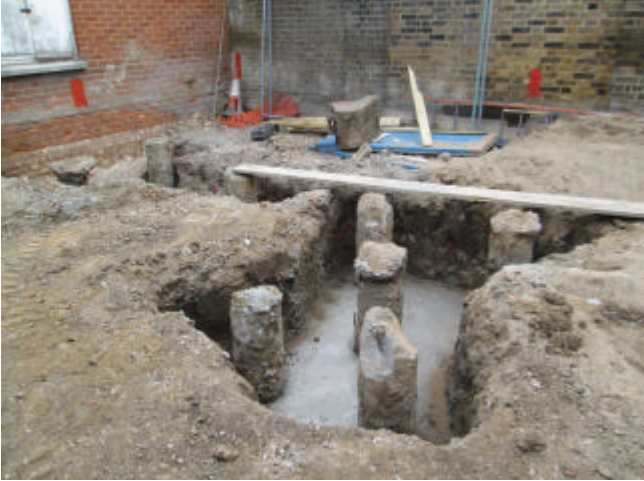
DP 13. North-eastern foundation trench.  
Looking north-east.

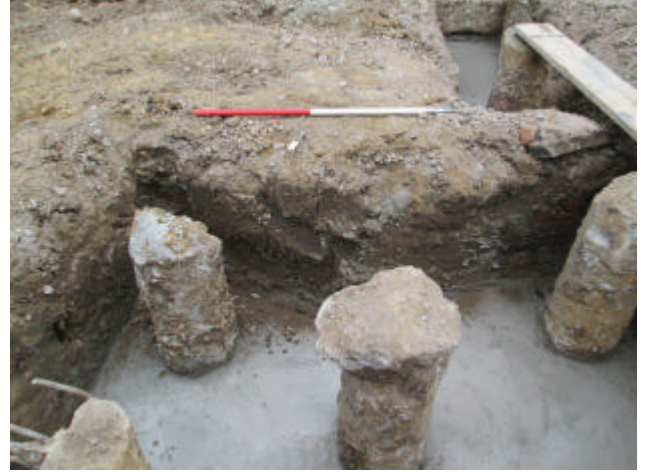
<i>Sample section 7 (DP 14)</i> <i>North/eastern foundation trench, facing south-south-east</i> <i>0.00 = 12.72m AOD</i>		
0.00 – 0.10m	L1000	Modern layer of crushed CBM. As above.
0.10 – 0.80m+	L1001	Made ground. As above.

DP 14. North-eastern foundation trench.  
Sample section 7. Looking north-north-west.
