**THE BARN AT ACTONS FARM
HIGH WYCH
HERTFORDSHIRE**

HISTORIC BUILDING RECORDING

Level 3

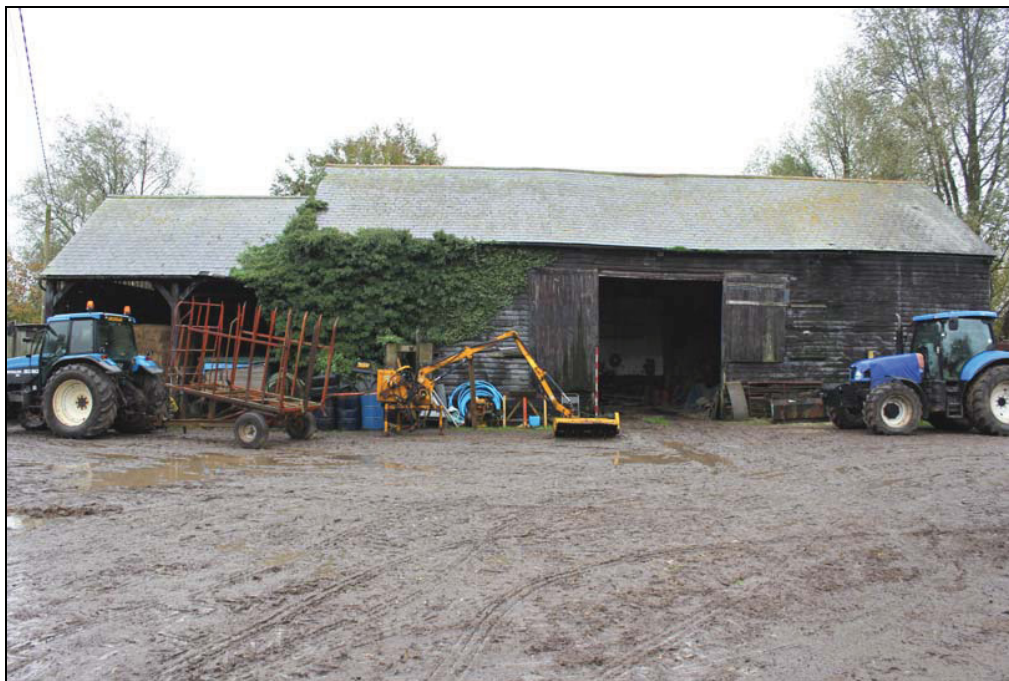
Plate 1 The barn at Actons Farm, High Wych, taken from the north-west (DP 1)

5.1 The barn forms part of a wider assemblage of buildings associated with the adjoining farm. It is currently used for storage of old furniture and several carts. The attendant open-fronted, two-bay cart shed lies to the north, while further storage is provided by a flimsy lean-to on the rear, east side (Plates 1 & 2).

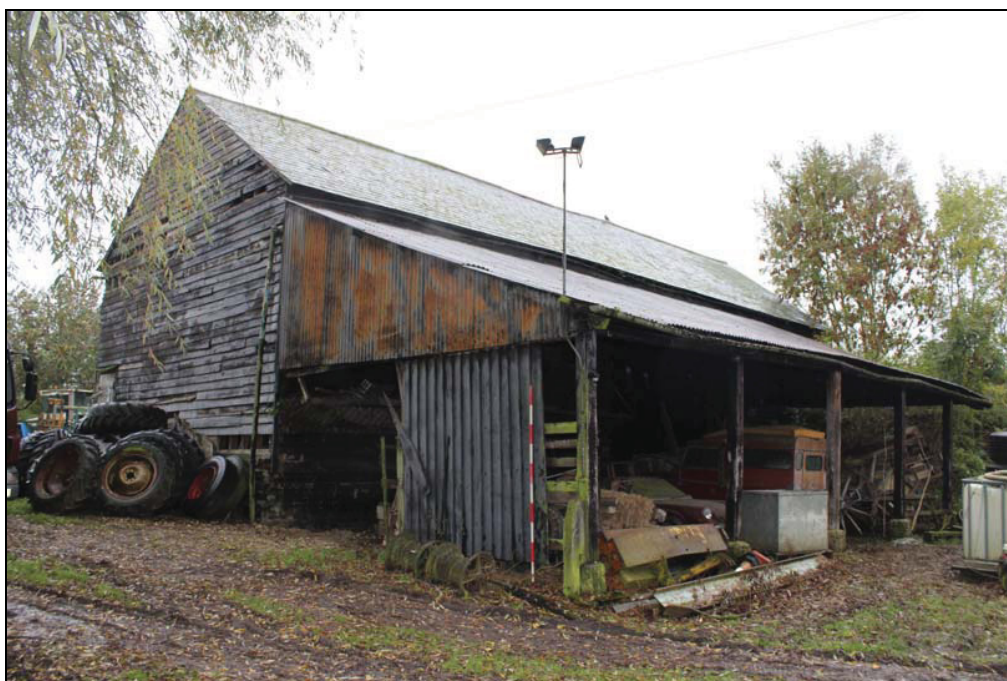
Plate 2 Lean-to to the rear of the barn (east elevation), taken from the south (DP 4)

5.3 The modern lean-to extends along the eastern elevation and is of an ephemeral flimsy construction with posts standing on concrete bases, supporting a simple roof of rafters and horizontal ribs, all attached to the original barn on a single batten, slotted into u-shaped metal cleats. Secondary external timbers carry the corrugated roof. A manger attached to the rear face for livestock must be a later addition, as its presence impedes the functioning of the main doors on this side.

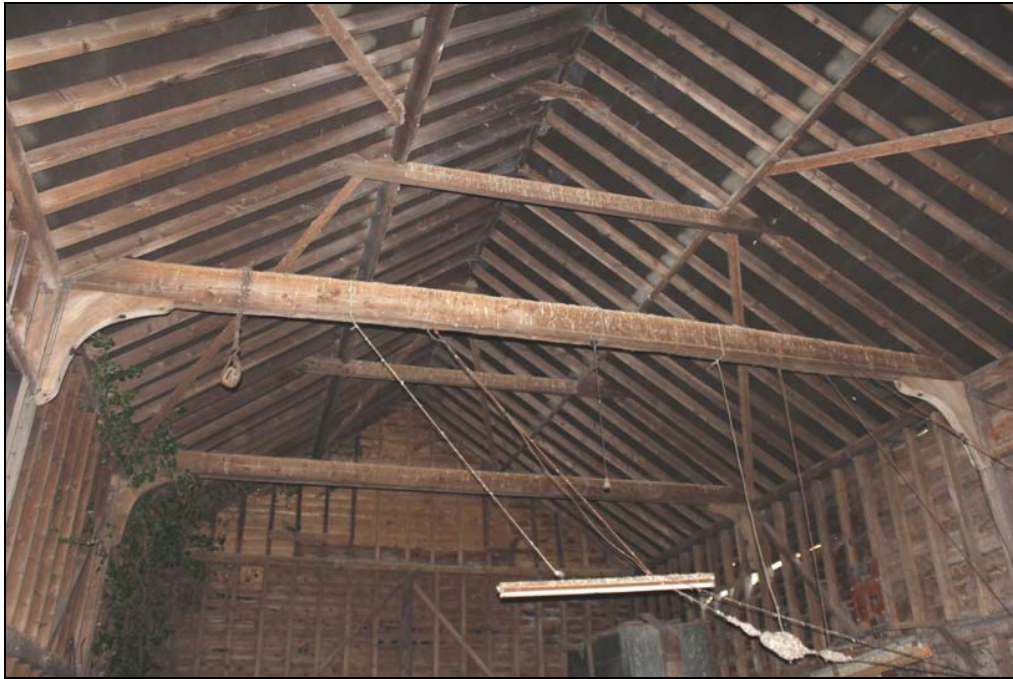
Plate 3 Roof structure above the barn, taken from the south-west (DP 19)

5.4 The barn is divided into five bays, with a central, wider bay to accommodate the doors. The frame is very well preserved and is highly regular in form, comprising even, machine-sawn softwood of regular scantling, in primary-braced panels with slender studwork. The truss-form is of tie-beams carried by principal posts and triangulated by solid, shaped oak brackets. Independent collars support a single purlin in each pitch. Common-rafters ride over the back to a ridge-board at the apex (Plate 3). In the lower

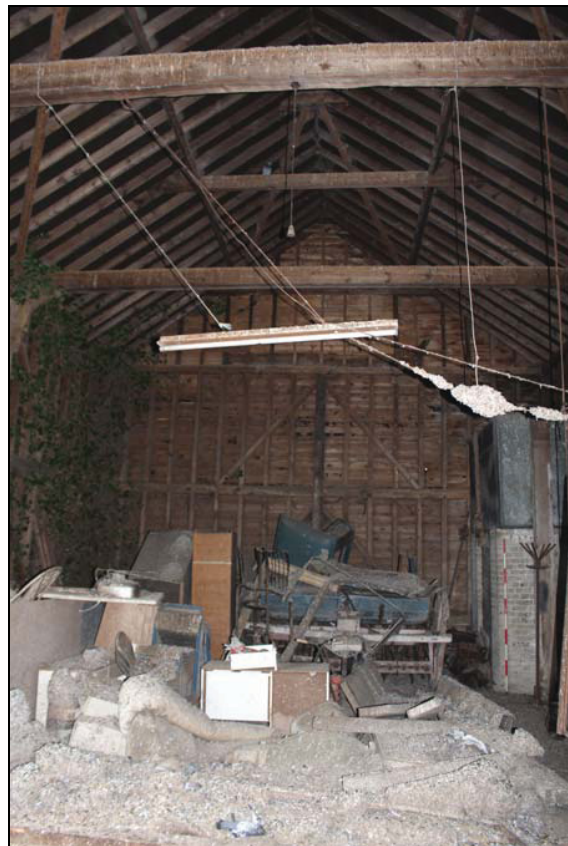
Plate 4 North gable end, interior, taken from the south-west (DP 13)

5.5 The northern gable end is entirely regular and original, with a central prick-post rising to the tie-beam (Plate 4). Downward primary bracing from the central post supports eight studs in each panel above and below in-line mid-rails. Similar studwork extends to the upper gable above the tie-beam. The weather-boarding, which has been protected by the adjoining cart shed is all of softwood with some replacement at high level.

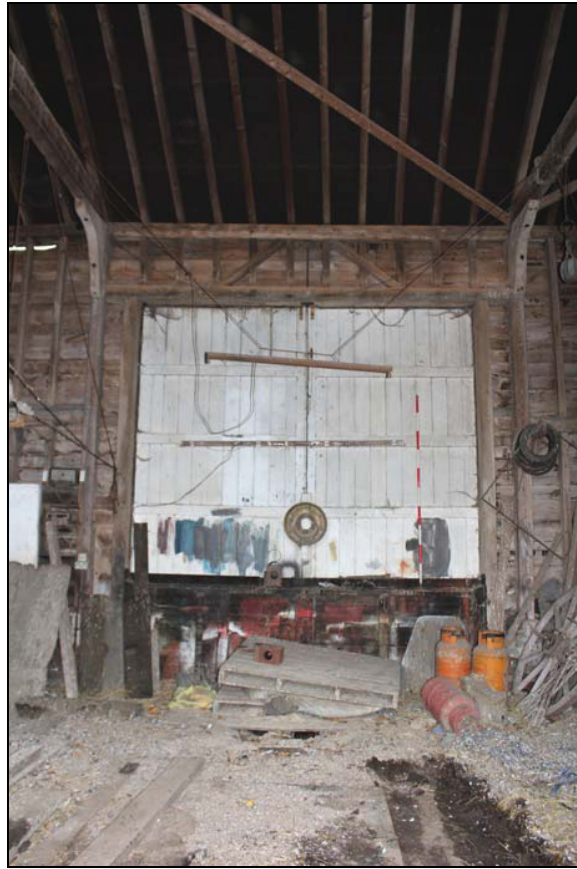
Plate 5 Doors to the eastern panel, Bay 3, taken from the north-west (DP 20)

5.11 The doors are boarded with ledges to the rear. They rest on external iron rails, and retain metal rollers to allow them to slide open. They may be later replacements, but the absence of evidence for earlier hinges suggests that they are original. The threshing board and brackets survive on the east but only one bracket remains on its counterpart, on the northern jamb.

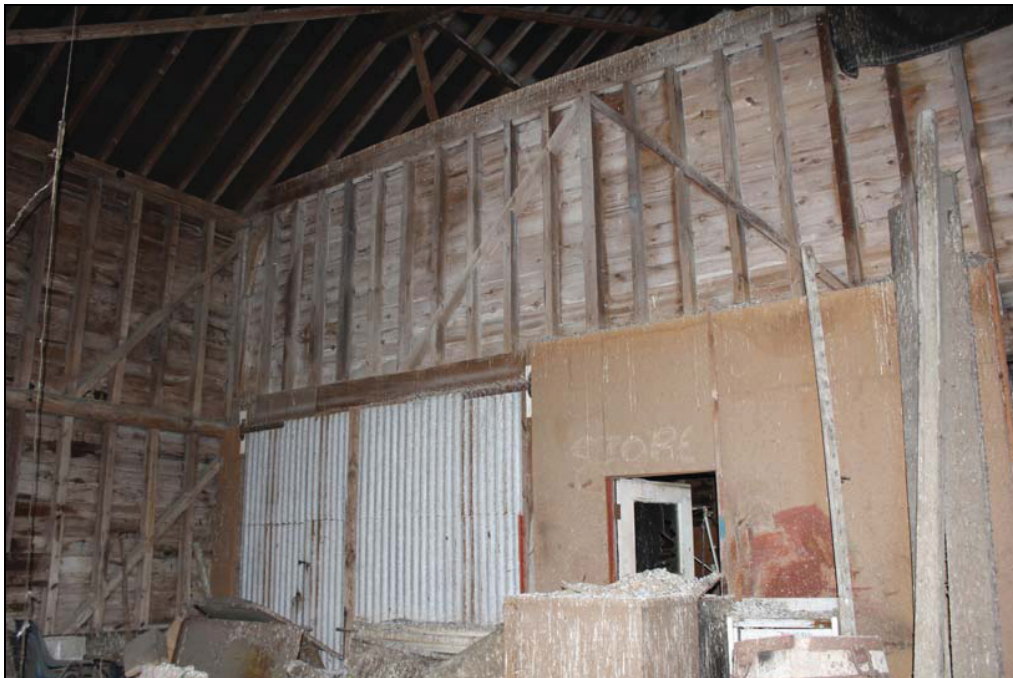
Plate 6 Dwarf wall, tiles and sill on the south east taken from the E (DP 6)

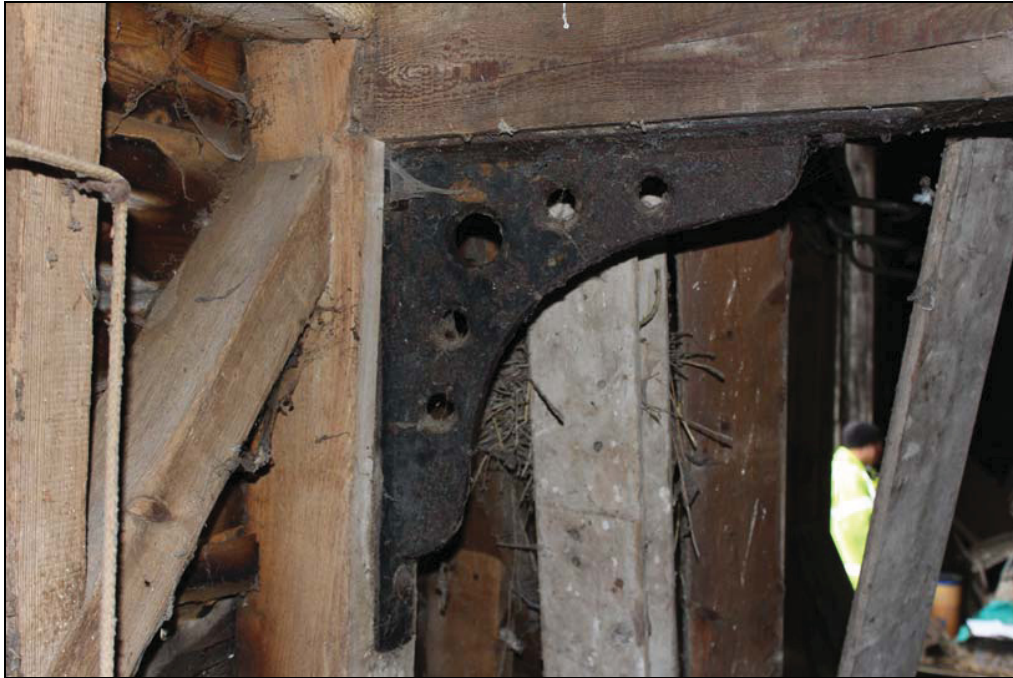
Plate 7 *Decorative iron brace to tie-beam, Bay 4, taken from the south (DP 10)*

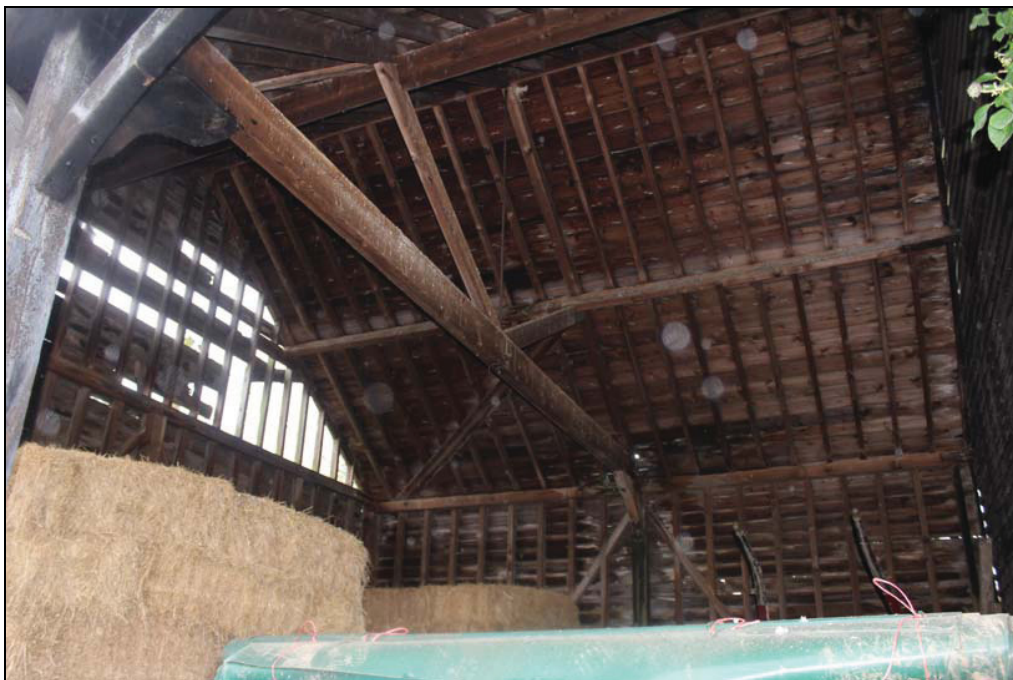
Plate 8 Roof structure above the cart shed, taken from the east (DP 11)

5.18 The cart-shed appears in structure and scale to be contemporary with the barn, though has a slightly different truss form (Plate 8). It comprises two bays defined by outer oak posts. The central truss at the bay divisions is open, though its eastern post has been badly affected by water ingress. However, this has yet to cause substantial decay and appears salvageable. On the west, the wall-plates to the open bays and the tie-beams are supported three ways by short, slightly curved braces. The softwood tie-beam has raking queen struts which are slightly notched to clasp the purlins. A central iron king-rod adds extra tension. The roof has flat, nailed-on wind-braces to the purlin.

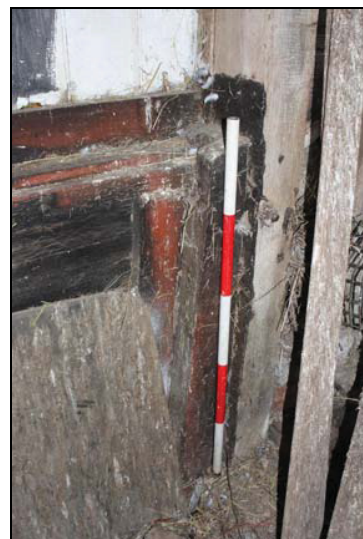
22

Threshing leap to the eastern doors, Bay 3, taken from the north

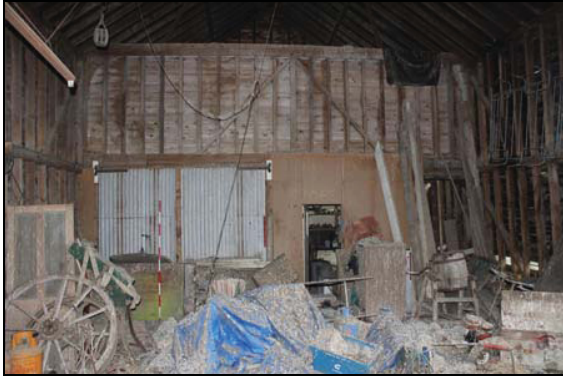
25

Partition to Truss 4 with enclosed store at lower level and hay loft above (Bay 5), taken from the north-east

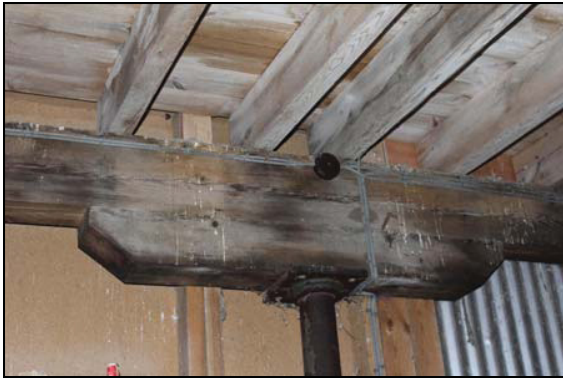
27

Steel stanchion and bolster supporting the tie-beam, Bay 5, taken from the south-east

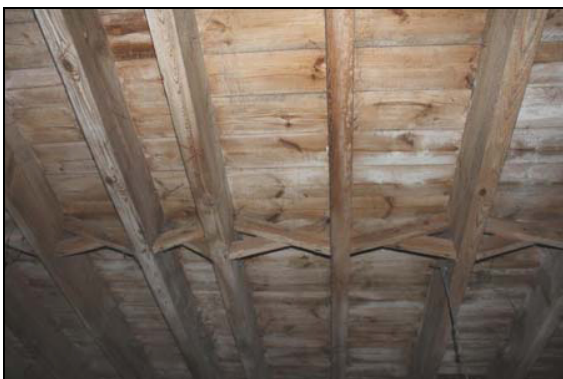
29

Laced bracing to the common-joists forming the ceiling above the store, Bay 5, taken from the north-east
