**QUEEN ADELAIDE PUBLIC HOUSE, LONDON ROAD,
SHENLEY, HERTFORDSHIRE**

**HISTORIC BUILDING APPRAISAL &
ARCHAEOLOGICAL EVALUATION**

HER request No. 299/12

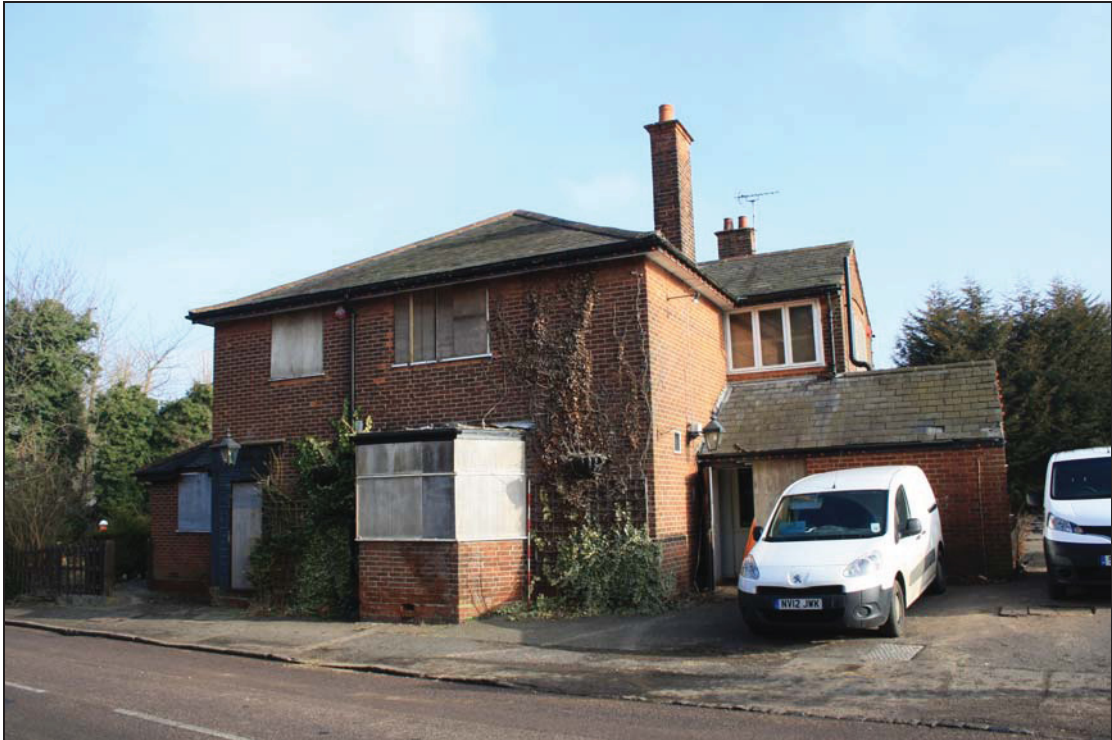
Plate 1 South-west elevation of the public house, taken from the south-west (DP 01)

6.1 The building is brick-built and rises over two storeys to a hipped roof occupying a generally square plan with a short projection on the southern side, the principal public façade fronting south-west onto London Road (Plate 1). The building has been extended with a number of single-storey units in the 1950s and later.

6.3 Typical of the interwar period, there is a marked lack of decorative embellishment and the construction is solid and simple, while other features express the style of architecture. For example, the original entrance to the building was recessed and the upper floor supported by a timber corner post. This has now been infilled with horizontal timber boarding and a modern door. To the south-east a large three-cant bay window has a flat roof and above, at

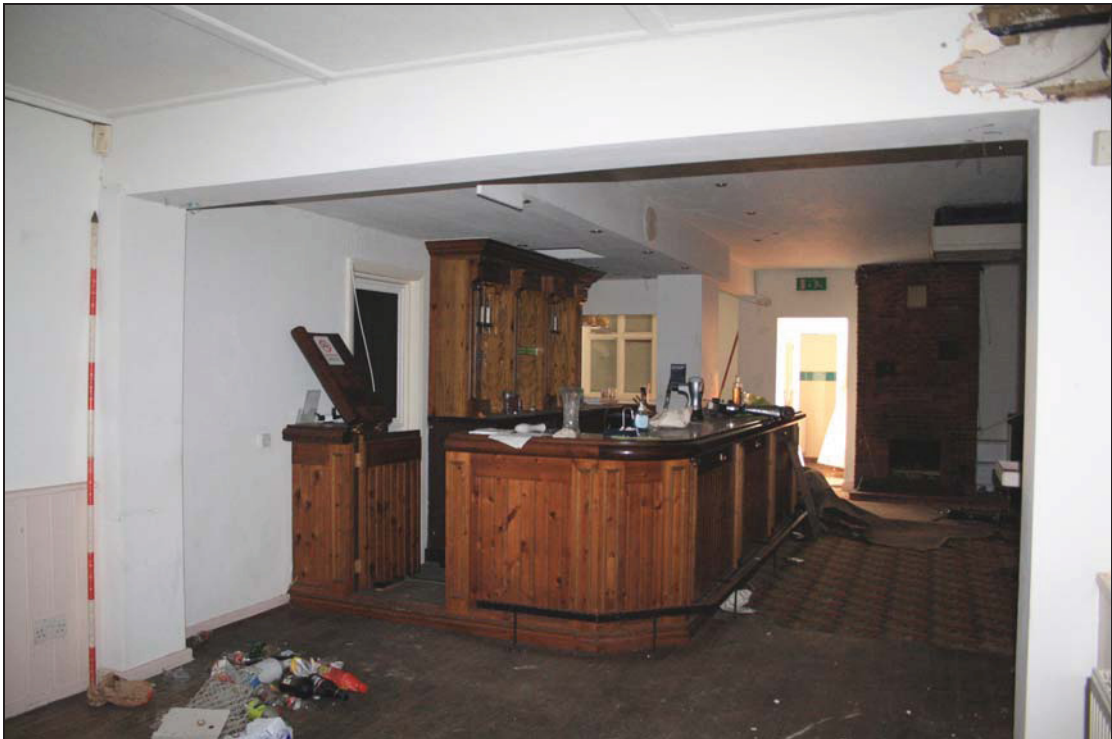
Plate 2 Main public bar area (GF01), taken from the west (DP 07)

6.6 The public bar occupies the majority of the ground floor which is all open-plan (Room GF01), the north-west area having been pushed out to provide further space (Plate 2). The bar lies centrally and the staircase and service rooms are housed to the rear.

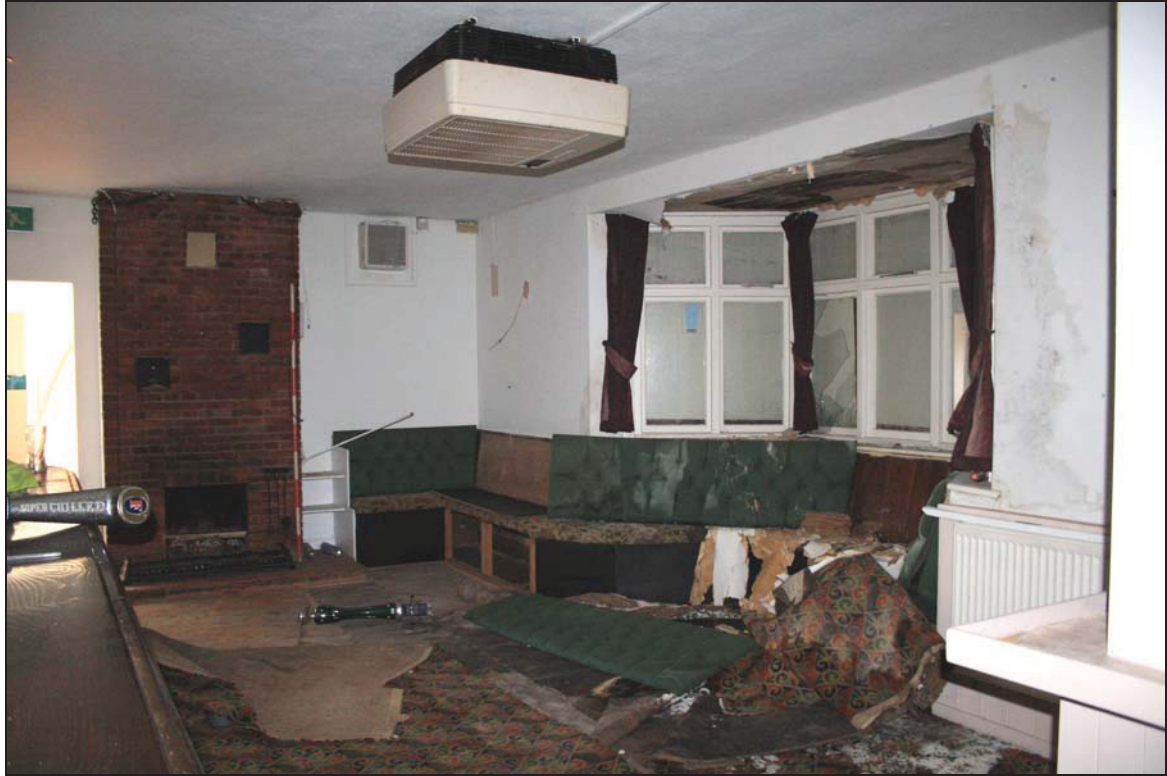
Plate 3 Main public bar area (GF01) with fireplace and bay window, taken from the north (DP 08)

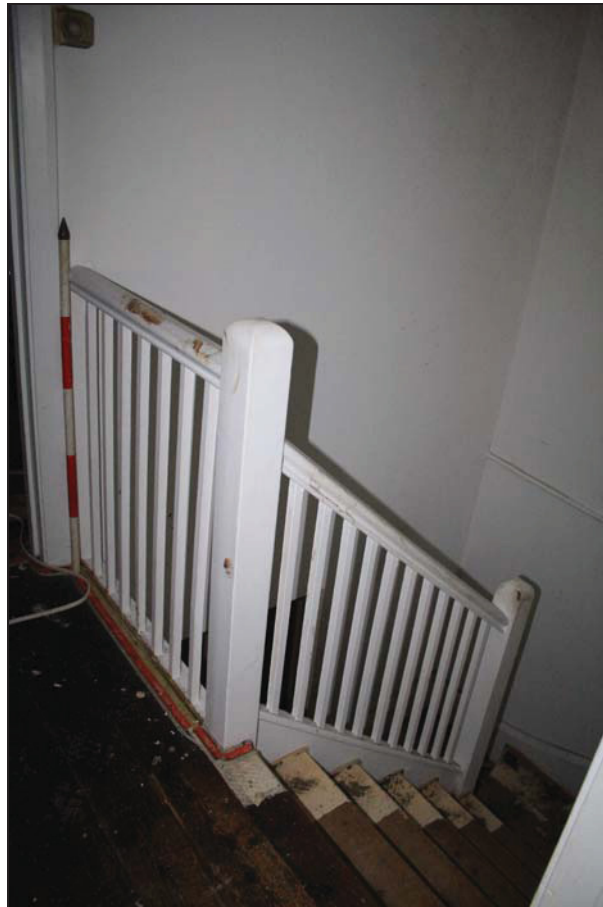
Plate 4 View of the staircase at first floor level (FF01), taken from the south (DP 15)

6.10 The staircase is largely original, though has been reconfigured at lower level to rise from the rear lobby, although originally appears to have risen from the south-west. The original element rises in dog-leg form with softwood risers and nosed treads around square newels. The lower portion is enclosed with vertical boarding but above the balustrade rises on a closed string with stick balusters and a moulded handrail (Plate 4). The landing at first floor level is irregular in shape and has a single four-pane light in the ceiling from the roof. It is unknown if this was intended to provide light although the roof structure appears original and so may instead be a later insertion. A full-height cupboard on the landing has had the doors removed but inspection within reveals it to be a later addition. Three good-sized bedrooms are given access from the landing as well as a bathroom and further smaller room. All door surrounds at this level are modern and the doors removed. The rooms are laid out with common features including slender softwood floorboards, plain skirting boards and pictures rails, with the two larger rooms having full-height cupboards to either side of the chimney stack. The windows follow a pattern of two or three-light casements, with one or two apparently retaining the original catches and stay bars with scalloped ends. The bathroom is mostly stripped out but metal brackets on one side may have supported the original sink. Otherwise two out of three fire surrounds survive in the larger bedrooms (Plates 5-6). They are cast-iron and modest in appearance but with delicate mouldings and simple timber shelves.

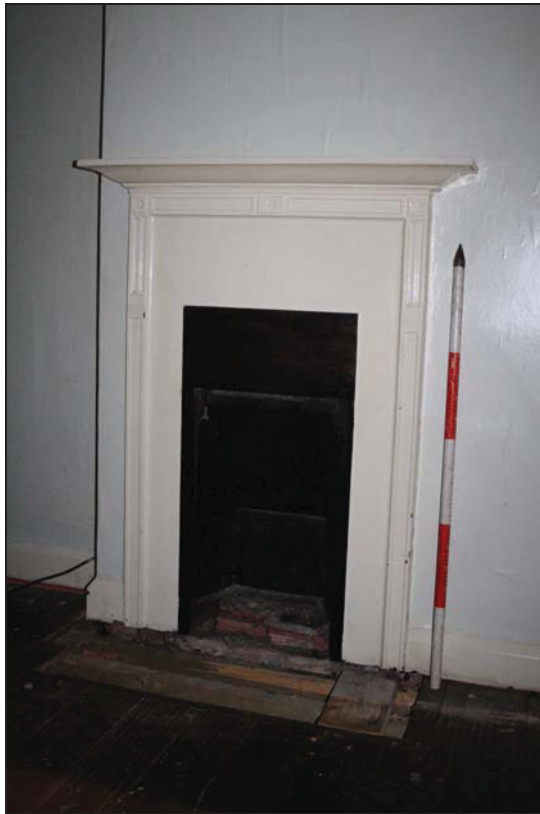
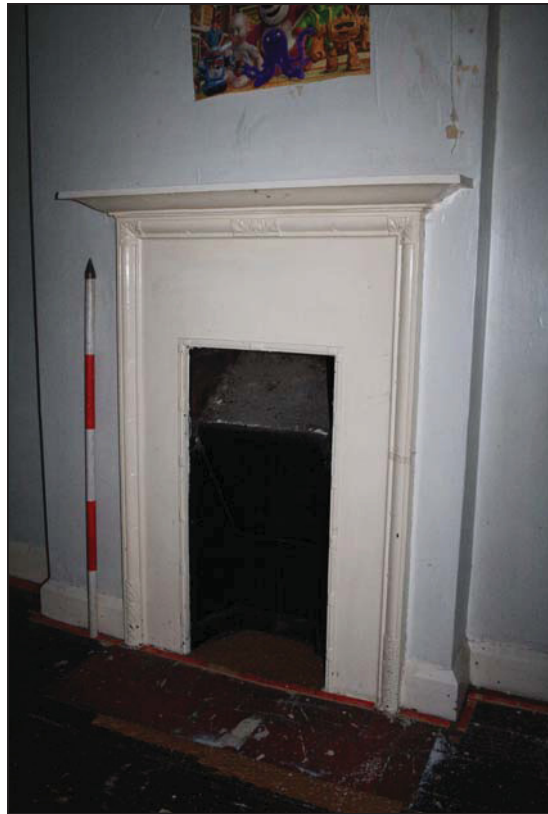
Plate 5-6 Fire surrounds at first floor level in Rooms FF02 and FF06 (DPs 19 and 24)

7.3 At upper level the original layout survives with three bedrooms, a bathroom and a further smaller room. Good original features survive such as the cast-iron fireplaces, a bracket for the original sink as well as window furniture in one or two places, although the level of refurbishment means that almost all other features are modern replacements.

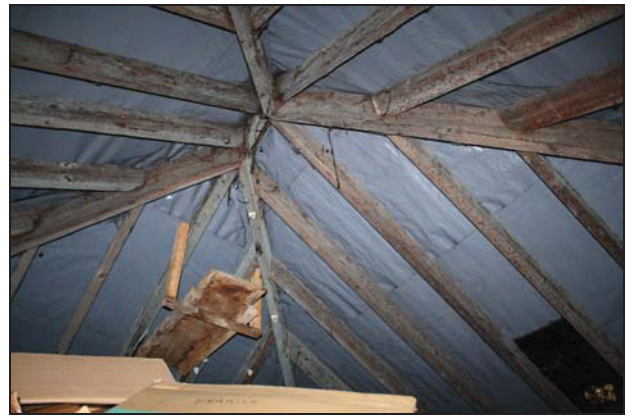
DP 22
View of the roof structure, taken from the north-west

6.11 An obscured view of the roof was gained via a hatch on the landing. It is all of slender softwood construction, hipped on all sides so that slender rafters rise over a single purlin in each pitch to a short ridge piece at the apex. The roof form of the gabled element is not visible.

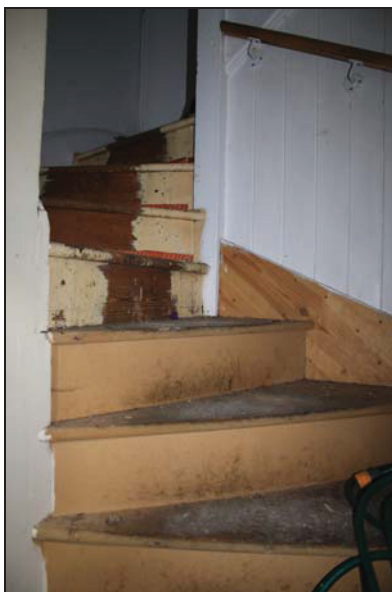
DP 29

View of the lower replaced section of the staircase, taken from the west

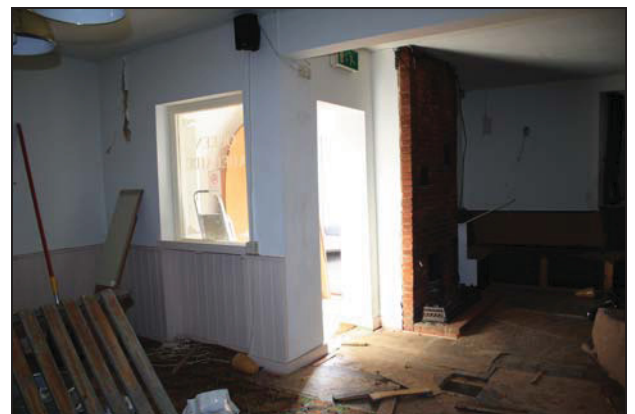
DP 30

Room GF02 showing former doorway and later internal window, taken from the north

6.9 In the south-east corner a distinct space (Room GF02) is nevertheless open-plan with the bar area. This room latterly held a pool table and gives access to the rear service area as well as the ladies WCs. A transom and mullion window on the south-east has aluminium catches, while the chimney stack projects into the room on the north-east but the dado boarding extends around and it is not evident if there was originally a fireplace here. In addition, a single glazed internal window to the entrance lobby lies in the position of a former doorway, presumably the original entrance to the saloon bar. The rear service rooms include a small lobby from the back door where the staircase rises as well as a rear kitchen, also given access directly from the bar. This is plain with a concrete floor and modern fixtures and fittings though the chimney stack on the north-east is expressed. To the north-west the extension is constructed from modern blockwork and latterly formed a store. A boarded double door leads to the exterior.

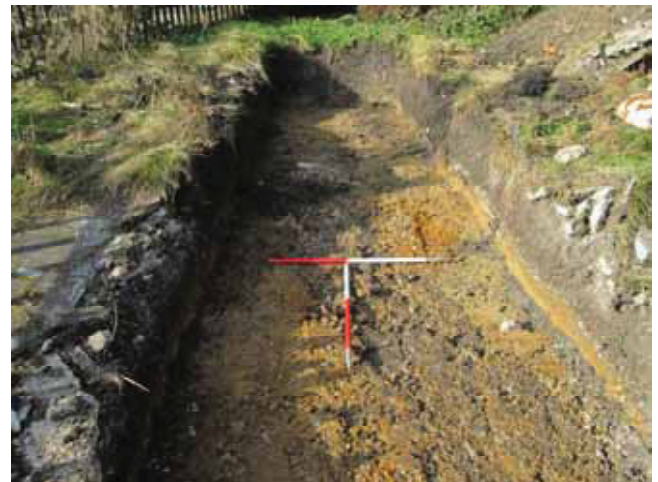
DP 4. Trench 1. Soakway M1002 and Drain M1004. Looking north-west.

M1002 was a circular feature (1.40m in diameter; DP 4) located in the west/central part of the trench. It was constructed of red frogged bricks (0.230 x 0.110 x 0.065m) bonded with white mortar. The wall of the feature was one course of bricks wide and it was in bad state of preservation. The interior of the feature was filled with L1003, a mid to dark grey, loose, silty sand with occasional CBM fragments. M1002 may have been a soakway connected on its south-eastern side to F1004.

F1004 was a linear feature (4+ x 0.65m; DP 4). It appeared to lead from the former public house to the soakway. The fill of the feature was L1005, a light grey, compact, silty clay with frequent CBM fragments and roots. F1004 may have been a drain probably containing ceramic pipe in its lower part.

Both features were modern (20th century).

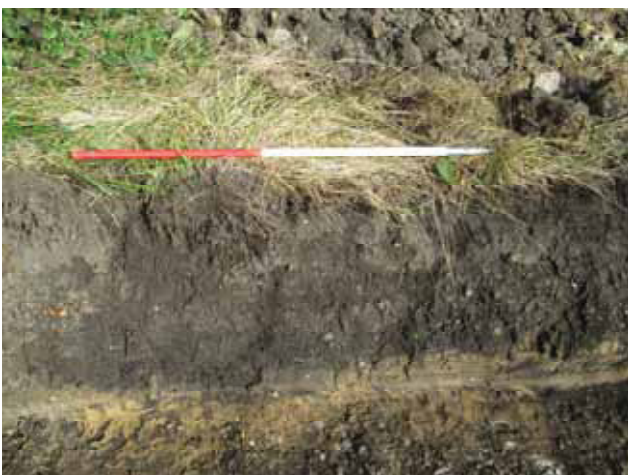
DP 5. Trench 1, north-west end. Sample section 1A. Looking north-east.

<i>Sample section 1A (DP 5): north-west end, south-west facing</i> <i>0.00 = 129.42m AOD</i>		
0.00 – 0.73m	L1000	Topsoil. Mid to dark grey, friable, sandy silt with occasional CBM fragments.
0.73 +	L1001	Natural mid yellow and greenish yellow, compact, clay.

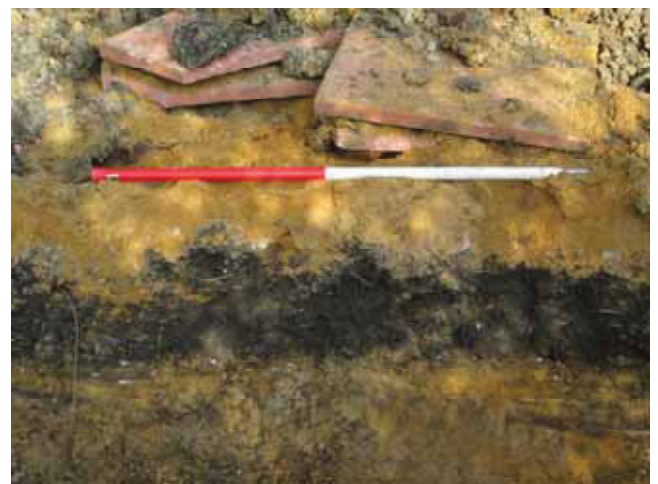
DP 6. Trench 1, south-east end. Sample section 1B. Looking north-east.

<i>Sample section 1B (DP 6): south-east end, south-west facing</i> <i>0.00 = 129.60m AOD</i>		
0.00 – 0.20m	L1006	Basal layer for pavement stones (removed). Mid yellow, loose, sand.
0.20 – 0.60m	L1000	Topsoil. As above.
0.60 – 0.82m	L1001	Natural clay. As above.

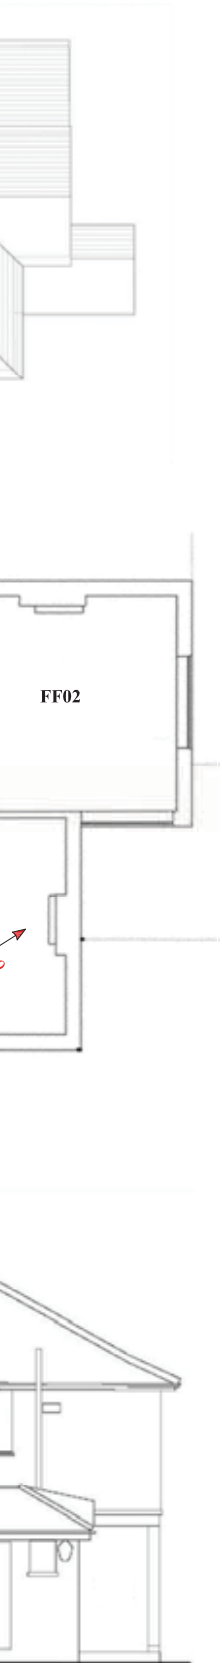
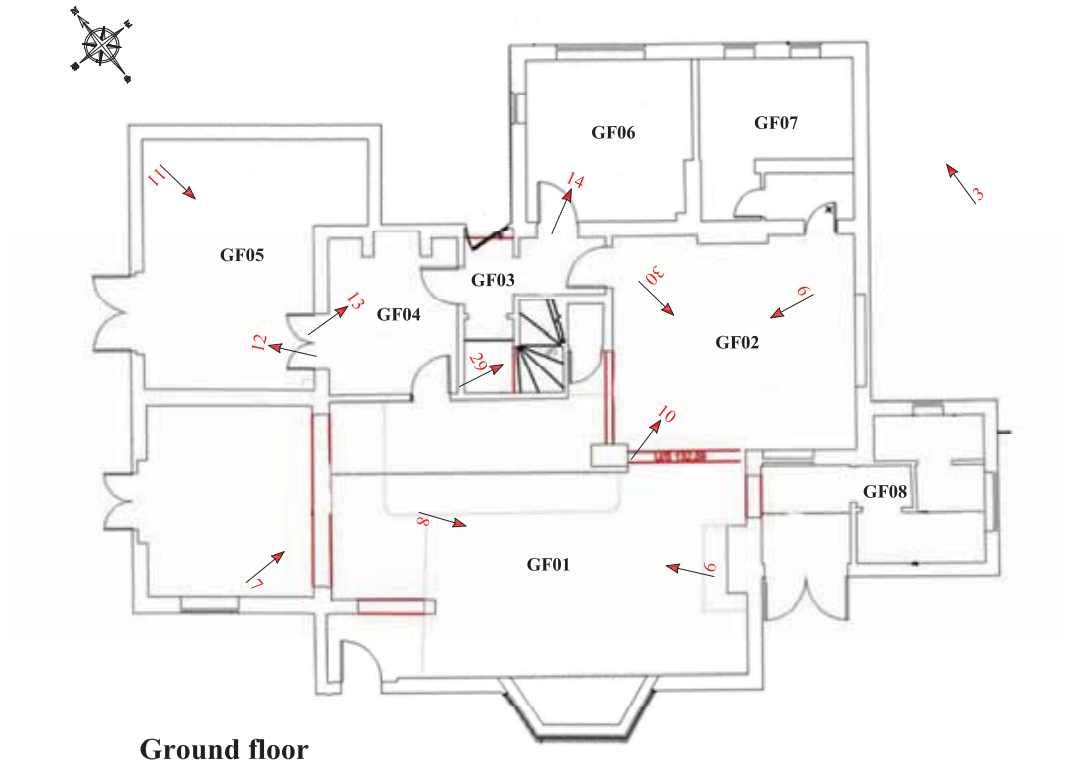
Archaeological Solutions Ltd
Fig. 11 Floor plans and elevations
Scale 1:150 at A3

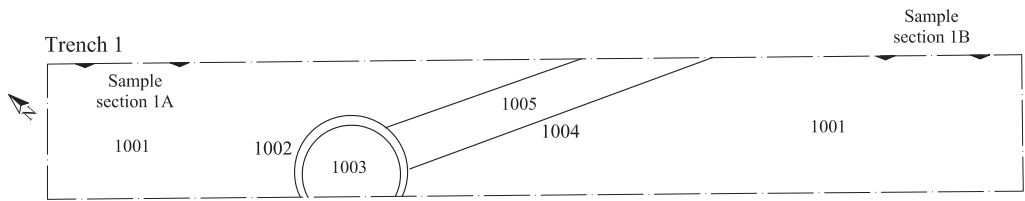
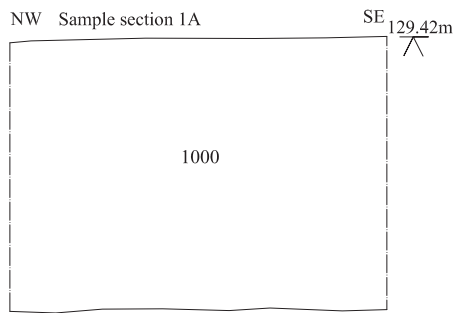
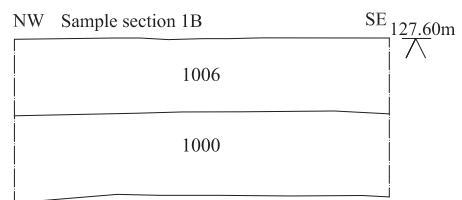
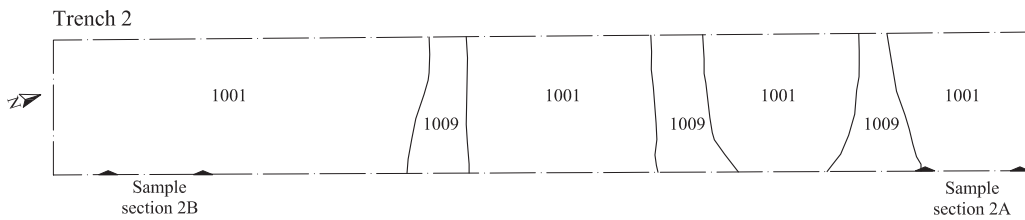
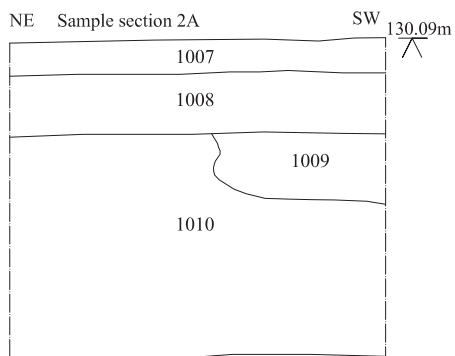
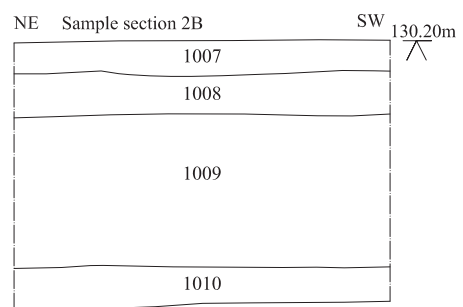
Archaeological Solutions Ltd
Fig. 12 Trench plans and sections
 Scale Plans 1:100, sections 1:20 at A4

Description: A modern (20th century) soakway and drain (M1002 and F1004, respectively) were present in the trench.
