**LIBURY HALL, GREAT MUNDEN, WARE, HERTFORDSHIRE
SG11 1JD**

ARCHAEOLOGICAL EVALUATION

Authors:	Laszlo Lichtenstein (Fieldwork & report) Antony R.R. Mustchin (Editor)	
Illustrations:	Kathren Henry	
NGR: TL 3439 2348	Report No. 4469	
District: East Herts.	Site Code: AS1648	
Approved: Claire Halpin MIFA	Project No. P5276	
Signed:	Date: 27 November 2013 Revised: 12/11/2014

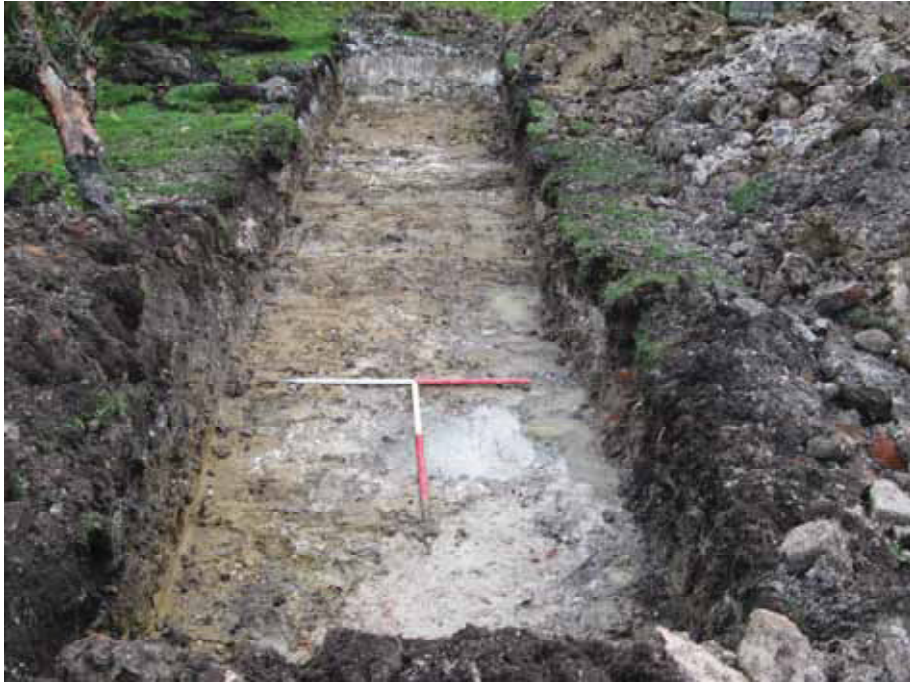
DP 3: Trial Trench 1 (post-excavation)

Description: The remains of a modern (19th century) brick wall foundation traversed Trench 1.

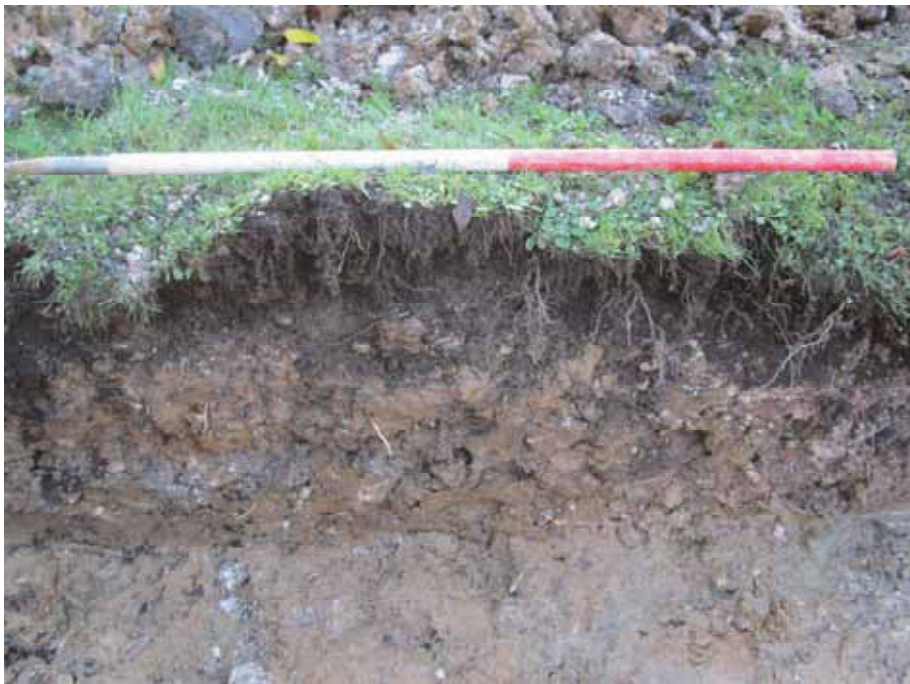
DP 4: Sample Section 1 (looking S)

<i>Sample section</i> 0.00 = 112.67m AOD		
0.00 – 0.14m	L1000	Topsoil. Dark grayish black, friable, clayey silt with occasional tile and brick fragments.
0.14 – 0.23m	L1001	Made ground. Light yellowish brown, firm, silty clay with frequent chalk flecks
0.23 – 0.54m	L1002	Subsoil. Mid grayish brown, compact, silty clay with occasional medium angular flint nodules and small chalk flecks
0.54m +	L1003	Natural. Light orange brown, compact, clay with moderate chalk flecks and flint nodules.

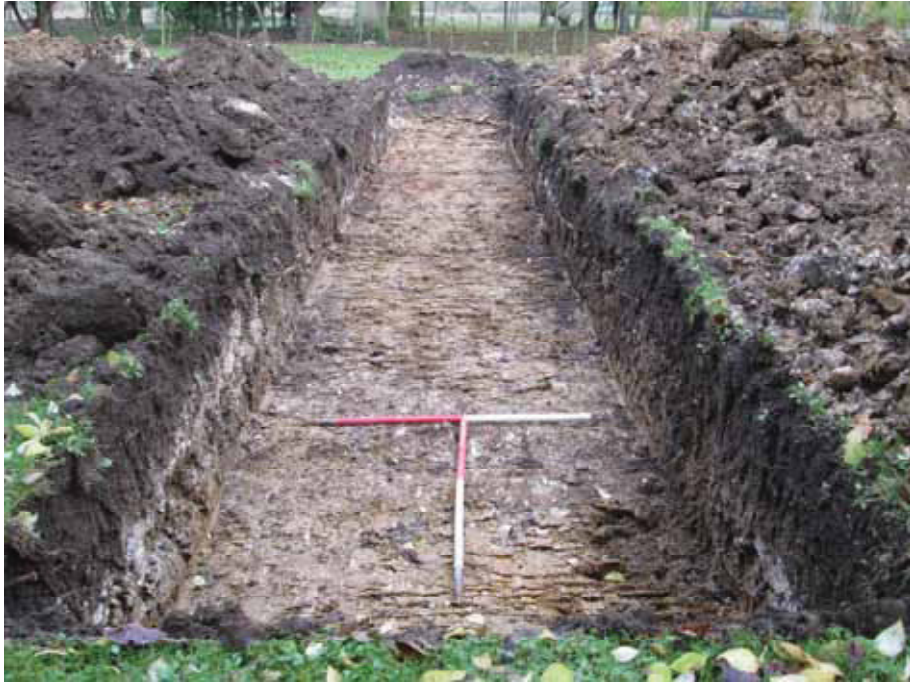
DP 5: Trial Trench 2 (post-excitation)

Description: No archaeological features or finds were present.

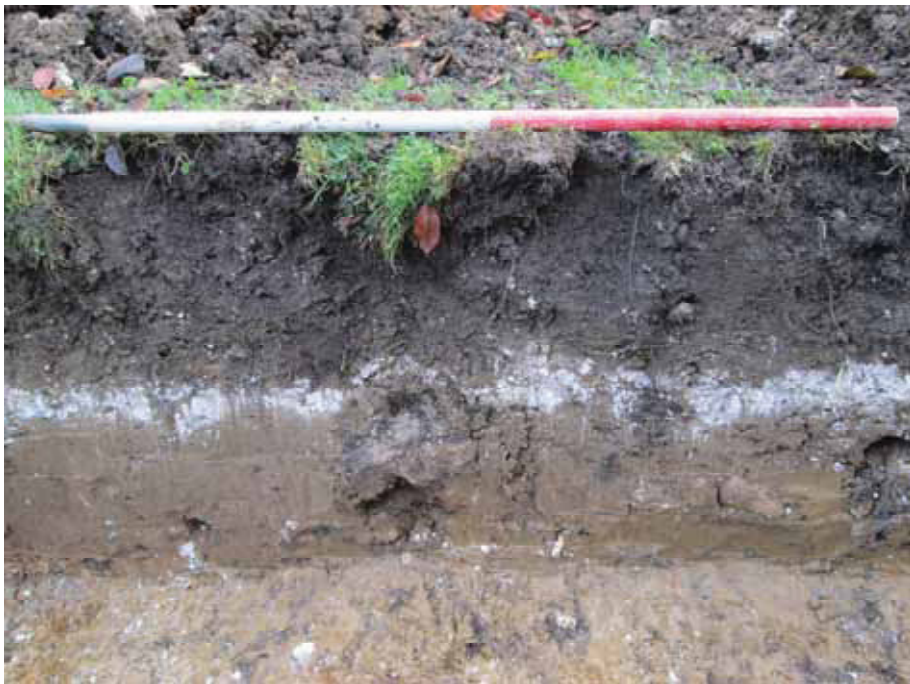
DP 6: Sample Section 2 (looking SE)

<i>Sample section</i> 0.00 = 112.43m AOD		
0.00 – 0.29m	L1000	Topsoil. As above Tr.1.
0.29– 0.35m	L1001	Made ground. As above Tr.1.
0.35 – 0.62m	L1002	Subsoil. As above Tr.1.
0.62m +	L1003	Natural. As above Tr.1.

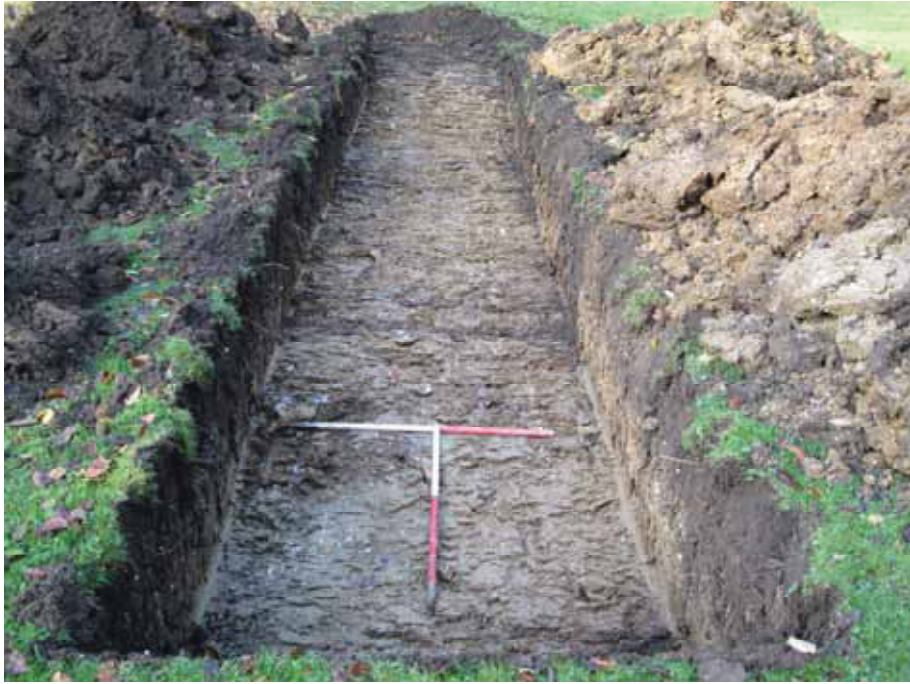
DP 7: Trial Trench 3 (post excavation)

Description: No archaeological features or finds were present.

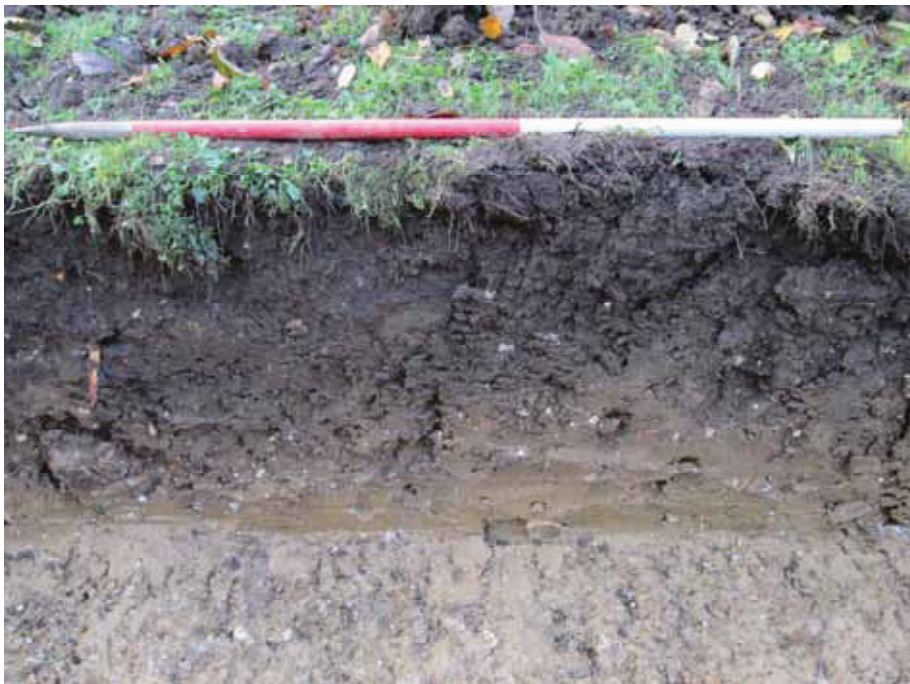
DP 8: Sample Section 3 (looking SW)

<i>Sample section</i> 0.00 = 112.65m AOD		
0.00 – 0.39m	L1000	Topsoil. As above Tr.1.
0.39 – 0.60m	L1002	Subsoil. As above Tr.1.
0.60m +	L1003	Natural. As above Tr.1.
