**BARN ADJACENT TO THE BROWN BEAR P.H.,
THE STREET, BRAUGHING, HERTFORDSHIRE**

**HISTORIC BUILDING RECORDING &
ARCHAEOLOGICAL MONITORING OF TRIAL PITS**

Authors:	Tansy Collins BSc Will Waring BA Kathren Henry	
NGR: TL 39741 25122		Report No: 4719
District: East Hertfordshire		Site Code: AS 1712
Approved: Claire Halpin		Project No: 5940
MifA Signed:		Date: 4 th November 2014

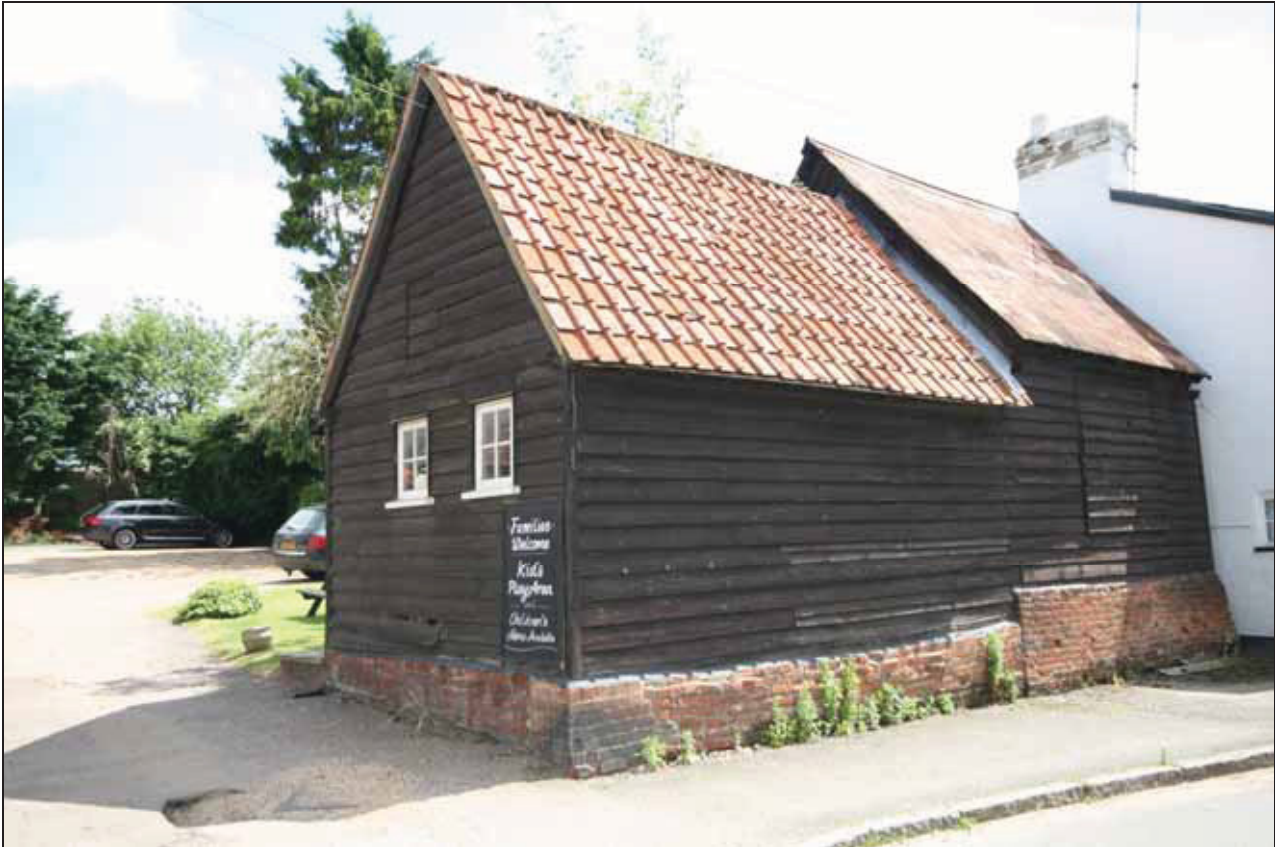
6.1 View of the west side of the assessment building prior to the start of works. Note the straight joint in the brickwork and varying roof cladding.

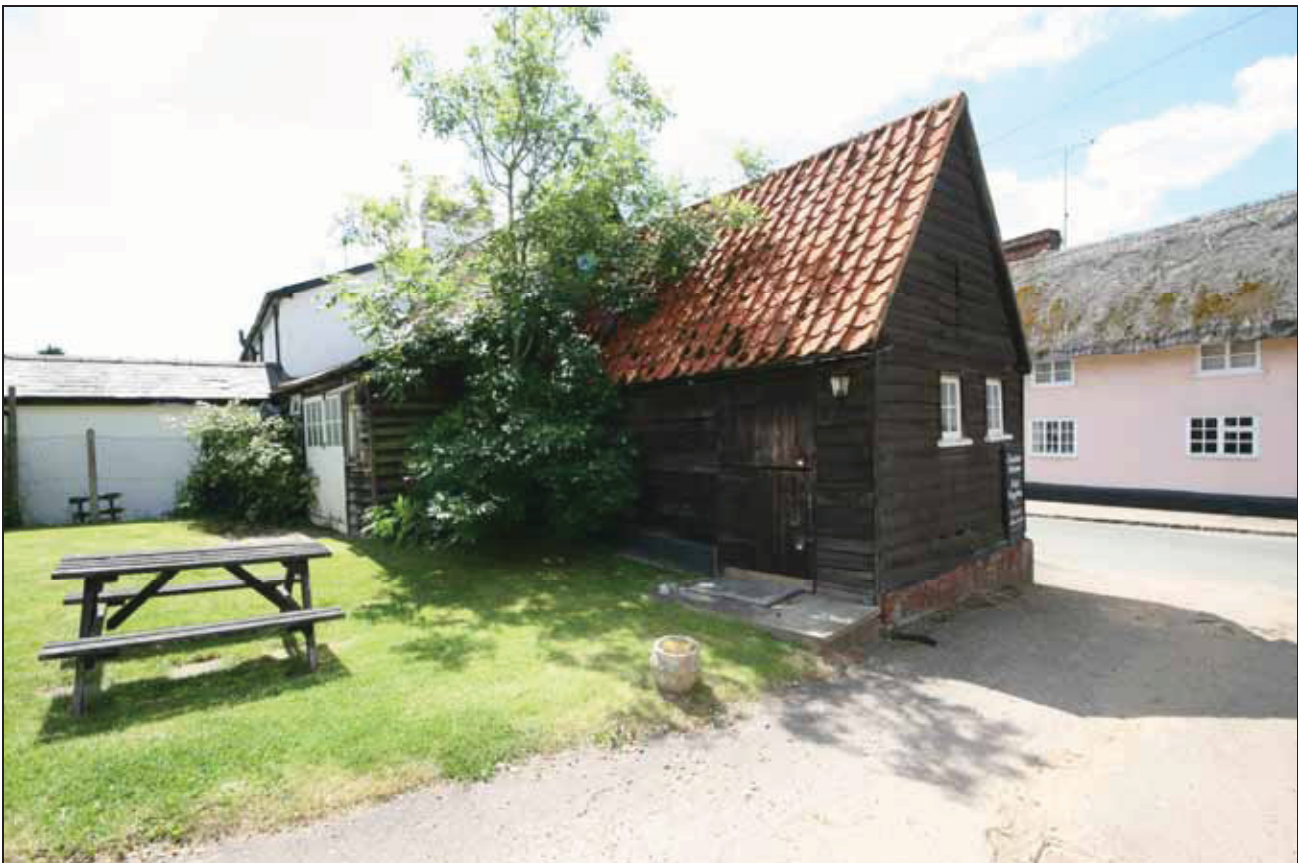
6.2 View of the east side of the assessment building prior to the start of works. The early 20th century rebuilding of the east range is visible enclosed by typical double garage doors.

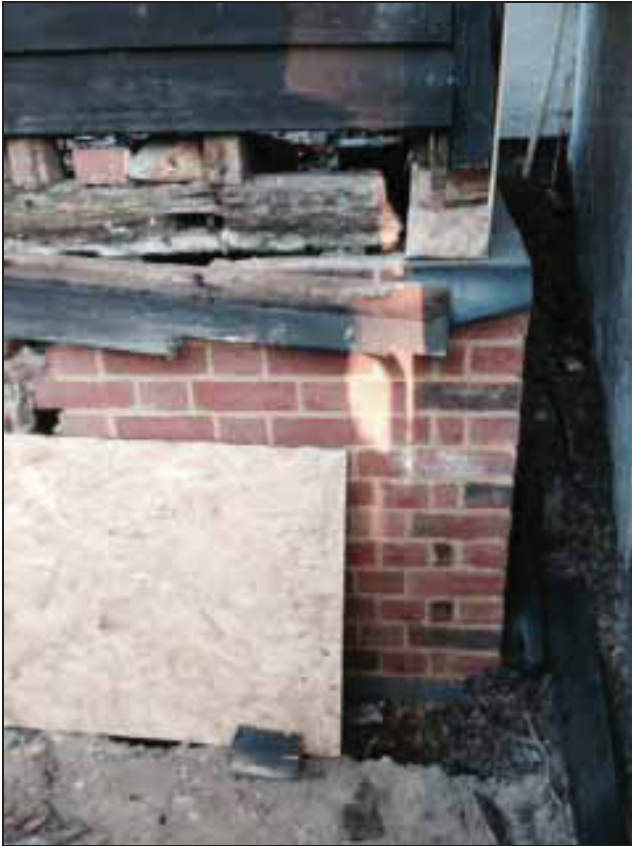
6.3 Detail of the south-west corner of the building. The dwarf wall has been replaced but the original sole-plate is visible.

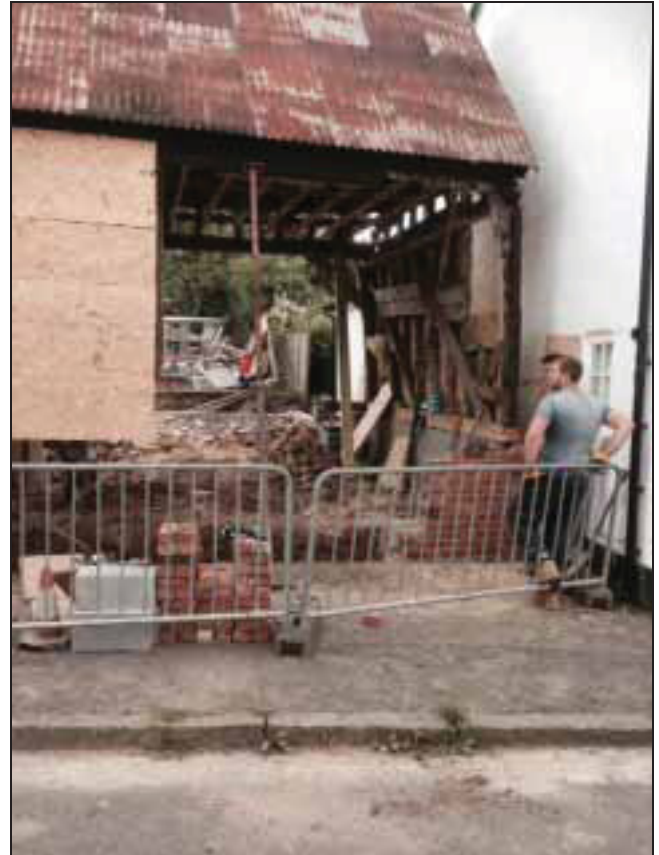
6.4 Working shot during the planned works. This shows the dwarf wall and sole-plate on the west removed as well as the pent-roofed unit on the east.

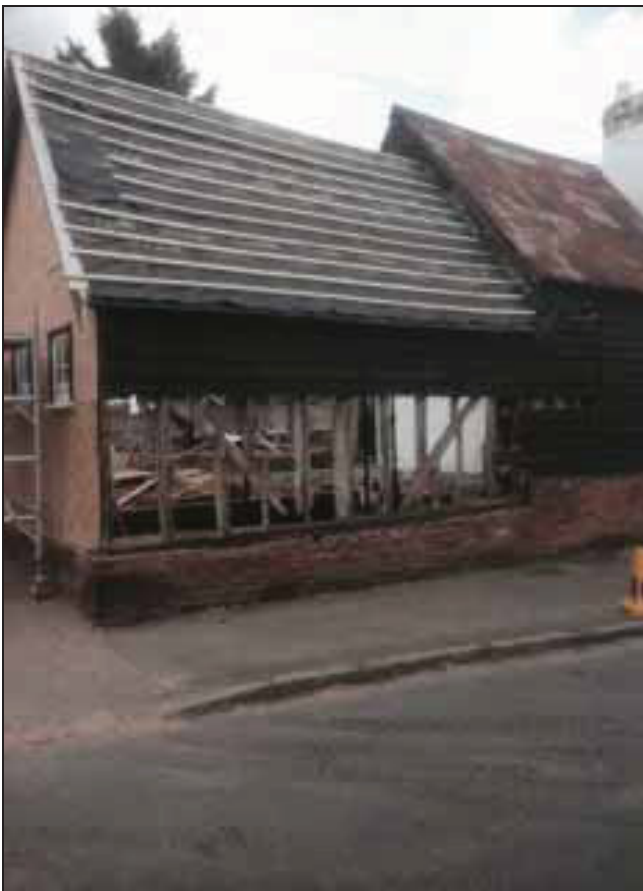
6.5 West side of the building. The weatherboarding has been partially removed though the underlying timber-framing is visible above the sole-plate and dwarf wall.

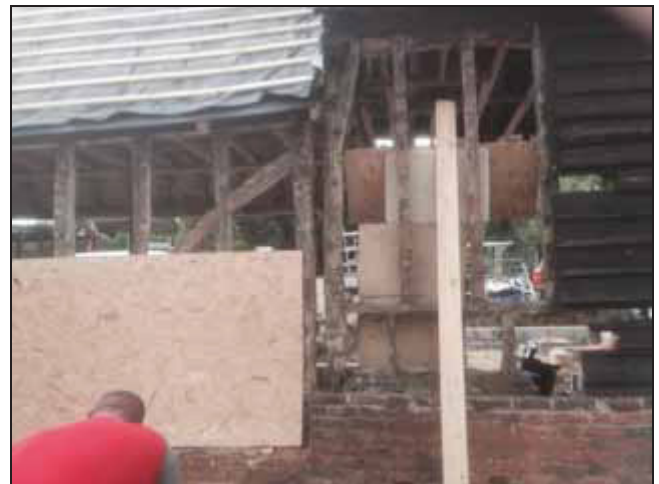
6.6 West side of the assessment building at the junction between the two ranges. The jowled post (right) is clearly visible.

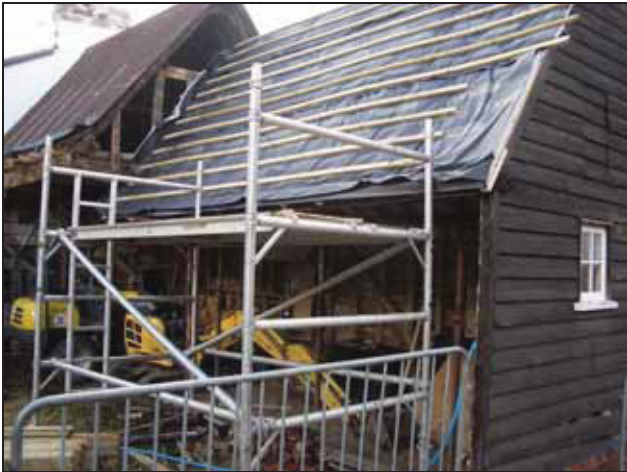
6.7 East side of the building following removal of the pan-tiles as well as the timber-framing on this side.

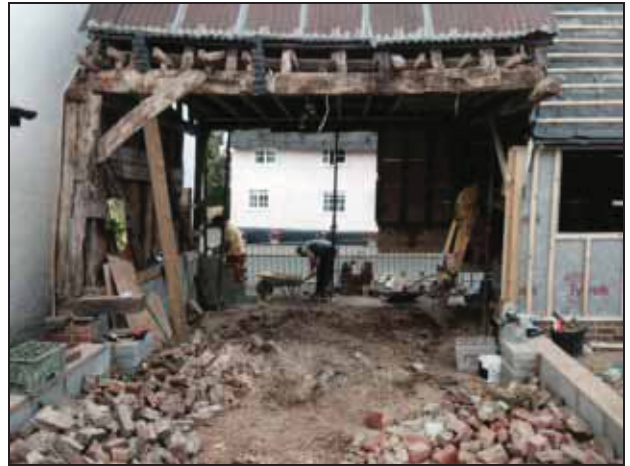
6.8 East side of the building (south unit) following removal of the early 20th century pent-roofed element and during construction of the extension.

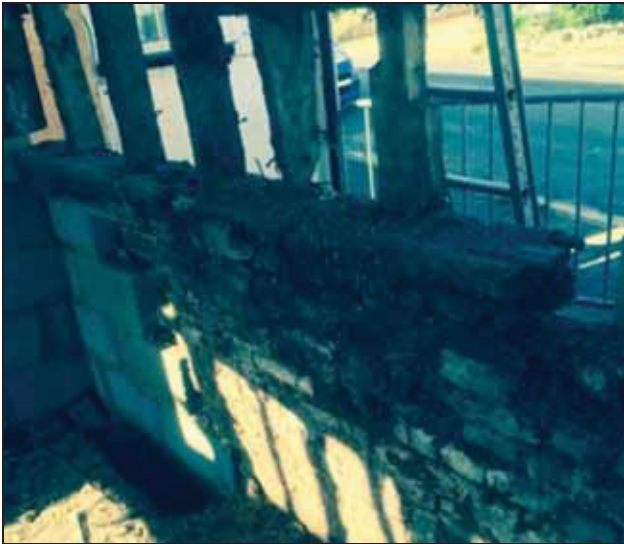
6.10 West side of the south unit showing surviving sole-plate with the corner below rebuilt in blockwork

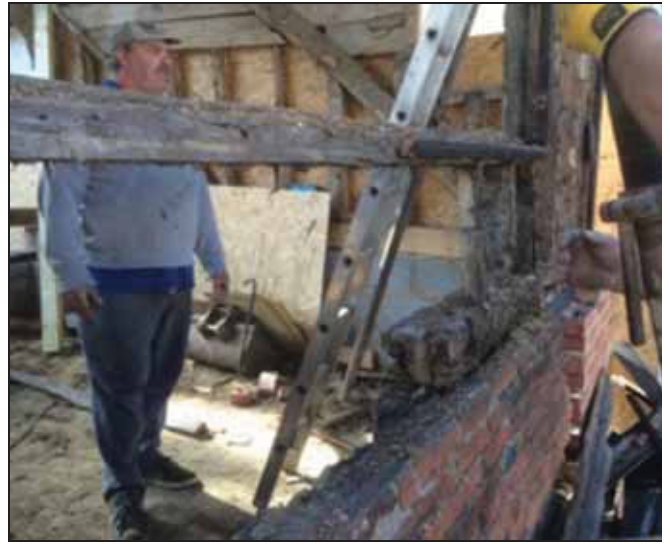
6.11 West side of the south unit showing fragment of sole-plate over the early brickwork of the dwarf wall

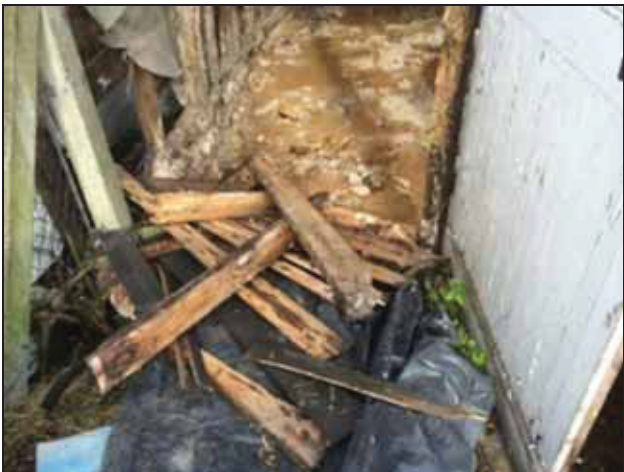
6.12 Area of the east pent-roofed extension with removed studs

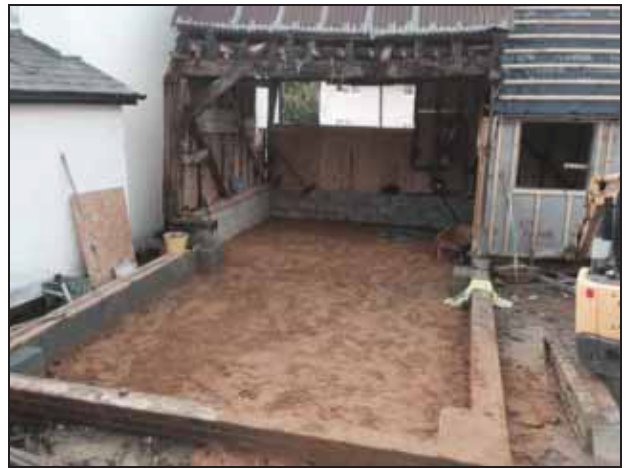
6.13 East side of the building (south unit) following removal of the early 20th century pent-roofed element and during construction of the extension.

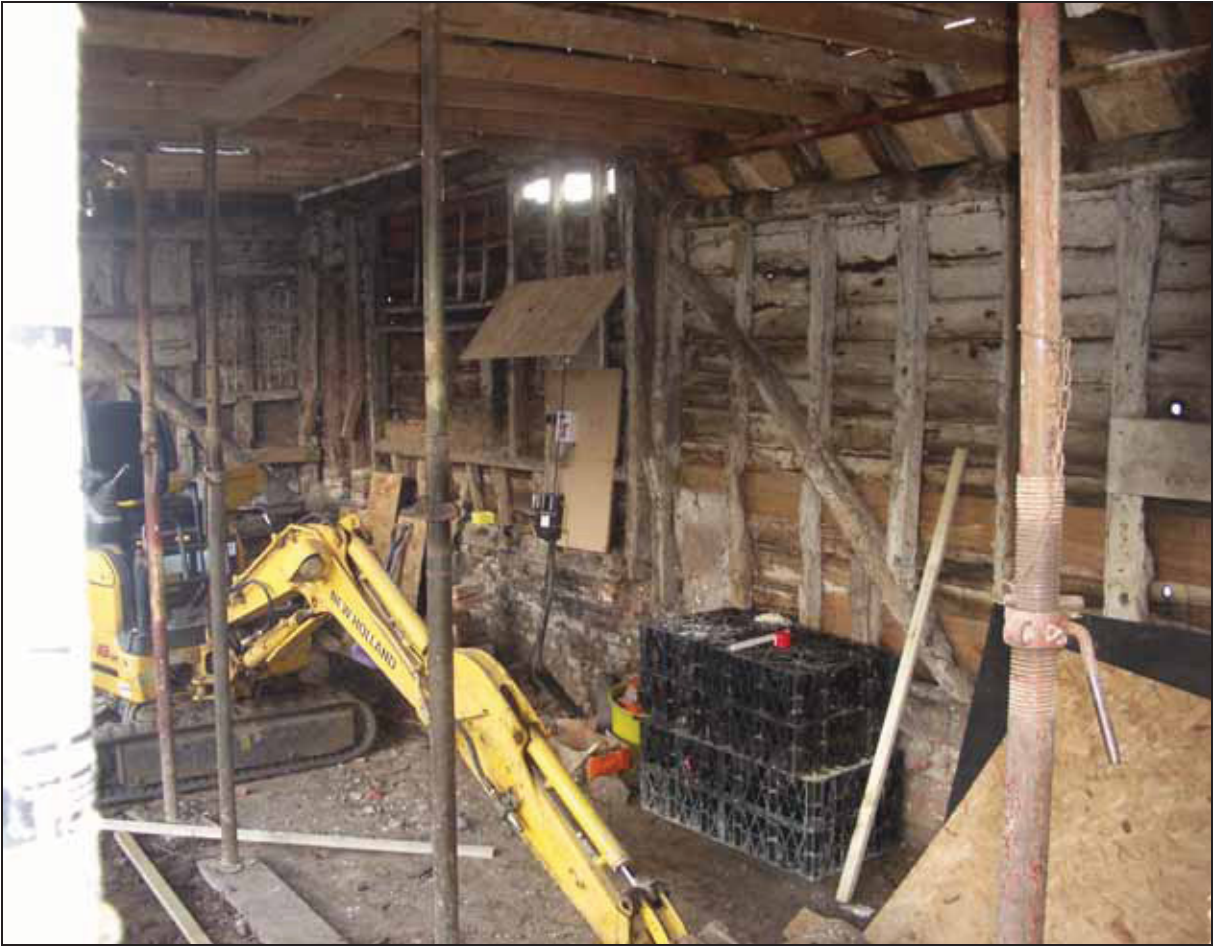
6.14 Interior of the building during planned works showing primary-braced studwork on the right with the former apertures visible to the rear.

5.12 The second phase of remodelling appears to have been carried out in the 18th century and saw the replacement of the wall panels with a primary-braced system of studwork. The timber used is variable as a number of the original more robust studs from the earlier phase have been reused, with additional members being of more slender character.

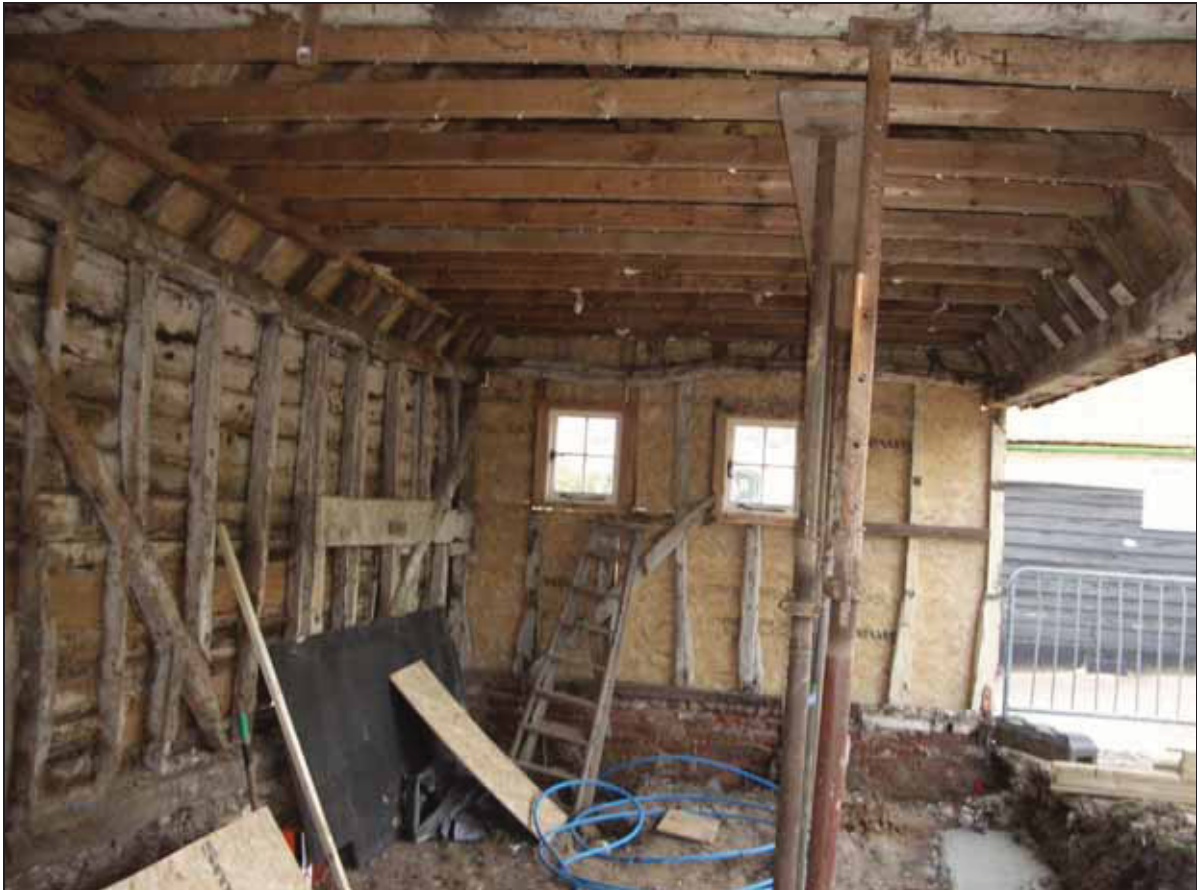
6.15 Interior of the north unit showing timber-framing of the west and north walls. Note the weatherboarding to the rear on the left.

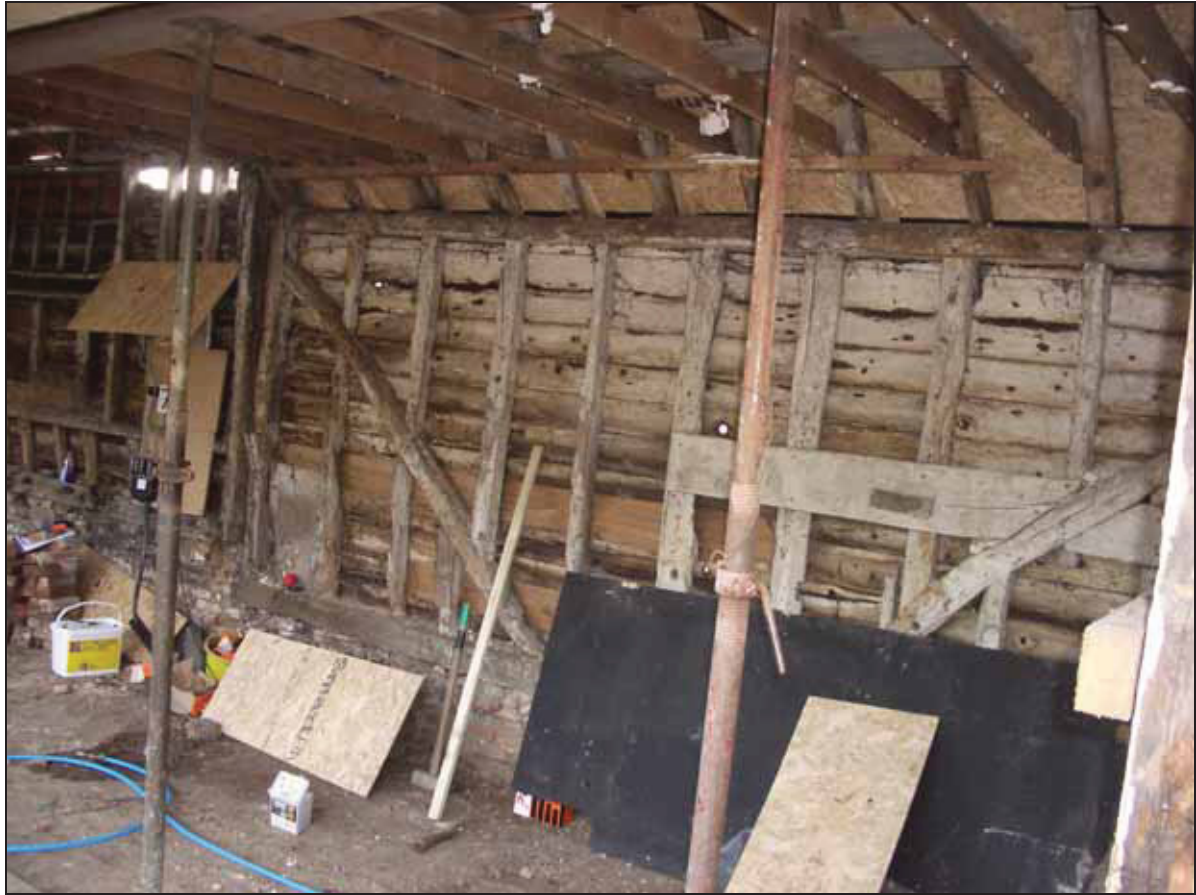
6.16 West wall of the north unit showing weatherboarding to the rear. The sole-plate is visible as well a small section of the brickwork of the dwarf wall.

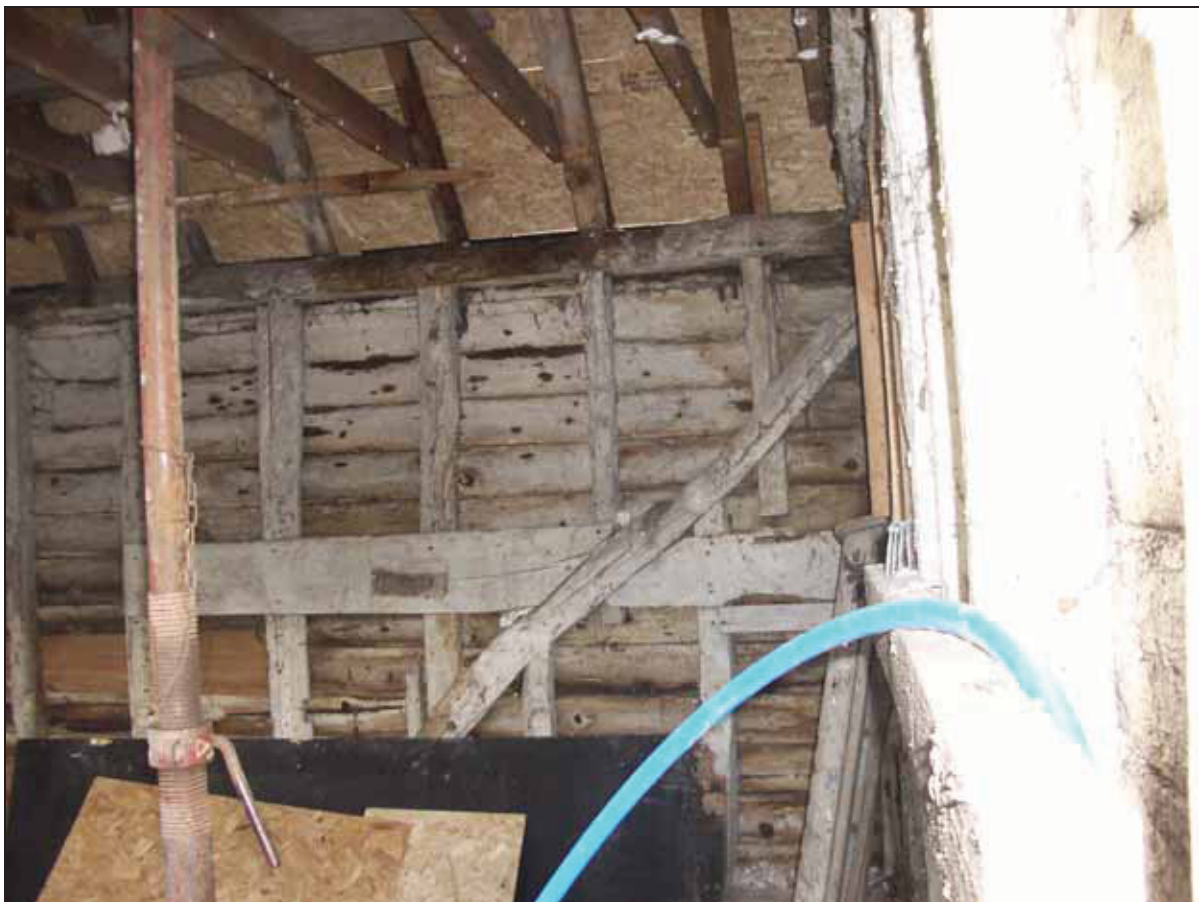
6.17 Detail of the west wall of the north units showing studwork with later applied brace.

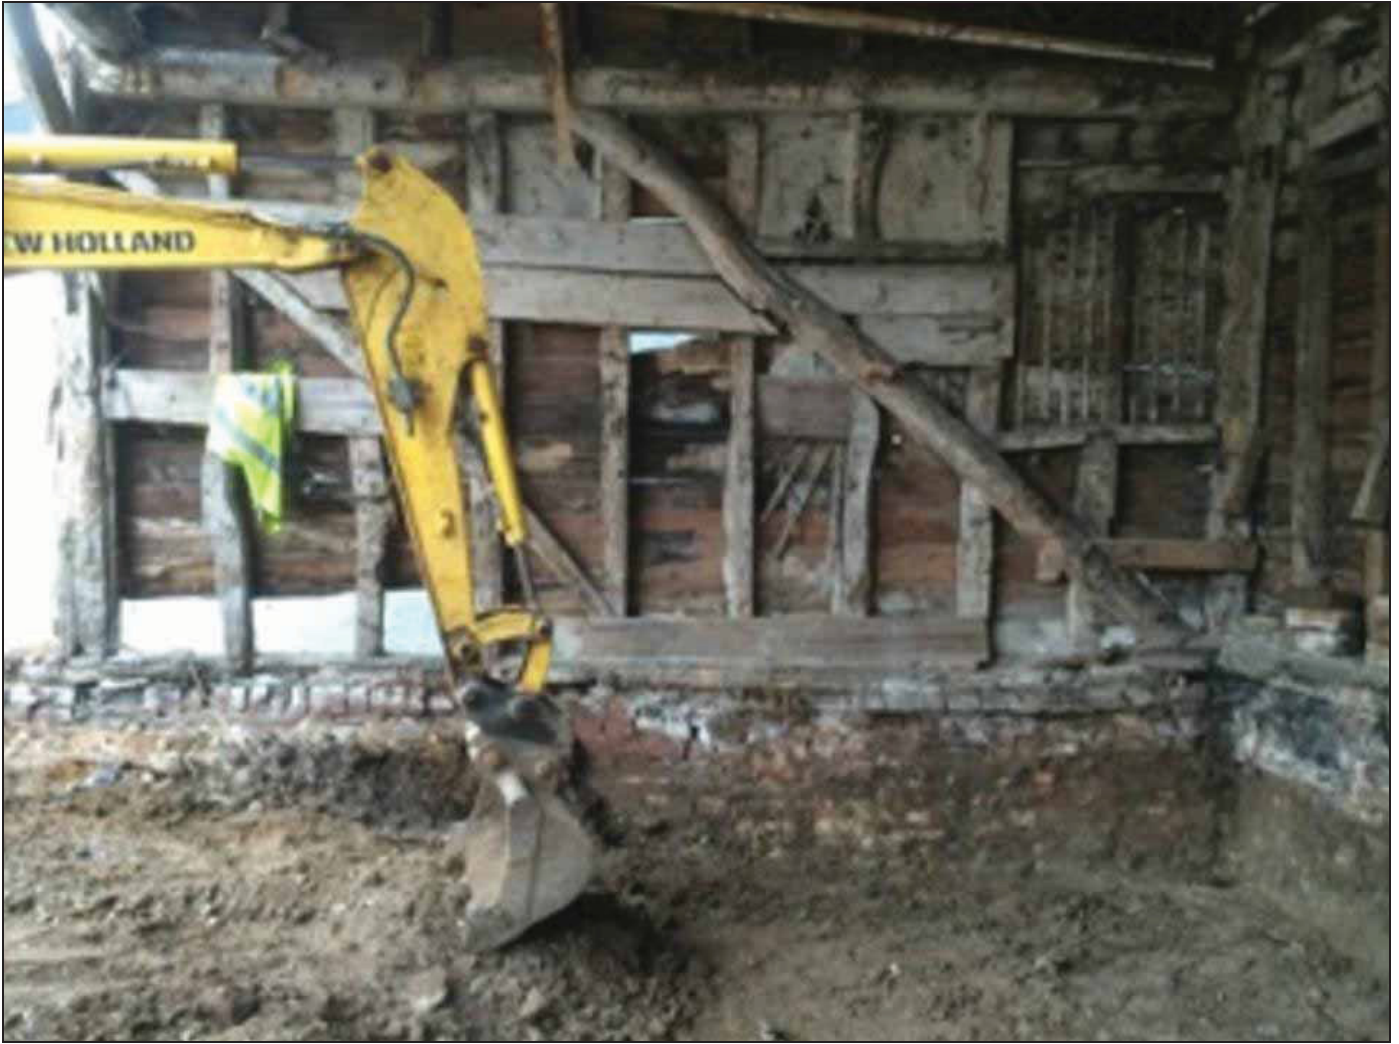
6.18 South wall of the south unit taken during floor reduction works. The former aperture is visible on the right. What appears to be sections of historic lath and plaster are visible infilling the gaps between the studs.

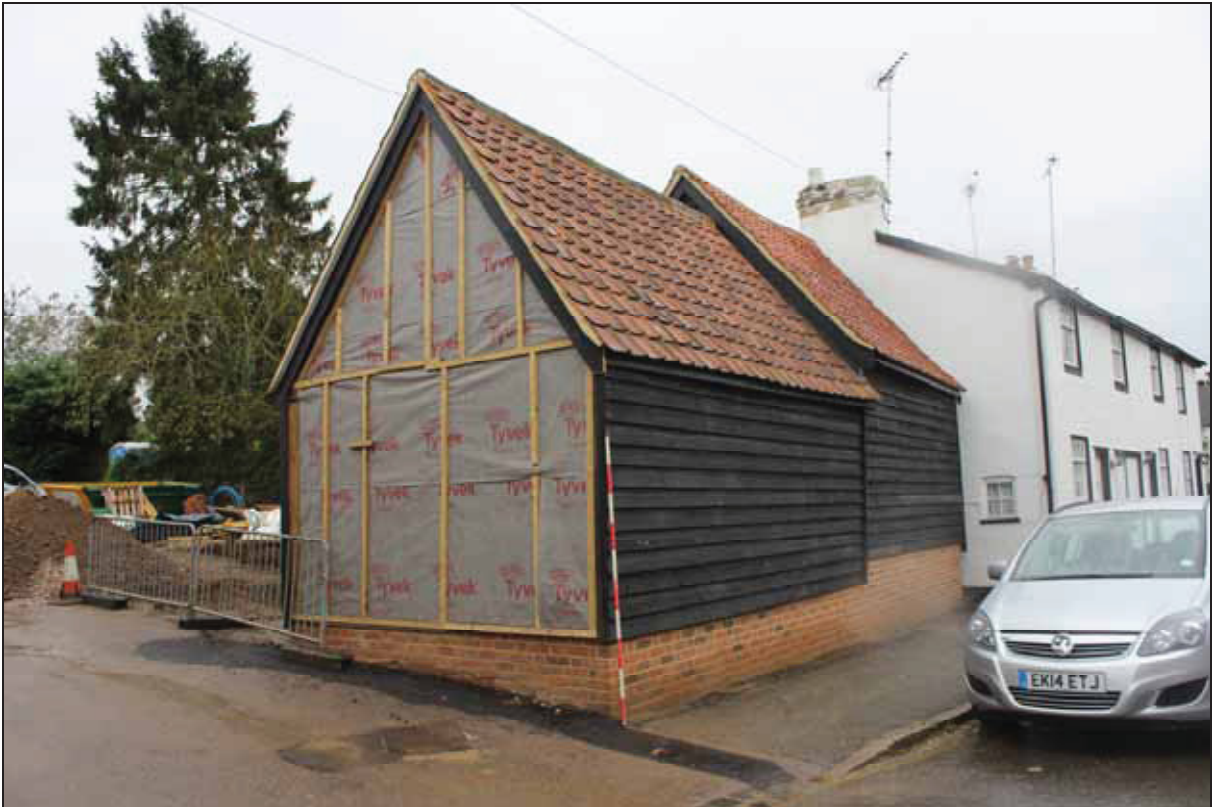
Plate 1 North and west elevations, taken from the north-west (DP 1)

5.2 As noted, the planned works were well advanced at the time of the survey. Works already carried out included the rebuilding of the brick dwarf wall and the replacement of the external weatherboarding and roof covering (Plate 1). Internally, the sole-plate has been replaced all round and timber-framing partially removed, particularly the east side and an area on the west. The wall-plates appear to survive, as well as the roof structure. However, a number of photographs taken during the works were provided by the client and along with the surviving historic fabric allowed an adequate understanding of the building and its historic development.

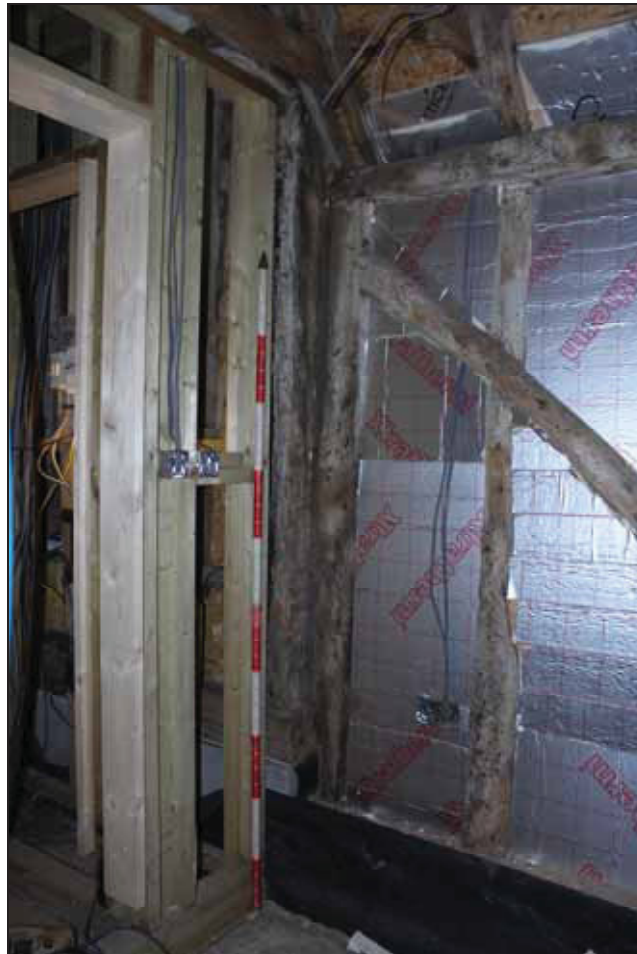
Plate 2 Detail of the junction between the two units showing adjacent posts marking the structural divide, taken from the north-east (DP 14)

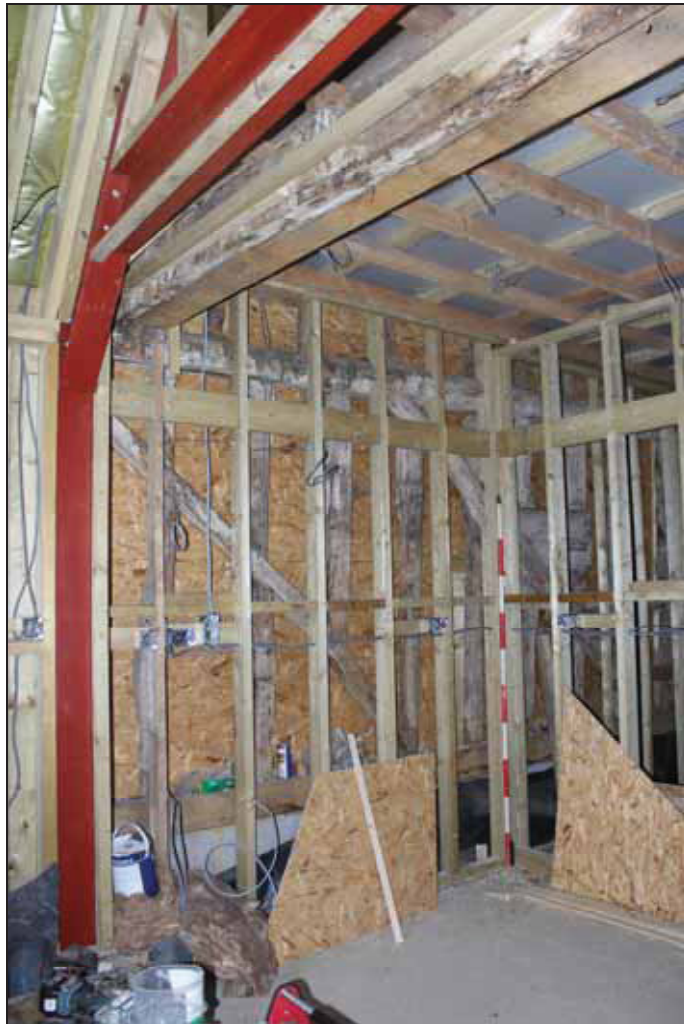
Plate 3 View of the south wall with east binding joist/tie-beam visible above (Area 1), taken from the north (DP 21)

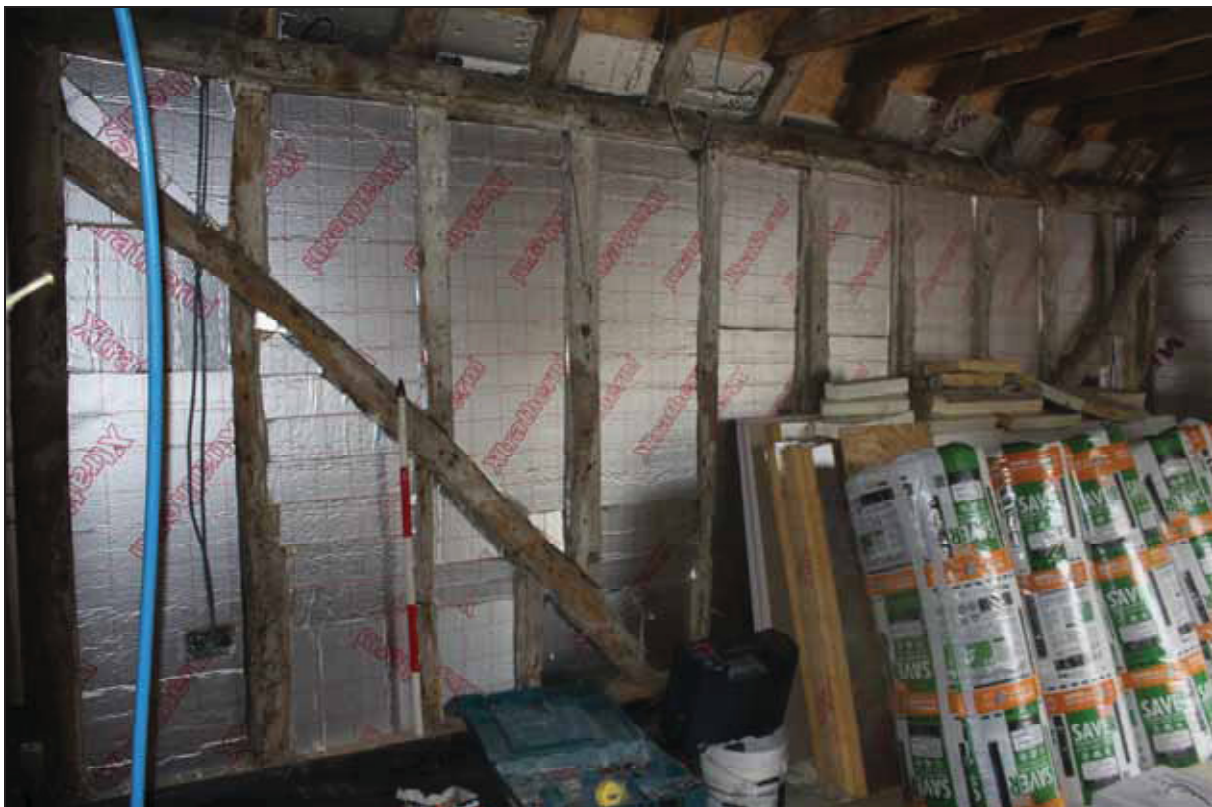
Plate 4 West wall of Area 2, taken from the south-east (DP 8)

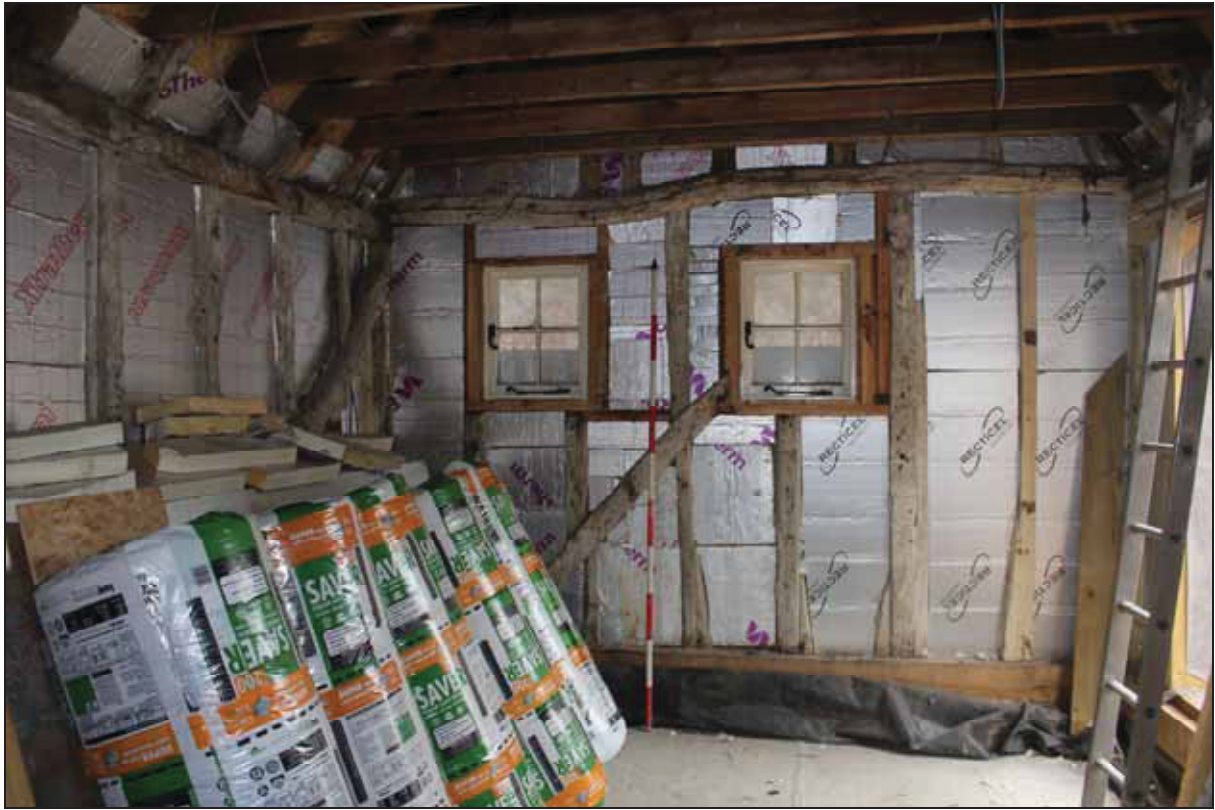
Plate 5 Timber-framing exposed on the west and north walls (Area 2), taken from the south (DP 6)

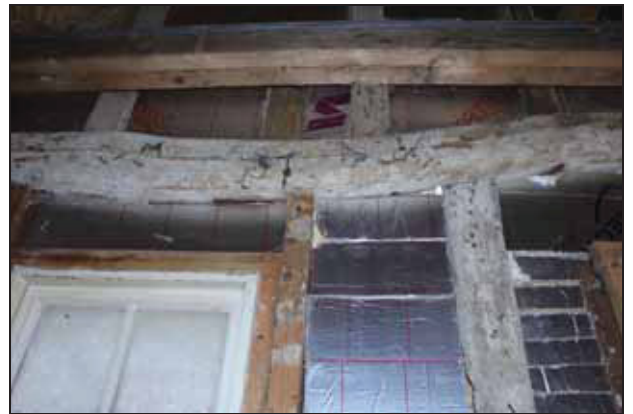
DP 10
 Detail of the north wall-plate (Area 2) showing redundant mortice for stud removed with the insertion of the casement window, taken from the south

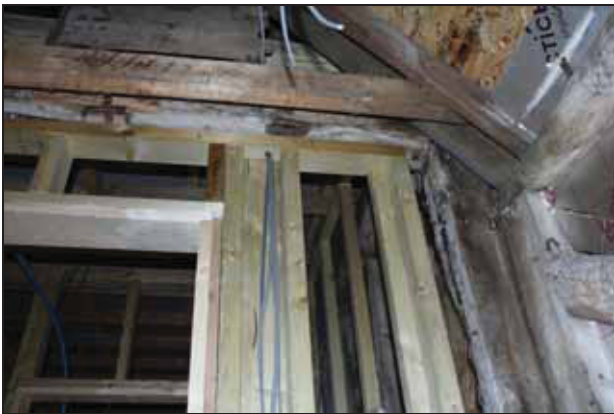
DP 15

Detail of the junction between the two units showing empty pegged mortices in the soffit of the south unit wall-plate, taken from the north

5.10 Wall-plates survive on the north and south, though that on the south largely replaced and scarfed in to the earlier fabric at the west end, and retain mortices in the soffit for original studwork though the existing studwork on the south is later, see below, and the north side is now open with the adjoining unit.

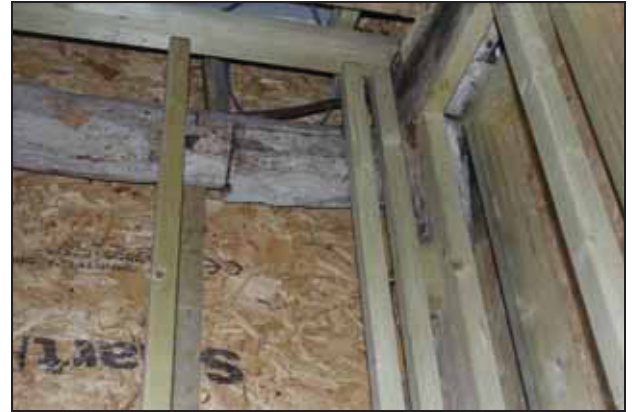
DP 20
Crude scarf joint in an area of repair on the south wall-plate (Area 1), taken from the north

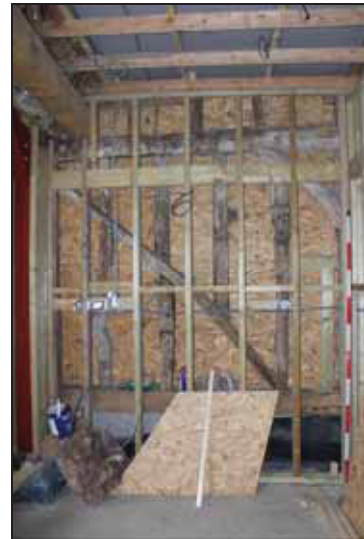
DP 22
View of the south wall showing primary-braced studwork (Area 1), taken from the north

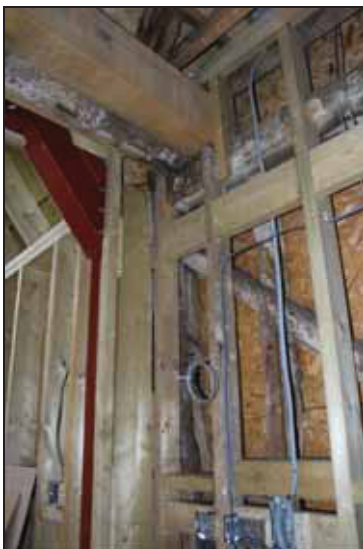
DP 23
Detail of the south-east corner post showing binding joist offset from the position of the bay post, taken from the north-west

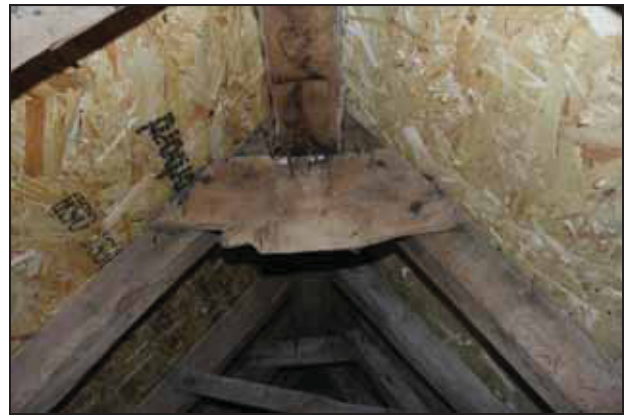
DP 28

Detail of a nailed-on yoke piece below the ridge purlin in the roof space over Area 1, taken from the south

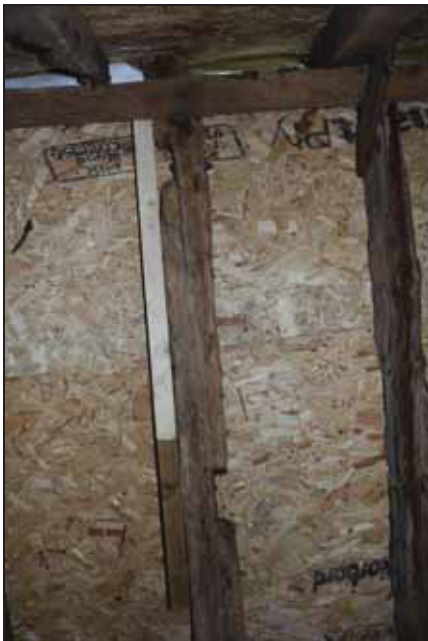
DP 29

Detail showing a reused timber used in the roof structure over Area 1, taken from the west

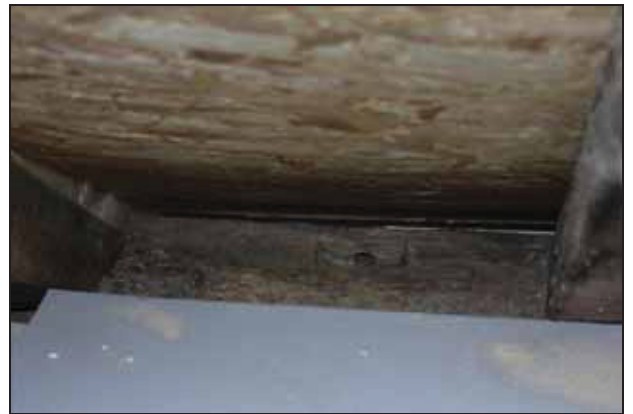
DP 30

View of the west tie-beam (Area 1) showing pegged mortice in the upper face for a lost stud relating to the earlier arrangement, taken from the east
