**PEMBERTON BUILDING, ALBAN CITY SCHOOL,
7 HATFIELD ROAD, ST ALBANS,
HERTFORDSHIRE**

HISTORIC BUILDING RECORDING

Level 4

Author: Lauren Wilson MA PCIfA Lee Prosser PhD Kate Higgs MA (Oxon.) Kath Henry (Graphics)	
NGR: TL 1503 0754	Report No: 5134
District: St Albans City and District	Site Code: AS1827
Approved: Claire Halpin MCIfA	Project No: 6564
Signed:	Date: 26 May 2016

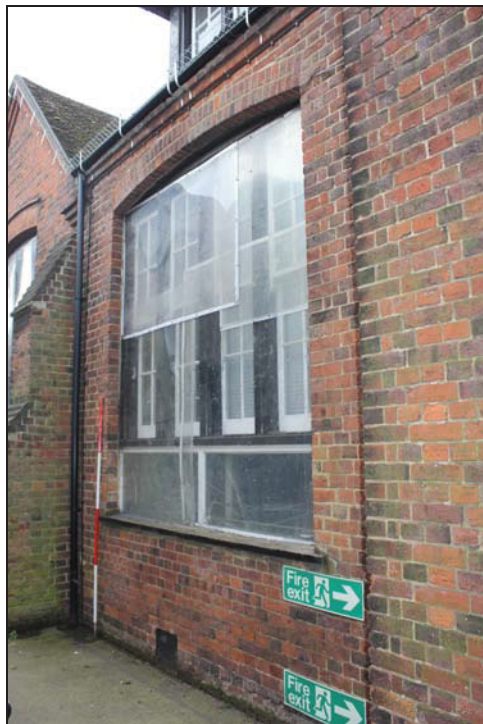
Plate 6 Window on the east elevation, taken from the north-east (DP 16)

5.5 Adjoining to the south is a wide, large four-light mullioned window, each with a four-over-four sash, which has been dropped by 0.5m to insert extra panes (Plate 6). This is clearly distinguishable by the replacement of the stone sill with timber and disturbance in the brick jambs. The window sits beneath a simple cambered arch with no drip mould and below a three-light dormer window, each with six panes of pivoting casement form, within a heavily moulded Tudor-style

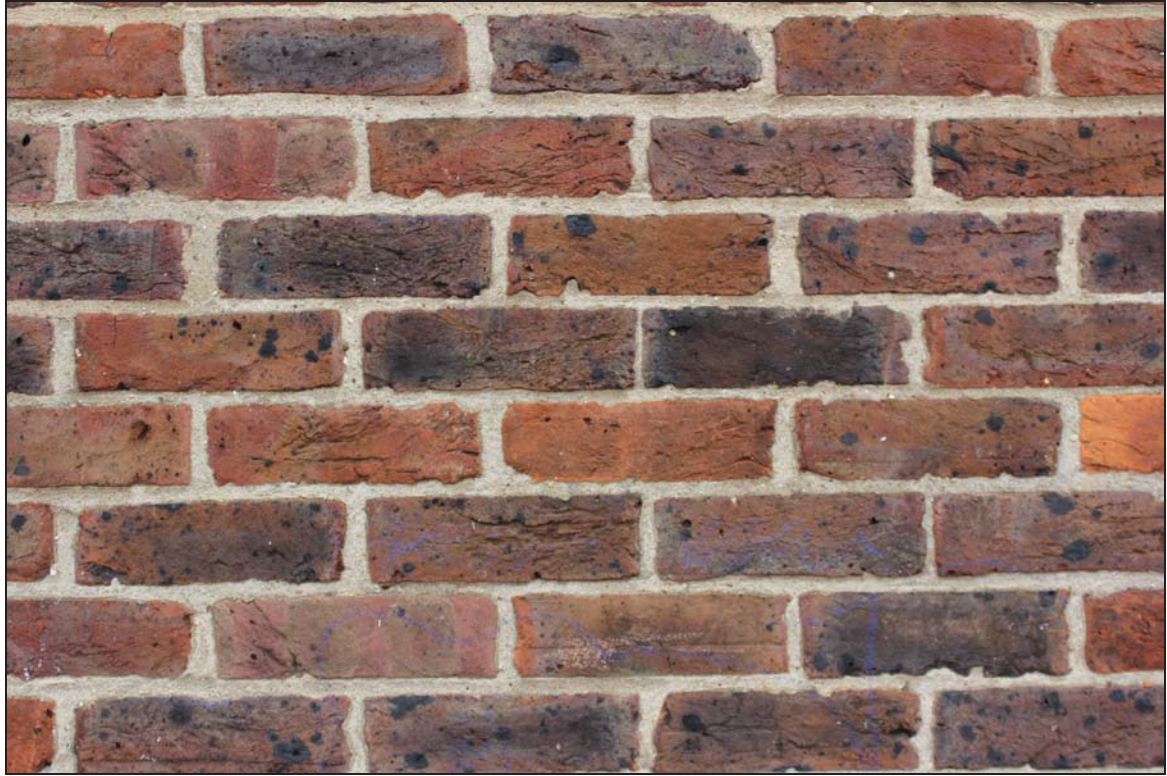
Plate 11 Brickwork on the west elevation, taken from the west (DP 11)

5.9 The flat-roofed extension which fills the rest of the re-entrant angle is undistinguished but care has been taken to match the brickwork, which is laid in stretcher bond (Plate 11). Four windows of four-light form on the south end and two windows on the west have all been replaced in plastic. A second dormer window is visible on the roof of the main classroom range, flat-roof and multi-paned. A second chimney rises from between Classrooms 2 and 3 (Plate 12).

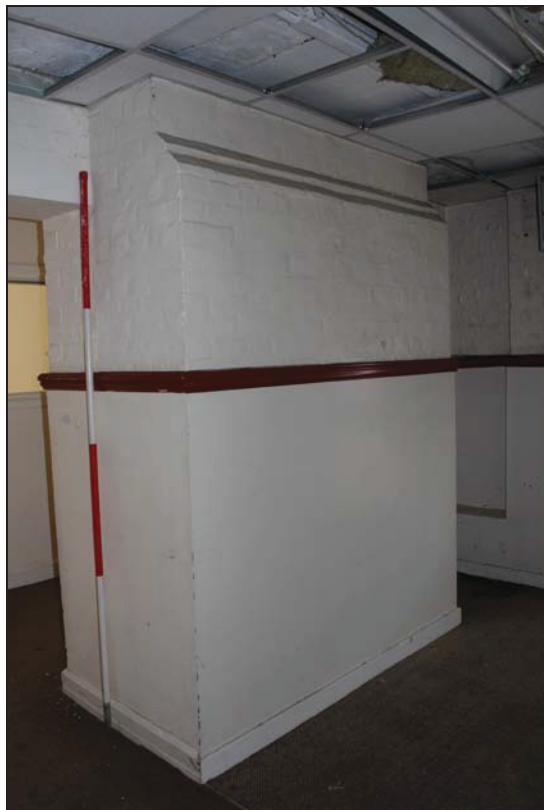
Plate 30 Chimney stack on what would have been the west external wall of Classroom 3, taken from the north-west (DP 83)

upper level, multi-paned with four light pivoting casements. At lower level large supporting jambs remain in situ. The west wall preserves traces of a stack for a stove which rises to the little blind gable noted above (Plate 30).
