**LAND EAST OF CAMBRIDGE ROAD, PUCKERIDGE,
HERTFORDSHIRE**

ARCHAEOLOGICAL TRIAL TRENCH EVALUATION

| NGR: TL 38403 22880 | Report No: 5165 |

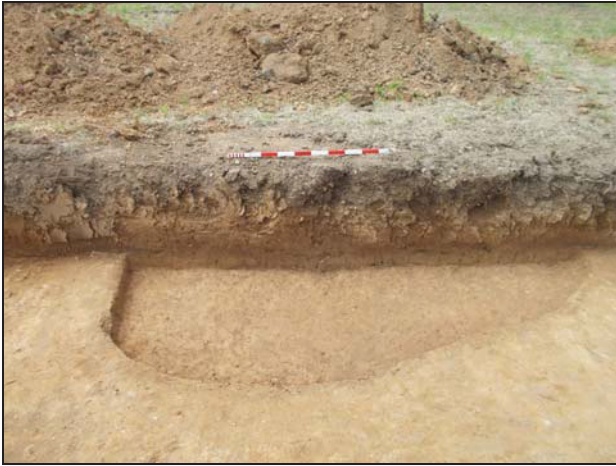
1
F1007 in Trench 2 looking north-west

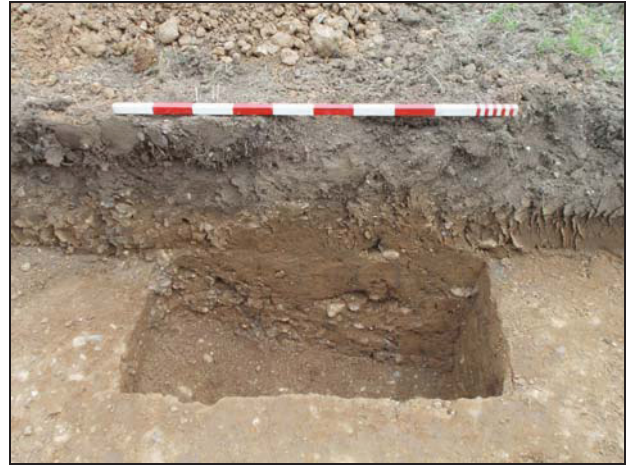
Pit F1010 was sub-circular (1.00+ x 0.50+ x 0.38m) with moderately sloping sides and a concave base. Its fill (L1011) was a friable, orange brown silt with frequent rounded and sub-rounded gravel. It contained no finds.

2
F1010 in Trench 2 looking south-east

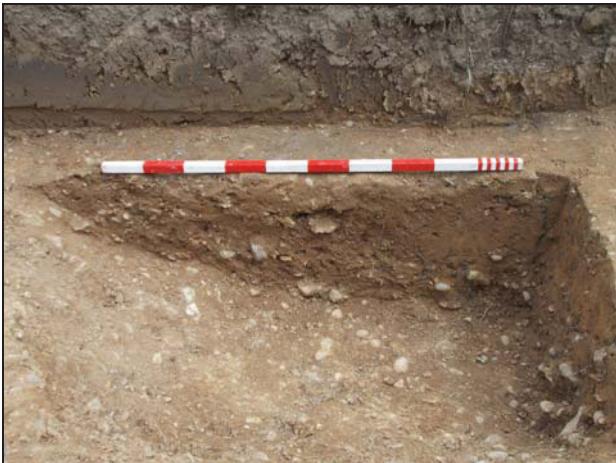
F1012 was an irregular linear feature (1.00+ x 0.66 x 0.39m), with moderately sloping sides and a concave base. Its fill (L1013) was a friable, orange brown silt with frequent rounded and sub-rounded gravel. It contained no finds.

3
F1012 in Trench 2 looking south-east

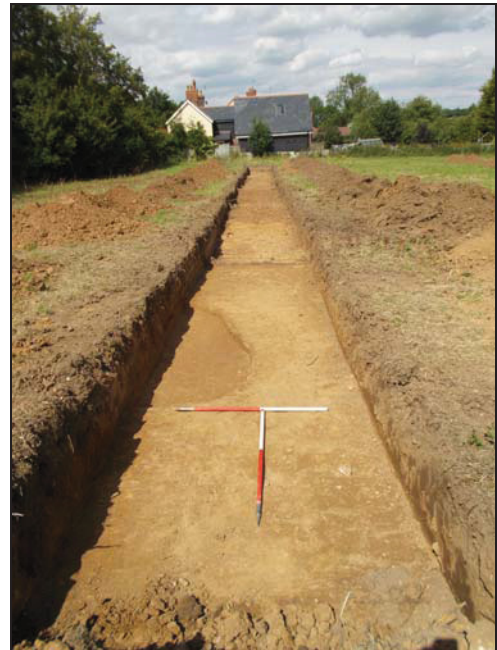
Description: Trench 2 contained a two undated Pits F1008 and F1010, and an undated irregular linear feature, F1012.

4
Post-excavation view of Trench 2 looking north-east

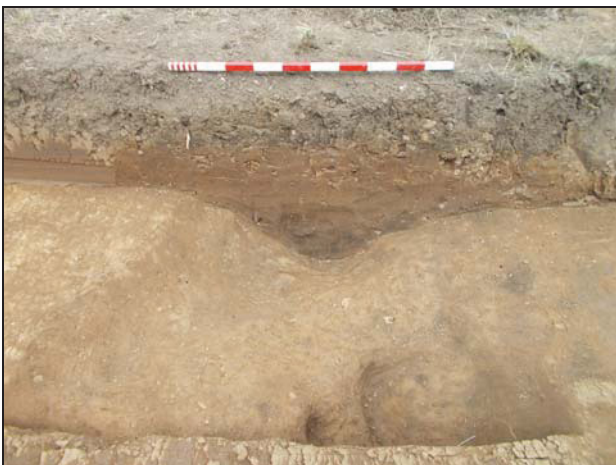
Ditch F1014 was linear (1.80+ x 1.30 x 0.11m), orientated northeast / southwest, with moderately sloping sides and a concave base. Its fill (L1015) was a firm, mid grey orange clay silt. It contained no finds.

5
F1014 in Trench 3 looking north-east

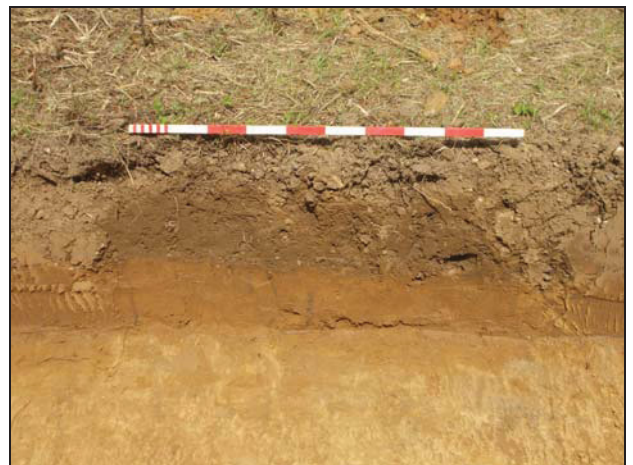
6
Sample Section 3A in Trench 3 looking north-east

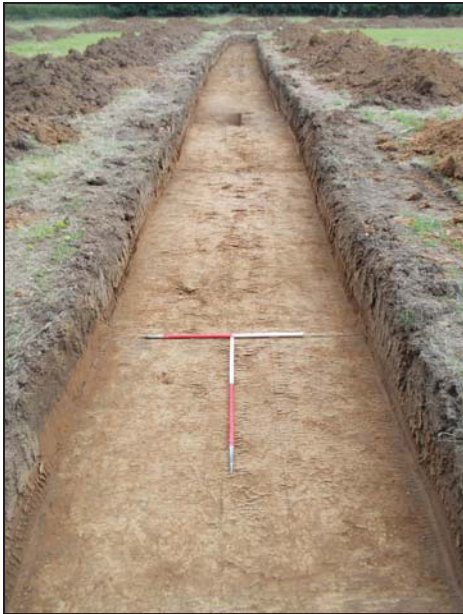
Description: Trench 3 contained undated Ditch F1014.

7
Post-excavation view of Trench 3 looking south-east

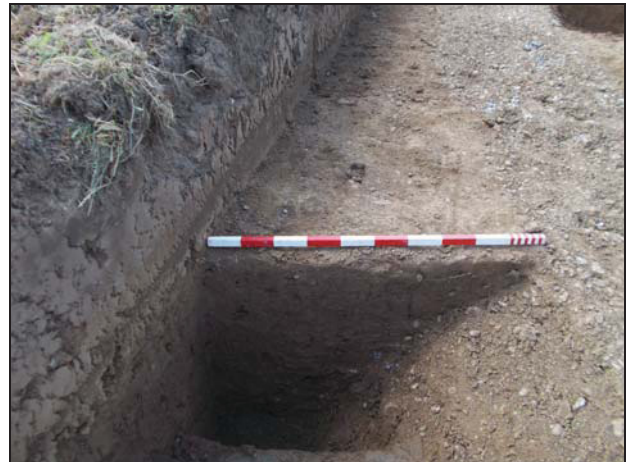
Ditch F1004 was linear (8.00+ x 1.80+ x 0.72+m), orientated N / S, with a

moderate sloping northwest side. The base was not reached. Its fill (L1005) was a compact, pale yellow brown sandy silt, with moderate small stones. It contained a struck flint (9g).

8
F1004 in Trench 4 looking north-west

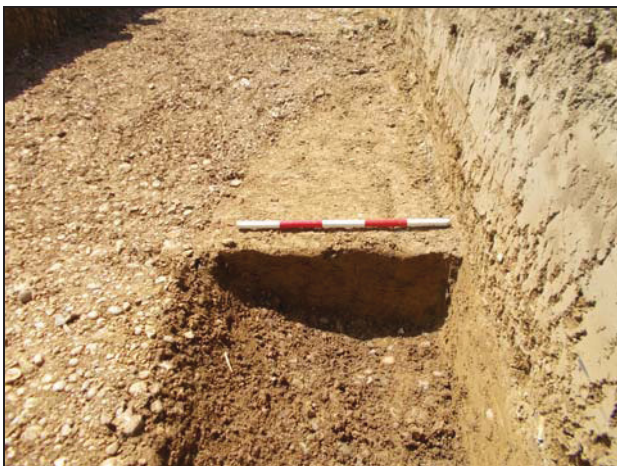
F1006 was a curvilinear feature (6.00+ x 0.60+ x 0.26m) of possible natural origin. It had moderate sloping sides and a concave base. Its fill (L1007) was a compact, pale yellow brown sandy silt that contained no finds.

9
F1006 in Trench 4 looking south-west

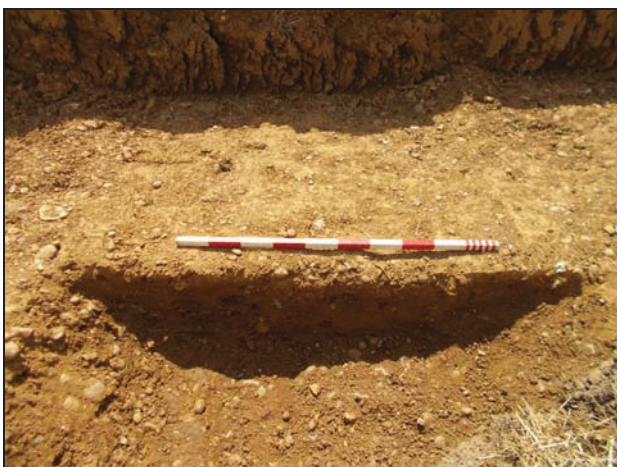
Ditch F1018 was linear (1.80 x 1.60 x 0.31m), orientated northeast / southwest, with moderately sloping sides and a concave base. Its fill (L1019) was a compact, mid brown sandy silt, with moderate small stones. It contained two fragments of highly abraded Roman CBM (55g).

11
F1018 in Trench 10 looking south-west

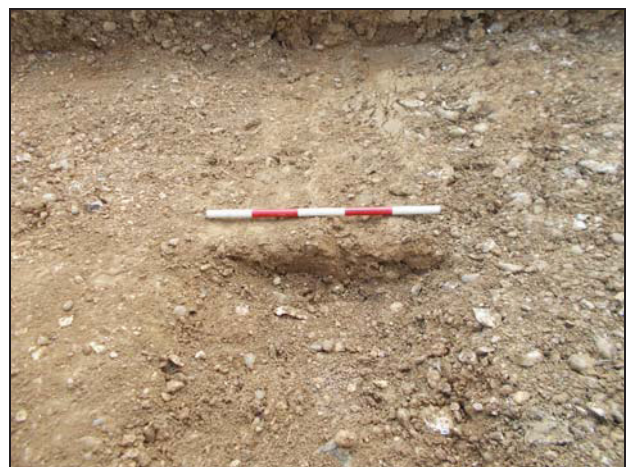
Ditch F1020 was linear (1.80+ x 0.53 x 0.11m), orientated northeast / southwest, with gently sloping sides and a concave base. Its fill (L1021) was a firm, pale-mid brown sandy silt, with frequent small stones. It contained no finds.

12
F1020 in Trench 10 looking south-west

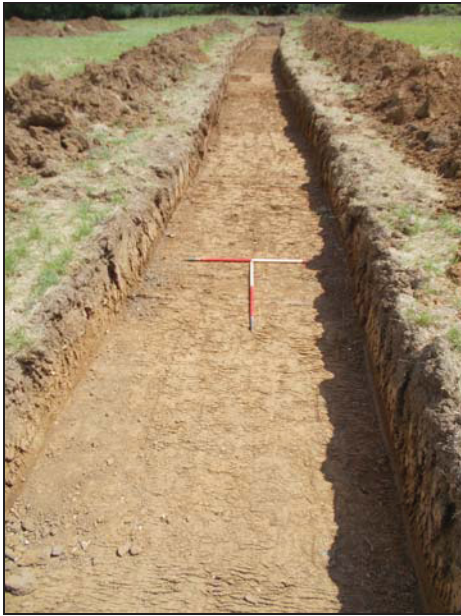
Description: Trench 10 contained undated Ditches F1018 and F1020.

13
Post-excavation view of Trench 10 looking south-east

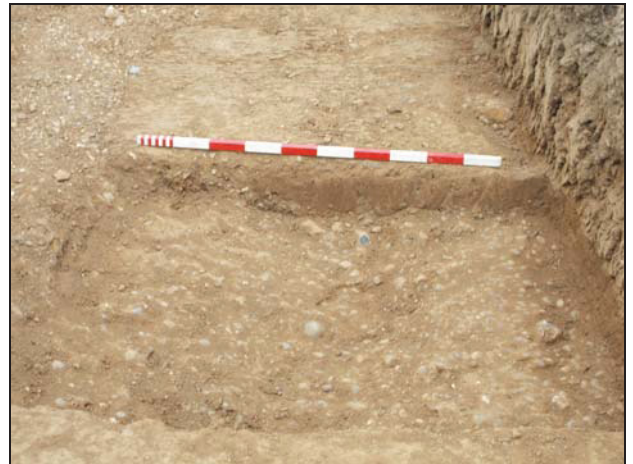
14
F1024 in trench 13 looking north-east

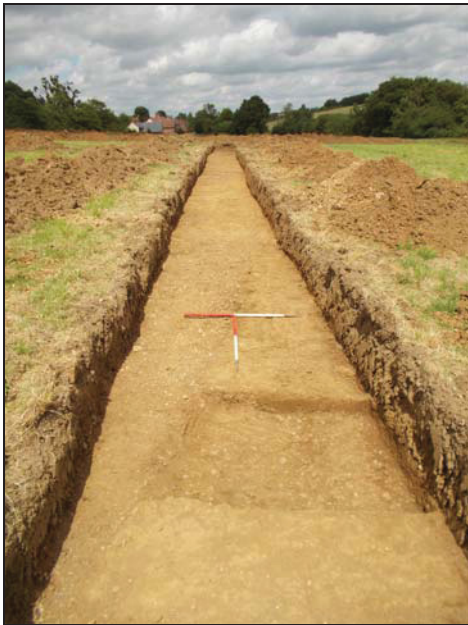
15
Post-excavation view of Trench 13 looking north-east
