**LAND EAST OF SAINSBURY'S CAR PARK, ALBION STREET,
KING'S LYNN, NORFOLK**

**MONITORING OF WORKS UNDER
ARCHAEOLOGICAL SUPERVISION AND CONTROL**

Authors:	Vinny Monahan (Fieldwork and report) Antony R.R. Mustchin (Editor) Peter Thompson (Background)	
Illustrations:	Thomas Light	
NGR: TF 62085 20170		Report No: 4803
District: King's Lynn and West Norfolk		Site Code: ENF 135902
Approved: Claire Halpin MfA		Project No: 6039
Signed:		Date: 19 March 2015

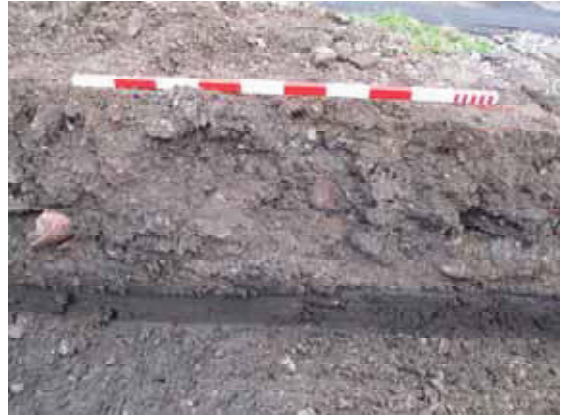
DP2: Sample Section 1, looking E

<i>Sample section 1 (Figs. 3-4; DP2)</i> 0.00 = 4.95m AOD		
0.00-0.50m	L1000	Made ground. Friable, mid yellow to light greyish brown silty sand with moderate, small to medium modern CBM (brick) rubble
0.50-0.63m	L1001	Made ground. Compact, dark brown silty sand with occasional, small CBM (brick) rubble

Description: Sample Section 1 contained no archaeological deposits.

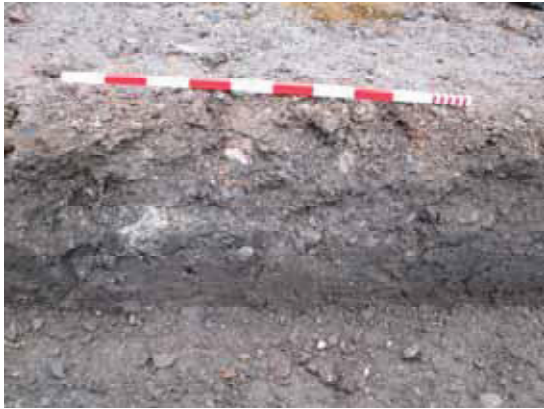
DP3: Sample Section 2, looking S

<i>Sample section 2 (Figs. 3-4; DP3)</i> 0.00 = 4.95m AOD		
0.00-0.40m	L1000	Made ground. See Sample Section 1
0.40-0.70m	L1001	Made ground. See Sample Section 1

Description: Sample Section 2 contained no archaeological deposits.

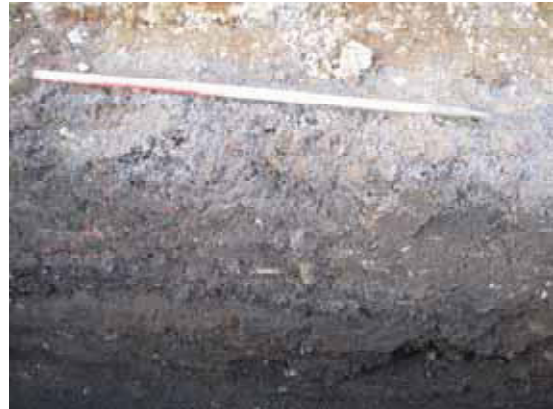
DP4: Sample Section 3, looking W

<i>Sample section 3 (Figs. 3-4; DP4)</i> 0.00 = 4.95m AOD		
0.00-0.20m	L1000	Made ground. See Sample Section 1
0.20-0.60m	L1001	Made ground. See Sample Section 1
0.60-1.31m+	L1007	Disturbed layer. Friable, mid greyish brown silty sand with moderate, small mixed Victorian building rubble

Description: Sample Section 3 contained no archaeological deposits.

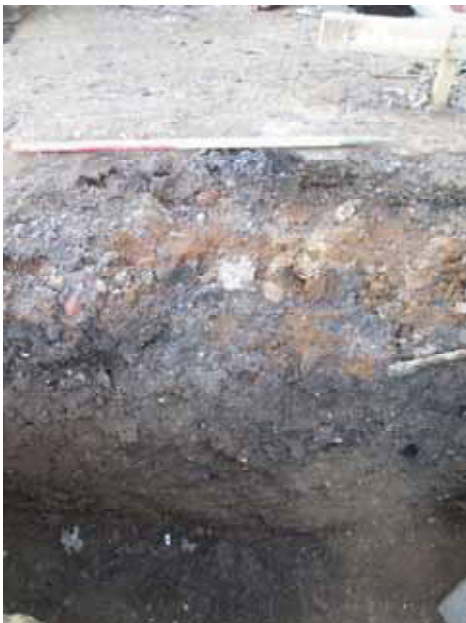
DP5: Sample Section 4, looking S

<i>Sample section 4 (Figs. 3-4; DP5)</i> 0.00 = 4.95m AOD		
0.00-0.26m	L1000	Made ground. See Sample Section 1
0.26-0.61m	L1001	Made ground. See Sample Section 1
0.61-1.50m+	L1007	Disturbed layer. See Sample Section 3

Description: Sample Section 4 contained no archaeological deposits.

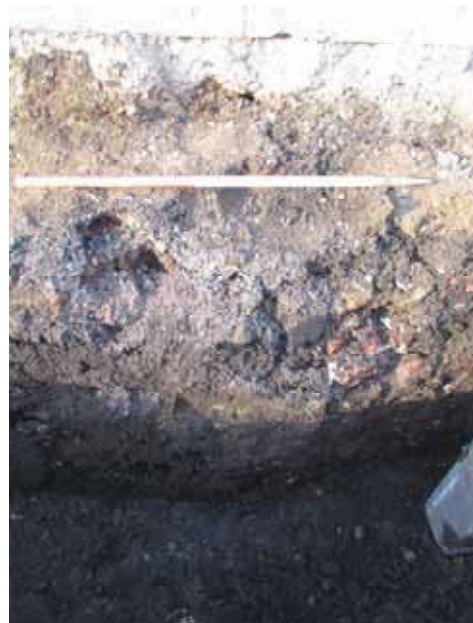
DP6: Sample Section 5, looking W

<i>Sample section 5 (Figs. 3-4; DP6)</i> 0.00 = 4.95m AOD		
0.00-0.30m	L1000	Made ground. See Sample Section 1
0.30-1.04m+	L1001	Made ground. See Sample Section 1

Description: Sample Section 5 contained no archaeological deposits.

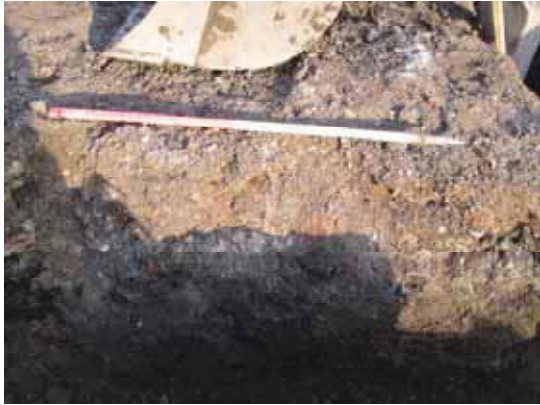
DP7: Sample Section 6, looking N

<i>Sample section 6 (Figs. 3-4; DP7)</i> 0.00 = 4.95m AOD		
0.00-0.28m	L1000	Made ground. See Sample Section 1
0.28-0.88m+	L1001	Made ground. See Sample Section 1

Description: Sample Section 6 contained no archaeological deposits.

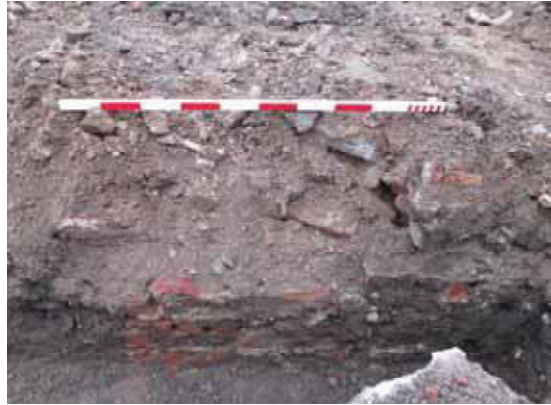
DP8: Sample Section 7, looking E

<i>Sample Section 7 (Figs. 3-4; DP8)</i> 0.00 = 4.95m AOD		
0.00-0.10m	L1000	Made ground. See Sample Section 1
0.10-0.40m+	L1006	Rubble backfill. Loose, light greyish yellow sand with frequent mixed CBM (brick) rubble
0.40-0.75m+	L1001	Made ground. See Sample Section 1

Description: Sample Section 7 contained Wall M1003 (incorporating Mortar L1005) and Construction Cut F1004.

In Sample Section 7, M1003 was a N-S aligned section of brick wall, forming part of a structure (possibly a cellar) with an E-W aligned section of the same wall (see Sample Section 8). M1003 comprised high fired, unfrogged red bricks (each measuring 200 x 100 x 80mm) in stretcher bond, bonded by a pale yellow/ grey/ white mortar (with occasional small pebble inclusions; L1005). In Sample Section 7, M1003 survived to a height of 0.64m+. The wall was contained by Construction Cut F1004 (see below) and was stratigraphically sealed by Rubble L1006.

In Sample Section 7, Construction Cut F1004 truncated Made Ground L1001. The cut appeared linear in plan and had vertical sides; its base was not reached (recordable dimensions: 1.00+ x 0.38m+). Within the exposed section, F1004 was stratigraphically sealed by Wall M1003. The cut appeared to have been deliberately excavated to contain M1003.

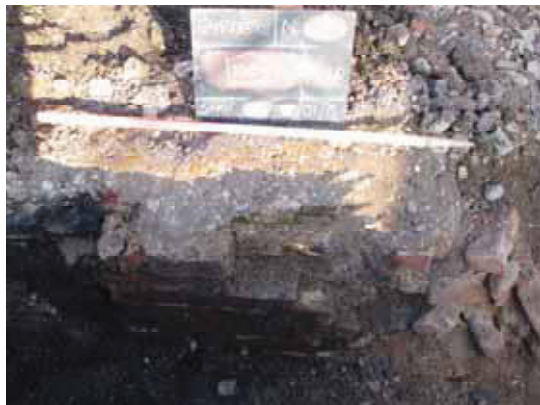
DP9: Sample Section 8 (W end), looking N

<i>Sample Section 8 (Figs. 3-4; DP9)</i> 0.00 = 4.95m AOD		
0.00-0.20m	L1000	Made ground. See Sample Section 1
0.20-0.80m+	L1001	Made ground. See Sample Section 1
0.20-0.80m+	L1006	Rubble backfill. See Sample Section 7

Description: Sample Section 8 contained Wall M1003 (incorporating Mortar L1005) and Construction Cut F1004.

In Sample Section 8, M1003 was an E-W aligned section of brick wall, forming part of a structure (possibly a cellar) with a N-S aligned section of the same wall (see Sample Section 7). M1003 is described above. In Sample Section 8, M1003 survived to a height of 0.60m+. Once again, the wall was contained by Construction Cut F1004 (see below) and was stratigraphically sealed by Rubble L1006.

In Sample Section 8, Construction Cut F1004 truncated Made Ground L1001. The cut appeared linear in plan and had vertical sides; its base was not reached (recordable dimensions: 2.24 x 0.60m+). Within the exposed section, F1004 was stratigraphically sealed by Wall M1003.

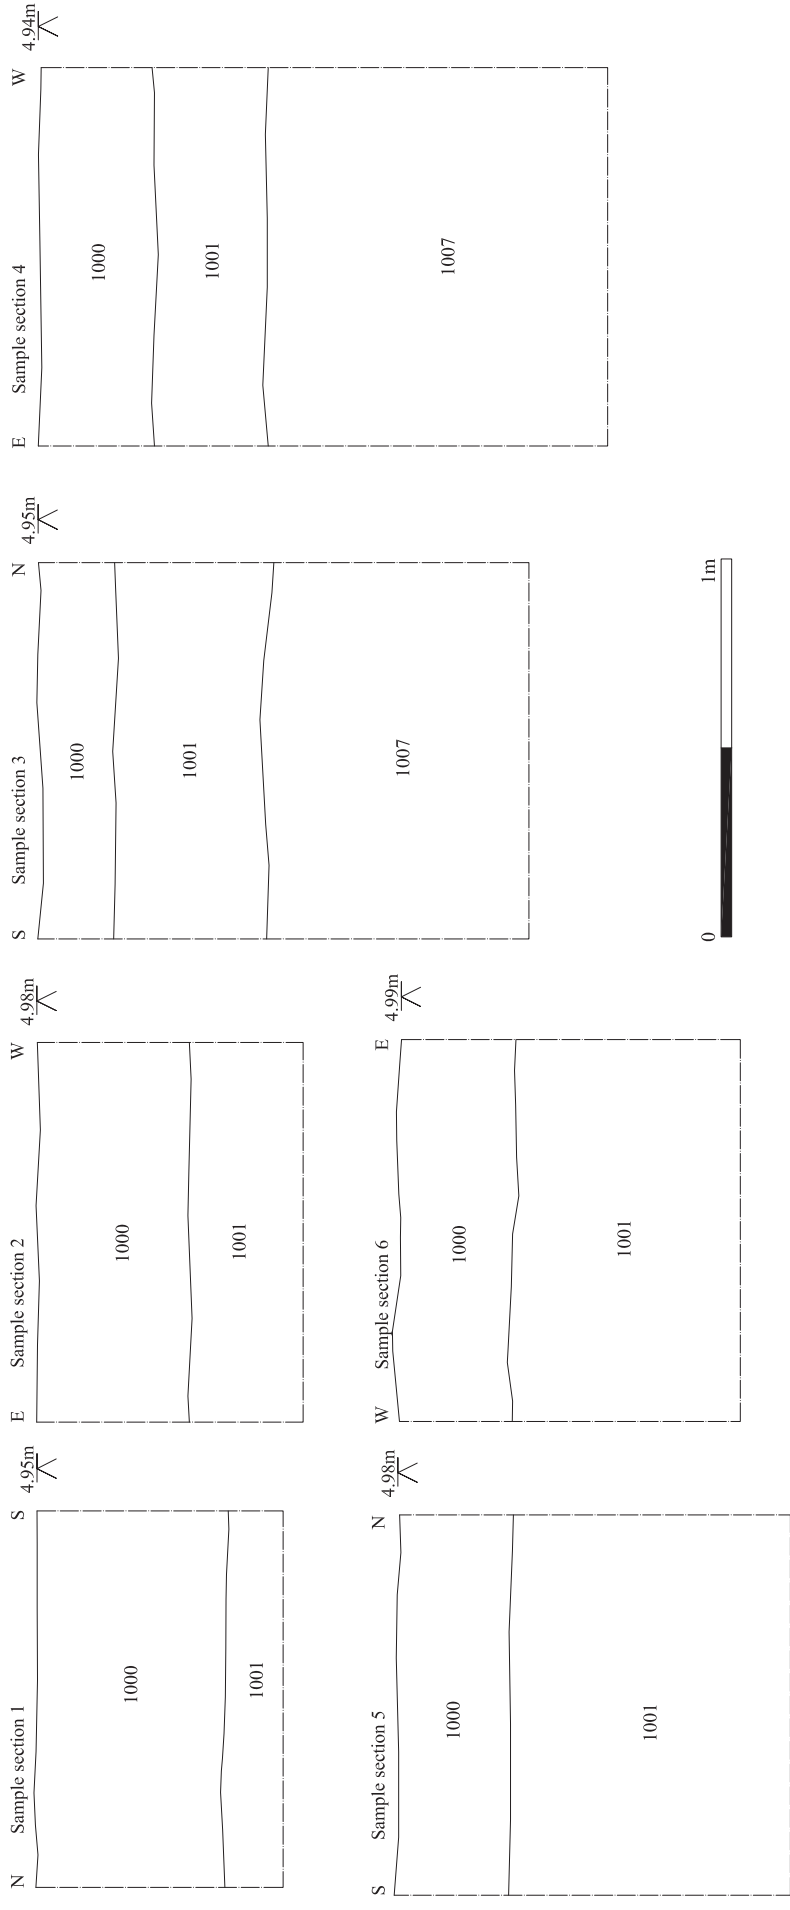
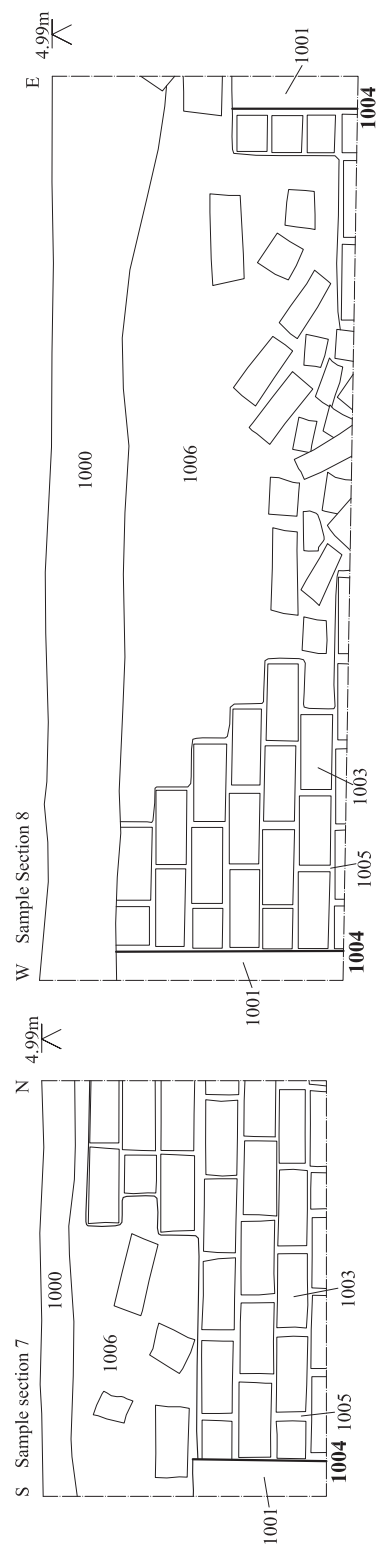
6.1 The encountered stratigraphy was recorded in eight sample sections:
