**PEACHY HOUSE, 39 ILFORD HILL, ILFORD  
LONDON BOROUGH OF REDBRIDGE**

**AN ARCHAEOLOGICAL EVALUATION**

Authors: Zbigniew Pozorski	
NGR: TQ 4330 8630	Report No: 5035
District: LB of Redbridge	Site Code: ILL.15
Approved: Claire Halpin	Project No: 6137
Signed:	Date: 27 January 2016

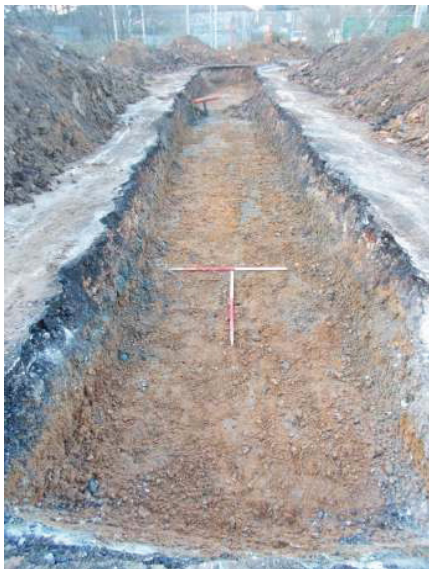
DP 3. Trench 1. Looking north-west.

*Description:* No archaeological features or finds were present.

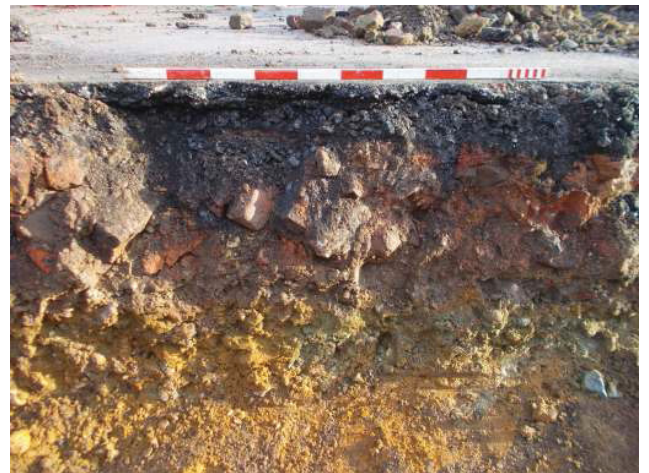
DP 4. Trench 1, north-west end. Sample section 1A. Looking north-east.

<i>Sample section 1A (DP 4): north-west end, south-west facing</i> <i>0.00 = 9.43m AOD</i>		
0.00 – 0.09m	L1000	Modern tarmac. Surface of car park.
0.09 – 0.34m	L1001	Modern made ground, base for tarmac. Compacted CBM and concrete rubble with yellow sand.
0.34 – 0.47m	L1002	Made ground. Mid grey, friable, silty sand with small stones.
0.47m +	L1003	Natural mid to dark yellow and occasionally grey, loose, sandy gravel with sandy patches.

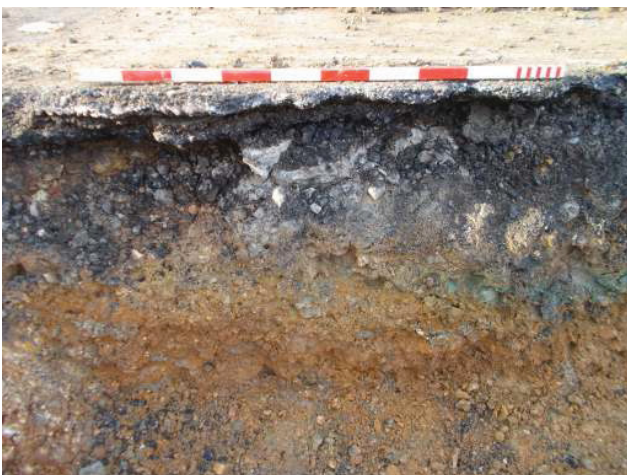
DP 5. Trench 1, south-east end. Sample section 1B. Looking south-west.

<i>Sample section 1B (DP 5): south-east end, north-east facing</i> <i>0.00 = 9.37m AOD</i>		
0.00 – 0.09m	L1000	Tarmac. As above.
0.09 – 0.33m	L1004	Modern concrete rubble.
0.33 – 0.46m	L1002	Made ground. As above.
0.46 – 0.49m	L1005	Made ground. Mid greenish blue, compact, sandy silt, probably contaminated.
0.49m +	L1003	Natural gravel. As above.

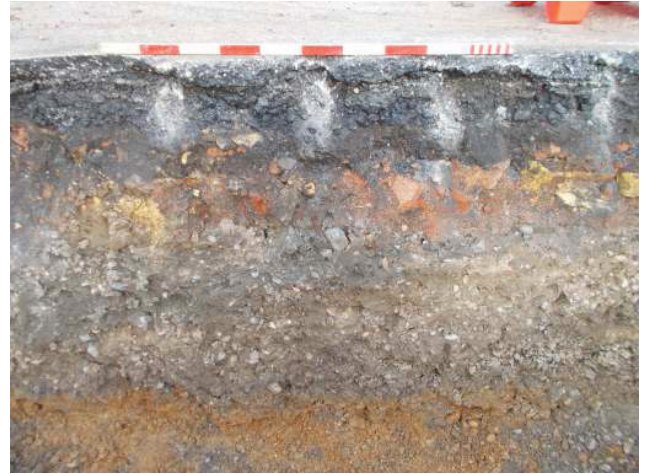
DP 8. Trench 2, north-east end. Sample section 2A. Looking north-west.

<i>Sample section 2A (DP 8): north-east end, south-east facing</i> <i>0.00 = 10.07m AOD</i>		
0.00 – 0.16m	L1000	Tarmac. As above, Tr. 1.
0.16 – 0.43m	L1001	Made ground. As above, Tr. 1.
0.43 – 1.05m	L1002	Made ground. As above, Tr. 1.
1.05m +	L1003	Natural gravel. As above, Tr. 1.

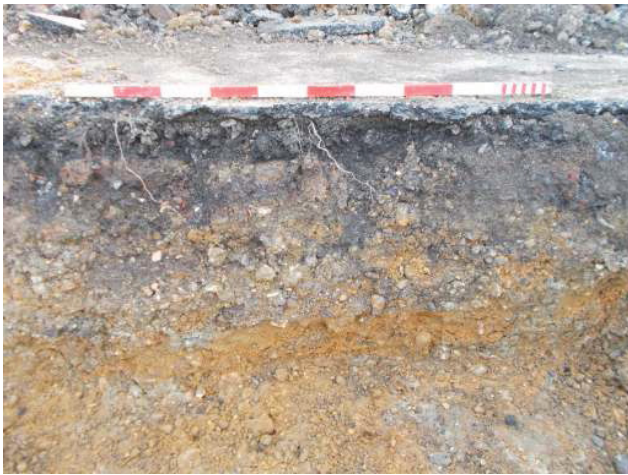
DP 9. Trench 2, south-west end. Sample section 2B. Looking south-east.

<i>Sample section 2B (DP 9): south-west end, north-west facing</i> <i>0.00 = 9.82m AOD</i>		
0.00 – 0.10m	L1000	Tarmac. As above, Tr. 1.
0.10 – 0.25m	L1001	Made ground. As above, Tr. 1.
0.25 – 0.45m	L1006	Made ground. Mid yellow and grey, loose, redeposited natural gravel with mid grey sandy silt.
0.45m +	L1003	Natural gravel. As above, Tr. 1.

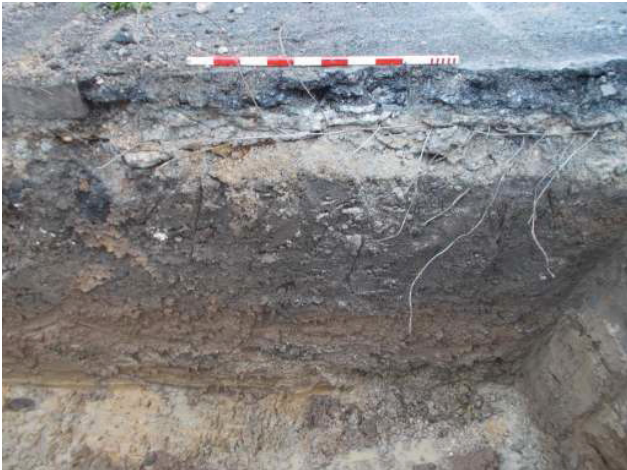
DP 13. Trench 3, north-west end. Sample section 3A. Looking south-west.

<i>Sample section 3A (DP 13): north-west end, north-east facing</i> <i>0.00 = 11.98m AOD</i>		
0.00 – 0.16m	L1007	Modern tarmac. Surface of car park.
0.16 – 0.34m	L1008	Modern reinforced concrete.
0.34 – 0.82m	L1009	Modern made ground. Dark grey, friable, clayey silt with occasional CBM fragments and debris.
0.82 – 1.00m	L1010	Made ground. Mid brown, friable, clayey silt.
1.00 – 1.10m	L1011	Mid to dark grey, friable, sandy silt with moderate small stones.
1.10m +	L1012	Natural light yellow and grey, compact, clay.

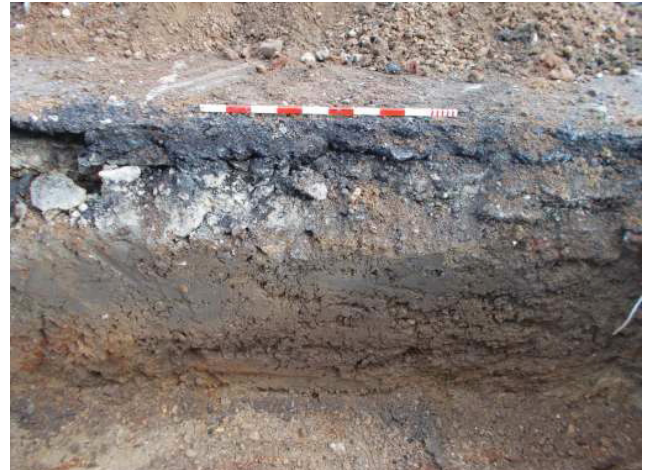
DP 14. Trench 3, south-east end. Sample section 3B. Looking north-east.

<i>Sample section 3B (DP 14): south-east end, south-west facing</i> <i>0.00 = 11.83m AOD</i>		
0.00 – 0.19m	L1007	Tarmac. As above.
0.19 – 0.42m	L1008	Made ground. As above.
0.42 – 0.49m	L1013	Crushed CBM and yellow, loose, sand.
0.49 – 0.91m	L1010	Made Ground. As above.
0.91m +	L1003	Natural gravel. As above, Tr. 1.

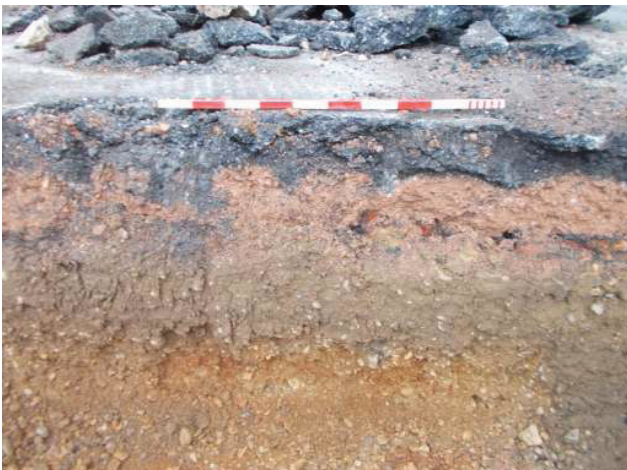
DP 17. Trench 4, north-east end. Sample section 4A. Looking north-west.

<i>Sample section 4A (DP 17): north-east end, south-east facing</i> <i>0.00 = 11.85m AOD</i>		
0.00 – 0.18m	L1007	Tarmac. As above, Tr. 3.
0.18 – 0.39m	L1018	Base for tarmac. Light red, fine crushed CBM, and compacted.
0.39 – 0.78m	L1019	Made ground. Light to mid brown, friable, sandy silt with frequent small stones.
0.78m +	L1003	Natural gravel. As above, Tr. 1.

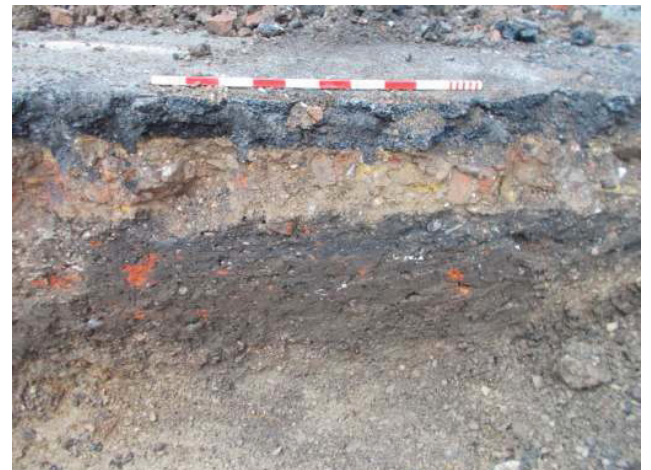
DP 18. Trench 4, south-west end. Sample section 4B. Looking south-east.

<i>Sample section 4B (DP 18): south-west end, north-west facing</i> <i>0.00 = 10.85m AOD</i>		
0.00 – 0.17m	L1007	Tarmac. As above, Tr. 3.
0.17 – 0.41m	L1020	Made ground. Layer of compacted modern CBM rubble with yellow sand and light brown silt.
0.41 – 0.53m	L1021	Dark grey, compact, sandy silt with frequent CBM fragments.
0.53 – 0.89m	L1022	Made ground. Mid to dark brown, compact, sandy silt with frequent CBM fragments.
0.89m +	L1003	Natural gravel. As above, Tr. 1.

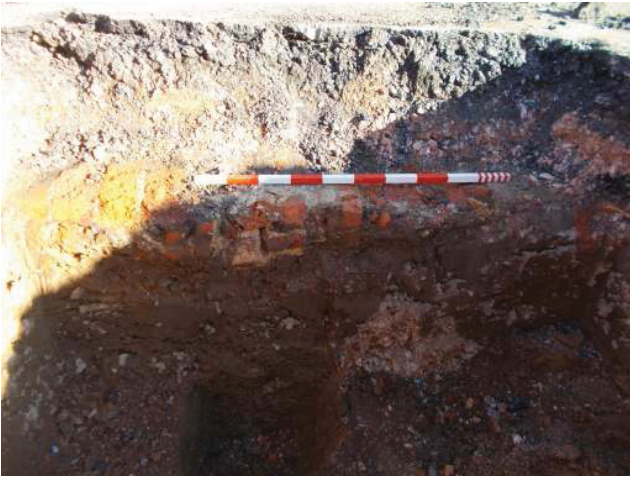
DP 19. Trench 4. Wall M1023. Looking north-east.

Wall M1023 (1.80+ x 0.20+ x 0.22m; DP 19) was located in the north-eastern end of the trench and was poorly preserved. It was present beneath L1018, at c.0.40m below the existing ground level, and was aligned north-west / south-east. It comprised two courses of red bricks (0.225 x 0.110 x 0.055m) bonded with creamy mortar. The wall overlay Made Ground L1019 and Pit F1024. The wall was 19<sup>th</sup> century.

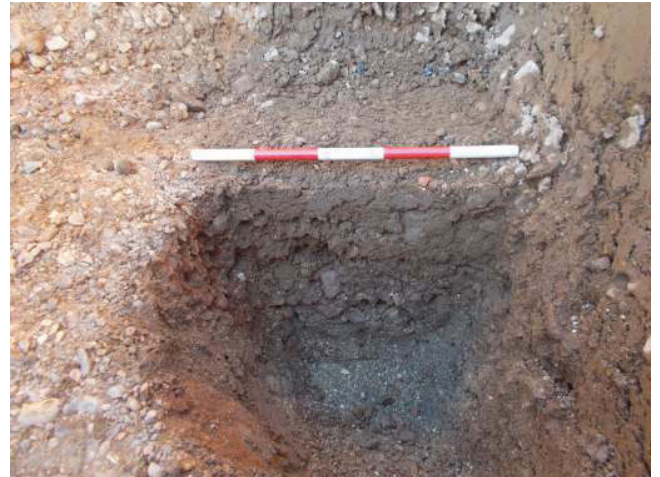
DP 20. Trench 4. Pit F1024. Looking north-west.

Pit F1024 was rectangular (0.92+ x 0.53+ x 0.38m; DP 20). It had steep sides and a flattish base. Its fill, L1025, was a dark grey, friable, sandy silt with occasional small stones. No finds were present.

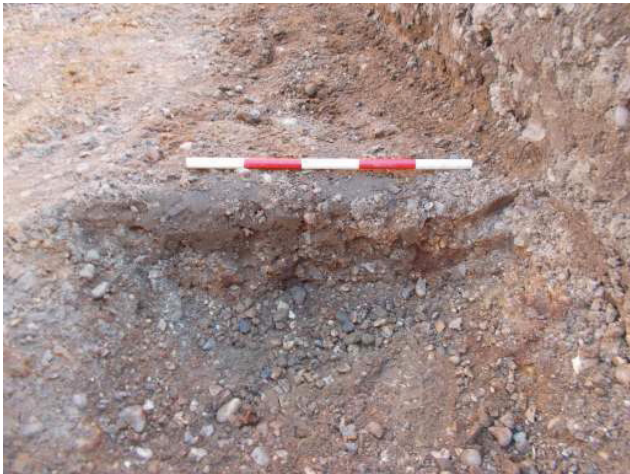
DP 21. Trench 4. ?Ditch F1026. Looking east-north-east.

Ditch F1026 was linear (3.85+ x 0.78 x 0.19m; DP 21). It had gently sloping sides and a slightly concave base. Its fill, L1027, was a mid grey, friable, sandy silt with frequent small stones. No finds were present.

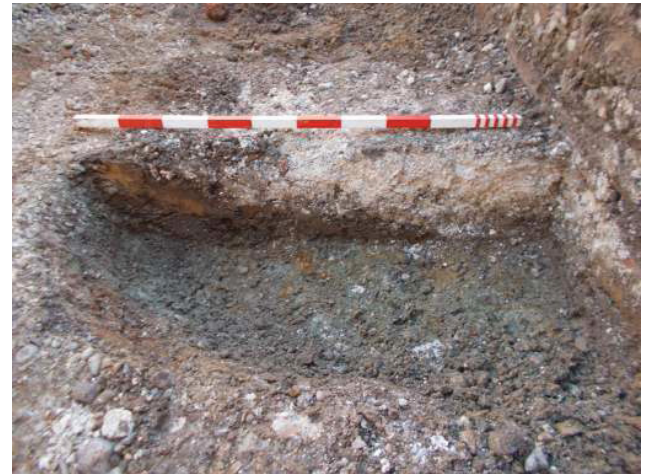
DP 22. Trench 4. Pit F1028. Looking north-east.

Pit F1028 was irregular in plan (2.05 x 1.07+ x 0.24m; DP 22). It had moderately sloping sides and a flattish base. It contained two fills. The upper fill, L1029 (0.19m thick), was a deposit of white, friable, chalk. The basal fill, L1030 (0.05 – 0.24m thick), was a mid to dark greenish brown, friable, clayey silt with yellow sand and small stones. L1030 contained sherds of modern china.

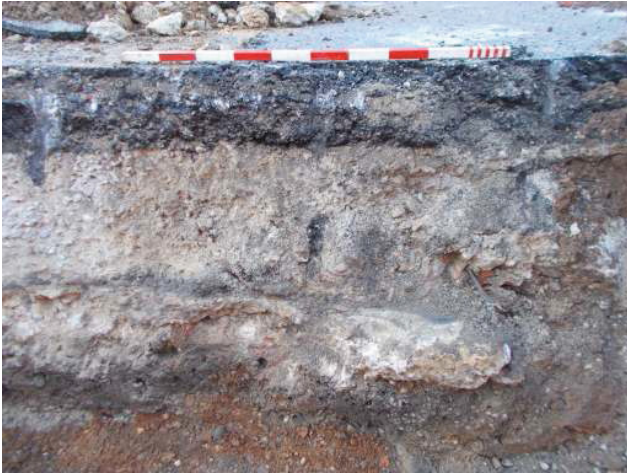
DP 25. Trench 6, north-west end. Sample section 6A. Looking south-west.

<i>Sample section 6A (DP 25): north-west end, north-east facing</i> <i>0.00 = 11.45m AOD</i>		
0.00 – 0.21m	L1007	Tarmac. As above, Tr. 3.
0.21 – 0.61m	L1031	Modern light grey concrete.
0.61 – 0.79m	L1032	Modern light grey concrete, possible floor.
0.79 – 0.88m	L1033	Dark grey, friable, sandy silt with frequent charcoal flecks.
0.88m +	L1003	Natural gravel. As above, Tr. 1.

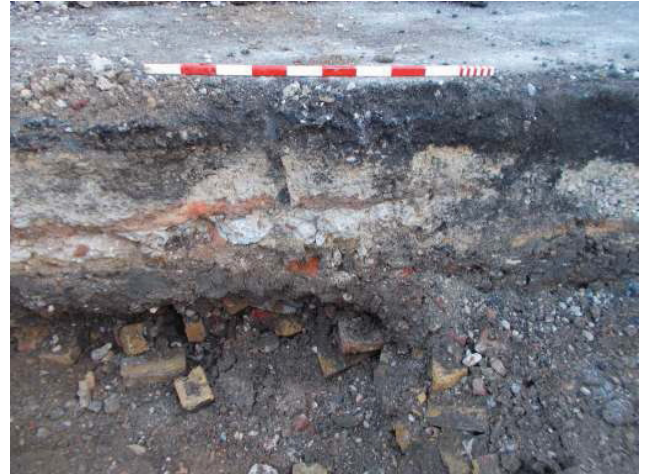
DP 26. Trench 6, south-east end. Sample section 6B. Looking north-east.

<i>Sample section 6B (DP 26): south-east end, south-west facing</i>		
<i>0.00 = 10.89m AOD</i>		
0.00 – 0.21m	L1007	Tarmac. As above, Tr. 3.
0.21 – 0.41m	L1031	Concrete. As above.
0.41 – 0.46m	L1034	Layer of compacted crushed CBM (red bricks).
0.46 – 0.58m	L1032	Concrete. As above.
0.58m +	L1035	Loose modern backfill. CBM, sand, debris.

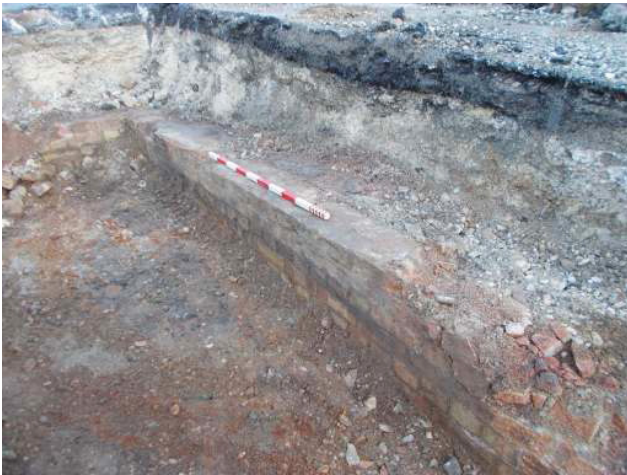
DP 27. Trench 6, Wall M1038. Looking north-north-west.

Wall M1038 (4.10 x 0.80+ x 0.48m; 0.22m wide; DP 28) was constructed of red and occasional yellow frogged bricks (0.225 x 0.105 x 0.055m) bonded with grey mortar and without regular coursing. The two lowest courses of bricks created two ledges (0.05m wide each). The wall overlay a concrete foundation c.0.10m wider than the brick structure. The wall was tied to concrete blocks, a smaller one (0.60 x 0.60m) at the north-west end and large (1.30 x 1.30m+) at the south-east end. M1038 extended towards the south-west and was almost certainly was part of a building which fronted Ilford Hill.

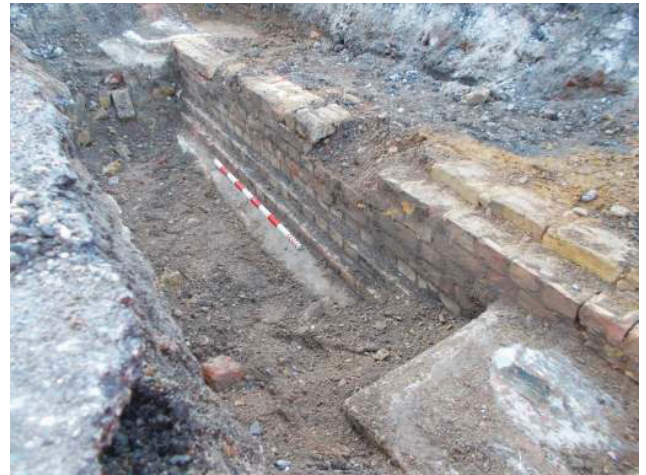
DP 28. Trench 6, Wall/Foundation M1039. Looking south-south-east.

Wall M1039 (3.80 x 1.75+ x 0.40m+; 0.22m wide; DP 27) was constructed of red bricks (0.225 x 0.105 x 0.055m) set in regular English Cross bond. The wall was adjacent to M1039, to the immediate south, but appeared to be a separate structure. Its construction cut, F1036, was an irregular trench which cut the natural gravel and was backfilled with a dark grey, friable, silty sand mixed with the gravel (L1037). The wall was likely part of a former building which extended towards south-west and was located directly to the rear of buildings fronting Ilford Hill, likely an extension.
