**BREWERY YARD MALTINGS, WATTON ROAD,
WARE, HERTFORDSHIRE**

AN ARCHAEOLOGICAL EVALUATION

Authors: Zbigniew Pozorski	
NGR: TL 35528 14493	Report No: 5149
District: East Herts	Site Code: AS 1825
Approved: Claire Halpin	Project No: 6539
Signed:	Date: 15 June 2016

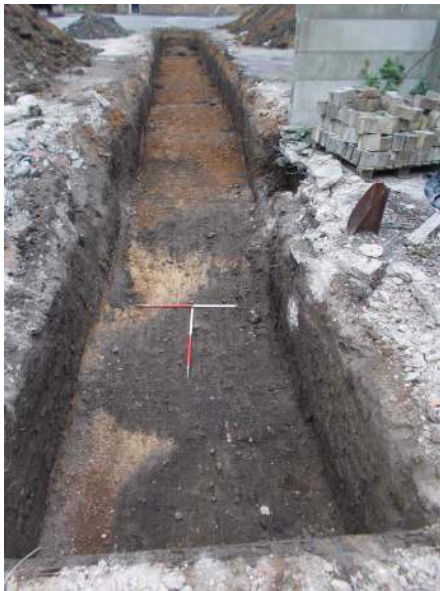
Three large pits (F1041, F1043 and F1045) were present in the eastern end of the trench (DP 3). The pits appeared of modern date with CBM fragments overlying their fills. They were not excavated due to health and safety concerns regarding their significant depth (c.1.20m below existing ground level).

DP 3. Trench 1, unexcavated Pits F1041, F1042 and F1044. Looking west-north-west.

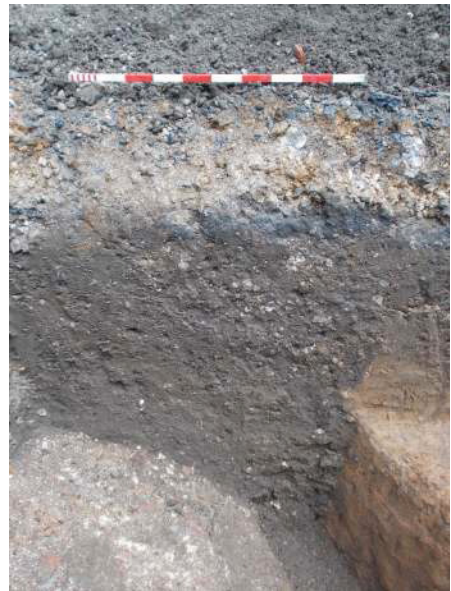
Ditch F1005 was linear (2.00+ x 1.75+ x 1.25m+; DP 4), orientated north / south. It had vertical sides and its base was unseen. Its fill, L1006, was a mid brownish grey, friable, sandy silt. It contained 18th – 19th century pottery (5; 20g) fragments, animal bone (59g) and oyster shell (1; 10g).

DP 4. Trench 1, Ditch F1005. Looking north-north-east.

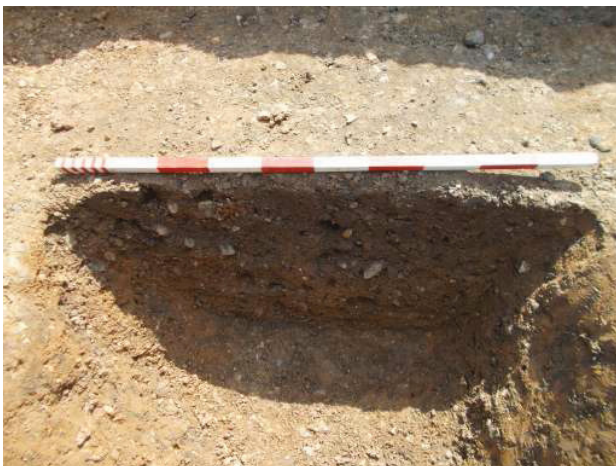
Pit F1022 was sub rectangular in plan (1.20 x 1.01 x 0.46m; DP 5). It had near vertical sides and a flattish base. Its fill, L1023, was a light brown, friable, silty sand with frequent small stones. It contained a residual sherd of medieval (12th – 13th century) pottery (1; 11g), slag (1; 9g), post-medieval and medieval CBM (145g) and animal bone (12g).

DP 5. Trench 1, Pit F1022. Looking south-south-west.

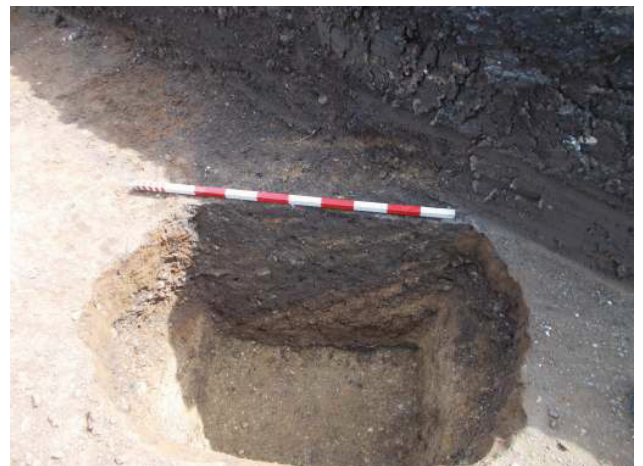
Pit F1024 was sub rectangular (1.50 x 0.97 x 0.77m; DP 6). It had vertical sides and a flattish base. Its upper fill, L1025, was a mid grey, friable, silty sand. It contained CBM (16g) and animal bone (5g); Its basal fill, L1026, was mid yellow and brownish yellow, loose, silty sand. It contained no finds.

DP 6. Trench 1, Pit F1024. Looking south-south-east.

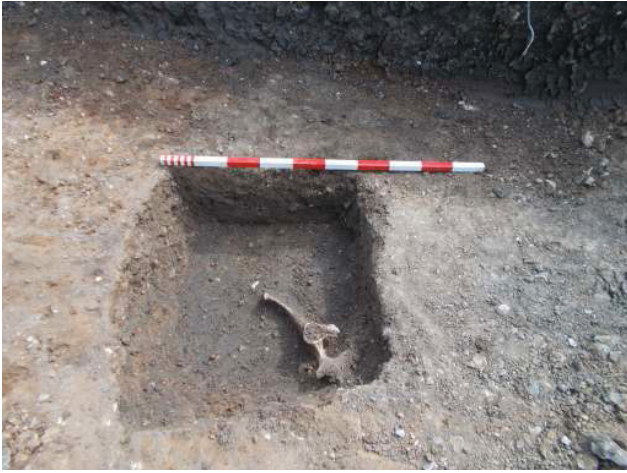
Pit F1028 was rectangular (1.62 x 0.91 x 0.20m+; DP 7). It had near vertical sides and its base was unseen. Its fill, L1029, was a light to mid grey, friable, sandy silt. It contained 17th – 18th century pottery (3; 15g).

DP 7. Trench 1, Pit F1028. Looking south.

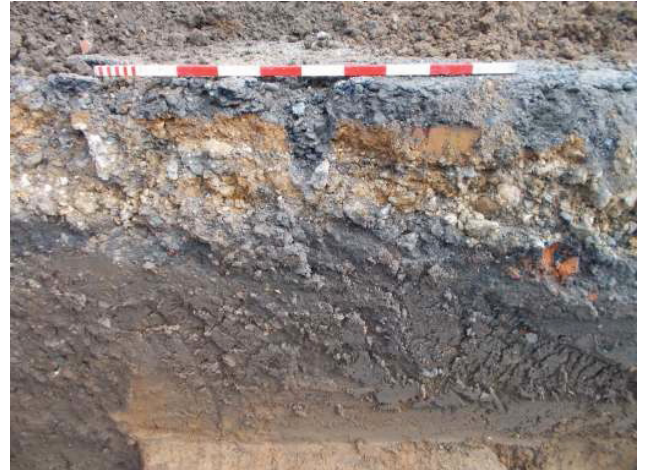
<i>Sample section 1A (DP 8): west end, south-south-west facing</i> 0.00 = 35.38m AOD		
0.00 – 0.09m	L1000	Modern tarmac.
0.09 – 0.19m	L1001	Levelling layer. Mid yellow, compacted, CBM rubble with sand and grey crushed concrete.
0.19 – 0.28m	L1002	Made ground. Dark grey, friable, sandy silt with moderate CBM fragments.
0.28 – 0.82m	L1003	Subsoil. Mid greyish brown, compact, clayey silt.
0.82m +	L1004	Natural mid orange yellow, loose, gravel and firm sandy silt.

DP 8. Trench 1, west end. Sample section 1A. Looking north-north-east.

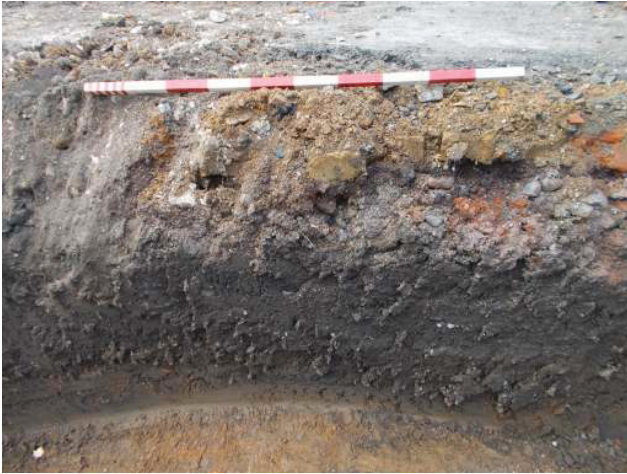
<i>Sample section 1B (DP 9): east end, north-north-east facing</i> 0.00 = 35.06m AOD		
0.00 – 0.07m	L1013	Modern concrete.
0.07 – 0.33m	L1001	Levelling layer. As above.
0.33 – 1.17m	L1021	Made ground. Dark grey, compact, clayey silt with occasional small CBM fragments.
1.17m +	L1004	Natural gravel and silt. As above.

DP 9. Trench 1, east end. Sample section 1B. Looking south-south-west.

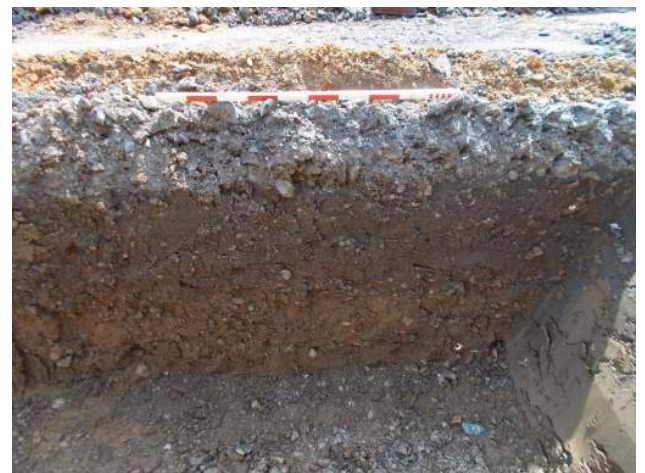
<i>Sample section 2A (DP 12): west end, north facing</i>		
<i>0.00 = 35.20m AOD</i>		
0.00 – 0.09m	L1000	Modern tarmac. As above, Tr. 1.
0.09 – 0.15m	L1001	Levelling layer. As above, Tr. 1.
0.15 – 0.41m	L1018	Levelling layer. Light to mid grey, loose, mixed stone, concrete rubble and sand.
0.41 – 0.88m	L1039	Made ground. Mid to dark brownish grey, compact clayey silt with occasional small CBM fragments.
0.88 – 1.27m	L1040	Subsoil. Light brow, compact, clayey silt.
1.27m +	L1004	Natural gravel and silt. As above, Tr. 1.

DP 12. Trench 2, west end. Sample section 2A. Looking south.

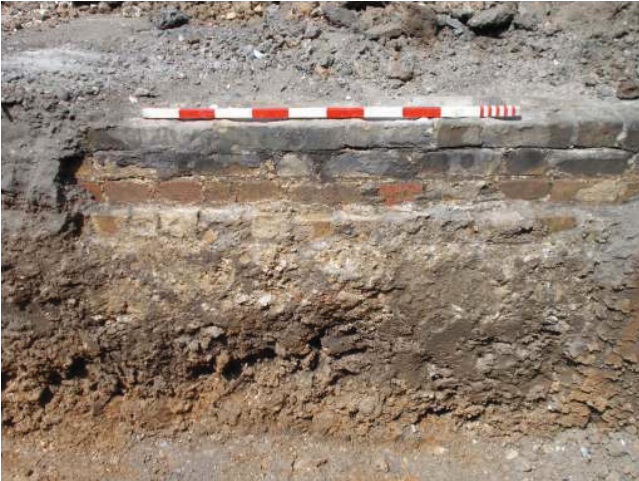
<i>Sample section 2B (DP 13): east end, south facing</i>		
<i>0.00 = 35.27m AOD</i>		
0.00 – 0.31m	M1019	Brick wall.
0.31 – 0.61m	L1020	Light yellowish grey, compact, mixed mortar, sand and CBM fragments.
0.61 – 1.02m	L1040	Subsoil. As above.
1.02m +	L1004	Natural gravel and silt. As above, Tr. 1.

Wall M1019 (10+ x 01.15+ x 0.31m; DP 13) was parallel to the walls of the existing maltings. It was present just below modern tarmac and it was constructed with yellow frogged bricks (0.220 x 0.105 x 0.060m) bonded with light grey mortar. It overlay L1020, likely a basal layer for the foundation. The wall is of late 18th – mid 20th century date (CBM report below).

DP 13. Trench 2, east end. Sample section 2B with Wall M1019. Looking north.

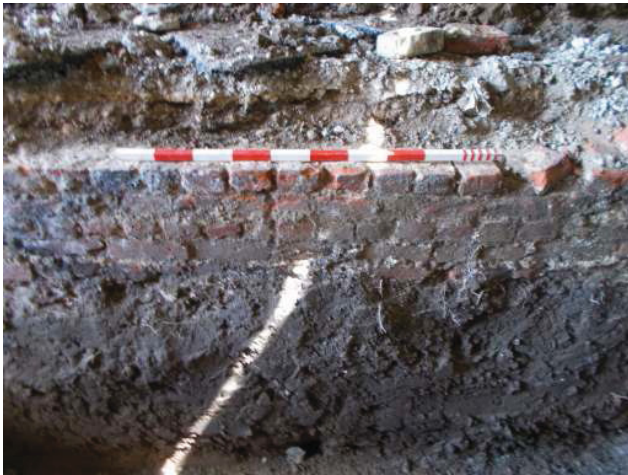
<i>Sample section 3A (DP 15): central part, west facing</i>		
<i>0.00 = 35.15m AOD</i>		
0.00 – 0.10m	L1013	Modern concrete. As above, Tr. 1.
0.10 – 0.25m	L1014	Modern made ground. Concrete and CBM rubble with sand.
0.25 – 0.63m	M1015	Brick wall.
0.63 – 1.20m	L1017	Made ground. Dark grey, compact, clayey silt with occasional small CBM fragments. Similar to L1021.
1.20m +	L1004	Natural gravel and silt. As above, Tr. 1.

Wall M1015 (4.30+ x 0.20+ x 0.36m; DP 15) was revealed 0.25m below the existing floor level. It was constructed of red bricks (0.220 x 0.105 x 0.060m) bonded with yellow sandy mortar. The wall was parallel to the north/south walls of cartshed to the east and maltings to the west. M1015 is dated to the 18th - early 19th (CBM report below).

DP 15. Trench 3. Sample section 3A with Wall M1015. Looking east.

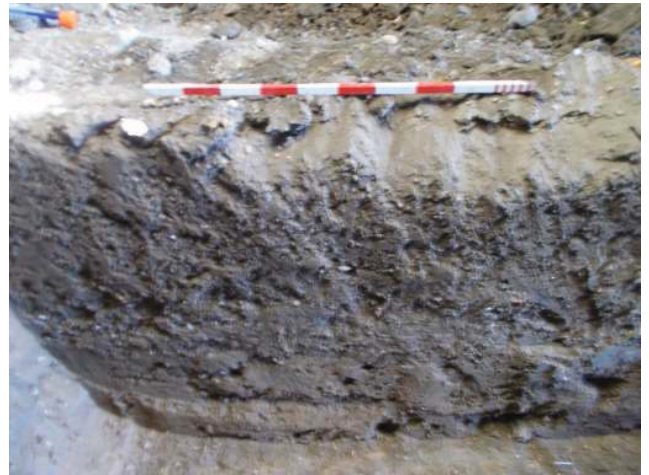
<i>Sample section 3B (DP 16): south end, east facing</i> 0.00 = 35.17m AOD		
0.00 – 0.24m	L1014	Modern made ground. As above.
0.24 – 0.80m	L1017	Made ground. As above.
0.80 – 1.44m	L1012	Subsoil. Mid to dark brownish grey, friable, sandy silt with occasional CBM fragments.
1.44m +	L1004	Natural gravel and silt. As above, Tr. 1.

DP 16. Trench 3, south end. Sample section 3B. Looking west.

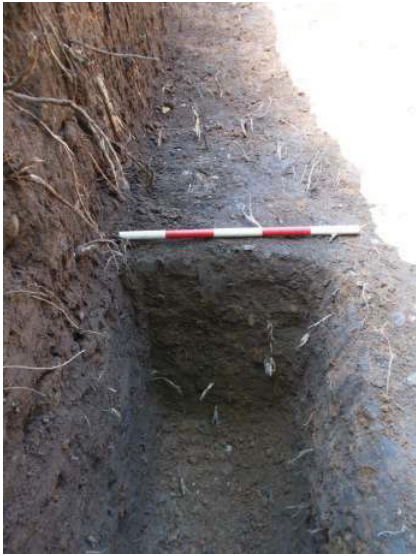
Pit F1008 was rectangular (2.10 x 0.50+ x 0.53m; DP 19). It had steep, near vertical sides and a flattish base. Its fill, L1009, was a mid to dark grey, friable, sandy silt. It contained 15th – 16th century pottery (2; 67g), CBM (128) and animal bone (13g).

DP 19. Trench 4, Pit F1008. Looking west.

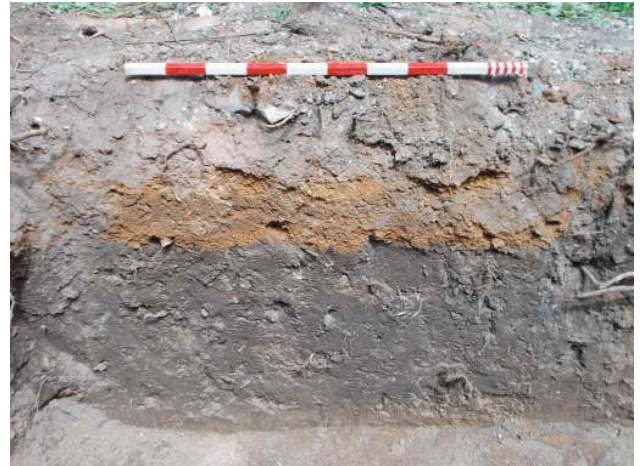
<i>Sample section 4A (DP 20): west end, south facing</i> 0.00 = 35.16m AOD		
0.00 – 0.22m	L1010	Topsoil. Light brownish grey, loose, sandy silt with frequent roots.
0.22 – 0.47m	L1011	Mid orangey yellow, loose, sand.
0.47 – 1.14m	L1012	Subsoil. As above, Tr. 3. It contained 18 th – 19 th C pottery (3; 170g).
1.14m +	L1004	Natural gravel and silt. As above, Tr. 1.

DP 20. Trench 4, west end. Sample section 4A. Looking north.

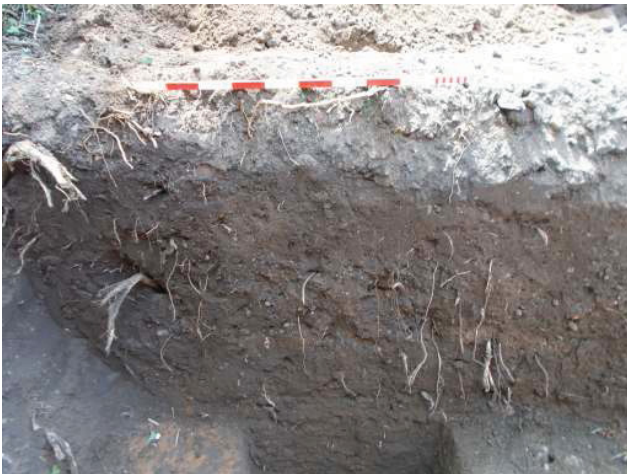
<i>Sample section 4B (DP 21): east end, north facing</i> 0.00 = 35.13m AOD		
0.00 – 0.28m	L1010	Topsoil. As above.
0.28 – 1.30m	L1012	Subsoil. As above, Tr. 3.
1.30m +	L1004	Natural gravel and silt. As above, Tr. 1.

DP 21. Trench 4, east end. Sample section 4B. Looking south.

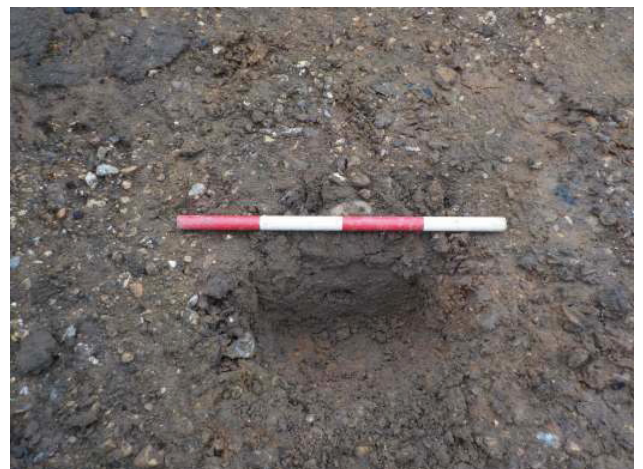
Post Hole F1030 was sub circular (0.24 x 0.23 x 0.09m; DP 24). It had steep sides and a concave base. Its fill, L1031, was a dark greyish brown, firm, sandy clay. No finds were present.

DP 24. Trench 5, Post Hole F1030. Looking south.

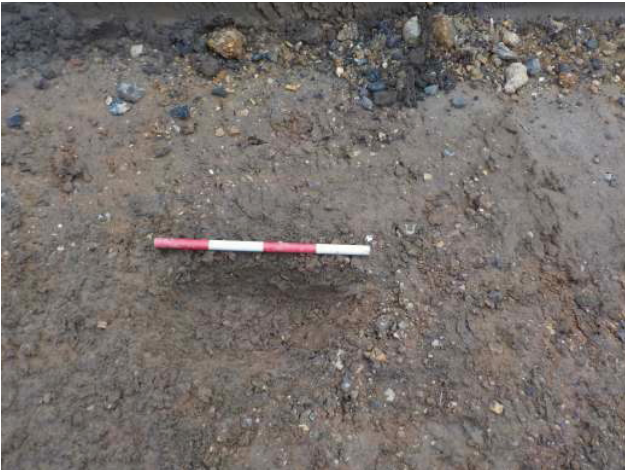
Post Hole F1032 was sub circular (0.34 x 0.30 x 0.11m; DP 25). It had steep sides and concave base. Its fill, L1033, was a dark greyish brown, firm, sandy clay. No finds were present.

DP 25. Trench 5, Post Hole F1032. Looking south.

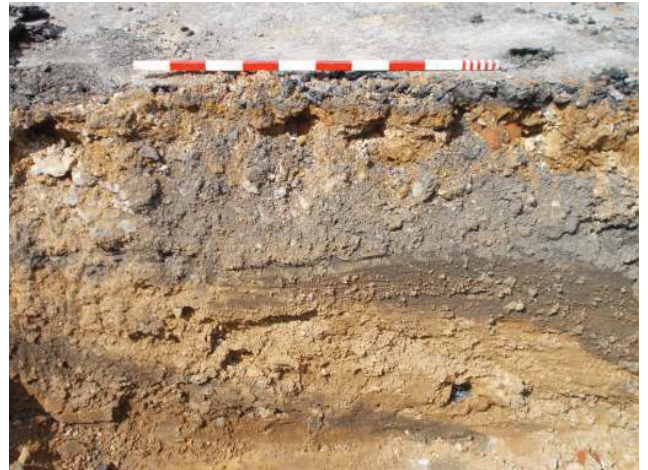
<i>Sample section 5A (DP 26): west end, south facing</i>		
<i>0.00 = 35.25m AOD</i>		
0.00 – 0.09m	L1000	Modern tarmac. As above, Tr. 1.
0.09 – 0.25m	L1001	Levelling layer. As above, Tr. 1.
0.25 – 0.53m	L1002	Made ground. As above, Tr. 1.
0.53 – 0.66m	L1035	Fill of Soakway F1034.
0.66 – 1.00m+	L1036	Fill of Soakway F1034.

DP 26. Trench 5, west end. Sample section 5A. Looking north.

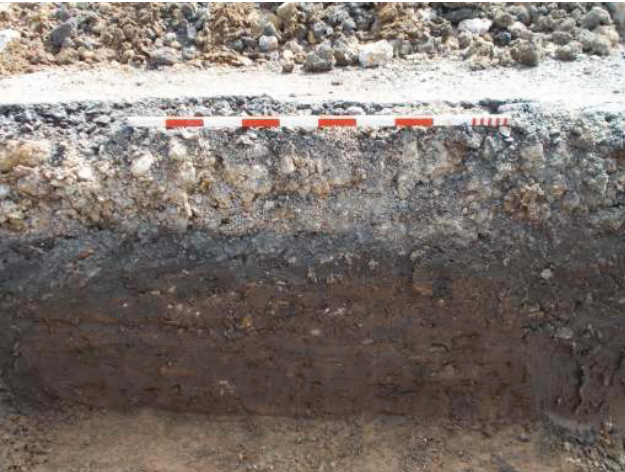
<i>Sample section 5B (DP 27): east end, north facing</i>		
<i>0.00 = 35.15m AOD</i>		
0.00 – 0.10m	L1000	Modern tarmac. As above, Tr. 1.
0.10 – 0.30m	L1001	Levelling layer. As above, Tr. 1.
0.30 – 0.42m	L1002	Made ground. As above, Tr. 1.
0.42 – 0.89m	L1003	Subsoil. As above, Tr. 1.
0.89m +	L1004	Natural gravel and silt. As above, Tr. 1.

DP 27. Trench 5, east end. Sample section 5B. Looking south.
