**LAND AT PINE LODGE AND PINEHURST,  
GARDINERS CLOSE, BASILDON,  
ESSEX**

**AN ARCHAEOLOGICAL EVALUATION**

Authors: Zbigniew Pozorski	
NGR: TQ 72064 90412	Report No: 5243
District: Basildon	Site Code: BAGC16
Approved: Claire Halpin MCIfA	Project No: 6070
	Date: 2 November 2016

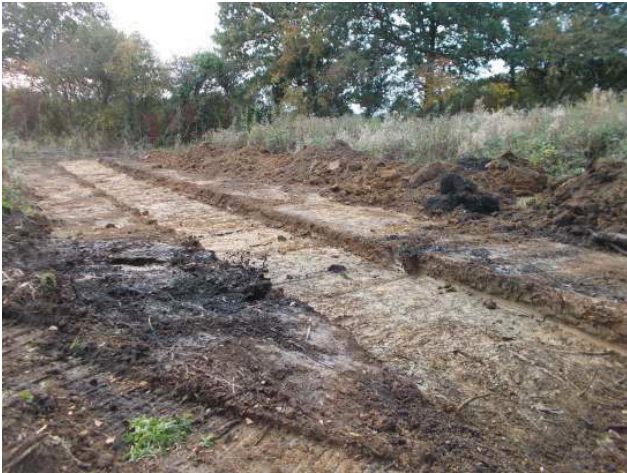
*Description:* No archaeological features or finds were present.

DP 1. Trench 1. Looking west.

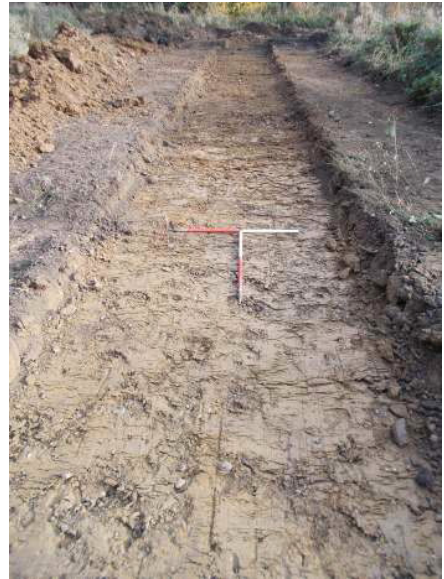
DP 2. Trench 1. Looking north-east.

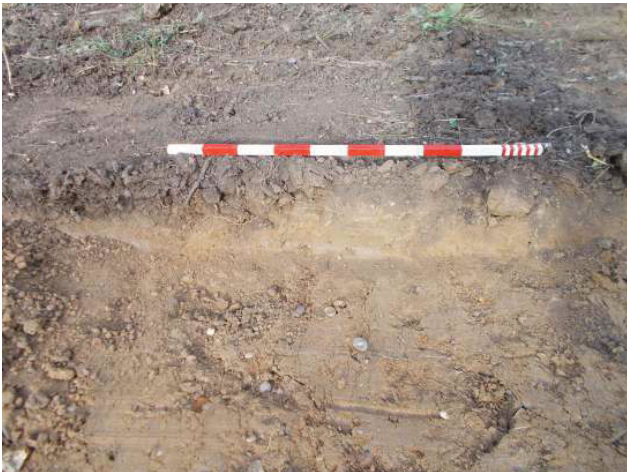
<i>Sample section 1A (DP 3): south-west end, south-east facing</i> <i>0.00 = 30.29m AOD</i>		
0.00 – 0.08m	L1000	Topsoil. Mid to dark brownish grey, friable, sandy silt.
0.08 – 0.21m	L1001	Subsoil. Light to mid brownish yellow with some grey, friable, clayey silt.
0.21m +	L1002	Natural light to mid brownish yellow with occasionally mottled grey, compact, clay.

DP 3. Trench 1, south-west end. Sample section 1A. Looking north-west.

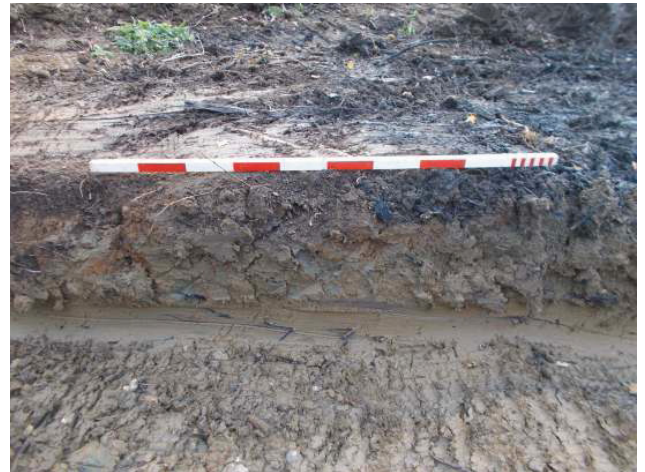
<i>Sample section 1B (DP 4): north-east end, north-west facing</i> <i>0.00 = 30.20m AOD</i>		
0.00 – 0.08m	L1003	Dark grey, loose, topsoil mixed with shredded wood, all composted.
0.08 – 0.21m	L1001	Subsoil. As above.
0.21m +	L1002	Natural clay. As above.

DP 4. Trench 1, north-east end. Sample section 1B. Looking south-east.

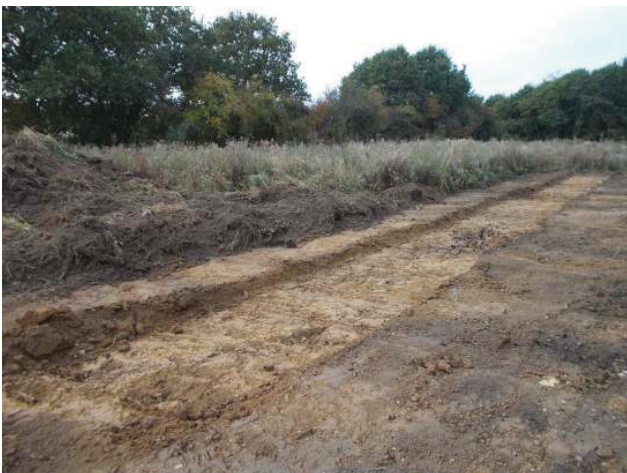
*Description:* No archaeological features or finds were present.

DP 5. Trench 2. Looking north-west.

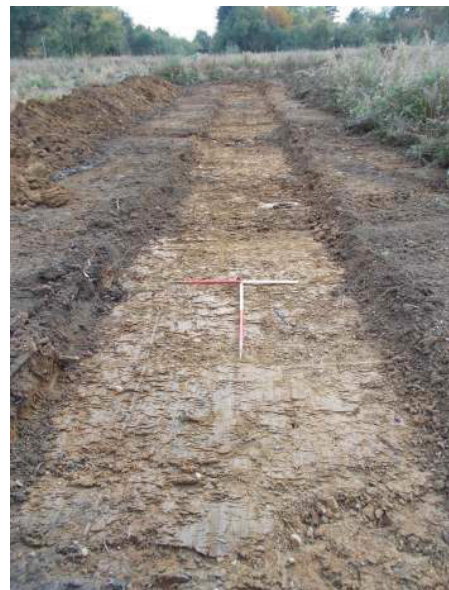
DP 6. Trench 2. Looking south.

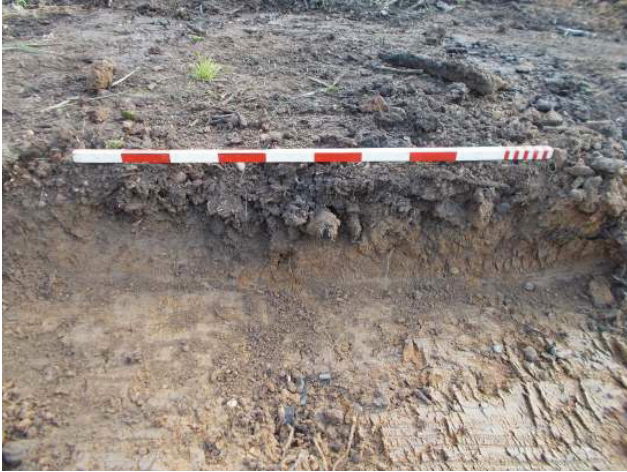
<i>Sample section 2A (DP 7): north end, west facing</i> <i>0.00 = 30.41m AOD</i>		
0.00 – 0.15m	L1000	Topsoil. As above, Tr. 1.
0.15 – 0.23m	L1001	Subsoil. As above, Tr. 1.
0.23m +	L1002	Natural clay. As above, Tr. 1.

DP 7. Trench 2, north end. Sample section 2A. Looking east.

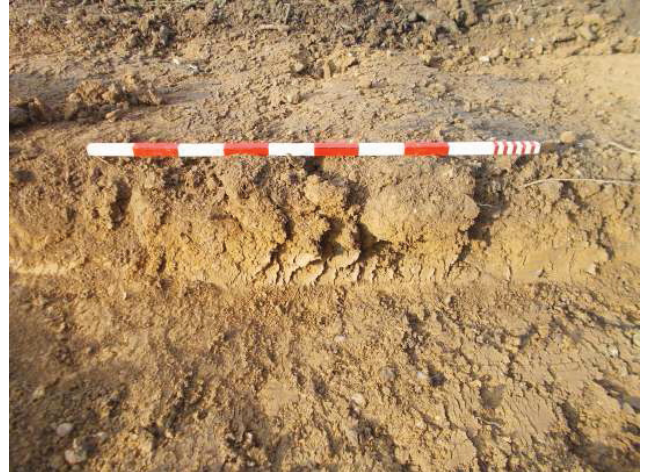
<i>Sample section 2B (DP 8): south end, east facing</i> <i>0.00 = 30.71m AOD</i>		
0.00 – 0.05m	L1000	Topsoil. As above, Tr. 1.
0.05 – 0.15m	L1001	Subsoil. As above, Tr. 1.
0.15m +	L1002	Natural clay. As above, Tr. 1.

DP 8. Trench 2, south end. Sample section 2B. Looking west.

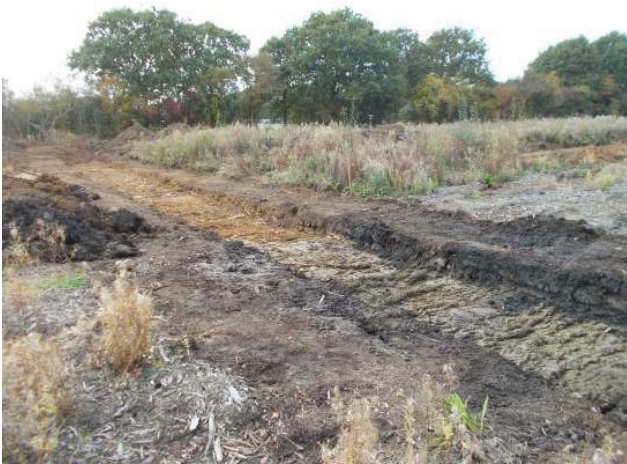
*Description:* No archaeological features or finds were present.

DP 9. Trench 3. Looking north-west.

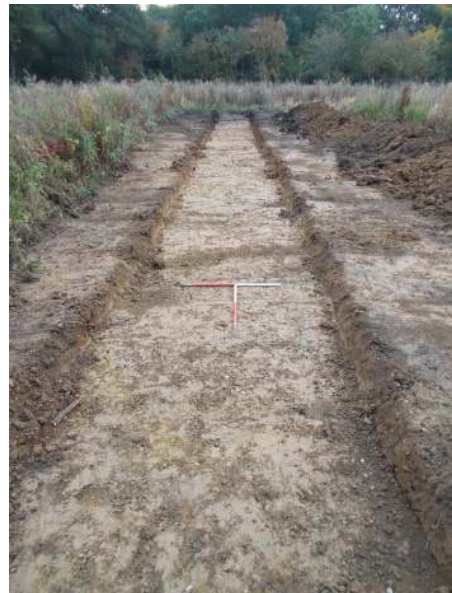
DP 10. Trench 3. Looking east.

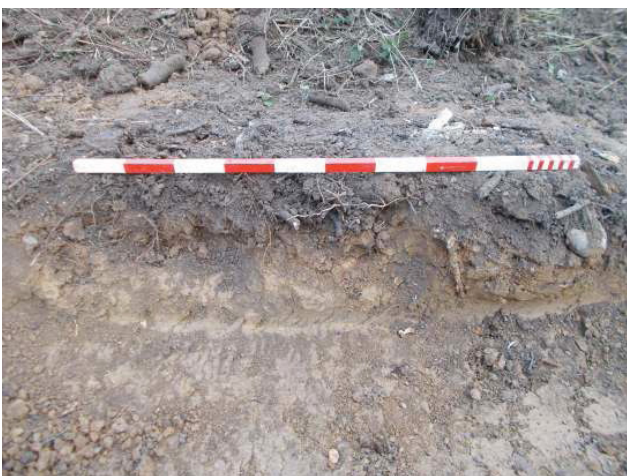
<i>Sample section 3A (DP 11): west end, south facing</i> <i>0.00 = 31.17m AOD</i>		
0.00 – 0.06m	L1000	Topsoil. As above, Tr. 1.
0.06 – 0.15m	L1001	Subsoil. As above, Tr. 1.
0.15m +	L1002	Natural clay. As above, Tr. 1.

DP 11. Trench 3, west end. Sample section 3A. Looking north.

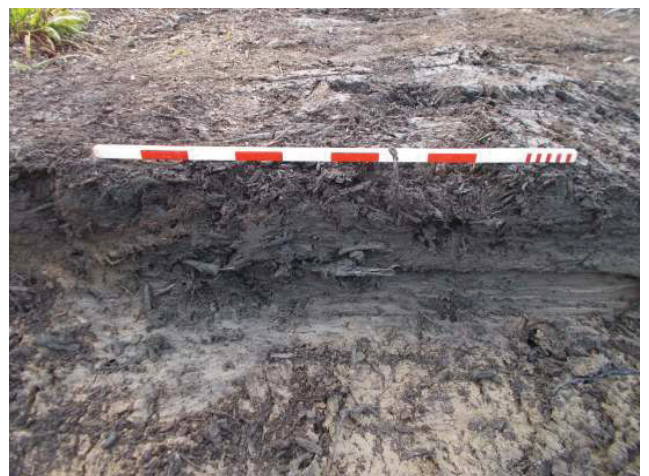
<i>Sample section 3B (DP 12): east end, north facing</i> <i>0.00 = 31.10m AOD</i>		
0.00 – 0.33m	L1003	Topsoil + compost. As above, Tr. 1.
0.33m +	L1002	Natural clay. As above, Tr. 1.

DP 12. Trench 3, east end. Sample section 3B. Looking south.

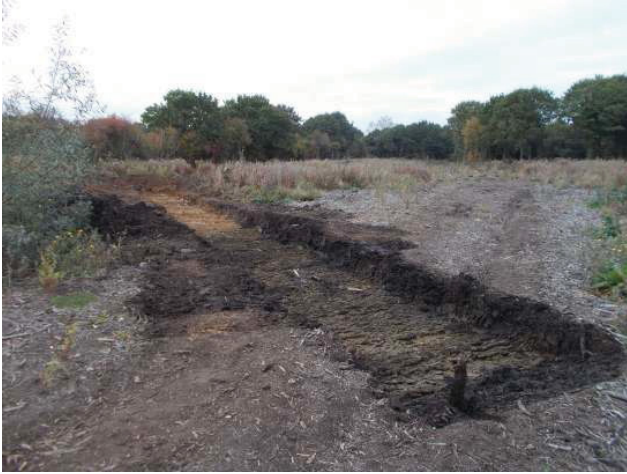
*Description:* No archaeological features or finds were present.

DP 13. Trench 4. Looking north.

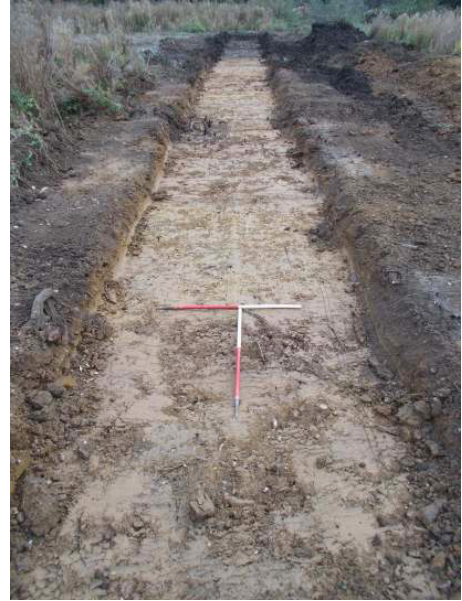
DP 14. Trench 4. Looking south-east.

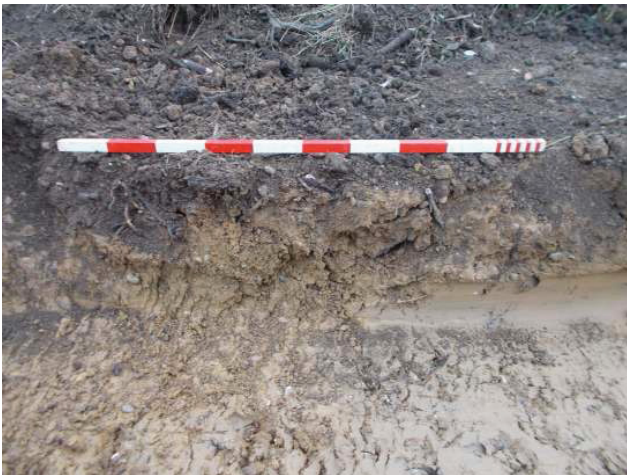
<i>Sample section 4A (DP 15): north-west end, south-west facing</i> <i>0.00 = 31.60m AOD</i>		
0.00 – 0.09m	L1000	Topsoil. As above, Tr. 1.
0.09 – 0.19m	L1001	Subsoil. As above, Tr. 1.
0.19m +	L1002	Natural clay. As above, Tr. 1.

DP 15. Trench 4, north-west end. Sample section 4A. Looking north-east.

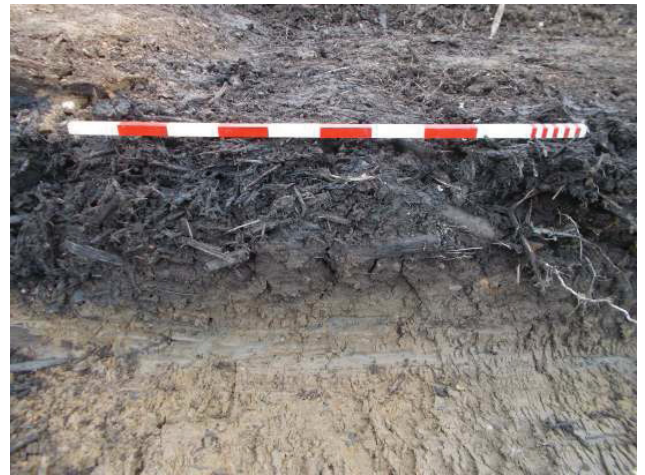
<i>Sample section 4B (DP 16): south-east end, north-east facing</i> <i>0.00 = 31.79m AOD</i>		
0.00 – 0.23m	L1003	Topsoil + compost. As above, Tr. 1.
0.23 – 0.30m	L1001	Subsoil. As above, Tr. 1.
0.30m +	L1002	Natural clay. As above, Tr. 1.

DP 16. Trench 4, south-east end. Sample section 4B. Looking south-west.

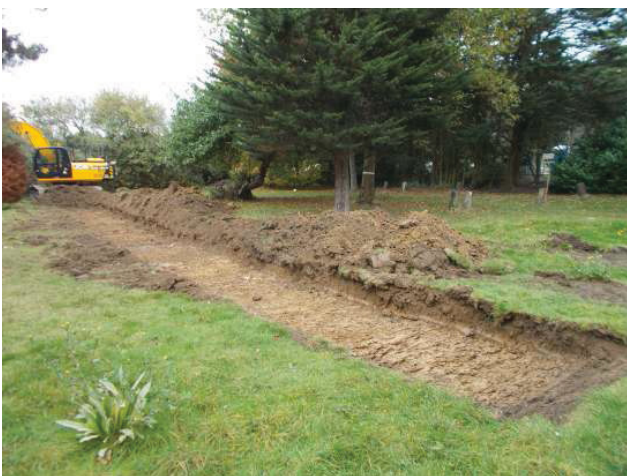
*Description:* No archaeological features or finds were present.

DP 17. Trench 5. Looking north-east.

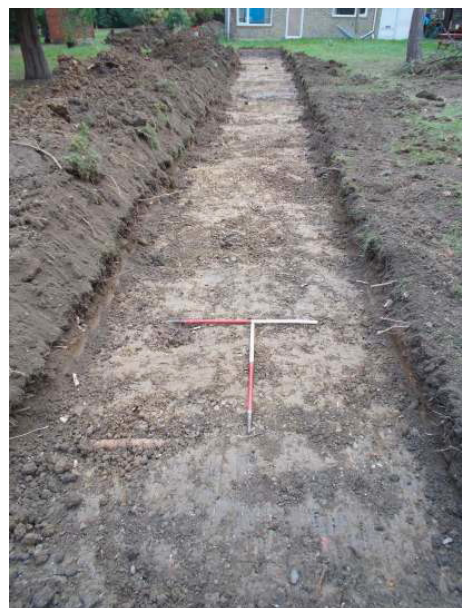
DP 18. Trench 5. Looking south.

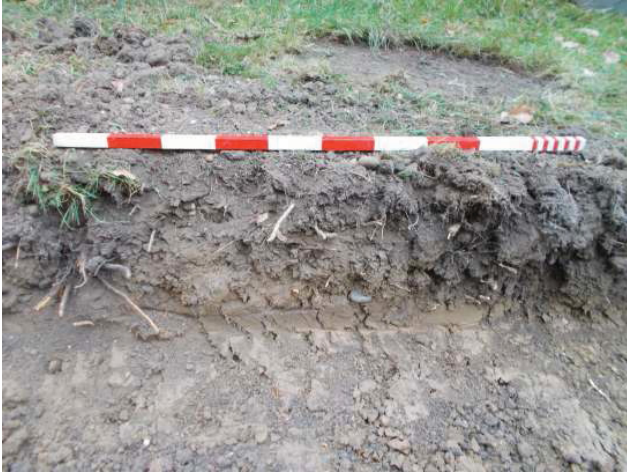
<i>Sample section 5A (DP 19): north end, east facing</i> <i>0.00 = 32.49m AOD</i>		
0.00 – 0.13m	L1004	Topsoil (garden area). Mid grey, friable, clayey silt with frequent roots.
0.13 – 0.20m	L1001	Subsoil. As above, Tr. 1.
0.20m +	L1002	Natural clay. As above, Tr. 1.

DP 19. Trench 5, north end. Sample section 5A. Looking west.

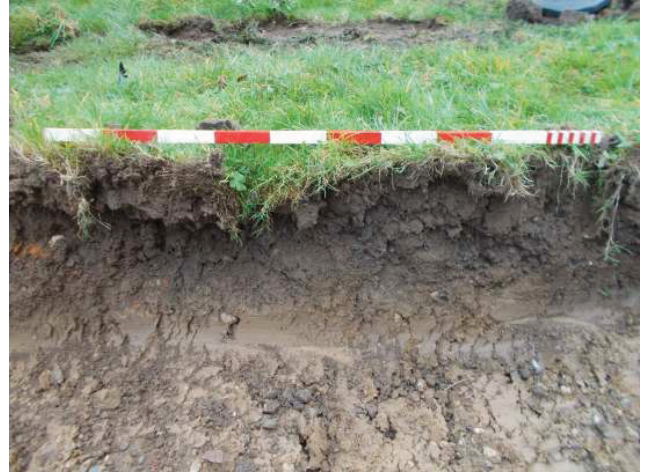
<i>Sample section 5B (DP 20): south end, west facing</i> <i>0.00 = 32.78m AOD</i>		
0.00 – 0.27m	L1004	Topsoil (garden area). As above, S.S. 5A.
0.27 – 0.34m	L1001	Subsoil. As above, Tr. 1.
0.34m +	L1002	Natural clay. As above, Tr. 1.

DP 20. Trench 5, south end. Sample section 5B. Looking east.

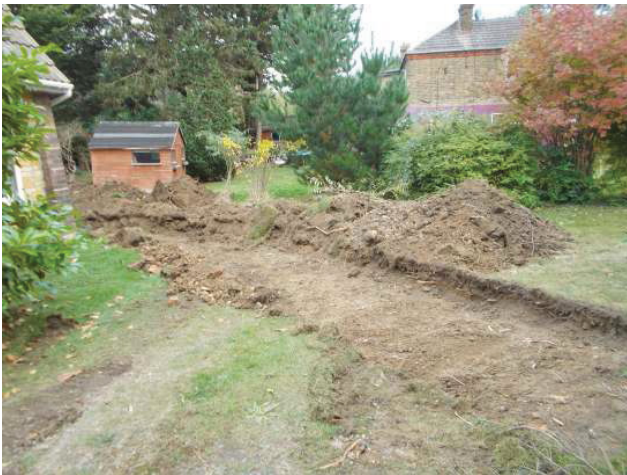
*Description:* No archaeological features or finds were present.

DP 21. Trench 6. Looking north-east.

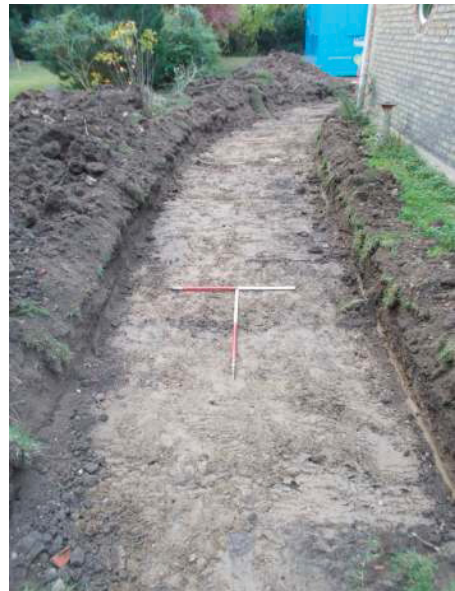
DP 22. Trench 6. Looking south.

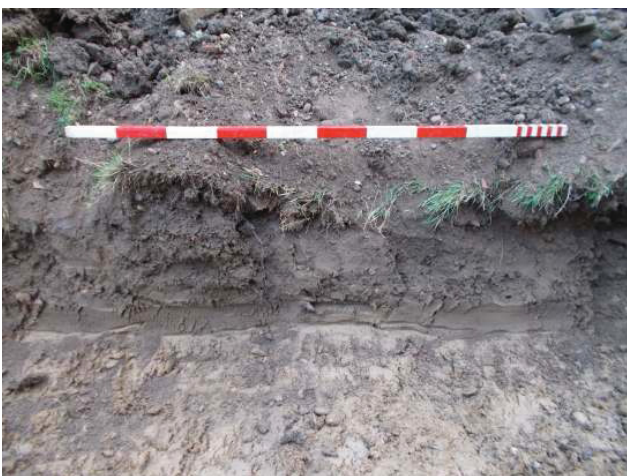
<i>Sample section 6A (DP 23): north end, east facing</i> <i>0.00 = 32.86m AOD</i>		
0.00 – 0.23m	L1004	Topsoil (garden area). As above, Tr. 5.
0.23 – 0.27m	L1001	Subsoil. As above, Tr. 1.
0.27m +	L1002	Natural clay. As above, Tr. 1.

DP 23. Trench 6, north end. Sample section 6A. Looking east.

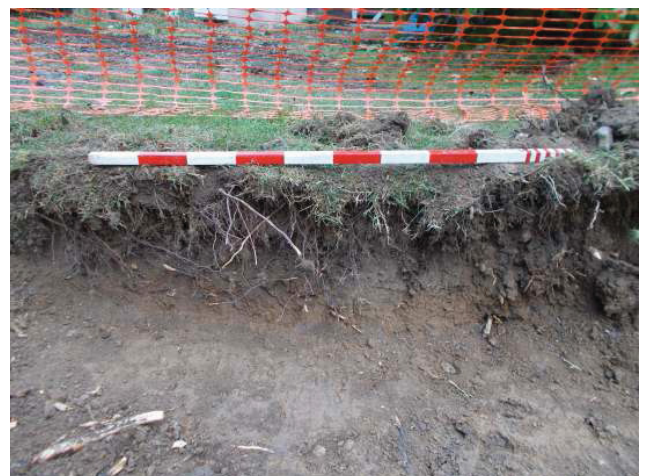
<i>Sample section 5B (DP 24): south-west end, south-east facing</i> <i>0.00 = 33.05m AOD</i>		
0.00 – 0.21m	L1004	Topsoil (garden area). As above, Tr. 5.
0.21 – 0.28m	L1001	Subsoil. As above, Tr. 1.
0.28m +	L1002	Natural clay. As above, Tr. 1.

DP 24. Trench 6, south-west end. Sample section 6B. Looking north-west.
