LAND ADJACENT TO KILNSIDE,
TUNBRIDGE WELLS ROAD, MARK CROSS,
EAST SUSSEX

AN ARCHAEOLOGICAL
'STRIP, MAP & SAMPLE' EXCAVATION

Authors: Zbigniew Pozorski	
NGR: TQ 58290 31749	Report No: 5264
District: Wealden	Site Code: AS 1860
Approved: Claire Halpin	Project No: 6897
MCI fA	Date: 9 December 2016

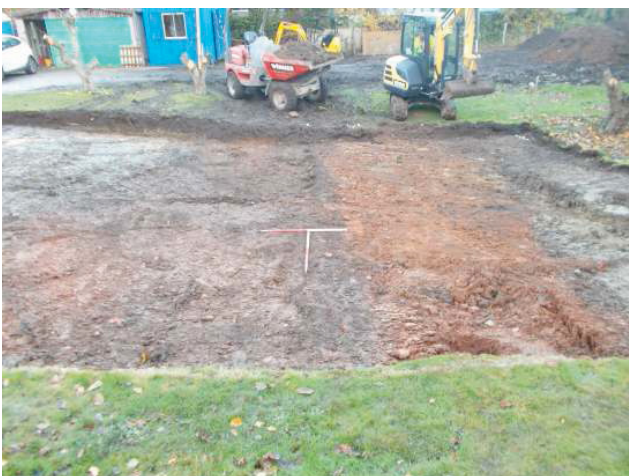
DP 5. Excavation area. Looking west-south-west.

6.1 The excavation area contained the remains of a large feature possibly comprising remains of the former brick kiln. F1003 (12.50+ x 6.30 x 1.30m; DP 5 – 7) was a rectangular pit which traversed the excavation area from west to east. The excavated section of the pit (DP 7 – 12) revealed it had irregular sides and a flat base. The uppermost fill, L1004, was present in the central and southern part of the feature. It was a mid to dark grey, friable, silt with frequent small CBM fragments (0.10 – 0.20m thick). The principal fill, L1005, was a mid red, friable, clayey silt with modern CBM (brick, tile and drain pipe) and clay rubble (1.25m thick). Although on the surface L1005 appeared to have been located only along the northern side of the pit it was actually present throughout the feature. The western sector of the pit contained L1006, a reddish yellow and grey, mixed CBM rubble and clay with some sandy silt and debris. L1006 was partially overlain by L1004. On the northern side of the pit, L1007, was a mid grey, friable, clayey silt with occasional CBM fragments (0.10 – 0.20m thick). On the opposite side a similar deposit, L1009, was present. At the base of the pit, L1008, was a dark grey, friable, clayey silt with frequent charcoal flecks (0.08 – 0.15m thick).

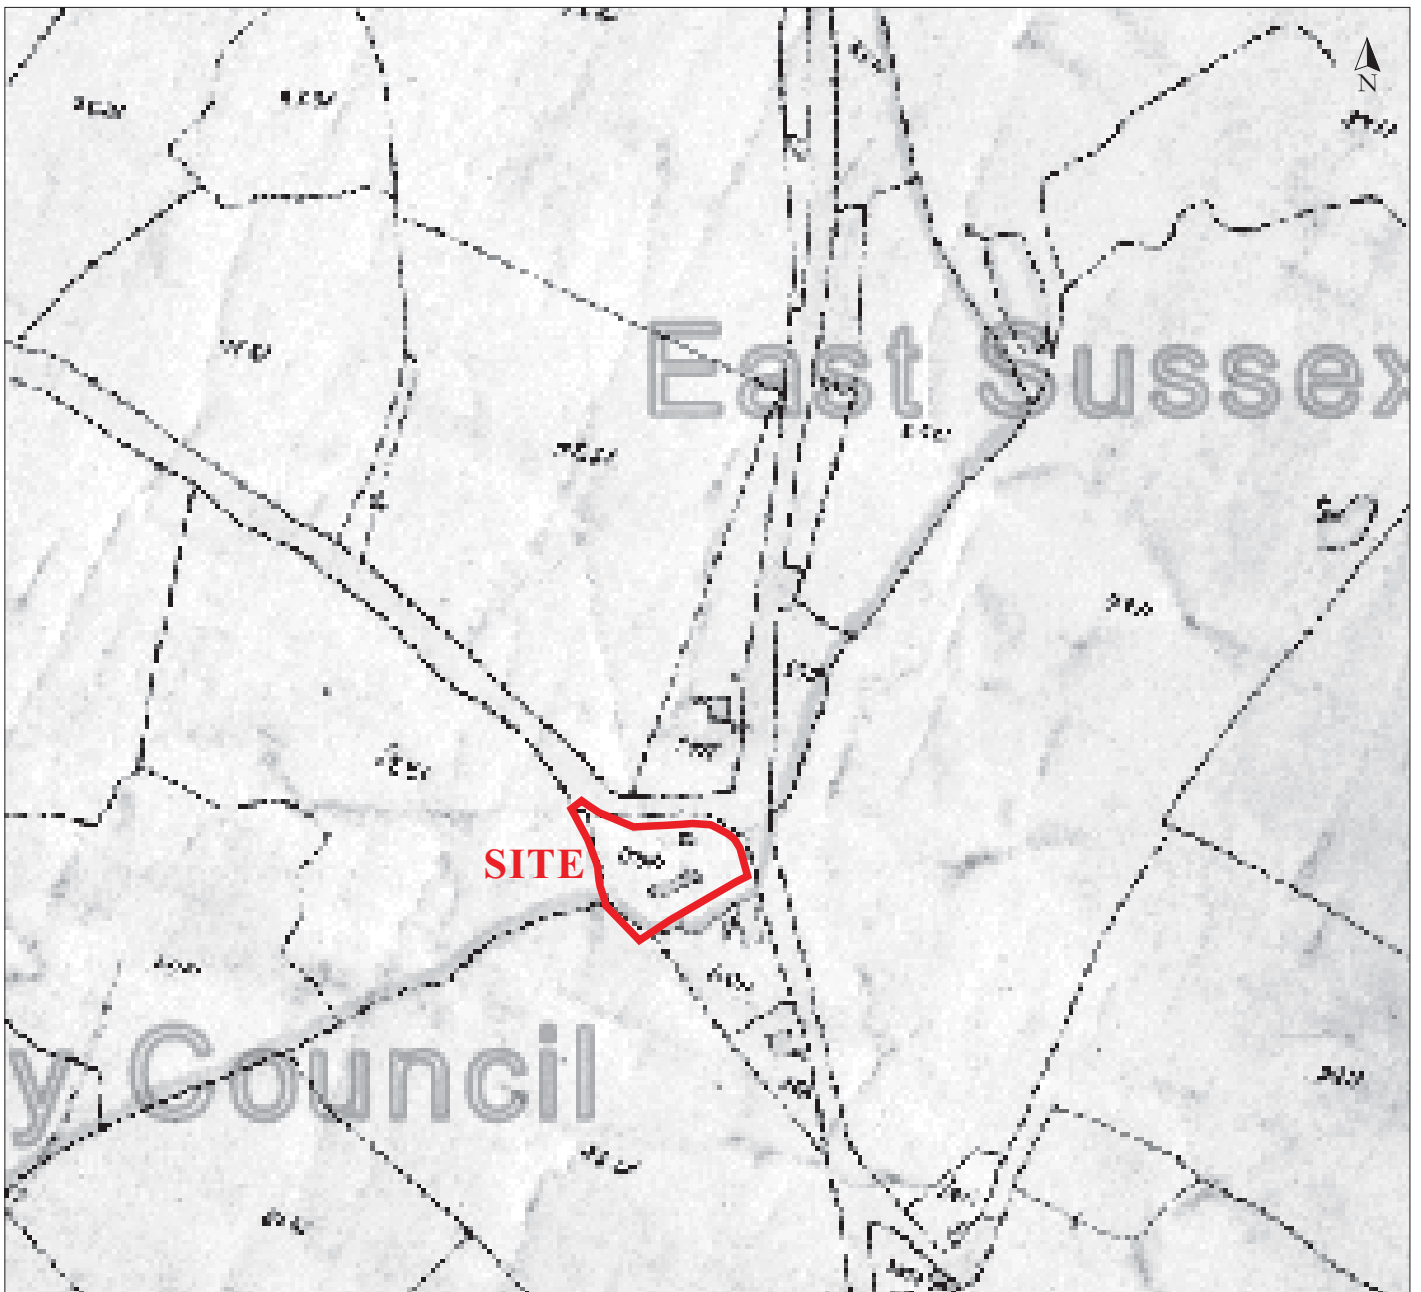
<i>Archaeological Solutions Ltd</i>
Fig. 3 Rotherfield tithe map, 1842
Not to scale
Marks Cross, East Sussex (P6897)

4.5 Cartographic sources depict the site from 1842 when the site is shown with two buildings, possibly a single kiln and drying shed (Fig. 3), but by 1878 the site is shown in more detail (Fig. 4). In 1878, the site includes long narrow buildings along the western and southern site boundaries and in the main area there are two structures that correlate to the area investigated in the position of the proposed new house footprint. The site is labelled as a brick and tile works, while at least one building in the centre is marked as a kiln. It is possible that both structures shown here are individual kilns or that the second building is an associated structure, perhaps representing the working floor for a kiln. The 1898 map (Fig. 5) depicts the same building but with additional detail to the buildings within the site but also shows a pond to the south, perhaps a former extraction pit. The narrow buildings within the site appear to be depicted as open-sided which is typical of drying sheds. Later OS maps (Figs. 6-8) show a single kiln structure which correlates to the west example on the earlier maps, as well as the narrow ranges noted above.

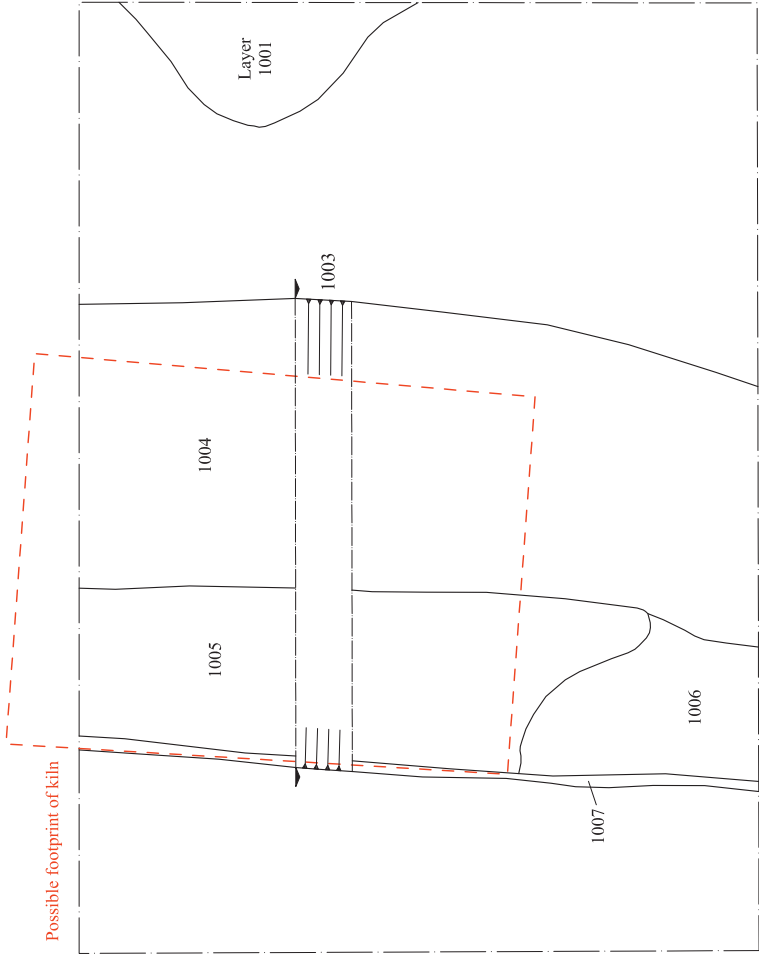
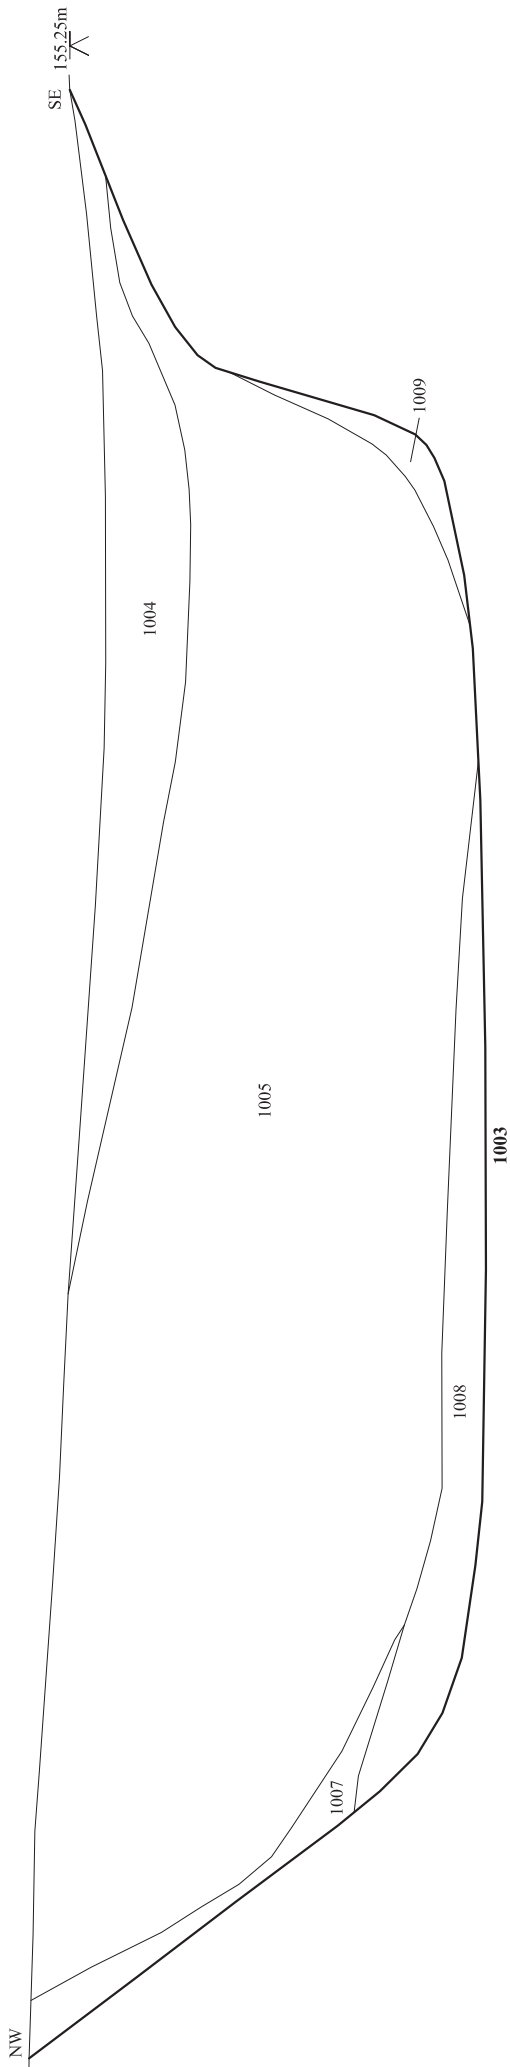
Archaeological Solutions Ltd
Fig. 9 Plan and section
 Scale 1:100 and 1:25 at A4
 Mark Cross, East Sussex (P6897)

6.2 On the western side of the excavated area was a rectangular structure (13+ x 5.50m+), part of a former row of small outbuildings. The latter were aligned along the western boundary of the site. Two perpendicular linear features (0.40m wide) were recorded, and three internal post holes. The feature appeared to contain no structural elements and was backfilled with similar material, mid grey, friable, clayey silt.

9.2 Within the excavation area Pit F1003 was the only feature present and may be consistent with the remains of a brick kiln that has been almost completely removed leaving only brick rubble and other backfill material, though an alternative scenario is suggested below. The presence of fired CBM rubble backfill and the alignment of the pit suggest the kiln consisted of a rectangular structure (c.6 x 5m) roughly parallel to Brickyard Lane to the north. The earthen bank to the east may mark the eastern extent of the west structure or form part of the adjoining building visible on historic maps in 1878 and 1898.
