15 – 17 NORTH STREET, BISHOP'S STORTFORD,
HERTFORDSHIRE

**HISTORIC BUILDING RECORDING
AND ARCHAEOLOGICAL MONITORING**

15 – 17 NORTH STREET, BISHOP’S STORTFORD, HERTFORDSHIRE

HISTORIC BUILDING RECORDING AND ARCHAEOLOGICAL MONITORING

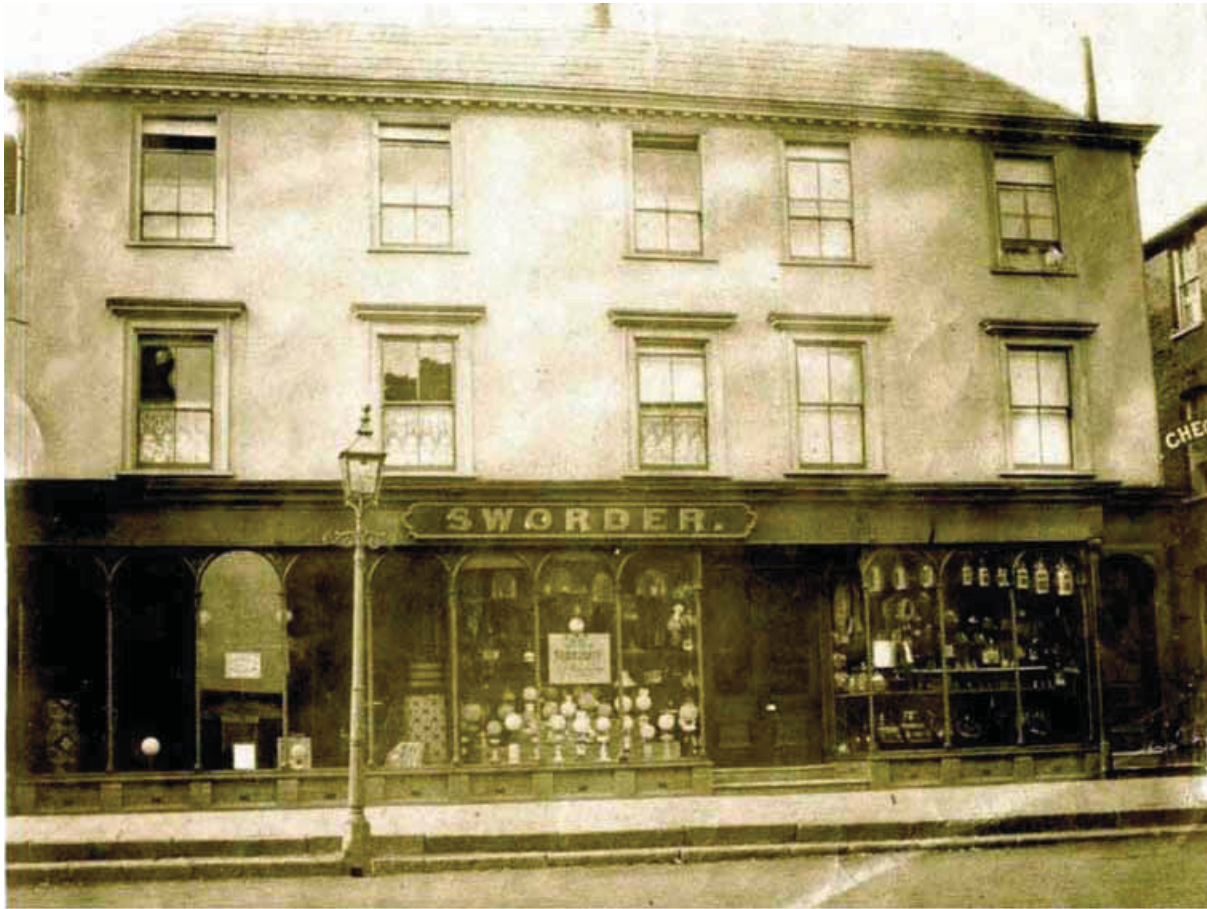
Circa 1900 view, No. 17 North Street

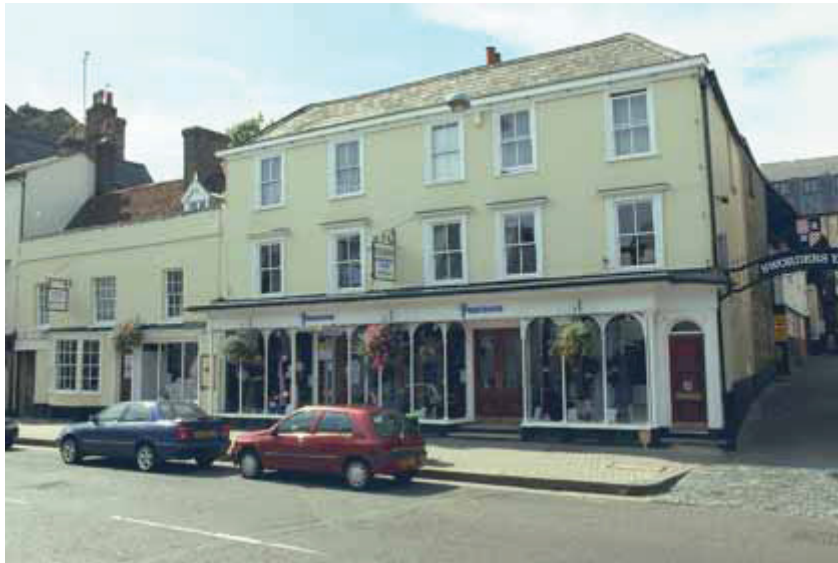
1. 5253 NORTH STREET (West Side) No 17 (Pearsons) TL 4821 SE:3/66 26.7.71 II
GV 2. Two houses now one shop. On south (formerly No 15), mid C18. Painted brick, steep old red tile roof. Two and a half storeys, 3 windows. Ground floor early C19 shop front with slim pilasters to door and modern north window. Triple-hung bowed sash window on south. Zigzag fan over door. First floor sash windows and band beneath parapet. One gabled dormer. C17 timber frame in rear of shop. On north mid C19. Stucco, slate hipped roof. Three storey, 5 windows. Ground floor, cast iron, arcaded shop front in 3 bays of 3 arches with spiralled mullions. Architraves and cornices to first floor windows, plain eaves.

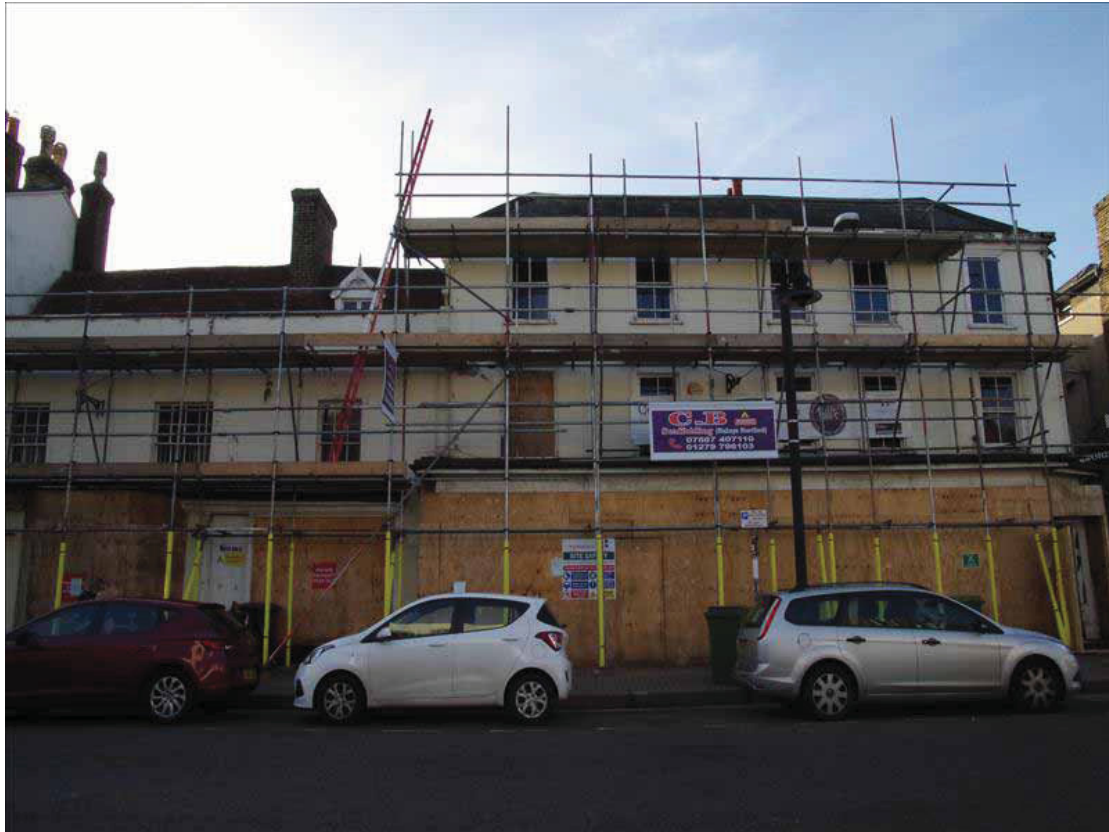
Plate 1 Main frontage of Nos. 15 – 17 North Street. Taken from the east (DP 1)

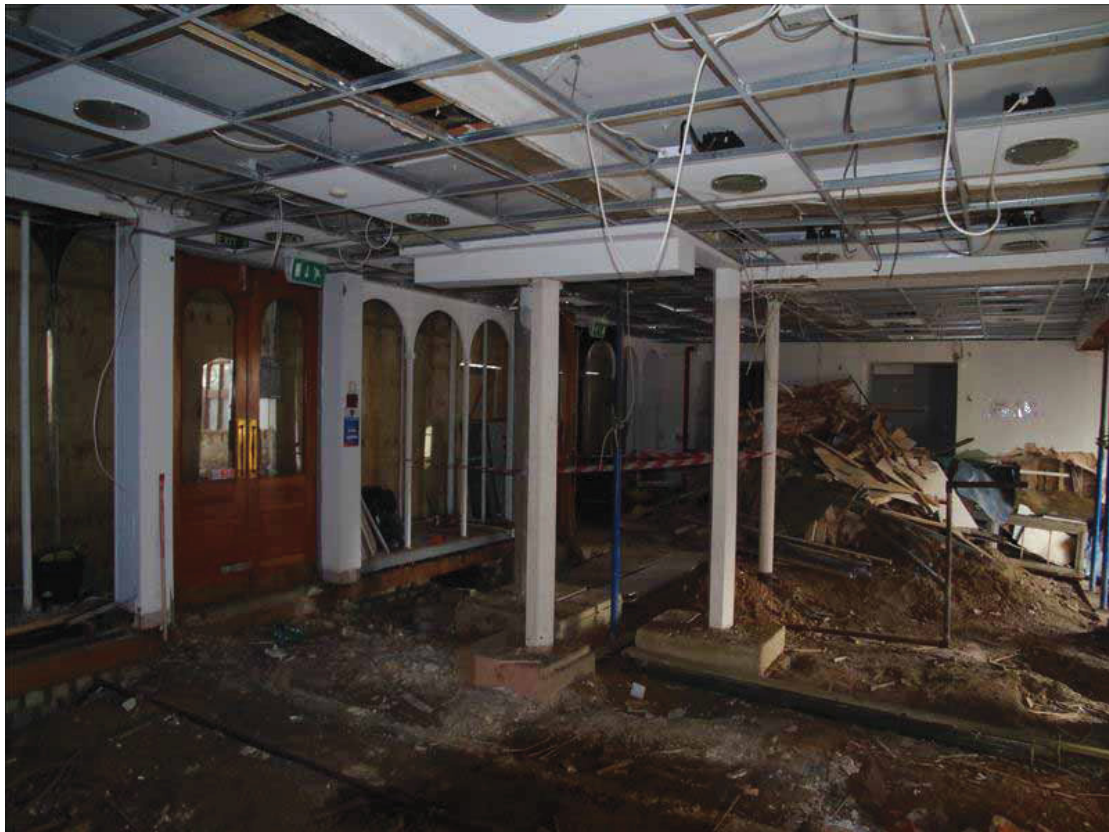
Plate 2 Main interior ground floor space of No. 17, showing cast iron shop front, and columns replacing the original chimney stack. Taken from the north-west (DP 2)

5.1 The ground floor of No. 17 (DPs 2 – 5) comprises a large open and consolidated space, which has been comprehensively altered and stripped of most features of interest. The general configuration of the historic ranges can still be discerned however. The location of the original chimney stack is now represented by three cement columns on concrete pads close to the main entrance (DP 2) which continue to support the surviving elements of the stack at upper level. To the north, the principal intermediate joist from the first phase of the building's development is now visible, as a heavily chamfered, but latterly boxed-in timber. Elsewhere, a suspended ceiling prevents further observation. To the rear is a canted wall of 18th century brick and the rear wall of a probable former stair turret. The rear range retains its principal joisting system, chamfered and lime-washed, with common joisting surviving, supporting wide 18th century boards above; the jointing is tenoned into the principals with a diminished haunch, which suggests a later 17th or early 18th century date. On the central, northern side of the ground floor space, internal stripping of the building has resulted in the exposure and destruction of a small cellar. The Victorian shop fascia also survives (DPs 2 & 5), comprising a pine lintel situated behind a cast iron shop façade; supported at ground level on un-mortared yellow gault 'Arlesey' bricks of mid- to later 19th century date.

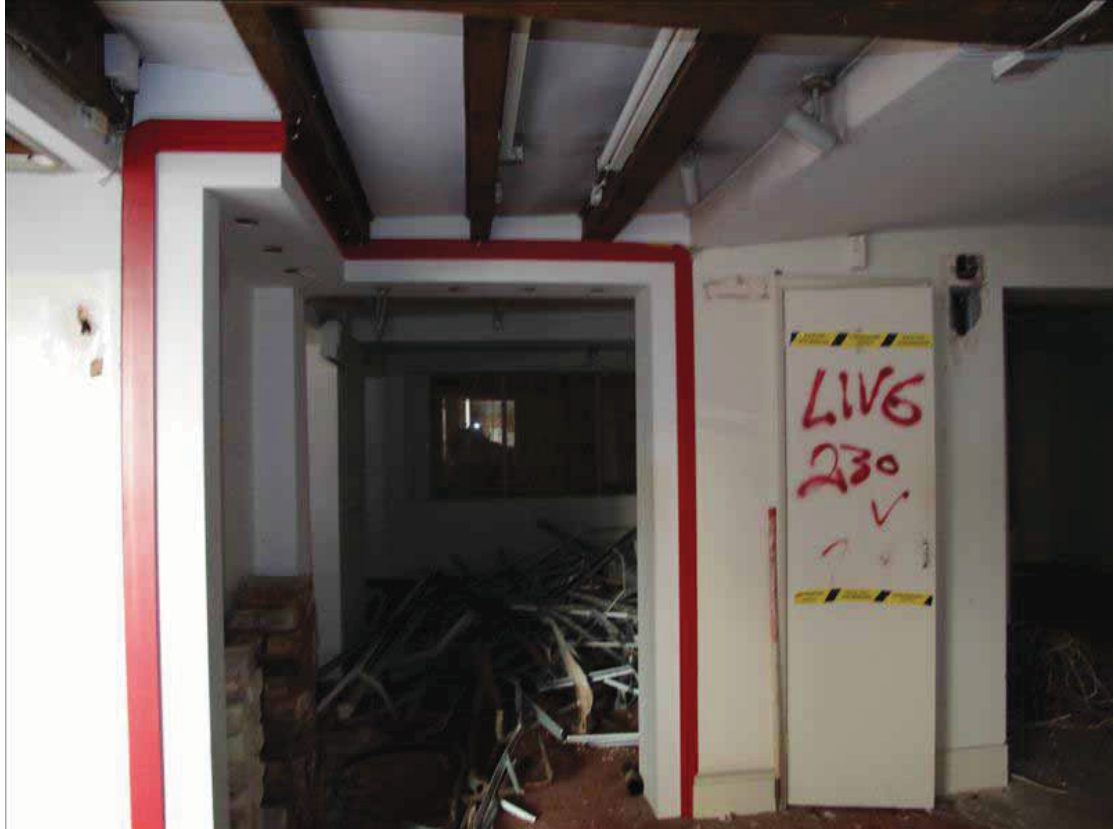
Plate 3 Interior ground floor space of No. 15, with modern room divisions and preserving roof timbers. Taken from the west (DP 7)

5.5 The ground floor of No. 15 North Street has been consolidated and subsequently re-divided arbitrarily with falsework (DPs 7 – 10). The remaining visible fabric comprises a series of principal and common ceiling joists which appear to define the positions of earlier rooms (DP 11 & 12). A large principal joist extends laterally east/west; likely an insertion to support historic north/south joists. All are heavily chamfered with diminished haunch and pendant soffit form. On the northern side, historic joisting defines five bays or cells with a series of principal joists, some are chamfered. None retain mortises for studwork and therefore there is no indication of earlier partitions. The two sides of the structure are divided by large timber and a Victorian cast iron stanchion. To the south is an east-west joist, chamfered and stopped at both ends. Nothing else is visible except in exploratory apertures where we see historic joisting and wide oak/elm floor boards above.

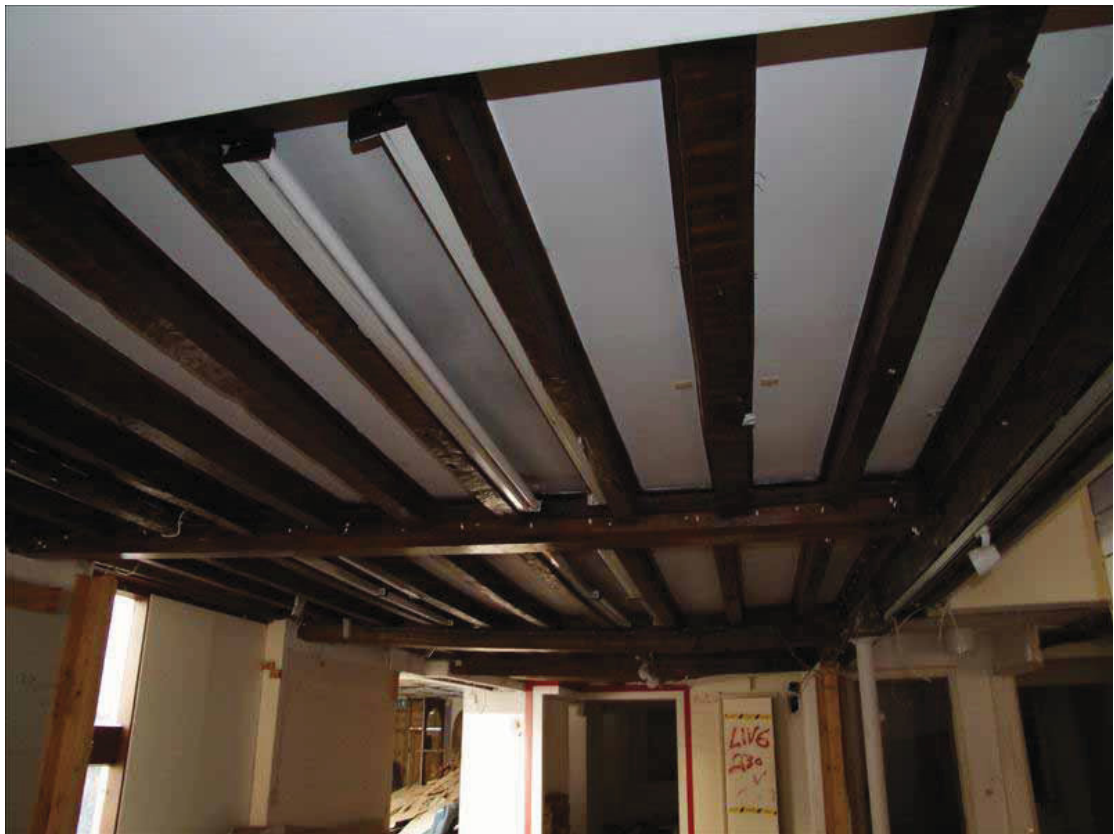
Plate 4 Roof timbers above ground floor of No. 15. (DP 11)

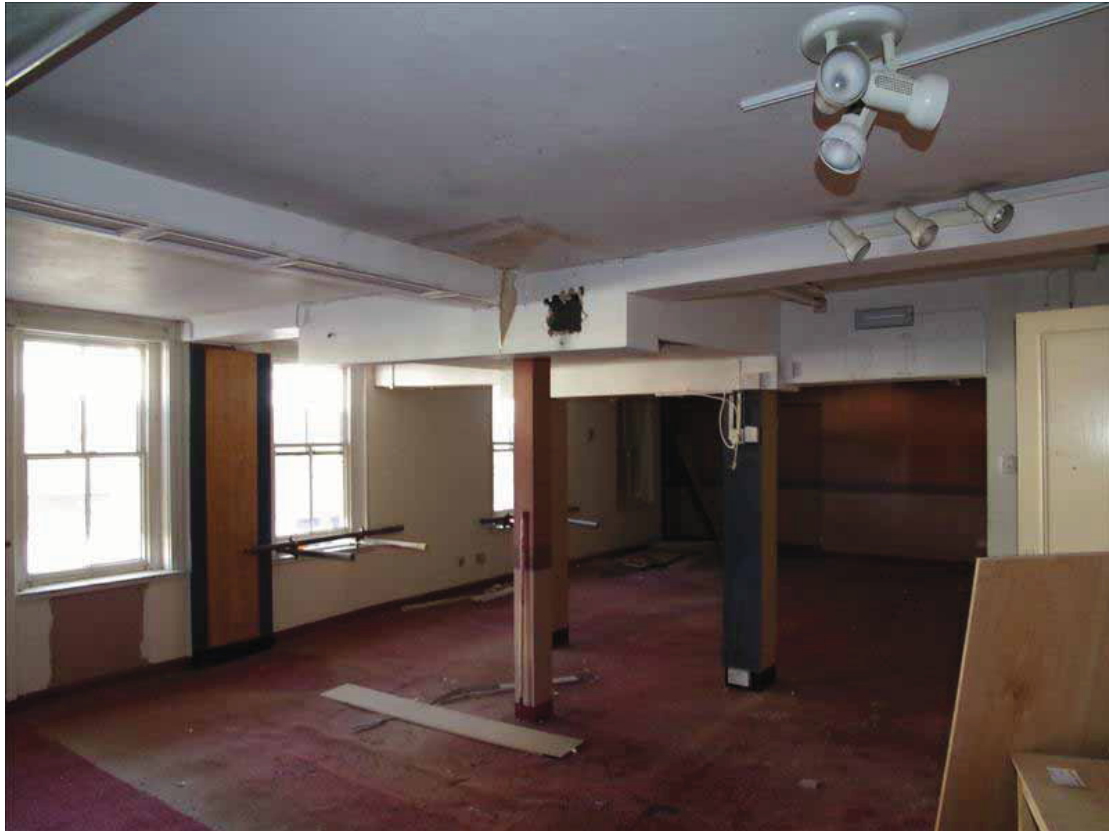
Plate 5 FF01, No. 17. Showing the 19th century sash windows and the three columns replacing the original chimney stack. Taken from the north-west (DP 13)

5.2 The first floor has also been consolidated into a single open space (FF01) (DPs 13 – 16), but with traces to indicate the earlier partitioning, including the presence of down-stands and boxed-in joisting where partition walls have been removed and earlier ceilings disguised. The stair to the upper floor is housed within its own turret but rises from this floor up to a second stair, having been inserted against the north wall. The stack which previously lay in the centre of FF01 has been replaced with boxed in steel columns. Where the stair originally returned to the lower level, we now see a small vestibule, retaining a large six-over-six, 18th century sash window. The windows to the five bays of No 17 comprise two-over-two, early to mid-19th century sash windows. The rear wing adjoining the stair turret comprises a single room (FF02) (DP 15), stepped up from the main floor level. This room houses a chimney stack in its western end, with niches on either side; two windows on the southern side consist of six-over-six, early 19th century sash windows.

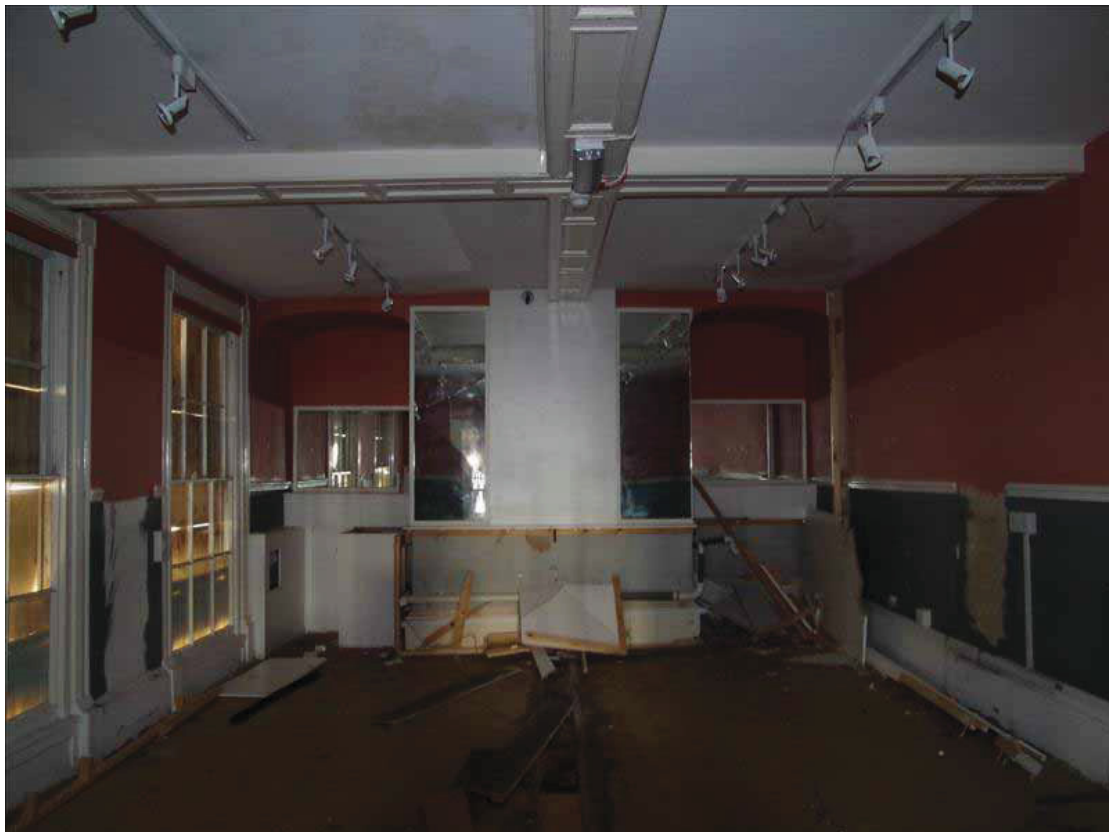
Plate 6 FF02, No. 17, showing chimney stack on the western wall, and two 19th century sash windows on the southern wall. Taken from the east (DP 15).

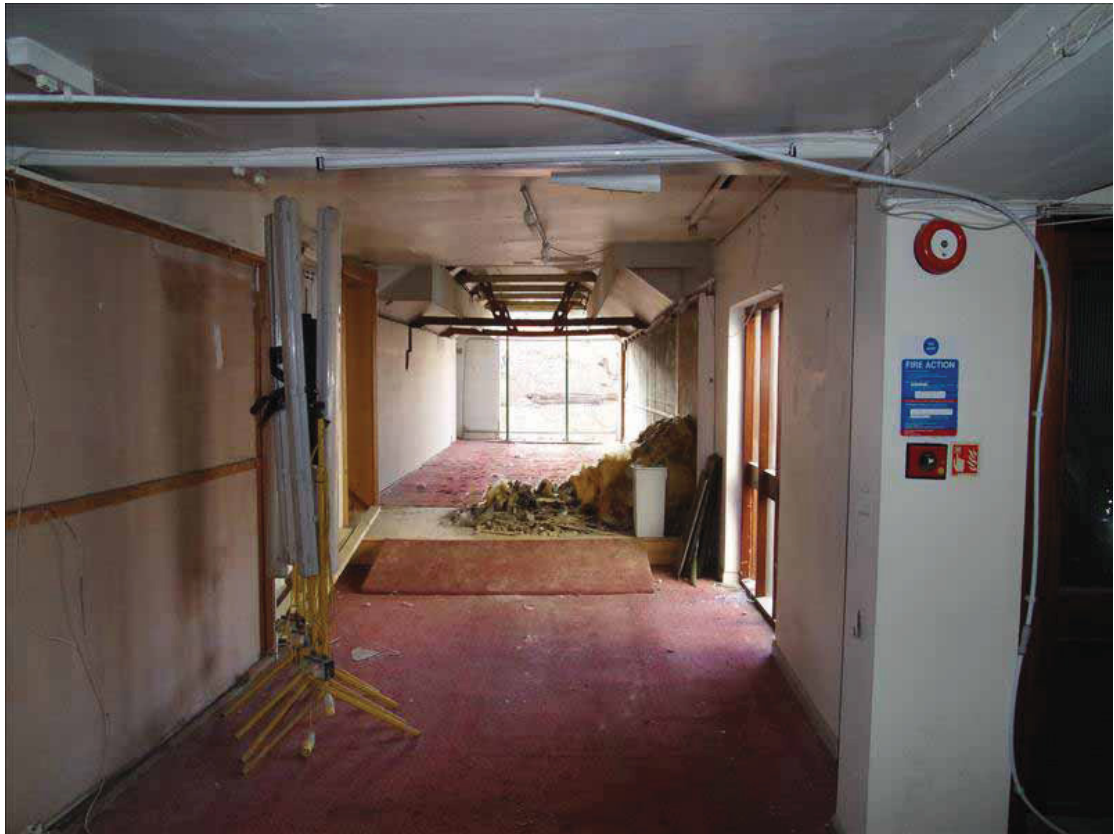
Plate 7 First floor rear range of No. 15, extended during use of the building as a department store. Taken from the east (DP 18)

5.7 The building's rear wing (FF01) is pushed out (DP 18), and was constructed after conversion to a department store. This range retains a decorative roof, comprising 2 chamfered pitch-pine tie-beams with brackets and raking queen struts with pierced trefoils and lozenges. A modern stair case rises on the southern side.

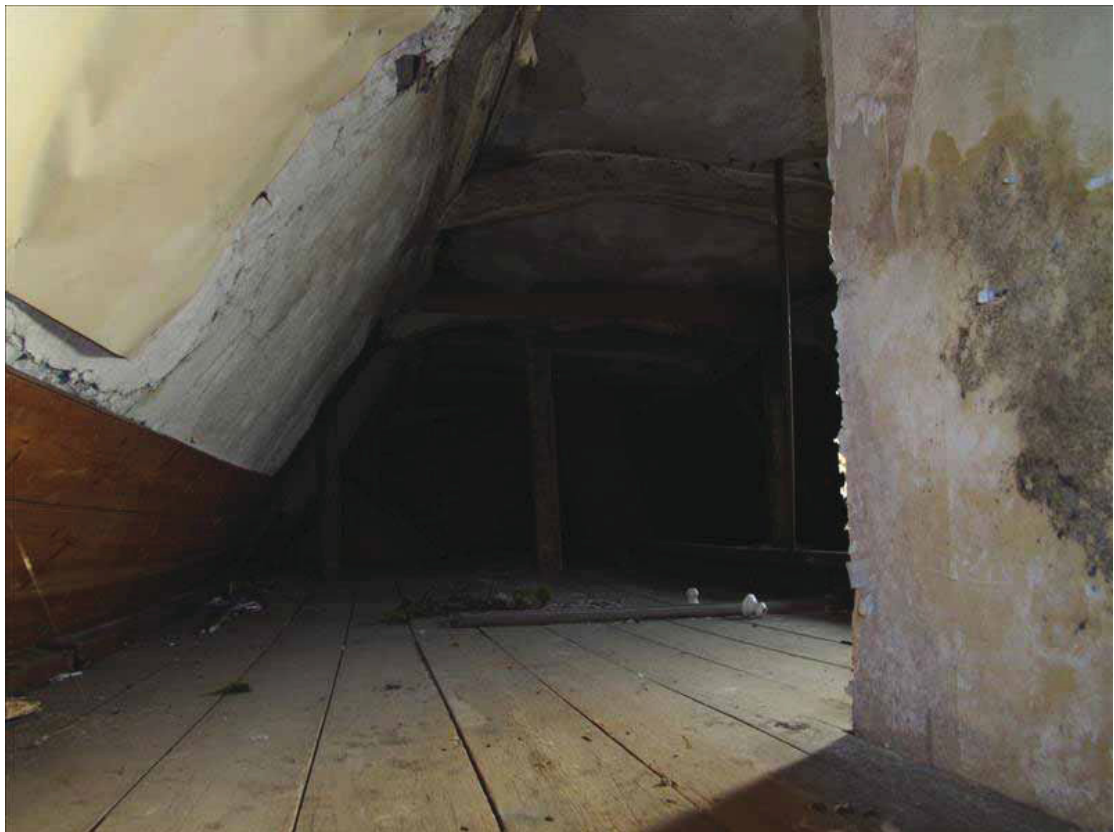
Plate 8 Roof structure above the main frontage of No. 15. Visible is the single truss with queen posts and cambered collars. Taken from the north (DP 25)

5.8 The frontage of the second floor is crowned by a single longitudinal roof (DP 25), interrupted by a chimney stack, as well as a short, rear lateral roof on the northern side only. The main frontage is a purlin roof with a single dormer behind a parapet (DP 24). The floor is conspicuous in retaining very wide oak/elm floor boards, but only the northern end survives. Originally, the whole roof would have been fully accessible before the floor level was raised in the 19th century to create grander rooms below. The roof is of clasped, side-purlin form, comprising three bays with a single truss with queen posts with intermediate cambered collars, all underdrawn.

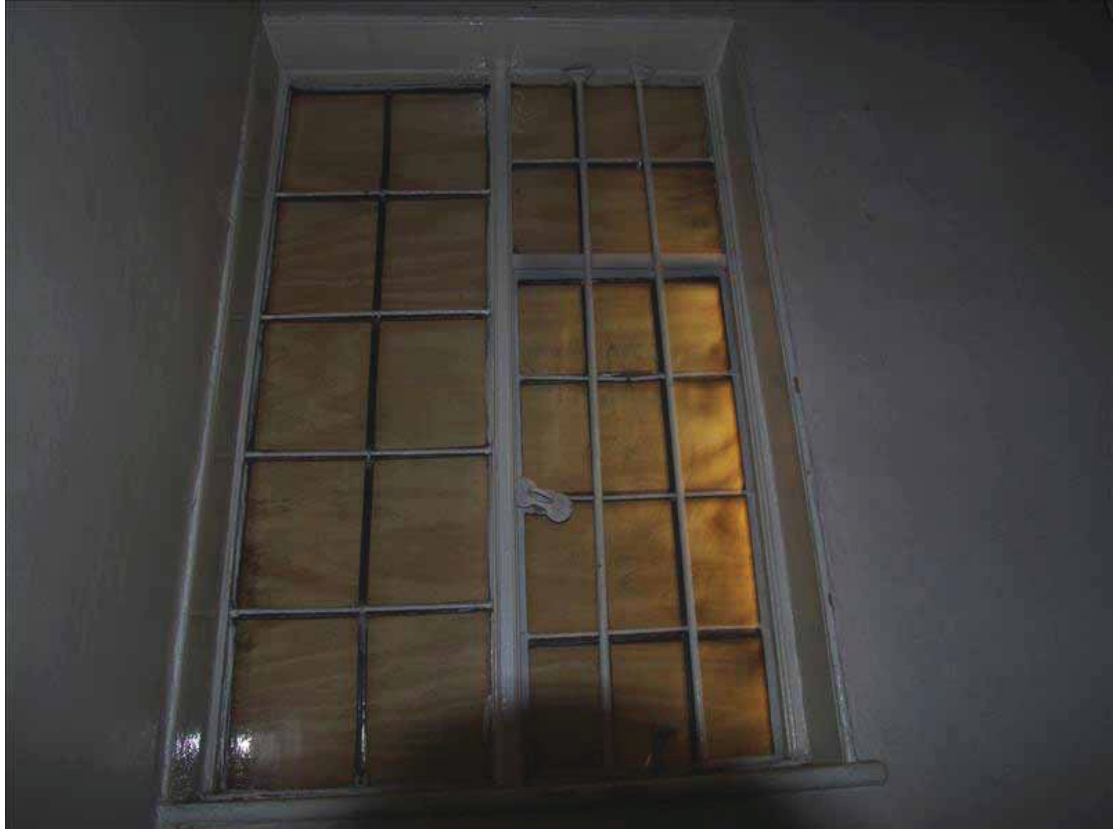
Plate 9 Early window preserved above stairway to second floor of No. 17. Retaining original casements and late 17th century moulding style, with iron catch and scrolled pull (DP 26)

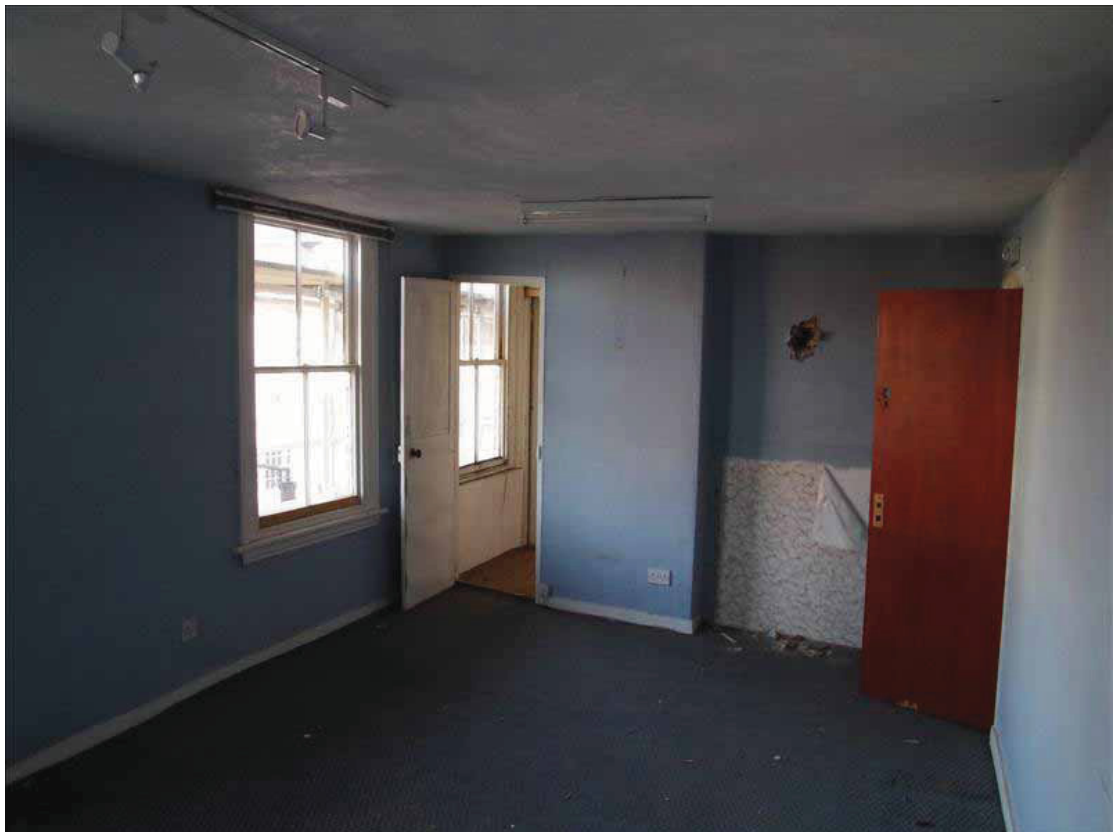
Plate 10 SF01, No. 17, showing sash windows with 1830s-1850s glazing bars, as well as preserved late 17th/early 18th century door, leading to SF1A (DP 32)

with 1830s to 1850s glazing bars. Late 17th to early 18th century doors to rooms SF1A to SF03 survive, being thin, two-panelled doors, one with H-L hinges, two with applied mouldings. SF01 is fairly simple with little historic fabric visible. SF02 has a 19th century pine floor and an 1830s cast iron fireplace with a solid surround (DP 30). Very little historic fabric is visible in SF03. The roof above the main frontage is of collar purlin form, of oak and soft wood, with jointed, nailed-on collars with clasped side purlins, typically later 17th or early 18th century in form.
