**THE POND HOUSE, BUGBY'S FARM,  
GREAT MUNDEN, HERTFORDSHIRE**

**ARCHAEOLOGICAL "STRIP, MAP & RECORD"  
INVESTIGATION AND  
ARCHAEOLOGICAL MONITORING & RECORDING**

Authors: Zbigniew Pozorski	
NGR: TL 3475 2392	Report No: 4911
District: East Herts	Site Code: AS 1431
Approved: Claire Halpin	Project No: 3692
Signed:	Date: 11 November 2015

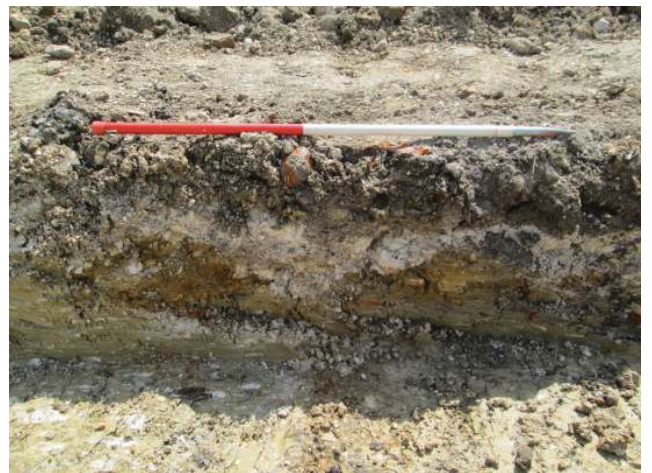
DP 6. Sample section 1. Looking east-south-east.

Sample section 1 (DP 6) Strip area for new extension, facing west-north-west 0.00 = 117.28m AOD		
0.00 – 0.16m	L1000	Modern made ground. Dark brown, friable, clayey silt with moderate CBM fragments.
0.16 – 0.29m	L1001	Made ground. ?Re-deposited natural white, loose and friable, chalk.
0.29 – 0.34m	L1002	Subsoil. Mid to dark brownish orange, compact, clayey silt.
0.34m+	L1003	Natural light greenish yellow, compact, clay with frequent chalk.

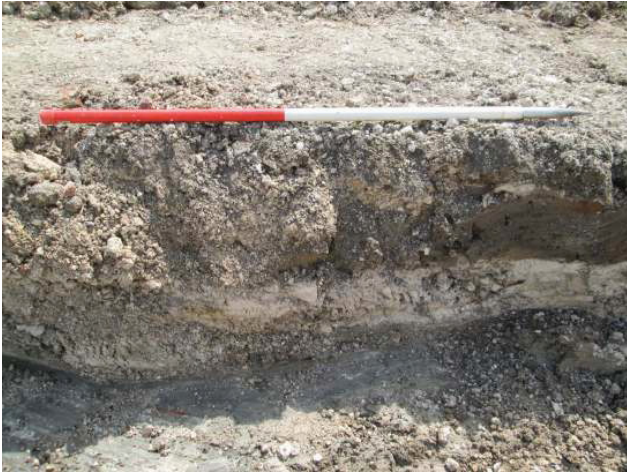
DP 7. Sample section 2. Looking east-south-east.

<i>Sample section 2 (DP 7)</i> <i>Strip area for new extension ,facing west-north-west</i> <i>0.00 = 117.33m AOD</i>		
0.00 – 0.34m	L1000	Modern made ground. As above.
0.34m+	L1004	Made ground. Re-deposited white, loose, chalk and mid grey, friable, clayey silt.

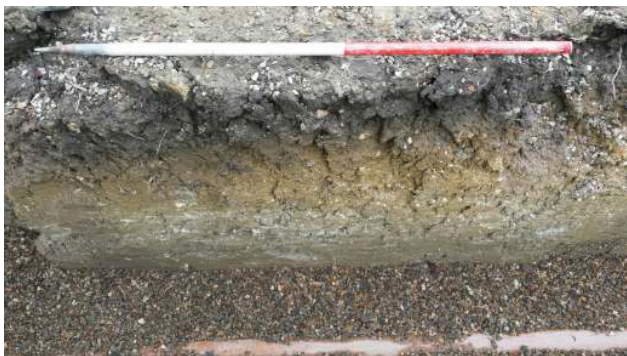
DP 11. Drainage trench. Sample section 3. Looking west.

<i>Sample section 3 (DP 11)</i> <i>Drainage trench, facing east</i> <i>0.00 = 117.07m AOD</i>		
0.00 – 0.23m	L1005	Topsoil. Dark grey, soft to friable, sandy silt.
0.23 – 0.57m	L1002	Subsoil. As above.
0.57m+	L1003	Natural clay. As above.

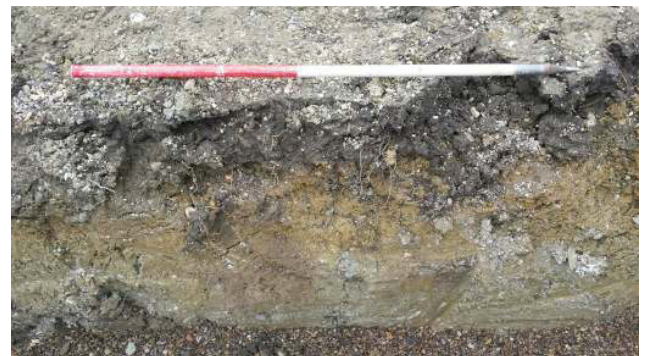
DP 12. Drainage trench. Sample section 4. Looking east.

<i>Sample section 4 (DP 12)</i> <i>Drainage trench, facing west</i> <i>0.00 = 117.40m AOD</i>		
0.00 – 0.17m	L1005	Topsoil. As above.
0.17 – 0.43m	L1002	Subsoil. As above.
0.43m+	L1003	Natural clay. As above.

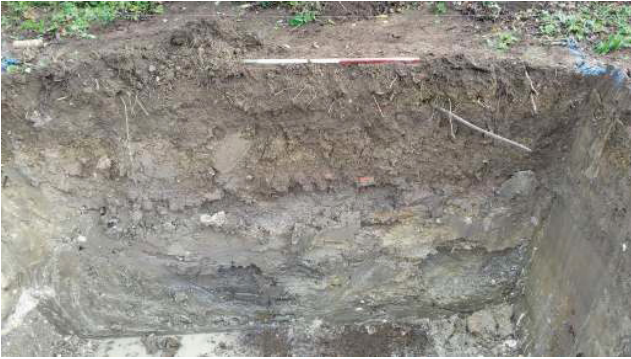
DP 13. Septic tank pit. Sample section 5. Looking north.

<i>Sample section 5 (DP 13)</i> <i>Septic tank pit ,facing south</i> <i>0.00 = 117.33m AOD</i>		
0.00 – 0.21m	L1005	Topsoil. As above.
0.21 – 0.41m	L1008	Made ground. Light yellowish brown, friable, silty sand.
0.41 – 0.66m	L1009	Made ground. Dark brownish grey, friable, sandy silt with occasional CBM fragments.
0.66 – 0.87m	L1010	Made ground. Light yellowish brown, friable, silty sand with occasional CBM fragments.
0.87 – 0.97m	L1011	Made ground. Dark brown, friable, clayey silt.
0.97m+	L1003	Natural clay. As above.

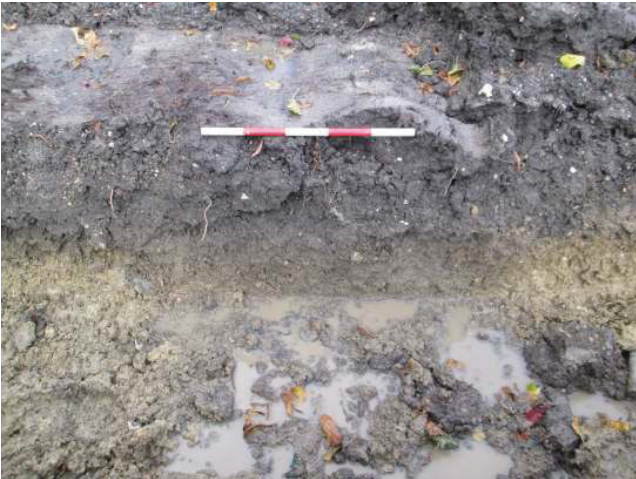
DP 15. ?Gully F1006. Looking west-north-west.

*Description: Undated Gully F1006 was recorded during the inspection of one of the emergency drainage trenches excavated to the south of the house and its new extension (Figs. 3-4).*

Gully F1006 was linear in plan (0.70+ x 0.83 x 0.30m+; DP 15), orientated west-north-west/east-south-east. It had moderately sloping sides and a concave base. Its fill, L1007, was a mid grey, compact, clayey silt. No finds were present.

9.2 In the event only an undated gully (F1006) was recorded to the south of the house. No residual finds were recovered.

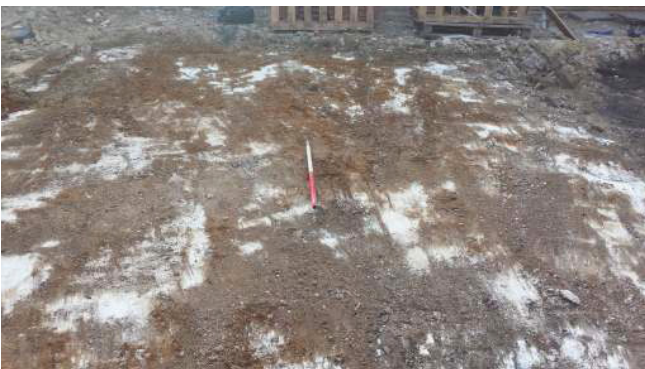
DP 17. Strip area to the north of the house. Looking west-north-west.

8.2 The area to the north of the house where a ground was reduced and levelled (0.20 – 0.40m) for the new garden, only deposits of modern made ground were present and natural geology was not exposed. The principal deposit within this area was L1014, a mixed mid brown and grey, friable, sandy silt and white chalk.
