**FORMER WOODHALL ARMS PUBLIC HOUSE, 17
HIGH ROAD, STAPLEFORD, HERTFORDSHIRE
SG14 3NW**

HISTORIC BUILDING RECORDING

Level 3

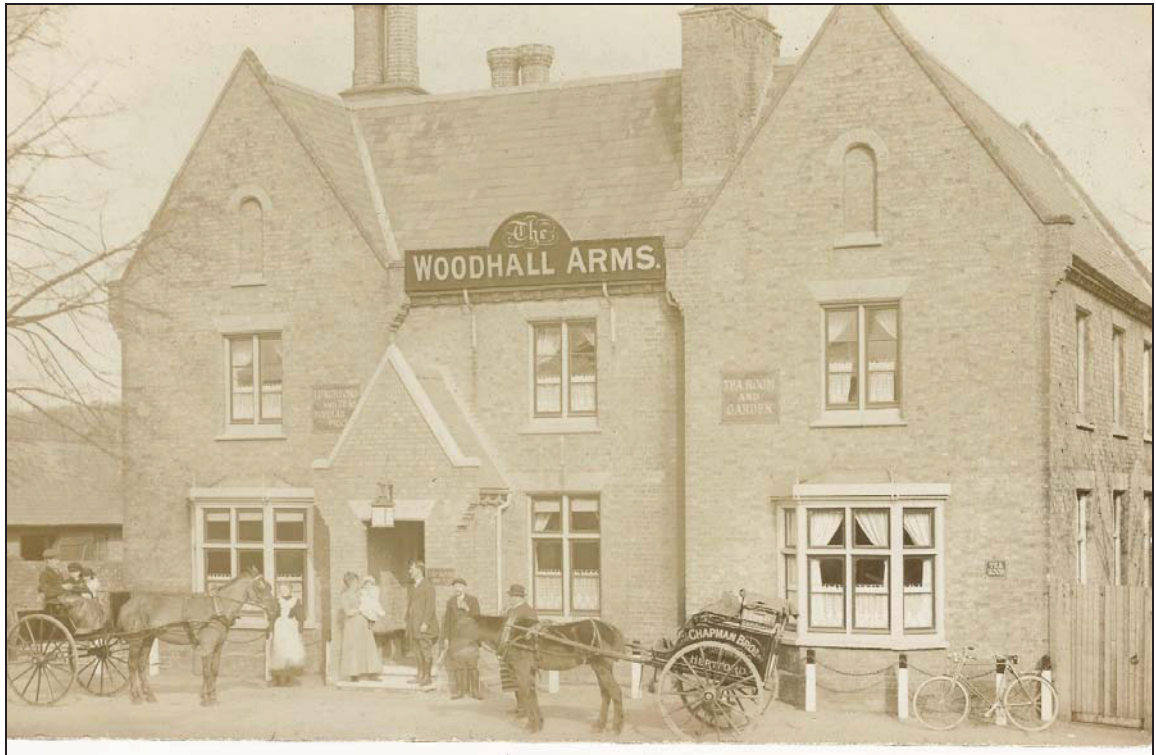
Above: Postcard, private collection, of the public house c. early 20th century, the two plaques on the gable ends read: 'Luncheons and Teas, Popular Prices' (left) and 'Tea Room and Garden' (right).

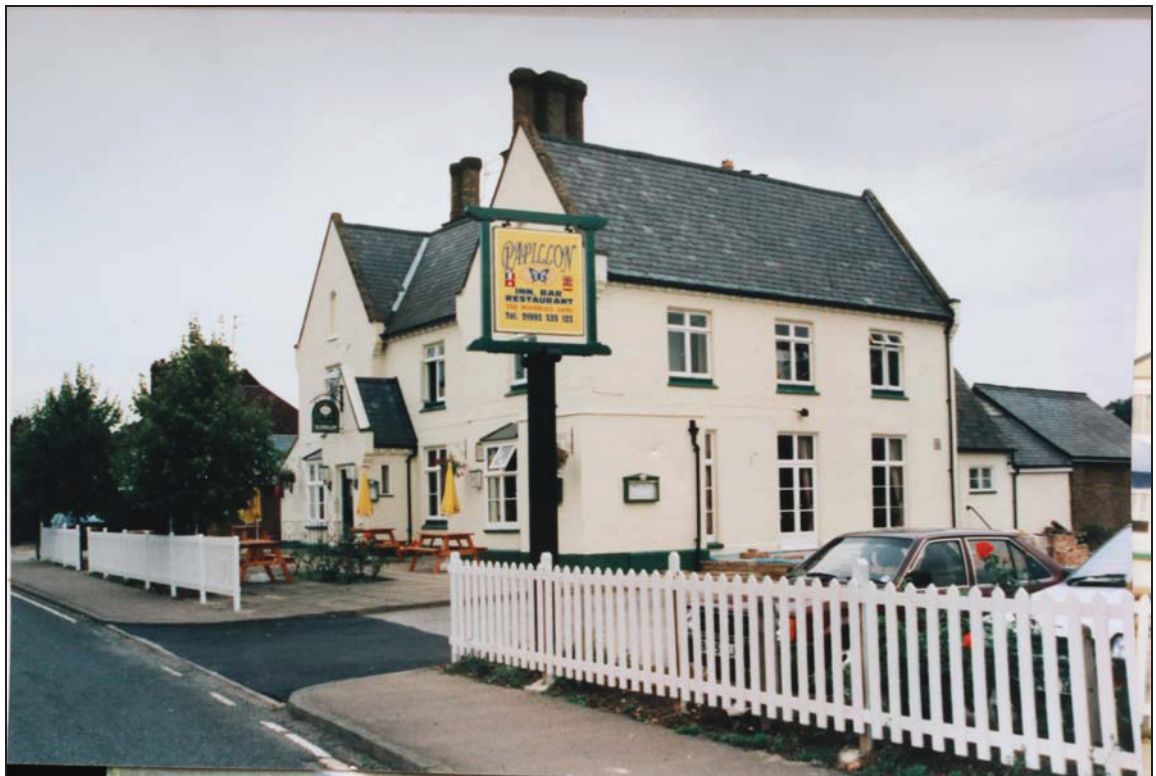
Above: Photograph probably dating from the late 20th century, showing the original form of the windows before the construction of the conservatory.

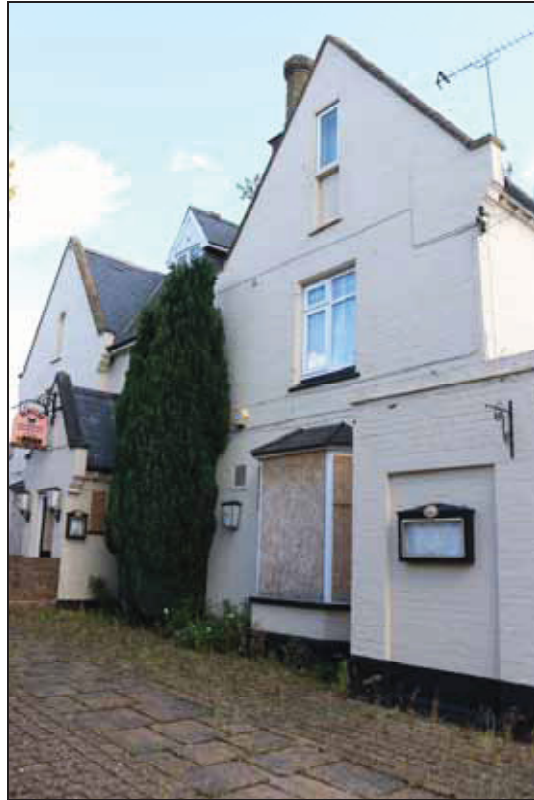
Plate 1 West elevation of the hotel, taken from the south-west (DP 001)

5.4 The main façade faces west and best exemplifies the mid-Victorian form. It has an entrance set slightly off-centre to the north, framed by gabled cross-wings (Plate 1). The main entrance is enclosed by its own gabled porch, decorated with kneelers as the gables. It preserves a door of three lower panels and three upper glazed lights, now filled with 1950s reeded glass. Adjoining the door windows at ground and first floor level have been replaced in uPVC

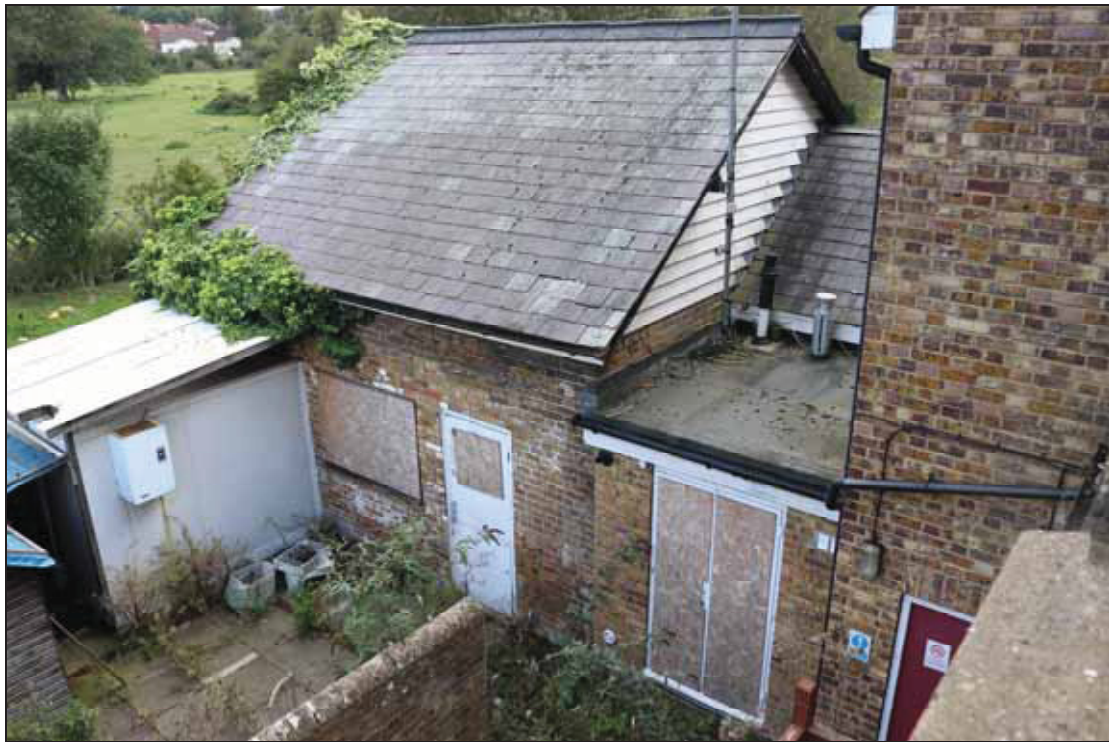
Plate 7 View of kitchen block from a first floor window in the hotel, taken from the north-west (DP 104)

5.9 Against the south gable the arrangement is more complex. A large contemporary service range (Plate 7), latterly housing the restaurant kitchen was probably originally attached to the main range by a single-storey connection, but this has been raised, with little attempt to match the historic form of the original brickwork. The earlier block is constructed in yellow brick, in Flemish bond and retains its slate roof. The outer, south face remains blank with pilasters, and is now fronted by the modern patio/terrace noted above (Plate 8). The inner face has been much disturbed by reconfiguring windows and doors. The whole rear area is enclosed in a small yard by modern fencing (Plate 9). Several ephemeral modern sheds and other structures fill the space.

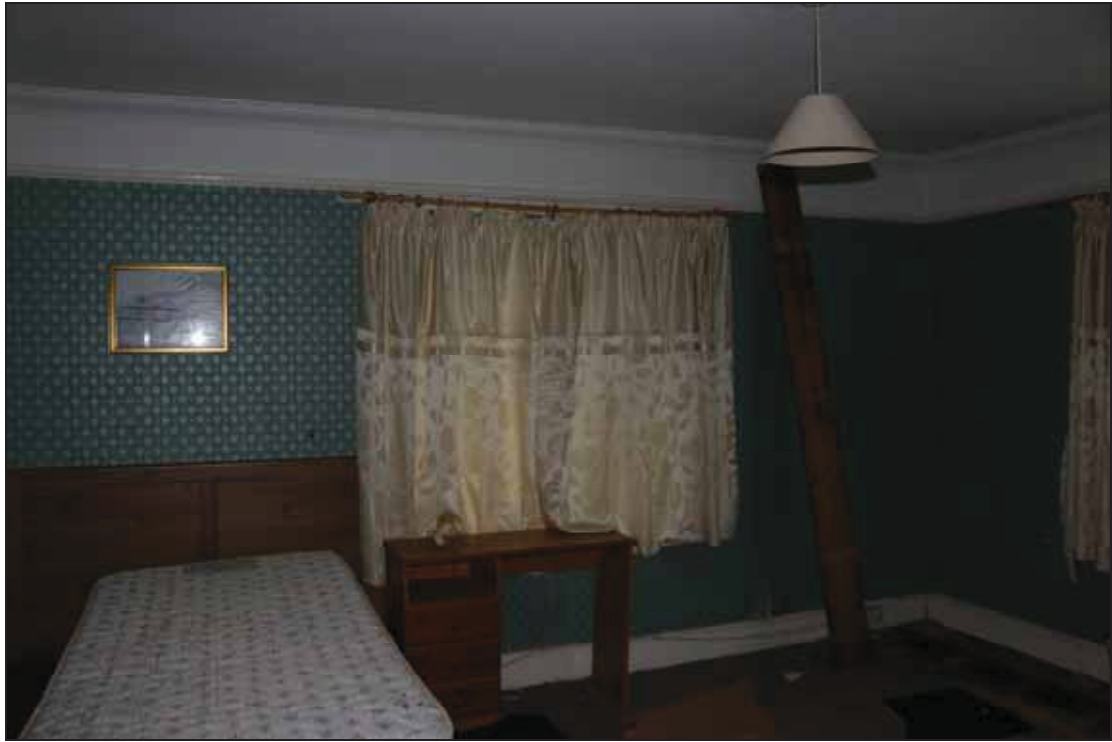
Plate 15 Room 5 on the first floor of the hotel, taken from the east (DP 084)

5.14 At first floor level, a central corridor gives access to guest bedrooms, all now dressed in mediocre hotel-style with plain walls and veneered maple doors (Plate 15). To a certain extent, the proportions of original rooms were maintained by the presence of the chimney stacks. Individual rooms are not described as nothing of historic interest survives, though a few retain plain, 19th century skirting boards, as noted above. In a central room overlooking the front a single linen cupboard survives with its Victorian panelled door (Plate 16).

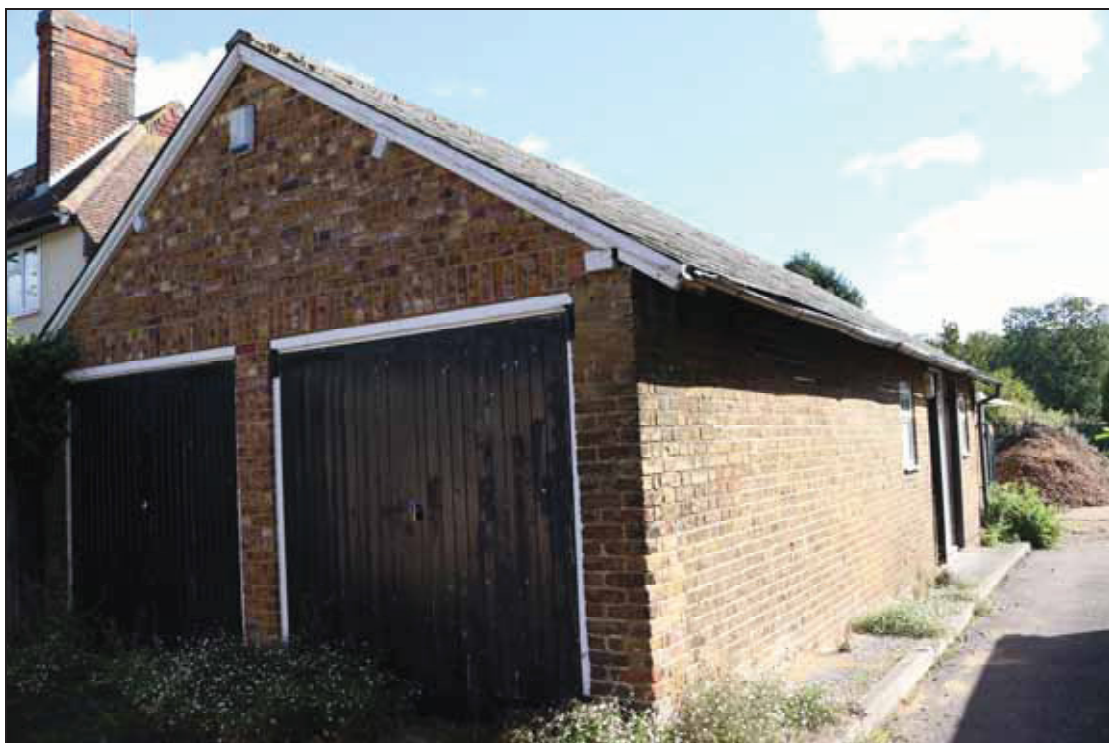
Plate 18 External view of the outbuilding, taken from the south-west (DP 003)

5.16 To the north, the original coach-house and stable block is of contemporary date to the main range. This is constructed in like brick and slate (Plate 18). As noted above, historic maps show that it extended further east, but has clearly

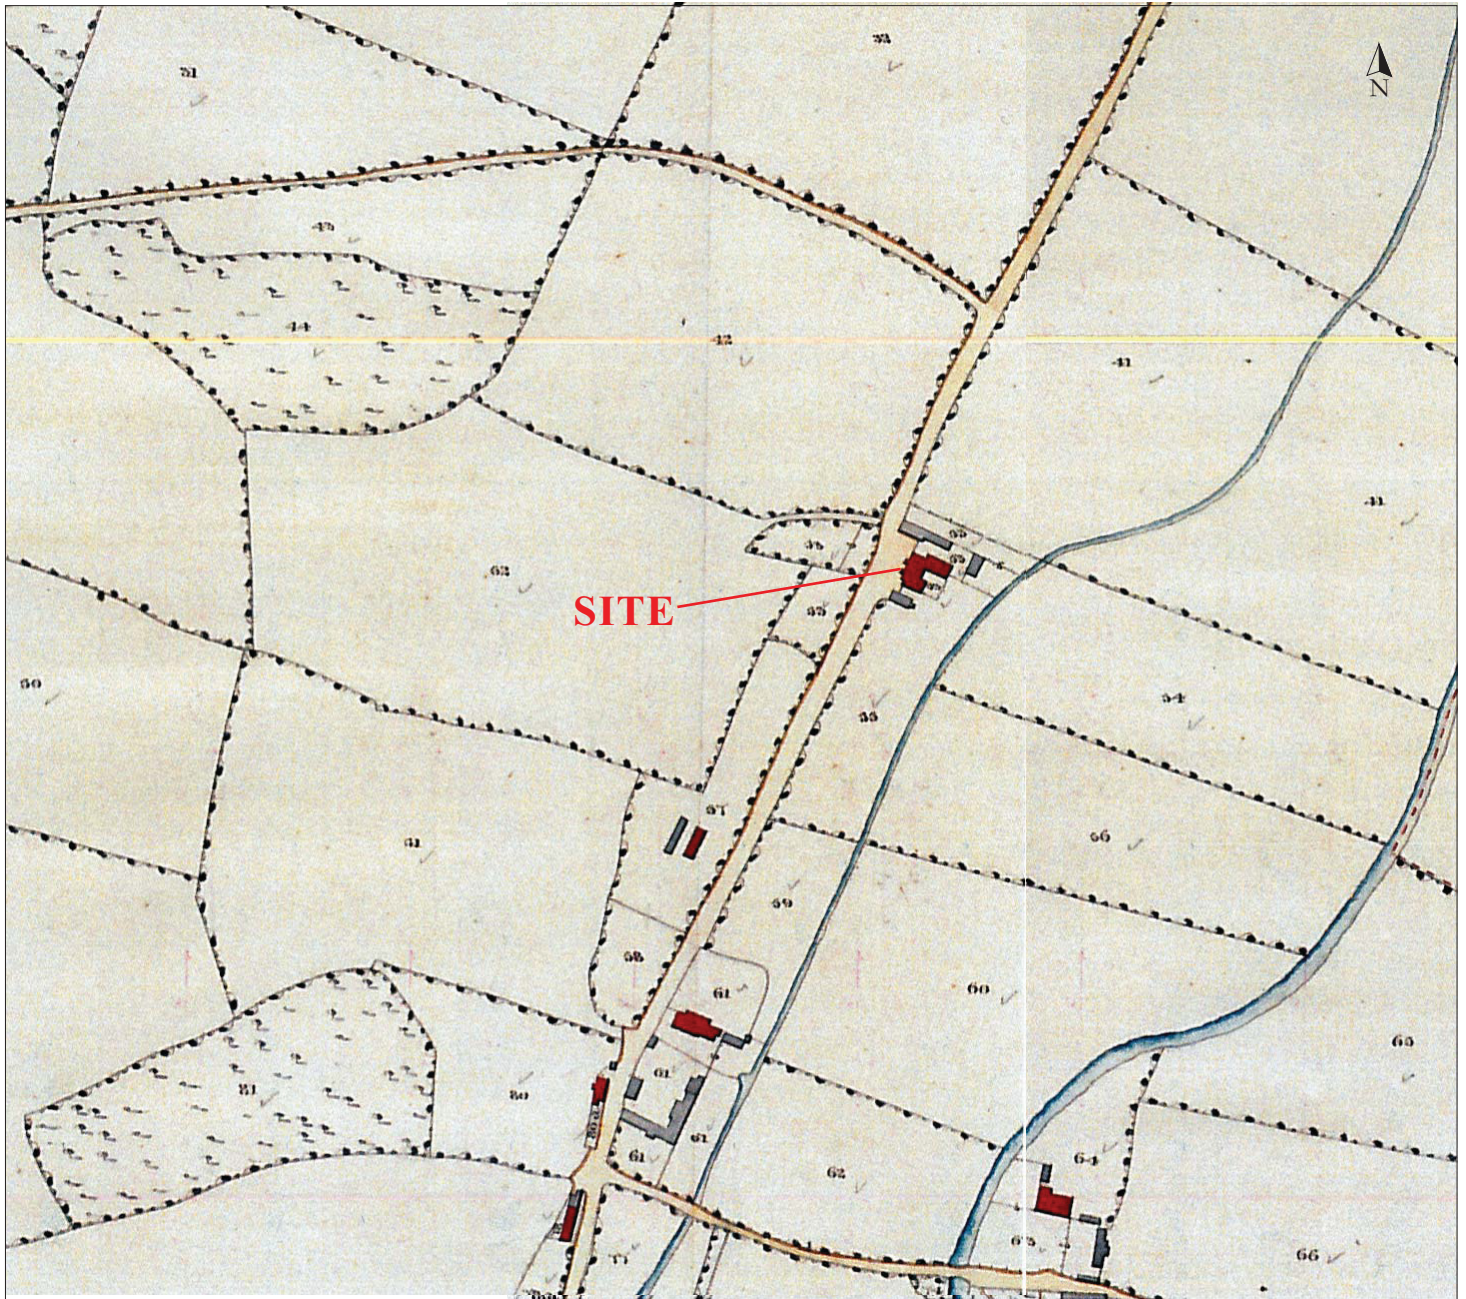
<i>Archaeological Solutions Ltd</i>
Fig. 3 Tithe map, 1839
Not to scale
The Woodhall Arms, Stapleford, Hertfordshire (P7259)

4.2.3 The 1839 tithe map shows the village with very few buildings; the church and two houses (one of them the rectory) on the east bank, with scattered properties along the road (Fig. 3). The Woodhall Arms then stood in isolation from the rest of the village and comprises a large building fronting the main road with two small projections along the frontage, and a large rear extension. Outbuildings to the north, south and east create a yard area to the north of the main building. The plot number #53 was occupied at this time by Joseph Neale. Mrs S. & Charles Neal were listed in the Post Office Directory twenty years later (Kelly & Co. 1855, 1346). Inconsistencies in the cartographic depiction and the architectural style make it unlikely that the building on the tithe map was the existing structure, though it occupies the same footprint.

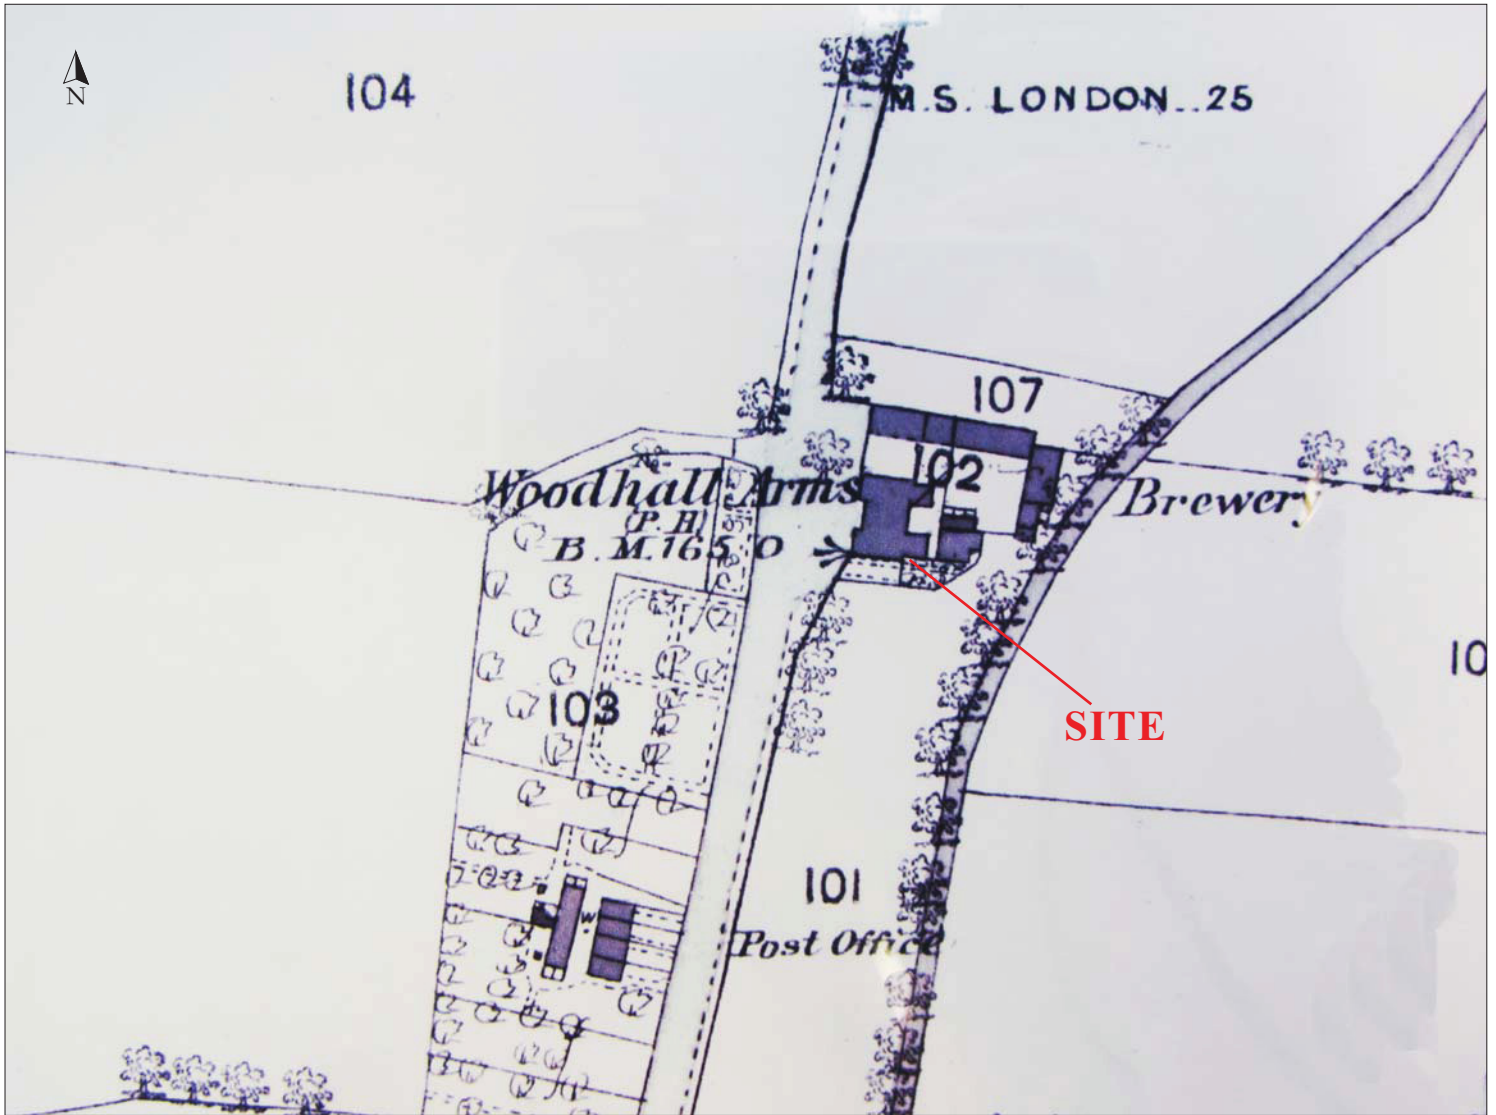
<i>Archaeological Solutions Ltd</i>
Fig. 4 OS map, 1880
Not to scale
The Woodhall Arms, Stapleford, Hertfordshire (P7259)

4.2.4 By the time of the first edition Ordnance Survey map of 1880, the existing building shows greater development (Fig. 4: HHER 30329). At the north end of the village on the main road was the Woodhall Arms (HHER 30329) and brewery, and near the south end was Stapleford Place (HHER 15597). The only other

properties in near proximity included estate cottages with gardens, four on the west side of the road and one on the east, to the south of Stapleford Place. Outbuildings were then much more extensive, occupying the northern boundary of the site, returning on the south and comprising a brew-house. Another outbuilding directly behind the building is also depicted. A small garden stood directly to the south, but larger recreation grounds stood on the opposite side of the road and may have been associated with the hotel.

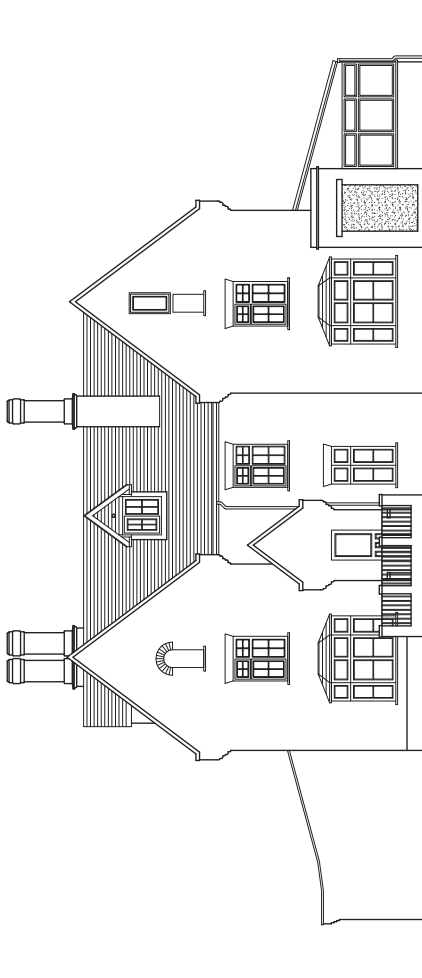
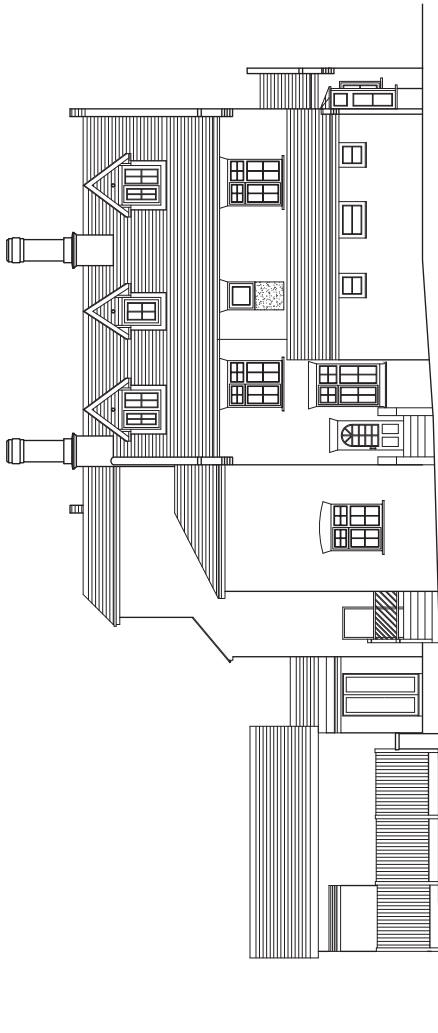
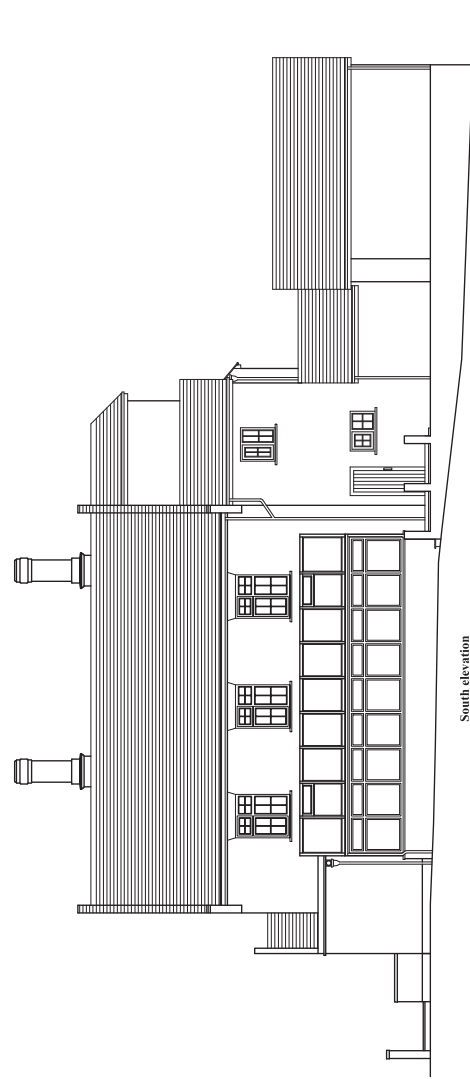
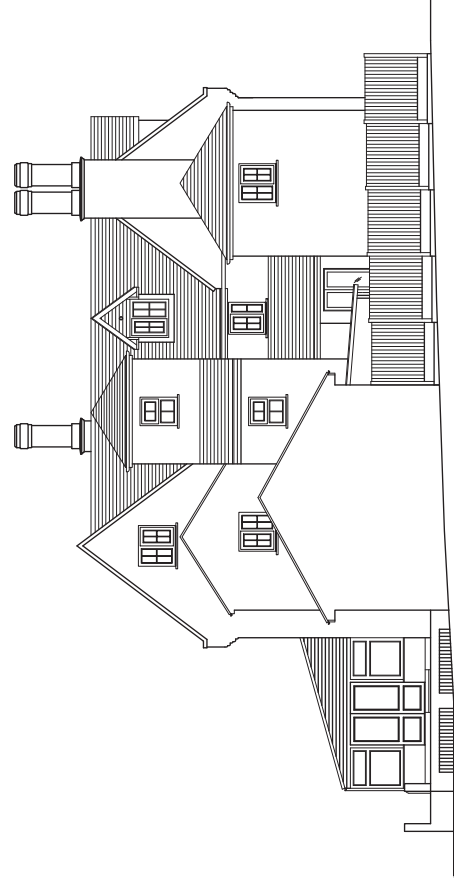
Archaeological Solutions Ltd
Fig. 13 External elevations
 Scale 1:150 at A3
 The Woodhall Arms, Stapleford, Hertfordshire (P7259)

Blocked aperture
