# ARCHAEOLOGICAL SOLUTIONS LTD

HELPESTONS MANOR, HOLLOW ROAD, FELSTED, ESSEX

ARCHAEOLOGICAL MONITORING AND RECORDING

Authors: Antony Mustchin (Field work and report)	
NGR: TL 70741 20152	Report No: 5472
District: Uttlesford	Site Code: FLHM16
Approved: Claire Halpin CMIfA	Project No: P6791
	Date: 27 October 2017

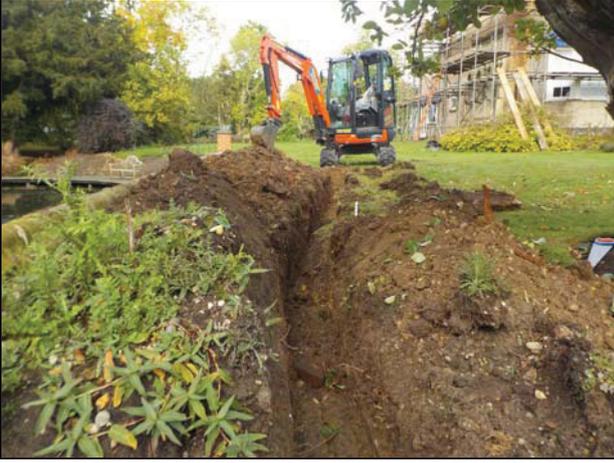
1  
Service trenches being excavated

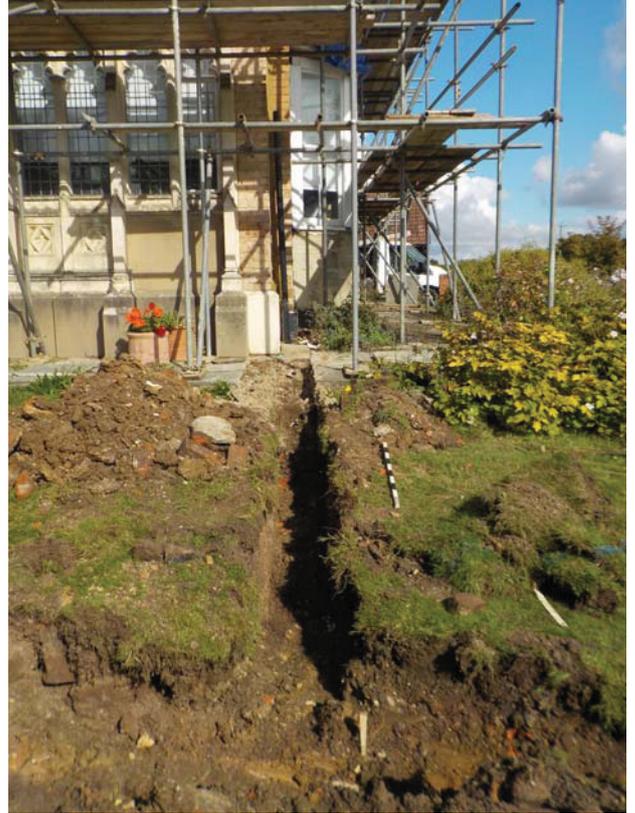
2  
Service trench leading to the house

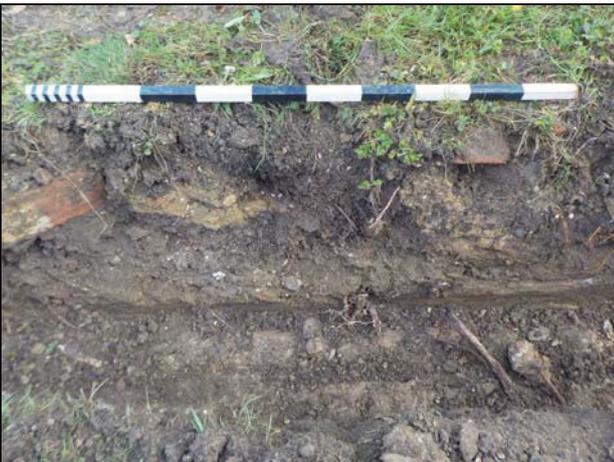
0.00 = 71.60m AOD		
0.00 – 0.21m	L1000	Topsoil. Firm, dark brown sandy clay with frequent small rounded stone, and moderate medium – large sub-rounded stone.
0.21 – 0.42m	L1001	Made ground. Firm, mid yellow brown sandy clay.
0.42m+	L1003	Natural deposits. Compact, dark yellow clay with occasional chalk flecks.

3  
Sample Section 1 looking north-east

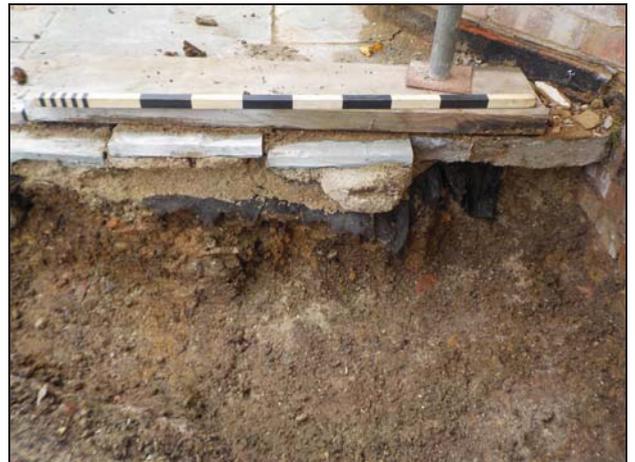
0.00 = 71.79m AOD		
0.00 – 0.04m	L1006	Existing paved surface. Pale grey stone paving slabs.
0.04 – 0.12m	L1007=L1008	Bedding for paving slabs. Pale grey mortar.
0.04 – 0.14m	L1009	Levelling layer for paving. Friable, pale yellow brown sharp sand.
0.00 – 0.10m	L1010	Pale grey concrete.
0.14 – 0.38m+	L1011	Made ground. Firm, mid yellow brown sandu clay with frequent CBM fragments, and moderate medium sub-angular stones.

4  
Sample Section 5 looking north-west

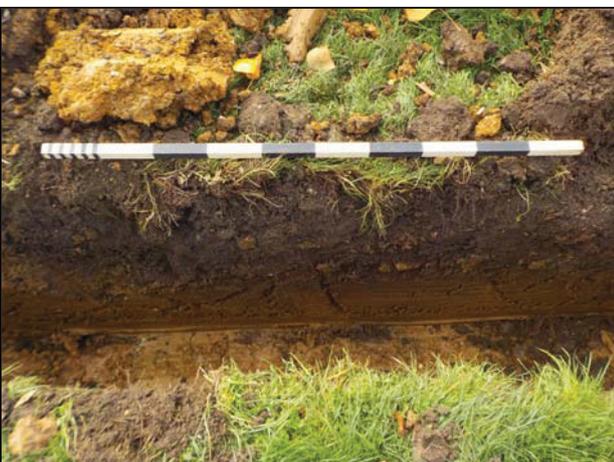
0.00 = 71.70m AOD		
0.00 – 0.18m	L1000	Topsoil. As Sample Section 1.
0.18 – 0.35m	L1002	Subsoil. As Sample Section 2.
0.35m+	L1003	Natural deposits. As Sample Section 1.

5  
Sample Section 7 looking south-west

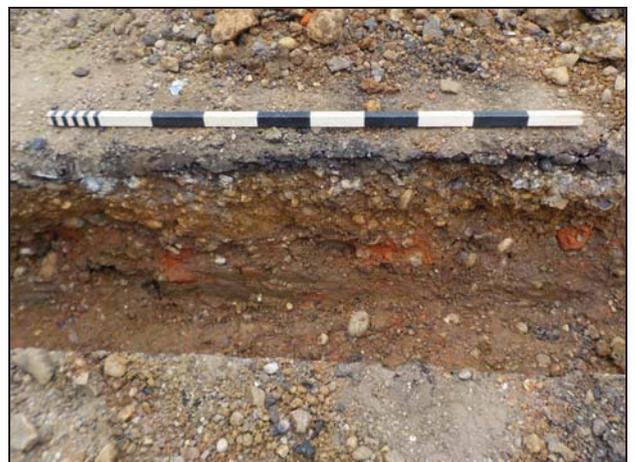
0.00 = 71.76m AOD		
0.00 – 0.05m	L1019	Modern driveway surface. Black asphalt overlain with pea gravel.
0.05 – 0.13m	L1020	Made ground. Mixed patches of pale grey and mid yellow brown sandy clay with gravel and concrete rubble.
0.05 – 0.23m	L1021	Made ground. Mixed patches of firm, dark yellow and pale grey clay with frequent gravel and occasional charcoal flecks.
0.23 – 0.40m+	L1018	Made Ground. As Sample Section 9.

6  
Sample Section 10 looking south

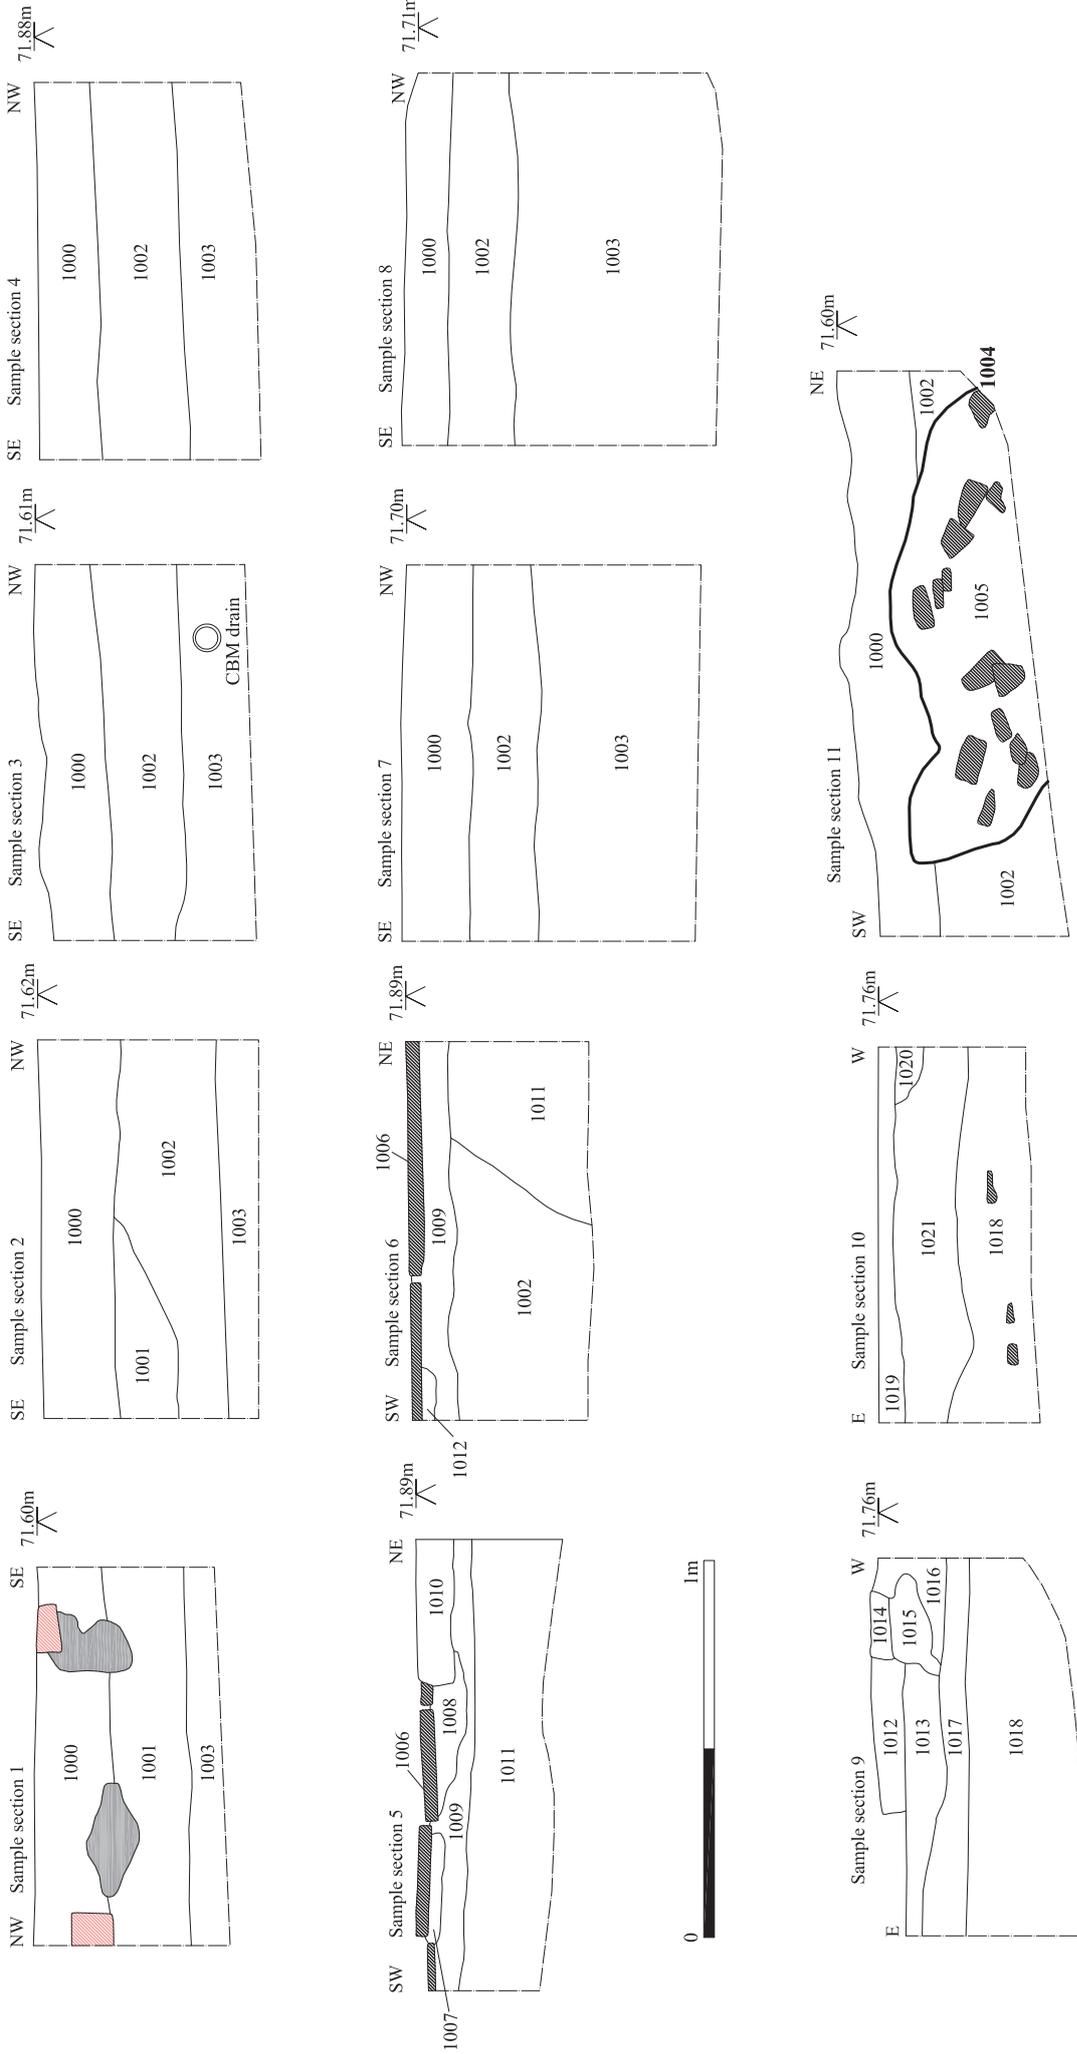
### Fig. 4 Sample sections

*Description: A modern soakaway, F1004, was visible in Section 11.*

F1004 was an irregular shaped modern soakaway (1.27 x 0.37m+). Its fill (L1005) was a loose, dark brown sandy clay with very frequent CBM rubble.
