**WIDMORE FARM, BRADDEN LANE,
GADDESSEN ROW, HEMEL HEMPSTEAD
HERTFORDSHIRE**

HISTORIC BUILDING RECORDING

Level 3

Authors:	Tansy Collins Mst Lauren Wilson MA (Background research)	
Illustrations:	Kathren Henry	
NGR: TL 03318 13350	Report No: 5394	
District: Dacorum	Site Code: AS1889	
Approved: Claire Halpin MCIfA	Project No: 6657	
	Date: 30 June 2017

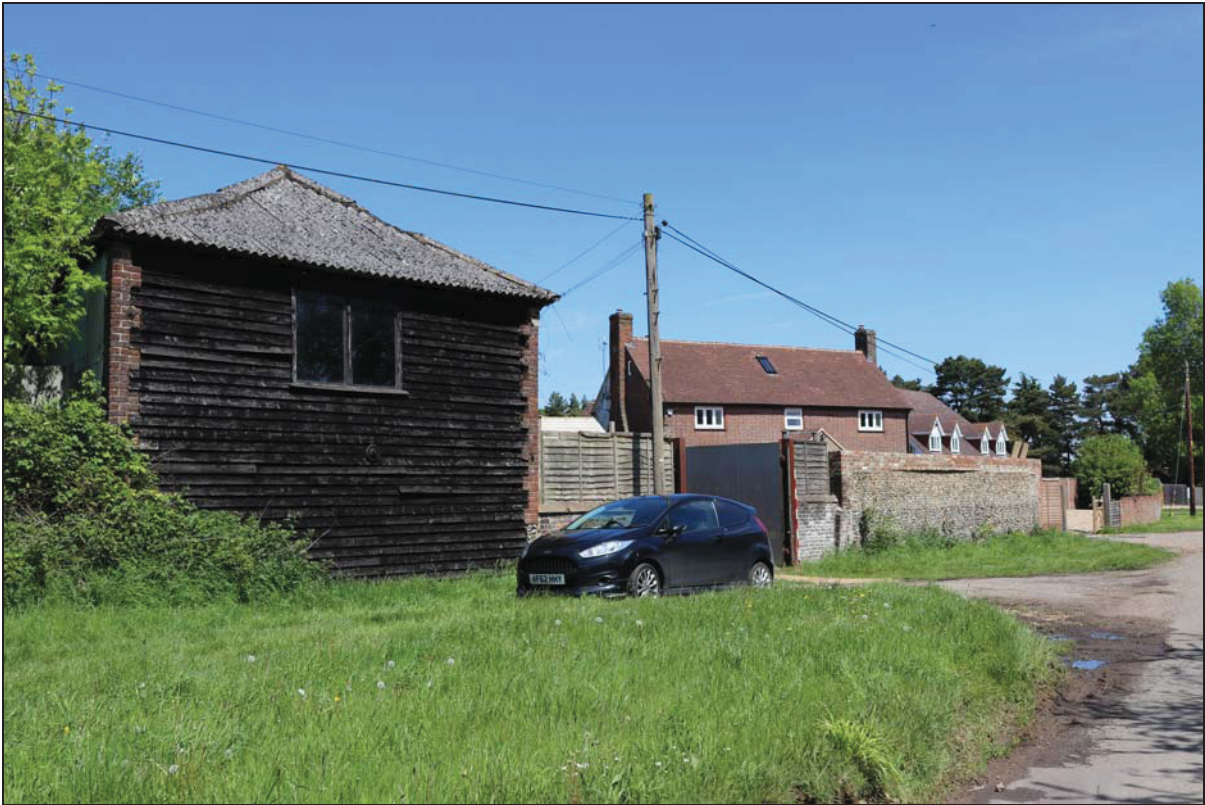
Plate 1 South side of the complex showing barn (outside investigation) and south side of Building 2 with entrance between, taken from the south-west (DP 25)

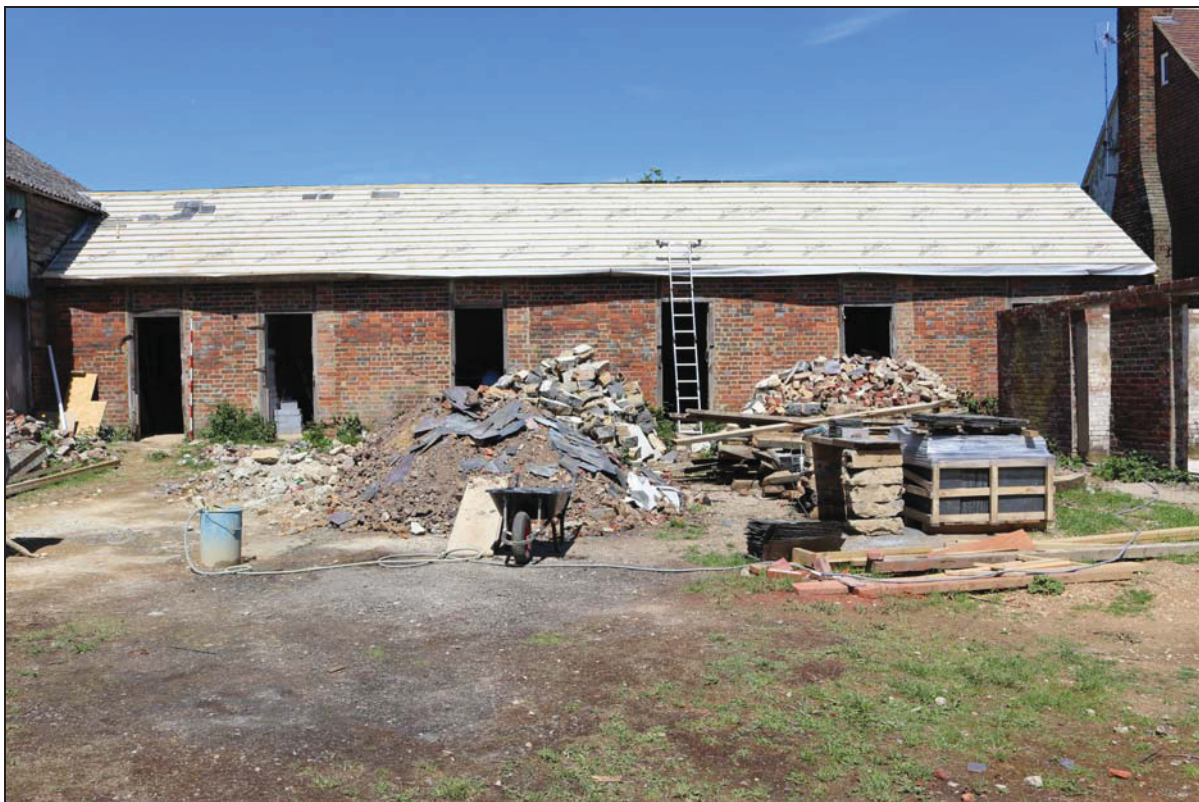
Plate 3 South elevation of Building 1, taken from the south (DP 27)

5.1 This structure consists of a narrow brick-built range extending east-west, all consistent with a date around the middle of the 19th century. It rises over a single storey to a pitched and gabled roof, and abuts the large structure to the west. This range likely originally formed stables and has a series of doorways on the south to the yard (Plate 3). The bricks measure 9" x 4½" x 2½" (229mm x 114mm x 64mm) and are typically 19th century, being a variable orange colour interspersed with overburnt headers, stretchers and kiss marks. There is no access provided to the north side though evidence suggests that elevation is all plain brickwork. On the south side, areas of original brickwork are laid in Flemish bond and marked by the survival of original lime mortar, which is buff coloured with a high aggregate content. Patching and repair is visible in later brickwork with cement pointing.

5.2 Six doorways lie on the south side, all narrow being 0.95m wide rising to full-height with timber jambs and upper panels of brick. However, four of these have been narrowed from wider examples that originally measured 1.23m wide as indicated by queen closers and rebuilt brickwork (Plate 4). The wider doorways would be more consistent with stable doors and likely included overlights for ventilation and lighting. These doorways formerly held split doors, indicated by strap hinges and although the doors are lost, the upper leaf hung on the opposite side to the lower leaf.

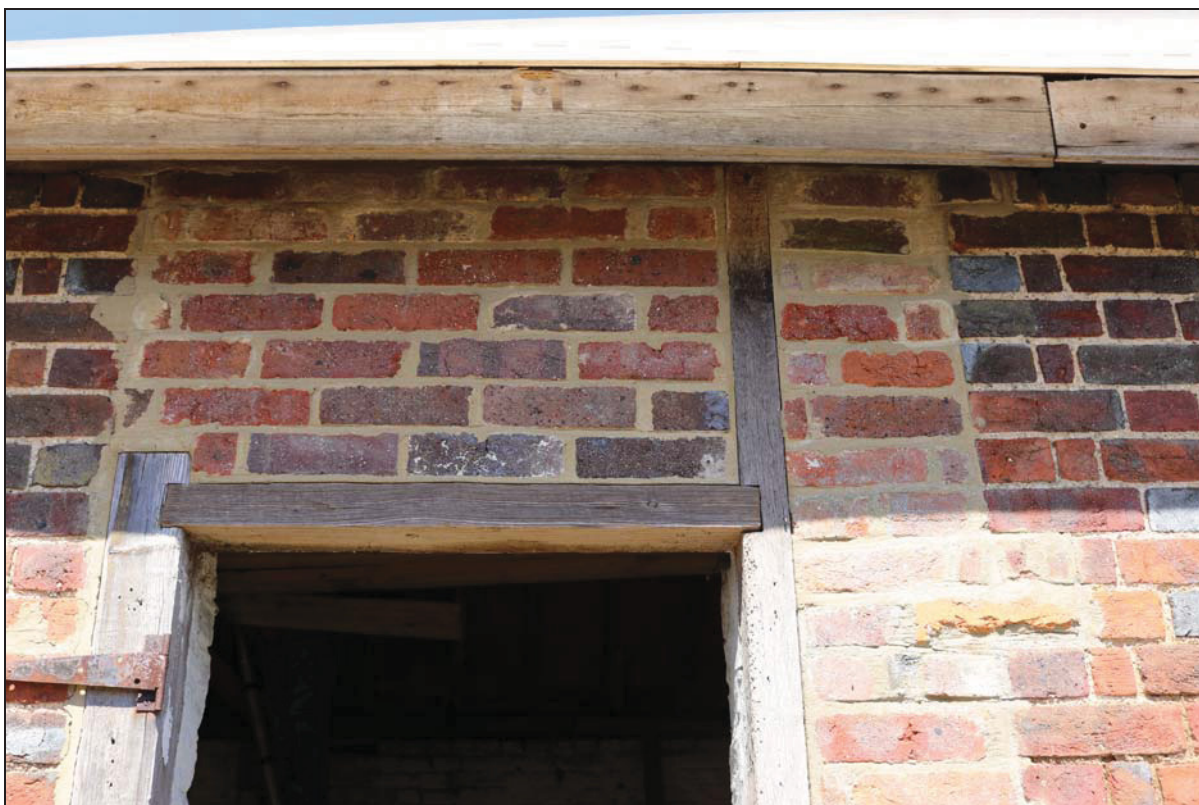
Plate 4 Detail of a doorway on the south side of Building 1 showing evidence for the reduction in doorway size, taken from the south (DP 13)

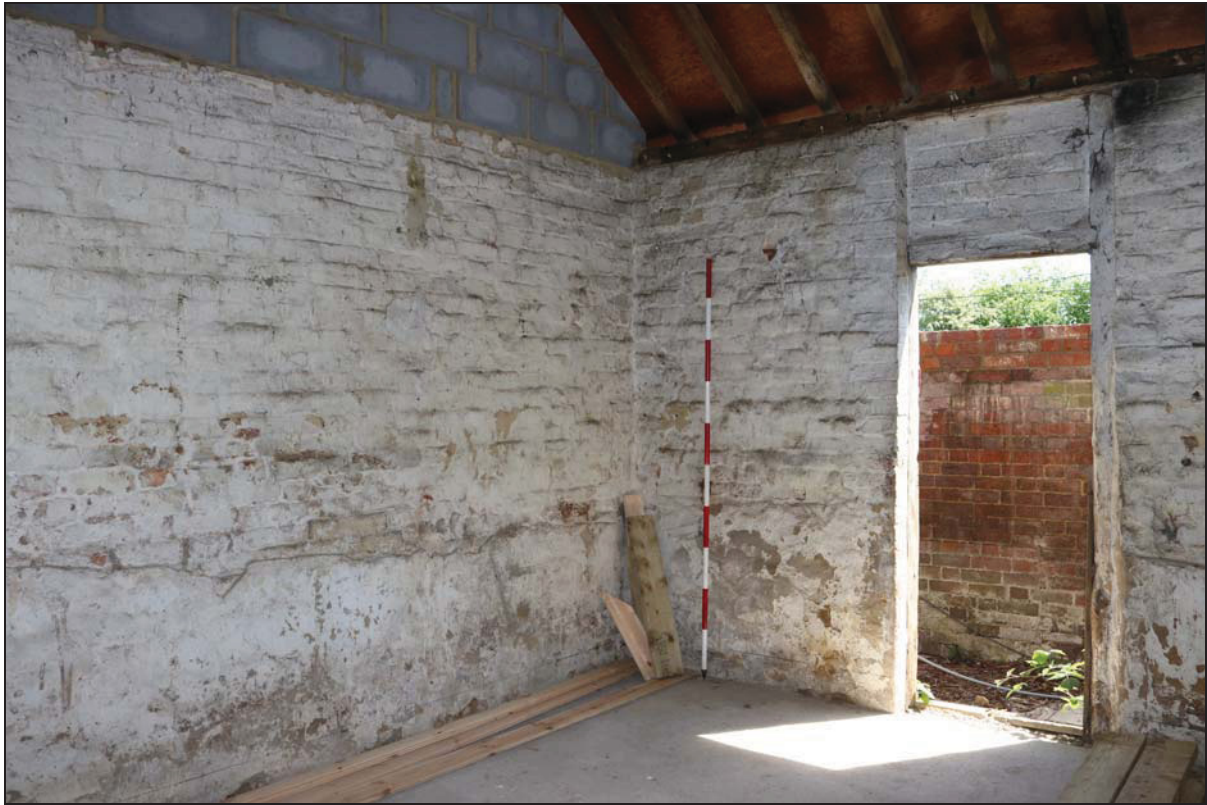
Plate 5 Bay 1 (Building 1) showing painted outer walls with cement render at low level, taken from the north-west (DP 29)

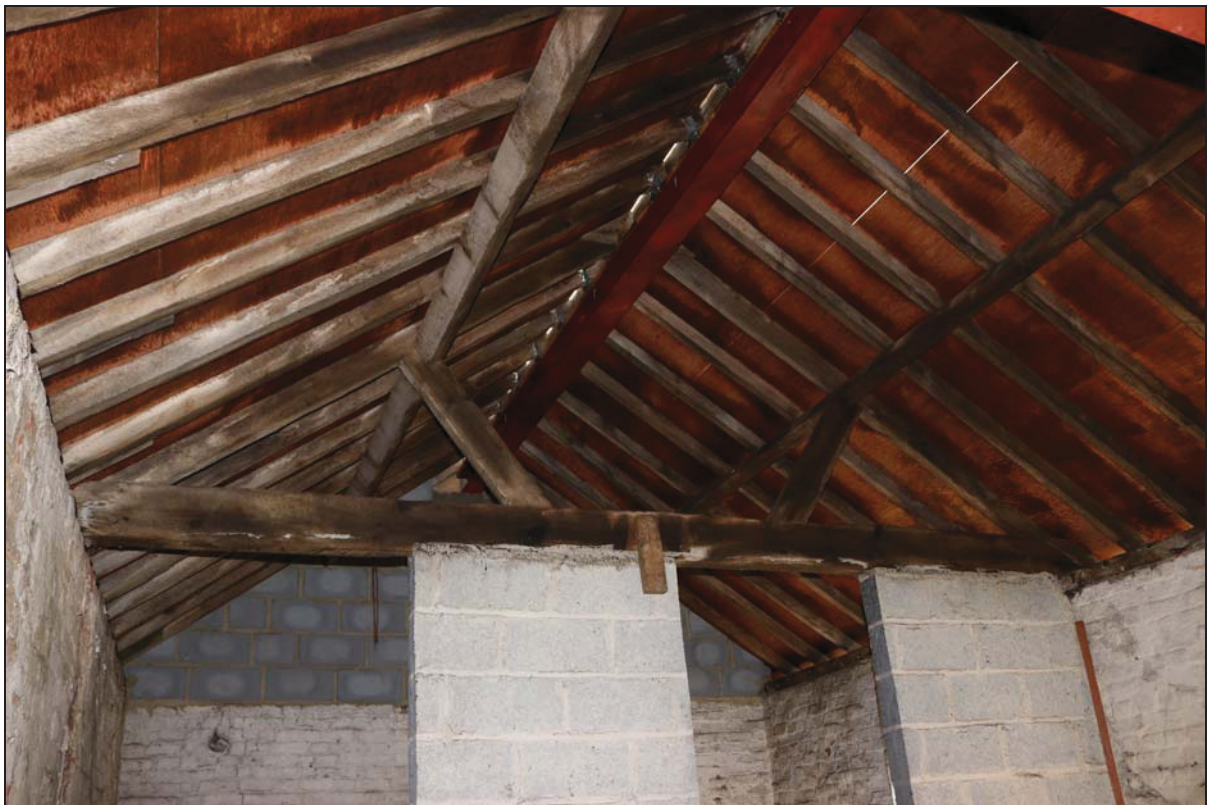
Plate 6 View of Truss 1 (Building 1), taken from the west (DP 37)

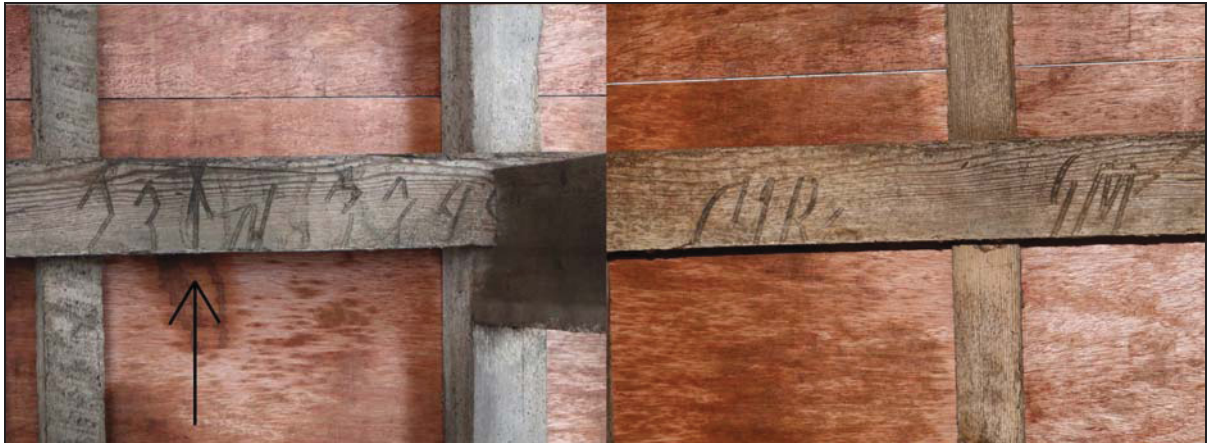
Plate 7 Composite image showing detail of the north purlin between Bays 1 and 2 (Building 1) showing Baltic bracking mark including the symbol for the port of Gdansk (indicated), taken from the south (DPs 33-34)

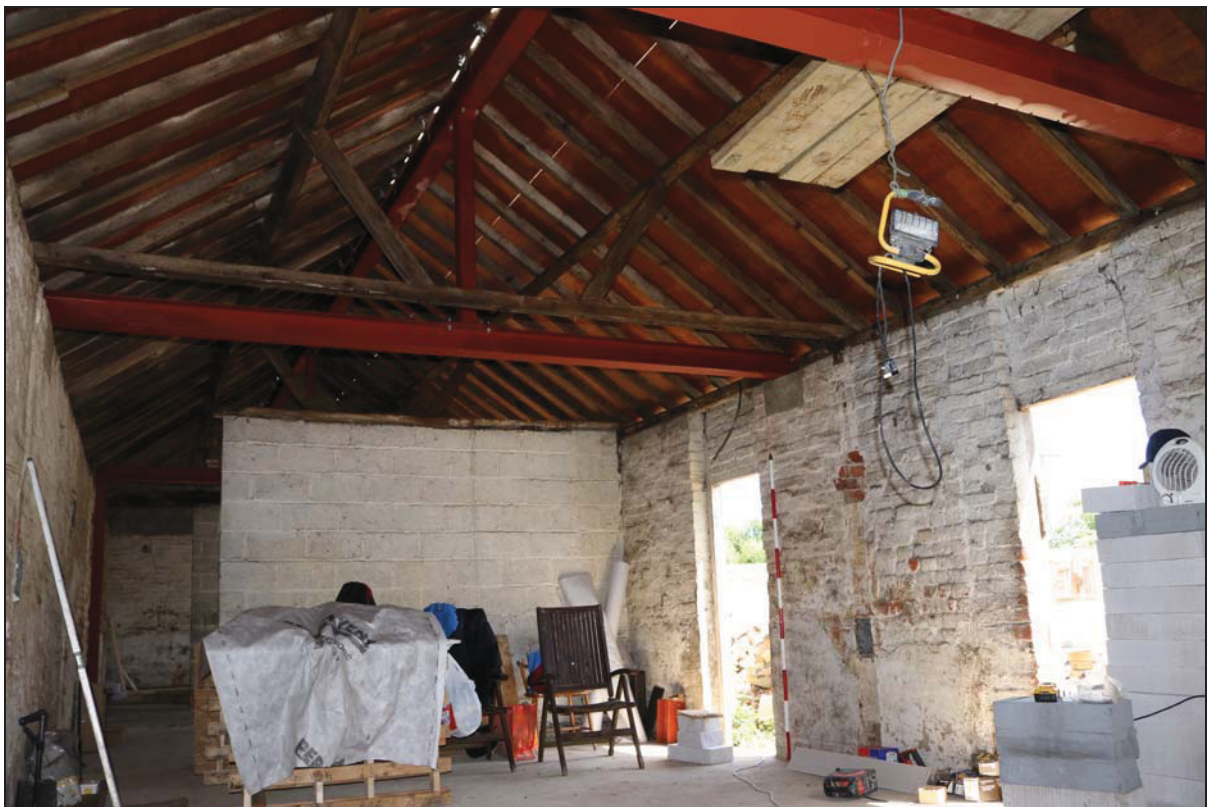
Plate 8 Bays 4 and 5 (Building 1) showing secondary timber truss (Truss 4) and recent inserted steel truss, taken from the west (DP 40)

5.10 The trusses between Bays 3 and 4 are replaced with two examples in softwood including tie-beam and raking struts of similar form but very slender and all nailed (Plate 8). Truss 3 lies over an existing blockwork partition, while Truss 4 has mortices in the soffit for a lower internal studwork partition (Plate 9). Truss 5 preserves fragments of the original fabric including the principal rafters with empty mortices for pegged raking struts and at either end stumps of the tie-beam survive, the rest removed during these works. The south purlin here has some scribed marks and what may be the end of the mark for Gdansk.

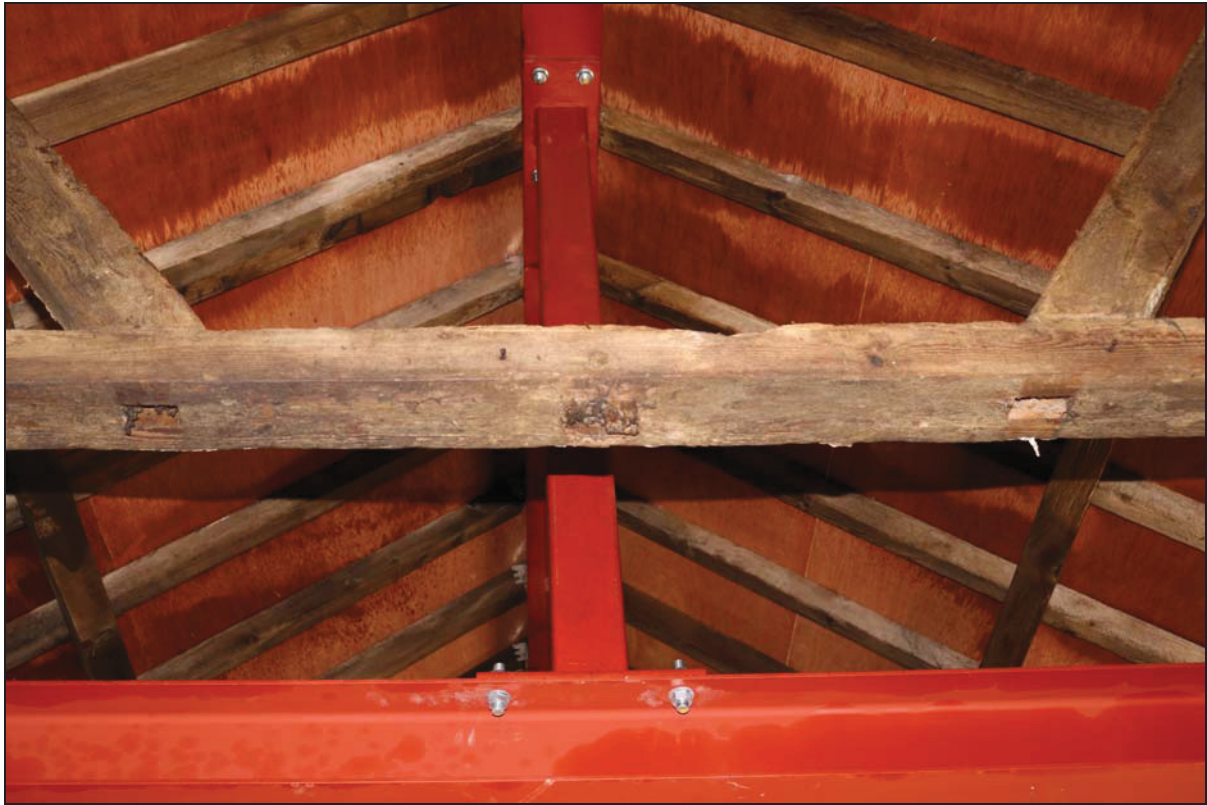
Plate 9 Detail of Truss 4 (Building 1) showing mortices for a lower studwork partition, taken from the west (DP 42)

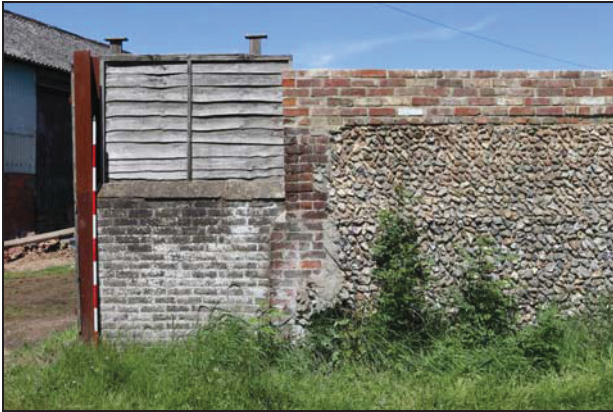
DP 3

South elevation of Building 2 (Unit 3, west end) showing flintwork with brick corner and boundary wall extending to the entrance, taken from the south

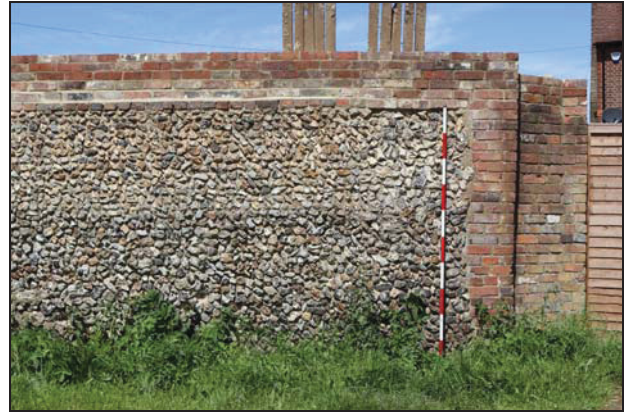
DP 4

South elevation of Building 2 (Unit 3, east end) showing flintwork with brick corner and rebuilt upper brickwork, taken from the south

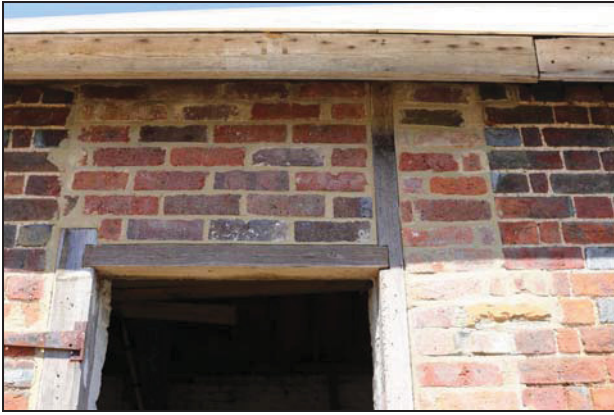
DP 13
 Detail of a doorway on the south side of Building 1 showing evidence for the reduction in doorway size, taken from the south

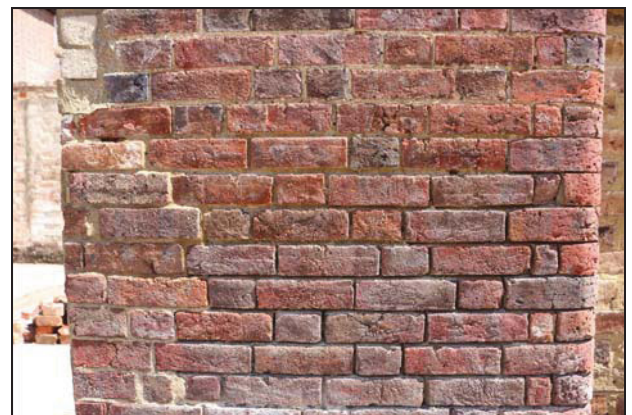
DP 18
 Detail of Building 2 (Unit 1, west side) showing brickwork with bull-nosed corner, taken from the west

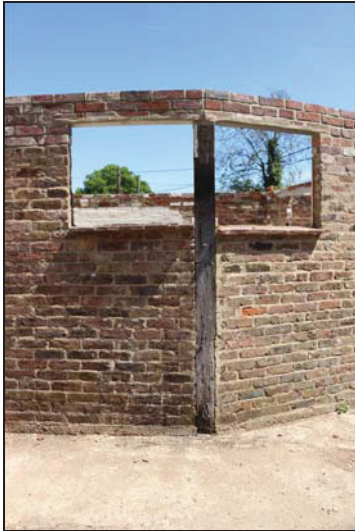
DP 19

Detail of Building 2 (Unit 2, west side) showing original timber post with rebuilt brickwork to either side, taken from the west

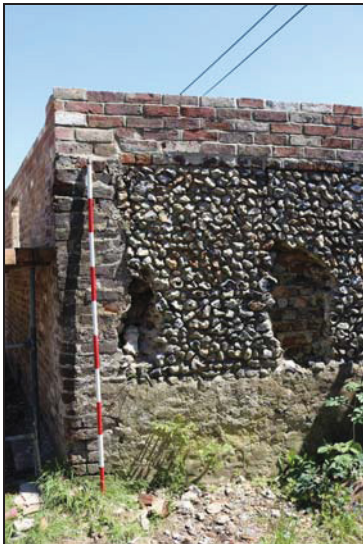
DP 21

West end of Building 2 (Unit 3) showing flint and brickwork with some rebuilding at upper level, taken from the west

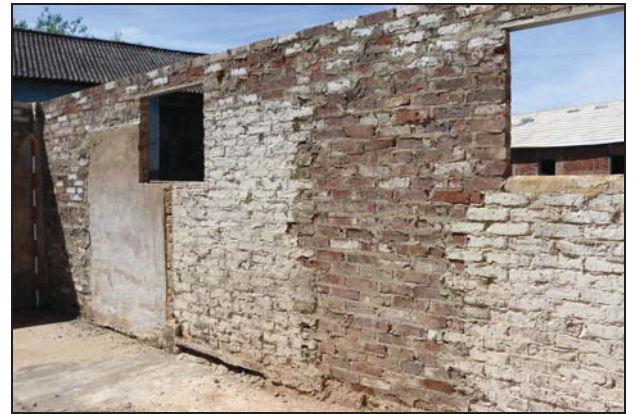
DP 22

North wall of Unit 3 (western area, Building 2) showing recently blocked doorways, taken from the south-east

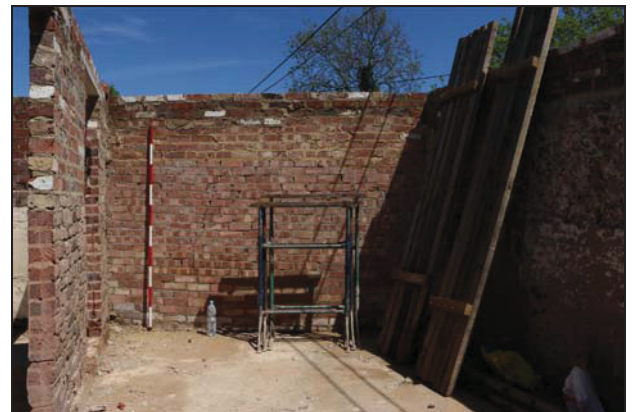
DP 24

East wall of Unit 3 (eastern area, Building 2) showing Fletton brick infilling of former aperture, taken from the west

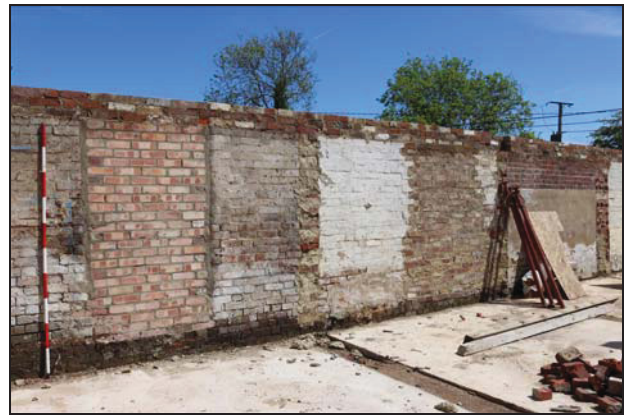
DP 28

East wall of Unit 1 (Building 2) showing blocked doorway and scarring where the original south wall of the unit has been removed, taken from the north-west

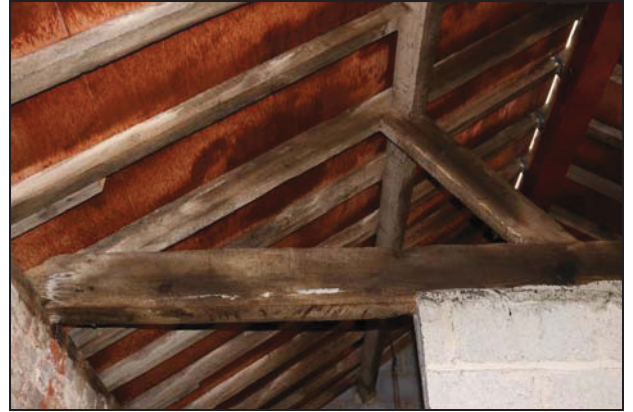
DP 32

Detail of Truss 1 (Building 1) showing tie-beam with pegged rafter and raking strut clasp the purlin, taken from the west

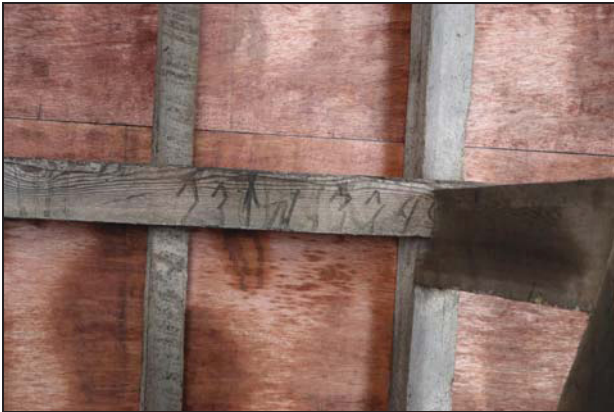
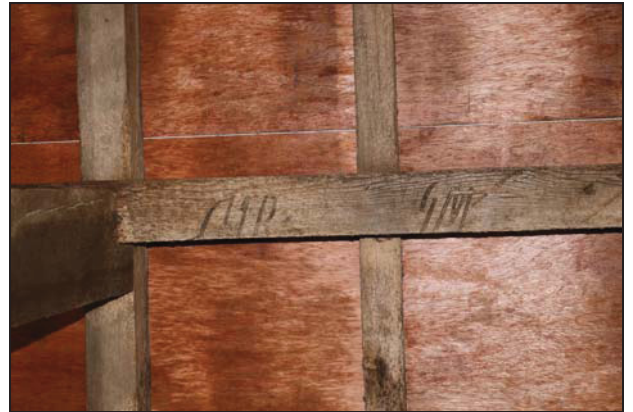
Detail of the north purlin between Bays 1 and 2 (Building 1) showing Baltic bracking mark, taken from the south

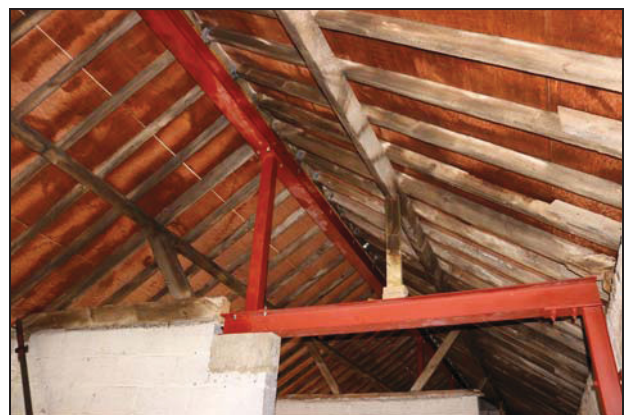
DP 36

Interior of Building 2 showing Truss 2 truncated for the insertion of steel members, taken from the east

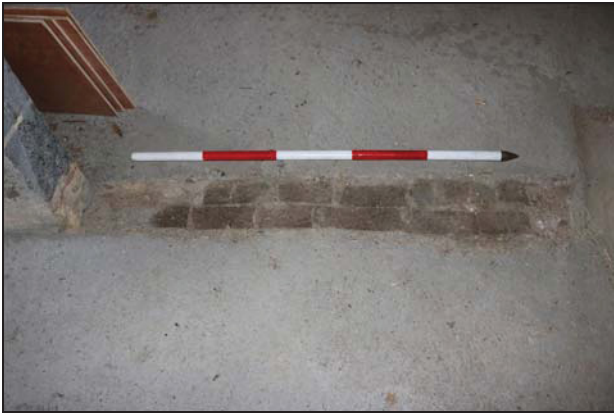
DP 37

Detail of the floor between Bays 2 and 3 (Building 1) showing fragments of surviving brickwork, taken from the east

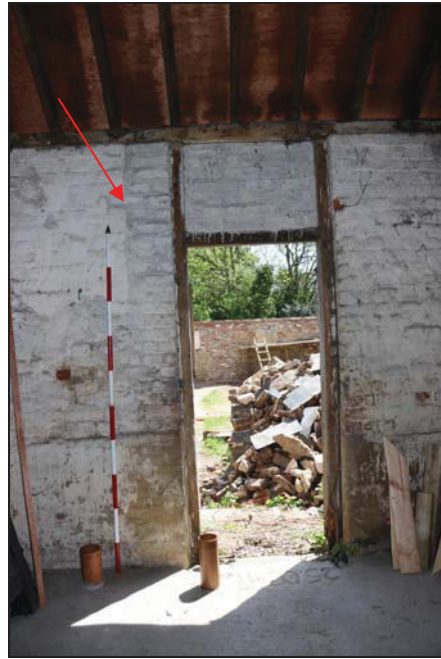
DP 38

South side of Bay 2 (Building 1) showing existing door surround with straight joint (indicated) demonstrating the original width of the doorway, taken from the north

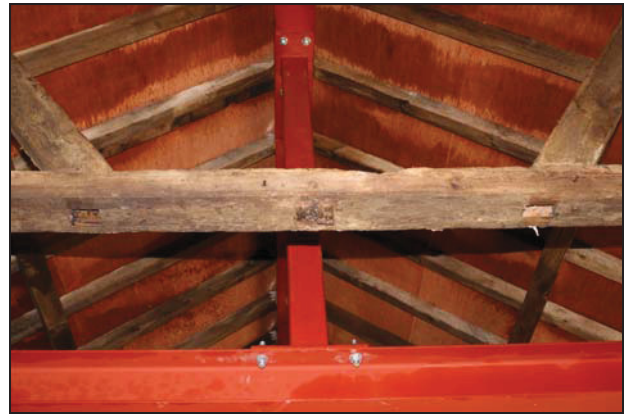
DP 42

Detail of Truss 4 (Building 1) showing mortices for a lower studwork partition, taken from the west

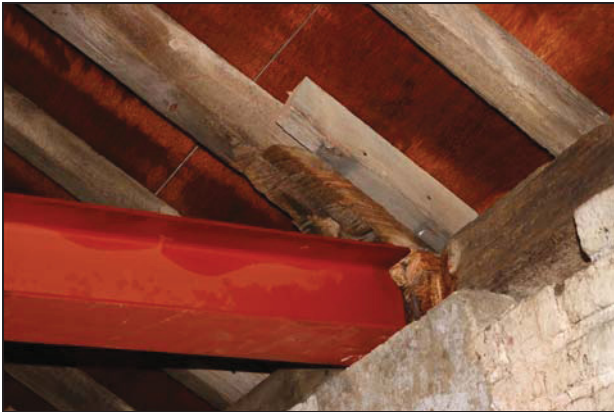
DP 43

Detail of Truss 5 (Building 1) showing sawn off north end of the tie-beam, taken from the east

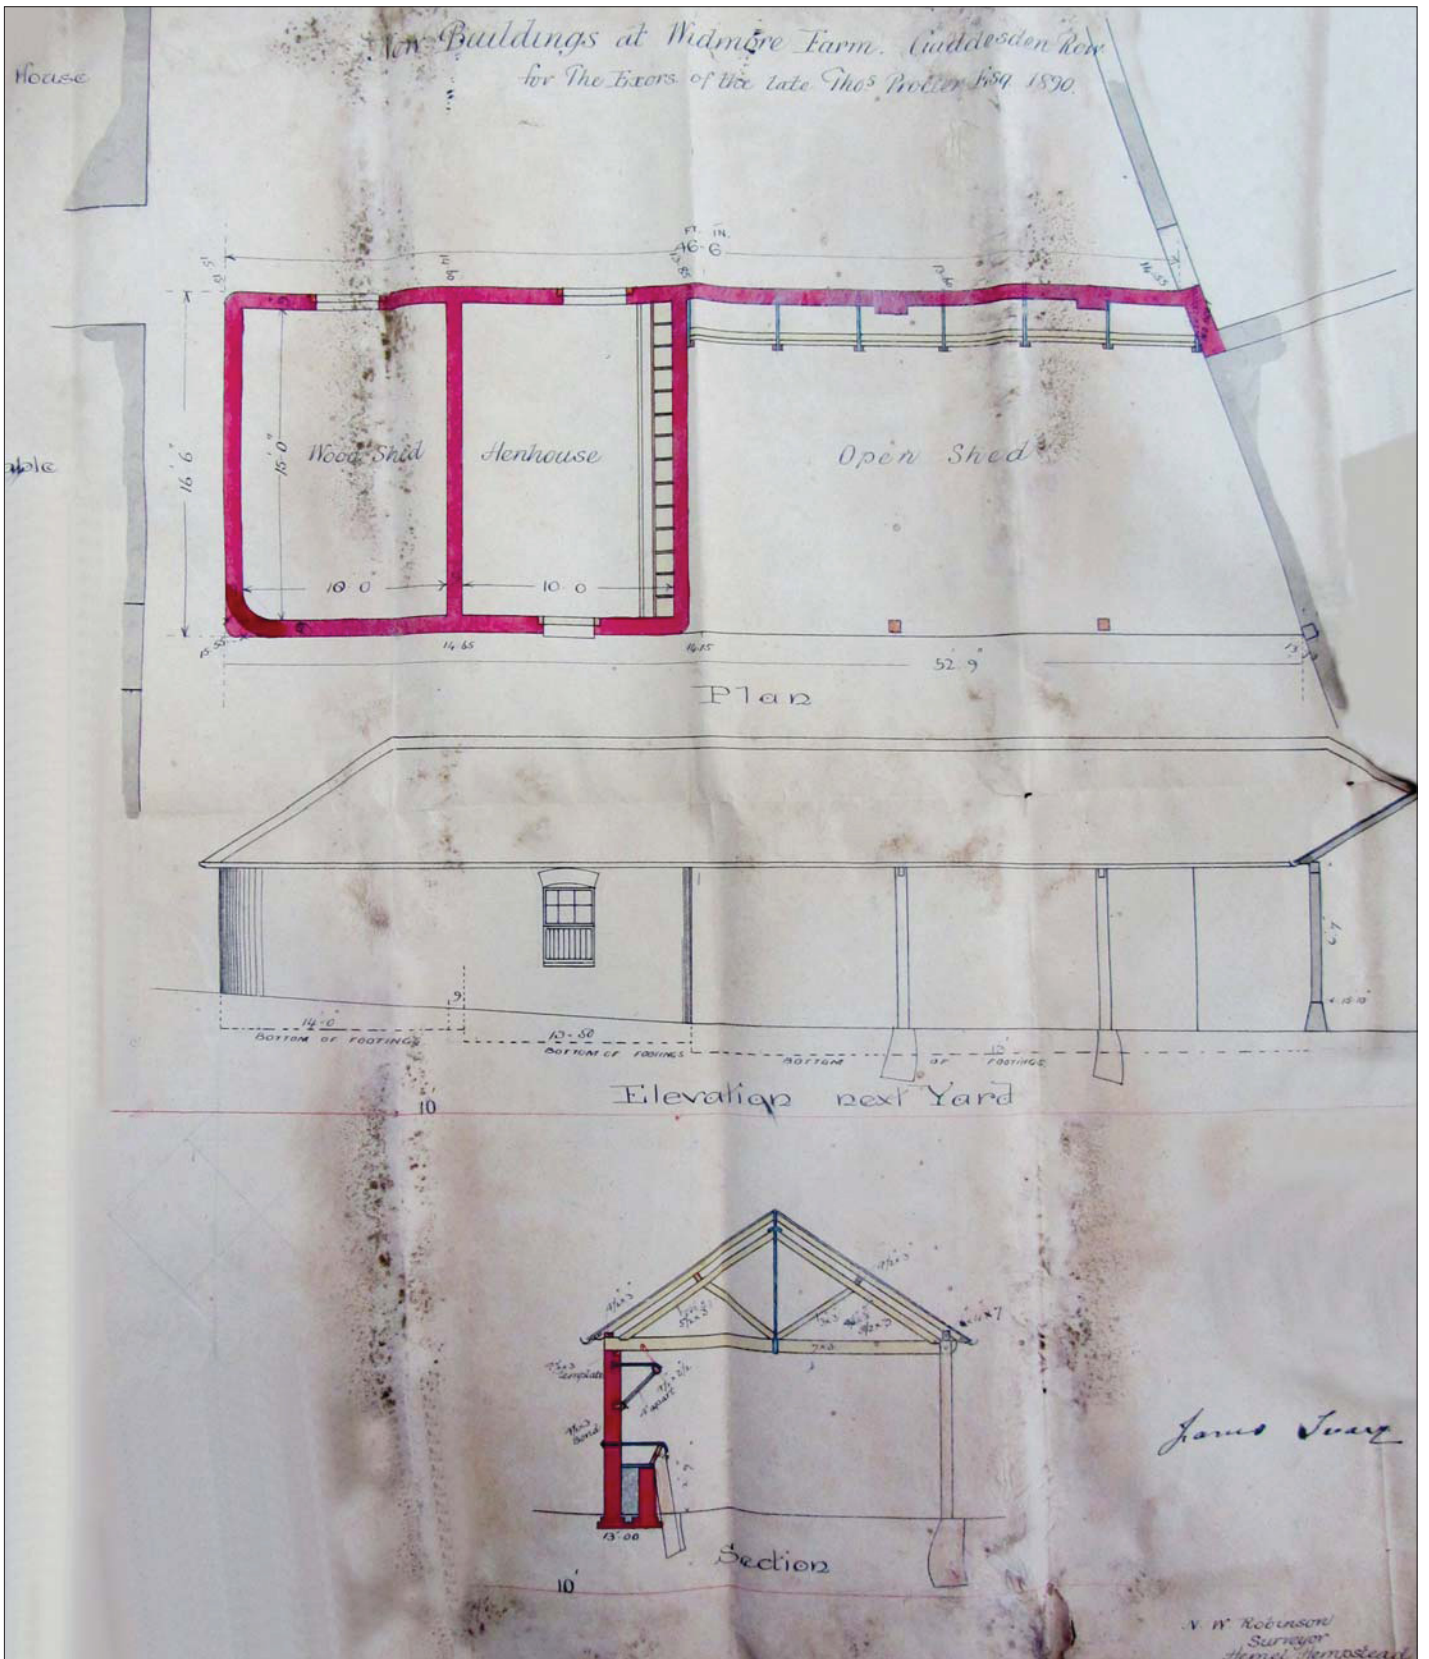
<i>Archaeological Solutions Ltd</i>
Fig. 7 Proposed plans, 1890
Not to scale
Widmore Farm, Bradden Lane, Hemel Hempstead (P6657)

4.2.5 A document survives that was produced in 1890 by N. W. Robinson, a surveyor of Hemel Hempstead. It comprises a set of proposal drawings for a new building at Widmore Farm (Acc No. DE/Md/34) and is accompanied by a letter and memorandum detailing the construction of Units 1 and 2 of Building 2, which consisted of a new open-fronted shed, henhouse and woodhouse. The drawings include a plan, elevation and cross-section (Fig. 7) and show the new range as having brick walls, a king post roof with iron king rod and mangers and troughs along the east wall. A letter along with the plan is transcribed in Appendix 4 and details the exact instructions left by the architect to the contractor about the construction of the building.
