BARN AT BENINGTON PARK FARM, BENINGTON,
HERTFORDSHIRE

ARCHAEOLOGICAL
MONITORING & RECORDING

Authors: Tansy Collins MSt Kathren Henry	
NGR: TL 3088 2354	Report No. 5509
District: East Herts	Site Code: AS 1882
Approved: Claire Halpin	Project No: 2529
MIfA Signed:	Date: 22 December 2017

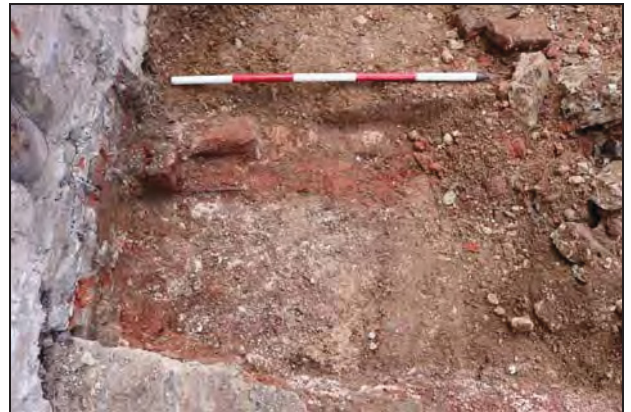
DP 4
Interior of north end of barn during ground reduction showing brick wall footing M1005, looking south

5.1.5 Brick floor M1001 abutted the outer walls of the barn though disturbance meant the relationship between the floor and brick wall footing M1005 was not evident. Brick wall footing M1005 had been truncated to floor level and sealed with concrete floor M1000. It was constructed of soft red brick measuring 9" x 4¼" x 2¼" (229mm x 108mm x 57mm). The bonding pattern was not determined. This wall abutted the outer walls of the barn and was hence a secondary phase, though small mortices cut into the outer walls of the barn above appear to have been inserted to partially tie in upper section of the brick wall. It was positioned immediately adjacent to an inserted aperture in the east wall of the barn that held pipework for a lost 19th century boiler.

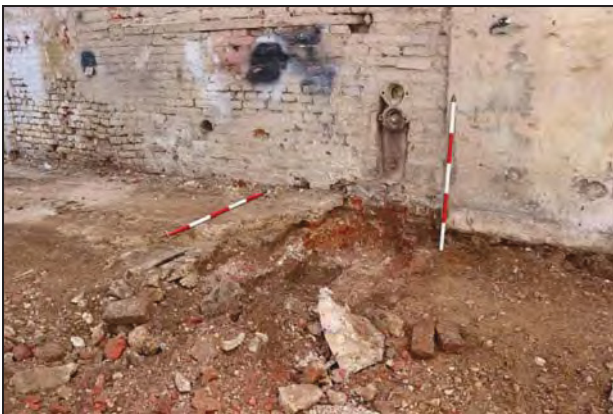
DP 5
Interior of north end of barn during ground reduction showing boiler inlet pipe in outer wall and remains of floor M1001 and wall M1005, looking north-east

5.1.4 Brick floor M1001 partially survived in the north end of the barn below concrete floor surface M1000 (0.1m deep). The floor surface was of soft red bricks, which measured an average of 9" x 4¼" x 2¼" (229mm x 108mm x 57mm) and were laid in running bond with no bonding material evident. The brick floor overlay a chalk deposit (L1002, 0.08-0.18m deep), seemingly a levelling layer to hold the floor, which itself overlay a further made ground deposit L1004 (0.21m+ deep). A further deposit was encountered within the barn at the north end close to the east wall. This consisted of L1003 which was a distinct area of compacted red brick rubble (0.15m deep and 0.45m wide). It did not appear to be cut into chalk layer 1002 and was possibly contemporary forming part of a levelling strategy to hold floor surface M1001 (Fig. 6).

6.2 Within the barn, ground reduction found that in most areas any previous floor layers that may have existed had been lost with the addition of thick poured concrete, reinforced with iron bars. At the north end, however, an area of surviving brick floor (M1001) and the footing of a brick wall (M1005) was encountered, all sealed by a thin poured concrete floor (M1000). Below the floor surface were levelling layers and made ground (L1002-L1004). Diagnostically, the brick of the floor was consistent with bricks produced in the late 17th and 18th centuries in the region (App. 4) and may be original to the barn or part of a slightly later secondary phase, while the wall structure M1005 was consistent with a 19th century date and may have been part of a phase associated with the establishment of a boiler here (pipework and a hatch marked 'boiler' survives in the east wall of the barn itself).

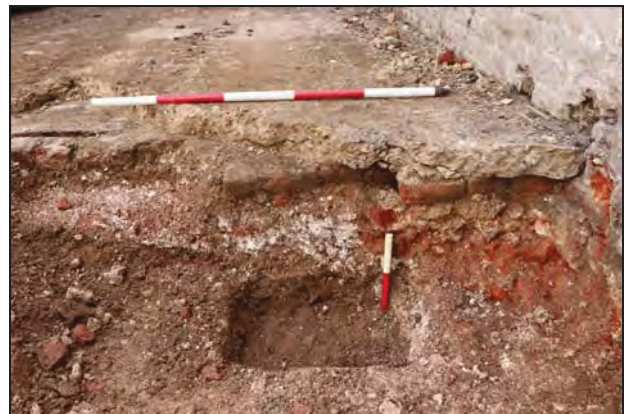
DP 6
Sample section 1, looking north

<i>Sample section 1</i> <i>0.00 = 113.08m AOD</i>		
0.00 – 0.10m	L1000	Floor surface. Concrete, high aggregate content.
0.10 – 0.18m	M1001	Floor surface. Soft red brick floor surface laid in running bond.
0.18 – 0.34m	L1002	Floor surface/levelling layer. Compacted chalk layer to hold floor surface M1001.
0.34 – 0.47m+	L1004	Made ground. Form mid grey brown clayey silt with a high proportion of soft red brick and tile fragments.

5.3.1 The stratigraphy within the barn at the north end consisted of concrete floor surface L1000 (0.1m deep) that overlay and sealed brick floor M1001 (0.08m). Brick floor M1001 overlay levelling layer L1002 (0.08-0.18m), which in turn was laid over made ground L1004 (0.21m+). The natural was not encountered within the north end of the barn, though elsewhere thick concrete flooring (up to 0.5m deep) directly overlay the natural geology.

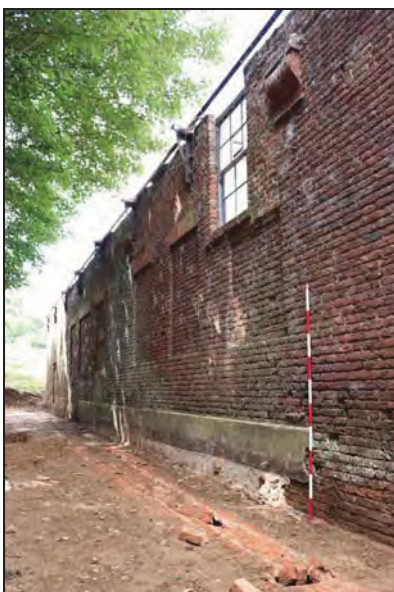
DP 11
Exterior of the barn (east side) after ground reduction showing brick culvert M1006, looking south-west

5.1.6 A small brick tunnel was encountered in the area of ground reduction to the east of the barn. This was consistent with an early system of drainage, perhaps 18th century in date, and extended approximately parallel with the barn. It was constructed of soft red bricks that measure an average of 9½" x 4¾" x 2¾" (241mm x 111mm x 70mm) with a pale buff coloured lime mortar. The tunnel measures 0.5m wide internally with a depth of at least 0.38m with the ceiling of the tunnel formed of a shallow brick arch (Fig. 6), with some bricks rubbed to a specific shape. Towards the north end, this tunnel was bisected by a Victorian drain containing the remains of glazed pipework. This extended west through the wall of the barn which is substantially disturbed in this area. On the opposite side of the barn, a further small brick arch was exposed in the west wall after the lowering of the floor level. The brick arch is of similar fabric to the barn itself though is not particularly accomplished and is likely to have been inserted into the pre-existing fabric. This is likely associated with brick tunnel M1006 and the Victorian pipework was added to replace part of the earlier system.

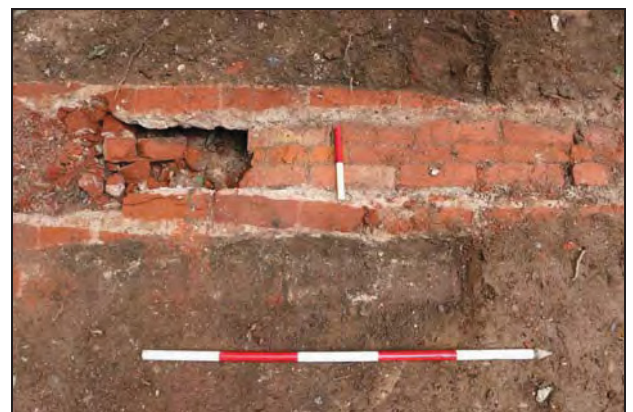
DP 12
Upper surface of brick culvert M1006, looking west

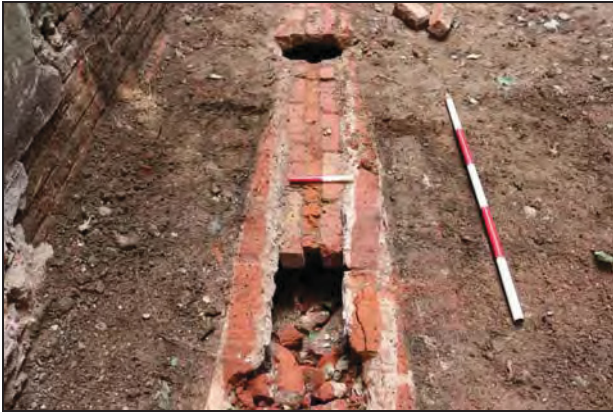
DP 13
View of brick culvert M1006, looking north

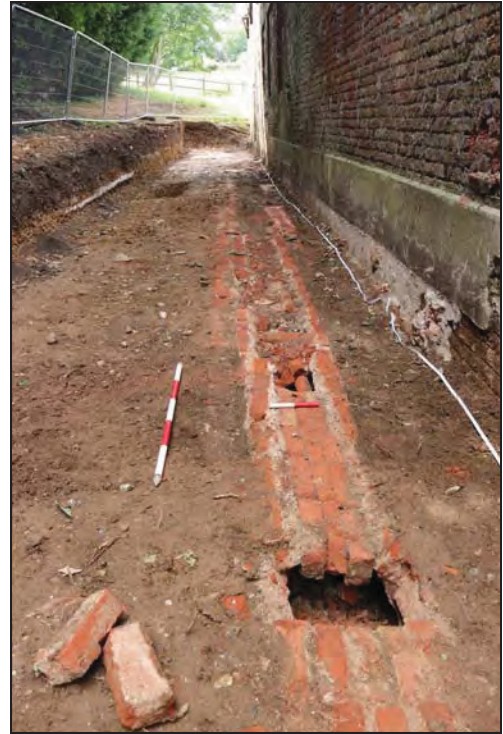
DP 14
View of brick culvert M1006, looking south

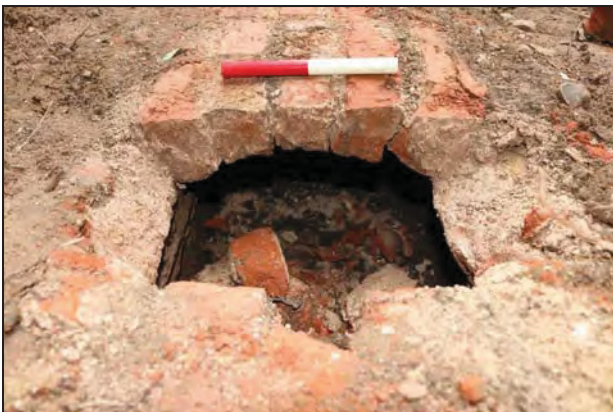
DP 15
View of the brick arch of culvert M1006, looking north

6.1 Monitoring and recording during groundworks around the barn found evidence for an early drainage system associated with the Benington Park estate. This feature was encountered during ground reduction outside the barn on the east side and comprised a small brick-arched culvert (M1006) extending north-south, constructed of red brick and measuring 0.5m wide internally with a depth of at least 0.38m (the base was not accessible). This feature was cut into natural clay and was later truncated by late Victorian ceramic pipework which extended east-west below the barn itself. The form and brickwork of the culvert appeared consistent with an 18th century date or perhaps very early 19th century.

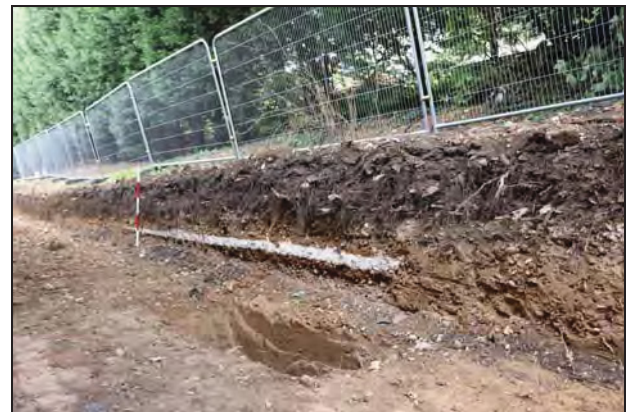
DP 16
Made ground layers (L1007-1008 and L1010-1011) on the east side of the barn with compacted chalk surface L1010, looking north-east

6.2 Above the culvert was a series of made ground layers (L1007-L1008 and L1009-L1010), with a single chalk floor surface (L1009) that may relate to a small unit visible here on historic maps. The upper layer (L1007) contained substantial demolition rubble including both brick and peg tiles. The specialist report notes the tiles are consistent with a date between the 17th and 19th centuries and so presumably those removed from the barn itself prior to the replacement of the roof in ironwork.

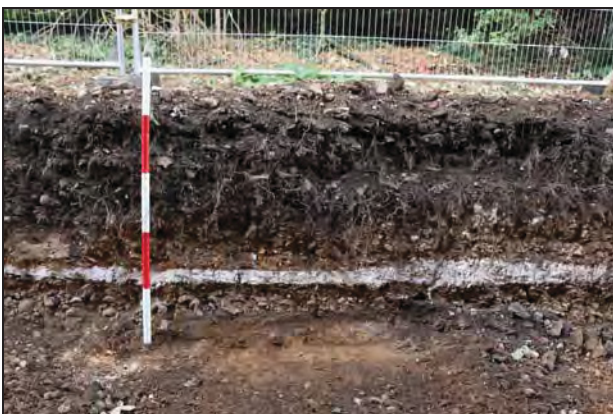
DP 17
Sample section 2, looking east

<i>Sample section 2</i> <i>0.00 = 113.60m AOD</i>		
0.00 – 0.40m	L1007	Made ground, building rubble. Mid brown loamy silt with very frequent brick and tile fragments
0.40 – 0.60m	L1008	Levelling layer/made ground. Light orange brown silty gravel.
0.60 – 0.68m	L1009	Floor surface. Compacted chalk layer.
0.68 – 0.81m	L1010	Levelling layer. Compact, firm grey brown gravel.
0.81 – 0.81m+	L1011	Natural deposit. Homogenous firm mid orange brown clay.

5.3.2 To the east of the barn in the area of ground reduction a deep layer of made ground demolition rubble L1007 (0.4m) overlay levelling layer/made ground L1008 (0.2m). L1008 in turn overlay made ground L1010 apart from in an area of a former probably ephemeral structure where it overlay compact chalk surface L1009 (0.05-0.09m). L1010 immediately lay over the natural geology comprising mid orange brown clay.

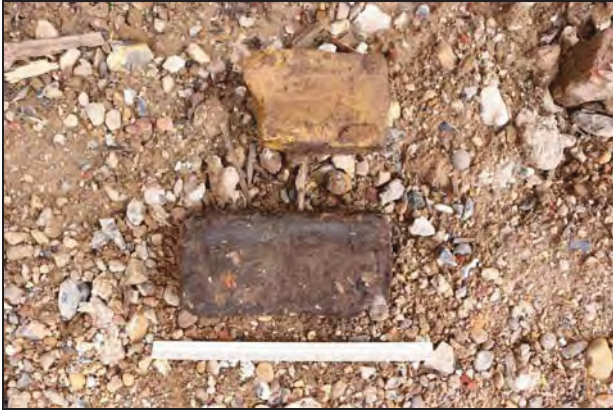
DP 19
Samples of later bricks found at the north end of the barn

The earliest variant of red brick was sampled from Floor L1001 and had dimensions of 220x100x60mm (8¾x4x2½ inches) with a slightly rough base, fairly regular arrises, and slightly creased faces; however it was given a superficially more regular appearance as the upper surface has been worn smooth, to a near glossy feel, by wear resulting from footfall across the floor that it formed part of. Bricks with these dimensions and technological traits were produced in the late 17th to 18th centuries in the region, potentially on one of the brickfields situated around Stevenage, Welwyn, Watton-at-Stone and Weston that are shown on late 19th century (1st edition) Ordnance Survey maps.

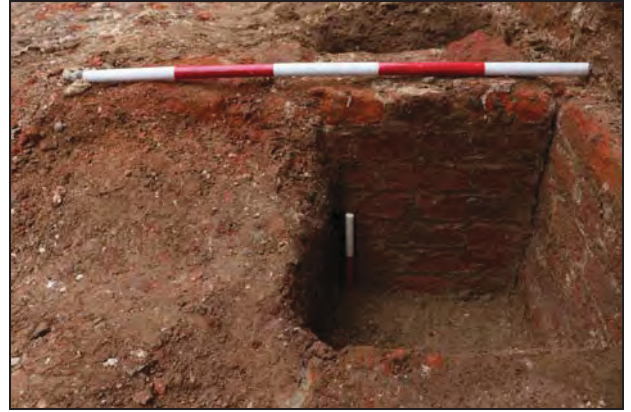
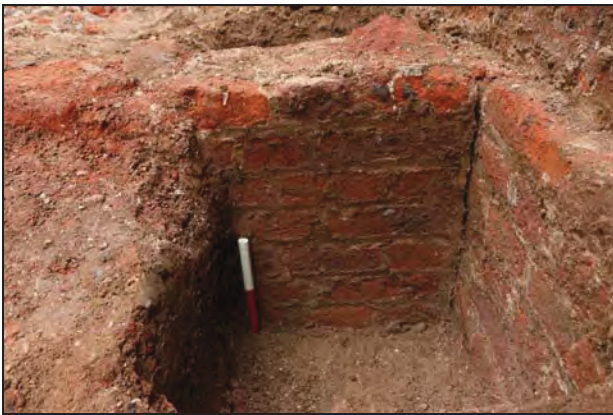
DP 20
Wall footing M1005 at the north end of the barn (north half) with straight joint to outer barn wall, looking south

DP 21
Wall footing M1005 at the north end of the barn (north half) with straight joint to outer barn wall, looking south

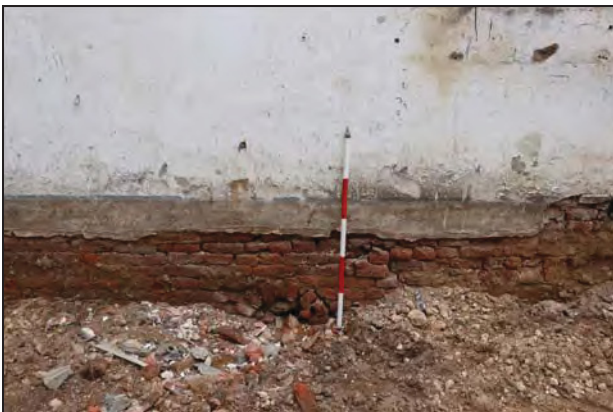
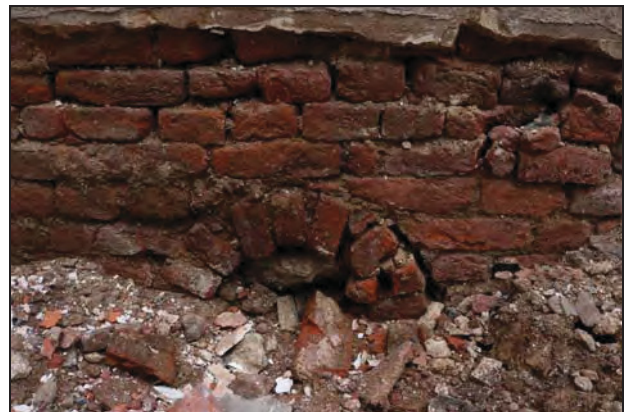
DP 23
Brick arch on the east side of the barn (north half) following ground reduction, looking west

DP 24
Brick arch on the east side of the barn (north half) following ground reduction, looking west

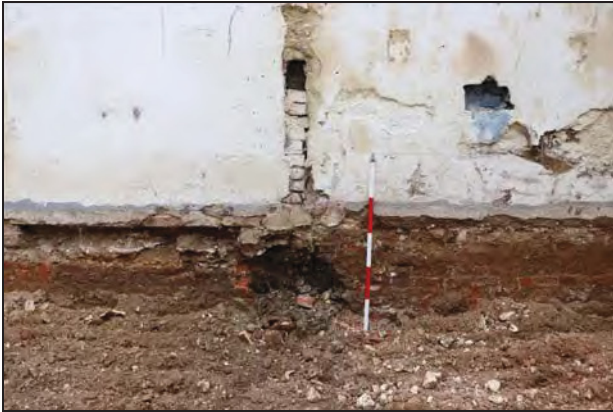
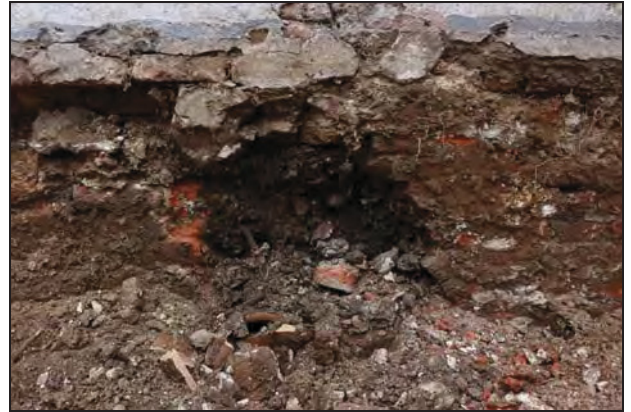
West side of the barn (north half) showing position of probable former brick arch corresponding with one on east but here disturbed, looking east

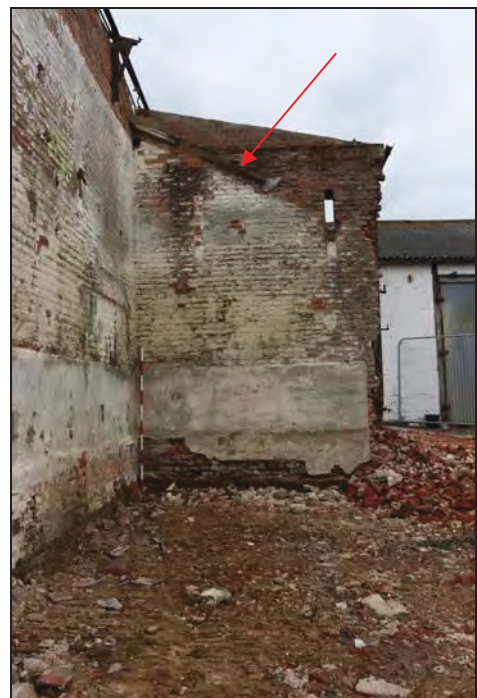
DP 28

North side of the barn porch following removal of the Dutch barn showing roof line (indicated) of former extension, looking south

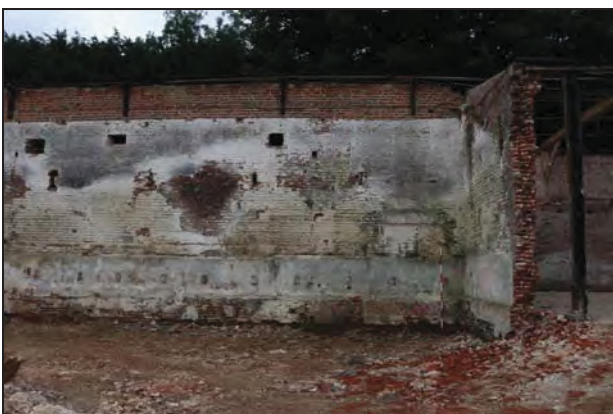
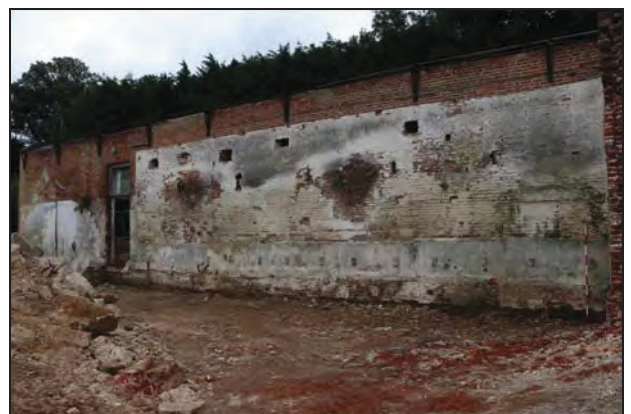
West side of the barn showing lime-washed walls marking the position of a former pent-roofed extension on this side, looking east

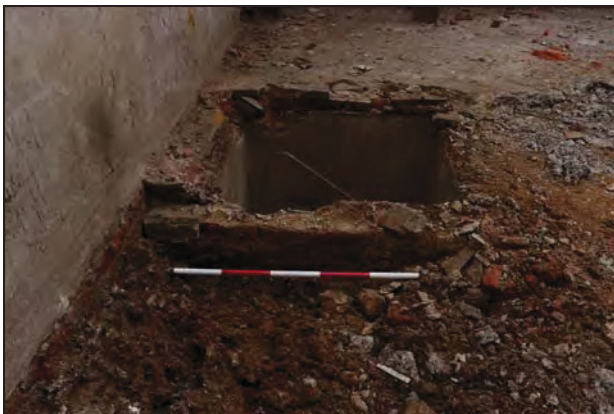
DP 33
20th century pit at the south end of the barn, looking east

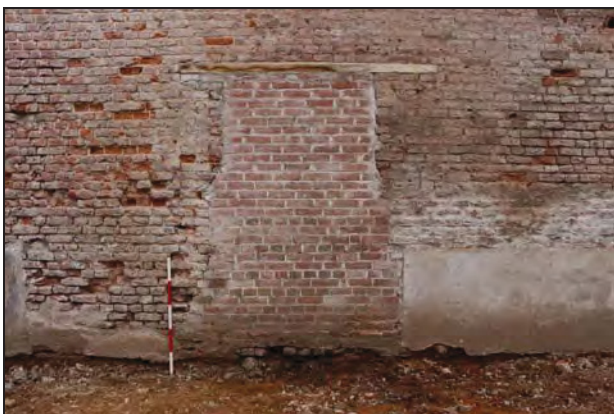
DP 35
Blocked doorway on the east side of the barn (south half), looking east
