ARCHAEOLOGICAL SOLUTIONS LTD

37b WEST STREET, HERTFORD, HERTFORDSHIRE

DOCUMENTARY & PHOTOGRAPHIC SURVEY

BUILDING MONITORING & RECORDING

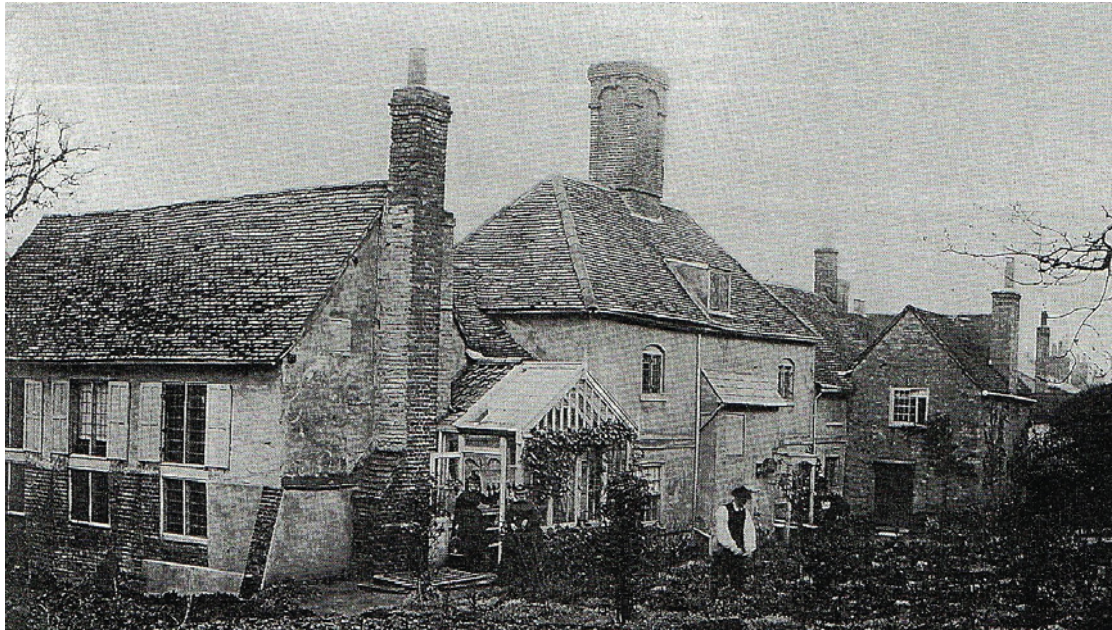
3.2.10 In 1890 the property sold to R.T. and W.F. Andrews for £525 who in the following year extended the building at the rear and divided it into four dwellings. The new owners turned over more of the former gardens and nursery land to new houses, numbers 39 to 43, built in the same cream Gault bricks which had been used in the extension of Bridgeman House. It was also at this time that the former concert room, by then the school wing, was rebuilt or refaced in brick. A photograph of the rear of the building shows this wing just prior to the building work. A similar view from approximately the same time is given by an undated glass plate in the collections at HALS (ref. D/EX888/6/W4). This second image is reproduced below as historic photograph 1.

1 Photograph taken c. 1880 before south-west wing was rebuilt in brick (ref: D/EX888/6/W4)

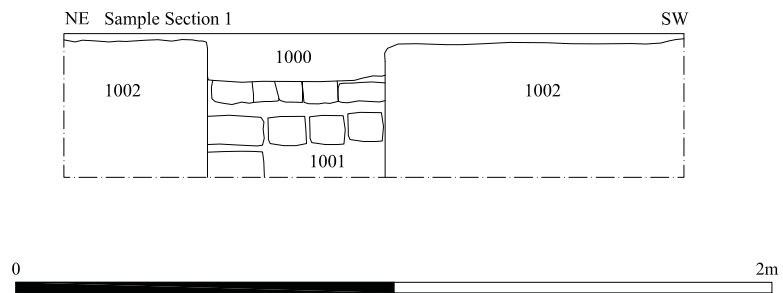
Archaeological Solutions Ltd
Fig. 13 Monitoring & recording
Scale plans at 1:100 & sections at 1:20 at A4

4.2.1 Four sample sections were selected in the excavated area. Their positions are recorded in the monitoring and recording plan of the cellar given in fig. 13 and detailed descriptions of each are given below.

The site was visited on 21st August and 11th September 2008 and the cellar area was inspected while the work was taking place. Notes were taken, along with colour photographs which were taken using an Olympus Camedia E20 digital camera. The locations of these shots are noted in the photographic location plan included as part of fig. 13.

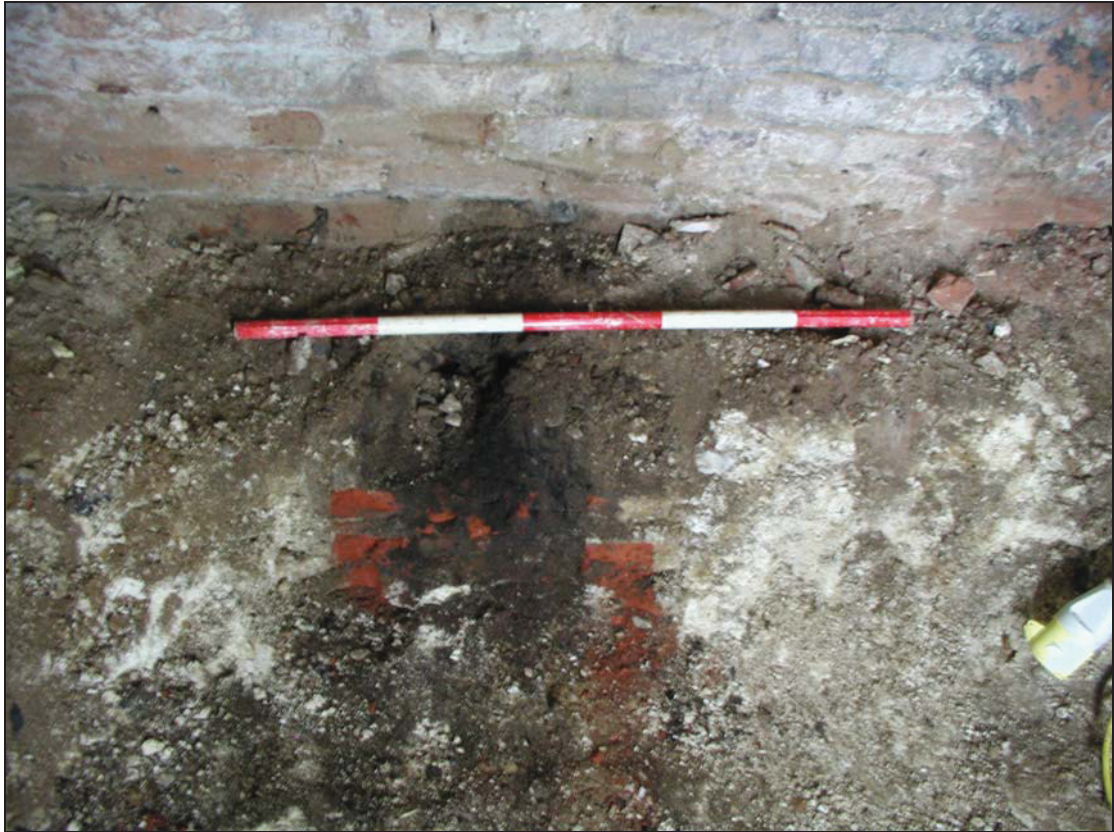
Sample section one

4.2.1.1 Sample Section 1: Fig. 14, Photograph

Sample section 1		
0.00 – 0.12m	L1000	Mid reddish brownish grey clayey silt with moderate sub-angular flint, occasional small pebbles and CBM
0.12 - 0m	L1002	Chalk natural.

Description: In the middle of the sample section remains of a low wall were visible.

M1001 was a low (0.1+x0.25x0.25m) wall probably forming part of an original foundation of a building. Red handmade bricks (0.22x0.11x0.07m) were used in construction and pale white lime mortar was used as a bonding material. Joints had a thickness of approximately 10mm.

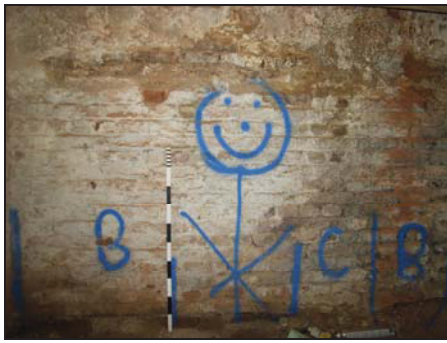
1.

This section of brickwork is generally laid in English bond and comprises bricks of dimensions 102mm x 63.5mm x 229mm (4" x 2.5" x 9") (photo 1). The uppermost five courses are laid less well than those below and utilise a form of stretcher bond although the bricks appear to be of the same dimensions as those found elsewhere. A large quantity of lime wash remains on this section of the wall and there are traces of a dark substance which may be coal dust.

South-west wall of north-east area of cellar, including section scheduled for removal, taken from the north-east

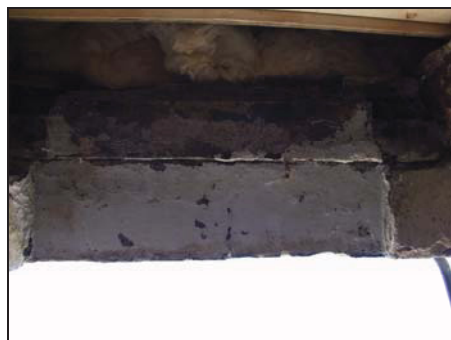
6.

The only feature of particular interest noted in the course of the building monitoring and recording was the wooden reveal to the entry point to the north-east cellar area which suggests that there was formerly at least a frame around the aperture if not a window or open bars.

Cill beam above entry point to north-east cellar area

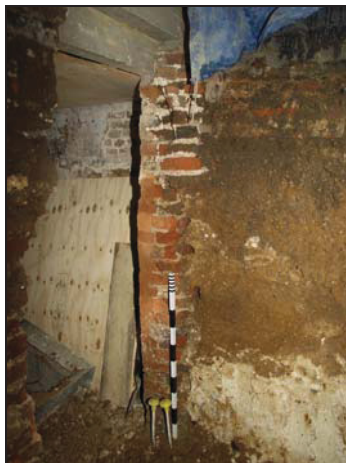
9.

This opening up work has revealed the brickwork in the new jambs (photos 9, 10 and 11). The bricks are of varying colours from orange through red to purple. They are bonded in a very flinty lime mortar. The excavation to the rear has also revealed some of what appear to be the foundations of the 17th century building, comprising a flint rubble layer and beneath this a layer of mixed purple and yellow bricks, the latter being in some cases very thin (photos 13 and 14).

North-east jamb to newly opened door at rear of north-east cellar area, taken from the south

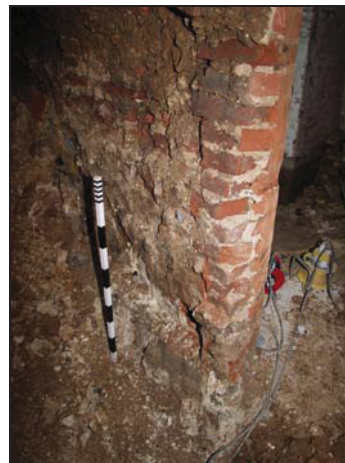
10.

South-west jamb to newly opened door at rear of north-east cellar area, taken from the east

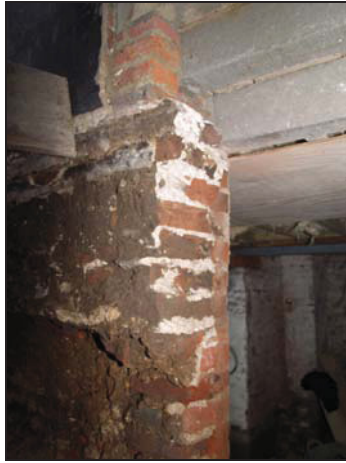
11.

Upper part of south-west jamb to newly opened door at rear of north-east cellar area, taken from the east

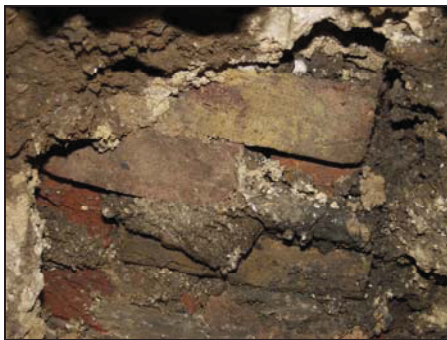
13.

Detail of brick to exposed area of rear cellar wall, taken from the south-east

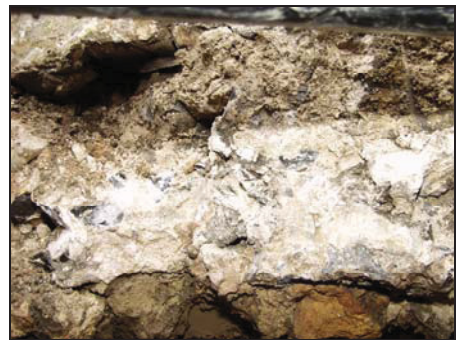
14.

Detail of flint to exposed area of rear cellar wall, taken from the south-east

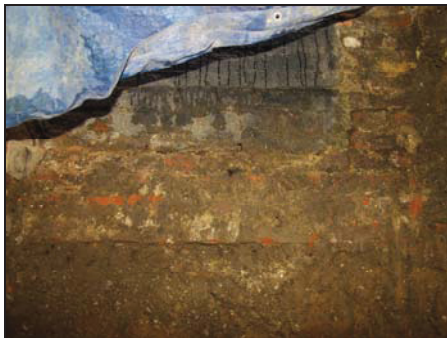
15.

Detail of brick courses to exposed area of foundations of south-east extension
