**CHURCH OF ST MICHAEL AND ALL ANGELS,  
BARTON TURF, NORFOLK**

**MONITORING OF WORKS UNDER  
ARCHAEOLOGICAL SUPERVISION AND CONTROL**

Authors:	Gareth Barlow (Fieldwork & Report) Tom Light (Illustrations)	
NGR: TG 34340 21860		Report No: 5389
District: Broadland		Site Code: ENF140903
Approved: Claire Halpin MCIfA		Project No: 6800
		Date: 30 June 2017 Revised 20 February 2018

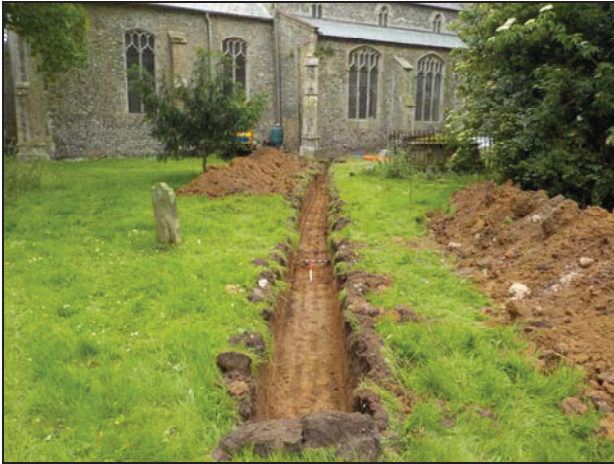
1  
General view of northern excavations looking south-west

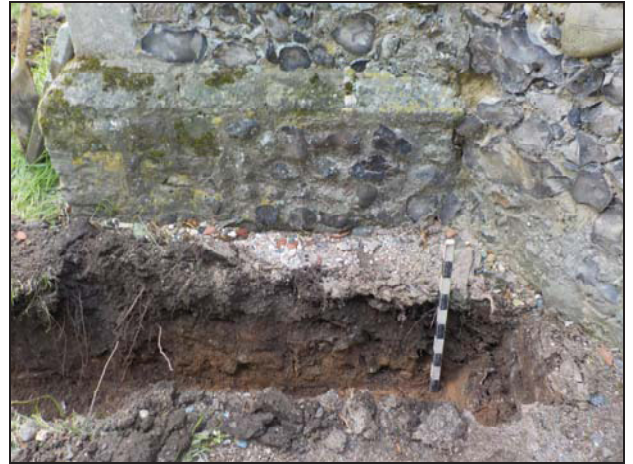
<i>Sample Section 1</i> <i>0.00m = 13.55m AOD</i>		
0.00 – 0.20m	L1000	Topsoil. Firm, dark grey brown silty sand with occasional small and medium sub-angular, sub-rounded, and rounded flints.
0.45m+	L1001	Subsoil. Firm, mid yellowish brown silty sand with occasional medium and large angular and sub-angular flints.

2  
Sample Section 1 looking south-east

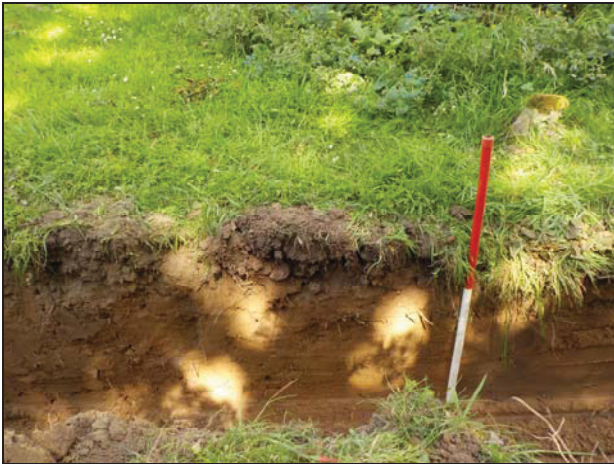
<i>Sample Section 2</i> <i>0.00m = 13.51m AOD</i>		
0.00 – 0.19m	L1000	Topsoil. As above
0.78m+	L1000	Subsoil. As above

3  
Sample Section 2 looking north-west

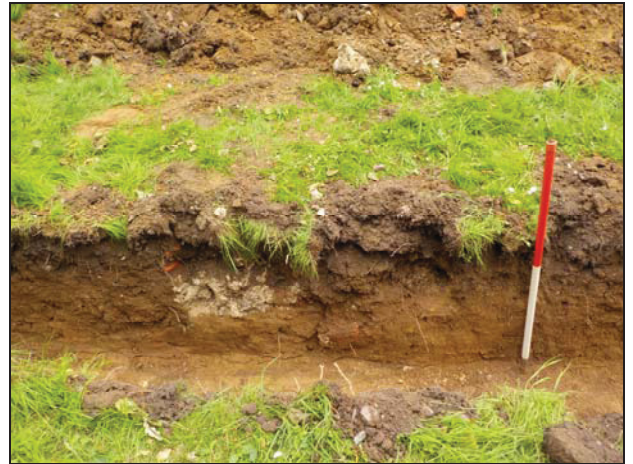
<i>Sample Section 3</i> <i>0.00m = 13.42m AOD</i>		
0.00 – 0.20m	L1000	Topsoil. As above
0.69m+	L1000	Subsoil. As above

4  
Sample Section 3 looking north-west

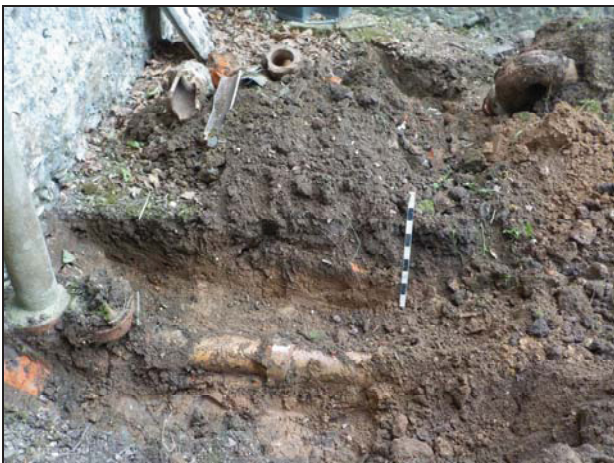
<i>Sample Section 4</i> <i>0.00m = 13.56m AOD</i>		
0.00 – 0.21m	L1000	Topsoil. As above
0.28m+	L1000	Subsoil. As above

5  
Sample Section 4 looking west

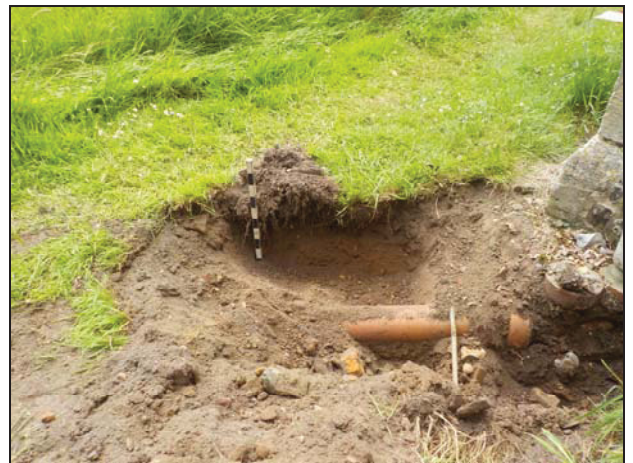
<i>Sample Section 5</i> <i>0.00m = 15.01m AOD</i>		
0.00 – 0.20m	L1000	Topsoil. As above
0.40m+	L1000	Subsoil. As above

6  
Sample Section 5 looking south-west

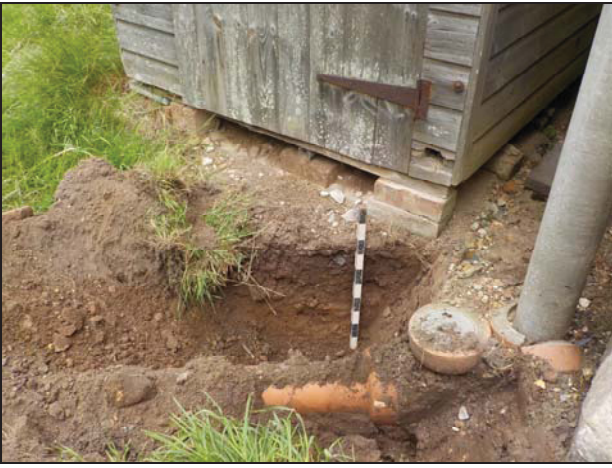
<i>Sample Section 6</i> <i>0.00m = 15.08m AOD</i>		
0.00 – 0.20m	L1000	Topsoil. As above
0.41m+	L1000	Subsoil. As above

7  
Sample Section 6 looking north-west

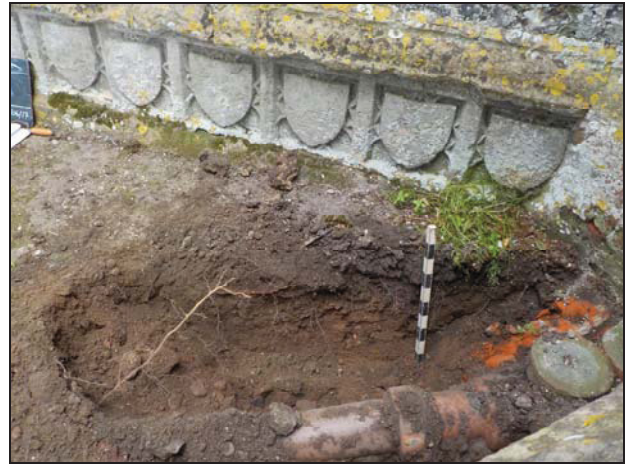
<i>Sample Section 7</i>		
<i>0.00m = 13.62m AOD</i>		
0.00 – 0.20m	L1000	Topsoil. As above
0.43m+	L1000	Subsoil. As above

8  
Sample Section 7 looking north-east
