**PHASE 3, LAND AT WHEATCROFT FARM, BRADWELL,  
NORFOLK**

**A PROGRAMME OF ARCHAEOLOGICAL MITIGATORY WORK  
(COMMENCING WITH INFORMATIVE TRIAL TRENCHING)**

Authors: Ekberg, I & Monahan, V. (Fieldwork and report)	
NGR: TG 5052 0310	Report No: 5753
District: Gt Yarmouth	Site Code: ENF 145639
Approved: Claire Halpin MCIfA	Project No: P4837
	Date: 31 January 2019; Revised 20 March 2019

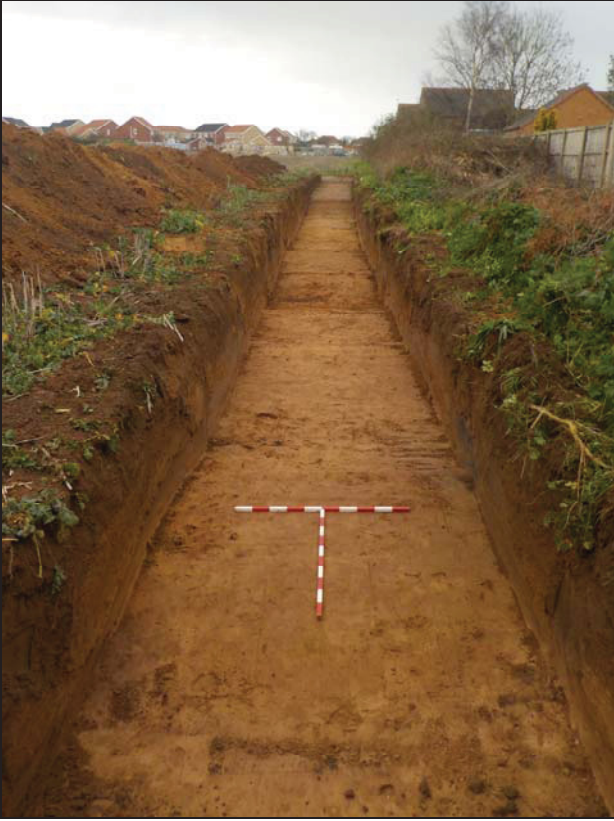
1  
Trench 1 looking west

3  
Sample section 1B looking south

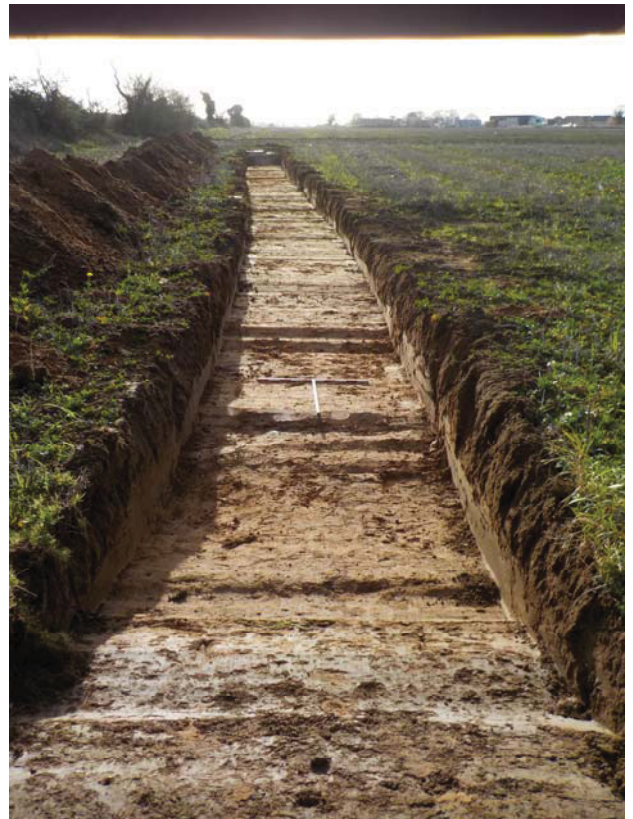
4  
Trench 2 looking south

5  
Sample section 2A looking east

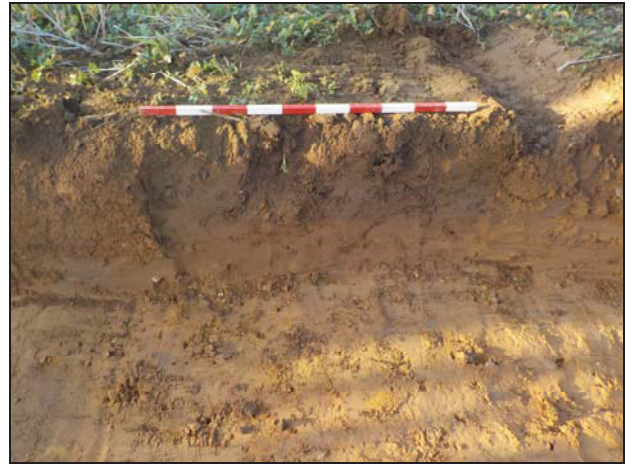
6  
Sample section 2B looking west

7  
Pit F4004 in Trench 2 looking west

Pit F4004 was sub-circular in plan (1.70+ x 1.31 x 0.45m). It had moderately sloping sides and a concave base. Its fill, L4005, was a friable, mid grey brown silty sand. It contained CBM (9g). F4004 cut ?Ditch F4006.

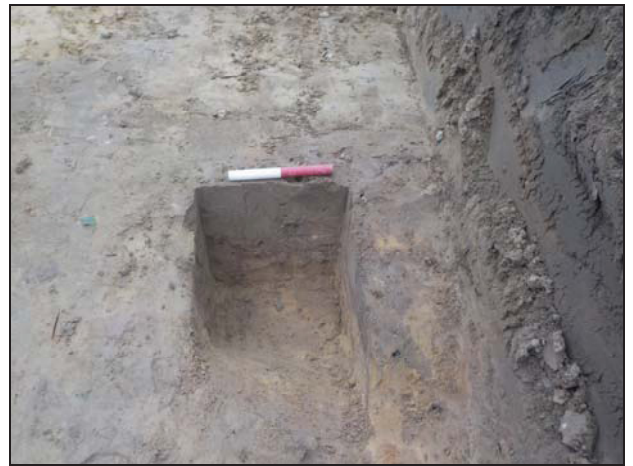
8  
Pit F4004 and ?Ditch F4006 in Trench 2 looking south

9  
Pit F4008 in Trench 2 looking east

?Ditch F4006 was linear in plan (1.80+ x 0.41 x 0.17m), orientated E/W. It had gently sloping sides and a flattish base. Its fill, L4007, was a friable, mid grey brown silty sand. It contained no finds. F4006 was cut by Pit F4004.

Pit F4008 was circular in plan (0.31 x 0.11m). It had moderately sloping sides and a concave base. Its fill, L4009, was a friable, dark grey brown silty sand. It contained no finds. F4008 was cut by Ditch F4010.

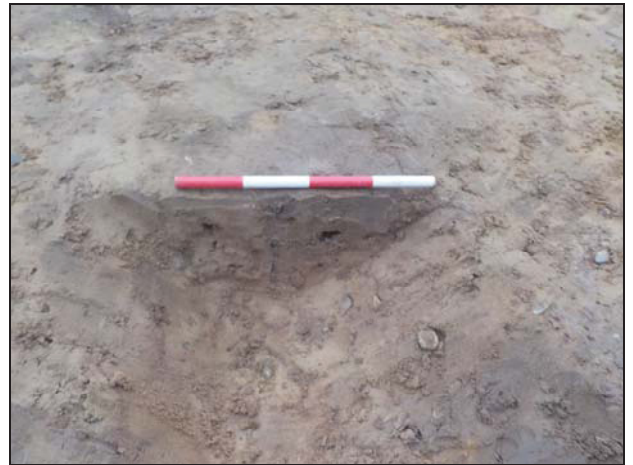
10  
Ditch F4010 in Trench 2 looking north-west

11  
Ditch F4012 in Trench 2 looking west

Ditch F4010 was linear in plan (1.80+ x 0.45 x 0.19m), orientated SE/NW. It had steep to moderately sloping and a concave base. Its fill, L4011, was a friable, mid grey brown silty sand. It contained no finds. F4010 cut Pit F4008.

Ditch F4012 was linear in plan (1.80+ x 0.91 x 0.25m), orientated E/W. It had moderately sloping sides and a concave base. Its fill, L4013, was a friable, mid grey brown silty sand. It contained no finds.

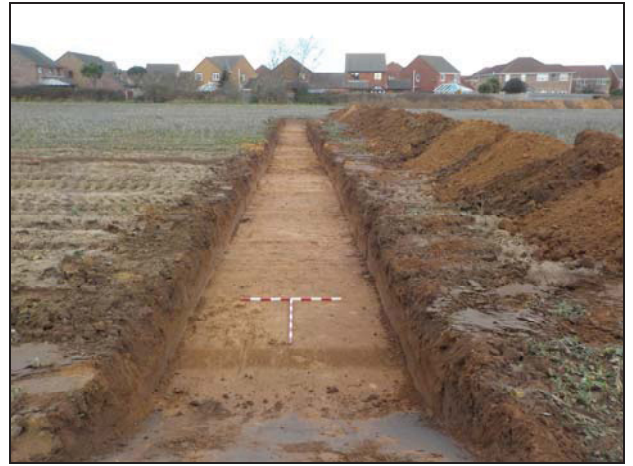
12  
Trench 3 looking south

13  
Sample section 3A looking east

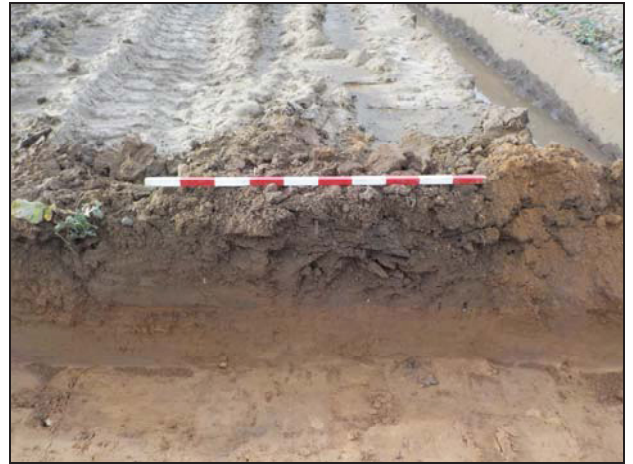
14  
Sample section 3B looking west

15  
Pit F4014 in Trench 3 looking north

Pit F4014 was sub-circular in plan (0.62 x 0.46 x 0.23m). It had steep to moderately sloping sides and a concave base. Its fill, L4015, was a friable, mid reddish brown silty sand. It contained no finds.

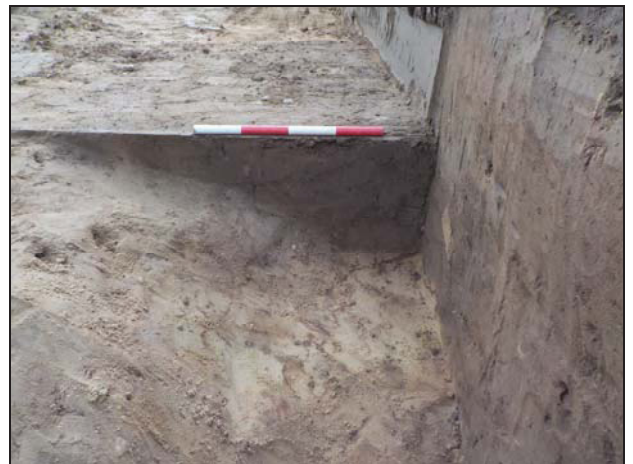
16  
Pit F4016 in Trench 3 looking south

17  
Pit F4016 in Trench 3 looking west

Large Pit F4016 was sub-circular in plan (3.24 x 0.82+ x 0.36m). It had moderately sloping sides and a concave base. Its fill, L4017, was a friable, mid grey brown silty sand. It contained no finds.

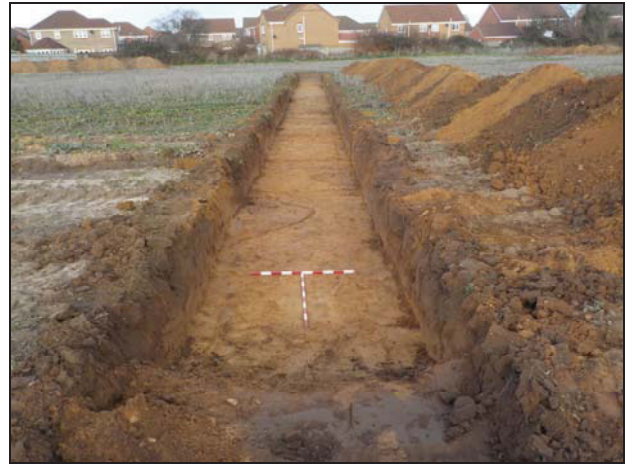
18  
Trench 4 looking north-east

19  
Sample section 4A looking south-east

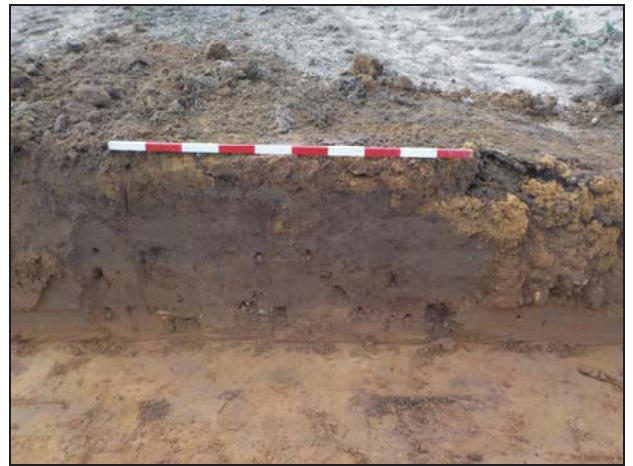
20  
Sample section 4B looking north-east

21  
Pit F4030 in Trench 4 looking east

Pit F4030 was sub-circular in plan (1.09 x 0.61+ x 0.46m). It had steep sloping sides and a concave base. Its fill, L4031, was a friable, pale reddish brown silty sand. It contained no finds.

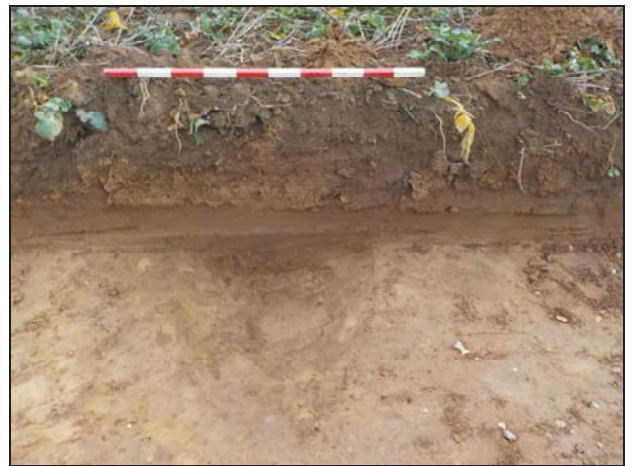
22  
Ditch Terminal F4032 in Trench 4 looking east

23  
Ditch Terminal F4034 in Trench 4 looking east

Ditch Terminal F4032 was linear in plan (0.76+ x 0.75 x 0.26m), orientated E/W. It had steep to moderately sloping sides and a flattish base. Its fill, L4033, was a friable, mid grey brown silty sand. It contained no finds.

Ditch Terminal F4034 was linear in plan (1.20+ x 1.11 x 0.19m), orientated E/W. It had moderately sloping sides and a concave base. Its fill, L4035, was a friable, mid reddish brown silty sand. It contained no finds.

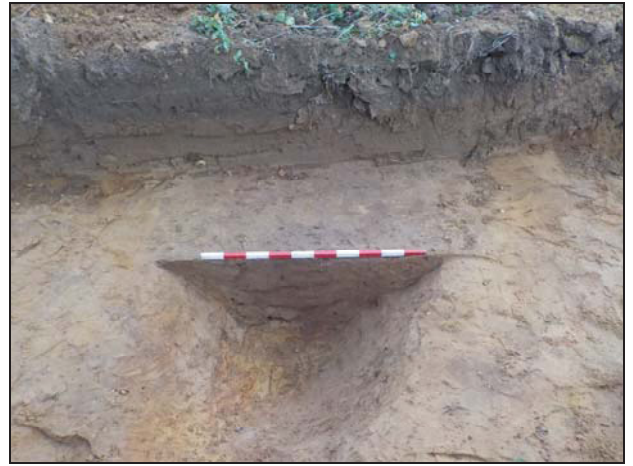
24  
Ditch Terminal F4036 in Trench 4 looking east

25  
Ditch Terminal F4038 in Trench 4 looking east

Ditch Terminal F4036 was linear in plan (1.80+ x 1.41 x 0.59m), orientated E/W. It had steep to moderately sloping sides and a narrow concave base. Its fill, L4037, was a friable, mid grey brown silty sand. It contained no finds.

Ditch Terminal F4038 was linear in plan (1.20+ x 1.55 x 0.71m), orientated E/W. It had steep to moderately sloping sides and a concave base. Its fill, L4039, was a friable, mid reddish brown silty sand. It contained no finds.

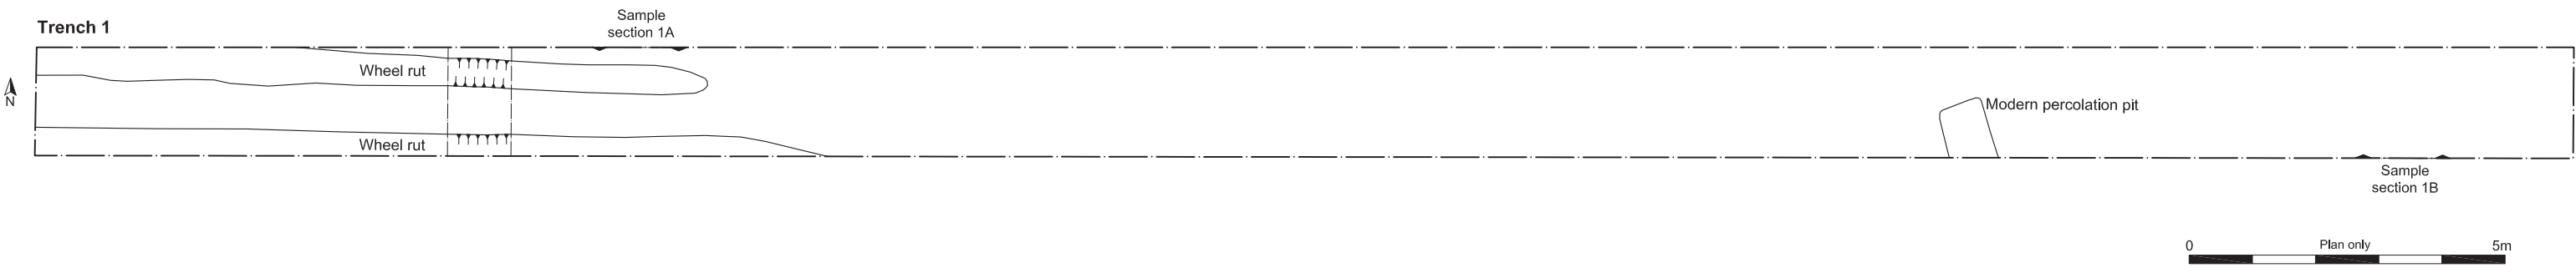
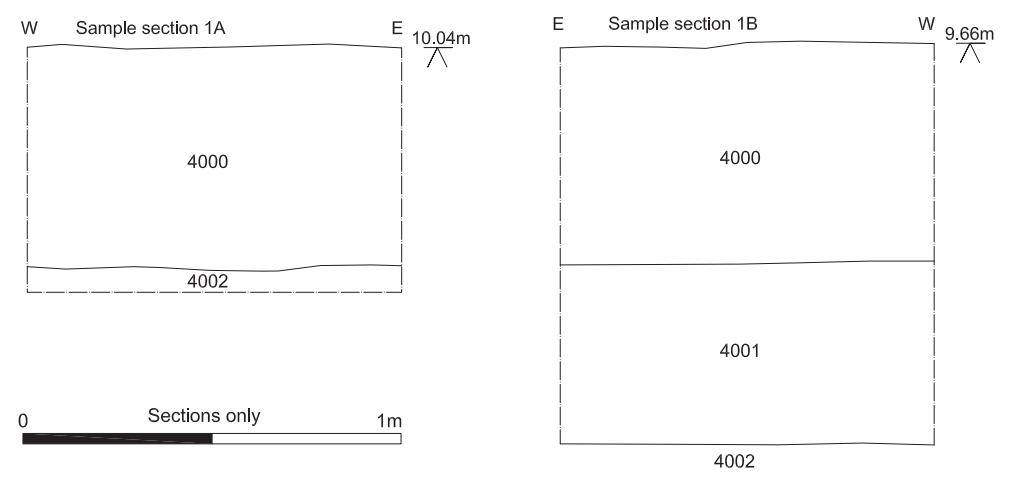
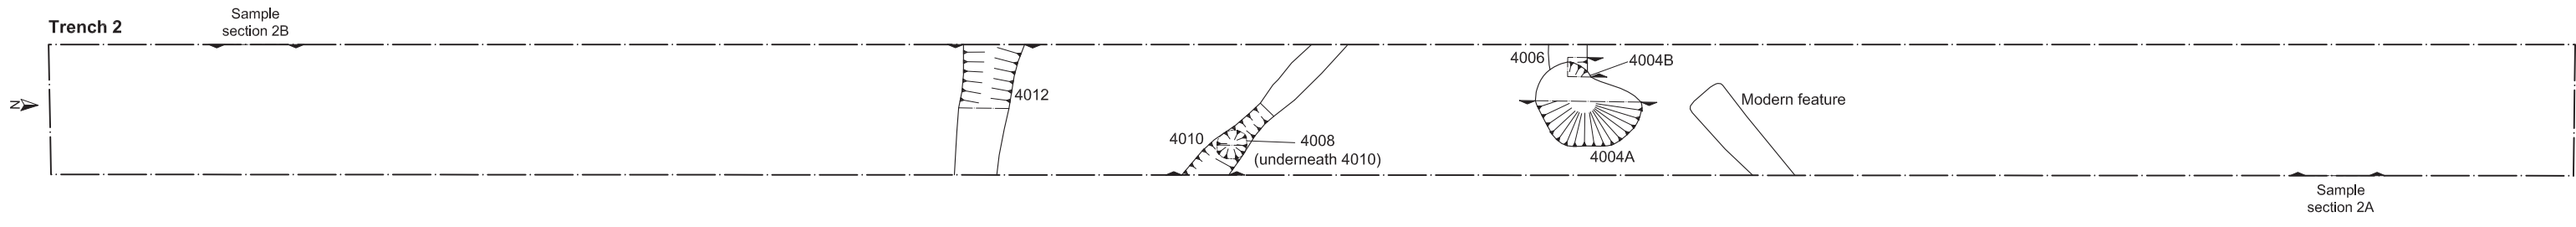
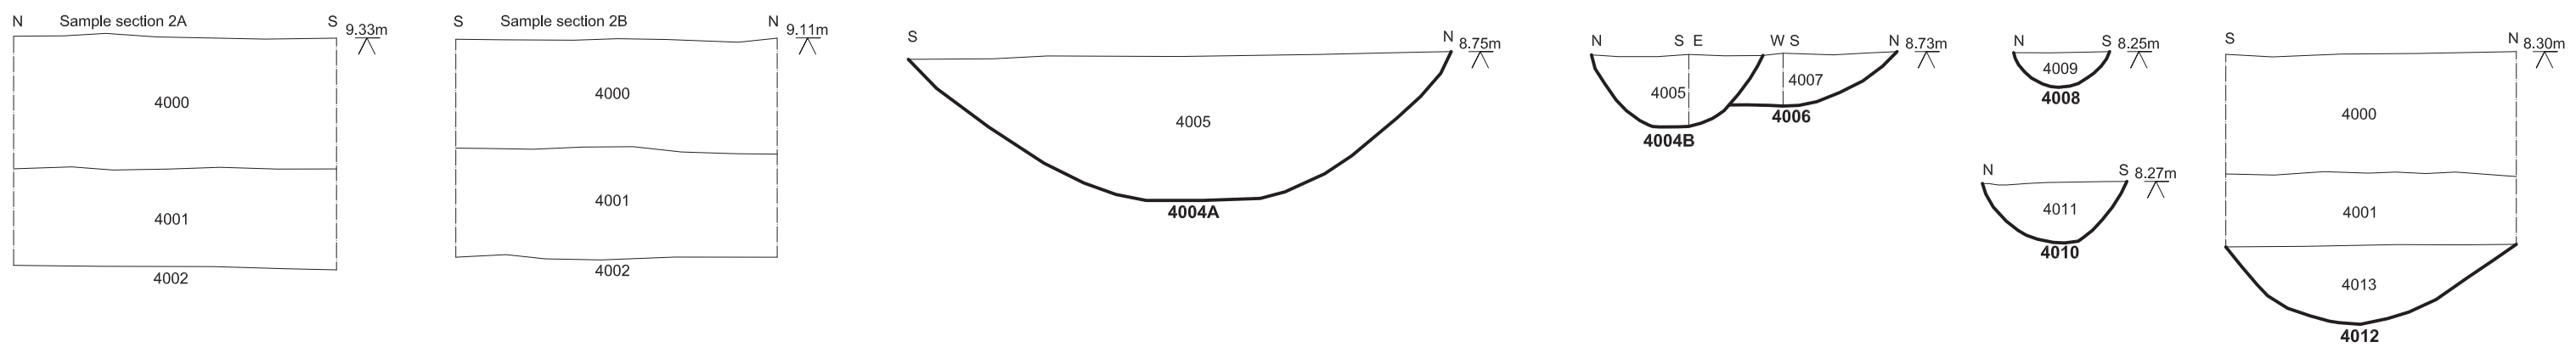
**Fig. 4 Trench plans and sections**

*Description: Trench 1 contained evidence of wheel ruts and a modern pit.*

*Description: Trench 2 contained Pits F4004 and F4008; Ditches F4006, F4010 and F4012; and a modern feature. Pit F4004 contained post-medieval CBM (9g). The other features contained no finds.*

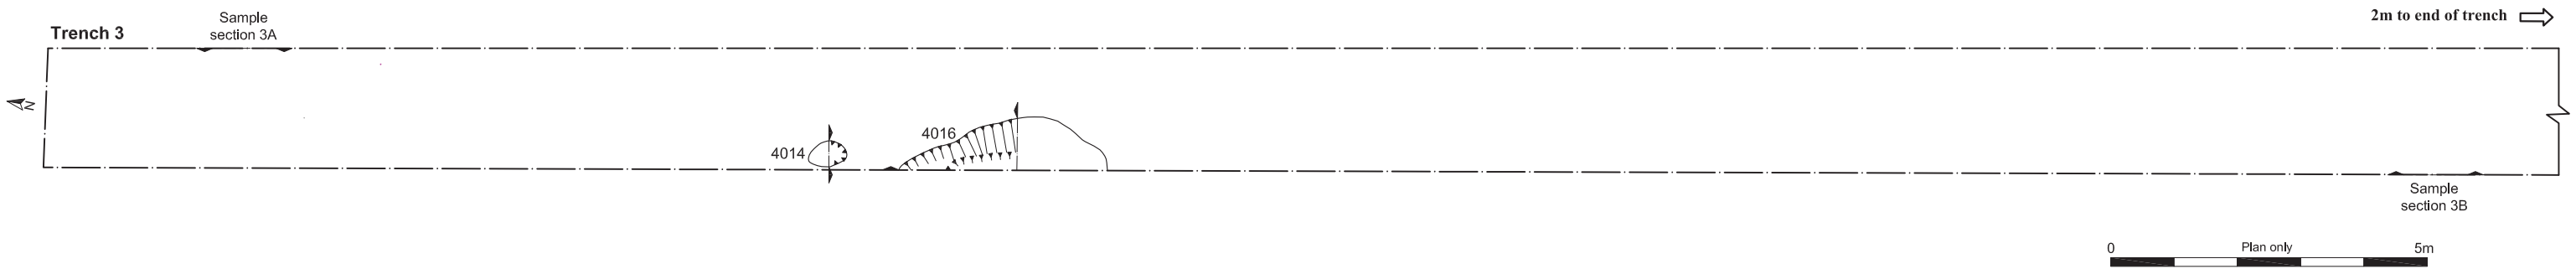
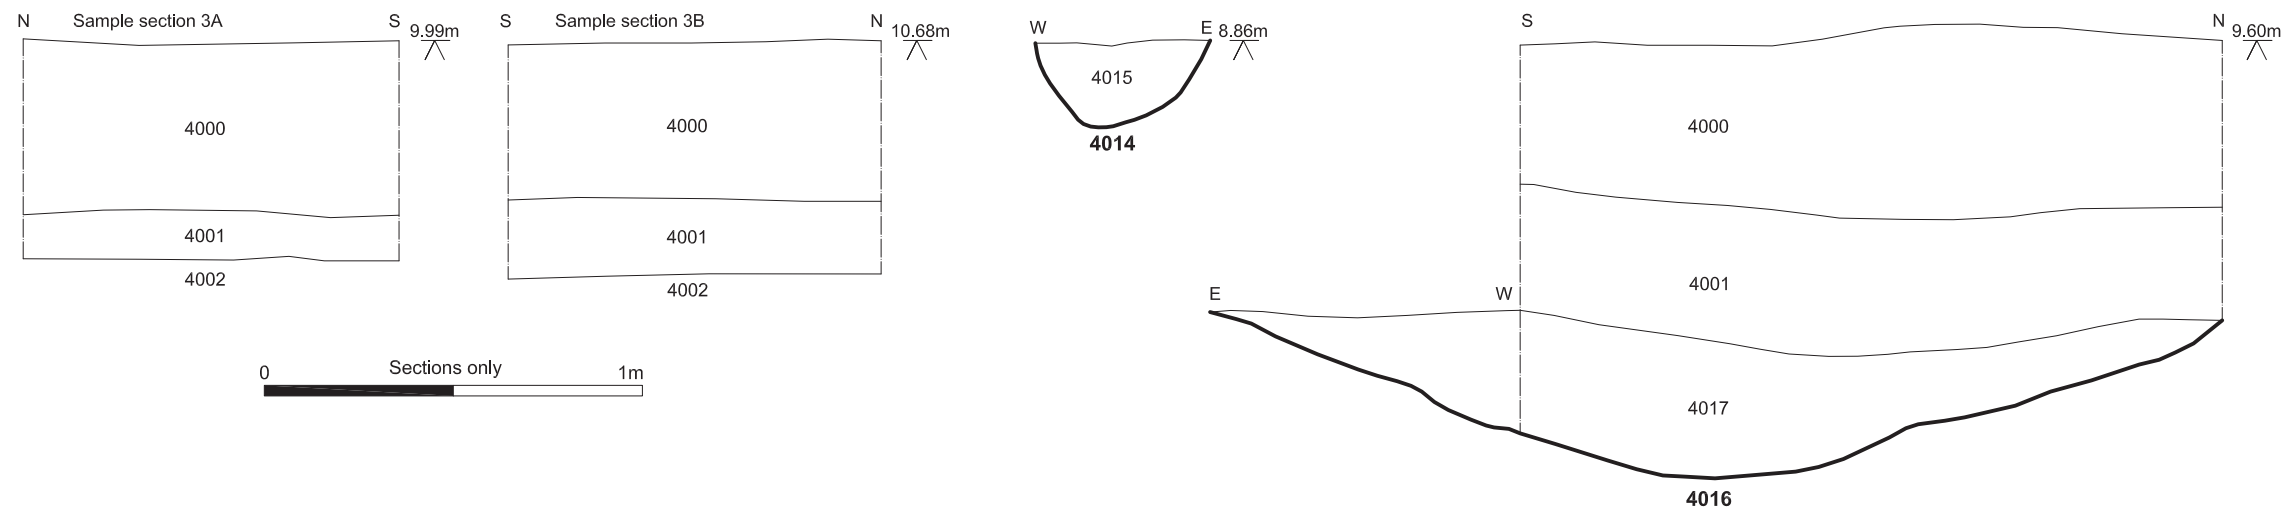
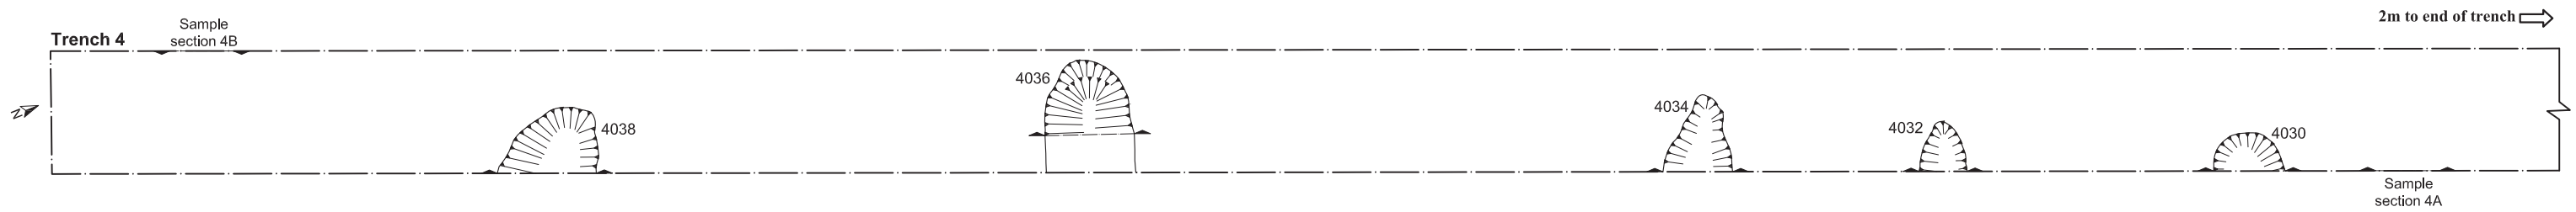
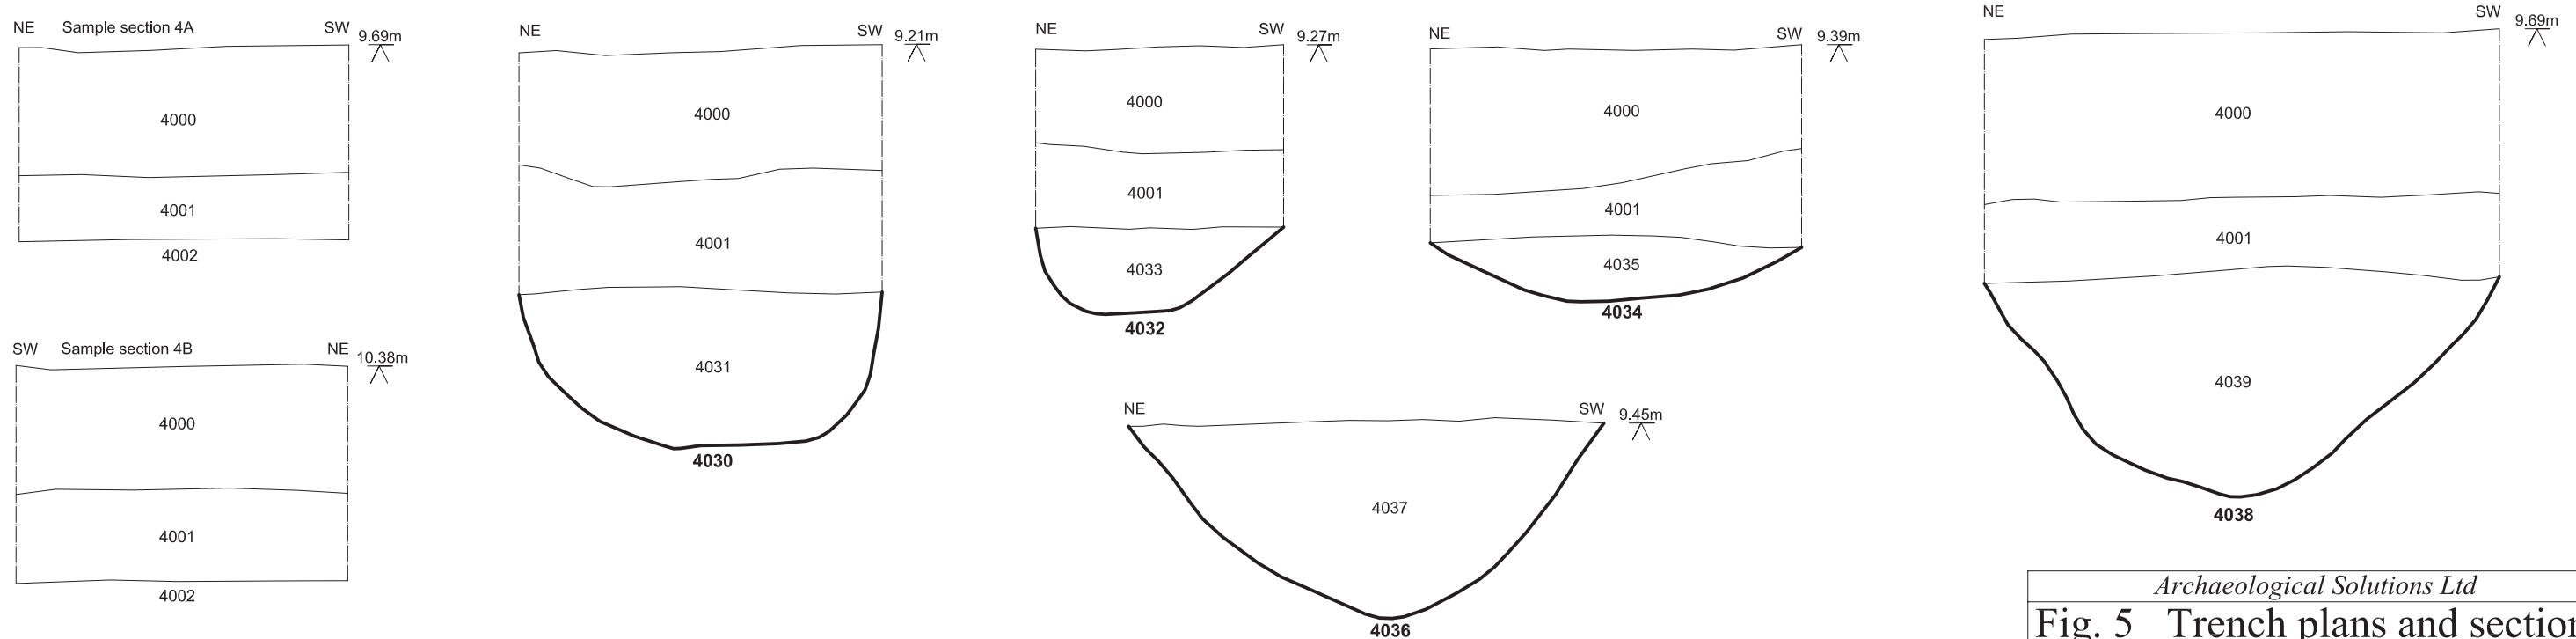
**Fig. 5 Trench plans and sections**

*Description: Trench 3 contained Pits F4014 and F4016. The features contained no finds.*

*Description: Trench 4 contained Pit F4030, and Ditch Terminals F4032, F4034, F4036 and F4038. The features contained no finds.*

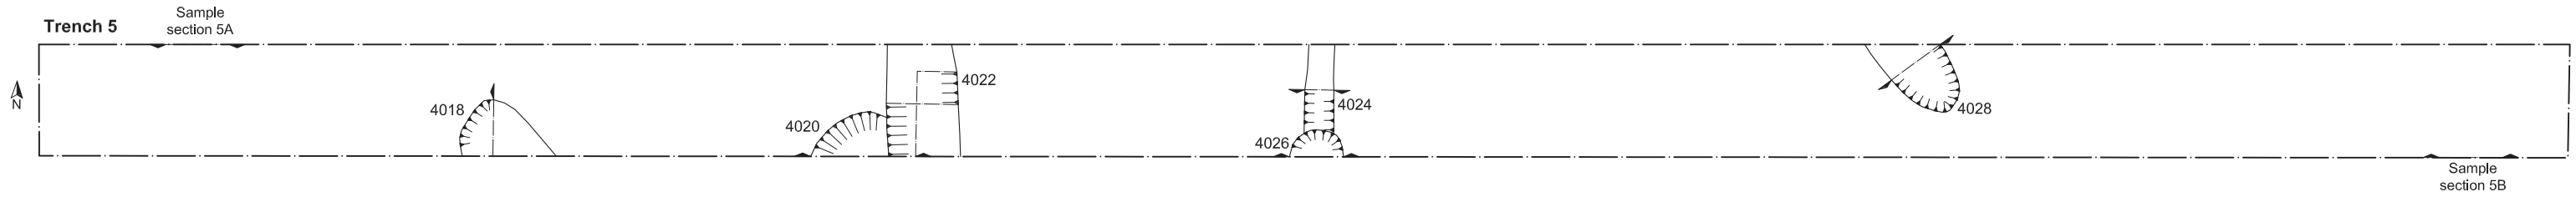
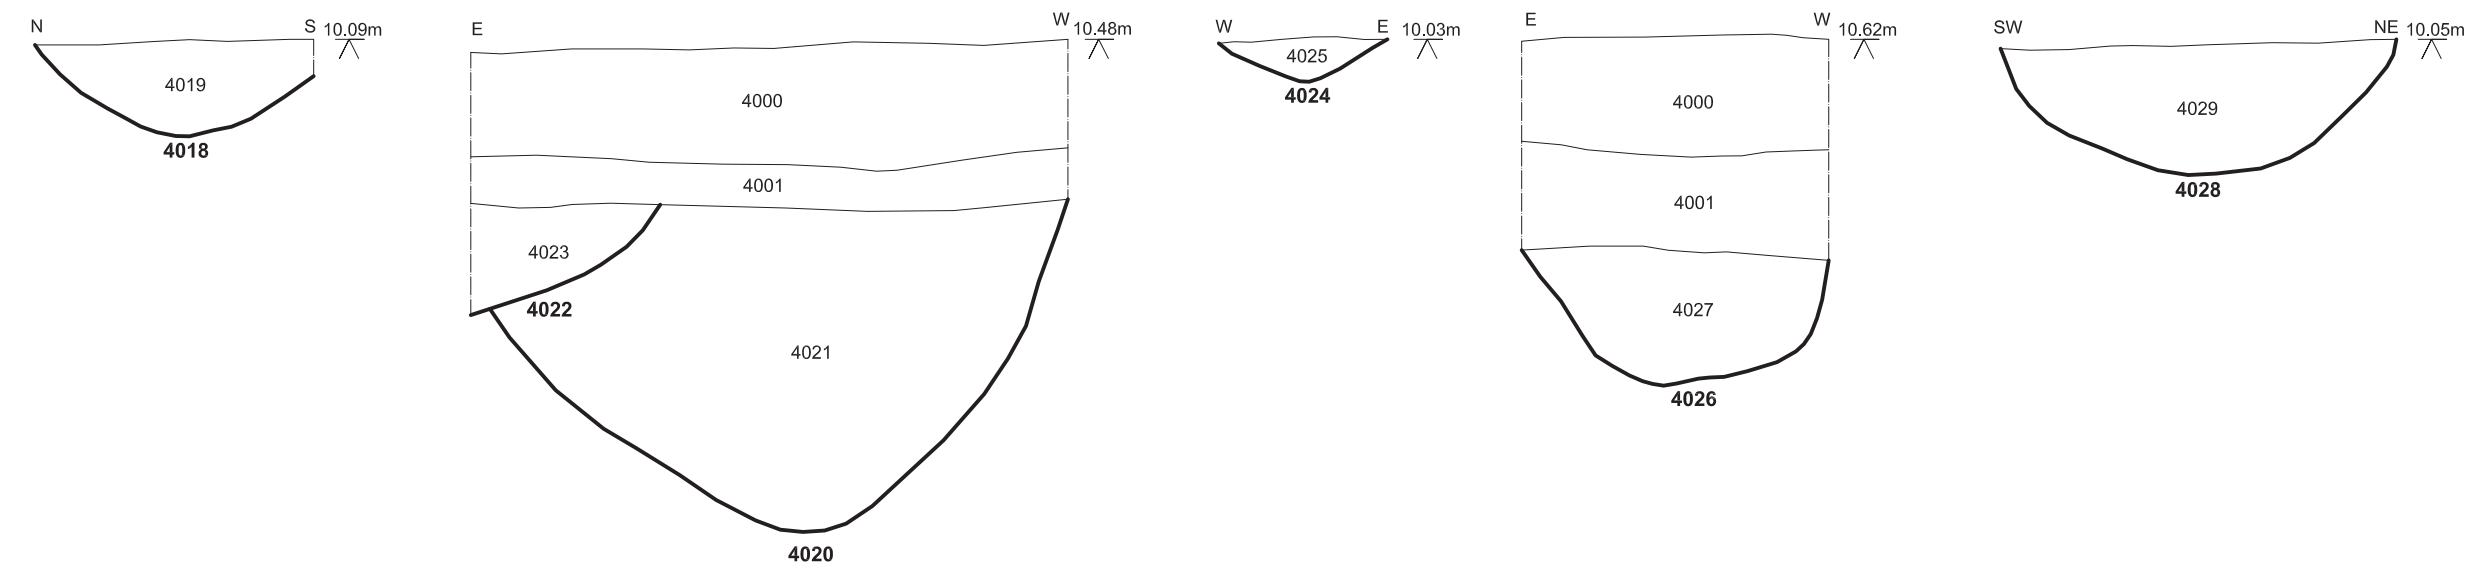
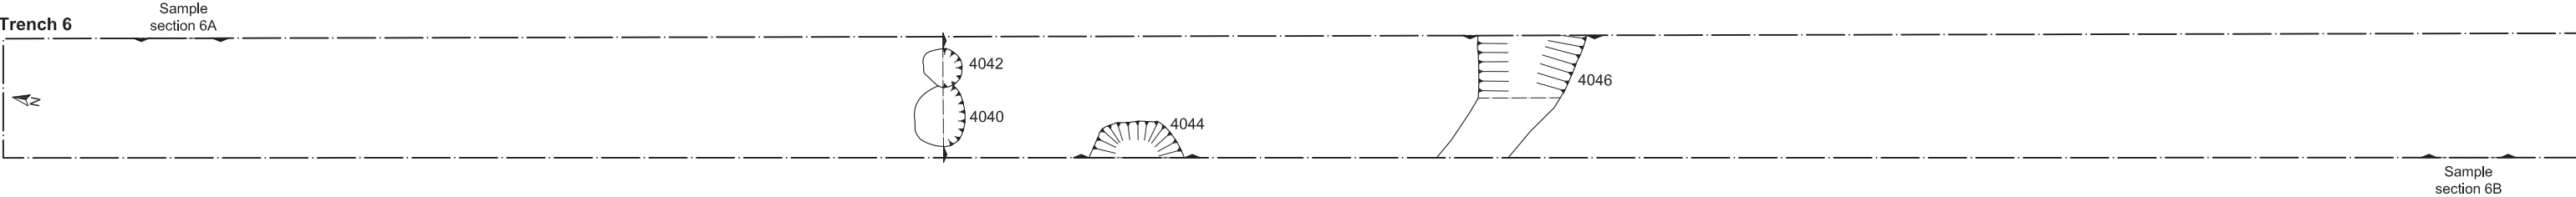
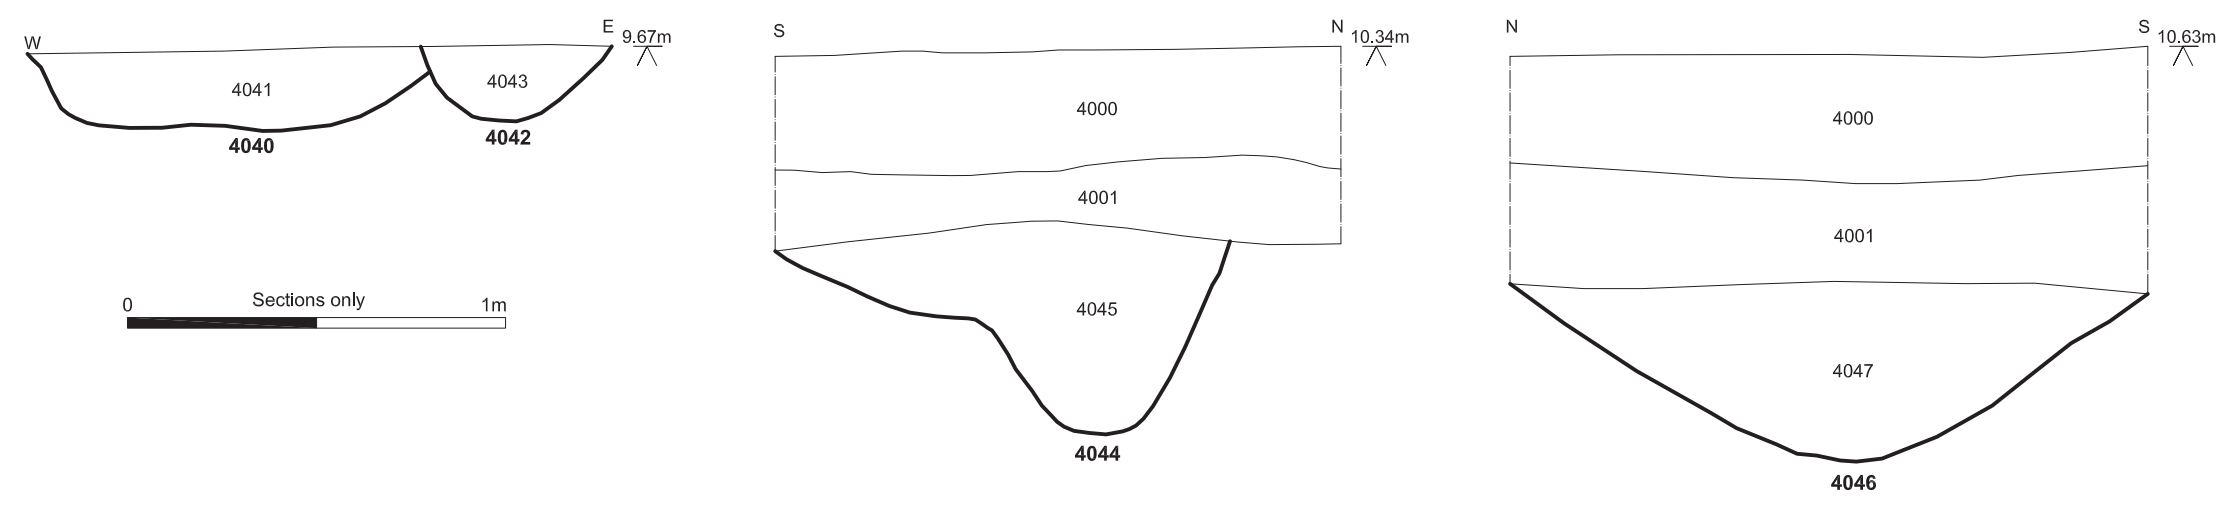
*Description: Trench 5 contained Pits F4018, 4020, and F4026; ?Pit F4028, and Ditches F4022 and F4024. The features contained no finds.*

Archaeological Solutions Ltd  
**Fig. 6 Trench plans and sections**  
 Scale Plans 1:100, sections 1:20 at A3  
 Land at Wheatcroft Farm, Bradwell, Norfolk (P4837)
