**LAND ADJACENT TO CHURCH INSTITUTE (THE FORGE), THE STREET, GREAT BARTON, SUFFOLK**

**HISTORIC BUILDING RECORDING**

Level 2

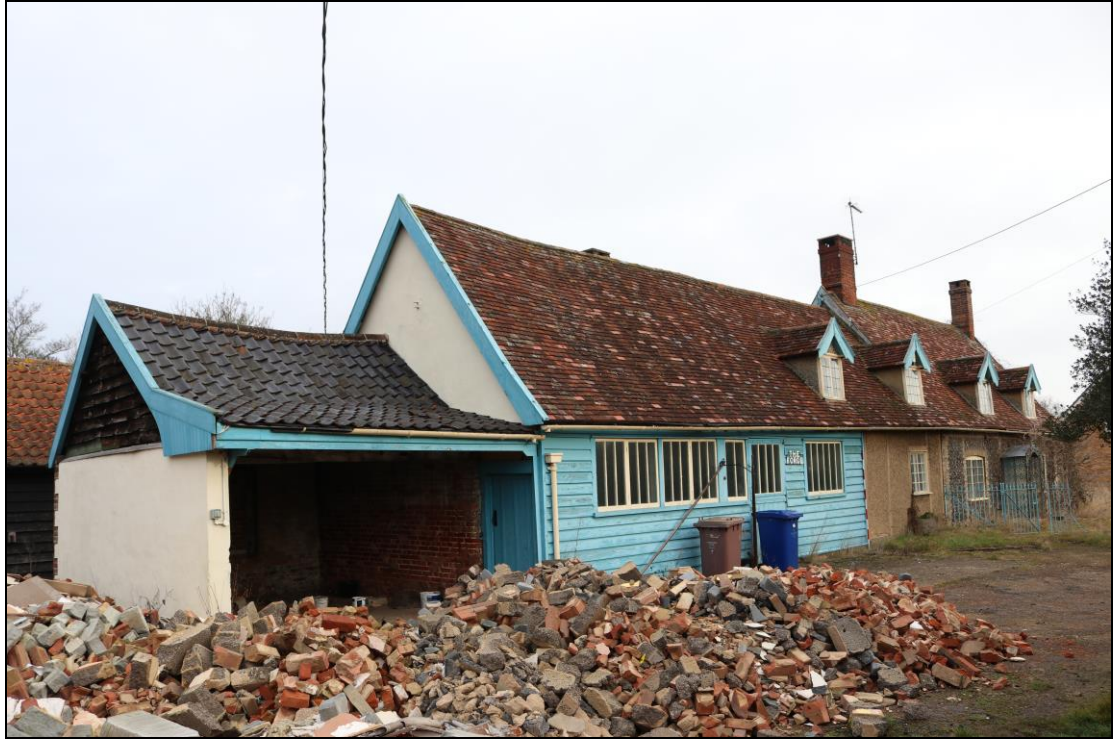
Plate 3 Exterior of the building, taken from the south-west (DP 001)

5.5 The end wall of the Workshop is housed within an open-sided Cartshed, itself having seen much alteration (Plate 3). The gable wall is of red brick, with a very light, soft lime mortar, and to a height of 1.5m the bricks are much worn. The Workshop is given access by a boarded door, inset from the face of the wall where the corner is rounded. Above the gable end is rendered and finished by painted barge boards.

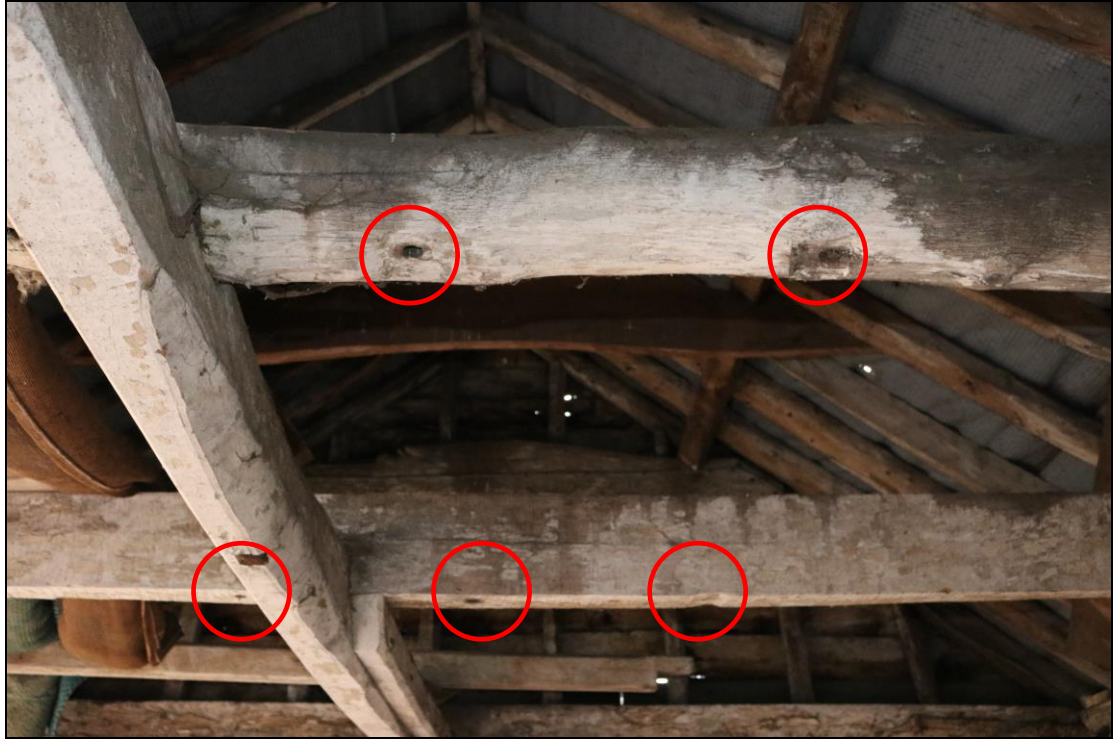
Plate 5 Roof structure over the Cartshed with detail of redundant peg holes (indicated), taken from the south-east (DP 122)

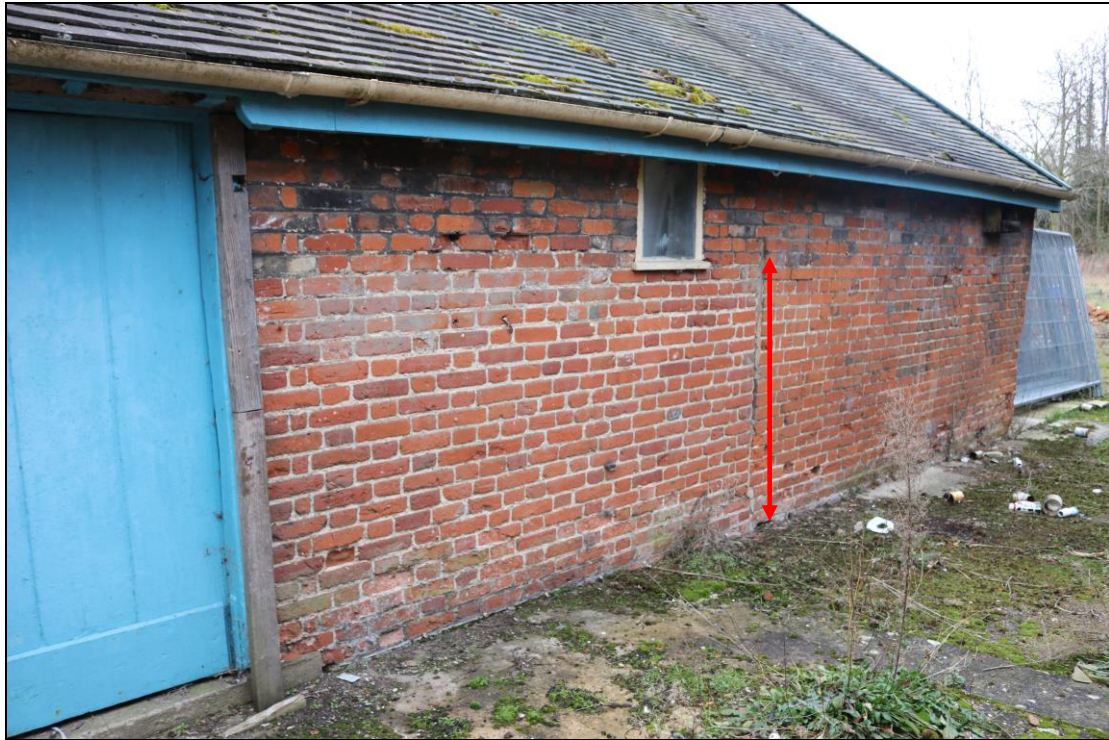
Plate 7 Rear wall of the Workshop, showing the straight joint in the brickwork (indicated), taken from the north-east (DP 013)

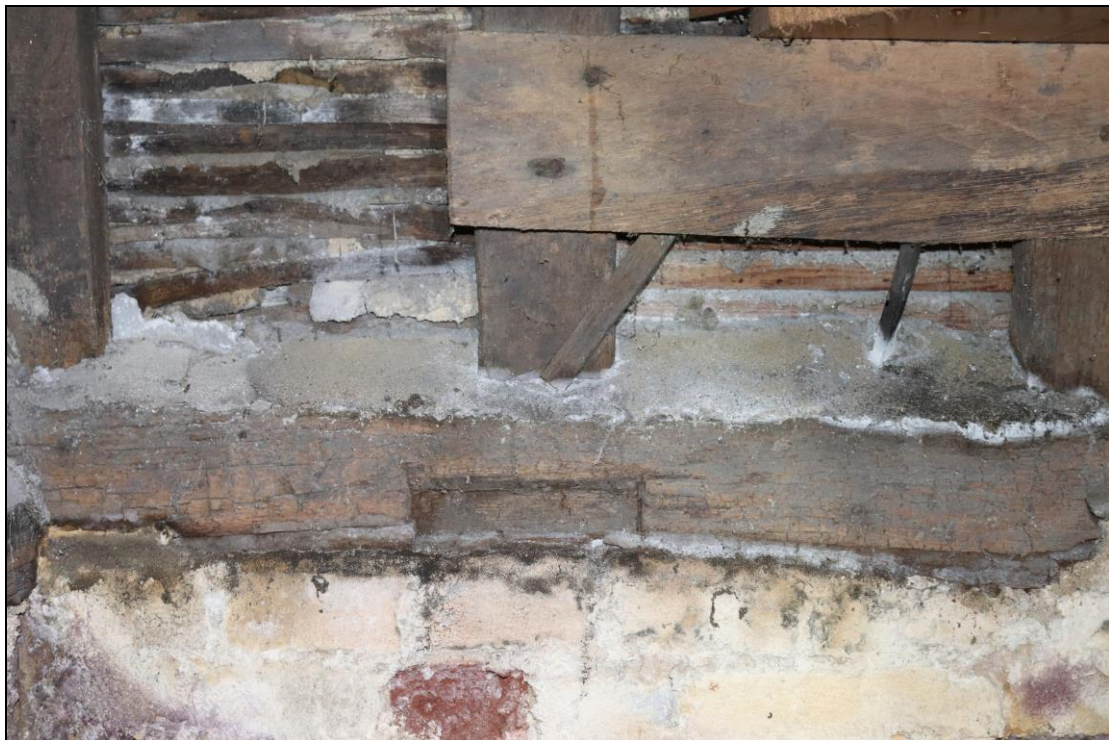
Plate 10 Exposed timbers in the under-stairs cupboard in GF01, showing brick sill and sole-plate with notch, taken from the south-east (DP 030)

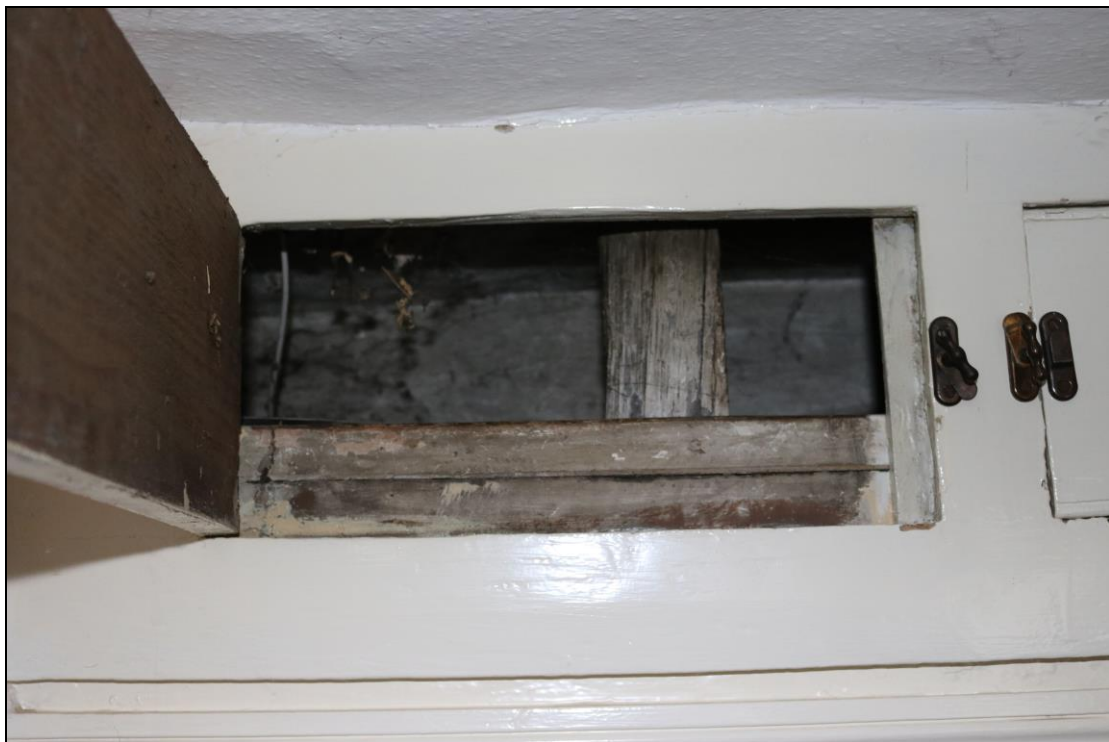
Plate 12 Detail of exposed timber including stud and horizontal, within a cupboard in GF02, taken from the south-west (DP 038)

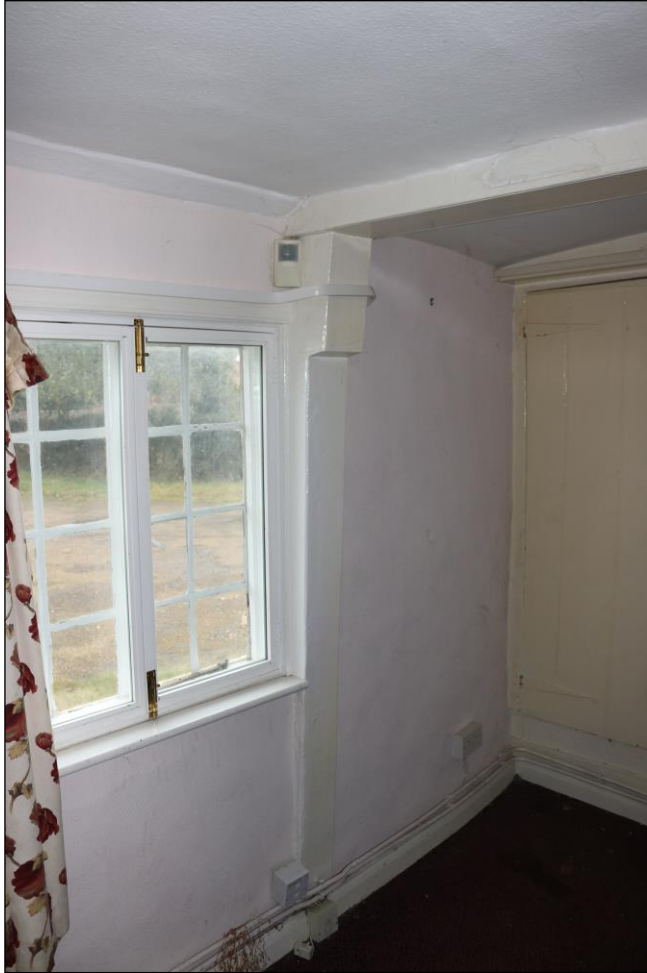
Plate 13 Splay-cut jowled post in GF02, with boxed-in binding joist above, taken from the north (DP 039)

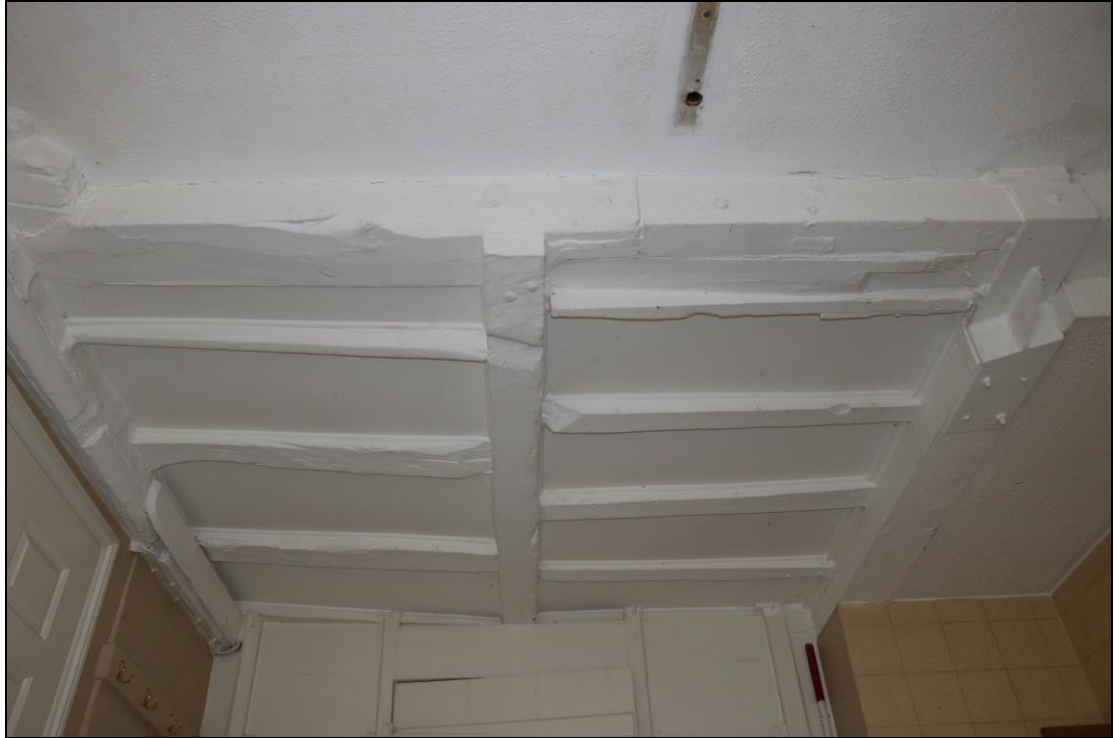
Plate 15      Detail of ceiling and face-halved scarf joint in GF03, taken from the north-west (DP 044)

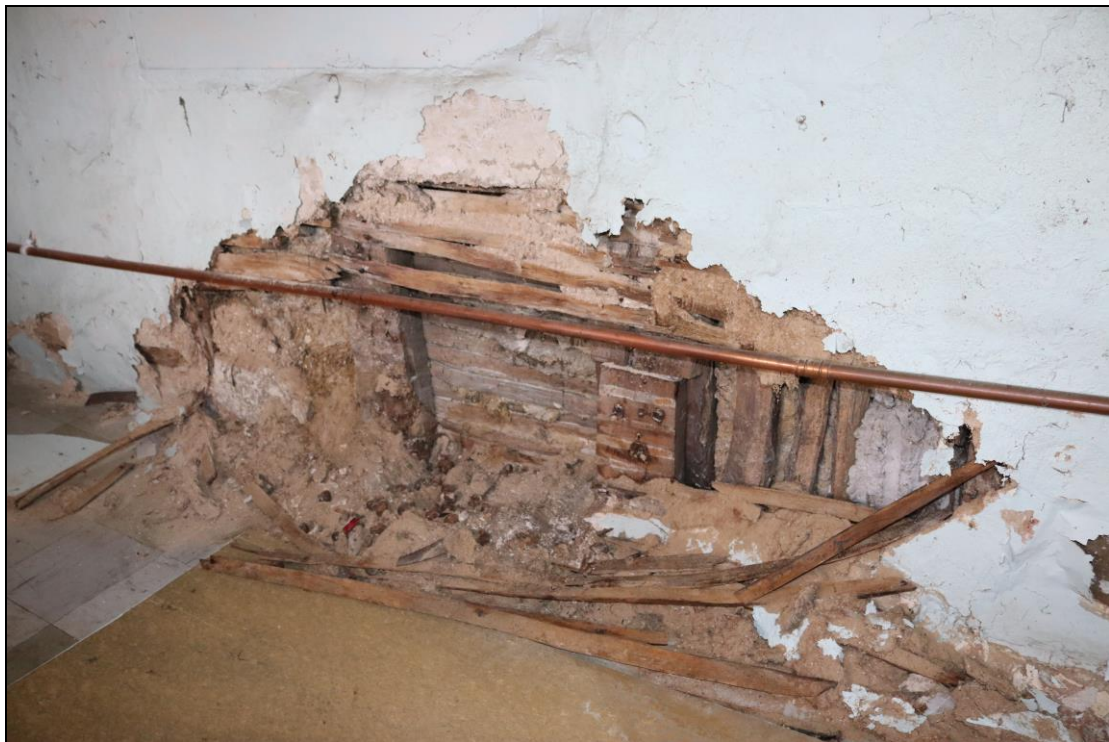
Plate 18 Detail of exposed timber-framing and phases of infill in GF04, taken from the north-west (DP 049)

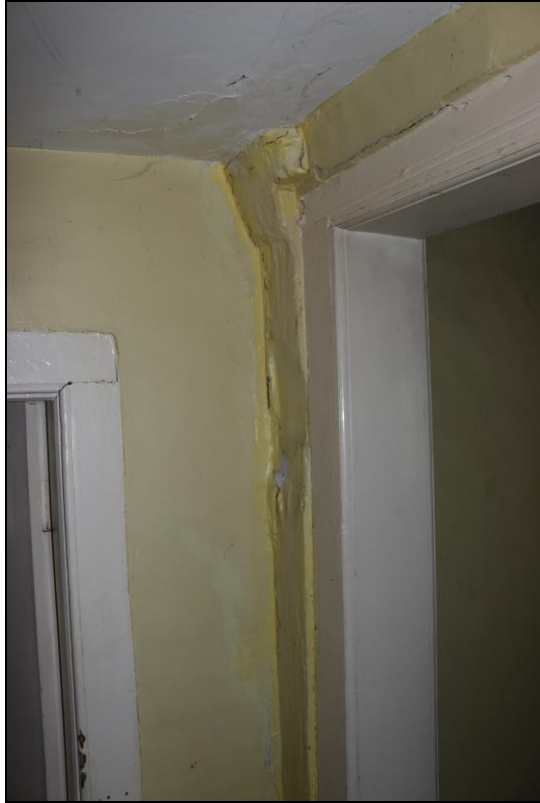
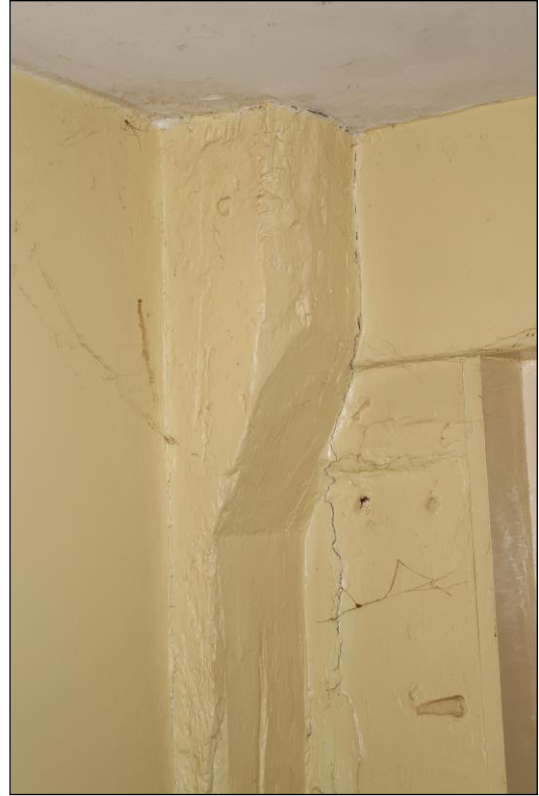
Plate 21      Detail of two splayed jowled bay posts in GF08, taken from the west, and south west (DP 052 & 056)

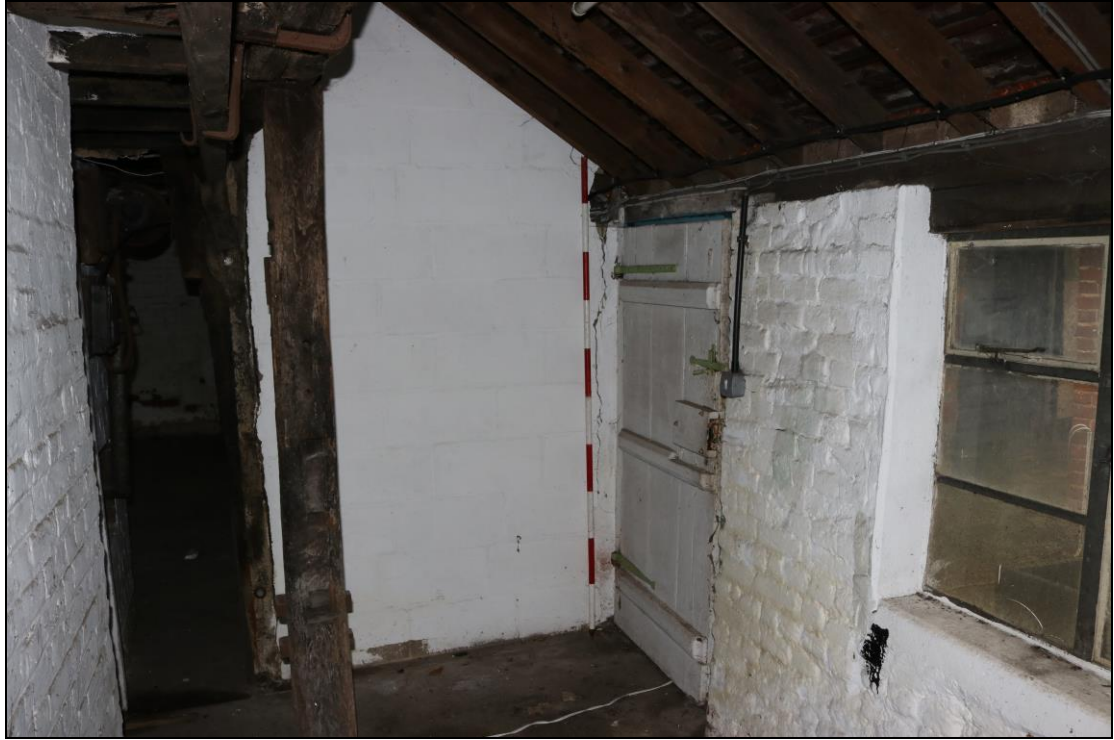
Plate 27 Area to the rear of GF09 in the aisled push-out, taken from the east (DP 118)

5.37 To the north a brick wall subdivides the bay and the resulting small room occupies the structural rear of the building, as well as the aisled push-out (Plate 27). The brick walls are of some age though the roof has been replaced and now comprises modern slender softwood. A door to the rear is hung on pintles, boarded, ledged to the rear with long strap hinges and a simple catch and large lock case. The wall between this and the aisle to the rear of GF10 is of modern blockwork.

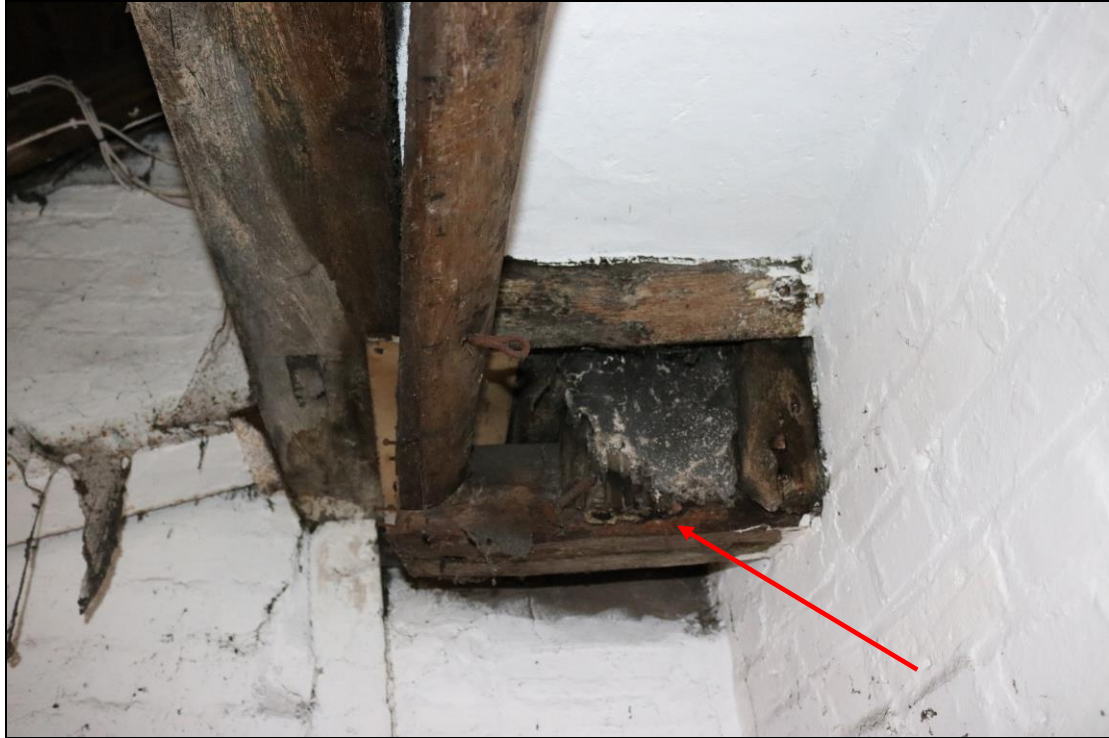
Plate 29      Detail of timber-framing in the area to the rear of GF09, showing some lath and plaster surviving (indicated), taken from the south-west (DP 116)

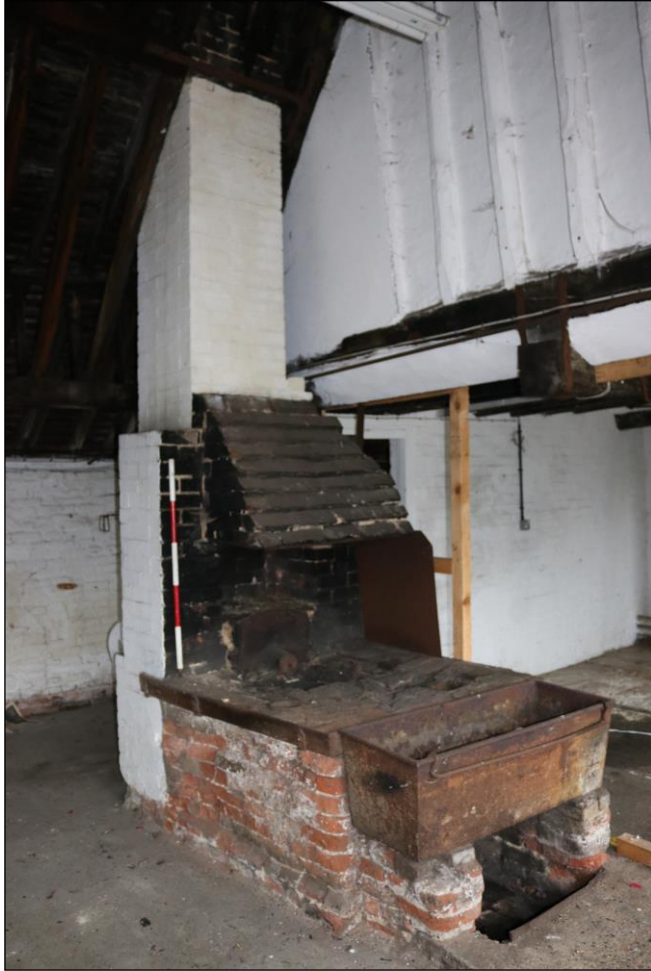
Plate 31 View of the forge in GF10, taken from the south (DP 092)

5.41 The brick forge abuts the bay division between GF10 and GF09 (Plate 31). The base of the forge is of red brick and appears to be of some age, whilst the rear area and stack may have been rebuilt in 19<sup>th</sup> century and perhaps later brick. The stack rises through the northern pitch of the roof where the purlin and a few rafters have been cut to accommodate it. The lower structure includes the brick base for the forge bed and short piers which support a slack tub (for quenching). The alteration noted above was perhaps associated with the removal of bellows and the introduction of mechanical or electrical systems for providing oxygen to the forge,

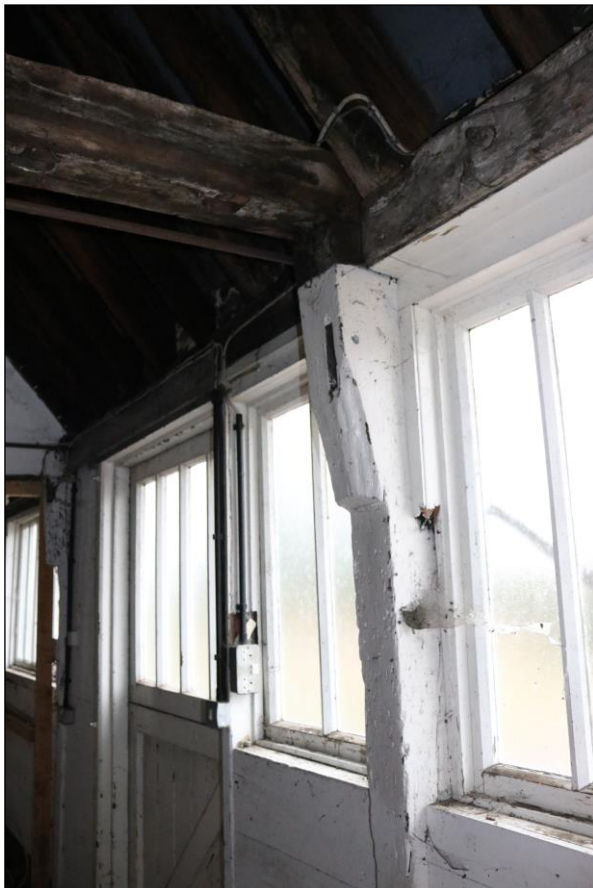
Plate 34 Detail of a jowled post to the bay division between GF10 and GF11, showing empty mortise for a downward brace, taken from the west (DP 106)

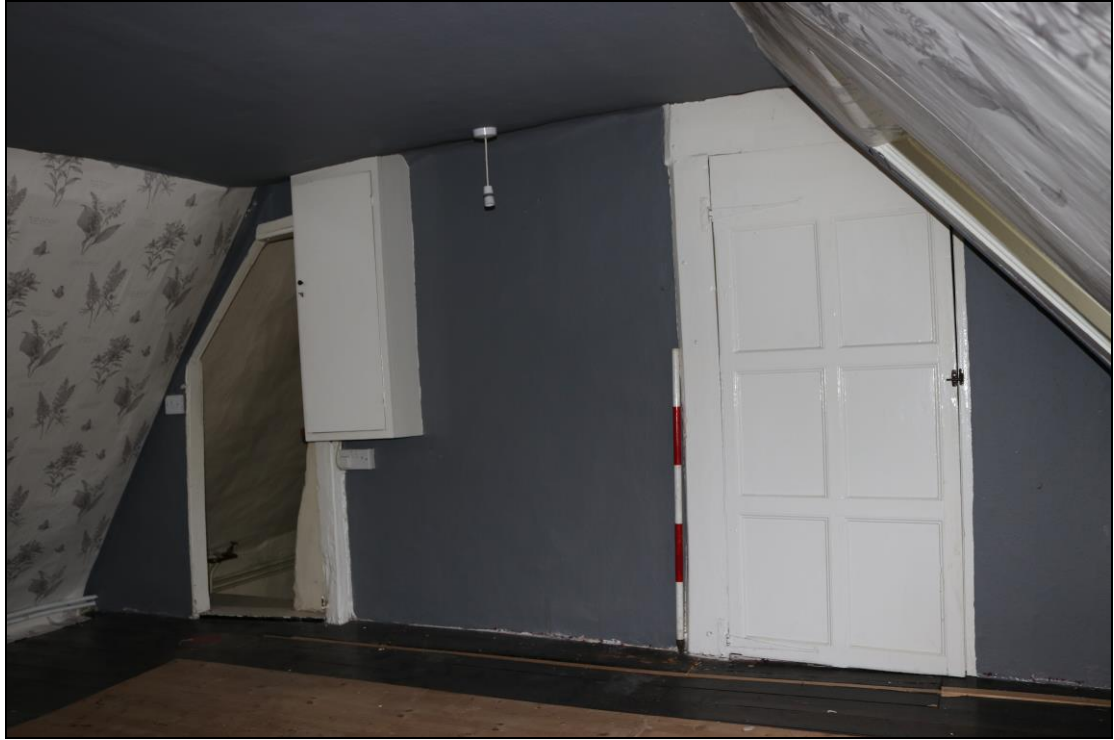
Plate 43 Interior of FF03, taken from the south-west (DP 084)

5.57 Accessed directly from the lobby to the rear of the chimney stack (Plate 43), and from FF04, this room occupied the roof space with dormer window similar to elsewhere. The floorboards have been replaced and now comprise narrow softwood boards laid north to south and there is no timber-frame visible.

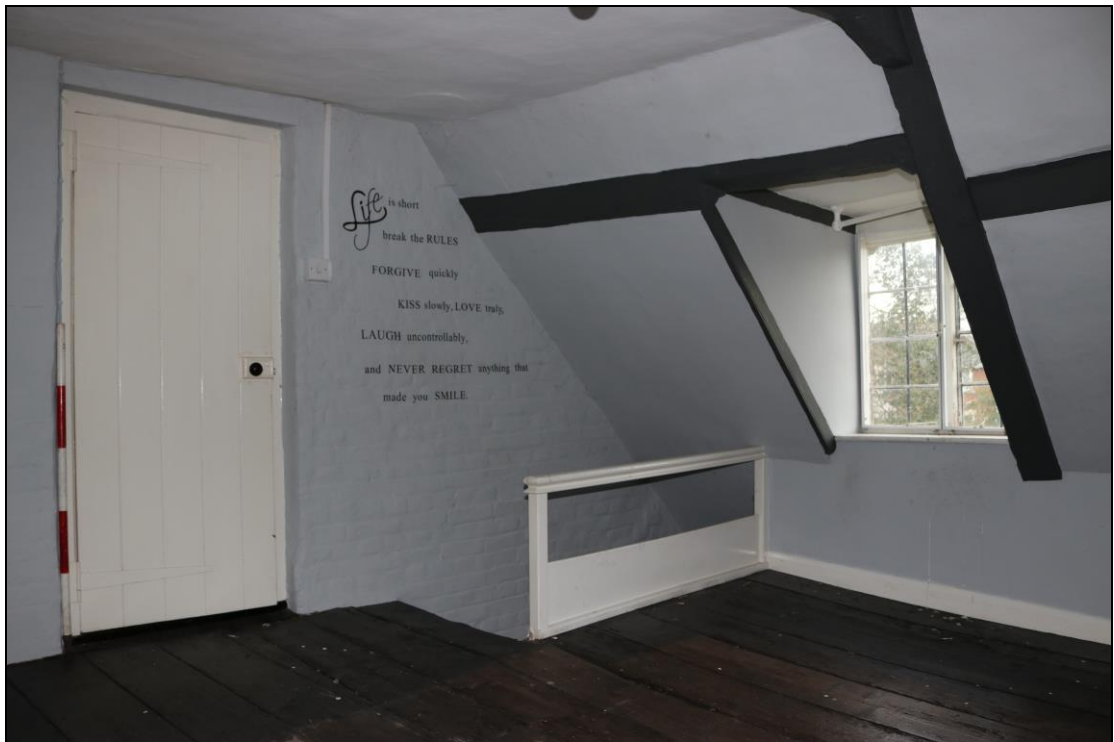
Plate 44 Interior of FF04, showing timber framed elements and the joggled butt-purlin roof form, taken from north-west (DP 064)

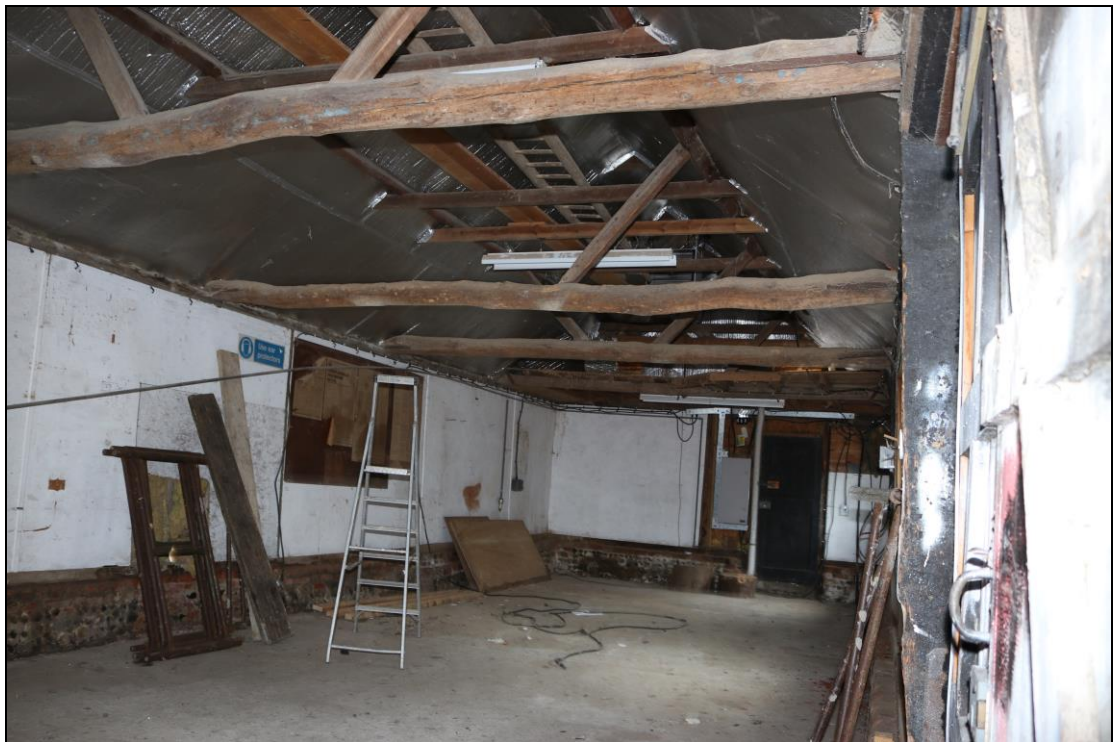
Plate 48 Interior of Outbuilding 1, Unit 1, taken from the east (DP 124)

5.63 Internally both units have been stripped of features and knocked-through to form one space. The roof over Unit 2 has been replaced with modern timber, that over Unit 1 (Plate 48) comprises poor quality timber with tie-beams, almost whole logs, raking struts to the purlins and the occasional collar.

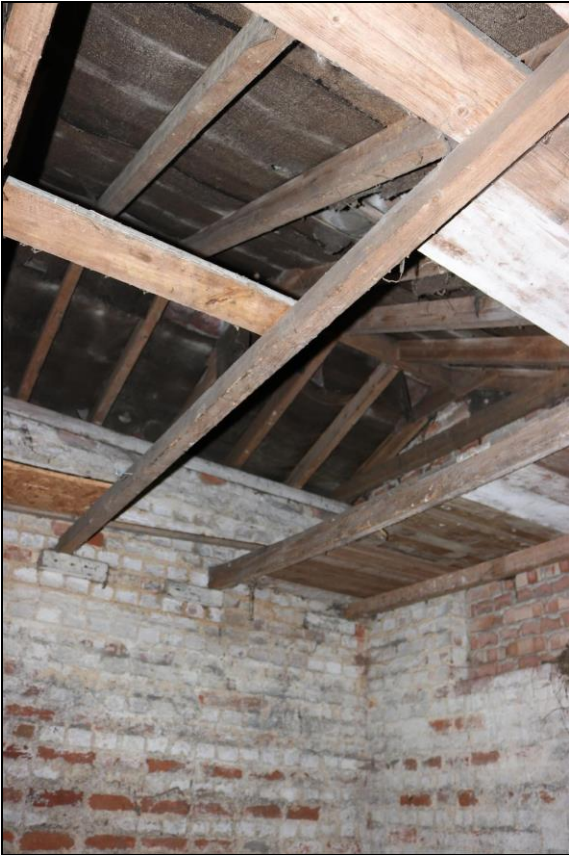
*DP 127*

*Detail of the roof structure in Outbuilding 2, with view of blocked aperture to the end wall, taken from the east.*
