**EMSID, 22 OLD BANK, PRICKWILLOW,
ELY, CAMBRIDGESHIRE CB7 4UT**

AN ARCHAEOLOGICAL EVALUATION

CHER ECB 5947

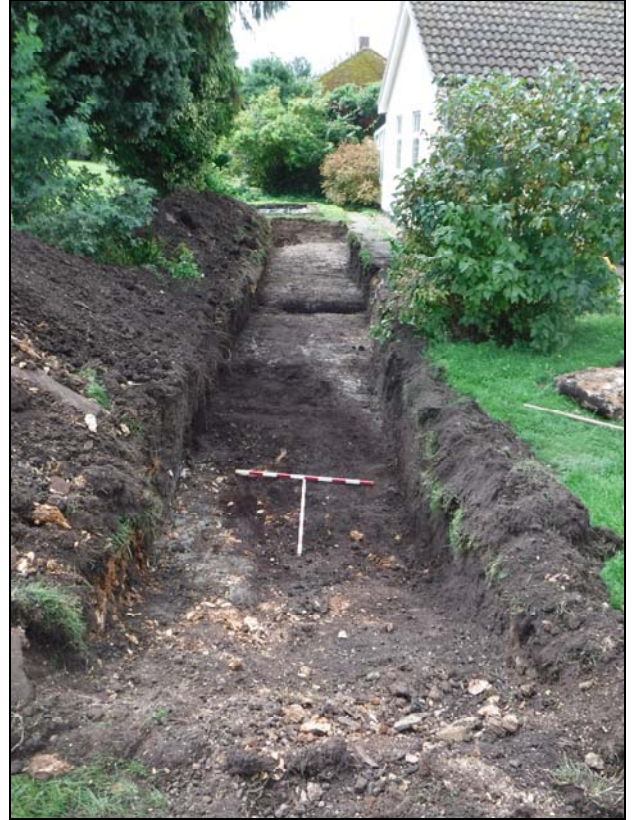
2
Trench 1 looking south

Description: Trench 1 contained no archaeological features or finds.

Features representing a modern service in the south of the trench and disturbance from a modern path in the north were identified.

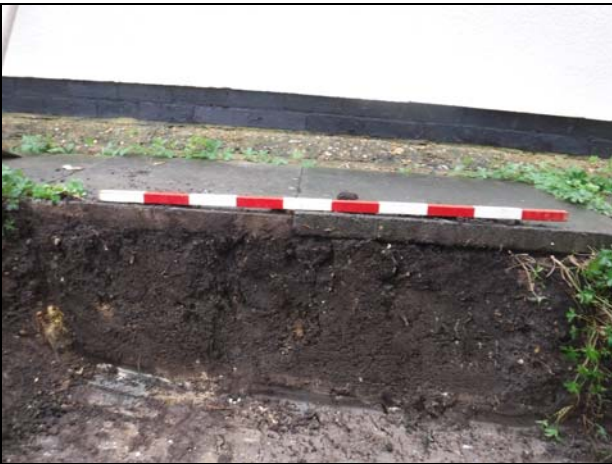
3
Sample section 1A

Sample Section 1A 0.00 = - 0.02m AOD		
0.00 – 0.06m	L1000	Paving slabs.
0.06 – 0.26m	L1001	Topsoil. Friable, dark red brown silty clay.
0.26 – 0.43m	L1002	Subsoil. Friable, mid brown grey peaty clay.
0.43m +	L1003	Alluvial clay deposits. Firm, dark blue grey clay.

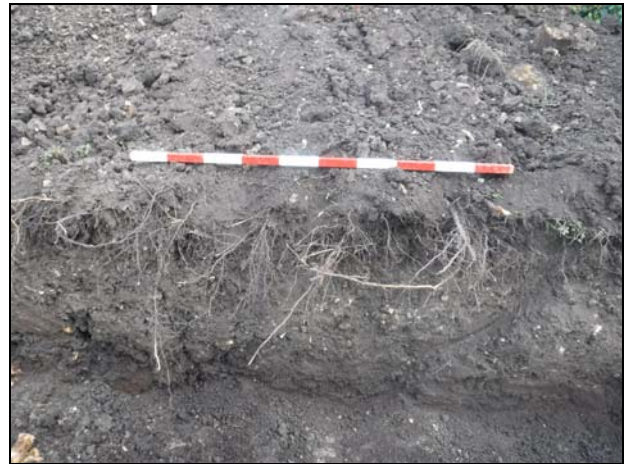
4
Sample section 1B

Sample Section 1B 0.00 = - 0.67m AOD		
0.00 – 0.27m	L1001	Topsoil, as above.
0.27 – 0.51m	L1002	Subsoil, as above.
0.51m – 1.70m	L1004	`Peat`. Organic silty clay.

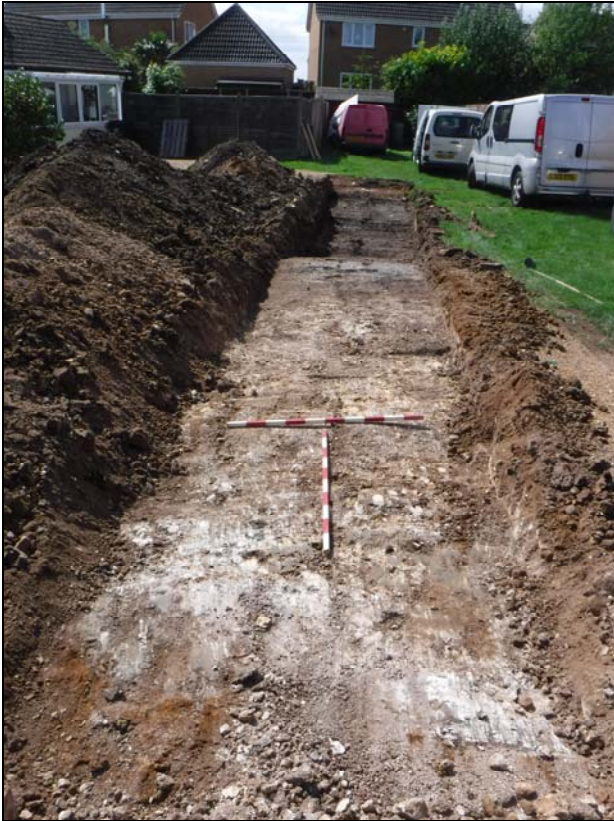
5
Trench 2 looking west

Description: Trench 2 contained no archaeological features or finds.

At the eastern end of Trench 2 (sample section 2B) below Made Ground L1005 was a significant embankment of compacted chalk (L1007) which appeared on inspection to be natural in origin. In the field this was interpreted as a natural chalk escarpment and recording subsequently treated this feature as a natural deposit. However, geologically this cannot be the case as the natural geology of the site is Kimmeridge Clay formation and a surface expression of chalk in this area would not be possible. The chalk bank is in fact a man-made feature representing a historic embankment on the south/ west of the River Great Ouse prior to its relocation in the first half of the 19th century (see below). A profile of the embankment is presented in Fig. 4.

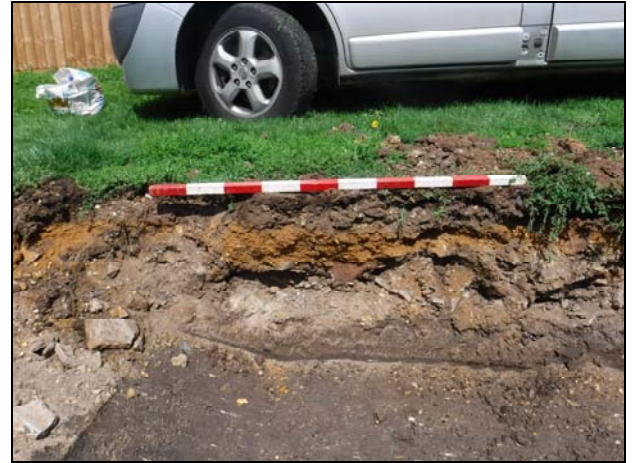
6
Sample section 2A

Sample Section 2A 0.00 = 0.17m AOD		
0.00 – 0.45m	L1005	Made ground. Firm, pale yellow grey mixed sand and building debris with frequent medium to large rubble.
0.45 – 0.54m	L1002	Subsoil, as above.
0.54m +	L1003	Alluvial clay deposits, as above.

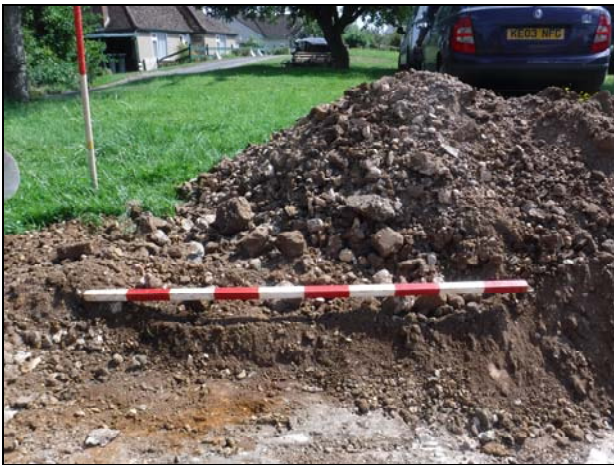
7
Sample section 2B

Sample Section 2B 0.00 = 0.56m AOD		
0.00 – 0.21m	L1005	Made ground, as above.
0.21m +	L1007	Chalk. Firm, pale grey to white chalk.
