**BARN AT PEMBROKE FARMHOUSE, BRADLEY
ROAD, BURROUGH GREEN, CAMBRIDGESHIRE**

HISTORIC BUILDING RECORDING

CHER ECB6090
OASIS No. 392297

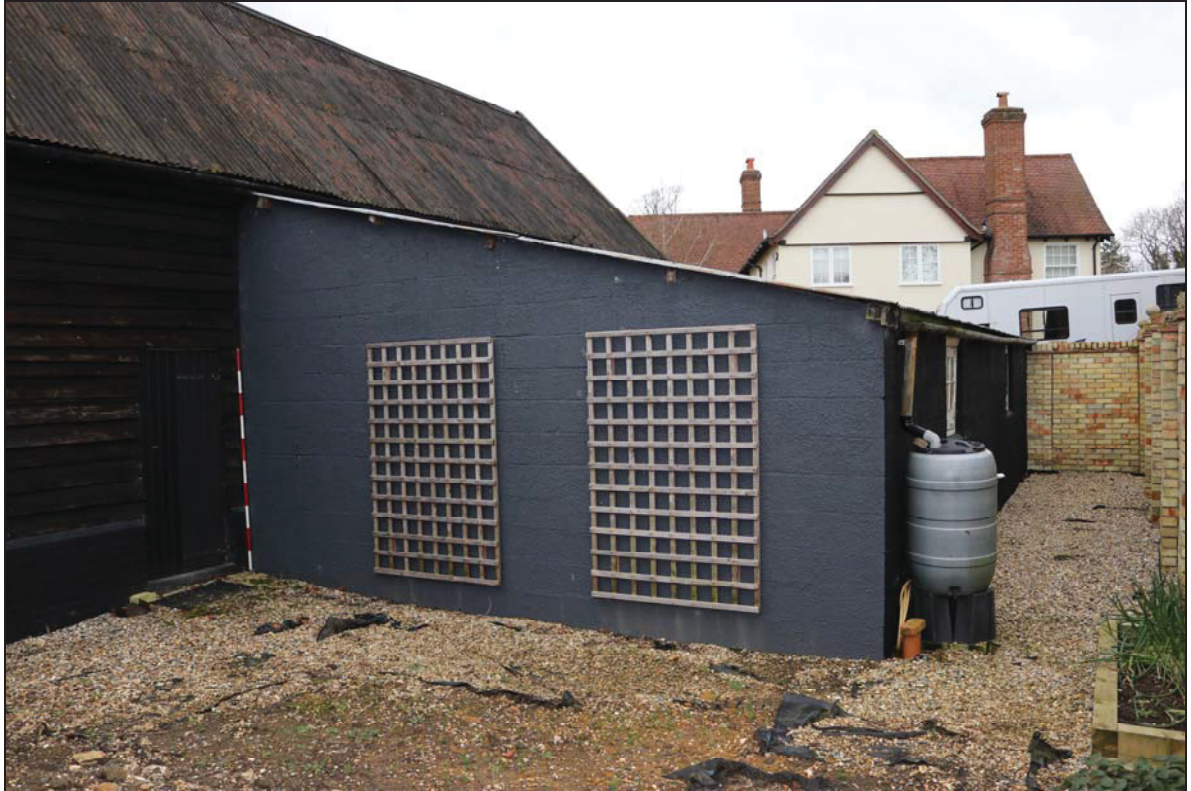
Plate 3 Exterior of the barn, taken from the south-east (DP 09)

4.1.2 The rear, northern elevation of the barn is mostly occupied by a large shallow-pitched pent-roof addition, built in modern cement blockwork (Plate 3). The remaining area of the facade retains its weather-boarding with a single, reset six-light window set within an earlier pitching door aperture.

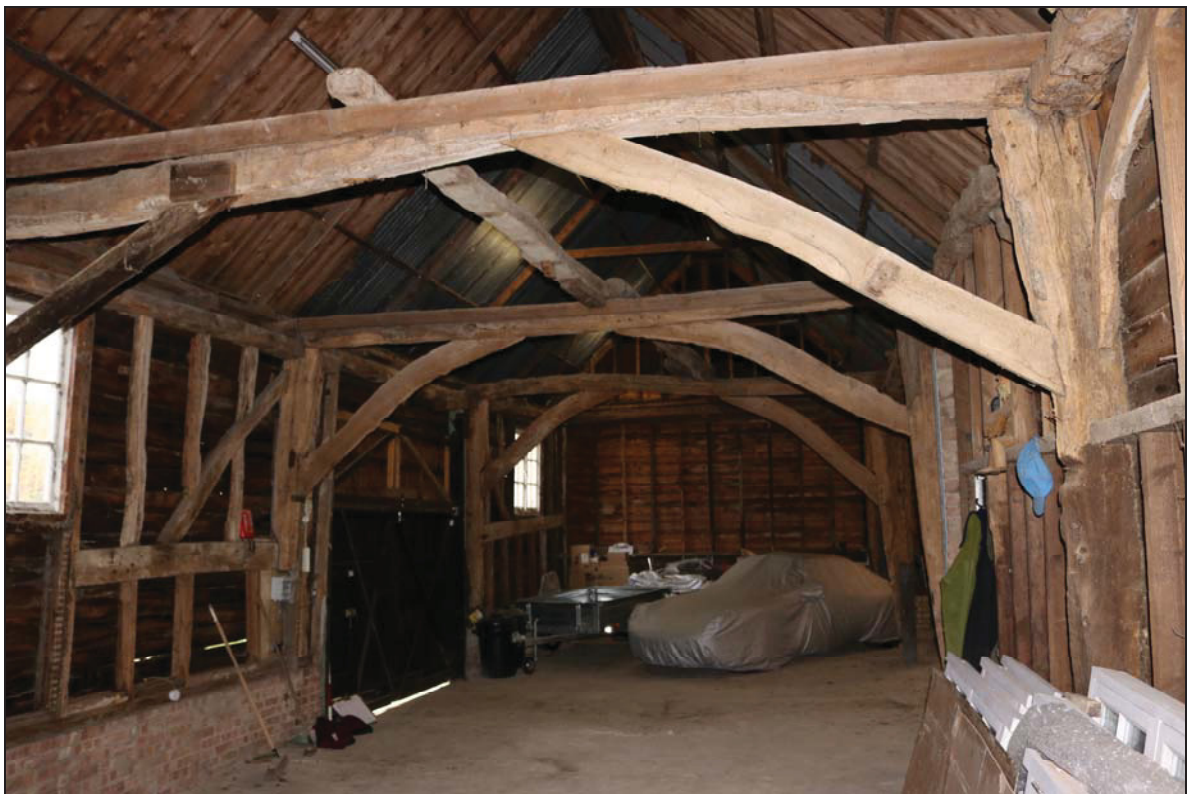
Plate 4 Interior of the barn, taken from the south-east (DP 10)

4.2.1 The interior, as noted above, has four bays (Plate 4). Internally, the brick dwarf wall is clearly of 20th century pink Fletton bricks. Everything above the tie-beam level is a modern replacement in flimsy softwood and of no historic interest. The original timber frame appears to be entirely of elm with some oak, and particularly waney. Principal posts, bracing, tie-beams, wall-plates and studwork are largely complete, though of variable quality, but much remains in good condition. There is no evidence of original studwork along the northern wall of the barn. Empty mortices for lost braces and further mortices for ties to the back of the principal posts indicate that the barn was once aisled on this side (Plate 5 and 6). Bays 2, 3 and 4 are all stiffened with a lateral horizontal member connecting the tie-beams. Some earlier modern structural interventions are also present; several of the principal posts have been truncated at the base and now sit on angled steel, and there is occasional replacement or infill of studs in softwood.

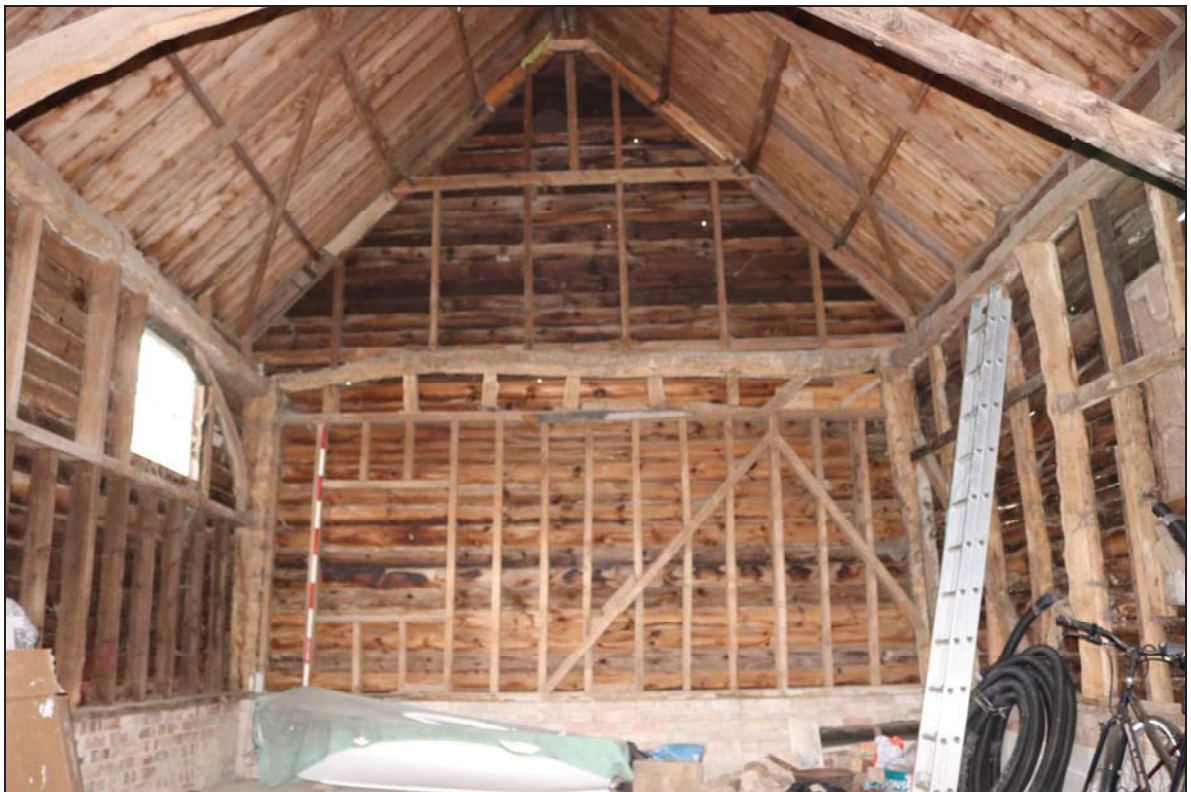
Plate 8 Eastern gable end of the barn, taken from the north-west. (DP 13)

4.3.1 On the eastern gable end only the corner posts and tie-beam are original (Plate 8). The upper stumps of the original studwork are also present, but have been truncated and replaced by a later pine-framed infill. Mortices are also present for bracing on both the corner posts and the tie-beam, both of which were originally pegged. The stumps of the inner common studs are also pegged, but there is no evidence of pegged studs above to the gable apex. This is a characteristic repeated on the tie-beams.

4.3.2 The lower level has been fitted with framing, of possible 19th century slender softwood, which incorporates an original pitching door. The presence of a pitching door within Bay 1 provides evidence that this area likely formed an internal subdivision relating to the former utilisation of the barn as a stable, as described in the sales particulars dating to 1925. The corner posts have very gentle splay cut jowls which are elongated, particularly in the southern corner.

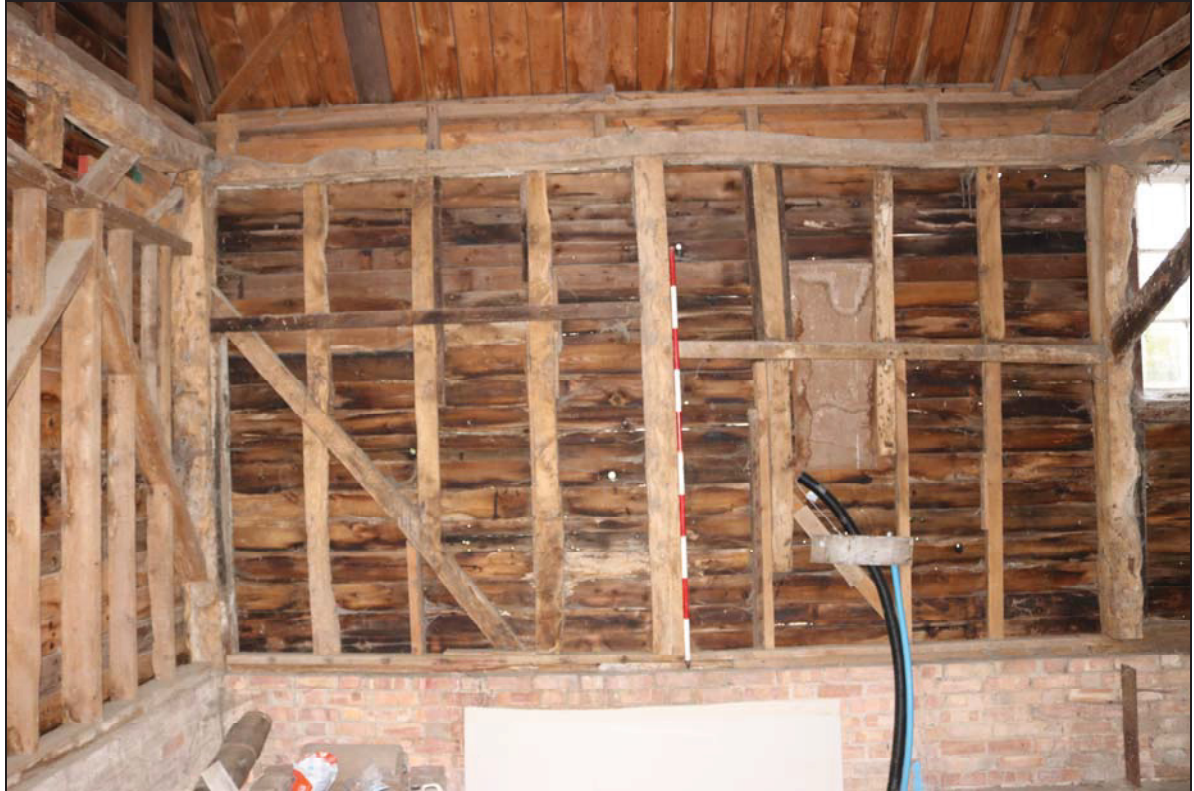
Plate 9 The southern side of Bay 1, taken from the north-east (DP 19)

4.3.3 The southern wall of Bay 1 retains a good wall-plate, waney on the upper face but with a sawn soffit (Plate 9). The original sole-plate does not survive. The wall plate is roughly scarfed to an older member at the junction of Bay 2. A primary downward brace in the eastern corner of the bay is pegged to the corner post. Seven common studs are present; the central studs being robust and set flush with the inner face of the wall-plate. All except one are pegged. Two of the studs at the western end of the bay are cut to allow the insertion of secondary members.

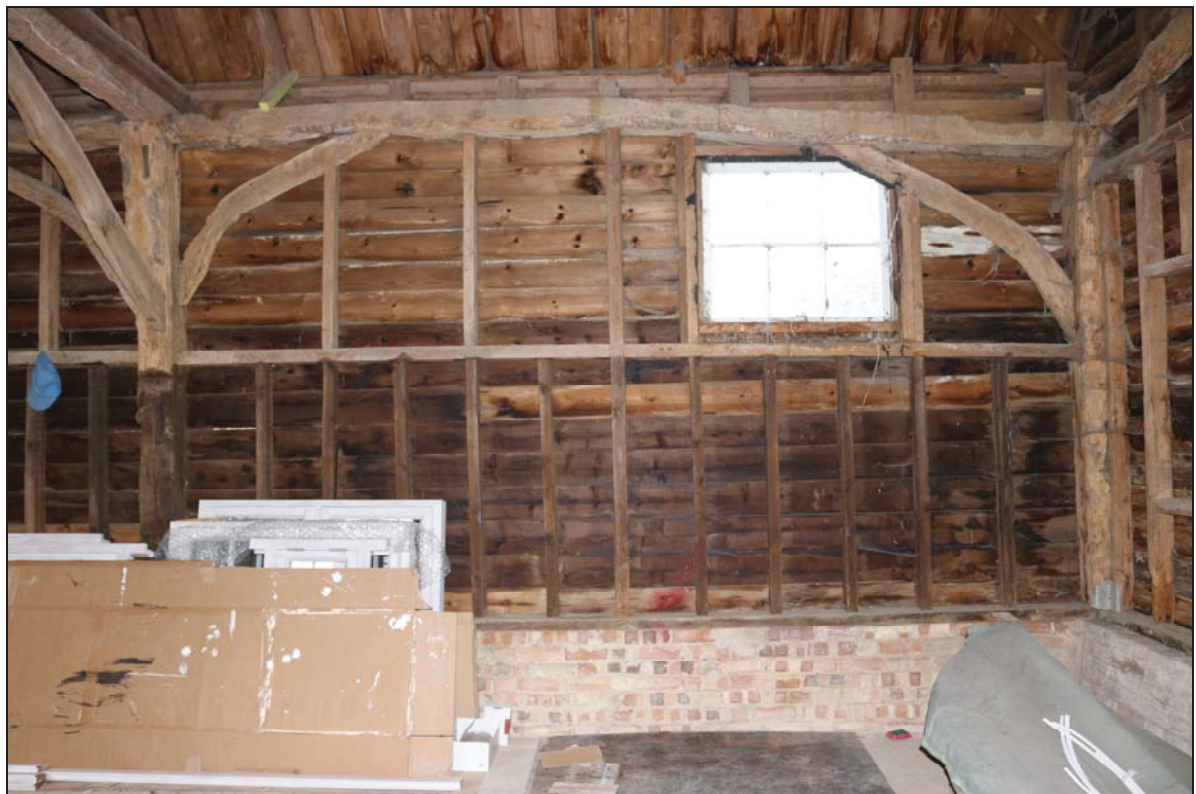
Plate 10 The northern side of Bay 1, taken from the south-west (DP 22)

4.3.4 The northern wall was formerly aisled and preserves a roughly-hewn elm arcade (wall) plate (Plate 10). The lower framing incorporates a mid-rail and evenly sawn 18th or 19th century studs. The window noted above from the exterior is a re-used sash of c.1830 date.

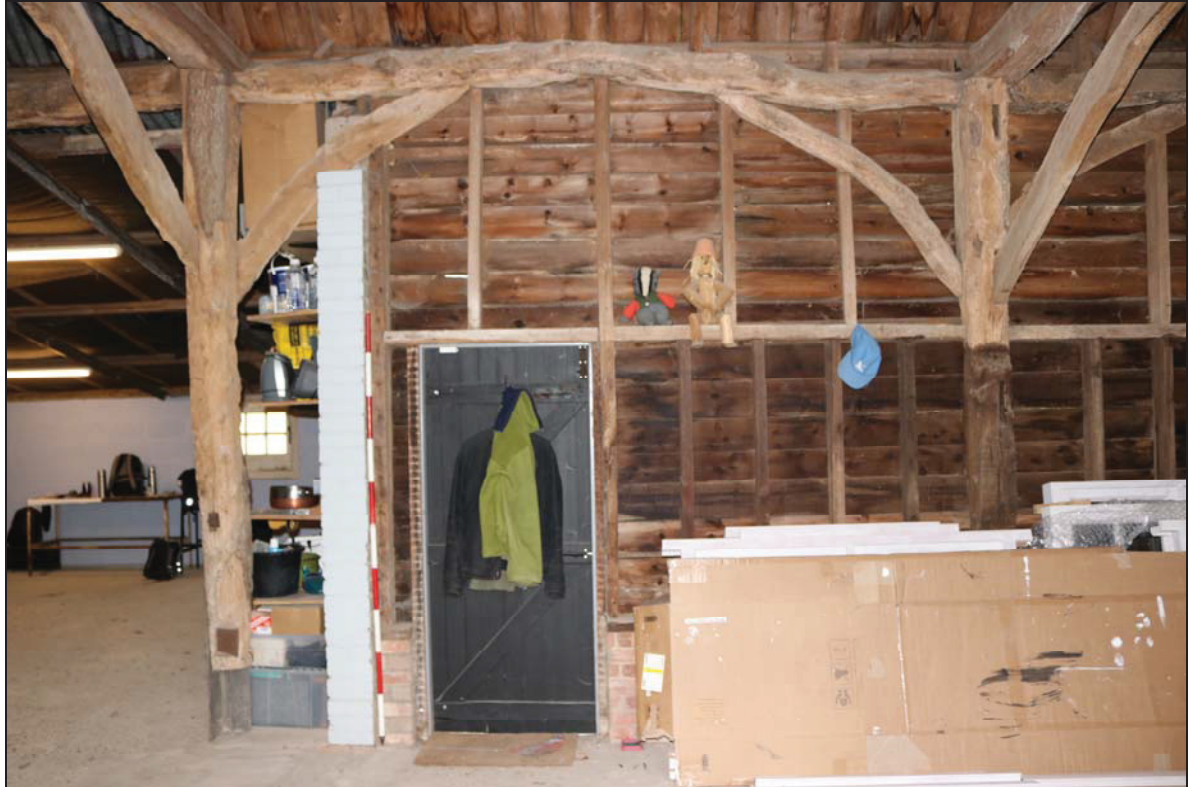
Plate 11 The northern side of Bay 2, taken from the south-west (DP 26)

4.3.5 Bay 2 preserves a principal post, a wall plate, and one good elongated brace to the tie-beam. The northern wall (Plate 11) comprises a waney wall plate with original braces, and softwood framing at lower level, as in the adjoining bay. A modern door on the northern wall gives access to the rear of the property. Both the posts and the tie-beams are roughly side-axed, with the western post being sawn on its western side.

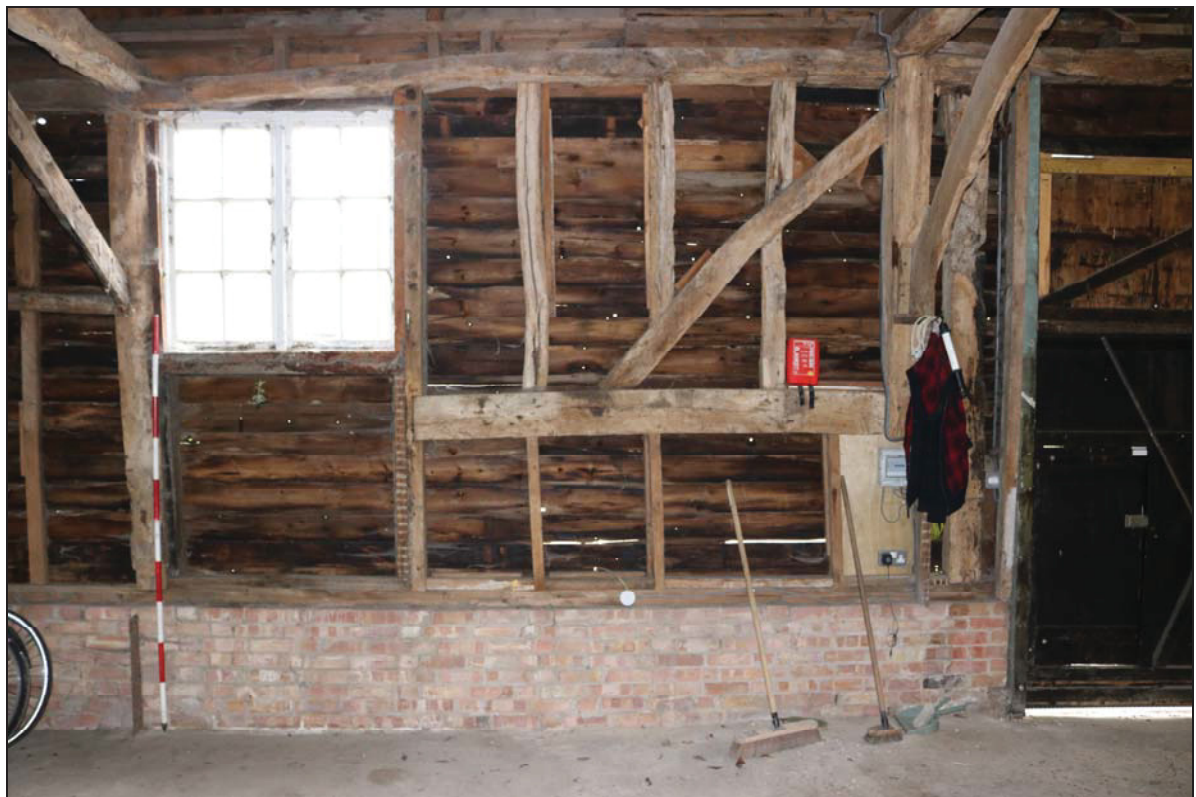
Plate 12 The southern side of Bay 2, taken from the north-east (DP 27)

4.3.6 The southern wall retains a primary brace, slightly cranked, from the west to the mid-rail (Plate 12). The mid-rail is cut at the east to insert an opening, but surviving pegs in the principal posts show that it continued to its corresponding member. Three original studs in the upper register at the western end are pegged to both wall-plate and mid-rail. Corresponding pegs beneath the mid-rail show these continued. An inserted window of 20th century date is also present within the southern wall of Bay 2.

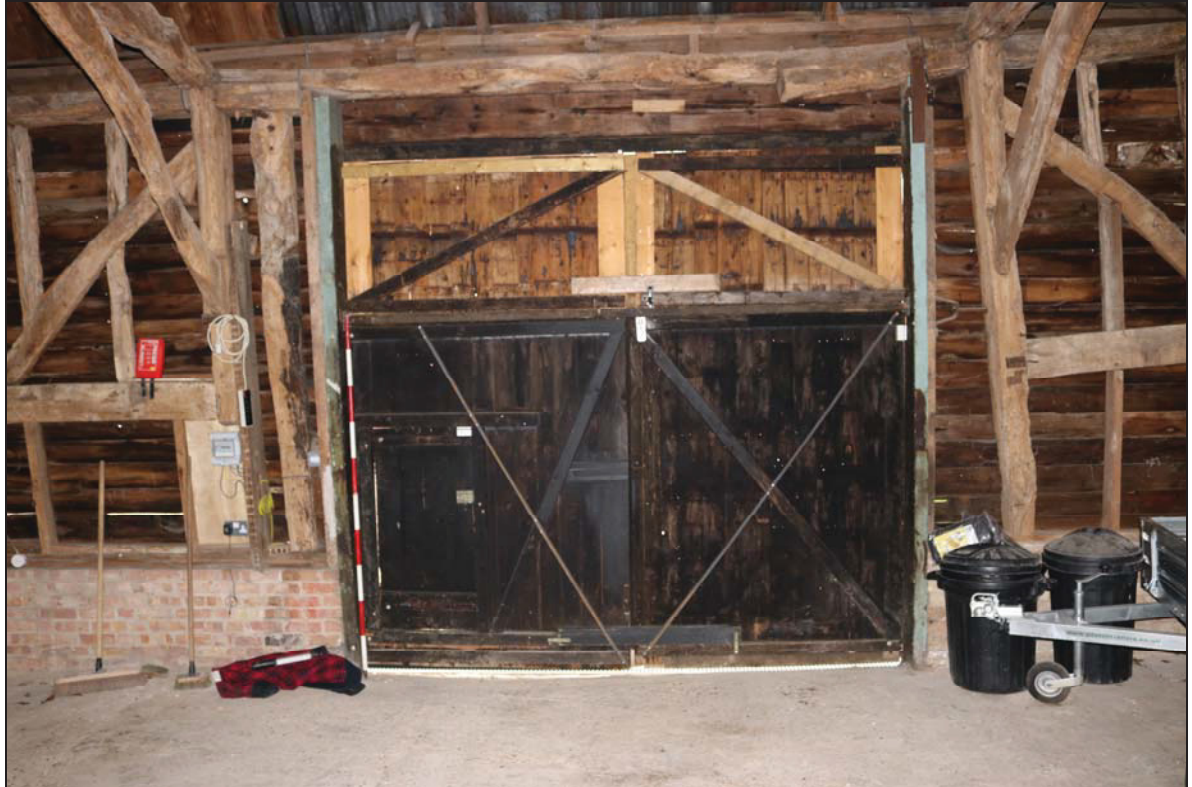
Plate 13 The southern side of Bay 3, taken from the north-east (DP 30)

4.3.8 The southern wall of Bay 3 (Plate 13) is occupied by a modern full height door and is partly supported by a tension rod threaded through the bay-post on the west. The doors are of no historic interest but the earlier jamb probably survives on the east. An empty mortice on the western side of the wall-plate indicates its original position. A new wall-plate has been scarfed across.

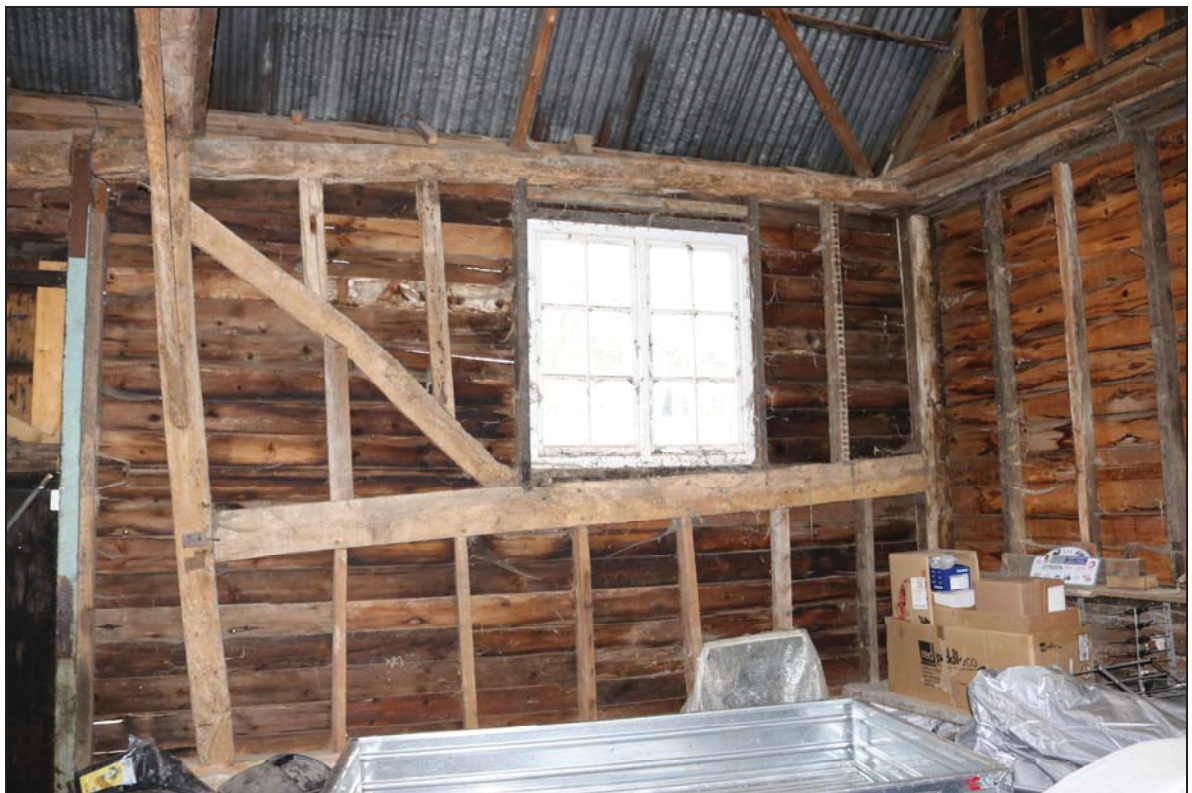
Plate 14 Southern side of Bay 4, taken from the north-east. (DP 37)

4.3.9 The southern wall (Plate 14) is well preserved with original mid-rail and primary brace from the east within the upper register. Two upper studs survive in the east but peg-holes demonstrate the presence of others which were removed to insert the existing casement window. The lower studs are all 19th century replacements, but utilise earlier the mortices. Of the western gable end only the northern corner-post and tie-beam remain, but mortices are present for bracing and some studwork.

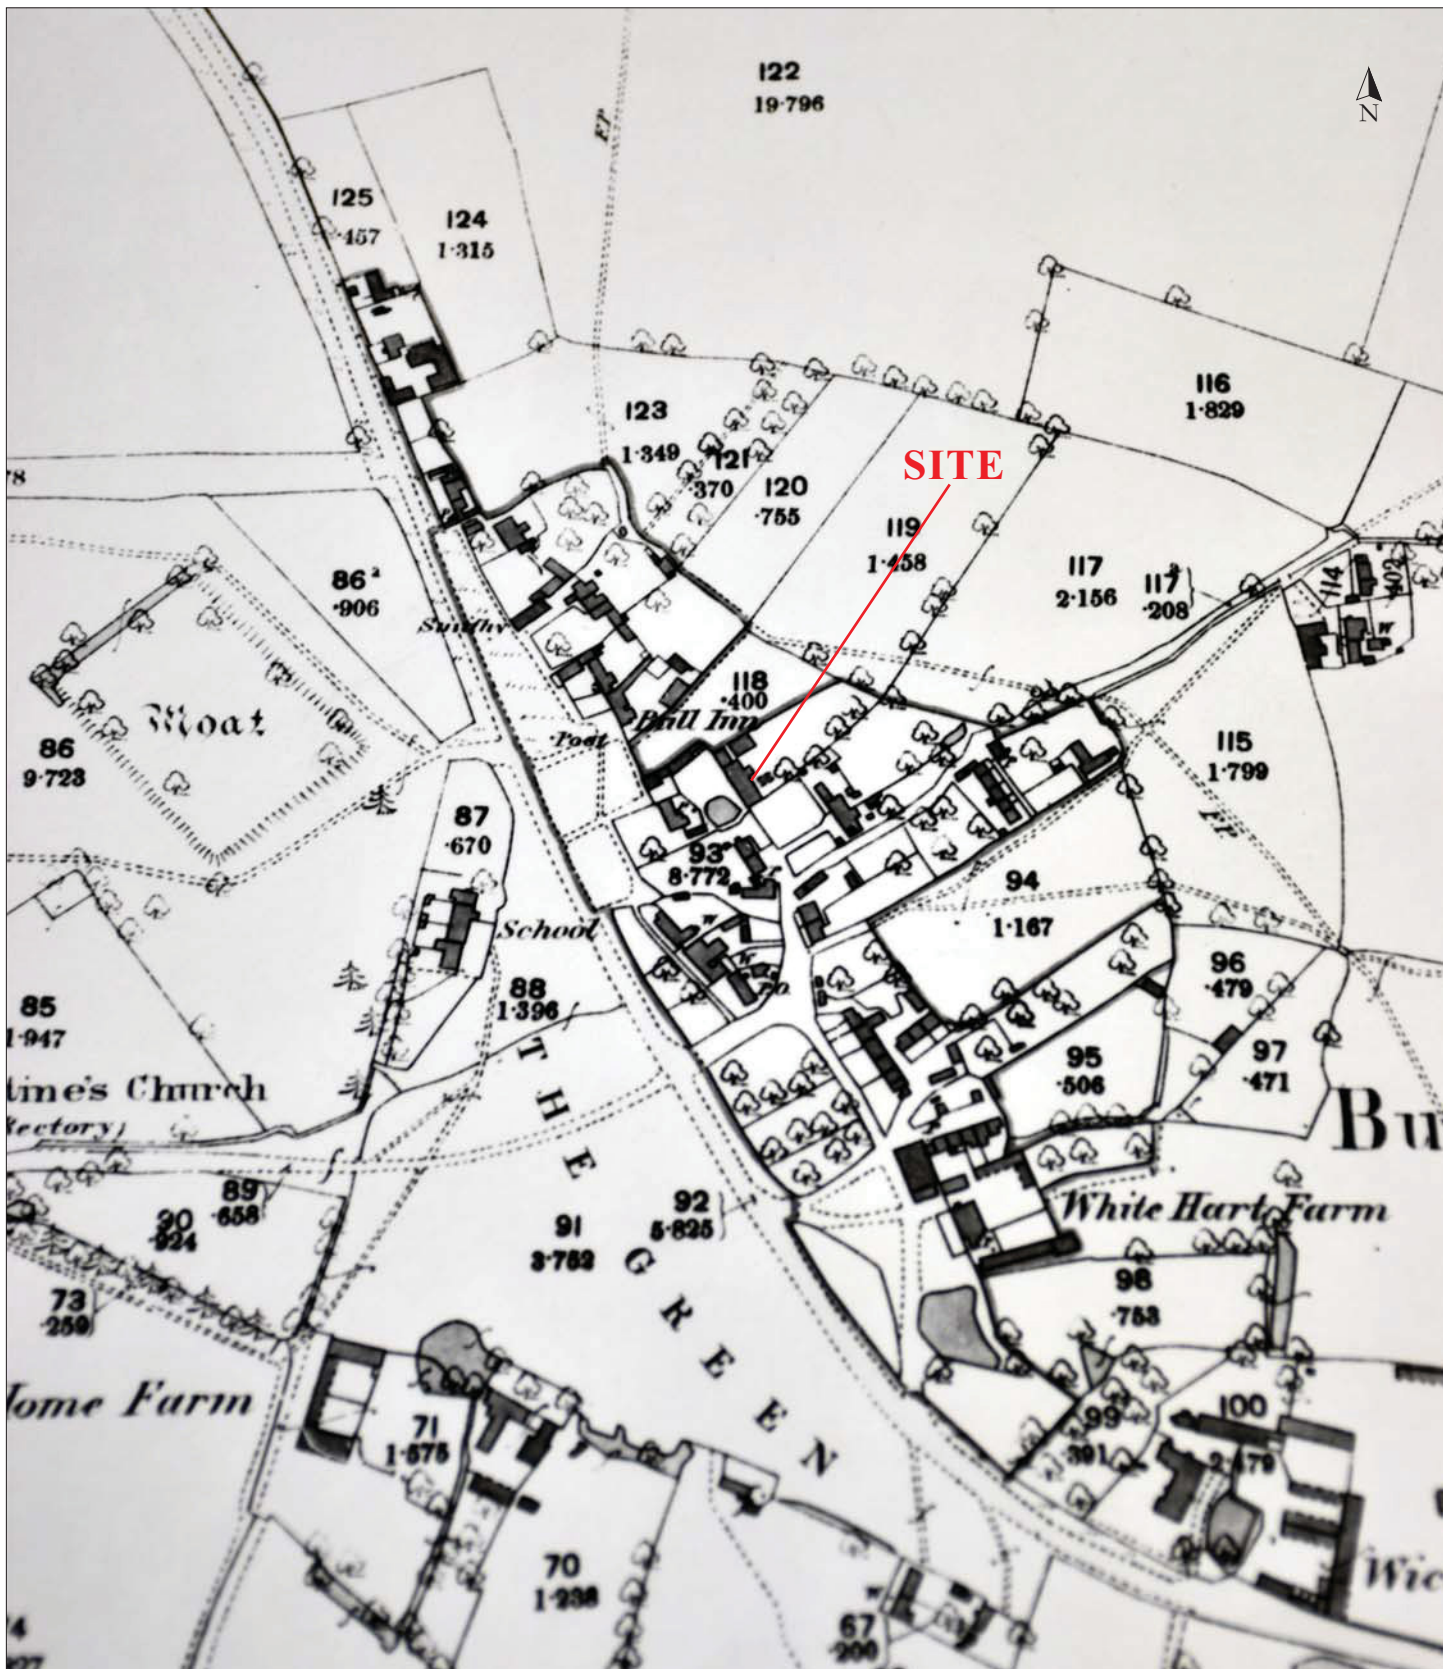
Archaeological Solutions Ltd
 Fig. 3 OS map, 1885
 Not to scale
 Barn at Pembroke Farm, Burrough Green, Cambs (P8206)

3.3.1 The structure is depicted on the 1885 1st edition OS map (Fig.3), with a small projection and a structure adjoining to the north. A further structure also appears extend towards the south-west from the northern end of the barn. A pond, which is no longer extant, lies between the barn and the farmhouse. In the eight years between 1885 and 1903 development appears to have been relatively limited
