**ST ANDREW & ST NICHOLAS CHURCH,
ST ANDREWS STREET, HERTFORD,
HERTFORDSHIRE**

**ARCHAEOLOGICAL
MONITORING & RECORDING**

Author: Rozwadowski, M	
NGR: TL 36395 12880	Report No: 3203
District: East Herts	Site Code: AS1169
Approved: Claire Halpin	Project No: 3170
Signed:	Date: October 2008

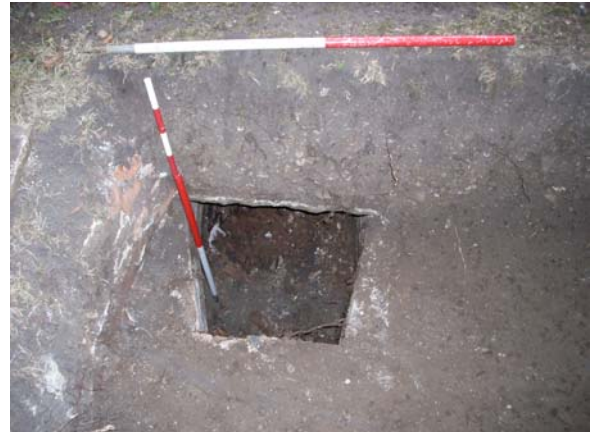
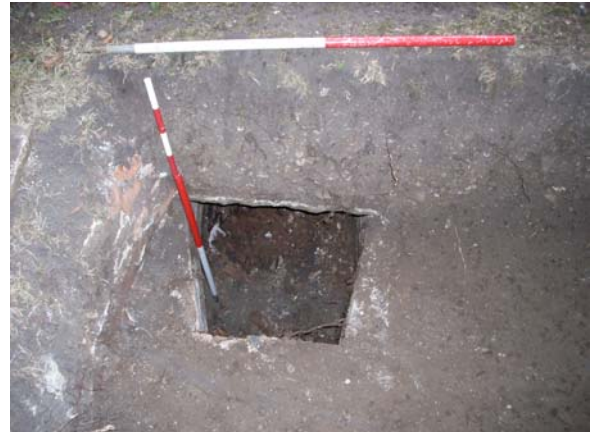
DP2 West soakaway. Revealed vault Burial 1000 with brick walls M1002 and covering slabs M1003 in section.

Burial 1000 (DP2, DP3, DP5) was placed within Cut F1001 (0.5m+ x 0.85 x 0.85m). The latter had vertical sides and flat base. M1002 was a red brick vault wall. The individual bricks were 0.22 x 0.11 x 0.06m, laid in a stretcher bond where visible, and bonded with a light brown sandy cement mortar. Where the edge of the vault was broken, a small view inside allowed the following to be recorded, before the vault was repaired and covered once more. The inside of the vault was whitewashed. The fragmentary remains of a wooden coffin (C1003), with iron handles was present, with the long bones of the inhumation exposed (S1010). The vault had been sealed with stone slabs M1007 (0.58 x 0.76 x 0.06m). Two of these slabs were visible in the exposed area, and probably two others were necessary to cover the whole vault. The slabs were cemented to the vault walls, with their top surface exhibiting slight polishing.

As a result of a discovery of these two undisturbed vaults the location of the soakaway was altered, and moved to the west, to avoid any further disturbance of the burials.

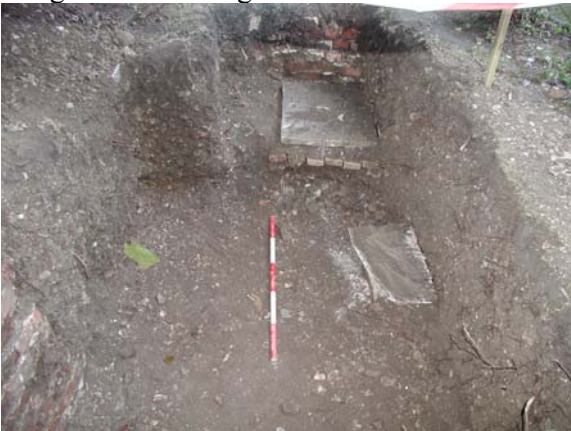
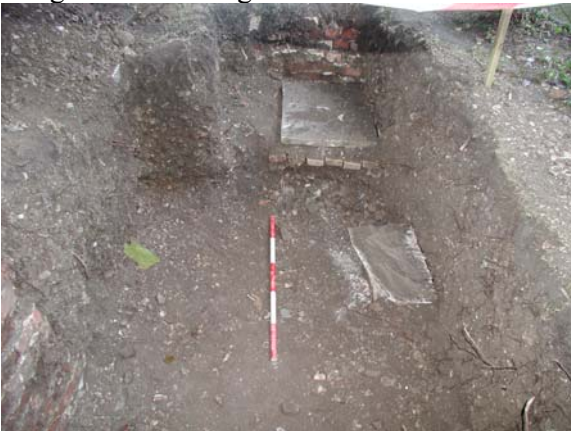
DP3 Western soakaway. Revealed vaults burials B1000 and B1011. Looking N

A second vault, Burial 1011 (DP2, DP4, DP6) was partially revealed, located to the south of Burial 1000. It was impossible to record the shape of Cut F1012 as insufficient was exposed. Inside this grave/vault cut, M1013 masonry walls were visible overlain by M1014, a stone slab. When the level of the vault was reached,

further mechanical excavation was suspended, and the covering slabs were not removed from this vault.

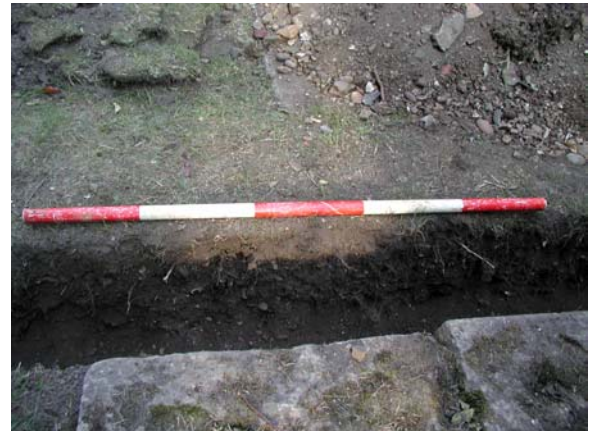
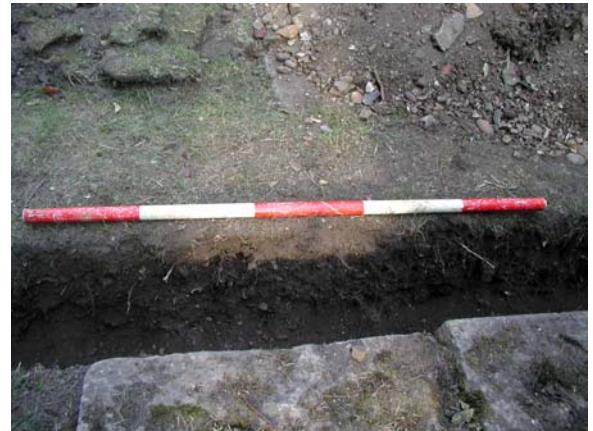
DP4 Sample section 4. Looking E.

Sample Section 4: Fig. 2 DP 7

<i>Sample section 4</i>		
<i>West facing</i>		
<i>0.00 ≈ 41.00m AOD</i>		
0.00 – 0.06m	L1009	Topsoil. As above
0.06m+	L1006	Made ground/churchyard soil. As above.
