**10-12 THE WASH, HERTFORD,
HERTFORDSHIRE**

HISTORIC BUILDING APPRAISAL

Authors: Matthew Williams MA MSc Lee Prosser BA PhD	
NGR: TL 3255 1261	Report No. 3148
District: East Herts	Site Code: AS 1162
Approved: Claire Halpin MIFA	Project No. 3240
Signed:	Date: September 2008

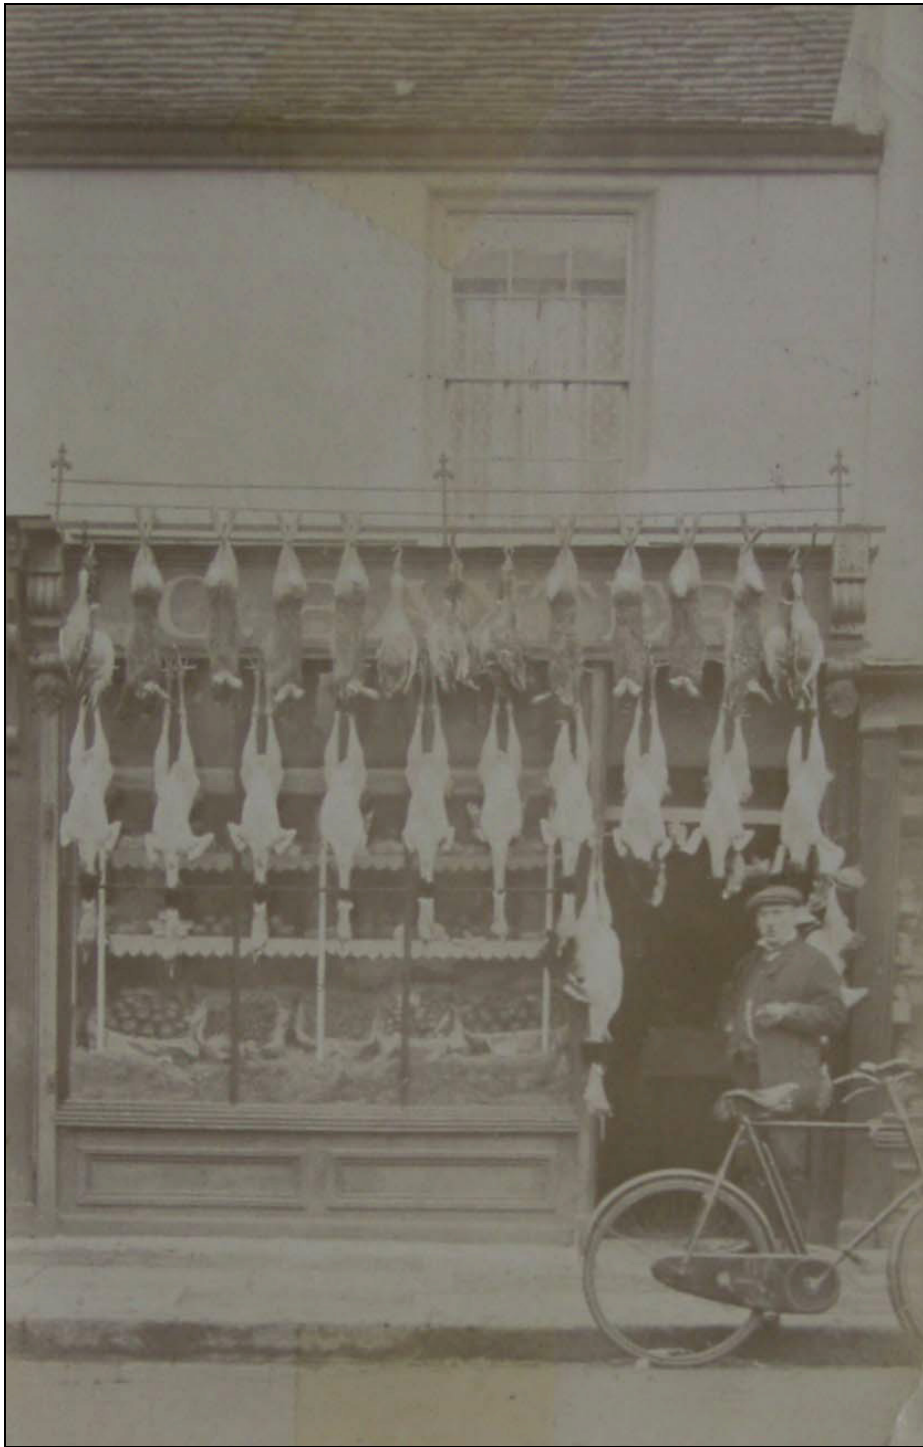
4.4 Additional evidence comes from a late 19th century photograph provided by the proprietor (see Historic Photograph below). This shows the original 19th century shop front of No. 10, comprising two thin heavily moulded wooden panels at the base, a large, flat, six-light window above and a painted fascia framed by wooden scrolls which reads “C BAXTER”. Above this the original six-over-six sash window can be seen prior to its replacement with the existing window.

Undated late 19th century photograph of No. 10 The Wash

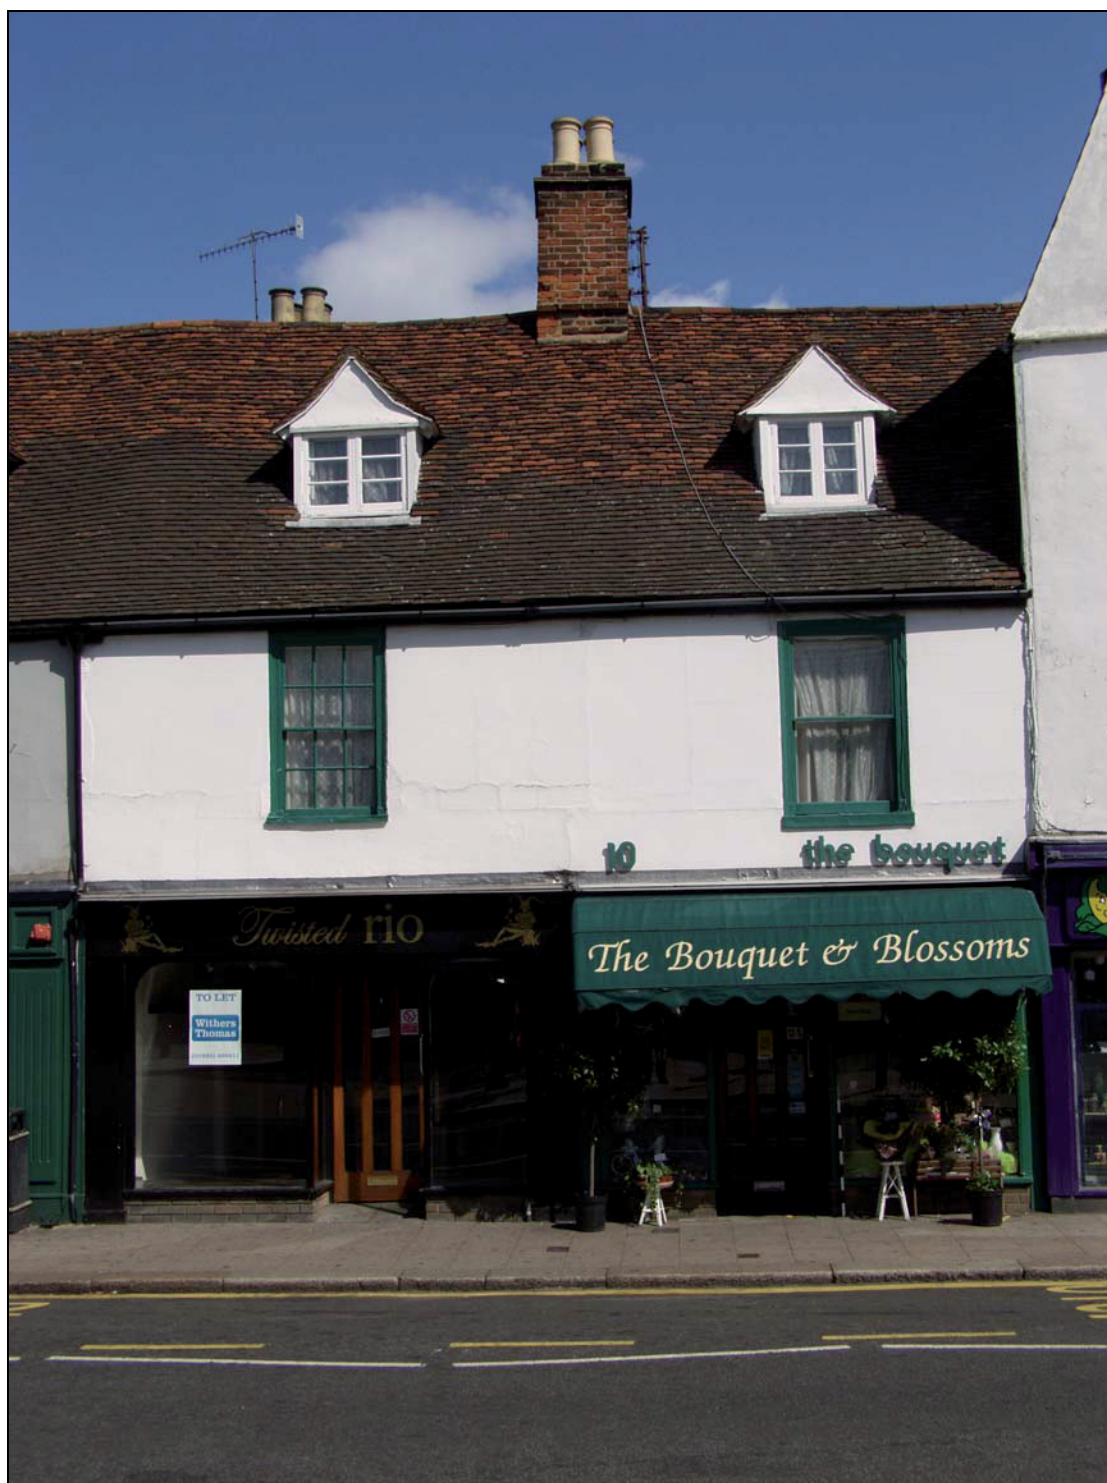
5.1.2 Both shops have entirely modern fascias and frontages at ground level (Plate 1). Above this the first floor is rendered and ashlar-lined. There are two sash windows at the upper level; a one-over-one to the south with an adjoining six-over-six. Both are set within flush sash-boxes.

1 West elevation of Nos. 10-12 The Wash, taken from the west (18)

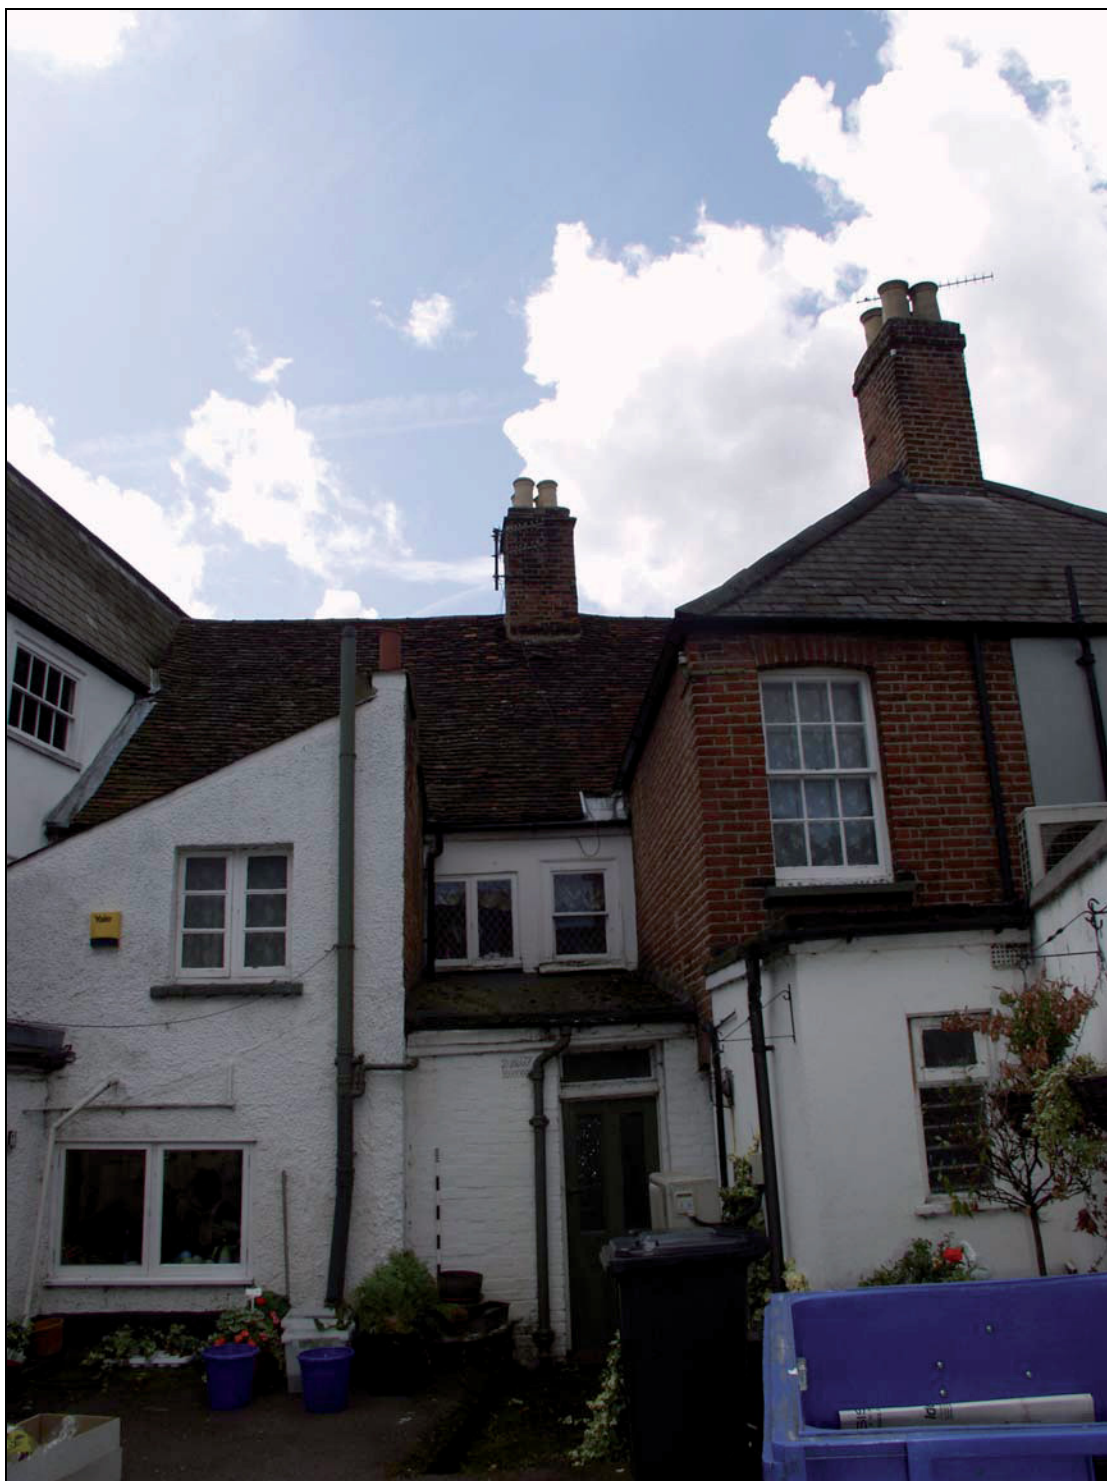
5.1.4 The rear (east) elevation has been modified considerably with several additions (Plate 2). The original range has been augmented to the north by a large block of red brick laid in Flemish bond, which serves this and the neighbouring property. This is typically Victorian with a brick stack with post, similar to the main range and grey slate roof. A single six-over-six sash window lights an upper bedroom, while the lower floor has been further extended with a small, flat-roofed lavatory. To the south, a second, pent-roofed block has been added, though the roof is perpendicular to the main range. Though now rendered with rough-cast and fitted with a modern casement window, the north return wall retains exposed 19th century brick, suggesting that it was added at the same time as the north block. The resulting gap left between these two additions was later spanned by a small, pent-roofed vestibule of brick with a 19th century door of four bead moulded panels with an overlight. The original roof has been replaced with modern asphalt.

2 East elevation of numbers 10-12 The Wash, taken from the east (24)

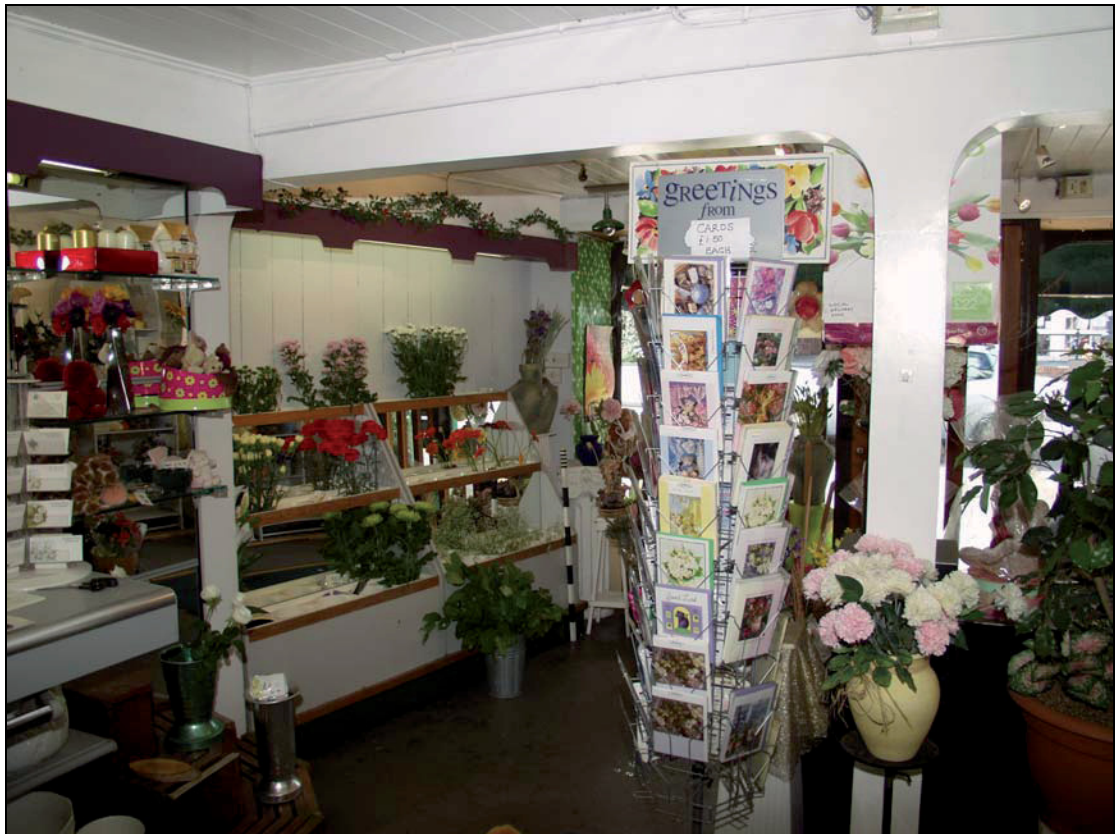
3 Front shop area, room one, taken from the north-east (21)

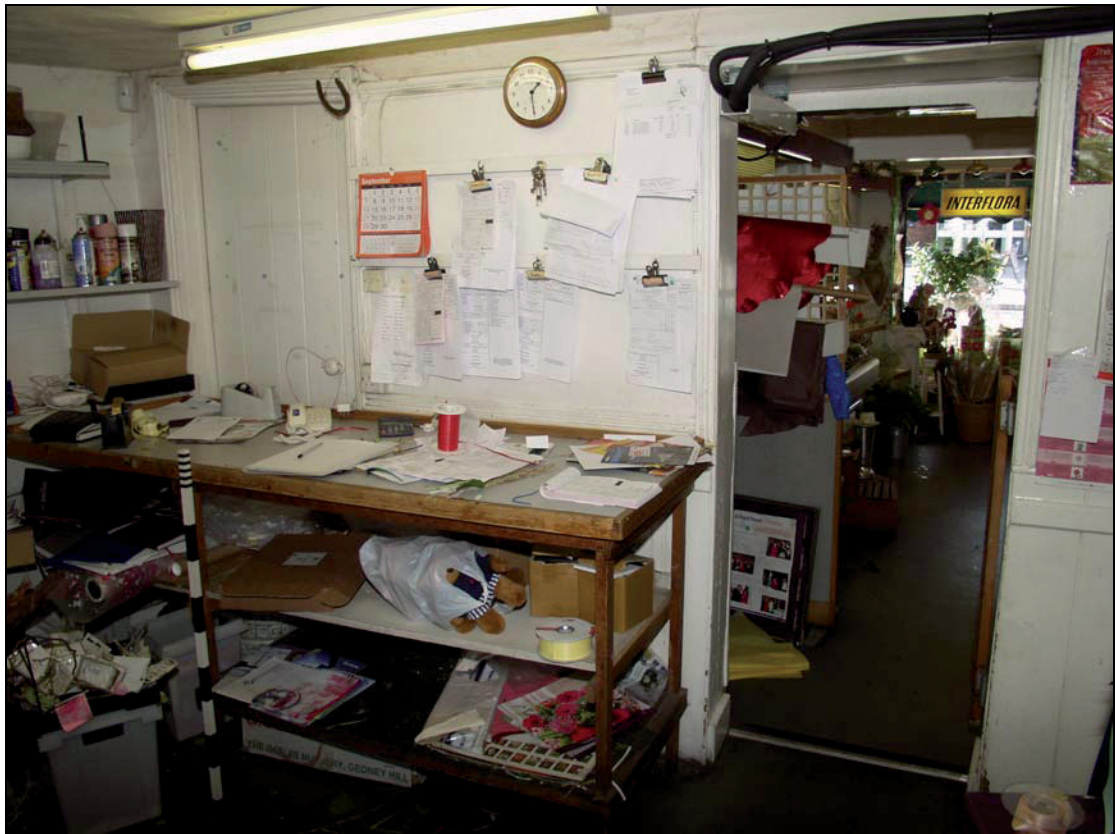
4 Room three taken from the north-east (19)

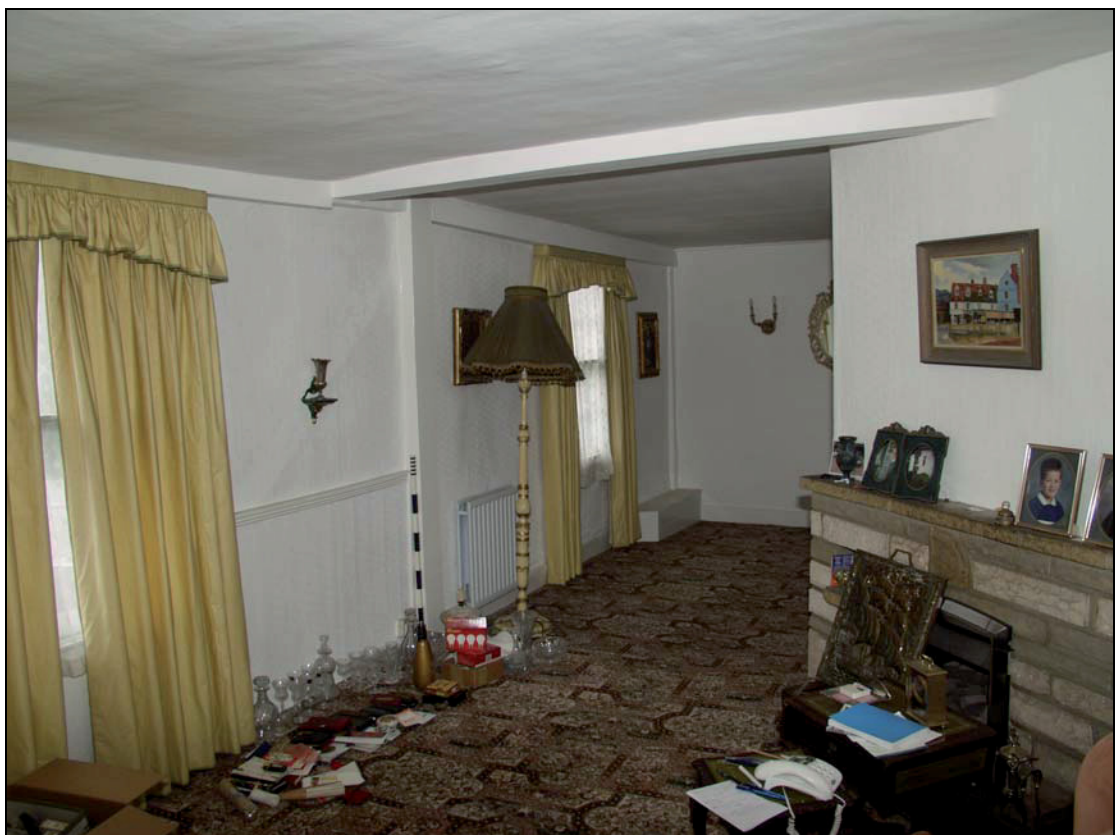
5 The first floor lounge, room seven, taken from the south-east (27)

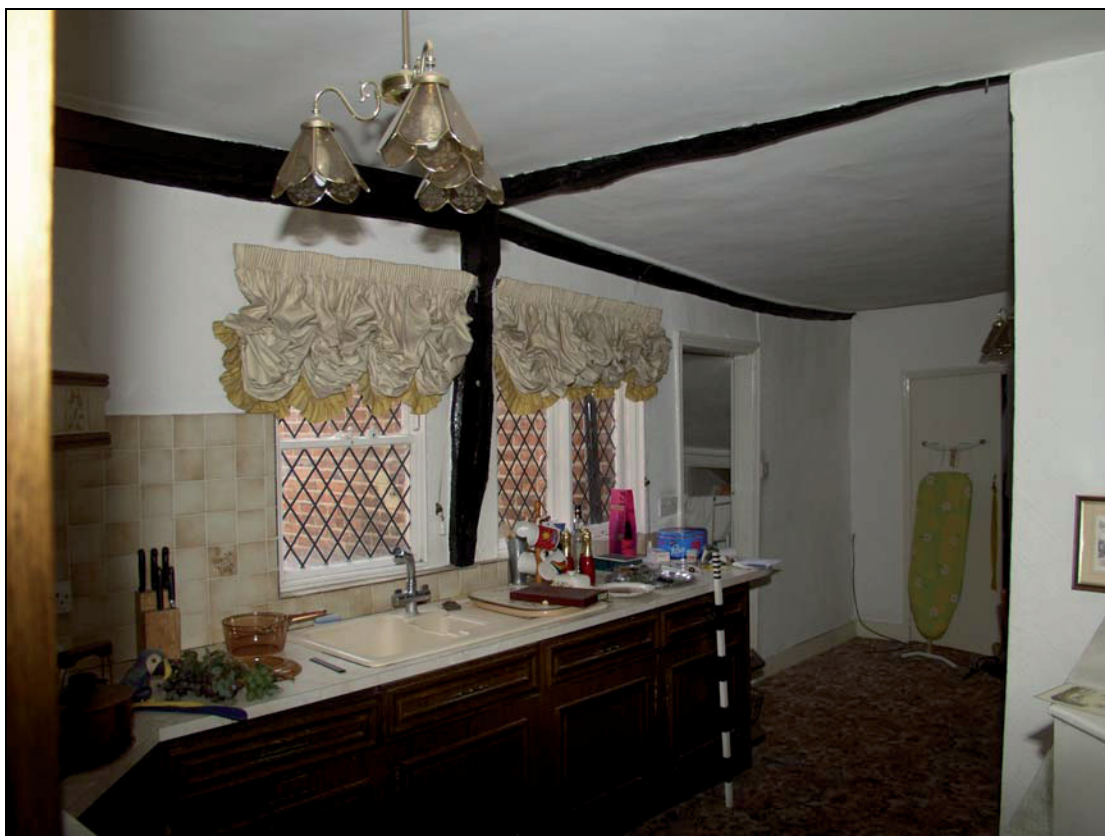
6 The first floor kitchen, room eight, taken from the north-west (29)

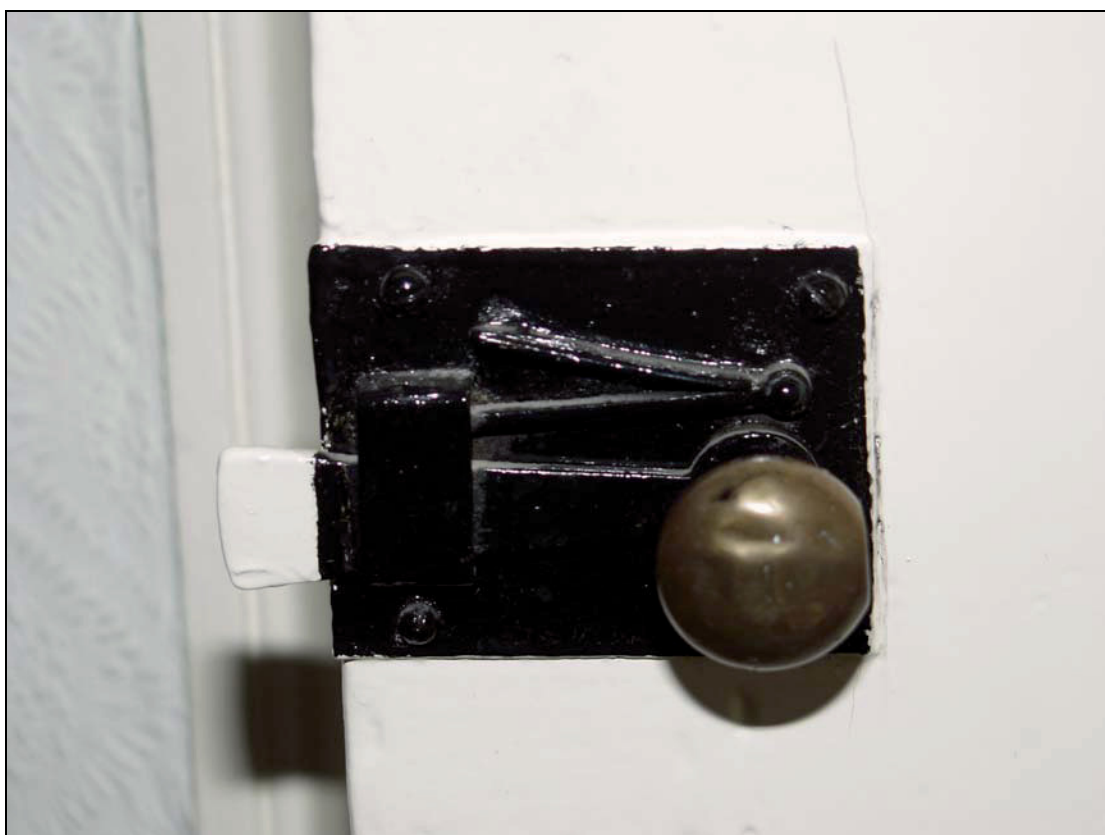
5.2.10 The only fixture of historic note is a door enclosing the staircase to the second floor. This has four wide boards with three nailed ledges to the rear, and blacksmith-made strap hinges, which appears to be 18th century in date. A good original latch mechanism also survives (Plate 7).

7 Detail of door latch to door between room eight and the staircase to room twelve (30)

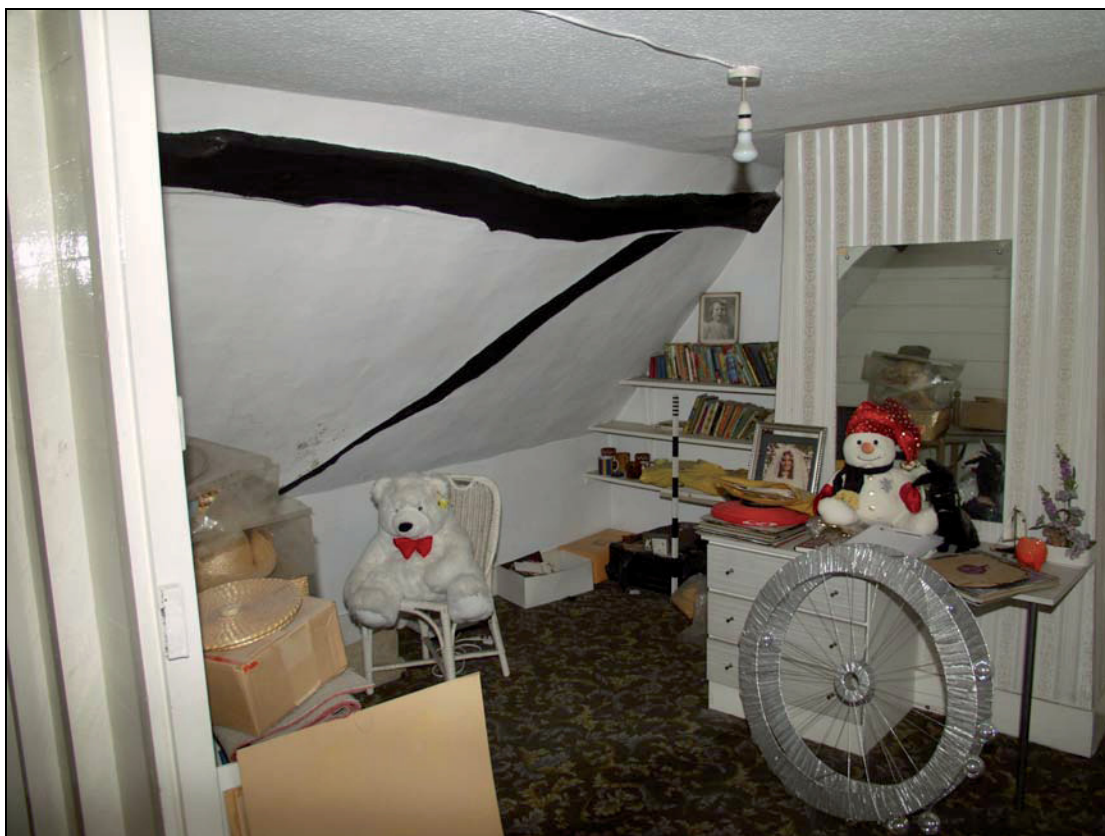
8 The north second floor bedroom, room 11, taken from the north-west (34)

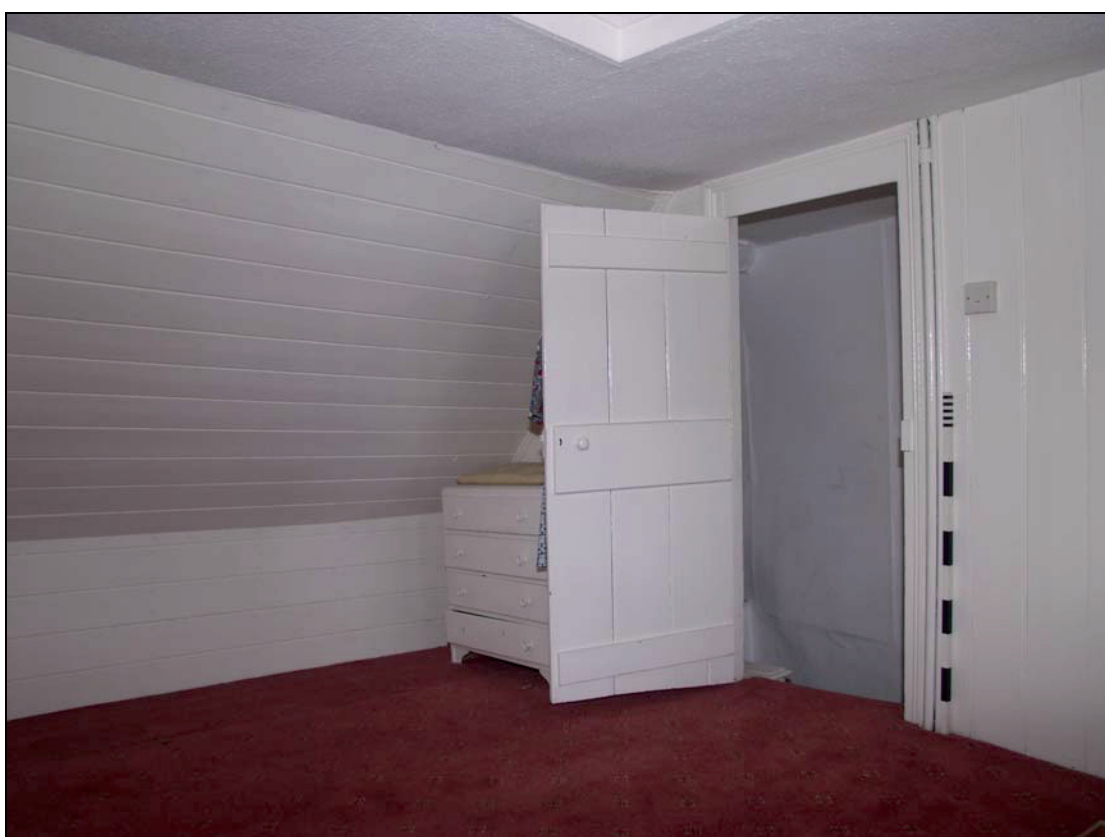
9 The south second floor bedroom, room 12, taken from the north-west (37)

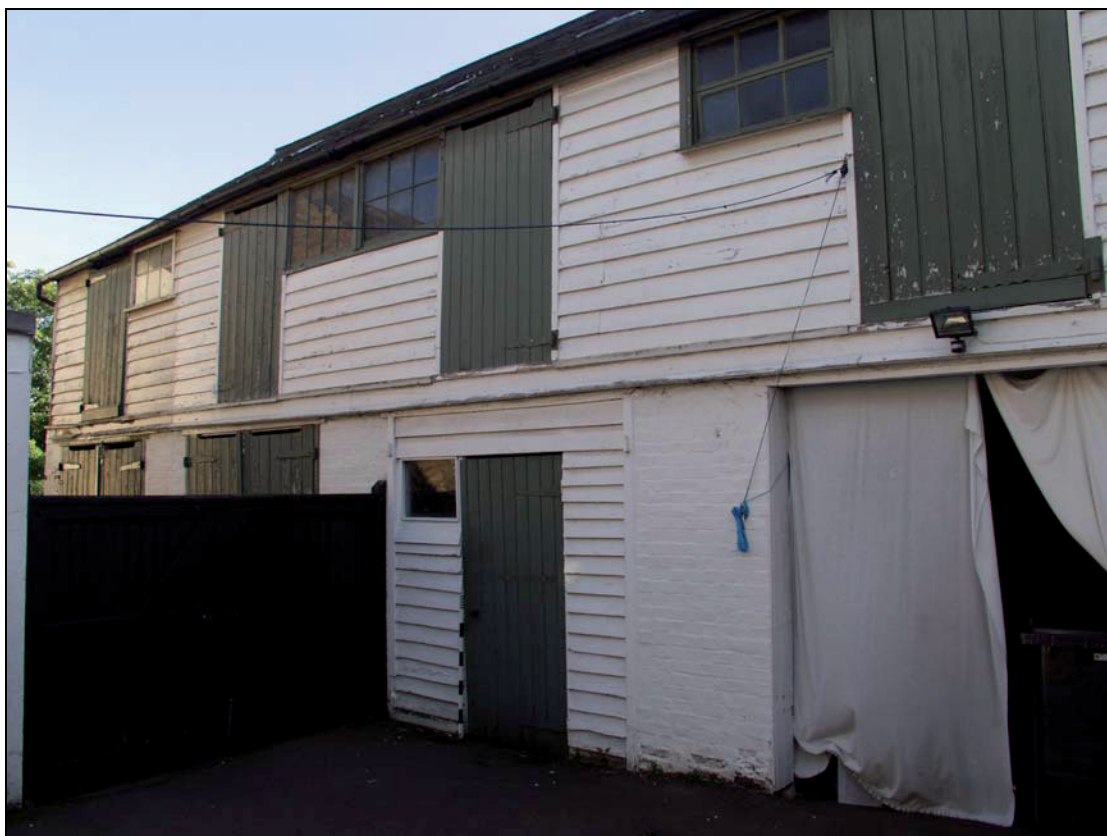
5.4.1 The outbuilding is of fairly modest construction, being of brick with weather-boarded timber above (Plate 10). The west elevation facing the yard was originally pierced by four large double doors for carts or similar vehicles, of which two remain. A third has been reduced in size to a single leaf, while the fourth has been removed, and is now open. The upper storey similarly frames four doors, set centrally over their lower counterparts, with little glazed windows to the side. The doors are vertically boarded and bead-moulded, with decorative hinges on pintles. There are slight variations in the glazing. A slate roof is pierced with rudimentary skylights.

10 West elevation of the cart shed, taken from the south-west (2)

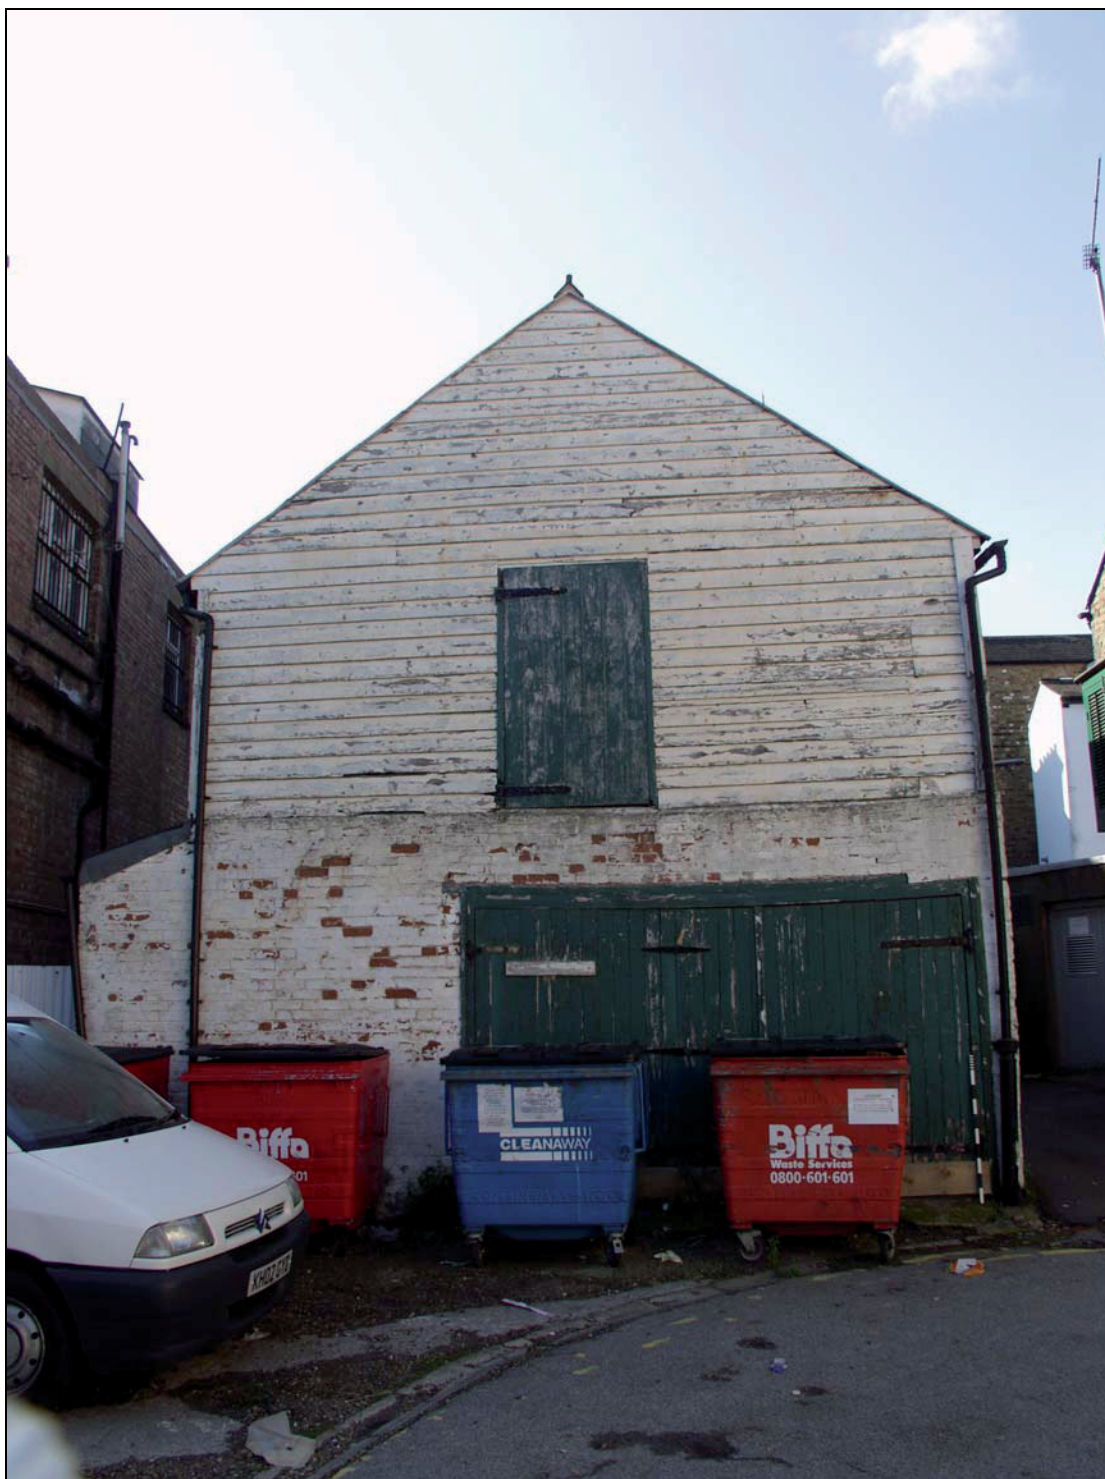
5.4.2 The north gable end is of brick with timber-framing above. A wide door at ground floor may be a later insertion, as the supporting lintel is rudimentary and now sagging (Plate 11). An upper loading door has decorative hinges as seen on the main front.

11 North elevation of the cart shed, taken from the north (4)

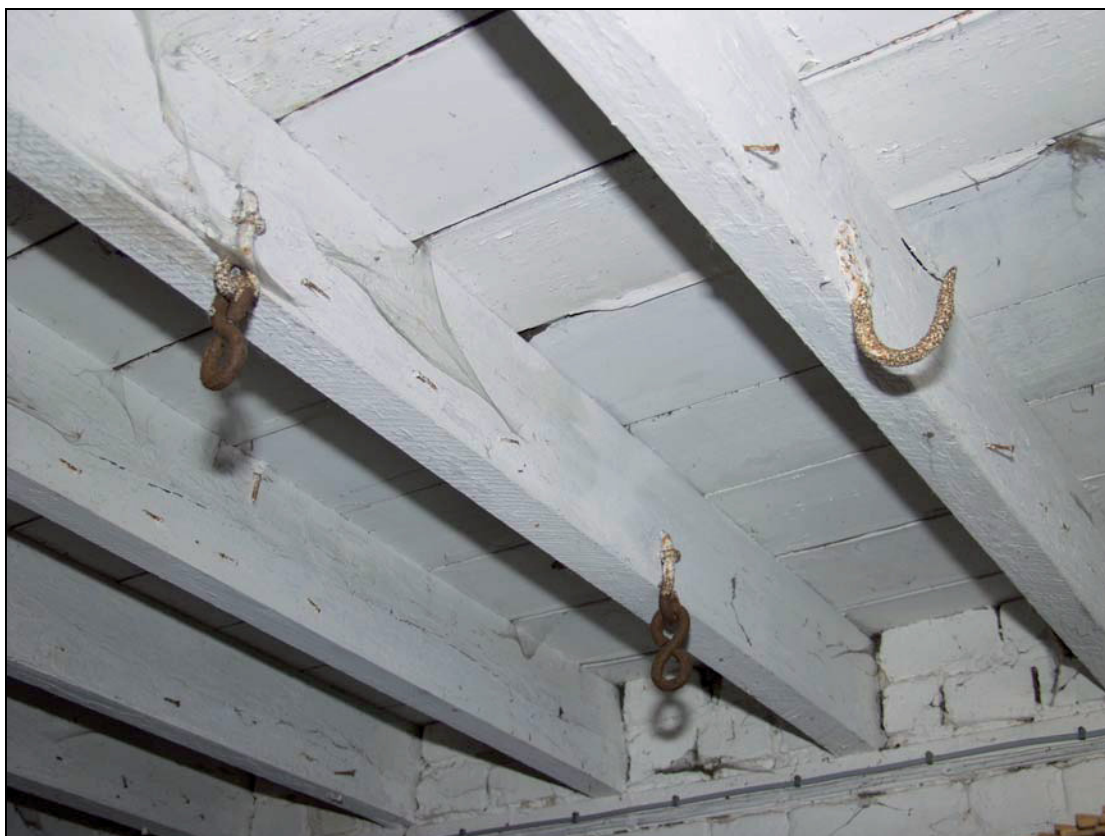
5.4.8 Modification is minor. Cell 1 has lost its front doors at ground floor level and now retains only the lintel as the jambs have been removed. We also see several large metal hooks in the ceiling joists (Plate 12) which may have been used for hanging meat when the property was a grocer's (see section four above and the Historic Photograph below). The ladder aperture with its hatch and fixing hasp survive but the entrance has been relocated to the east with a new vertical ladder. At first floor level the south end gable is not nogged but weatherboarded. The original loading door and

12 Detail of metal hooks on ground floor ceiling of outbuilding cell one (15)

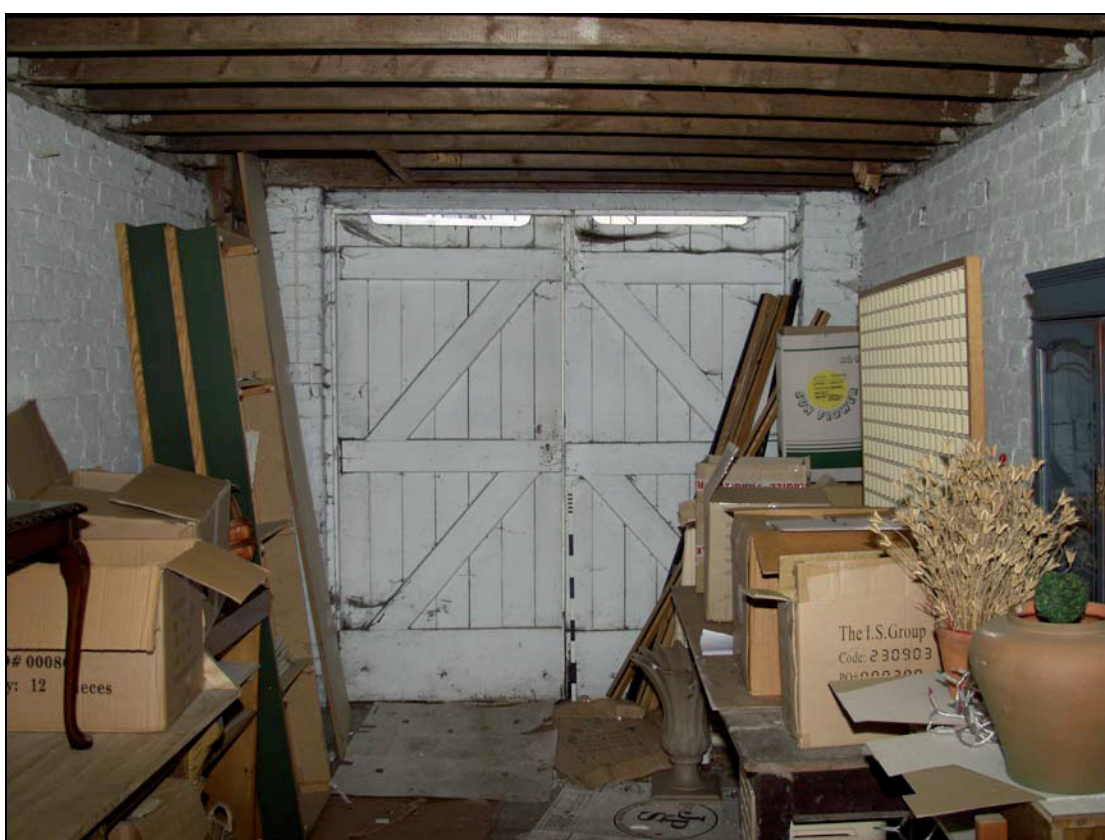
13 Ground floor of cell three, taken from the east (9)

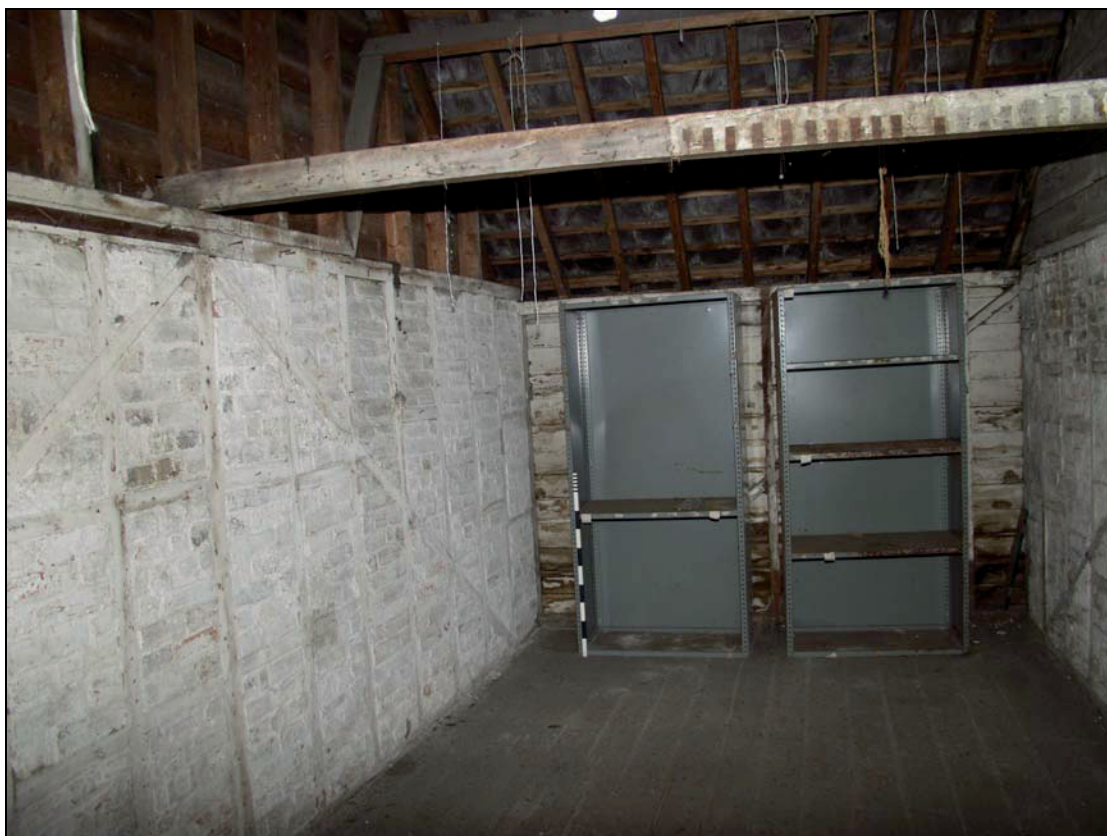
14 First floor of cell three, taken from the south-west (6)

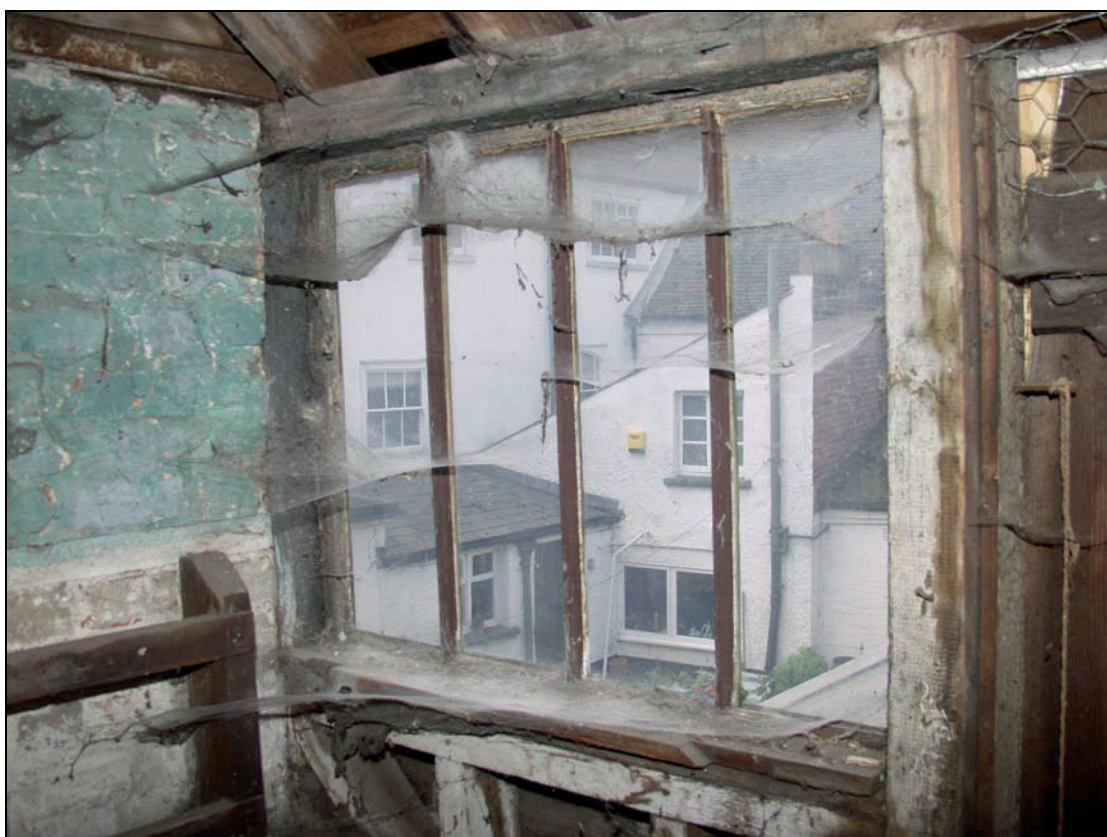
15 Detailing of window of first floor to cell three, taken from the north-east (8)

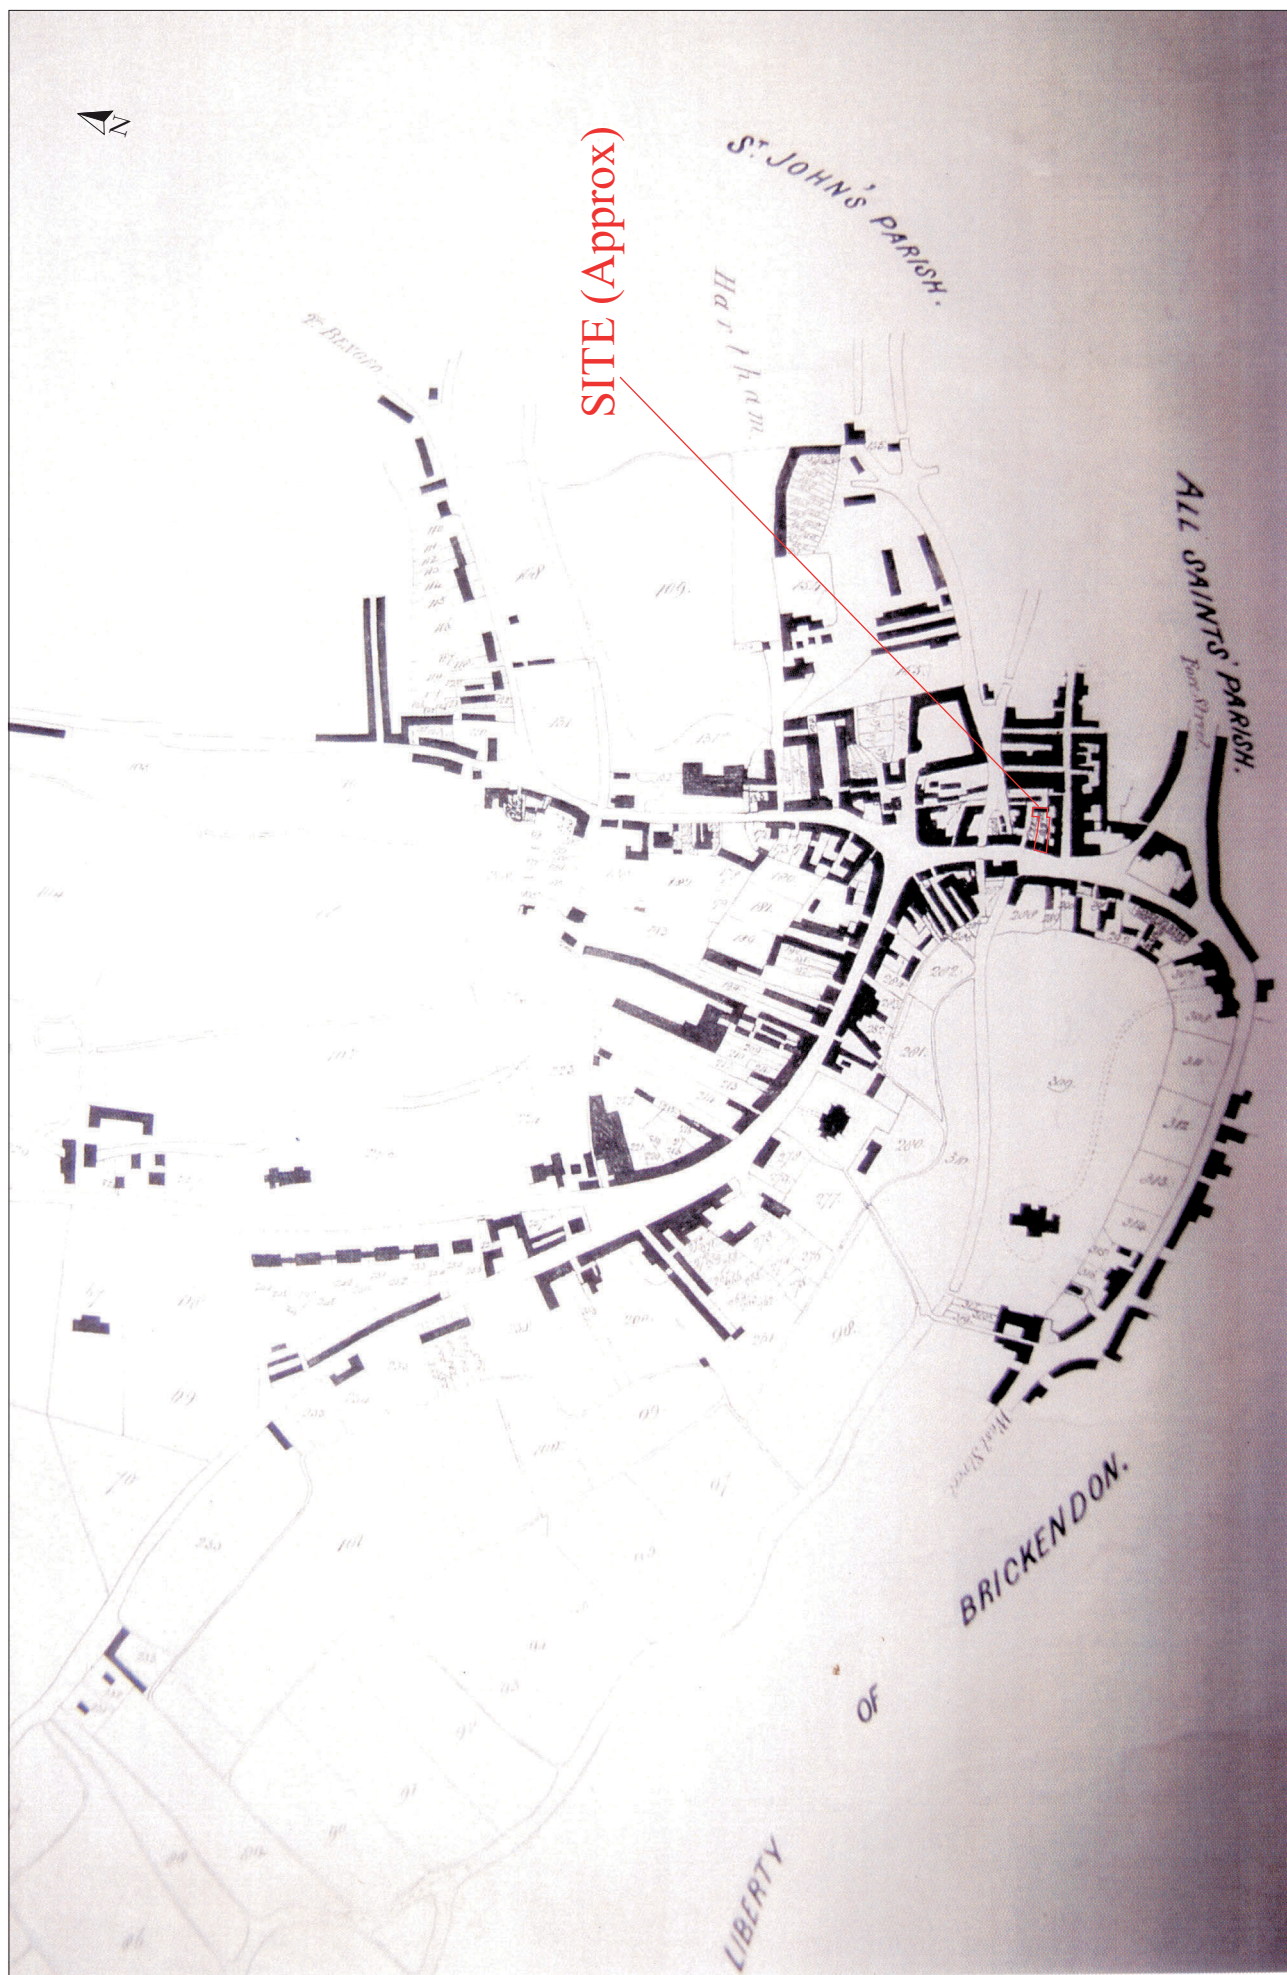
Fig. 3 St Andrew tithe map, 1838

4.2 The tithe map for the parish of St Andrew, Hertford, of 1838, shows the two main buildings to the street along with the main outbuilding to the east. The smaller connecting outbuilding to the south is present but it does not appear to stretch right to the east of the yard as it does today (Fig. 3). Also, by contrast with the site as it is today, the rear yard area is divided into two separate small pieces of land. Both are described in the attached Tithe Award as being owned by the Marquis of Salisbury and in use as flower gardens. The garden attached to No. 10 was occupied by Charles Stevens, while the garden attached to No. 11 was occupied by George Harding.
