**10-12 THE WASH, HERTFORD,
HERTFORDSHIRE**

HISTORIC BUILDING APPRAISAL

Authors: Matthew Williams MA MSc Lee Prosser BA PhD	
NGR: TL 3255 1261	Report No. 3148
District: East Herts	Site Code: AS 1162
Approved: Claire Halpin MIFA	Project No. 3240
Signed:	Date: September 2008

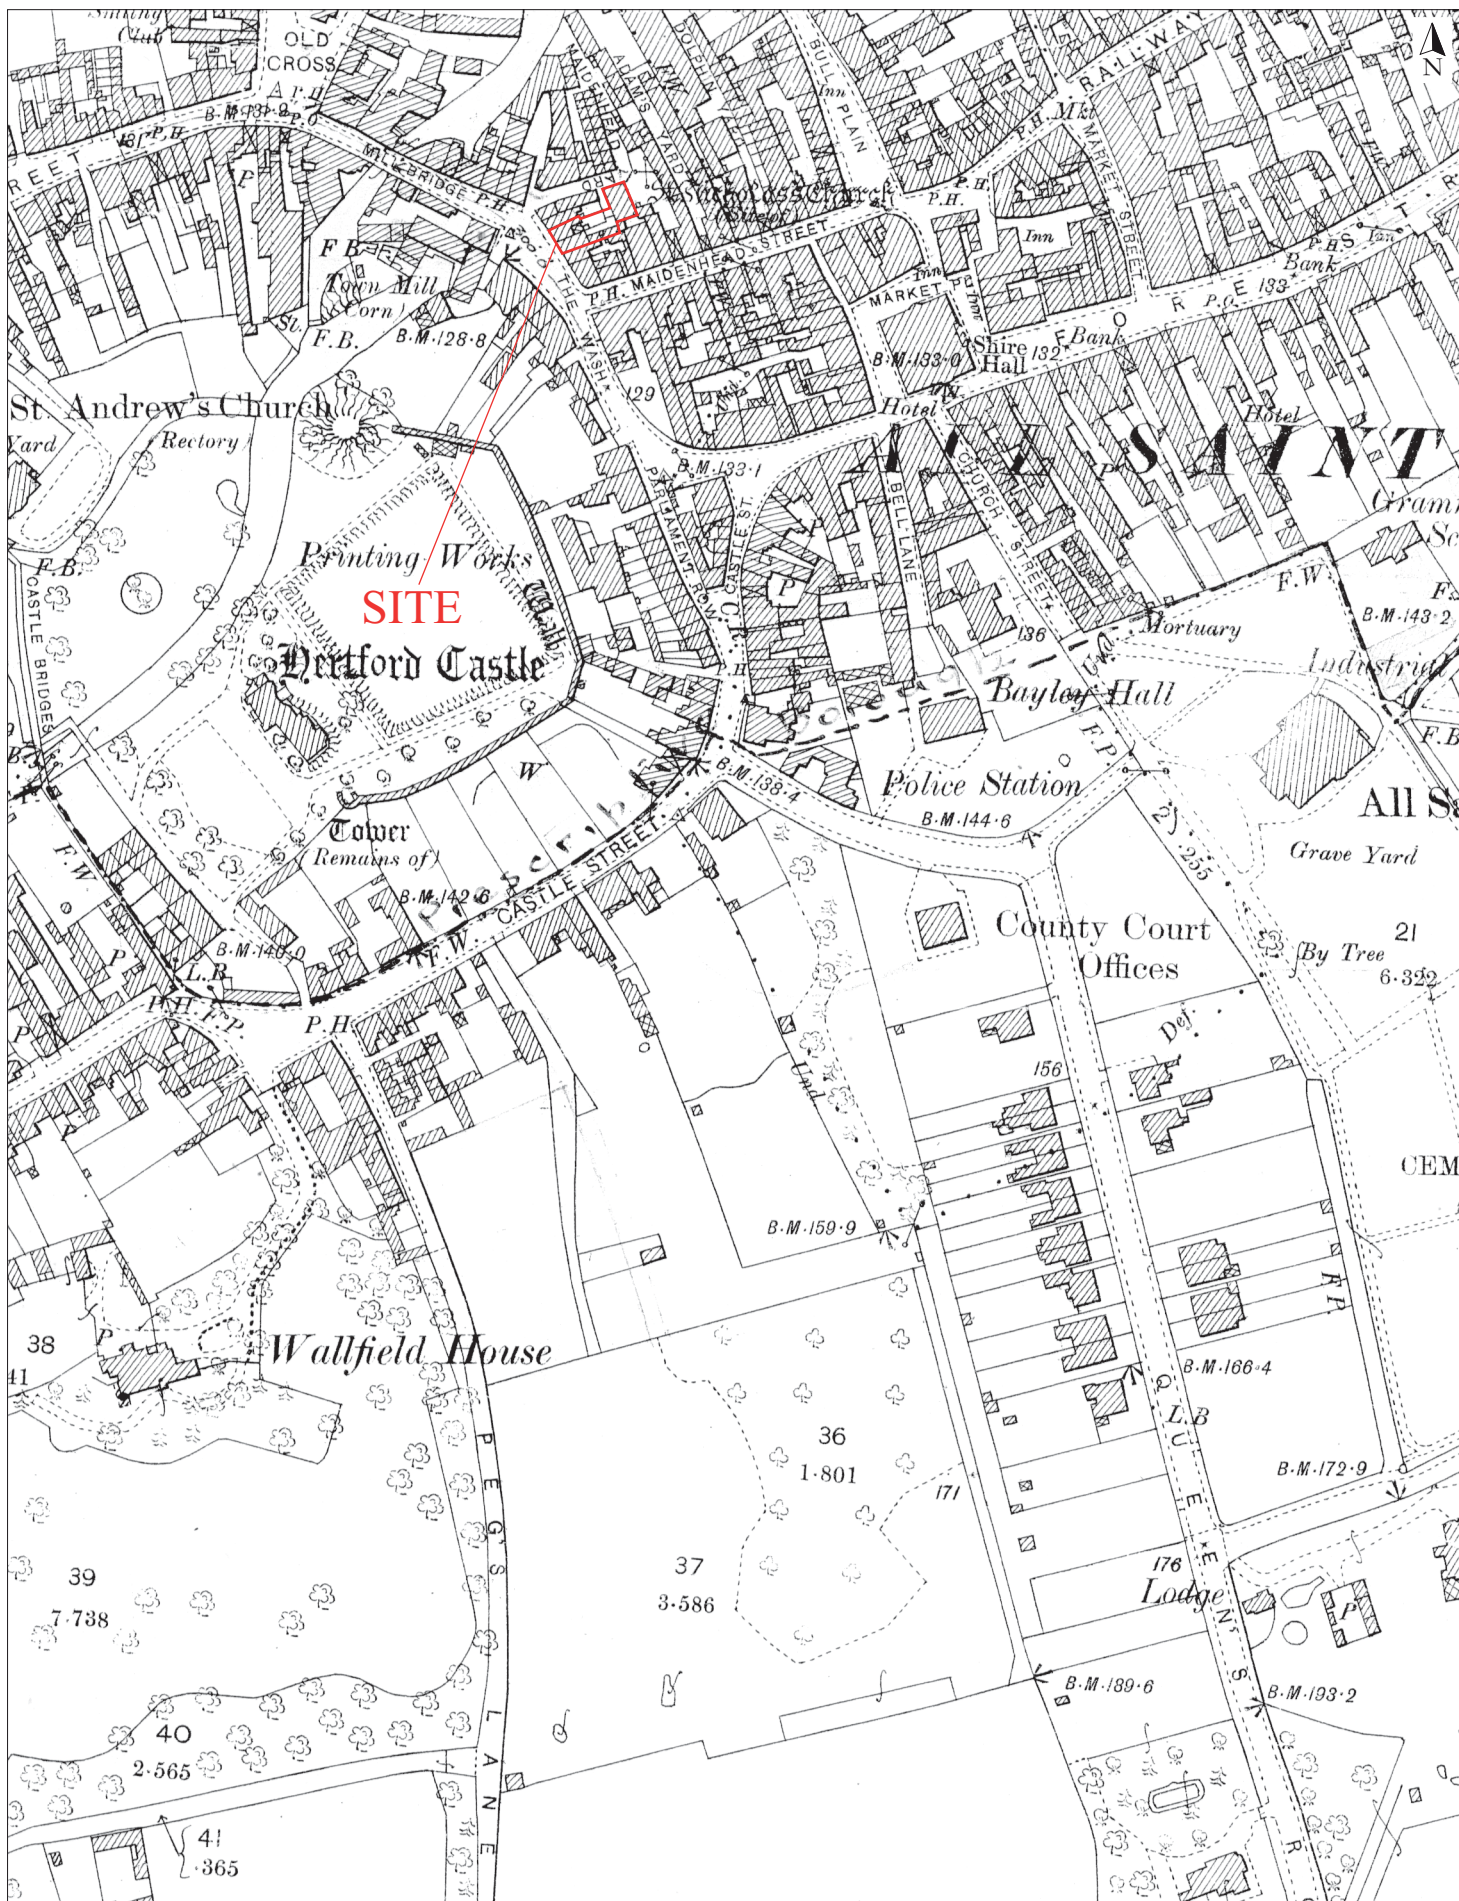
Archaeological Solutions Ltd
Fig. 4 2nd edition OS map, 1898
Scale 25 inch to 1 mile at A4

4.3 The site is also visible in the second edition Ordnance Survey map of 1898 (fig. 4). At this time the yard remained subdivided but the smaller of the two

outbuildings had assumed its present enlarged form by that date. In addition a cross-hatched area to the rear of No. 12 suggests the presence of a small greenhouse or similar covered glass area. By the time of the Ordnance Survey map of 1963 (Fig. 5) the site appears to be exactly as it is today, the two yards having been amalgamated.
